# HISTORIC BUILDING RECORDING

## Barn at Hill Top Farm, Aldwark, Derbyshire

ARS Ltd Report No: 2025/021

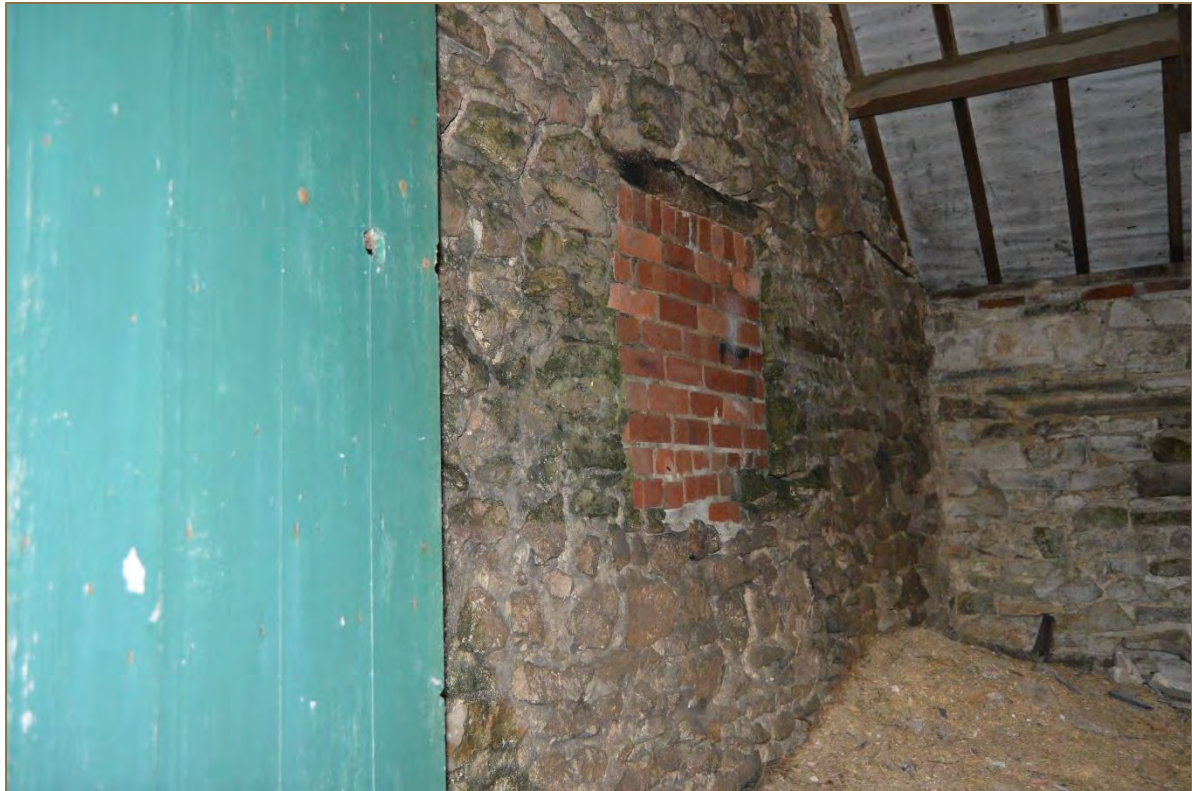
- 6.4.7 The easternmost first floor hayloft space (G1) is accessed via the stone stairs at the north east corner of the building. The stone east gable wall internally has a brick blocked window aperture (**Photograph 52**). Above, is a pigeon/poultry loft constructed from timber (**Photograph 53**). The un-plastered north and south walls of barn interior feature the structural tie stones observed externally. The first floor space across the whole of the building is open to the roof, which features rafters sat on purlins, some with collars, comprised of machine cut timbers (**Photographs 54**). These repair timbers support the later 20<sup>th</sup> or early 21<sup>st</sup> century clay tile roofing and waterproof membrane sheeting above. The west, internal dividing wall had a doorway adjoining the next room (leading to F2 which could not be accessed due to the condition of the floor). The flooring of the first floor is comprised of marine plywood. (**Photograph 55**).

*Photograph 52: Internal view of the east gable wall within the first floor of the barn. Note the bricked-up aperture formerly in the east elevation (looking south east). (File: HBR\_255)*

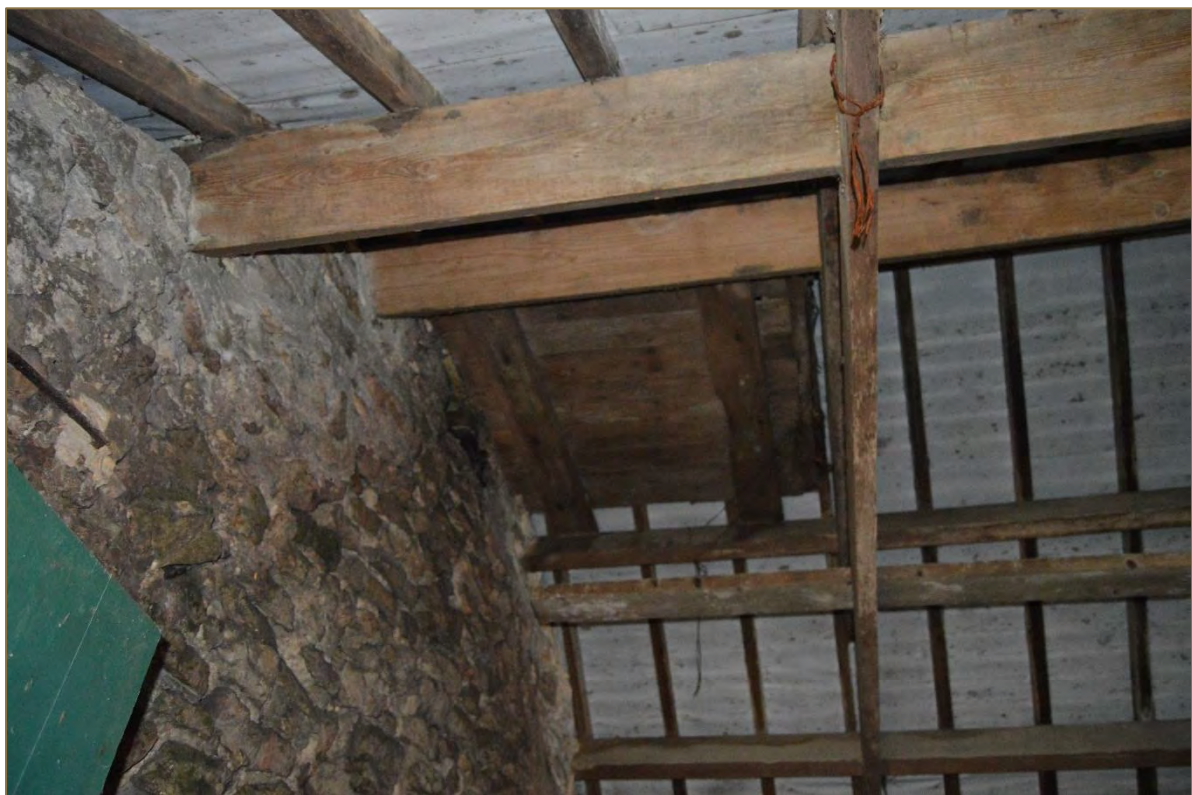
*Photograph 53: View of the poultry/pigeon loft accessed via the east gable wall within the first floor of the barn (F1) (looking south). (File: HBR\_257)*

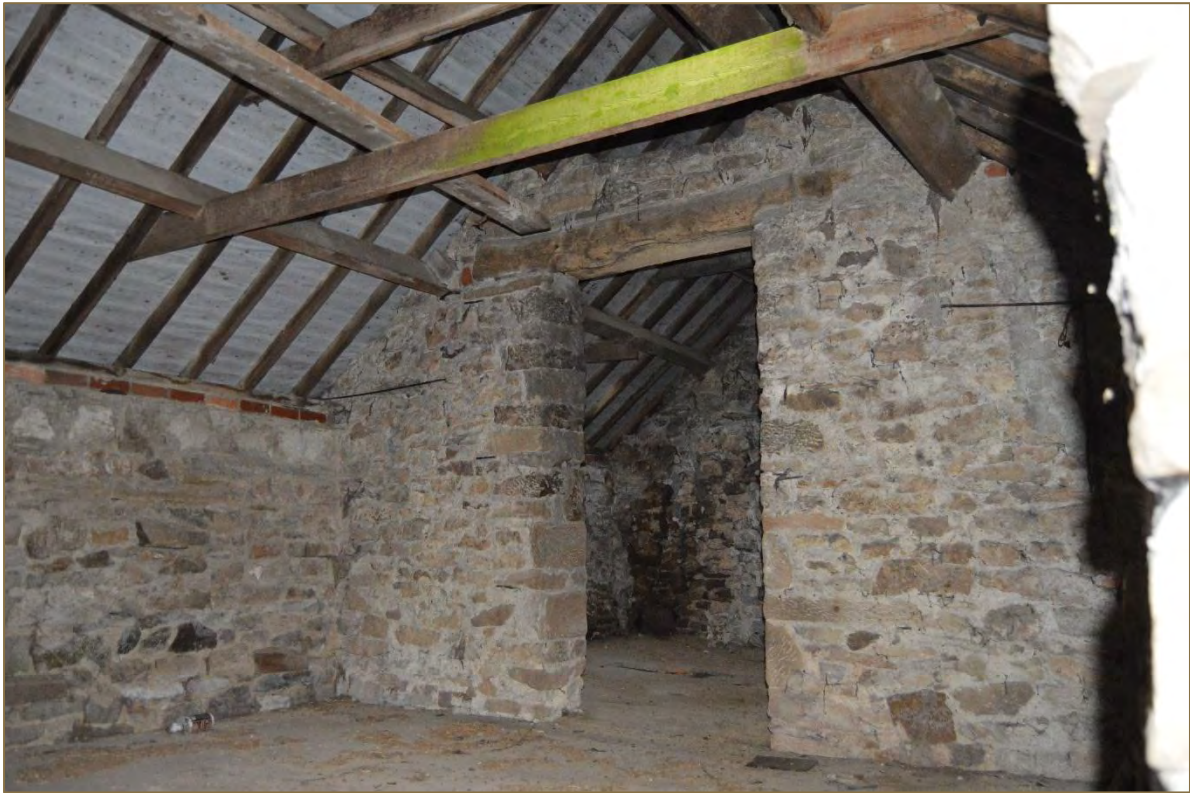
*Photograph 54: View of west dividing wall with access to the adjoining room (F2) on the first floor of the barn. (File: HBR\_252)*

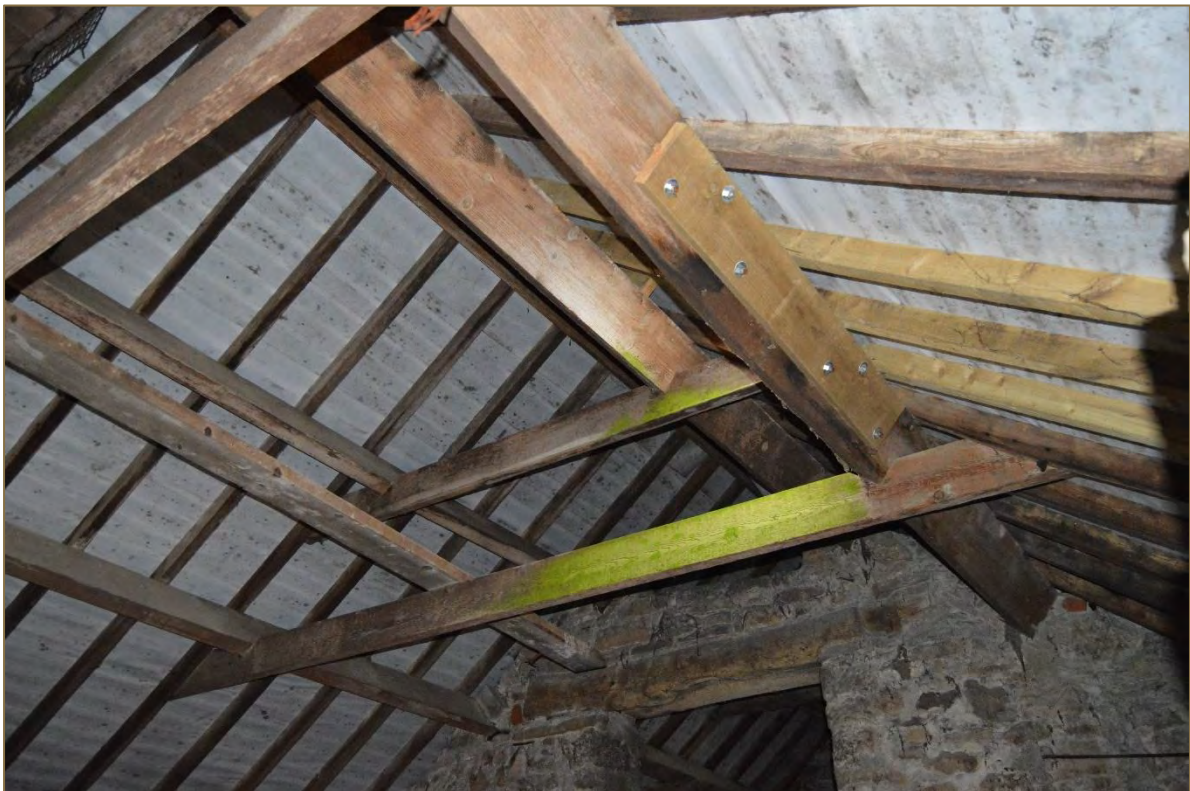
*Photograph 55: View of the roof structure over the first floor hayloft (F1) of the barn (looking south west). (File: HBR\_258)*

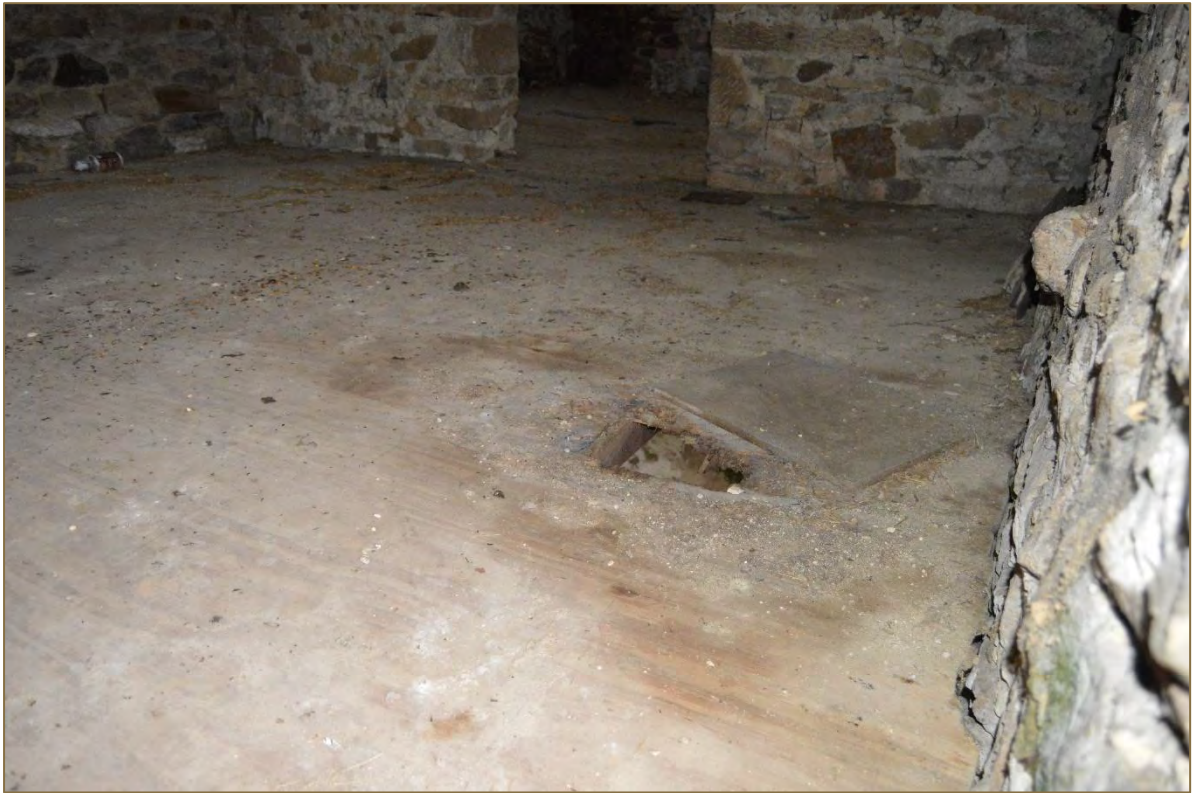
*Photograph 56: View of the plywood flooring of the first floor hayloft (F1) of the barn and through into the next room (F2) (looking south west). (File: HBR\_254)*

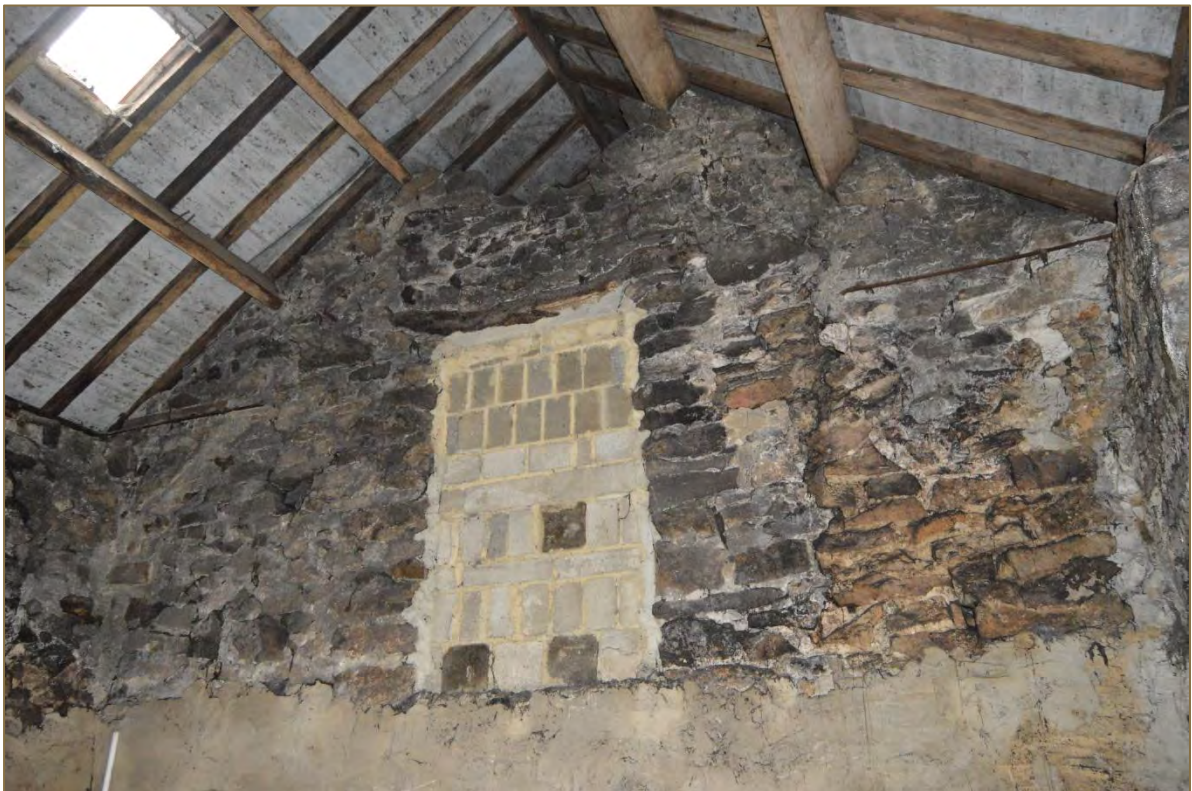
- 6.4.8 Moving west, the next two first floor spaces (F3 and F4) were devoid of flooring—indeed the easternmost retained no flooring or joists at all. Infilled joist slots however could be observed in the east and west walls along with a clear delineation of the wall surfaces finishes between the levels. In the upper portions of the eastern first floor wall there is an internal doorway blocked with modern, cement blocks (**Photograph 57**). Equally, this wall retains further indications of having undergone some alteration over time. The northernmost first floor wall of the space comprises a central pitching door, with ledged and braced timber plank door (**Photographs 58**). The opposite, south wall is devoid of architectural features. The eastern, first floor wall of the space features an open doorway aperture, with timber frame, to the westernmost room (F4)(**Photograph 59**).

*Photograph 57: View of the east dividing wall of the barn's non-extant first floor level, F3, inside G3 (looking east). Scale 2m. (File: HBR\_164)*

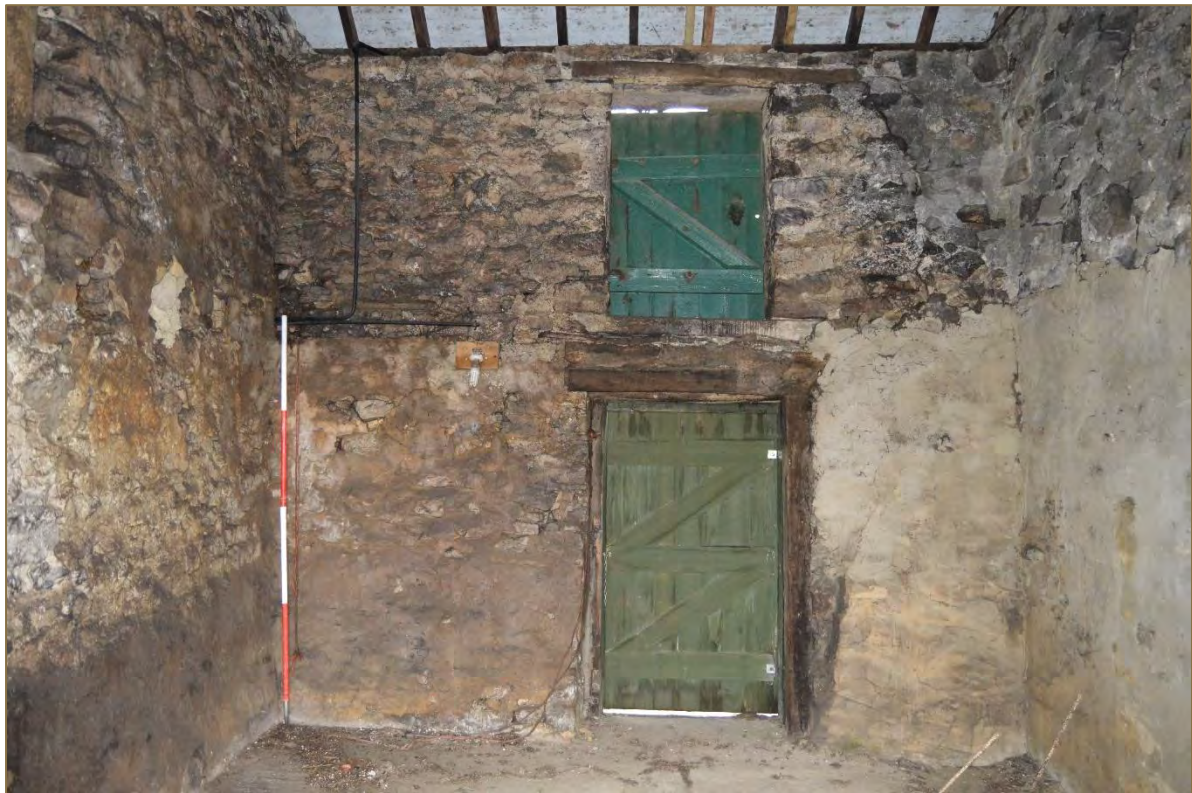
*Photograph 58: View of the north wall of the barn's ground and non-extant first floor level (G3/F3) (looking north). Scale 2m. (File: HBR\_157)*

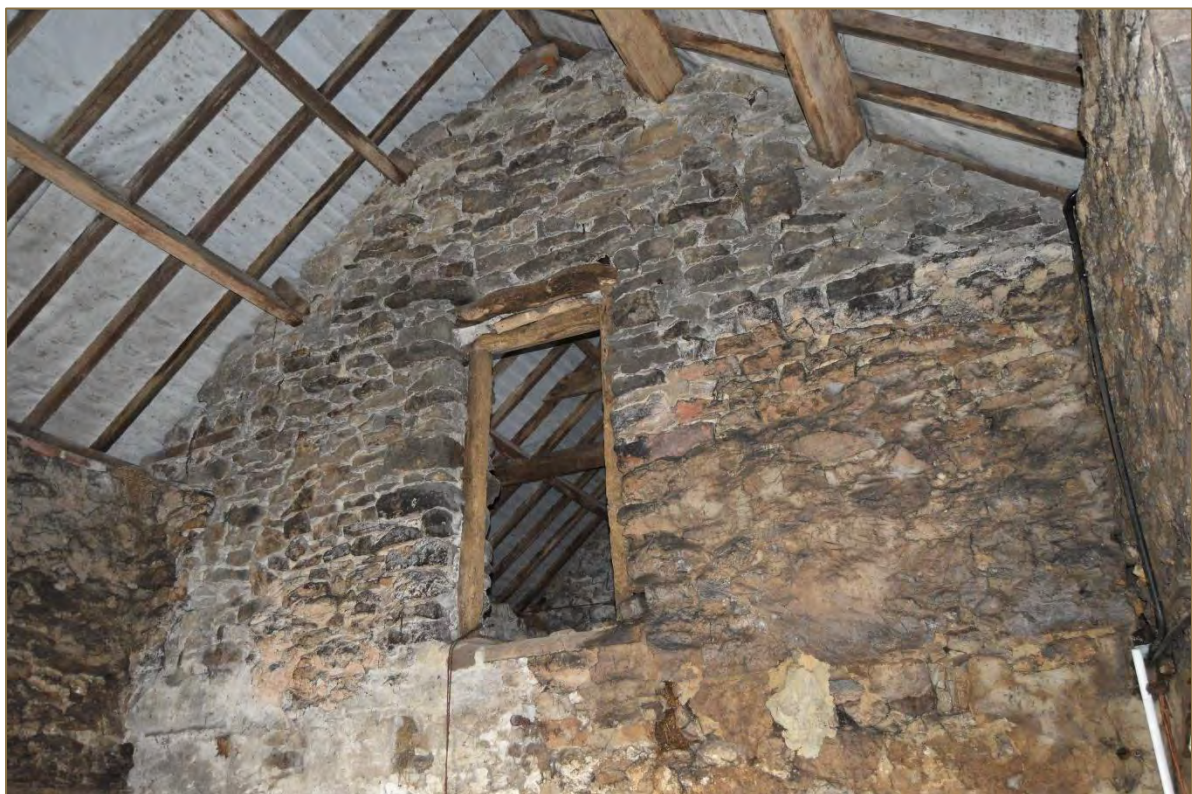
*Photograph 59: View of the west wall of the barn's non-extant first floor level (G3/F3) (looking west). (File: HBR\_155)*

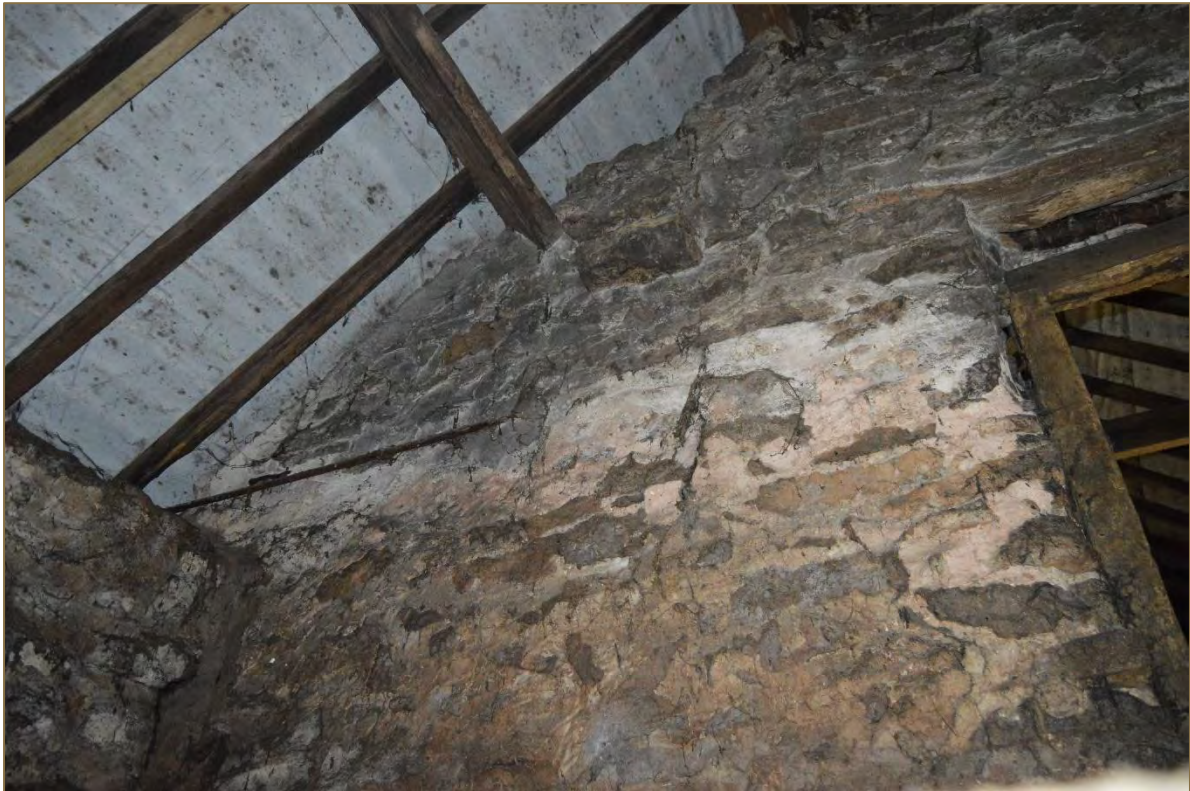
- 6.4.9 The westernmost first floor room of the barn (F4) again did not retain a floor but unlike the previous space, machine cut timber joists remained *in situ*. Again, these areas of the building had undergone modern repair. The eastern wall of the barn at first floor level features a central timber framed doorway aperture, with internal timber lintel, open to the next room (F3)(**Photograph 60 and 61**).

*Photograph 60: Restricted view of the barn's first floor eastern wall from the ground floor room (G4/F4)(looking east). (File: HBR\_149)*

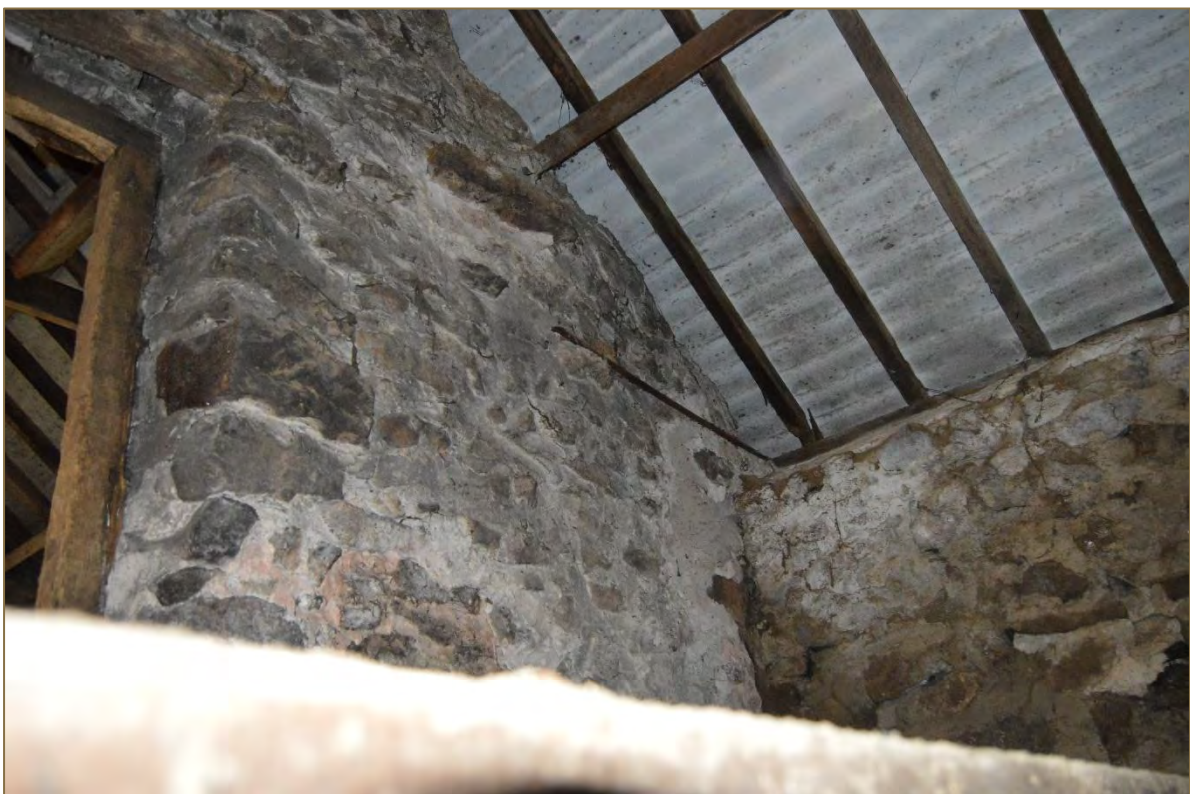
*Photograph 61: Restricted view of the barn's first floor eastern and southern wall from the ground floor room (G4/F4)(looking south east). (File: HBR\_151)*
