**Chatsworth House car park service trench.  
Results of an Archaeological Watching Brief.**

**ARS Ltd Report 2009/2**  
6<sup>th</sup> to 9<sup>th</sup> January 2009

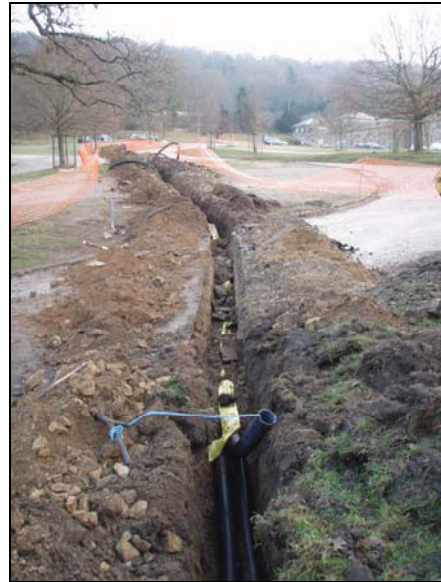
Excavated trench looking east towards  
the stables.

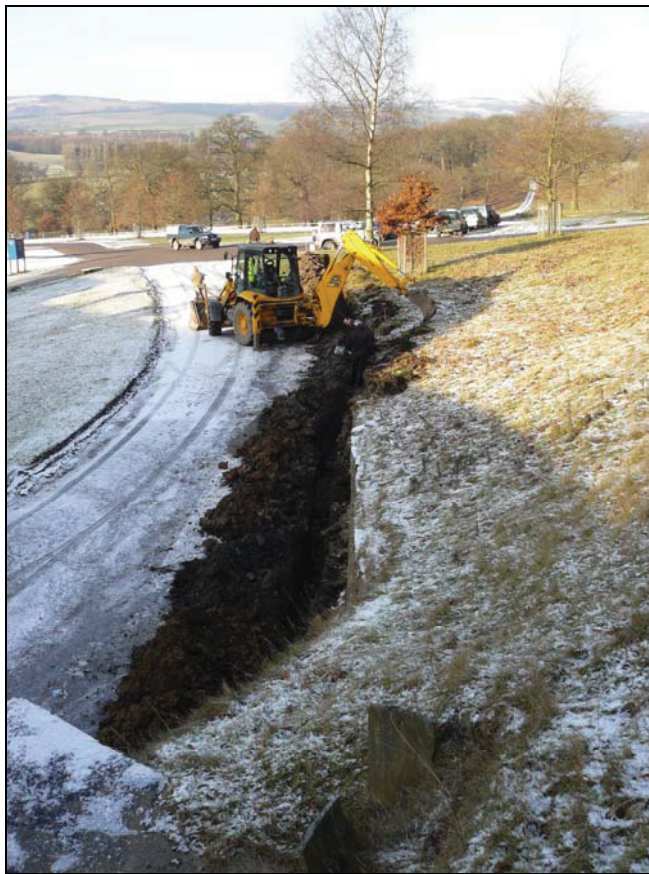
Fig. 3: Trench initial excavation. Facing north-west.

The trench then continued north-west on the grassed bank until a road was encountered. An imported topsoil of 150mm depth (004) was removed from the bank; this directly overlay the re-deposited clay (003) which was excavated to a depth of 0.6m at this location. Excavation into the bank exposed service pipes of gas, water and communication cables running east-west across the trench.

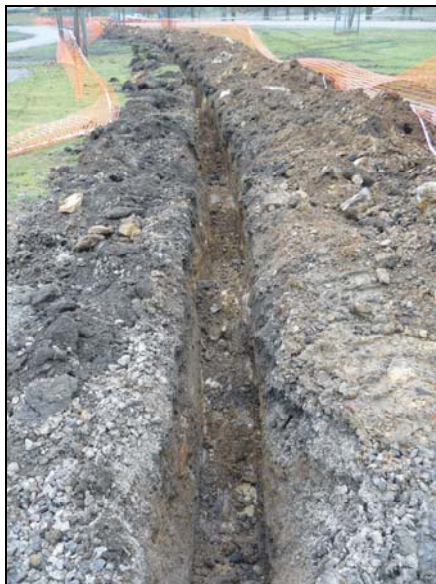
Fig. 4: Trench in managed grassland  
Facing west.

From the road crossing the trench continued north-west along an area of managed grassland, now excavated to a depth of 0.7m. Sandy topsoil (007) covered this area to a maximum depth of 0.2m and directly overlay natural

sandstone bedrock (006) (Figs. 4 & 5). Made ground was excavated above the bedrock approximately 60m from the compound, through two metalled tracks (009), a road (001) and banking (008) of the enclosure which housed the compound.
