George Street, Glossop, Derbyshire

**Report on an
Archaeological Evaluation.**

ARS Ltd Report No. 2009/63
February 2009

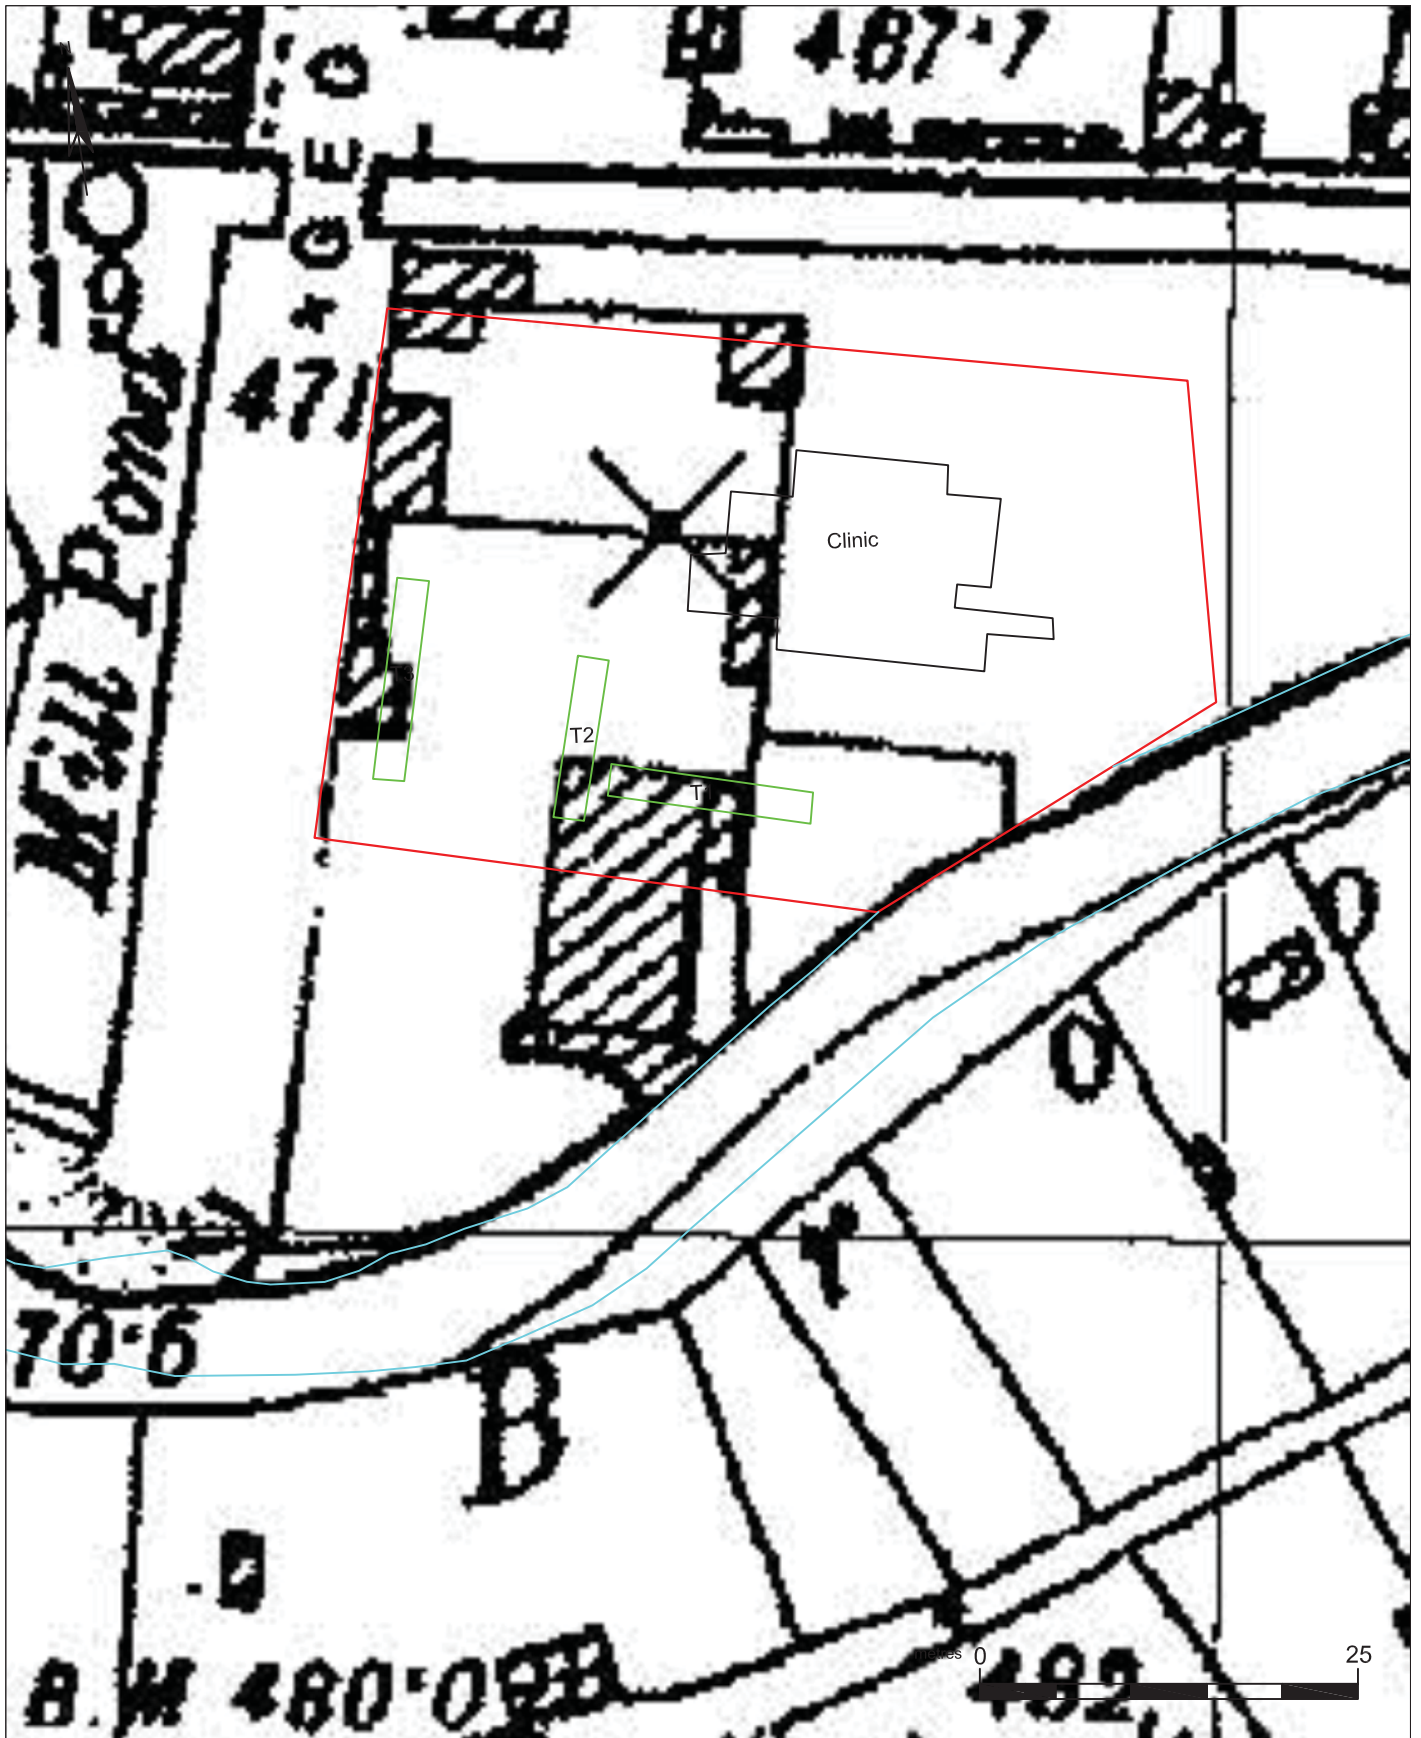
Figure 2.
 Site plan showing the location of the trenches in relation to the Ordnance Survey Map 1st Revision 1893-1915

- 5.1 The archaeological evaluation took the form of three test trenches, approximately 13m by 2m, and labelled 1 to 3 from east to west. Trench 1 was orientated along an east west axis while trenches 2 and 3 ran from north to south. The location of each trench can be found on the overall site plan (Figure 2) and were situated with the agreement of the DCA in order to maximise the chance of encountering any archaeological features of significance with reference to the supposed position of the constituent buildings of the iron foundry as recorded in maps of the site. Trenches 1 and 2 were therefore located in an attempt to capture elements of the supposed main building of the iron foundry while Trench 3 was located in order to capture aspects of the building or buildings fronting onto George Street.

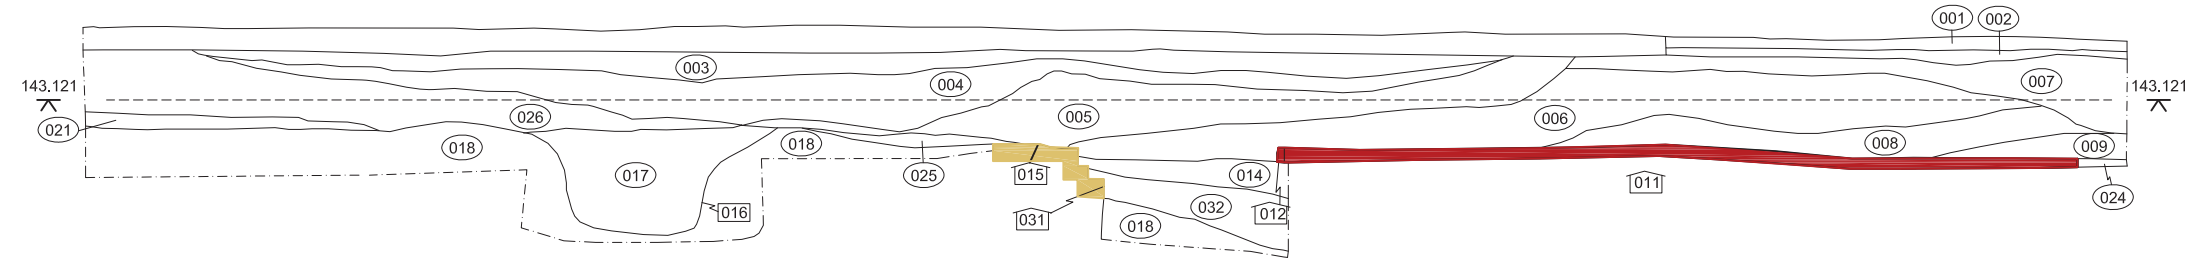
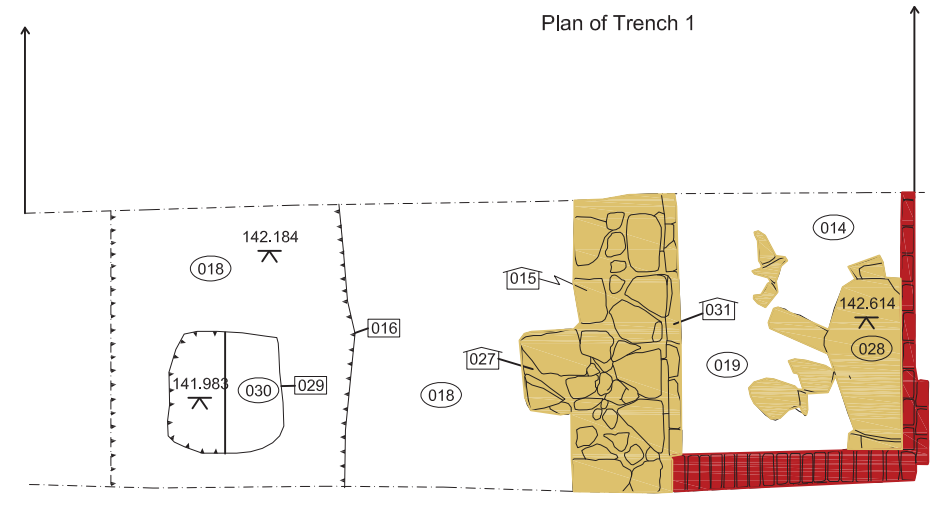
Figure 3 (Bottom) Drawn plan of Trench 1.
 Figure 4 (Top) Drawn South facing section of Trench 1.

South facing section of Trench 1

Plan of Trench 1

Plan of Trench 1 showing earlier level of archaeology

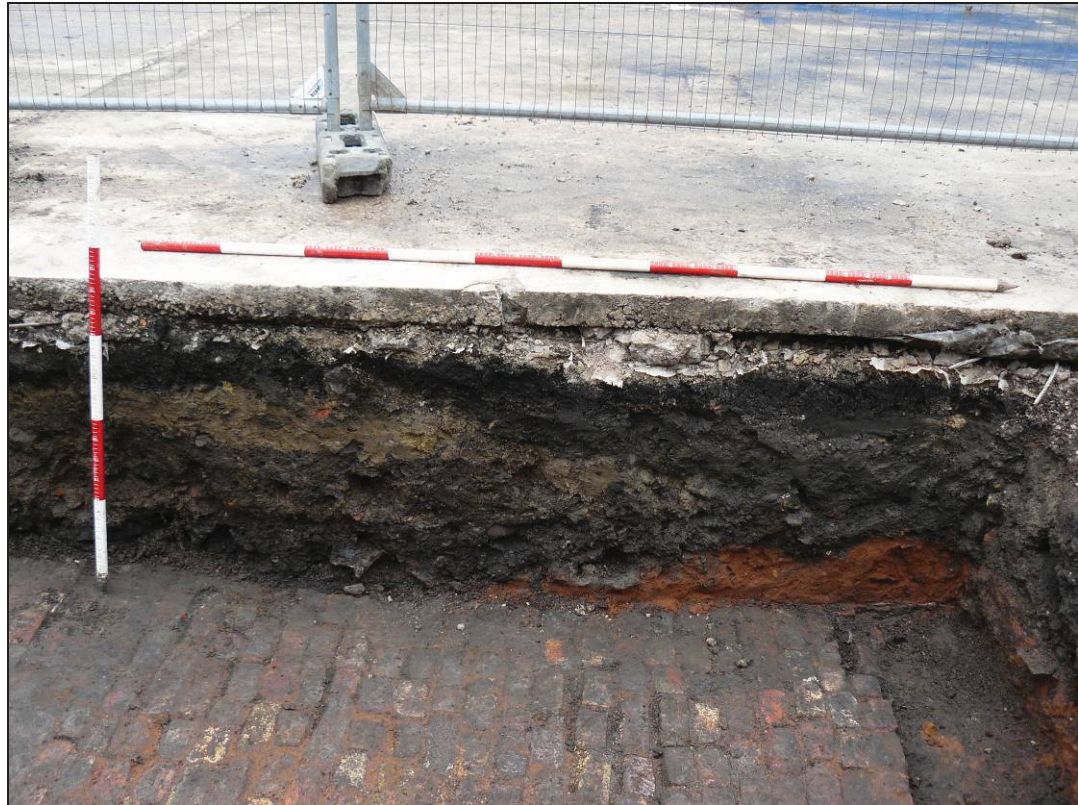
Figure 5. Deposits limited to the east terminus of the south facing section of Trench 1.

- 6.1.5 Overlying the series of deposits limited to the eastern and western section of the trench was a series of three distinct deposits that extended across much of the length and width of the trench (Figure 6). These consisted of deposits 003, 004 and 005 all of which mainly comprised of a large clinker component with variable amounts of red brick, sandstone and other demolition debris. 004 separated the two virtually identical black deposits of 003 and 005 and could be distinguished by a greater component of what appeared to be red dust, presumably derived from the demolition or crushing of red brick. These deposits appeared more extensive within the north facing section of the trench where the underlying sequence of deposition towards both the east and west end of the trench were less extensive.

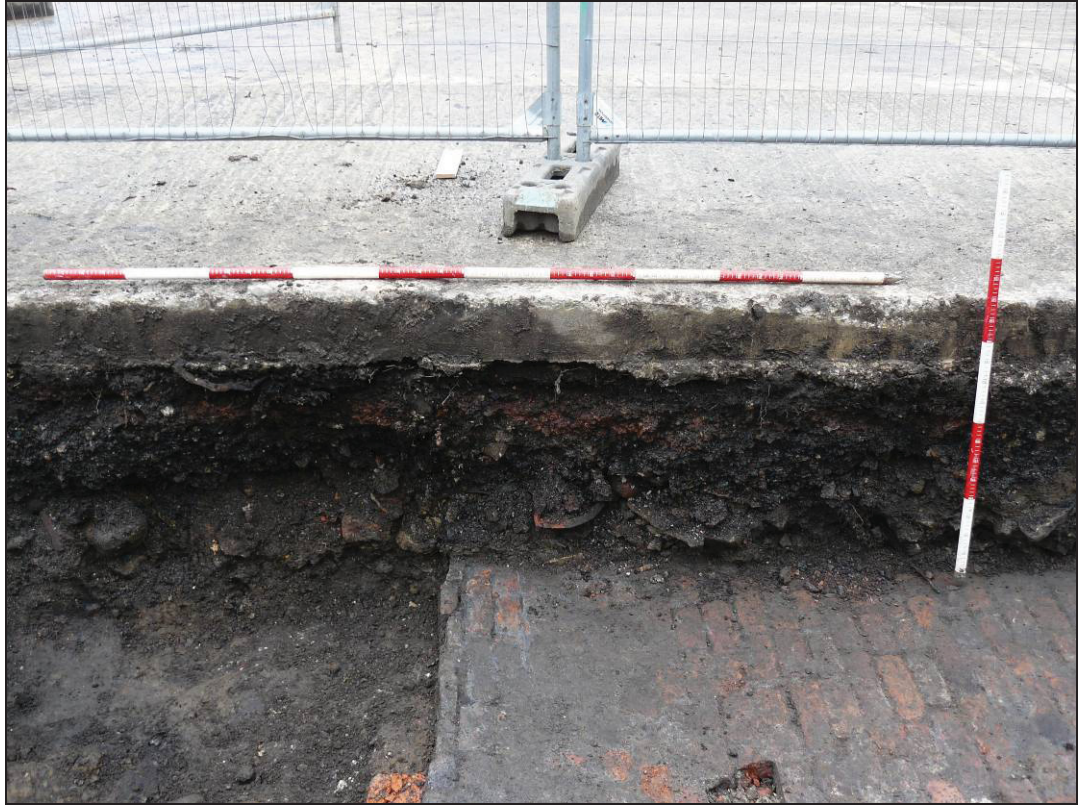
Figure 6. Deposits central to the South facing section of Trench 1.

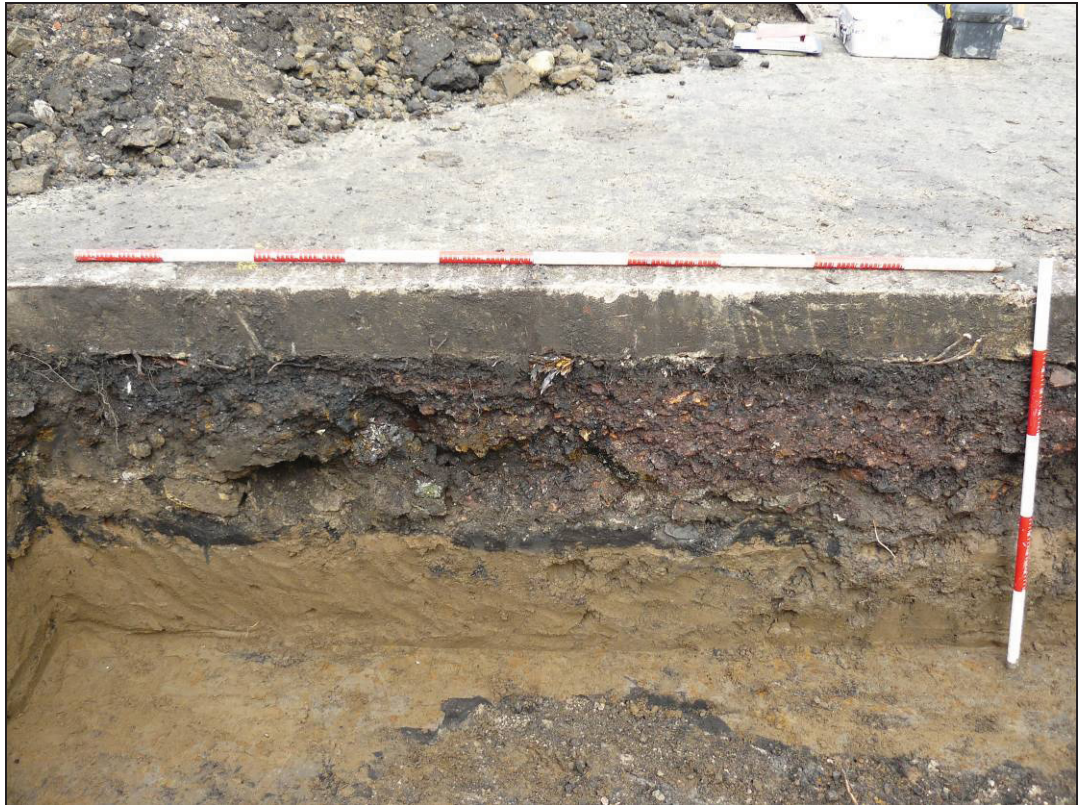
Figure 7. Deposits limited to the western terminus of the South facing section of Trench 1.

- 6.1.6 Towards the western terminus of the trench a further series of two deposits were observed below those described in 6.1.5 (Figure 7). The deposits extend east into the trench for approximately 4.7m and continue west beyond the limit of excavation where they appeared to correspond with similar deposits encountered in Trench 2. Upper most of the two deposits was context 026, which can be seen to reduce in thickness and increase in depth from west to east where it appeared to be relatively indistinguishable from, and may well be the same as, context 017, the fill of a cut feature (016) located to the east (detailed below). It also appears to correlate with deposit 204 visible as a discrete spread of material in plan (Figure 12) along the eastern edge of wall 207 and visible within the west facing section of Trench 2 (Figure 13). Here the deposit has been interpreted as a demolition layer due to the high content of sandstone and mortar fragments and it would appear that the deposit was

- 6.1.7 Below much of 026 a black silty sand deposit, context 021, extended east from the western trench terminus for a length of approximately 2m in both the north and south facing section. It obviously extended further west beyond the limit of excavation and potentially into Trench 2 where it appeared as a much thicker but identical deposit, context 205, recorded in both plan and west facing section. Here the deposit appeared to sit within a distinct cut [219] which extended east into section but no return edge was located further east within Trench 1. Context 021 terminated before the western edge of cut 016, however, the presence of context 025, identical in colour and consistency to 021, extending for a further 1.4m beyond the eastern return of 016, may indicate that the deposit originally continued as far as wall 015. It would therefore appear that the deposit represented by 021/205/025 is framed to the west by wall 207 in Trench 2 and to the east by wall 015 in Trench 1. As 021 directly overlaid the first natural level (018) and was confined between the east and west return walls of potentially the same structure, it may well represent an initial floor horizon or at least a levelling deposit for one. The deposit is also identical to the fill of a series of features cut into the natural, observed in plan and section within Trench 1 and possibly in plan within Trench 3. These are detailed separately below.

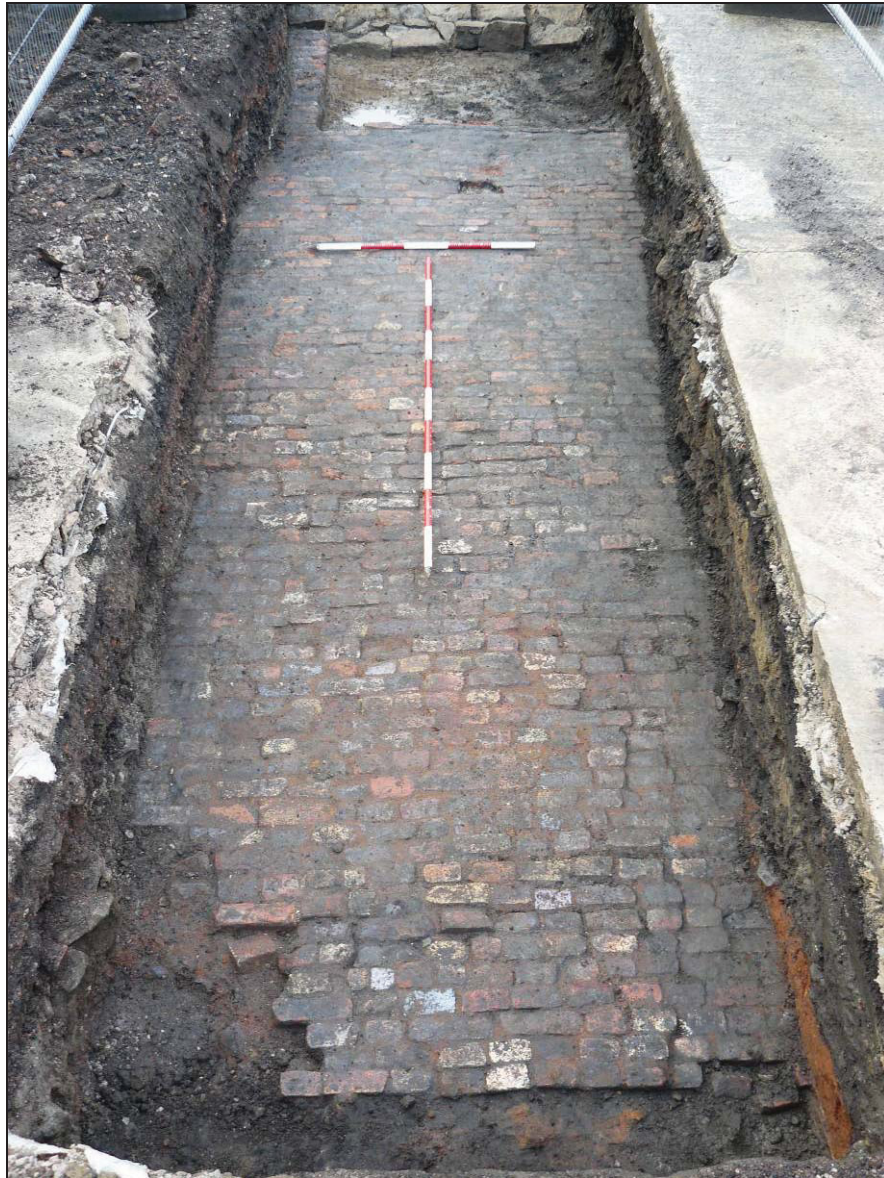
Figure 8. Floor 011 viewed facing west.

- 6.1.10 The floor consisted of mostly handmade non-frogged red brick, with individual dimensions varying but approximately 0.23m by 0.11m and 0.07m thick, and occasional fire brick additions. The fire brick additions appeared in a relatively random fashion within the various courses that comprise 011 and may well represent episodes of repair to the floor. The overall structure was laid out in the form of up to 86 courses in a single skin laid horizontally. The coursing appears in sections to be set

in a header and stretcher fashion although across much of the surface this appeared to break down into a more random pattern. The only bonding agent visible was a black ash mortar with occasional white lime inclusions of less than 0.01m in size. The position of the floor relative to the 1880 ordnance survey map depicting the iron foundry would suggest that the surface corresponds with a probable external courtyard area to the east of the main building.

- 6.1.11 The truncation of the floor surface at the north western corner of its extent appeared to be a deliberate feature as both contexts 012 and 013 could be identified as a deliberate lining and terminus to the western extent of the floor in this area. Context 012 represented a single course and single skin of handmade none frogged red spacer bricks, extending from north to south for approximately 1.35m along the western edge of 011. The bricks were set within the same black ash mortar as 011 and individual bricks measured on average 0.13m by 0.11m and 0.03m thick. Context 013 represents a single course and single skin of handmade none frogged red brick extending north to south for 0.87m along the western edge of 012. Individual bricks averaged 0.21m by 0.11m and 0.08m thick and were again set within a black ash mortar.

- 6.1.12 The absence of coursing beyond the western edge of 013 defined a rectangular feature which was bounded to the south by the extension of 011 along the southern edge of the trench and to the west by the eastern edge of sandstone wall 015 (Figure 9). It appeared to continue north into the section and was unbounded in this direction. The purpose of this area is uncertain but the shape and location of the feature corresponds well with an extension of the main iron foundry building in the vicinity of its north east corner as depicted on the ordnance survey map of 1880. It may be that this feature acted as an entrance to the main building. The truncation of the floor surface at the north western corner of its extent appeared to be a deliberate feature as both contexts 012 and 013 could be identified as a deliberate lining and terminus to the western extent of the floor in this area. Context 012 represented a single course and single skin of handmade none frogged red spacer bricks, extending from north to south for approximately 1.35m along the western edge of 011. The bricks were set within the same black ash mortar as 011 and individual bricks measured on average 0.13m by 0.11m and 0.03m thick. A single brick was retained as a sample. Context 013 represents a single course and single skin of handmade none frogged red brick extending north to south for 0.87m along the western edge of 012. Individual bricks averaged 0.21m by 0.11m and 0.08m thick and were again set within a black ash mortar. A single brick was retained as a sample.

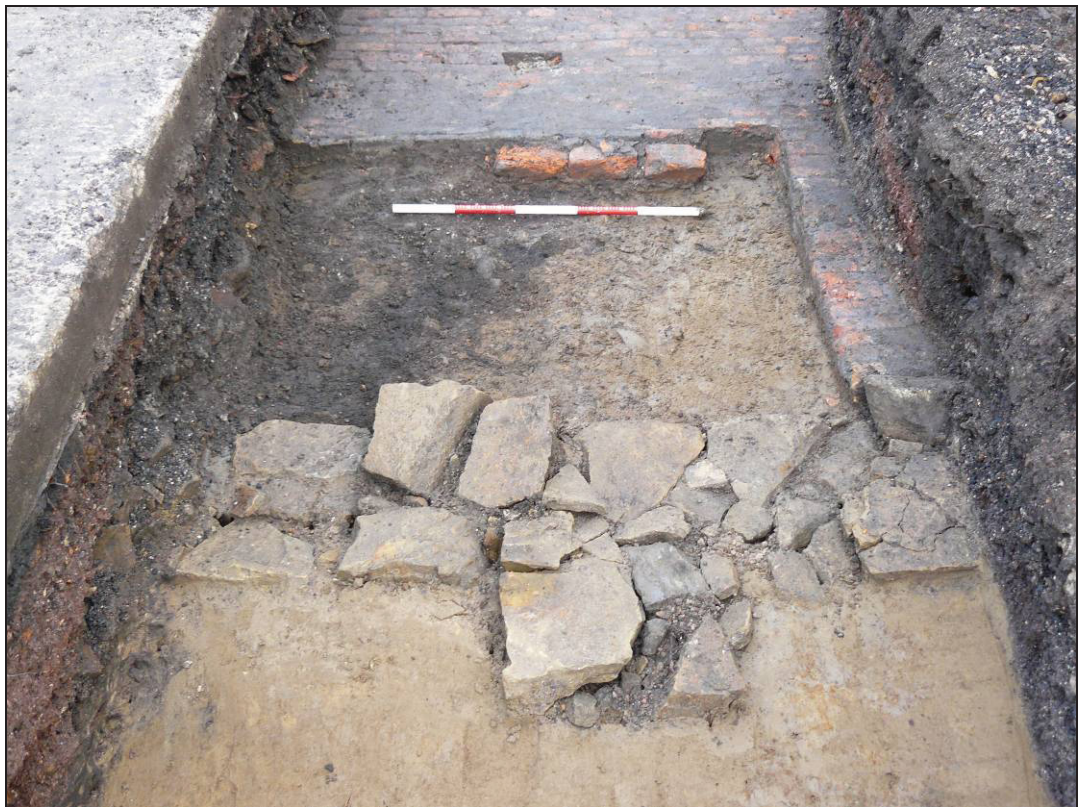
Figure 9. Wall 015 viewed facing East with the western feature within floor 011 immediately behind.

- 6.1.14 Context 015, 031 and 027 represented the lower courses of a sandstone wall, associated foundation deposit and construction cut respectively. This wall was observed in plan to extend north south across the entire width of the trench, approximately 5m east of the western terminus and marked the western limit of both the southern arm of floor 011 and the rectangular negative feature within it. 015 represents the upper section of the remaining wall and consisted of a single course and double skin of roughly hewn sandstone blocks with no clear bonding agent visible (Figure 9). In plan it was approximately 2m in length and 0.57m in width except where an apparent buttress extended west from a mid section along the western edge. This buttress extended west for a further 0.36m beyond the wall and was 0.5m in length north to south. The single course measured approximately 0.12m in depth.

Individual blocks varied in shape and size but were approximately 0.3m by 0.25m and 0.12m thick. Context 015 surmounts a three course and two skinned stepped foundation deposit encountered only in the exploratory section within the rectangular feature of 011. The first course extends east from under wall 015 for approximately 0.06m and then descends vertically for 0.1m, while the second and third course collectively extend east beyond this for 0.12m and descend for 0.14m to the base. The collective depth of the feature therefore is 0.24m with a projected width east-west, providing the foundation steps in the same manner along the western edge of 015, of approximately 1m. Like 015 the foundation courses comprise of roughly hewn blocks of variable size and shape with no visible bonding agent. Both structural deposits probably sit within a construction cut in the underlying natural deposits, however, this was only visible as context 027 along the western edge of the buttress. Presumably movement of particles within the natural sand levels has served to mask its existence elsewhere in plan. Little can therefore be said of this element of the construction.

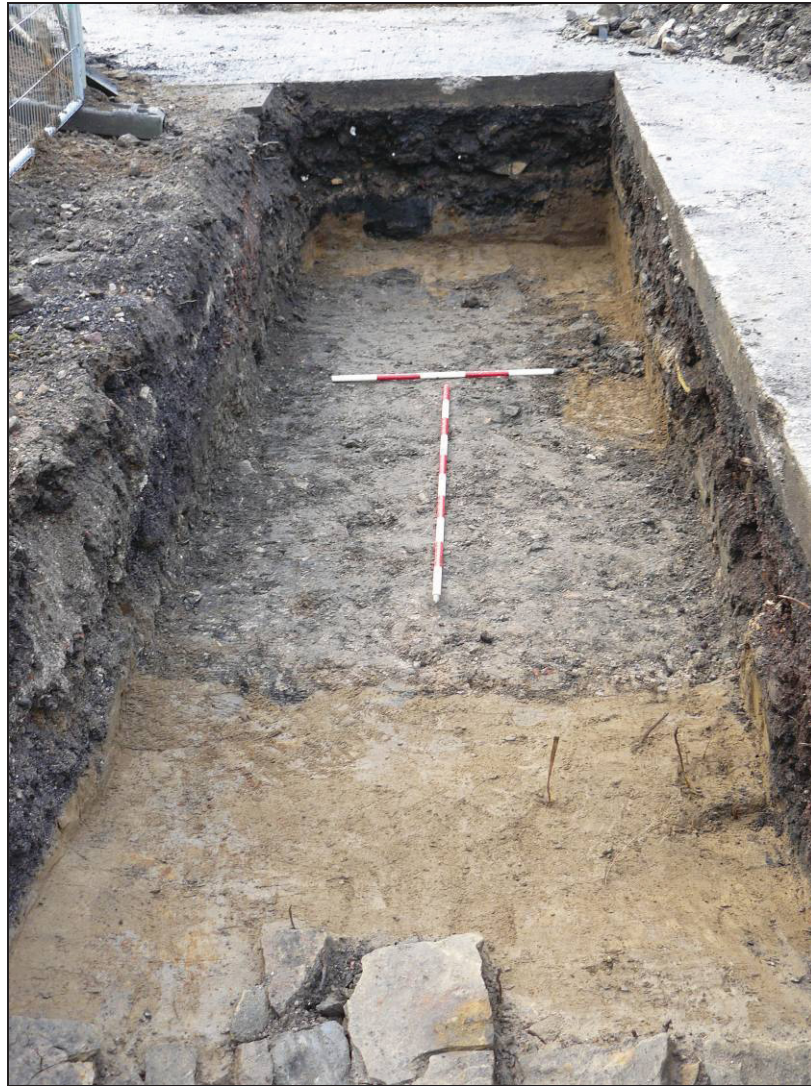
Figure 10. Cut 016 with fill 017 viewed in plan facing west and cut 022 evident in the lower area of the East facing section of the western trench terminus.

- 6.1.16 Cut 016 was filled by deposit 017 which appeared as a slightly darker brown black colour but was otherwise indistinguishable from the overlying deposit 026. 017 may therefore represent an extension of 026 pushed into cut 016. It was unclear what cut 016 and fill 017 represented given its internal position within the building collectively defined by walls 015 and 207. It may be that the feature represents an internal sub-surface structure removed during demolition of the building or alternatively simply the remains of a cut for an internal utility pipe or pipes.

- 6.1.18 The feature represented by cut 022 and fill 023 and observed only in the east facing section of trench 1 can be characterised as extending north south in section for approximately 0.4m and was 0.17m deep (Figure 10). It was cut into the natural at a depth of approximately 0.7m below the top of the concrete raft and approximately 0.5m north of the south west trench corner. The sides appear vertical and the base flat. The fill 023 was identical to fill 030 and overlying deposit 021.
- 6.1.19 The level of the natural was represented by context 018 and occurred at a depth of between 0.6m and 0.8m below the current ground level.

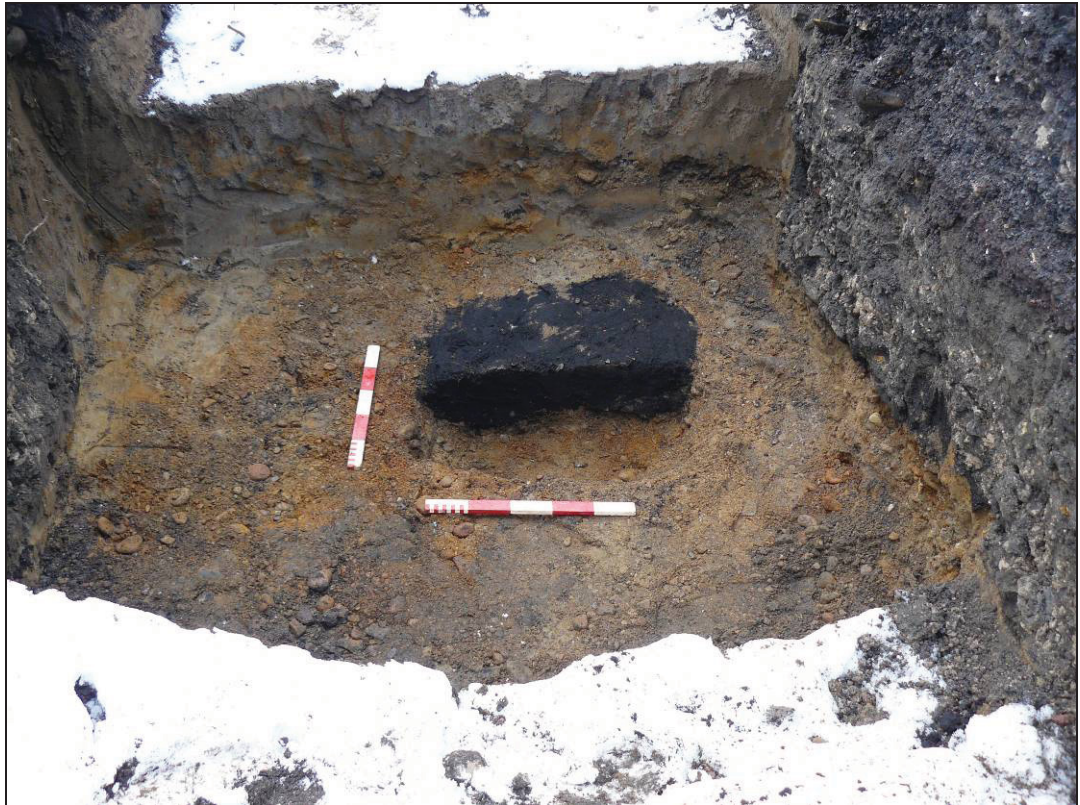
Figure 11. The West facing section through cut 029 and fill 030.

- 6.1.17 Below cut 016 in the exploratory sondage a further feature was revealed cut into the underlying natural deposits, represented by cut 029 and fill 030 (Figure 11). The cut appeared roughly square in plan with a dimension of 0.79m north south and 0.7m east west. The fill was half sectioned and revealed vertical sides approximately 0.2m deep but a slightly uneven base. The fill 030 was virtually identical to that recorded as context 021, 025 and 205 discussed above. It would appear that this feature may represent the remains of a large, square posthole but little clear purpose can be ascribed to it or other similar features.

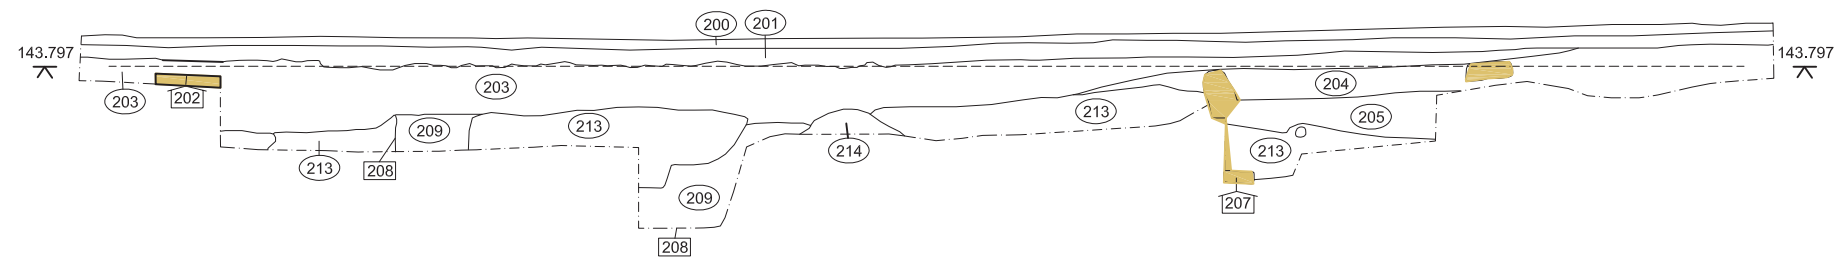
West facing section of Trench 2

Plan of Trench 2

Notes: (Top) Figure 12
 West facing section of Trench 2

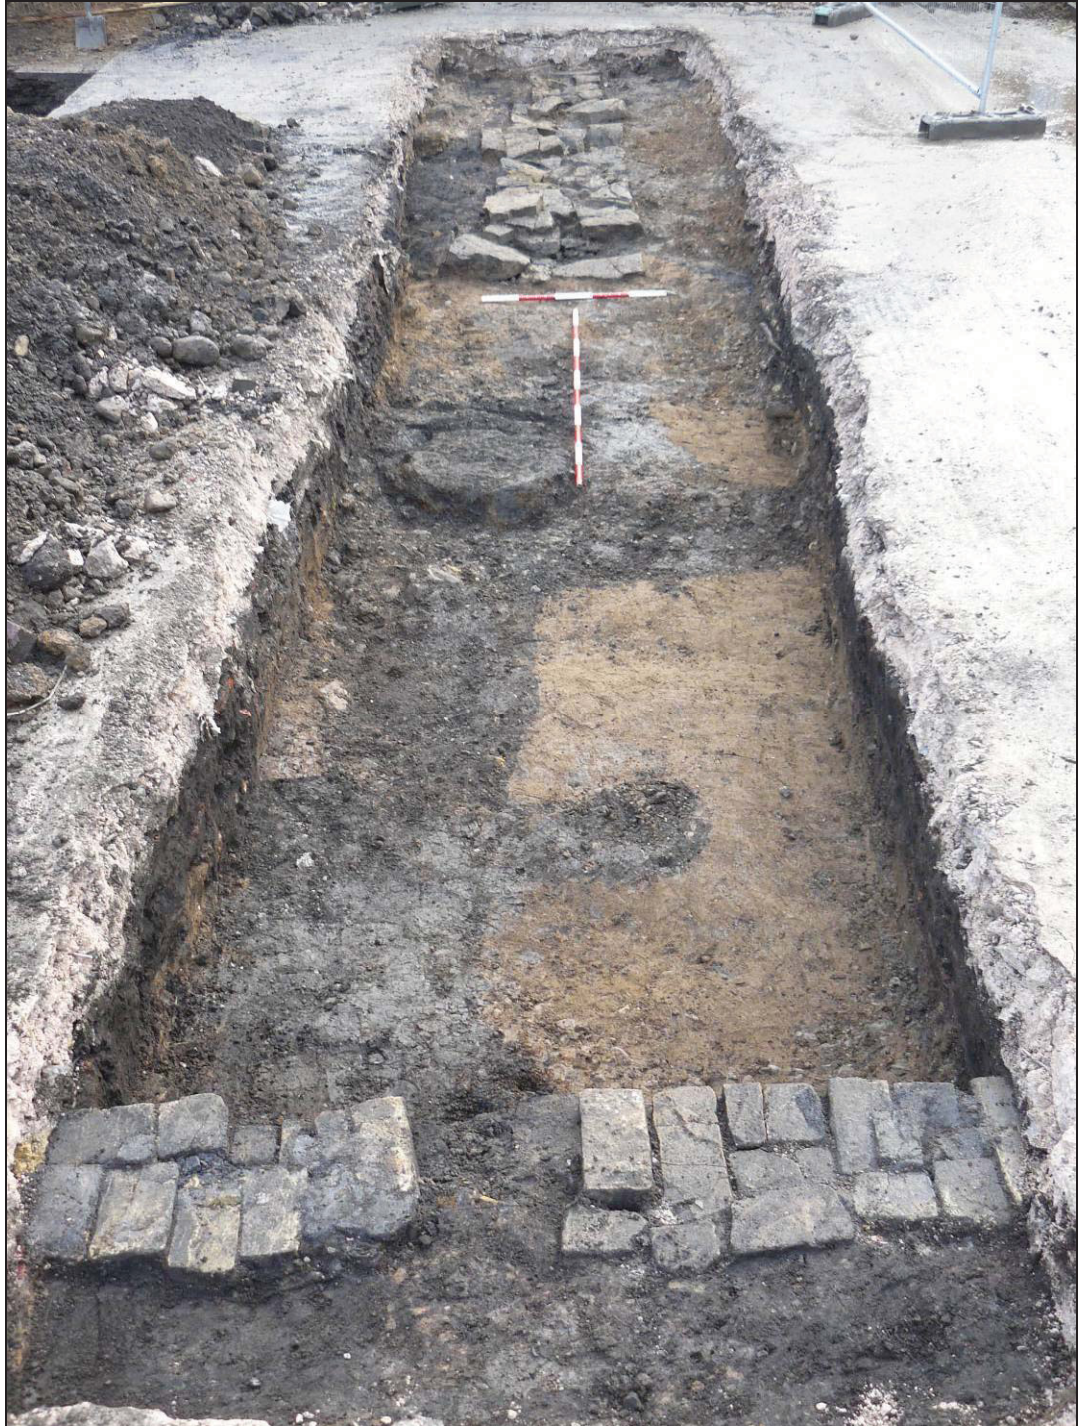
Figure 14. General shot of Trench 2 facing south showing wall 202 (foreground), cut 208 with fill 209 extending south (mid-ground) and wall 207 (background)

- 6.2.3 Directly below the hardcore level 201 lay a single course double skinned wall (202) located approximately 0.56m south of the northern trench terminus and extending east west across the entire width of the trench for approximately 2m, continuing both east and west beyond the limit of excavation (Figure 14). The wall was 0.4m wide and approximately 0.1m deep. The wall comprised of well dressed rectangular sandstone blocks of various sizes between 0.25m by 0.16m and 0.07m thick and 0.34m by 0.13m and 0.04m thick. They were set within a black ash mortar with occasional elements of lime inclusions less than 0.01m in size. The structure of the coursing appeared somewhat irregular with occasional header and footer formations and half blocks

- 6.2.11 The remaining feature is represented by cut 208 and fill 209, although in reality this probably represents a series of 3 or more cuts relating to the same phase of activity. The main body of the feature extends south from wall 202 along the eastern edge of the trench for up to 4.6m and was up to 0.8m wide and 0.8m deep. Several branches can be observed to cut across this main body in plan (see Figure 17). The fill (209) of each cut was indistinguishable indicating that they were at least backfilled at the same time. The only discernable change in the nature of the fill was the presence of context 214, a large sub-circular deposit in plan, approximately 1.1m in diameter and located just south of the junction between the main north south cut and the southern most westerly branch. This deposit consisted of a very hard ferrous material which appeared to have been poured into the cut and then allowed to set. An attempt was made to obtain a sample but the deposit resisted efforts to separate it. This deposit probably represents the pouring of a batch of molten iron, perhaps spoiled for some reason, into an existing convenient cut feature. The cut features probably relate to former utilities servicing the iron foundry.

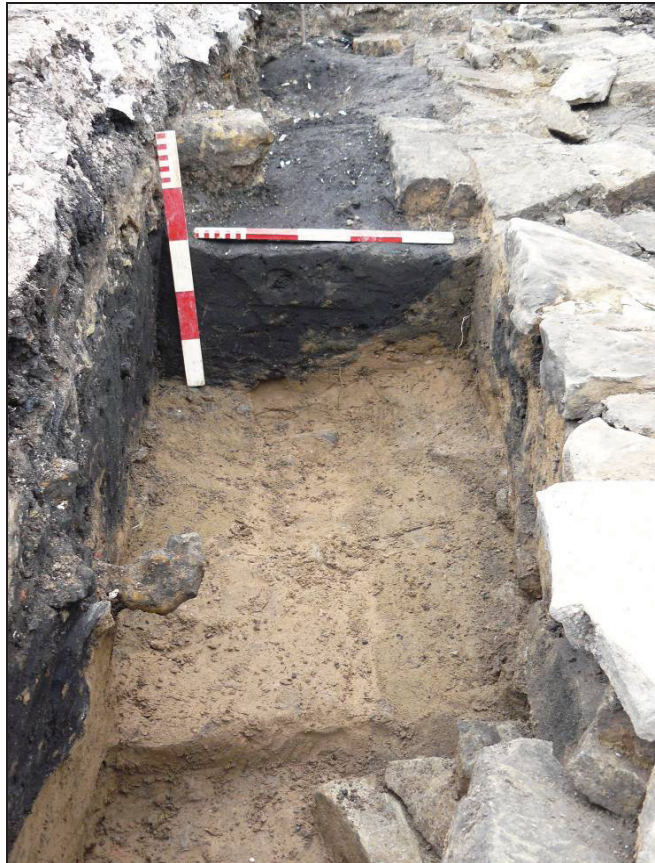
Figure 15. North facing section through deposit 205 exposing cut 219 and potential cut and fill 218 and 217 respectively.

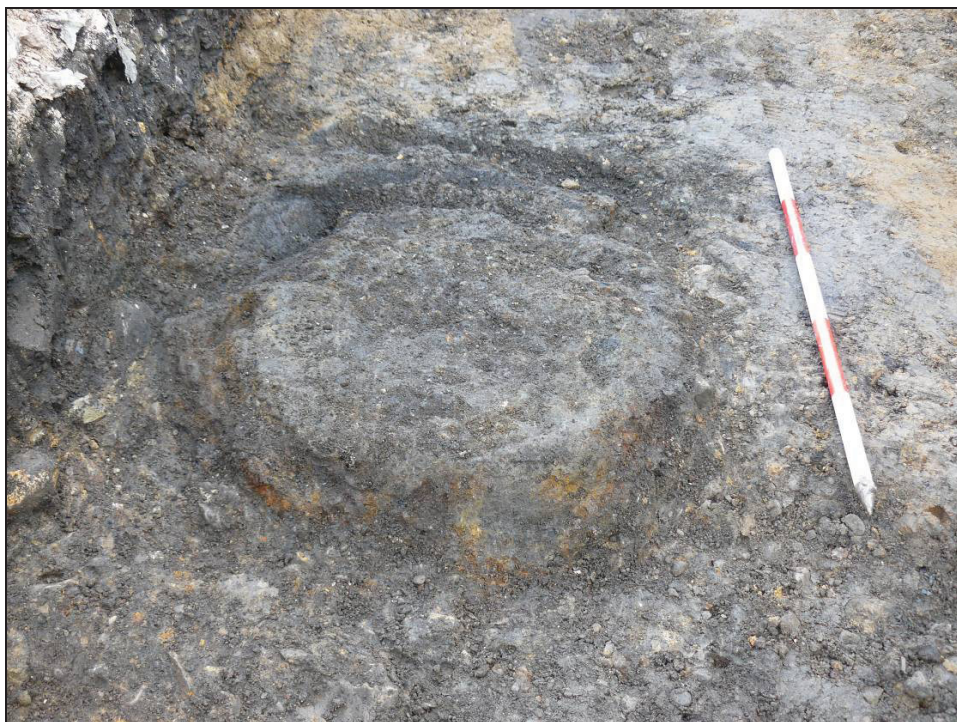
Figure 16. Ferrous deposit 214 viewed facing South.

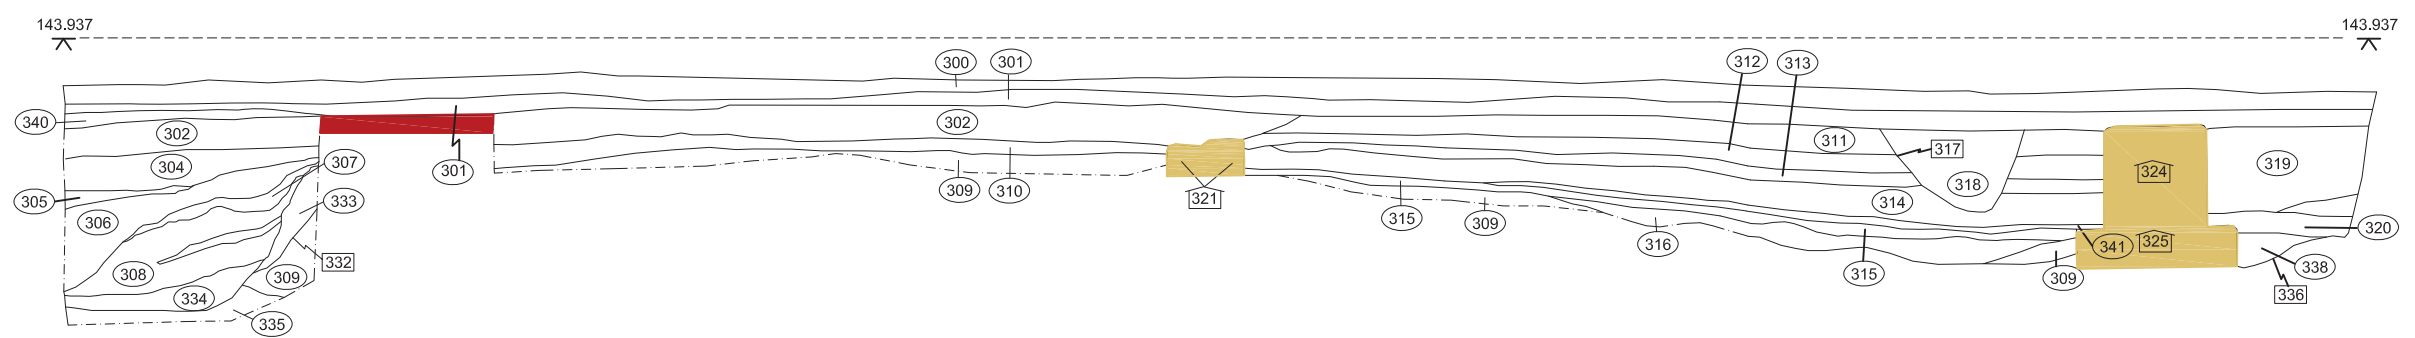
East facing section of Trench 3

Plan of Trench 3

Notes: (Top) Figure 17
 East Facing section of Trench 3

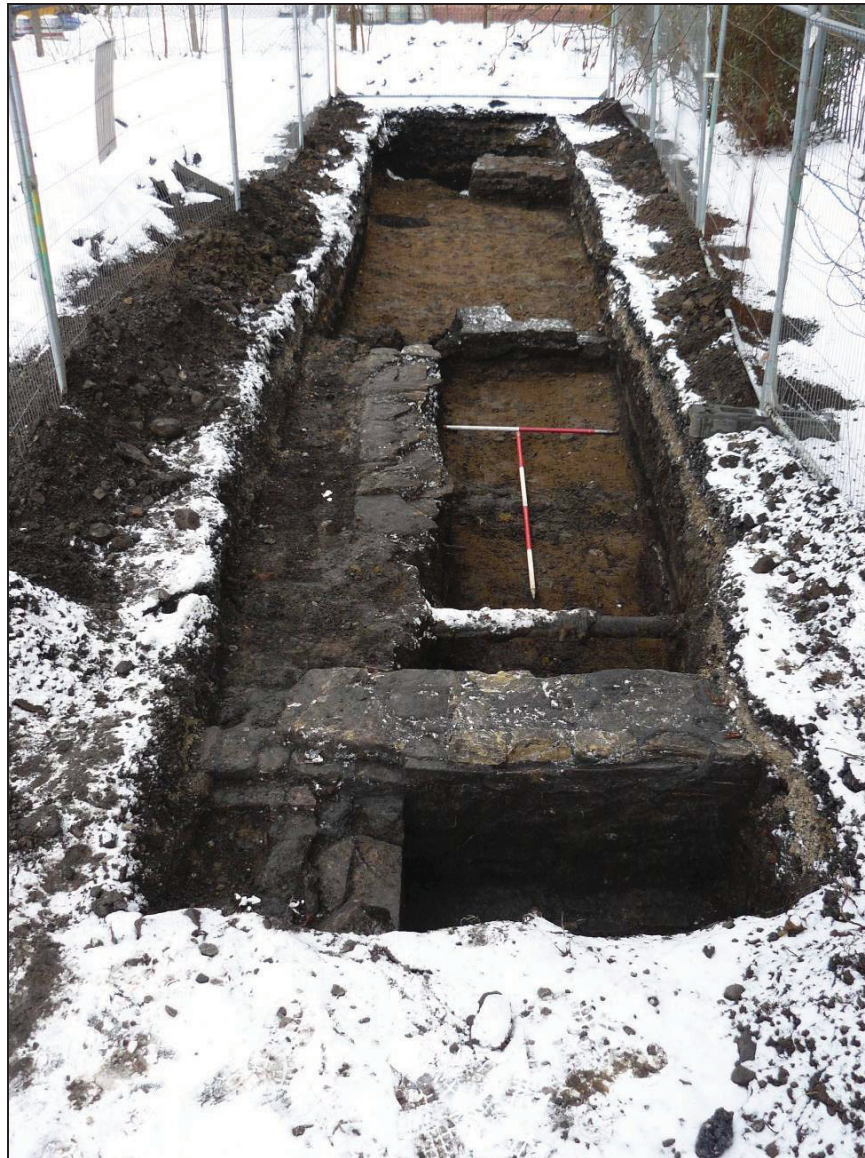
Figure 19. General shot of Trench 3 facing South with walls 324 and 326 (foreground), walls 321 and 322 (mid-distance) and structure 303 (background).

- 6.3.4 Approximately 0.3m west from the north east corner of the south facing section a substantial sandstone wall (326) was encountered extending due south for 0.88m. This was found to comprise of well dressed sandstone blocks of regular size and shape and constructed in up to 4 courses, with a depth of 0.44m, and two skins with a width of 0.48m (Figure 19). The blocks were set within a bonding matrix of black ash mortar containing no visible white lime inclusions. It extended north beyond the limit of excavation but the upper courses appeared to have been disturbed in this area by the insertion of a cast iron utility pipe that was just visible in section running east west approximately 0.3m below the trench surface. To the south 326 terminated against a more substantial sandstone wall (324) running east west across the entire width of the trench. It was unclear, due to the presence of mortar, if the two walls were keyed into each other. Wall 324 was found to be constructed of well dressed sandstone blocks of regular size and shape similar to those of 326. It comprised of at least six courses and three skins set within a black ash mortar identical to that of 326. The overall dimensions of the wall was 2m east west, continuing beyond the limit of excavation in both directions, 0.6m wide and 0.62m deep. A single course of red brick (342) was found to run along the north eastern edge of wall 324 from the eastern trench edge for approximately 0.42m. This was set within an identical black ash mortar used in the construction of 324 and 326 and traces of the mortar containing brick imprints may indicate that the course extended north along the east edge of 326. Individual bricks were handmade and none frogged with dimensions approximately 0.23m by 0.12m and 0.07m thick. Both 324 and 326 and their associated foundation deposits appear to relate to a substantial and well built

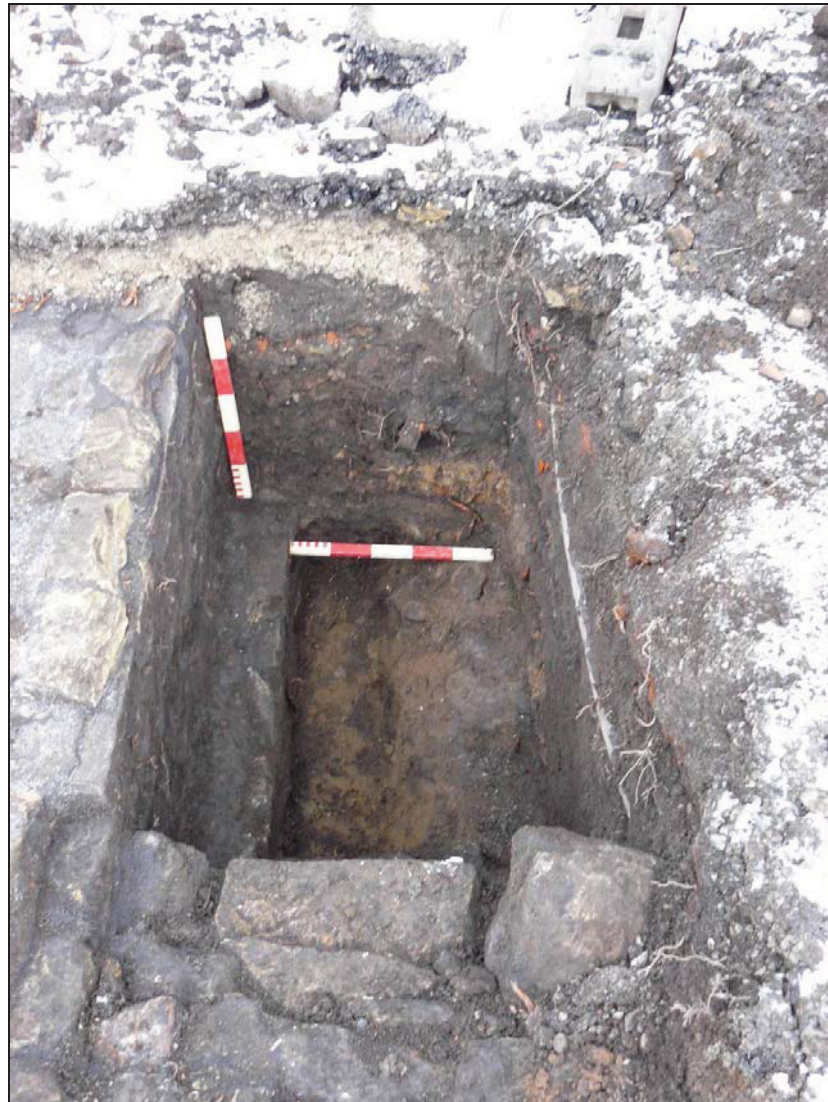
Figure 20. Foundation deposit 325 and associated features.

- 6.3.6 Removal of the deposits 319 and 320 revealed two further sandstone structures contexts 325 and 327 as well as two further deposits, contexts 338 and 339, within two cuts, contexts 336 and 337 respectively (Figure 20). Context 325 comprised of at least 2 courses of well dressed sandstone blocks of regular size and shape set within a black ash mortar. It extended north from below 324 for approximately 0.2m and ran east west along the entire edge of 324. It was also found to extend south from below 324 for a similar distance. This gives the structure an overall dimension of 1.95m east west, continuing under 324 in each direction, a total width of 0.9m and a depth of 0.15m. The structure represented a foundation deposit for wall 324. Context 327 was only observed along the western edge of wall 326 extending from beneath it in a westerly direction for approximately 0.2m. It comprised of at least two courses of well dressed sandstone blocks of regular size and shape within a black ash mortar. The structure obviously represented a foundation deposit for 326. Based upon the evidence of context 325, the foundation wall 327 probably also extended east beyond wall 326. This would give the structure an estimated width of approximately 0.8m, a length of 0.8m north south and a depth of 0.15m.

- 6.3.7 Both foundation deposits were found to be contained within a construction cut, each containing a back fill deposit as identified above. Context 336 represented the construction cut for wall 324 and foundation 325 and was identified in plan running parallel to 325 approximately 0.26m north of the structure. In section the cut was approximately 0.2m deep with a rounded break of slope at the top and bottom of an angled side and a flat base. No return edge was visible south of structure 325. The cut was filled by deposit 338. Context 337 represented the construction cut for wall 326 and foundation 327 and was visible in plan extending south from the south facing section approximately 0.2m west of structure 327. It extended for approximately 0.4m before intersecting with the more substantial cut 336. Cut 337 appeared very shallow at 0.1m deep with an angled side grading into the base and a slight break of slope at the top. It contained deposit 339 which was identical to context 338.

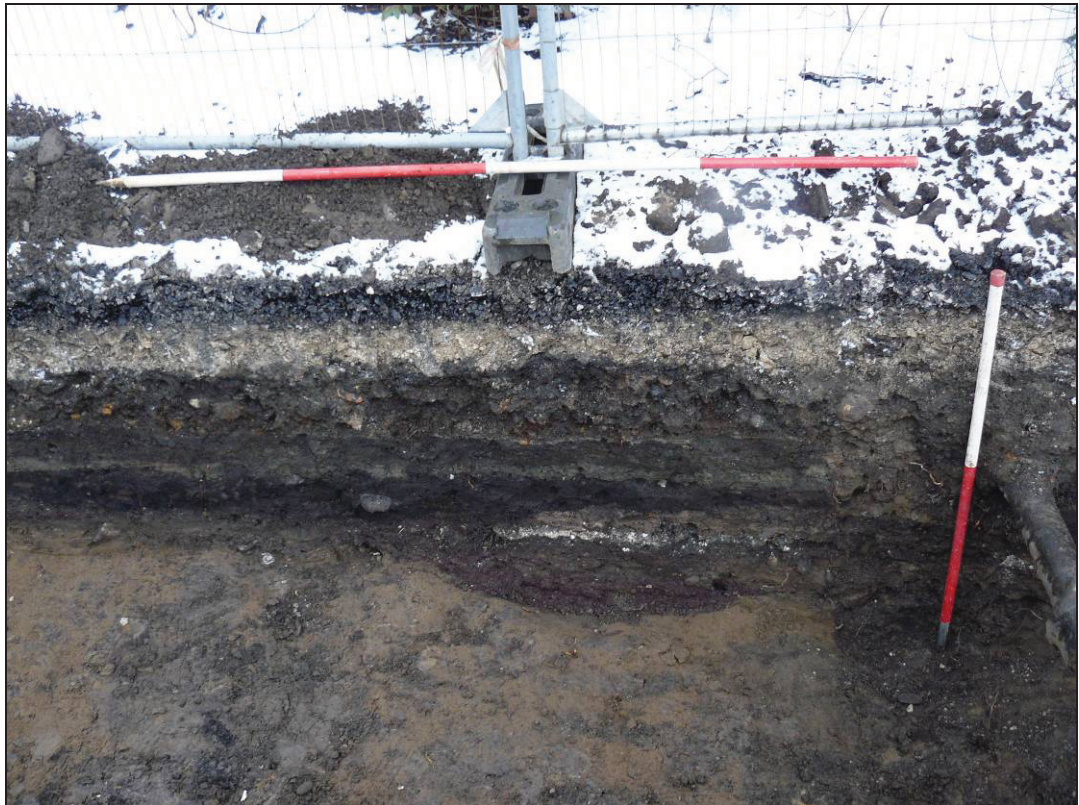
Figure 21. The depositional sequence in the East facing section of the area defined to the south by wall 321 and north by wall 324.
