George Street, Glossop, Derbyshire

**Report on an
Archaeological Evaluation.**

ARS Ltd Report No. 2009/63
February 2009

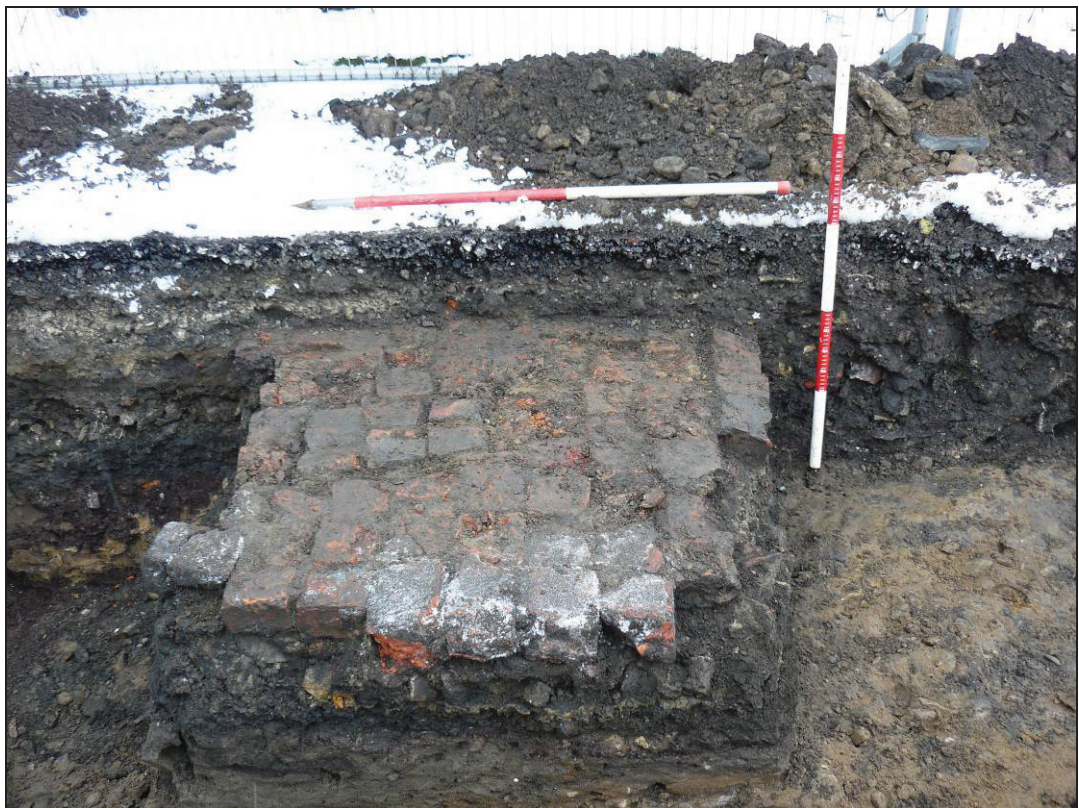
Figure 22. Isolated red brick floor surface/structure 303.

- 6.3.7 Stratigraphically sandwiched between 302 and 310/304 was a red brick constructed floor surface or column base represented by context 303 (Figure 22). This was located approximately 1.7m north of the southern trench terminus along the east facing section edge and extended 1m north south and 1.1m east west. It comprised of up to 10 courses of hand made none frogged red brick laid horizontally in a single skin. Individual elements of the surface consisted of half bricks with an average dimension of 0.12m by 0.1m and 0.07m thick, with no apparent bonding agent. The presence of this isolated structure is somewhat enigmatic but may have supported an upright post, possibly related to a gateway and site entrance of George Street for the original forge complex.

- 7.12 The occurrence of the red brick surface 303 may suggest the presence of an upright, perhaps a gate post, and that the current site entrance perhaps mirrored that of the original foundry.

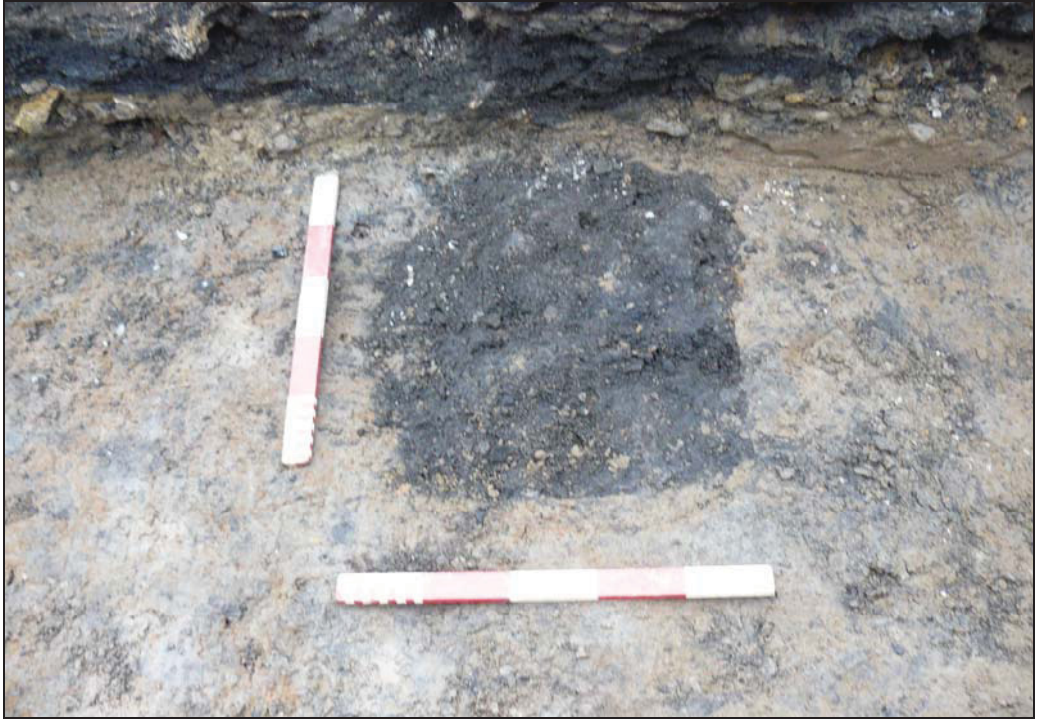
Figure 23. Square cut isolated feature, cut 330, fill 331, facing east.

- 6.3.9 The remaining feature to be identified in Trench 3 was an isolated cut feature 330 containing fill 331. It was cut into the natural and located 3.3m north of the southern terminus of the trench and 0.2m west of the eastern edge. It had a rectangular shape in plan measuring 0.56m east west and 0.49m north south but was not excavated due to the lack of time. The fill appeared to be identical to deposit 205 encountered in Trench 2 and 021 in Trench 1, as well as fill 030 and 023 of cuts 029 and 022 respectively. While the size and shape of the feature varies slightly from that of cut 029 and 022 in Trench 1 there are enough similarities to suggest that it be grouped with these features although they do not appear on this evidence to share any form of regular alignment. Irrespective of this the feature may perhaps best be interpreted as representing the base of a posthole (Figure 23).

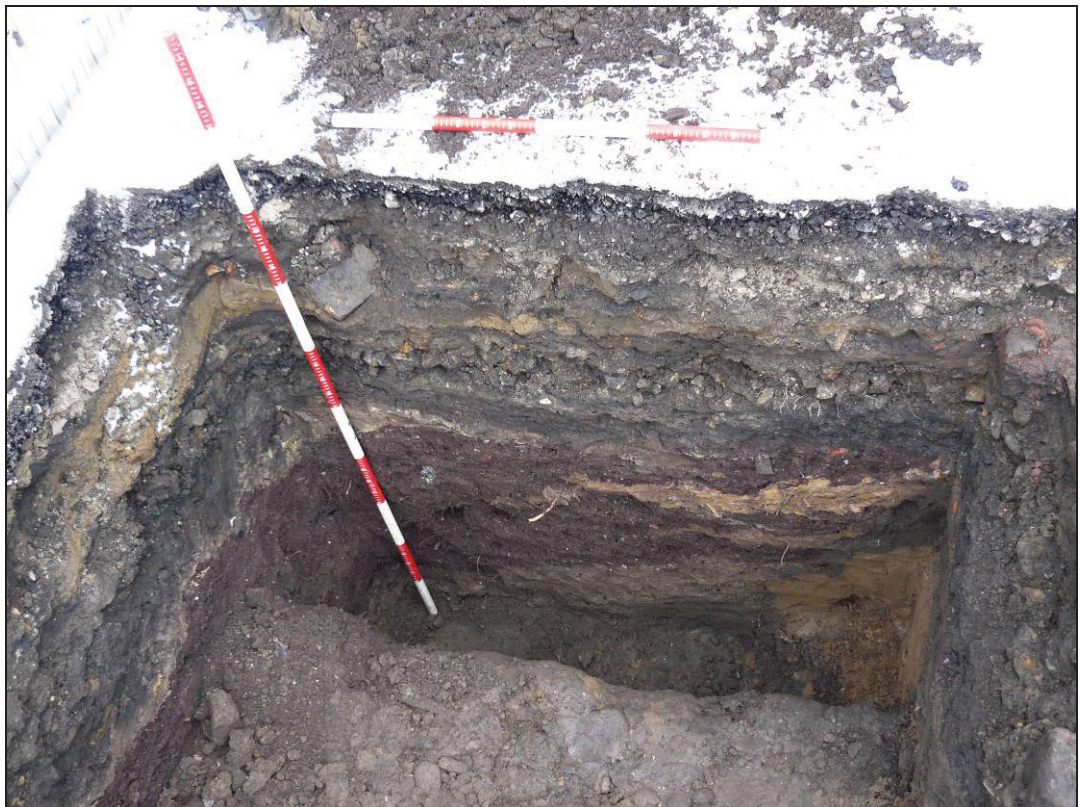
Figure 24. The depositional sequence within the East facing section of the South West corner sondage exposing pit cut 332.

- 6.3.8 To the south of structure 303 and underlying deposit 304/310 were a series of 6 deposits (contexts 305-08 and 333-4) revealed by an exploratory sondage to sit within a large cut feature, cut 332 (Figure 23). The presence of this feature was originally missed during machining and following its identification by the sondage could not be

adequately traced in plan. The full extent of the feature is therefore uncertain but did not appear in the west facing section of the trench and must therefore be confined to the south west corner. The sequence of fills appears to have been deposited in the cut from the northern edge as they all show a gradation towards the base from this point. Context 305 represents the upper most fill in the sequence and was observed in section to occur 0.7m below the trench surface, to extend north from the southern trench edge for approximately 0.97m and was between 0.05m and 0.14m thick. Below this context 306 can be seen to drop markedly in depth from the point 1.7m north, where it emerges below 303, towards the south where it continued into the north facing section but also to increase in thickness from 0.06m in the north to 0.54m in the south. Context 307 represented a distinct lens of light yellow brown clay 1.3m long north to south and of variable thickness up to 0.1m. In section it can be seen to drop from a northern limit of 0.6m below the trench surface to approximately 1.34m below the trench surface in the south. Context 308 may represent at least three different layers, two virtually distinct deposits separated in part by a thin lens of clay, which for convenience sake were amalgamated. This context was 1.5m in length north south and up to 0.6m thick and was mainly heaped against the northern edge of cut 332. Stratigraphically below 308 was context 334 occurring approximately 0.3m south of where cut 332 first appears in the sondage and at a depth of between 1.2m and 1.4m below the trench surface. This deposit extended south for 1.14m across the base of cut 332 and continued south beyond the limit of excavation. It partially overlaid the southern tip of deposit 333 which appeared to cascade down the northern edge of cut 332 and may represent re-deposited natural (see context 335). Cut 332 was only observed in the east facing section of the sondage south of 303 and was seen to emerge approximately 0.86m below the trench surface and descend south at an approximate angle of 45 degrees for 0.6m before a rounded break of slope at the base gave way to a relatively flat bottom extending south for a further 1.2m and then beyond into the limit of excavation. This cut and series of fill deposits probably constitute the remains of a dumping pit although this is based upon a very limited examination.
