# Archaeological Watching Brief at Green Lane, Chare End & Fenkle Street, Holy Island, Northumberland

## **ARS Ltd Report 2009/12** February 2009

In January 2009 Archaeological Research Services Ltd were commissioned by BT Openreach to undertake an archaeological watching brief during telecommunication ducting works on Holy Island, Northumberland. The work involved the excavation of ducting trenches on both grass verges and tarmac road surfaces. The ground works involved excavation of ducting and service box trenches on Green Lane, Chare End & Fenkle Street. The majority of the areas excavated were on ground which had been disturbed previously, through earlier ducting or road works, as was evident by the underlying made ground. In other areas the depth of excavation failed to penetrate beyond the topsoil.

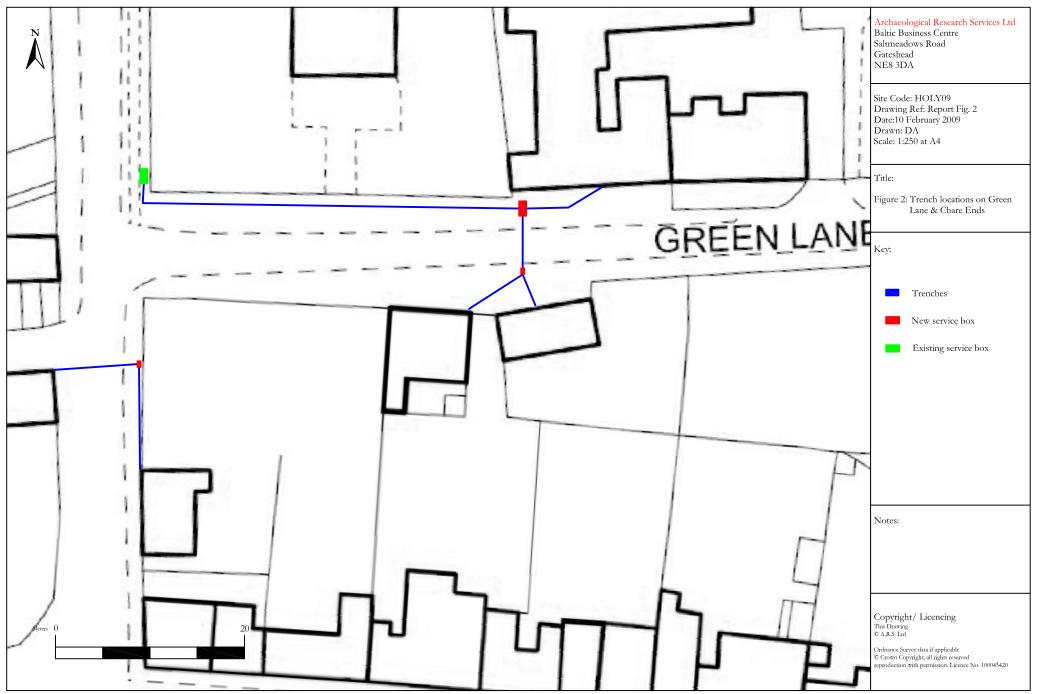
- 2.2 The ground works involved excavating trenches in three areas, Green Lane, Chare Ends & Fenkle Street (Figs. 2 & 3). A long trench measuring approximately 45 meters in length was excavated on the northern side of Green Lane (running east west, Fig. 2). The width of the trench was a consistent 0.30m. A service box trench was excavated measuring 1m in length by 0.5m in width this box served as a junction for two connecting ducts. To the east, the trench turned north east and connects with the church.

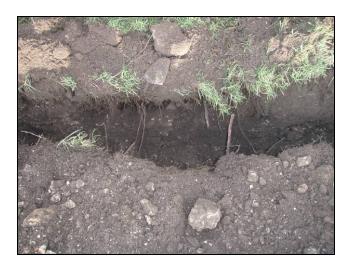
4.2. The 45m long trench of Green Lane (Fig. 4) was excavated 0.40m deep and its stratigraphy consisted of dark brown silty topsoil (004). Beneath the topsoil was a layer of made ground (005) which had a depth beyond that of the excavation. The connected service box trench (Fig. 5) was excavated to a depth of 0.50m and consisted only of the same dark brown topsoil (004) which had a depth beyond that of the excavation. The road crossing (Fig. 6) to the south of this box trench was excavated to a depth of 0.50m and consisted of a tarmac layer (001) which

Fig. 4 South facing section of Green Lane duct trench

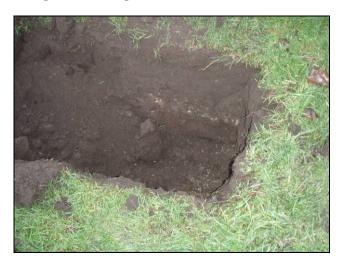
Fig. 5 Service box trench on Green Lane

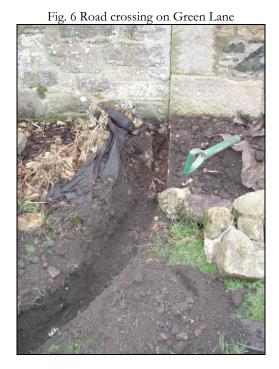
- had an underlying hardcore layer (002). Below the hardcore (002) was a layer of made ground (003) which had a depth beyond that of the excavation.
- 4.3. The two trenches leading off from the service box trench were excavated to a depth of 0.40m and the stratigraphy of both consisted of a dark brown silty topsoil (004) which had a depth beyond that of excavation (Fig. 7).

Fig. 7 Duct trench connection to 'Memnon' house on Green Lane

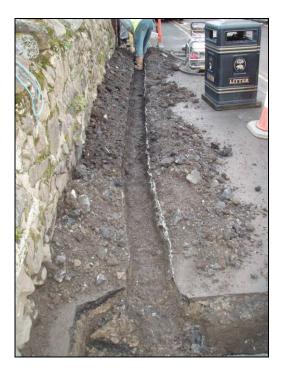
- 4.4. The service box trench on Chare End was excavated to a depth of 0.50m. The stratigraphy of this box trench consisted of a layer of tarmac (001). Directly underlying the tarmac (001) was a layer of hardcore (002) below which was a layer of made ground (003) also containing service ducts lain previously (Fig. 8). The two ducting trenches which ran of from the service box trench were excavated to a depth of 0.40m. Their stratigraphy comprised of a layer of tarmac (001). Directly underlying the tarmac was a layer of hardcore (002) which continued beyond the depth of excavation.

Fig. 8 Service box and ducting trench on Chare End

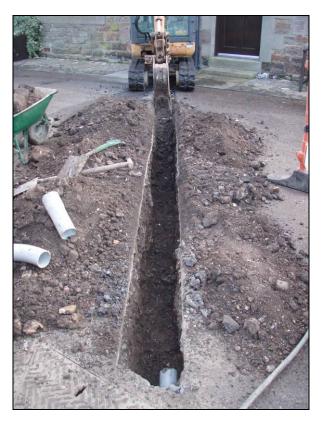
- 4.5. The ducting trench placed on Fenkle Street (Fig. 9) was excavated to a depth of 0.40m. The stratigraphy consisted of a layer of tarmac (001). Directly underlying the tarmac was a layer of hardcore (002). Beneath the hardcore layer (002) was a layer of made ground (003) which had a depth beyond that of the excavation.

Fig. 9 Fenkle Street road crossing
