**Watching Brief at Kedleston Hall,
Derbyshire.**

ARS Ltd Report 2009/18

Watching Brief at Kedleston Hall, Derbyshire.

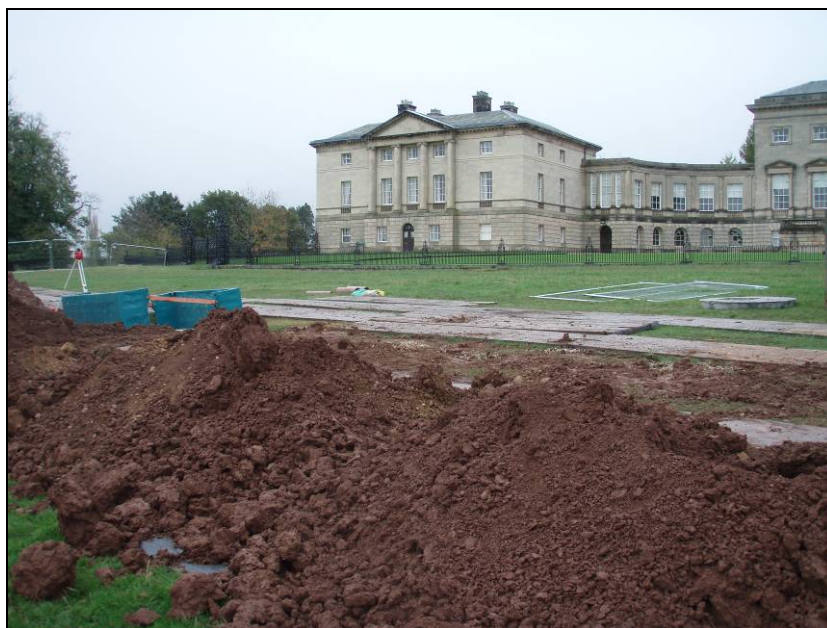
Fig. 2: View of Trench 1 showing proximity to the hall.

- 6.1.1 Trench 1 was orientated approximately east-west across the North Lawn in front of the main hall, connecting two previously existing manholes (Fig. 2). The trench initially had an approximate depth of 1.8m, gradually deepening to approximately 4.5m at the site of the other manhole.

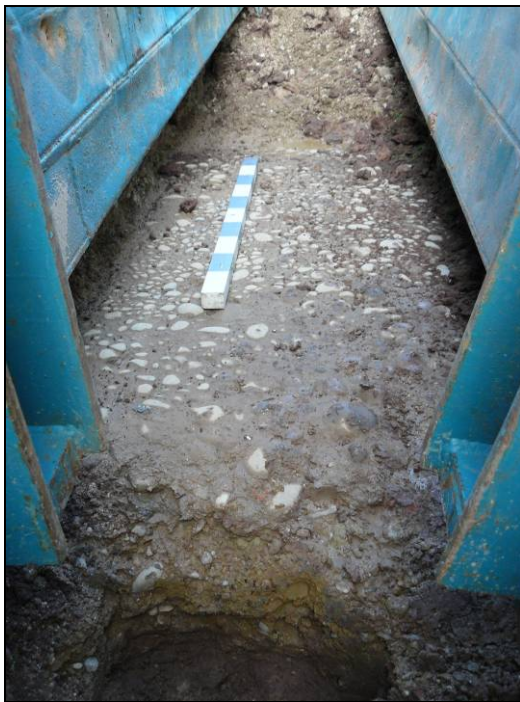
Fig. 4: Gravel path surface (504). Scale: 1m.

- 6.1.3 A compacted path surface (504) and (507) was uncovered 12.3m from the start of the trench which continued for a total length of 8m (Fig. 23, Appendix I). The surface was found approximately 1.25m below the modern ground level and consisted of a sandy compacted gravel surface (7YR 4/4) which contained rounded quartz pebbles (Fig. 4). Larger pebbles were noticeably higher in the deposit, forming the upper surface. The deposit had a maximum thickness of 0.3m. The surface appears to be the remains of a road or path relating to the formal gardens that pre-date the 18th century landscaping.

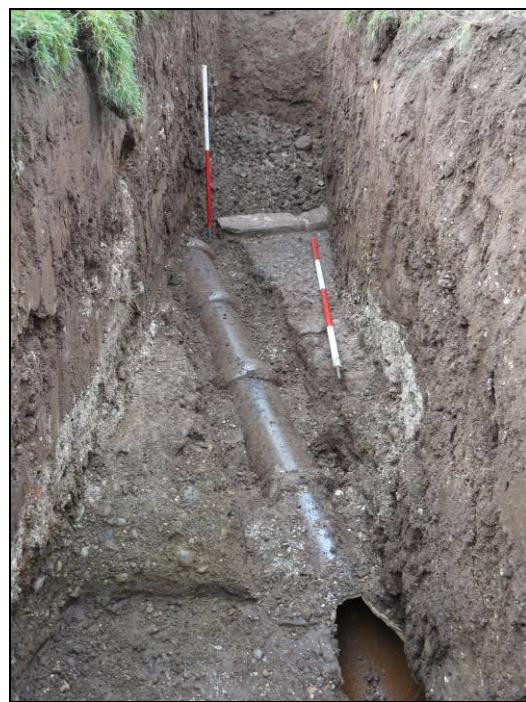
Fig 5: Gravel path surface (507) & edging stones cut by later ceramic drain (522). Scale: 1m & 2m.

- 6.1.5 Sandstone edging blocks (508) measuring 0.53m by 0.26m by 0.07m were found to exist running across the trench on a north-south alignment at the western limit of the gravel path surface (Fig. 5). The gravel surface in this area had been cut by a modern ceramic drain (522).
- 6.1.6 Below the gravel path was a buried soil horizon (502), probably the original topsoil. The context was a dark brown clayey silt containing frequent charcoal

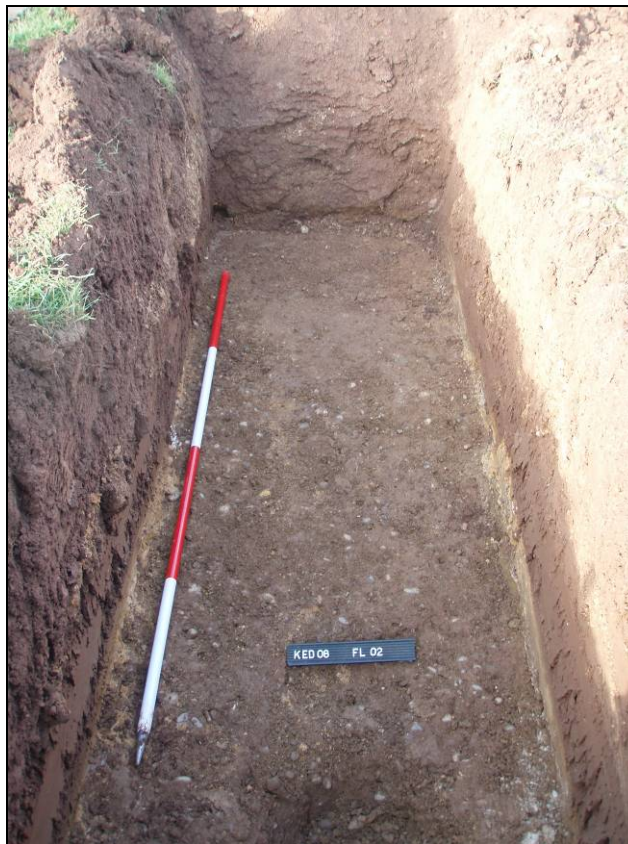
Fig. 6: Trench One: Surface two (507) continued, Scale: 2m (looking west).

- 6.1.7 Approximately 4m north-west from the manhole (1) in Trench 1 the gravel path surface (518) was encountered for a length of 10m (Figs. 3 and 6). The compacted layer of gravel and sand contained smaller pebbles than the previous road surfaces but nonetheless it was believed to be a continuation of (504) and (507) as it was at the same thickness and depth.

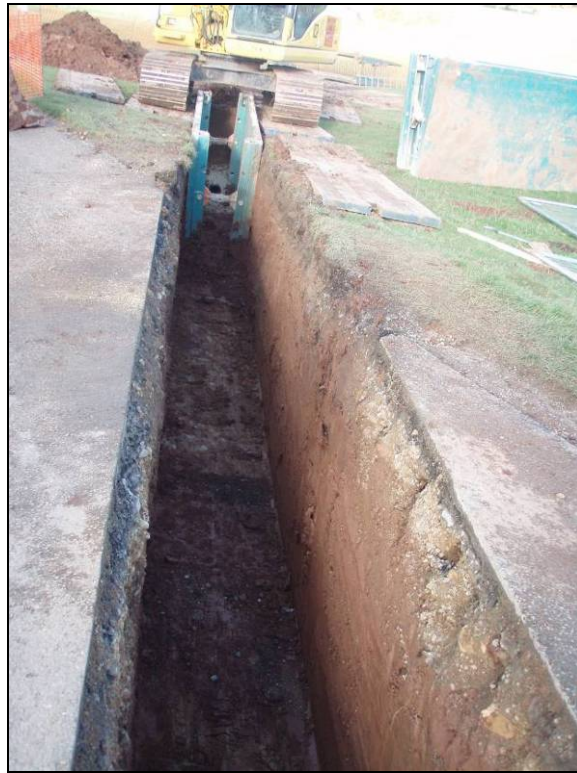
Fig. 7: View of Trench two coming across the road.

- 6.2.1 Trench 2 ran from an existing manhole positioned to the south of the access road across the road, over the grass bank and up to the existing manhole close to the house (Fig. 3). The trench required the excavation of two new manholes. The depth of the trench began at a depth of 1.85m and gradually became shallower, approximately 1.25m, towards the top of the slope. The stratigraphy of the trench comprised of a layer of tarmac and builders gravel which existed for a maximum depth of 0.3m, below which was the natural substrate clay (509) (Fig. 7).

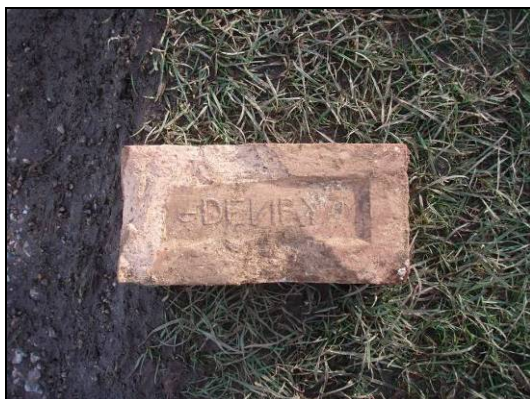
Fig. 8: Brick from demolition rubble printed with printed 'DENBY'.

6.2.2 Approximately 3m from the north edge of the road the remains of a modern brick building was found to exist below the topsoil approximately 0.15m below the modern ground level. The remains were identified before excavation started in the form of slight dips and rises in the grass and comprised of demolition rubble from a brick built building (Fig.10). The rubble (519) did not reveal any structural elements of the building and contained bricks, tiles, coal, slag and unidentified metal objects. The bricks measured 0.24m x 0.12m x 0.09m and had been mortared with cement; some were imprinted with the local manufacturer 'Denby' (Fig. 8). Some of the tiles had writing on them such as 'elect', indicating the tiles use as a cover or indicator of electric cables (Fig. 9).

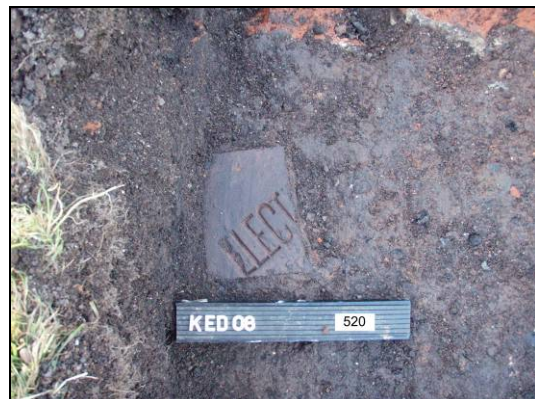
Fig. 9: Tile found amongst demolition rubble imprinted with 'ELECT'.

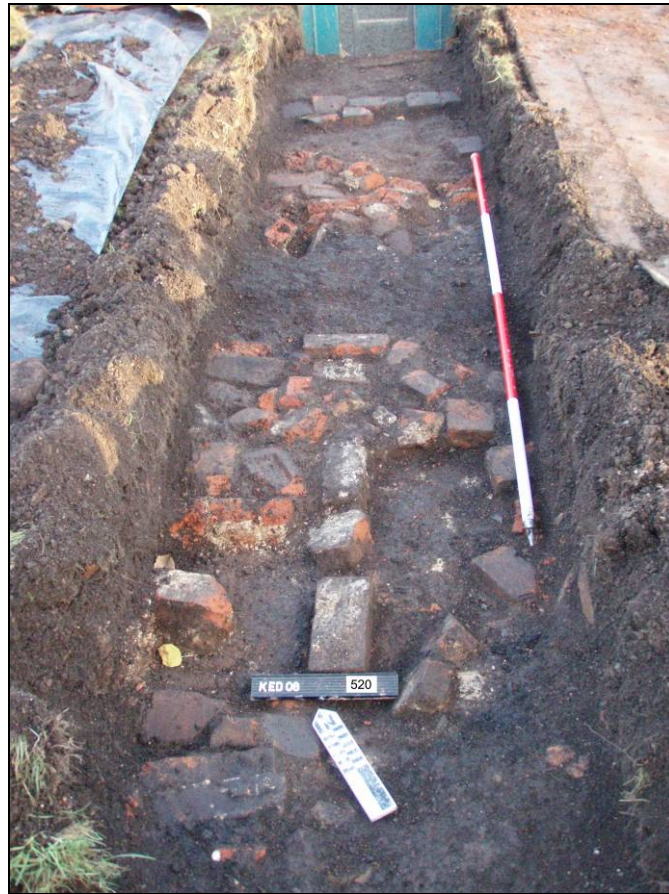
Fig. 10: View of demolition rubble in Trench 2, Scale: 2m (looking north).

- 6.2.3 The demolition rubble stretched for a length of 3.9m and is believed to be the remains of a temporary World War II camp present at Kedleston Hall during this period (Pers.Comm, National Trust Employee). The rubble, when removed, was found to be above a redeposited clay (520) that contained crushed bricks and coal. The natural alluvium was encountered between 0.2 - 0.3m below this deposit. No other deposits or finds were uncovered during the rest of the excavation of this trench.

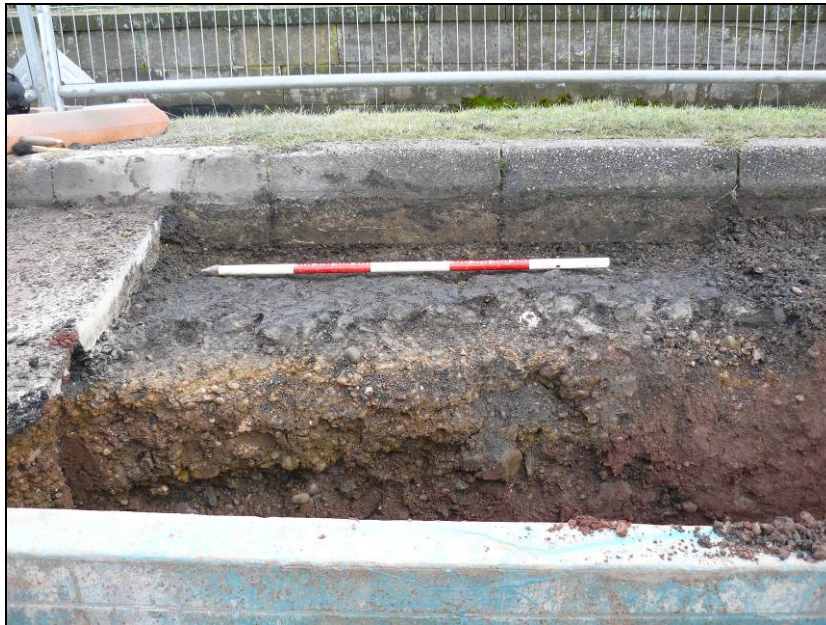
Fig. 11: View of gravel surface (507) below tarmac in Trench 3, Scale: 2m (looking east).

- 6.2.4 The trench continued across the road in front of the house in order to connect with an existing manhole. The gravel path surface (507) was encountered again below the tarmac at an approximate depth of 0.2m below the modern ground surface (Fig. 11). The edging stones for the present road were found to overlie the gravel path surface, leading to the interpretation that the surface may be an original road for the present hall rather than being related to the formal gardens. A lack of diagnostic finds from this level makes it difficult to ascertain the surfaces age and purpose of the surface.

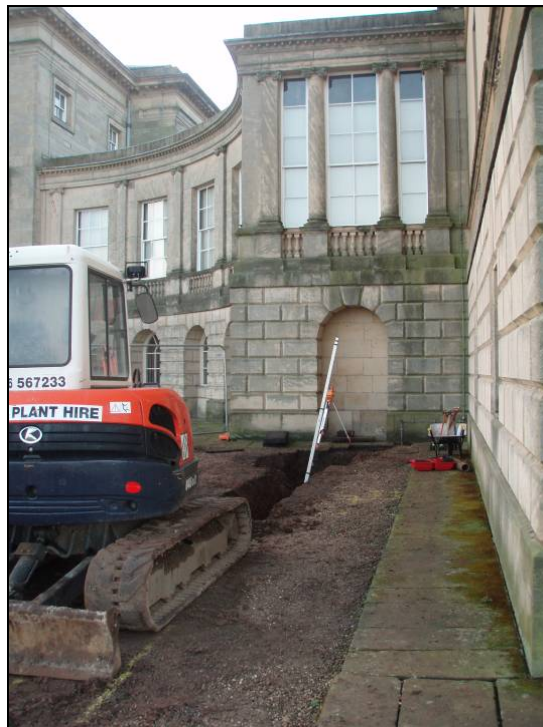
Fig. 12: Location of Trench 3 (looking south).

- 6.3.1 Trench 3 was located along the eastern wall of the Western Wing of the hall and connected a new pipe from the interior of the cellar to the National Trust's main drainage system (Figs. 3 and 12). The work was undertaken by a mini excavator with a toothless bucket that measured 0.5m in width.

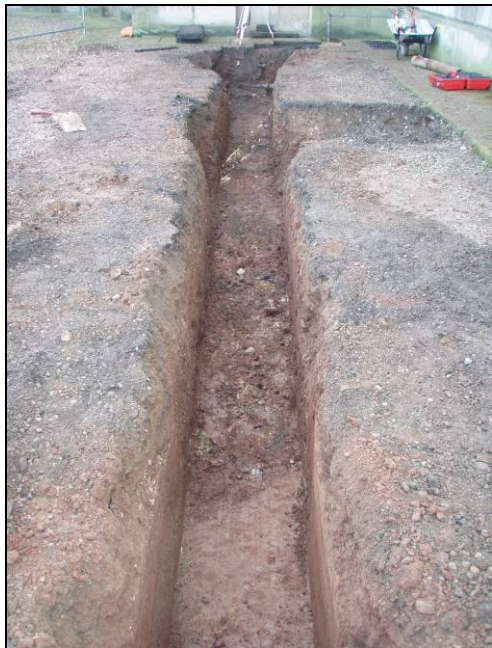
Fig. 13: Trench 3: View of trench, (looking south).

6.3.2 The ground was heavily disturbed for the first 10m of the trench with a number of services being present at different levels. Below the tarmac was made ground containing redeposited clay with bricks and pebbles (523) (Fig. 13). At approximately 10m from the southern end of the trench the made ground terminated. The clay substrate (509), encountered on site previously, was found to exist below the tarmac for the remainder of the trench. A ceramic drain (522) (Fig. 14), located roughly on a north-south alignment, was found to be disused and subsequently removed. All other services were left *in situ*.

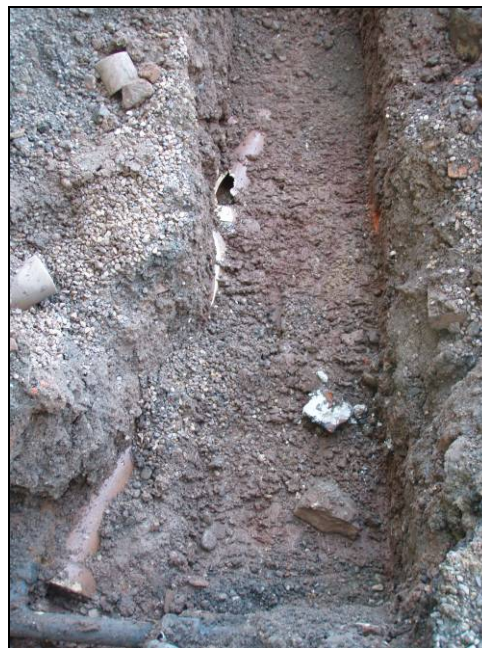
Fig. 14: View of ceramic pipe in Trench 3, (looking north).

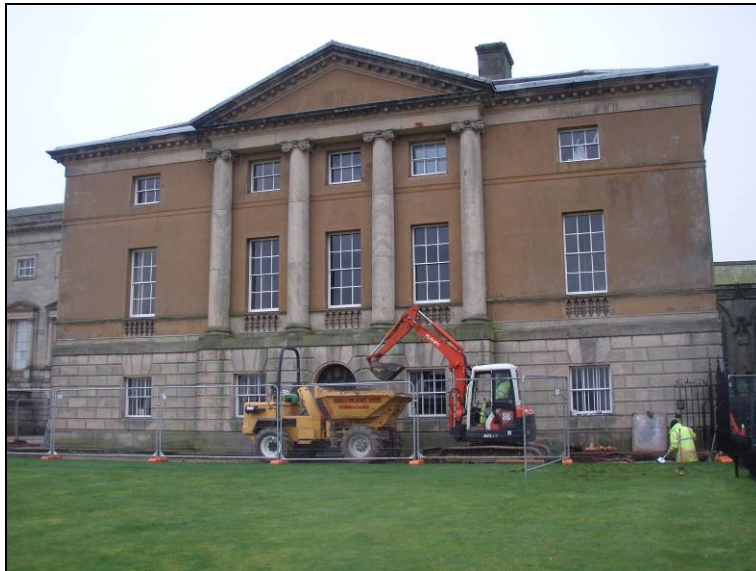
Fig. 15: View of the West Wing showing work to remove the grease trap underway.

6.3.3 Directly in front of the West Wing a pit for a replacement grease trap for the kitchen was excavated (Fig. 15). The pit measured 2m x 1.5m and had a maximum depth of 0.8m (Fig. 16). The soil around the original grease trap had been heavily disturbed and elsewhere the stratigraphy encountered consisted of a shallow layer of topsoil overlying the clay substrate (509). No archaeological deposits or artefacts were encountered in Trench 3.

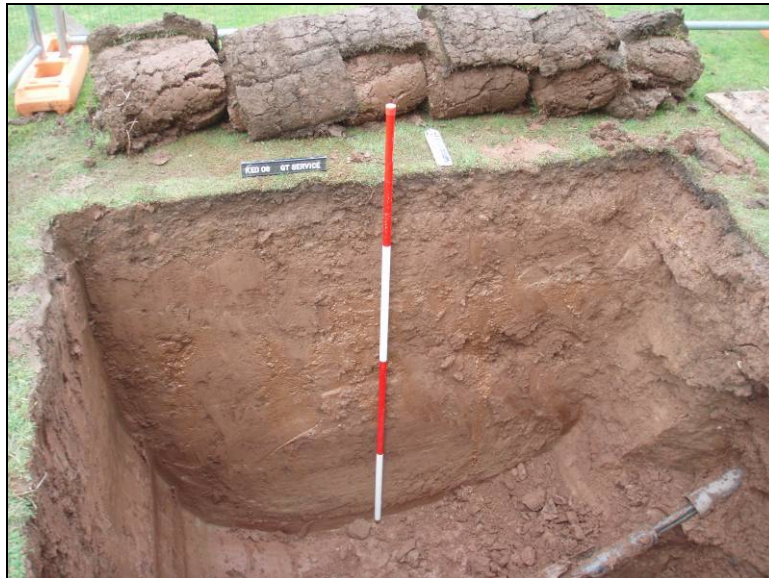
Fig. 16: View of the pit for the new grease trap, Scale: 2m (looking north).

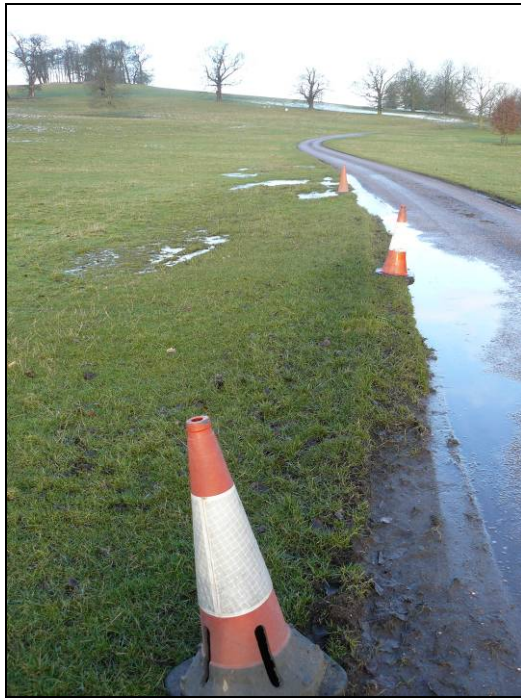
Fig. 17: View of flooded access road.

- 6.4.1 Due to flooding across the main access road a trench for a French drain was excavated along the road to the north of Trench 2 (Fig. 17). The trench measured 0.5m by approximately 15m and was between 0.6m and 0.7m in depth. The stratigraphy of the trench comprised of a thin layer of topsoil 0.1m in depth below which was the clay substrate (509) (Fig. 18). No archaeological deposits or artefacts were encountered during these works.

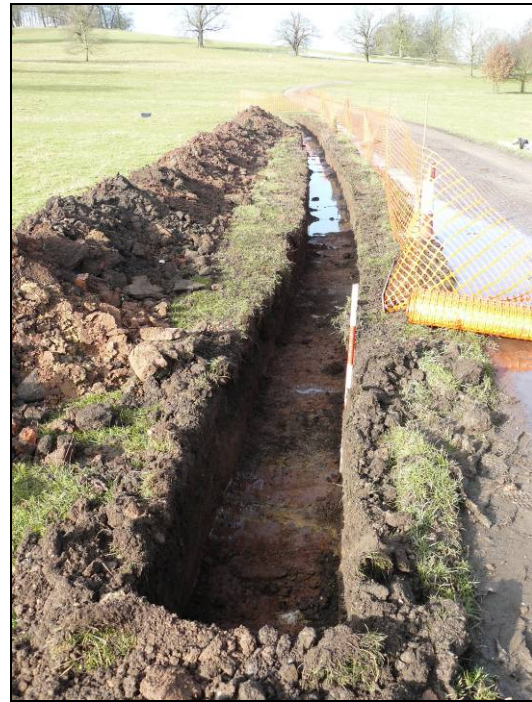
Fig. 18: Trench 4, looking west.
(Scale: 0.2m graduations)

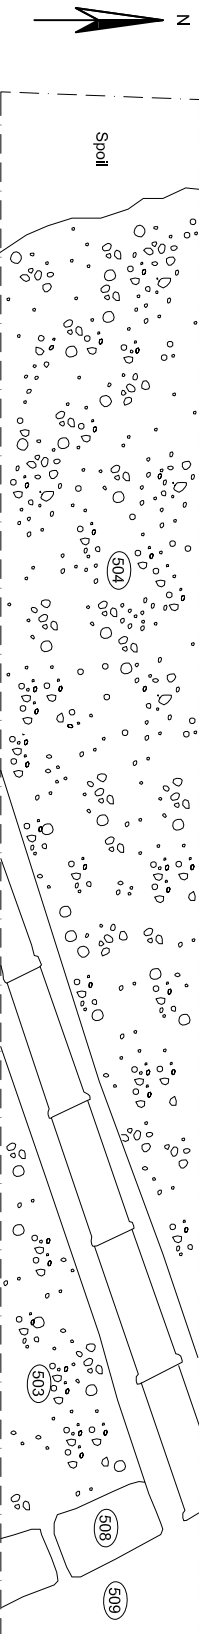
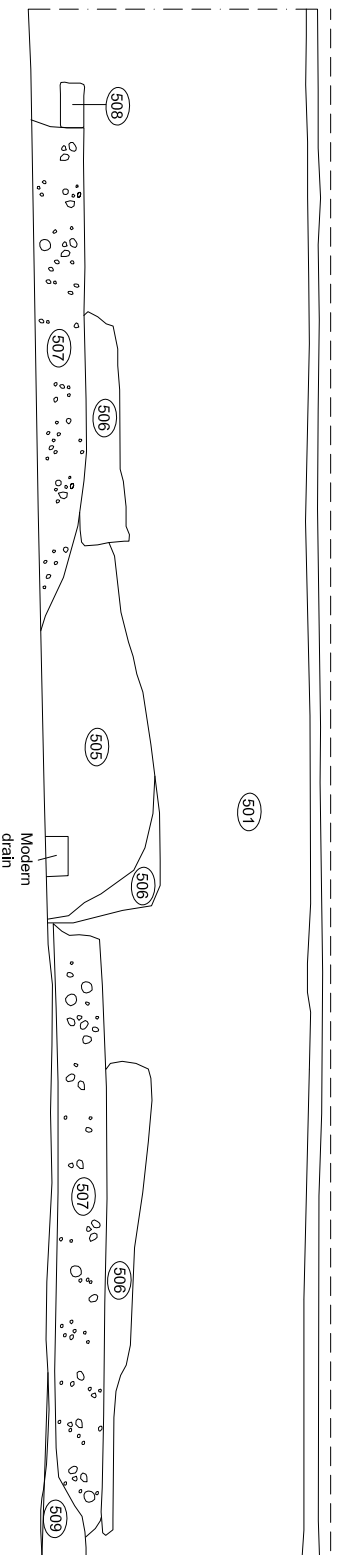
Figure: 19
 Plan and section of gravel
 path surface (Trench 1)

Plan of gravel path surface (Trench 1)

South Facing section of Trench 1 showing gravel path surface (Trench 1)

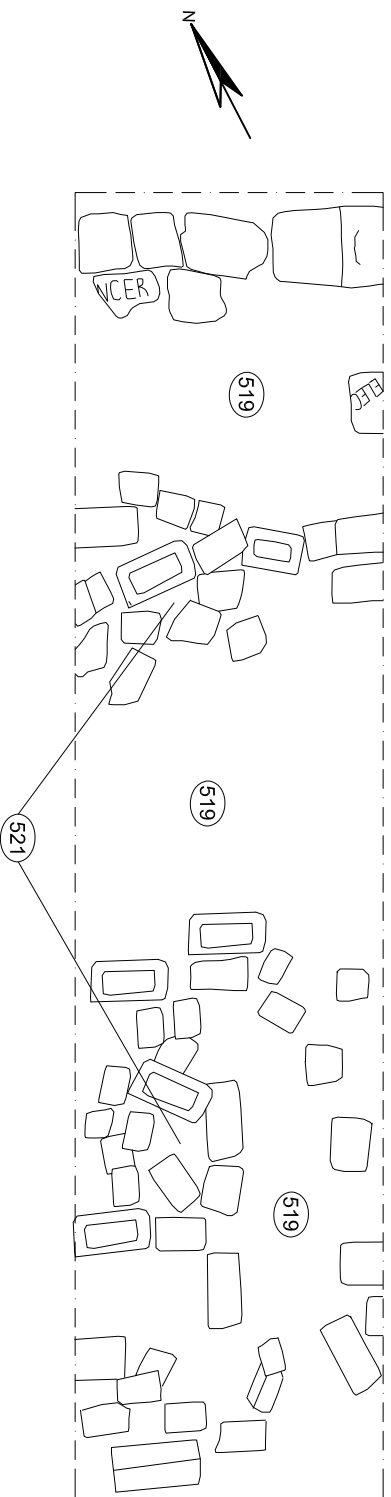
Figure 20
Plan and section of
demolition rubble (520)
found in Trench 2

Plan of brick demolition rubble (Trench 2)
