**Old Barn, High Street, Dronfield, Derbyshire**

**Report on an  
Archaeological Evaluation.**

**ARS Ltd Report No. 2009/54/75**  
March 2009

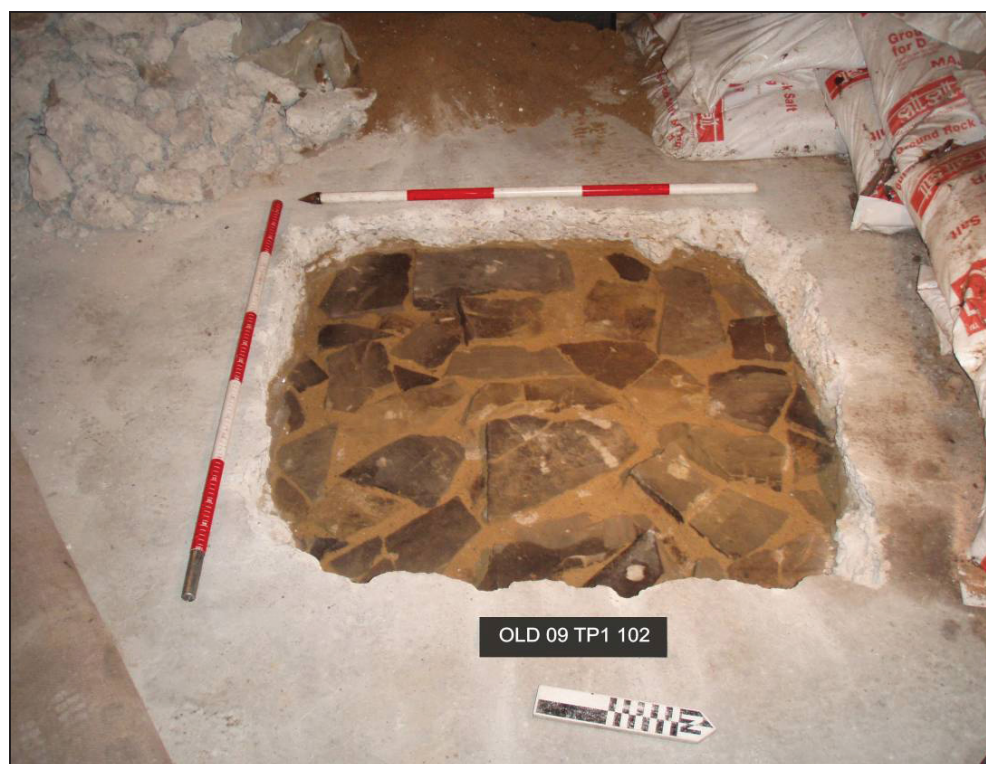
Figure 3. The sandstone floor in test pit 1, context 102, facing west.

of the surface suggested a post medieval origin, probably 20<sup>th</sup> century, but no dating evidence was recovered (Figure 3).

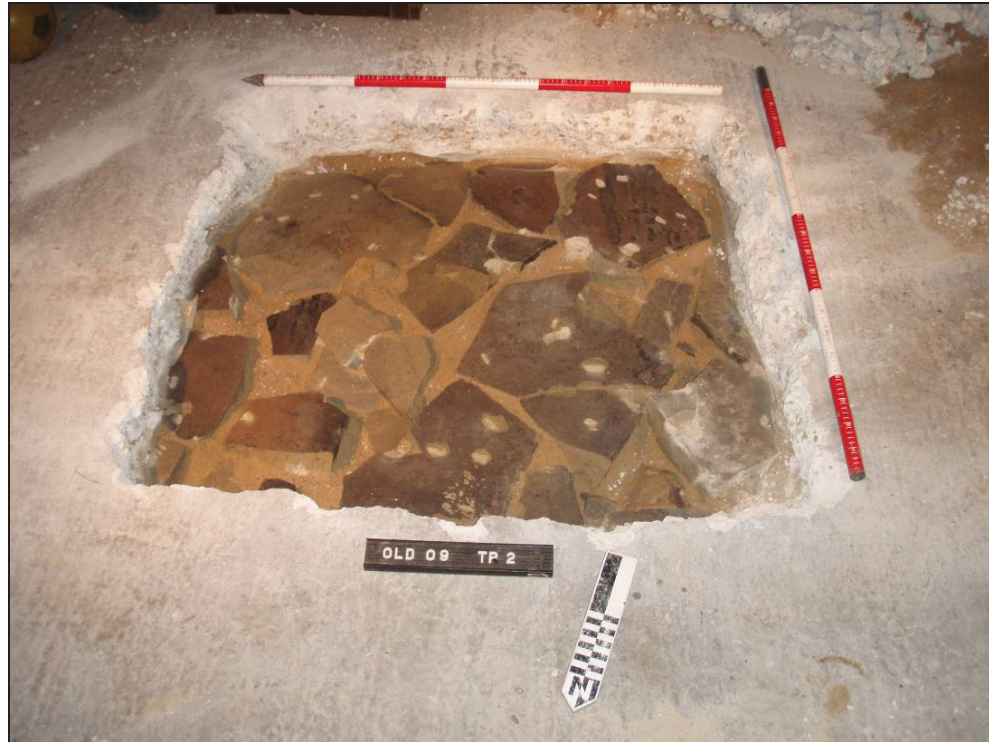
Figure 4. The sandstone floor in test pit 2, context 202, facing south.

- 6.2 Test Pit 2**
- 6.2.1 Test pit 2 was located approximately 2m south east of test pit 1 and over the same concrete deposit.
- 6.2.2 The contextual and stratigraphic sequence encountered was identical to that of test pit 1 and is represented by contexts 200-204 (see Figure 20.4). The sandstone floor was represented by context 202 and comprised of the same variable fragments of sandstone flag laid in an irregular manner (Figure 4)

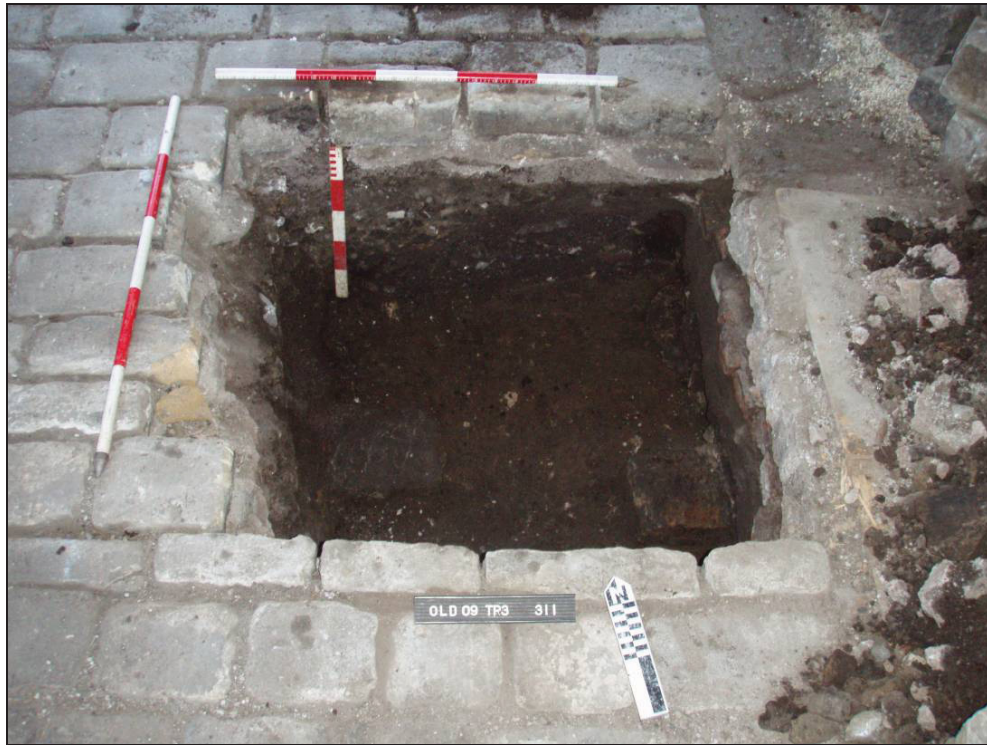
Figure 5. The south facing section of test pit 3

- 6.3.6 The deposit substantially increased in thickness from 0.01m in the east to 0.35m in the west and appeared to sit within a cut, context 303, of which only the eastern return was visible (see Figure 20.6). The cut and deposit may be associated with a modern drainage channel that currently runs through the centre of the barn from a man-hole to the north to one near the site entrance from High Street, although the line and appearance of the feature differs from that taken to represent the same utility line in test pit 14 further south (Figure 5).

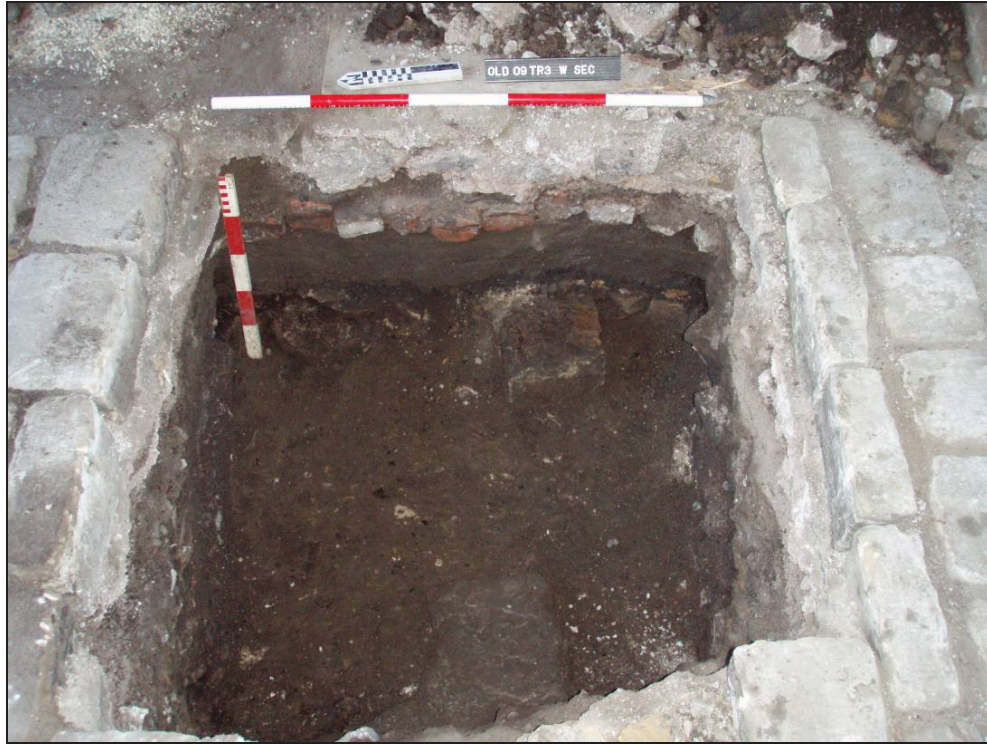
Figure 6. The west facing section of test pit 3.

- 6.3.7 Within the west facing section of the test pit multiple courses of a single skin red brick structure laid horizontally (306) were observed below the concrete. The structure did not appear to extend further west into the test pit but it was encountered in the east facing section of test pit 4 as context 401, approximately 2m further to the east (see Figure 20.6 and Figure 6).
- 6.3.8 Individual bricks appeared to be none-frogged and hand made with an approximate dimension of 0.22m by 0.1m and 0.07m thick.
- 6.3.9 The structure was held within a black ash mortar with little or no lime inclusions.

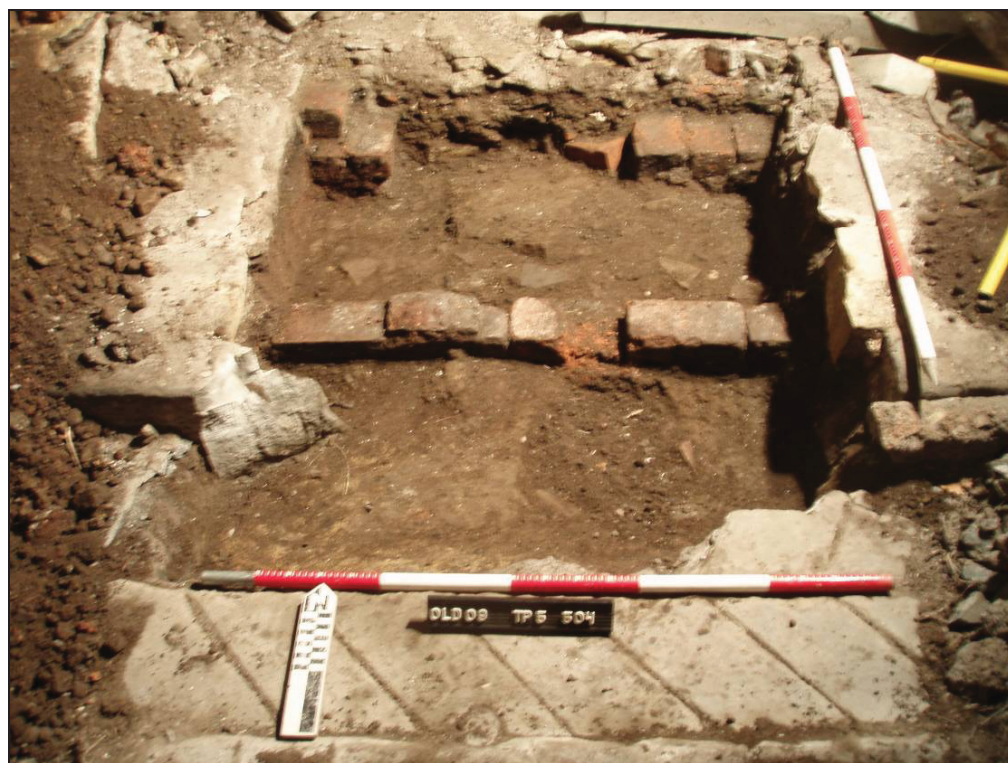
Figure 7. Red brick structures 505 (north) and 506 (south), facing north.

- 6.5.4 Deposit 507 covered two red brick structural features, context 505 and to the south 506, which ran parallel on an east west axis and were observed to extend

into test pit 7, located to the east, as contexts 704 and 705 respectively (Figure 7).

- 6.5.6 Structure 506 remained intact and consisted of a single skin and single course of the same none frogged red bricks set end on end. A black ash mortar was visible with no obvious lime inclusions.

- 6.5.7 Given the limited evidence available it is difficult to offer an interpretation for the red brick structures 505 and 506. They may have supported a floor surface, perhaps a wooden one as encountered in test pit 3. They are of post medieval date and probably relate to a phase of remodelling during the 19<sup>th</sup> century based upon the presence of the black ash mortar.

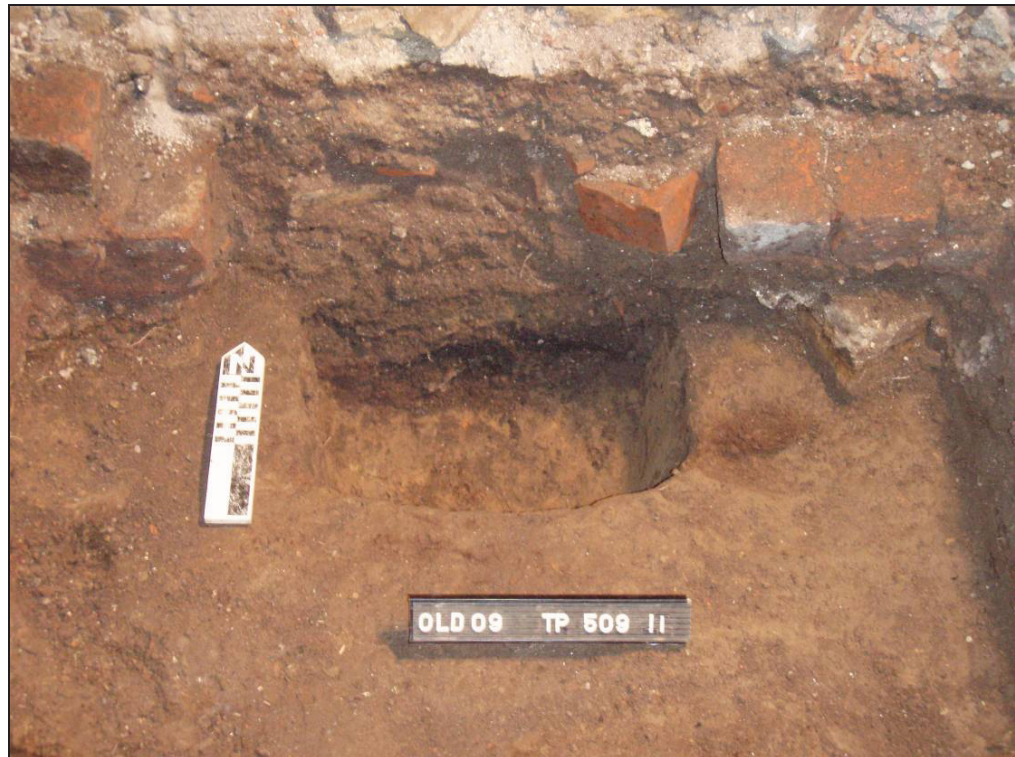
Figure 8. The south facing section of test pit 5 featuring cut 509.

- 6.5.8 As mentioned above, structure 505 had been truncated mid section by a cut, context 509, which in plan extended partially from the south facing section of the test pit and was square in shape with slightly rounded corners. In section it possessed near vertical edges extending for 0.2m with a sharp break of slope at the bottom and a flat base. It contained deposit 508 which featured elements of probable demolition debris. The cut almost certainly relates to the presence of a posthole of late post medieval 19<sup>th</sup> century date although its

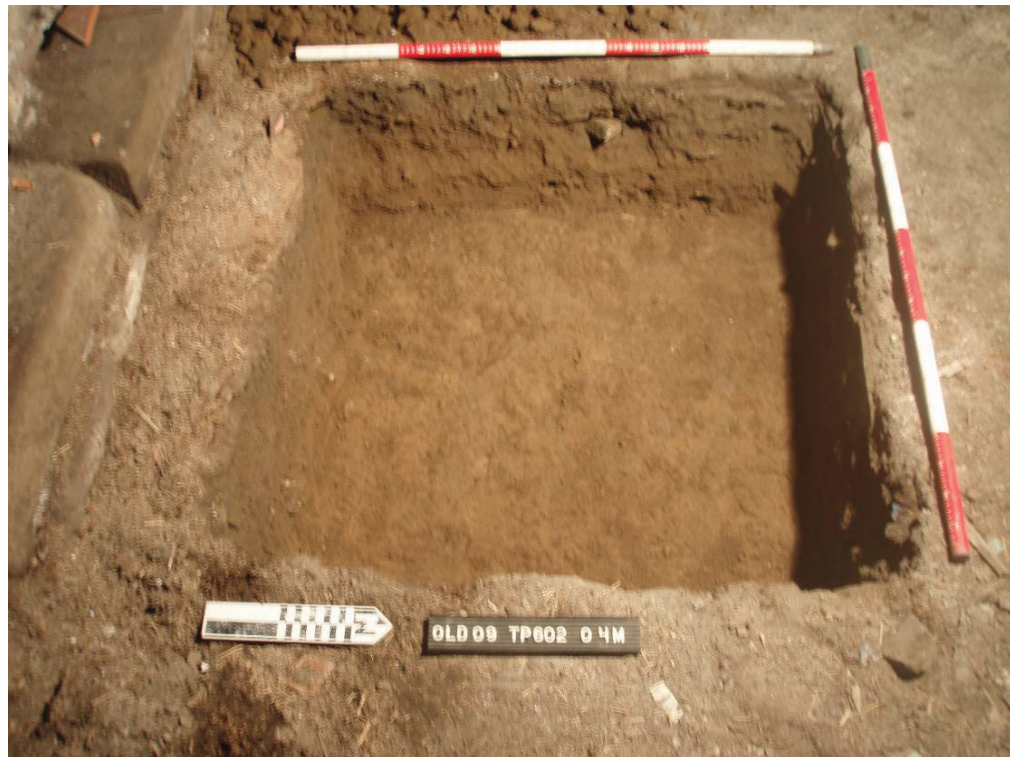
Figure 9. East facing section of test pit 6.

- 6.6.4 Below 601 was a soft light brown silty clay deposit, context 602, which was excavated to the full depth of the test pit at 0.6m below the current ground level. It was found to be clean and entirely devoid of cultural material and interpreted as a buried soil, probably the same as that encountered in test pit 5 and others, and believed to have been fossilised with the construction of the building.

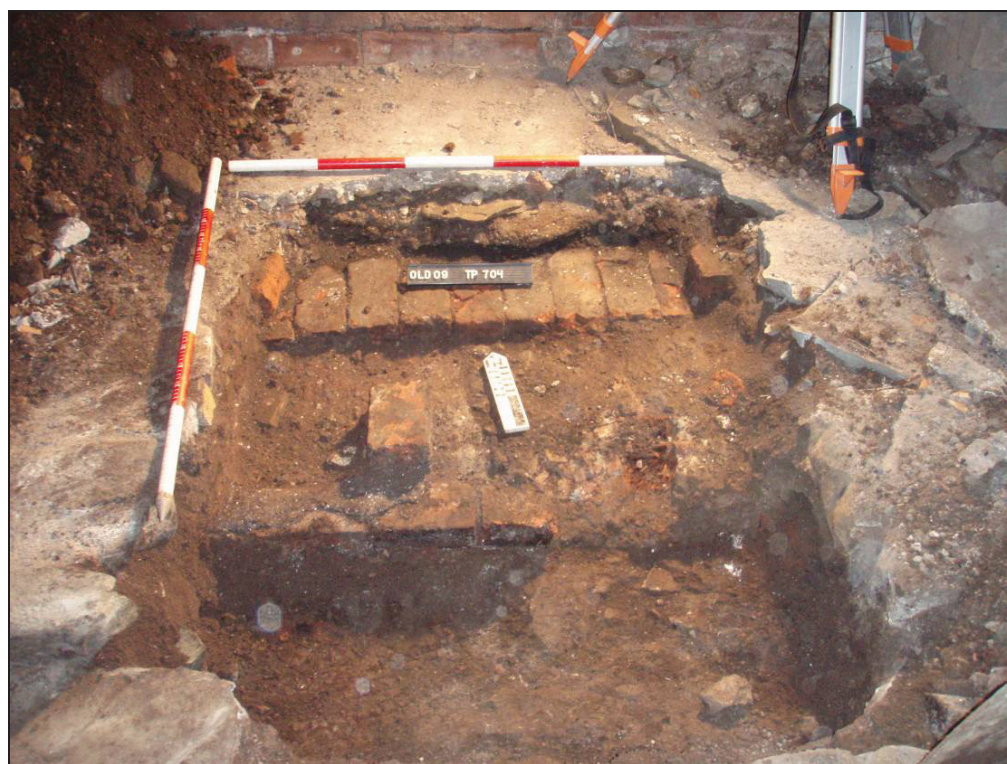
Figure 10. Test pit 7 featuring red brick structures 704 and 705.

- 6.7.4 As in test pit 5, immediately below the levelling deposits were two red brick structures running parallel to each other in an east west direction. Structure 704 ran across the entire width of the test pit along the northern limit of excavation and consisted of none frogged handmade red bricks set side by side within a black ash mortar. This represents an easterly extension of structure 505 in test pit 5. Approximately 0.4m to the south structure 705 consisted of several none frogged handmade red bricks set end on end with a black ash mortar. It extended east from the western limit of excavation for approximately 0.7m at which point it terminated in contact with deposit 709. A red brick structure extended north from 705, approximately mid way along its east west axis, and consisted of a two none frogged red bricks set in two courses extending vertically. This ancillary feature was assigned the same context number and suggests that the red brick structures may relate to an upstanding feature now removed. Structure 705 can be equated with 506 in test pit 5 (see Figure 21.2 and Figure 10).

- 6.7.5 Context 709, encountered at the eastern terminus of structure 705 (see figure 10), consisted of a concreted deposit containing fragments of red brick and sandstone. Its removal initially exposed a clay deposit, however, further examination of this feature revealed a more extensive deposit in the form of 710 that also contained mortared sandstone blocks at one level along its northern limit, compacted clay elements, as well as further concreted pockets.

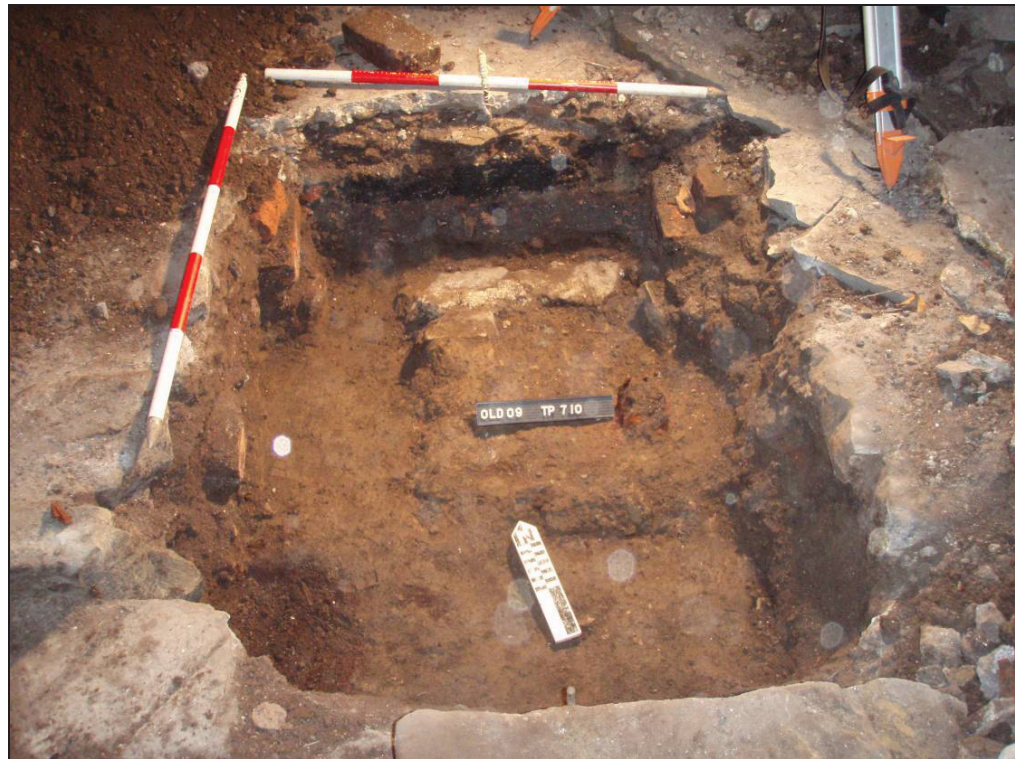
Figure 13. Test pit 7 with deposits 710 and 708 (centre) and cut 712 and fill 711 (bottom left corner).

The feature was roughly square in shape and extended down to the maximum depth of excavation and beyond. It encased a much smaller *in situ* vertical wooden post, structure 308, approximately 0.23m high (as excavated) and 0.11m long and 0.07m wide in profile. It is suggested that contexts 709 and 710 be amalgamated and represent a substantial packing deposit supporting the wooden upright structure 308. It is probable that the cut features encountered elsewhere as cut 712, 715 and indeed 509 and 513, represent similar structures for which the wooden post and surrounding packing has subsequently been removed. Again, however, such features do not appear to relate well with any of the visible upstanding structural elements above the test pits and probably relate instead to internal divisions rather than structural elements of the main barn frame. In any case the features relate to a phase of activity late in the history of the building and do not appear to relate to the medieval occupation of the site (see Figure 21.3 and Figure 11).

- 6.7.6 Two cut features appear to extend down from a point below deposit 702, cut 712 and fill 711, only partially evident in plan and the east facing section of the test pit, and cut 715 and fill 714, recorded only in profile within the west facing section of the test pit. Both features appear identical in form and content to those encountered in test pit 5 and therefore probably represent further square shaped, vertical sided and flat bottomed post holes in which the wooden upright and any packing material has since been entirely removed (Figure 21.4).

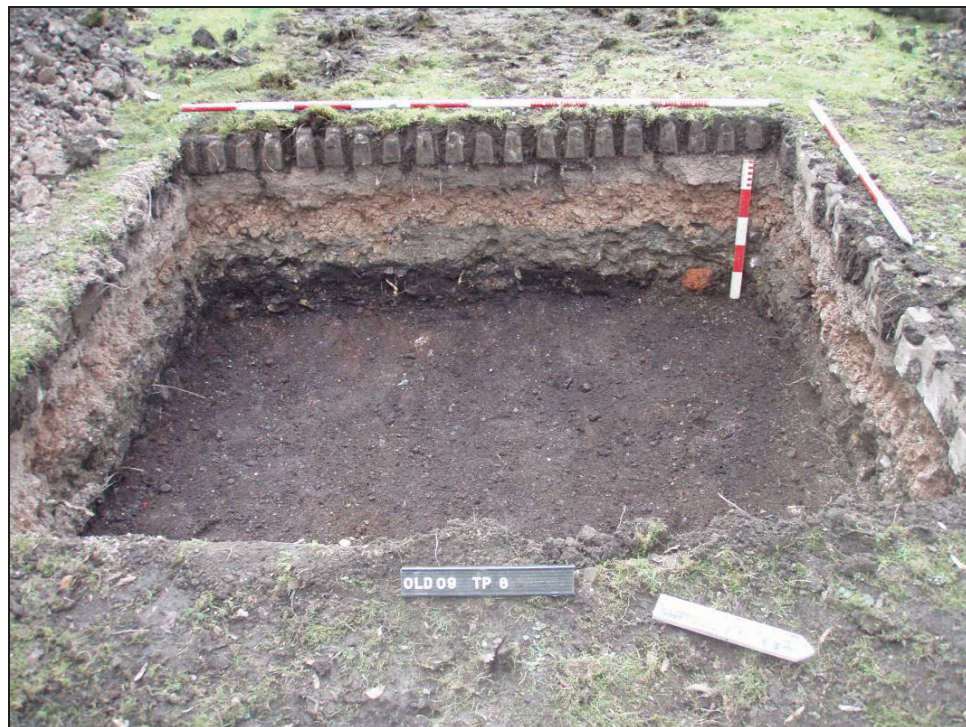
Figure 12. Test pit 8, east facing section.

6.8.3 Excavation to the maximum depth had removed approximately 0.2m of an underlying deposit that continued further to an unknown depth. This consisted of a clinker rich deposit and consequently may relate to an earlier, probably 19<sup>th</sup> century, phase of landscaping raising the ground level towards its current height (Figure 12).

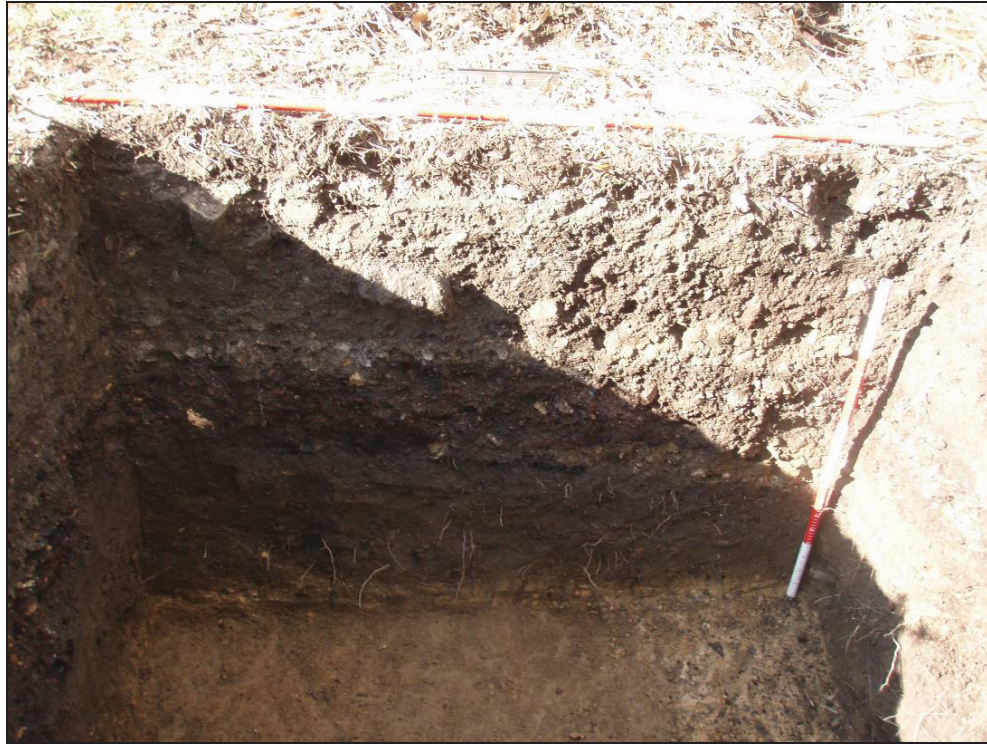
Figure 13. Test pit 10 south facing section.

- 6.10.4 The overlying deposits, contexts 1000 to 1005, consisted of variable layers of predominantly clinker elements with sandstone blocks of variable size, some up to 1m in length, randomly arranged from top to bottom. The deposits can therefore be seen to derive from a phase of landscaping, probably during the 19<sup>th</sup> century, in which the ground level was substantially raised to the current level (Figure 13).

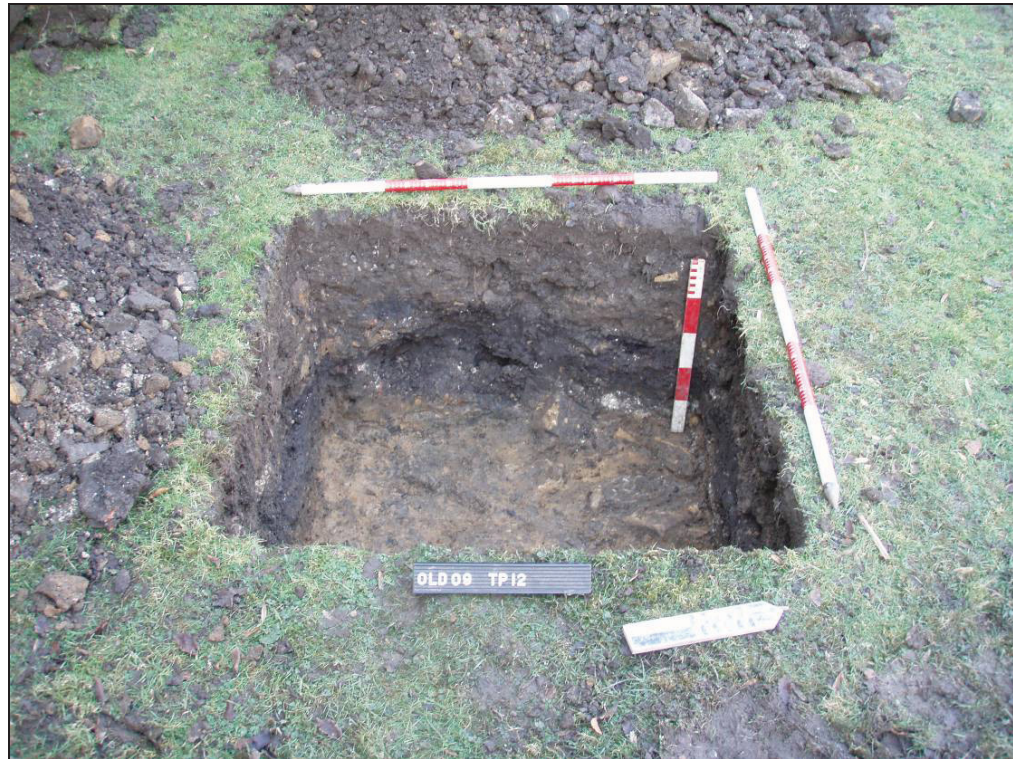
Figure 15. Test pit 12 east facing section.

- 6.12.4 Context 1203 represented the final deposit before reaching the level of clear natural boulder clay and was less than 0.1m thick. The deposit did not appear to represent made ground but may be the remnant of a buried soil or subsoil. No dating evidence was obtained from this deposit which could confirm or deny this (see Figure 22.1).

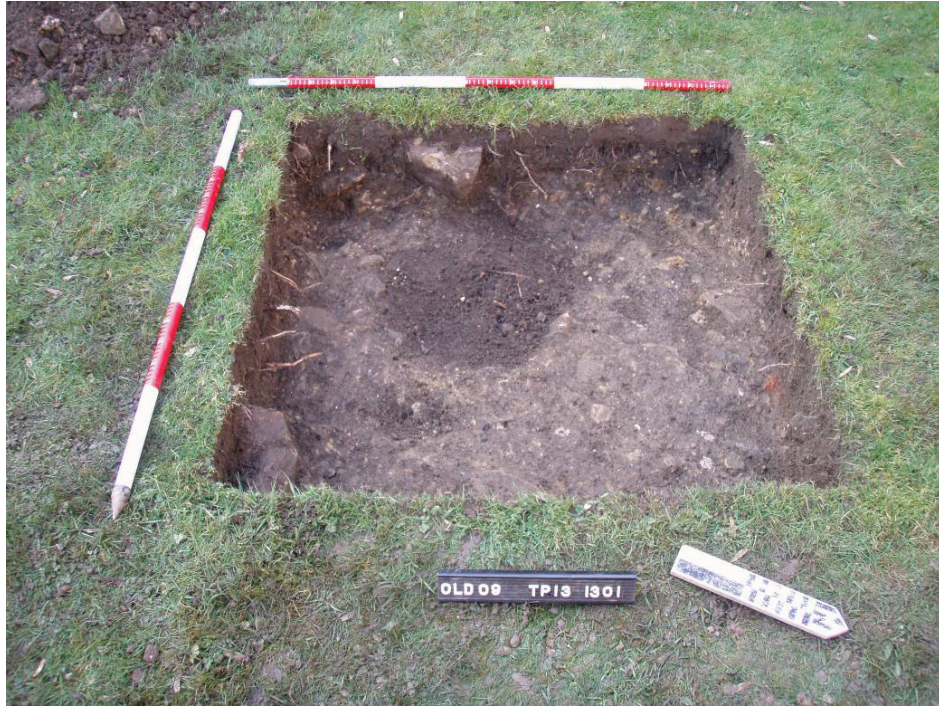
Figure 16. Test pit 13, posthole cut 1304 and fill 1303 in plan.

- 6.13.3 The overlying deposits of 1300 and 1301 represented shallow layers of made ground containing red brick fragments towards the base.
- 6.13.4 Below deposit 1301 and cut into the natural was a sub-circular feature represented by cut 1304 and fill 1303. The feature was half sectioned and the profile recorded before being fully emptied of the fill. No dateable finds were recovered from the fill. The profile of the cut was relatively shallow at 0.13m but had vertical sides to the south and a more gradual incline to the north. The break of slope at the bottom was rounded and the base flat (see Figure 22.5 and Figure 16).

- 6.13.5 The chronological sequence of this posthole is unknown. Given that the original structure is represented by the north south extension of the barn located approximately 10m further east, it is unlikely to have any structural relationship with the original building.

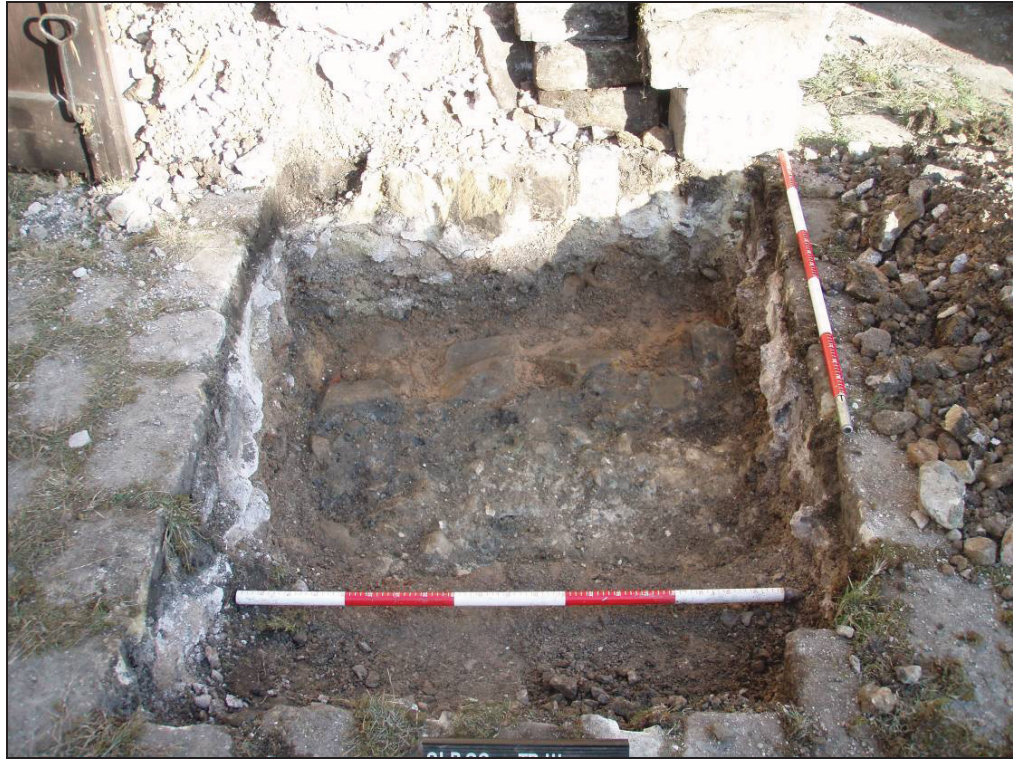
Figure 17. Test pit 14, west facing section and cut 1406 (foreground)

- 6.14.4 At the maximum level of excavation a linear feature, cut 1406 and fill 1405, was immediately obvious extending north south along the western edge of the test pit and approximately 0.6m wide. This undoubtedly represented the line of a modern drainage pipe extending north south through the centre of the barn as discussed in relation to test pit 3.

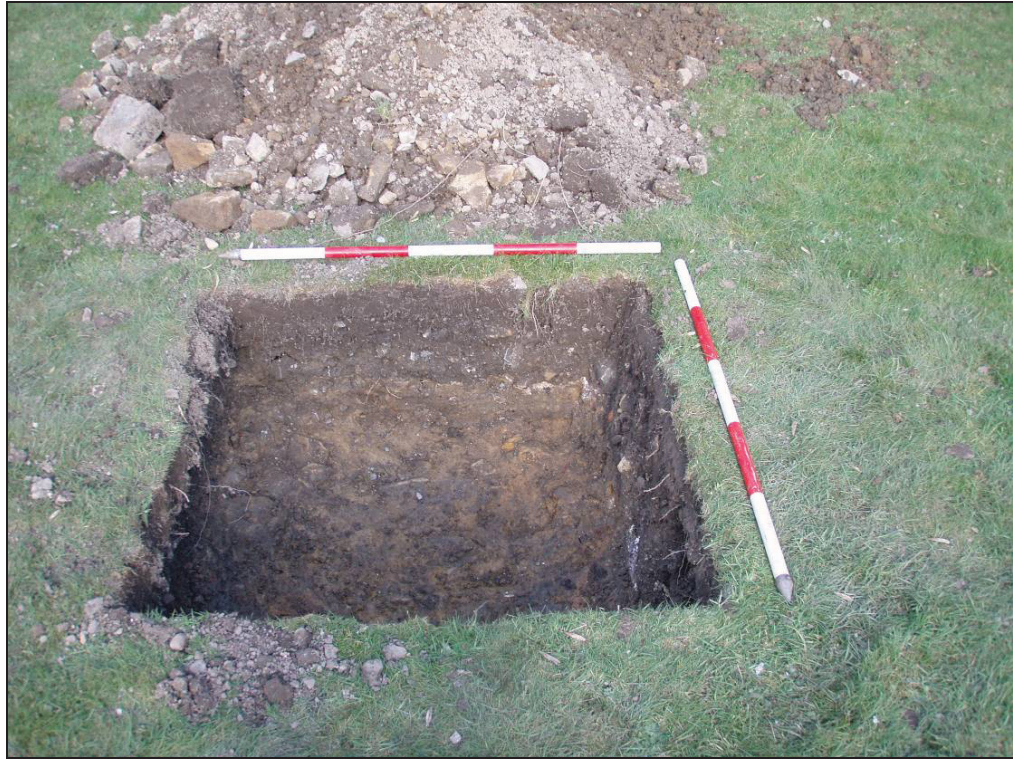
Figure 18. Test pit 15 south facing section.

- 6.15.1 Test pit 15 was located south of the southern most wall of the old barn over a grassed area.
- 6.15.2 Excavations reached a maximum depth of 0.45m before exposing a natural deposit of boulder clay in the form of context 1503 (see Figure 22.8).
- 6.15.3 Overlying deposits consisted almost entirely of made ground deposits, contexts 1500 and 1501, extending to a combined depth of 0.3m. As with deposits in test pit 12 to the rear of the barn it was unclear if the deposits related to 20<sup>th</sup> century landscaping of the site or a slightly earlier phase (Figure 18).
- 6.15.4 Similarly context 1502 may represent a further buried soil level or simply the natural formation of a subsoil after the laying of made ground. No dateable evidence was recovered to substantiate either case.
- 6.15.5 No other features of archaeological interest were encountered.

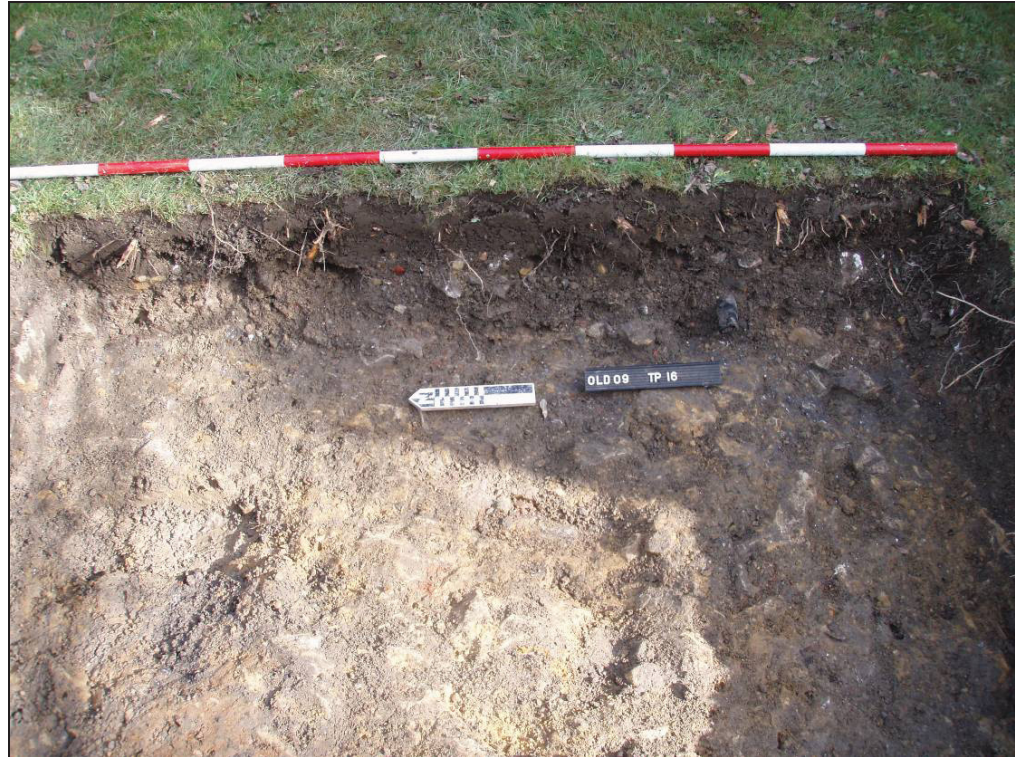
Figure 19. Test pit 16 west facing section (note the rubber pipe upon the natural at the right of the section)

- 6.16.1 Test pit 16 was located to the south of the barn and immediately north of where the current boundary wall extends west into the plot over a grassed area.
- 6.16.2 Excavations were undertaken by machine and reached a maximum depth of approximately 0.3m at which point the natural boulder clay was encountered in the form of context 1602 (see Figure 22.9).
- 6.16.3 The overlying layers of context 1600 and 1601 were found to represent modern made ground deposits as a section of rubber pipe was observed protruding out of the west facing section at the juncture with the natural. No cut was observed to contain this feature and it must be concluded that the overlying deposits were therefore 20<sup>th</sup> century in origin (Figure 19)
- 6.16.4 No other features of archaeological significance were encountered.
