Friary Road, Lichfield, Staffordshire

Report on a Watching Brief.

ARS Ltd Report No. 2009/63
February 2009

Report on a
Watching Brief – Phase Two.

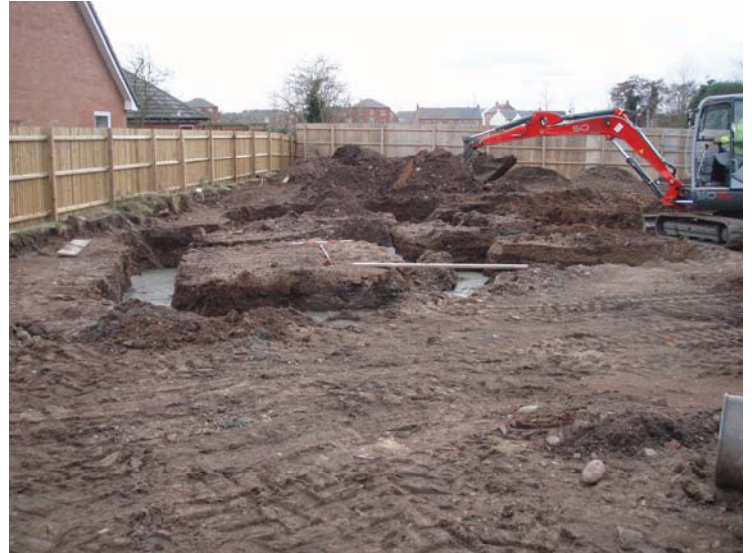
View of the foundation trenches after excavation facing south

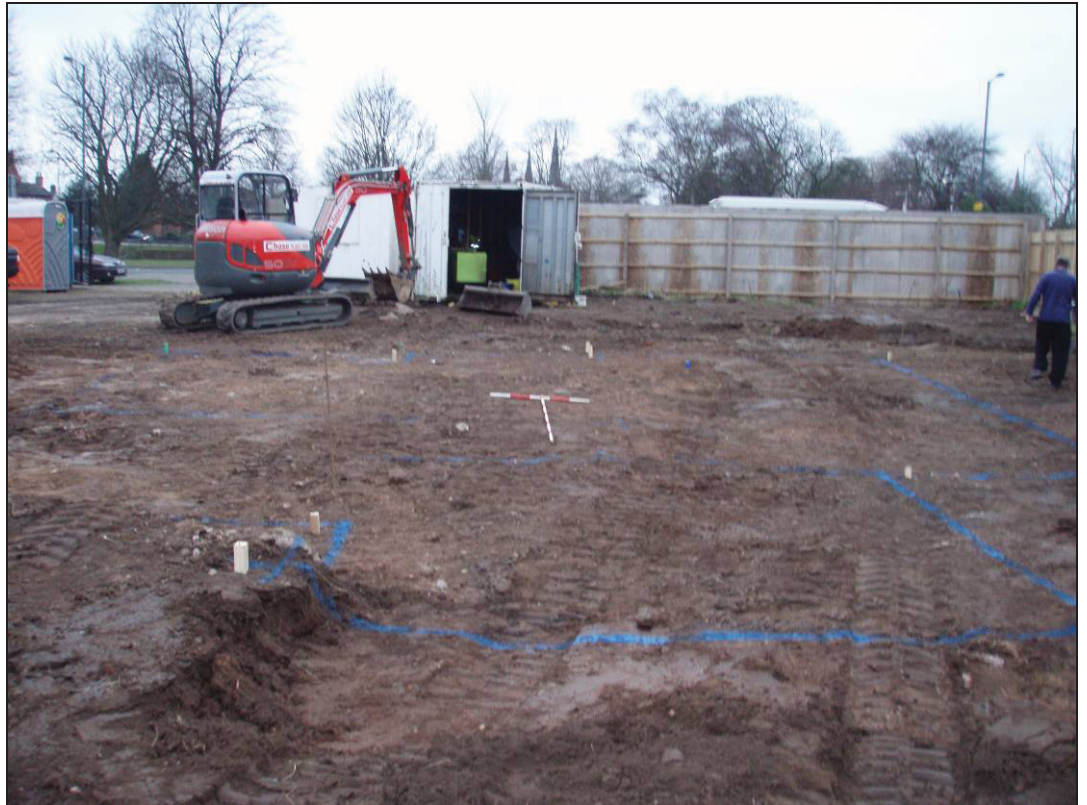
Figure 3. Stripped area prior to excavation of foundation footings

- 6.1 As detailed above, removal of the topsoil prior to arrival on site had reduced the ground level by an average depth of 0.3m across much of the eastern area in the vicinity of the intended building. This had also involved the removal of several concrete foundation deposits apparently associated with the modern 20th- century houses that formerly occupied the site. These were observed in the spoil heap and appeared not to exceed a depth of 0.4m. Reduction of the ground level in this case did not appear to have interfered with any potentially archaeologically significant deposits but had removed sections of modern 20th- century made ground deposits (Figure 3)

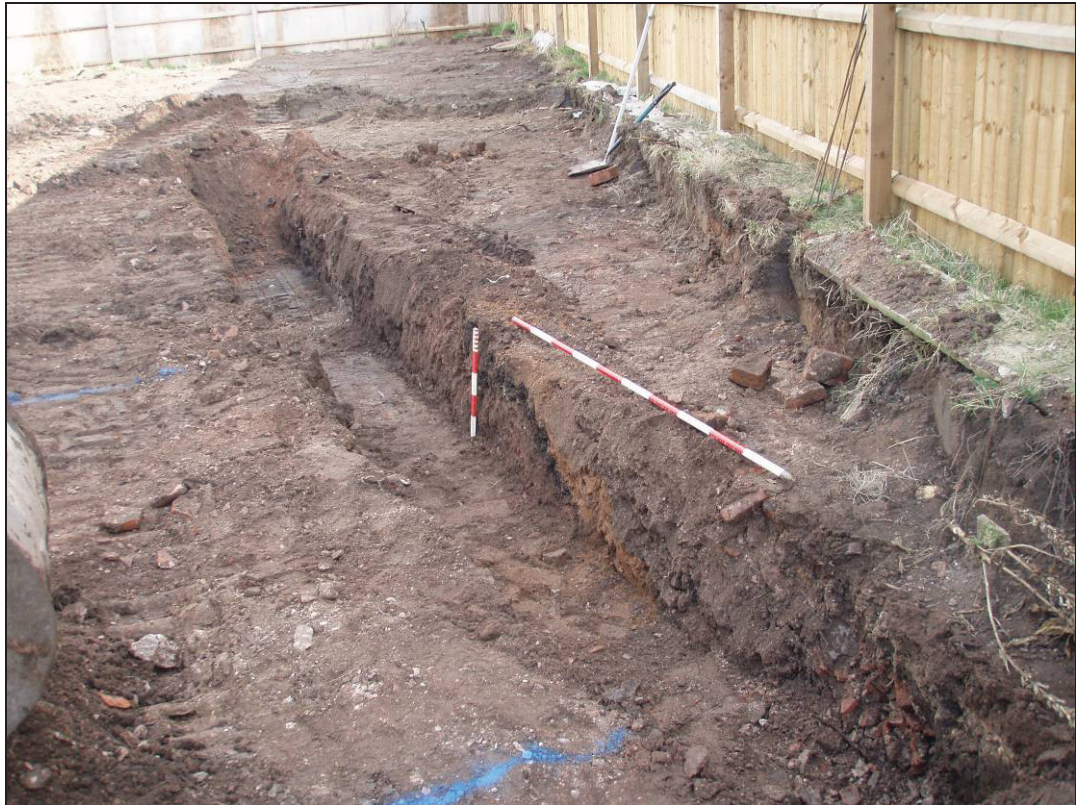
Figure 4. Oblique section of the most easterly foundation trench after initial ground reduction. Facing north.

- 6.2 After marking out the line of the foundation trenches excavation was undertaken along their line, reducing the ground a further 0.3m on average, to a maximum depth of approximately 0.6m below the modern ground surface. The trenches were observed in all cases to cut through a series of perhaps six or more extensive deposits that, due to the presence of significant quantities of modern building materials, were deemed to be 20th-century in origin (Figure 4). These deposits may relate to the decommissioning of a swimming pool, which reportedly occupied the site during the early 20th-century, and the building up of the ground prior to construction of the housing that occupied the site until this most recent phase of development.
- 6.3 No evidence of the mill or associated deposits or features were therefore encountered at this level.

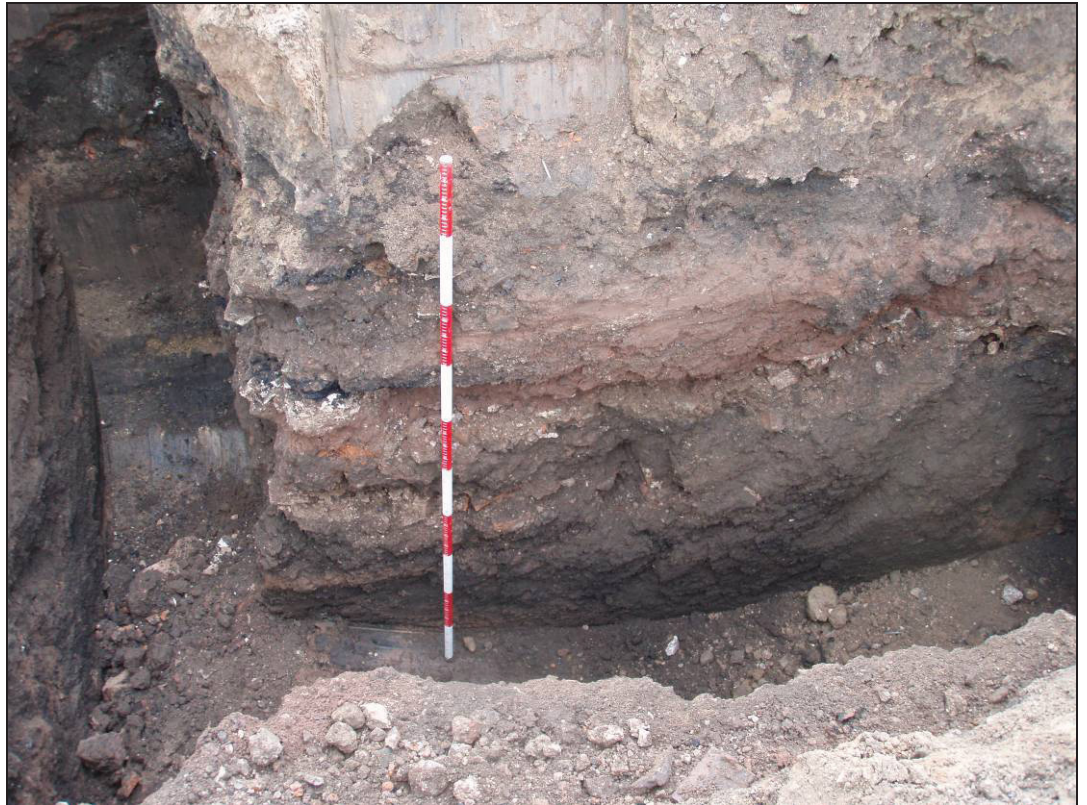
Figure 5. North facing section of a northern trench showing depth of made ground and upper bands of grey silts.

- 6.4 The footings were initially excavated to a maximum depth of 0.6m in accordance with the original architectural specifications and an initial test survey carried out in the western section of the site. This indicated the presence of natural deposits at this level, however, this clearly was not the case towards the east of the site and as a result the Clark of Works ordered the trenches to be reduced further as the made ground deposits were deemed to be too unstable for the purposes of construction. The trench level was subsequently reduced to the level of the underlying natural. This further phase of excavation revealed the deposition of made ground to continue to a depth of approximately 1.4m at which point a series of dark grey silty deposits were encountered. Due to the instability of the sections and the overall depths of the trenches these deposits could not be examined in any detail but were observed to extend in some areas to a maximum depth of 3.2m (Figure 5 and 6). At this depth they appeared to give way to an identifiable natural deposit of orange sand.

- 6.5 Due to the safety constraints mentioned above in relation to the depth and stability of the trenches the grey deposits could not be examined in situ and consequently could not be properly characterised or recorded in section. The deposits were examined as they were excavated and placed upon the spoil heap and found to differ slightly in character from north to south. Those deposits encountered further to the north of the site appeared to comprise a greater quantity of sand and silt while those to the south, particularly those deriving from the southern most trench of the building, contained a much higher organic content and were almost black in colour. The aroma of water logged deposits was also highly evident in this region

even when stood at some height above them at the level of the current ground surface. No cultural material was recovered from any of the grey deposits.

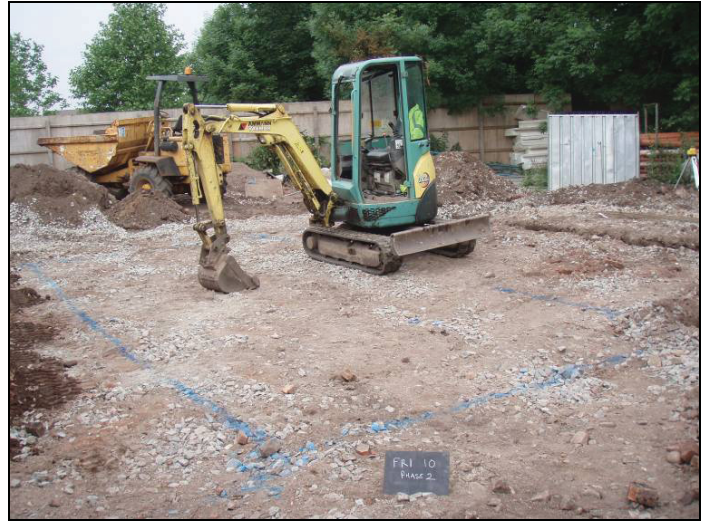
View of phase two excavation area. Facing south.

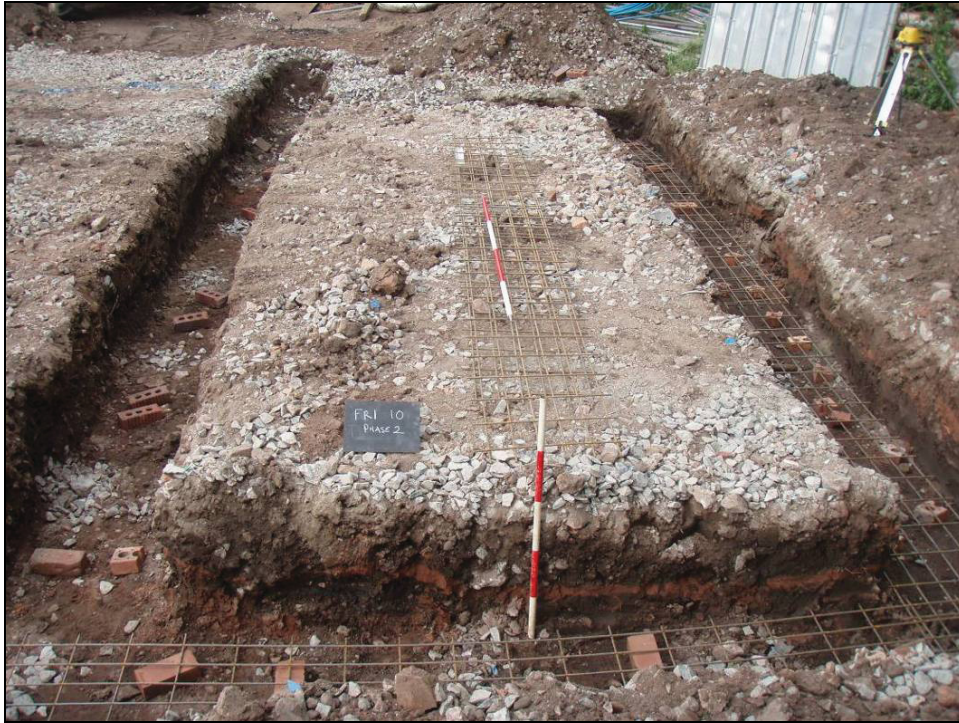
Fig. 3: Excavated area at the western extent of the site. Facing south. Scale 1m & 2m.

- 6.1. During excavation of phase one the initial deposits encountered were identified as modern made ground containing significant quantities of modern building debris, which extended to a depth of approximately 1.4m. The probability of a raised ground surface was substantiated by a concrete block retaining wall to the west and south of the site, which was standing to a height of 0.85m below site ground level at the western extent of the site, orientated north to south and adjacent to Trunkfield Brook.
- 6.2. The trenches were excavated to a depth of 0.6m and the material excavated consisted entirely of modern made ground (Figs 3, 4 &5).
