Friary Road, Lichfield, Staffordshire

Report on a Watching Brief.

ARS Ltd Report No. 2009/63
February 2009

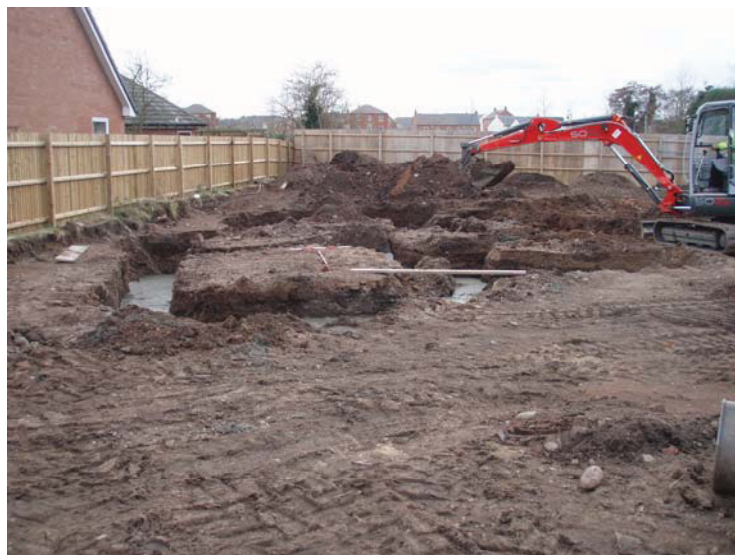
View of the foundation trenches after excavation facing south
