**Archaeological Watching Brief at
220 Mansfield Road, Derby.**

Report 2009/59

October 2009

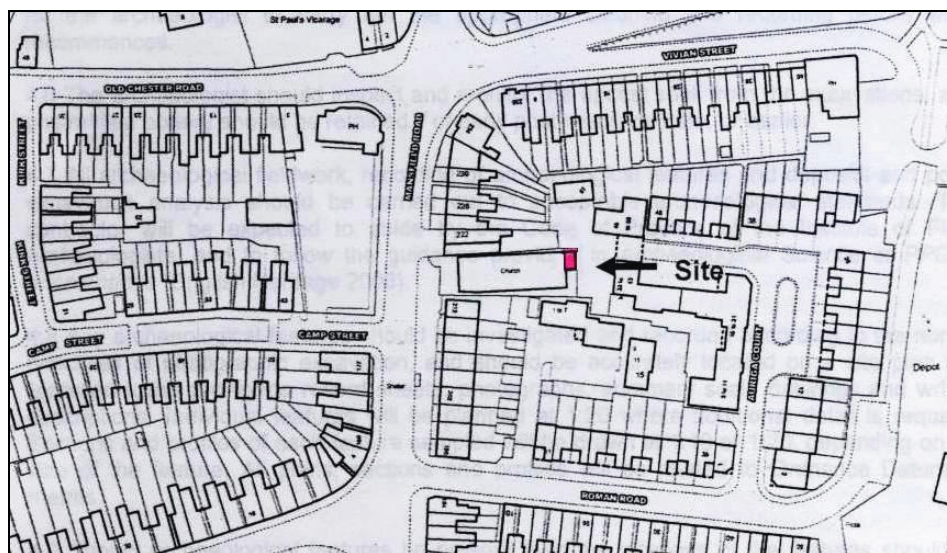
Figure 2: The present church with the proposed new extension shown in pink

1.1 In June 2009 Archaeological Research Services Ltd were commissioned by Malcolm Bayliss, Architect & Surveyor, to undertake an archaeological watching brief at Seventh Day Adventist Church, 220 Mansfield Road, Derby (Fig. 1). The work was carried out during groundworks for the construction of an extension at the north-west corner of the church (Fig. 2).

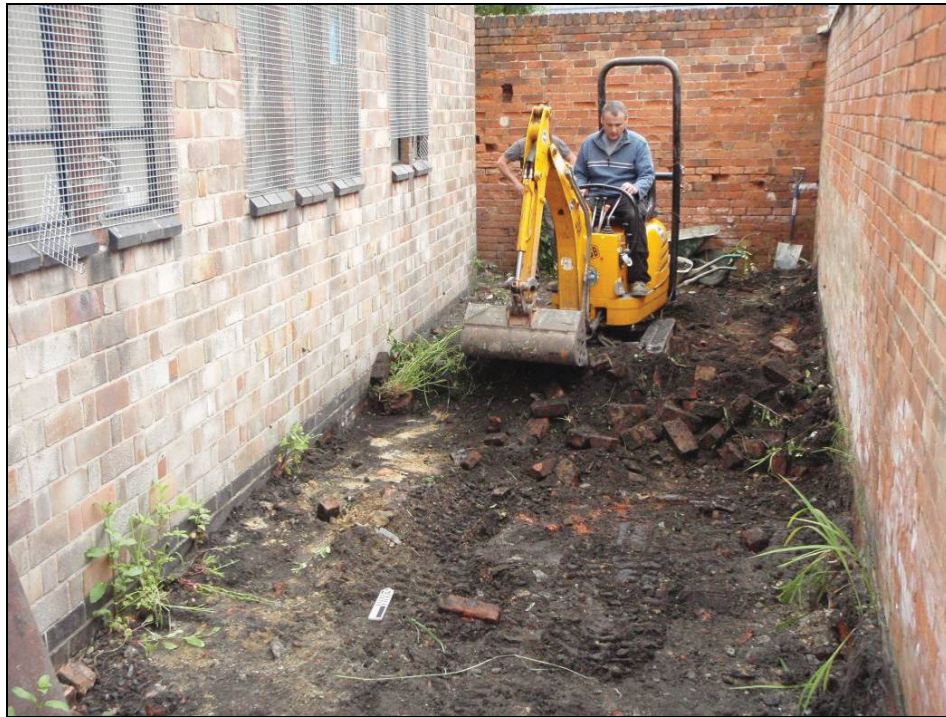
6.2 The project commenced with the excavation of a c. 10m long trench running from west to east and turning diagonally towards the north (Fig. 3). The trench was excavated to insert a drain pipe. The trench was 600mm wide and had a maximum depth of 500mm. The stratigraphy consisted of a thin layer of topsoil (101) c. 100mm thick over a made-ground layer (103) composed of dark brownish grey firm clayey silt with a general thickness of 400mm and containing

Figure 3: Excavation of drain trench, looking east

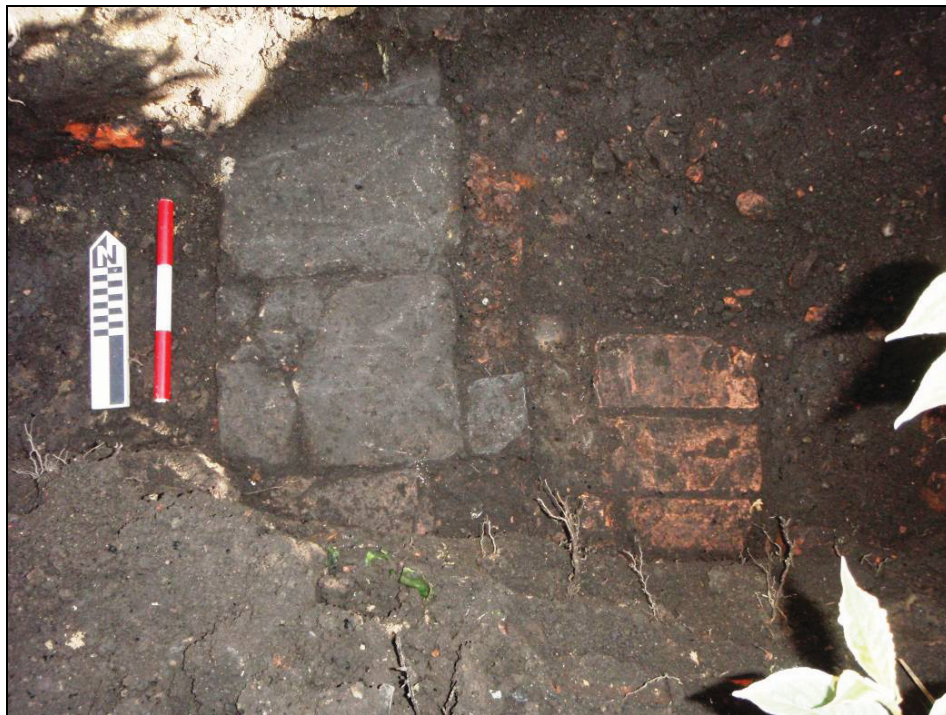
- 6.3 The remains of a brick wall (105) with an associated sandstone flagstone floor (104) were revealed at the eastern end of the trench at an approximate depth of 500mm below the present ground level (Fig. 4). The brick wall (105) was orientated north to south and consisted of two courses of orange red hand-made bricks (9½” x 4¾” x 3”) bonded with flush light whitish brown fine lime mortar (up to 15mm thick) and laid to English Bond. The floor (104) was situated on the western side of the wall and was composed mainly of three flagstones (350mm x 250mm x 100) made of dressed sandstone slabs with their base roughly squared, dry bonded and laid over a made-ground layer (119). The floor also contained a few brick fragments abutting the wall. Some of the bricks were laid on edge and others were laid on bed. These surviving masonry remains appear to have been constructed in the 19th century.

Figure 4: Remains of sandstone floor (104) and brick wall (105)

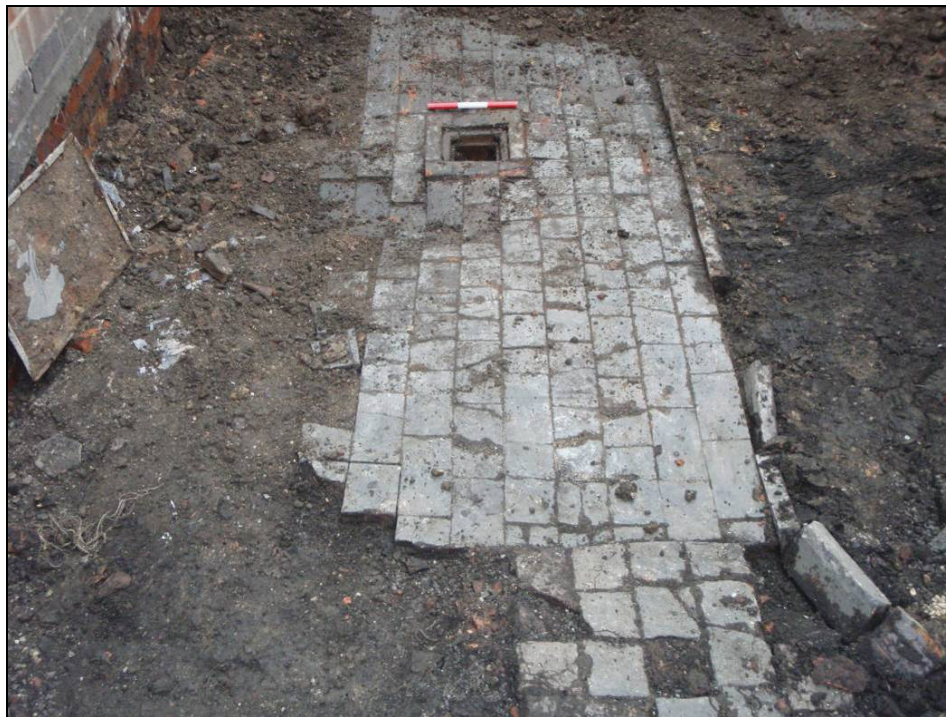
- 6.5 The external brick floor (106) was made of modern paving blue engineering bricks (9” x 4½” x 1½”) bonded with brownish black soft clayey silt and laid on bed to stretcher bond (North/South). There is a possible repaired/rebuilt area (108) on the south-east corner of the floor, which is made of similar bricks but had a distinct division. Adjacent to the main boundary wall (107), there was a rectangular area marked by brick edging which appears to have been used as a plant/flower bed filled by a dark brownish black firm clayey silt soil (109) with occasional charcoal flecks. The western side seems to have been cut by the foundation of the present church. Approximately in the centre of the paved floor there was a square drain opening (400 x 400mm). The characteristics of this floor indicate that it was a side/back yard area of the adjacent remnants of a house on the north.

Figure 5: Brick floor (106), looking north

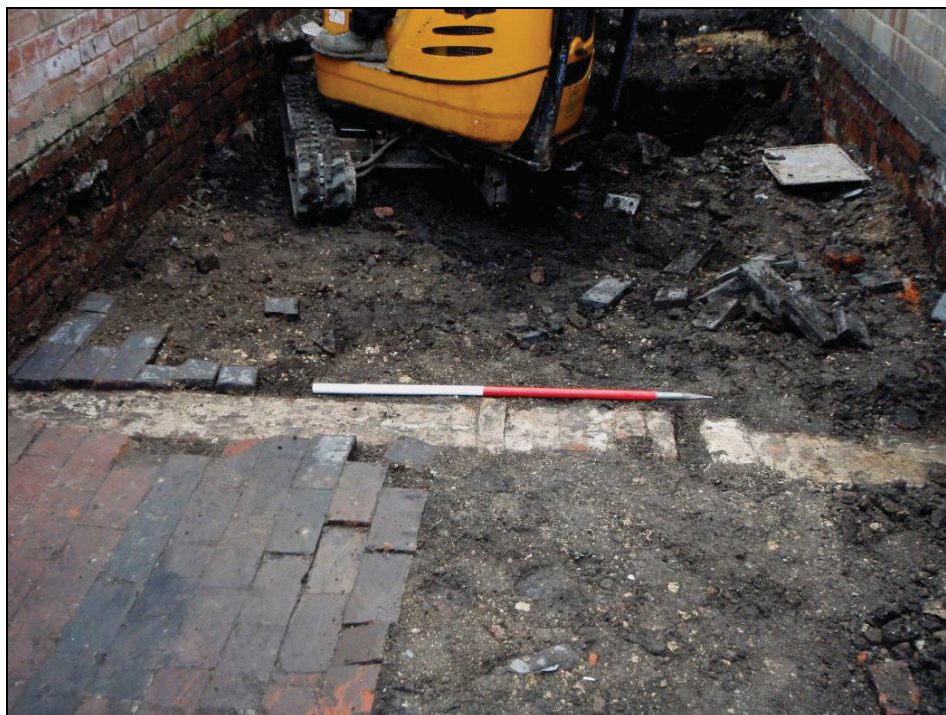
Figure 6: E/W brick wall (110), looking south

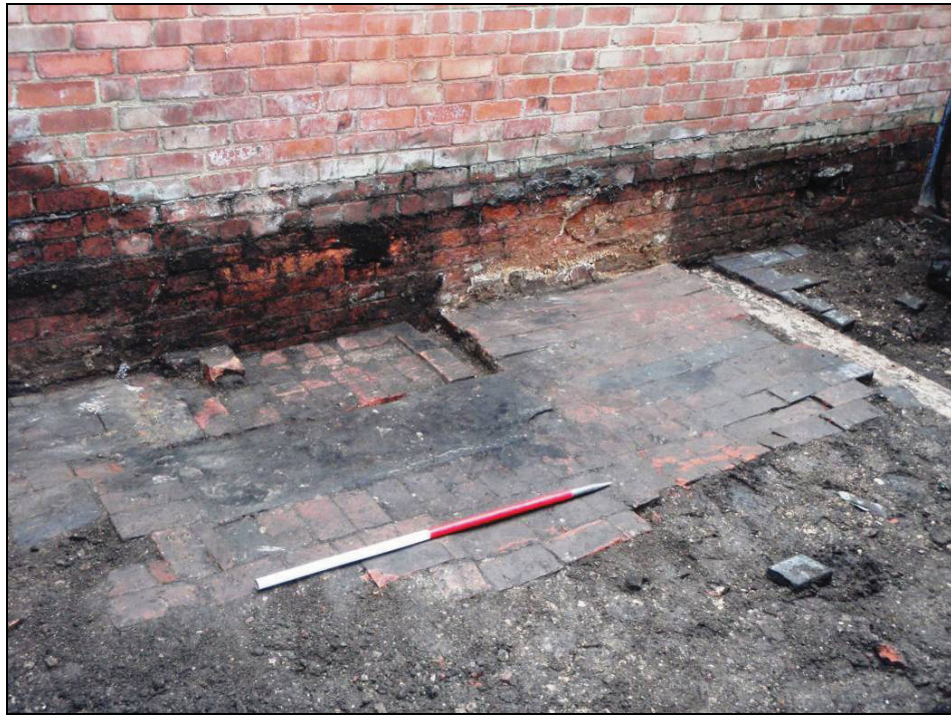
- 6.6 The internal brick floor (111) was also made of modern paving orange bricks (9” x 4½” x 1¾”) bonded with brownish black soft clayey silt and laid on bed to stretcher bond (N/S). The western side seems to have been cut by the foundation of the present church. Traces of a fire place (112) were identified against the eastern main boundary wall (107). These consisted of two parallel dismantled single veneer brick walls joined by a green sandstone slab (125mm long x 400mm wide). Around the remains of the fire place structure there were traces of surviving plaster over the main eastern boundary wall.

Figure 7: Brick floor (111) and remains of fire place (112), looking east

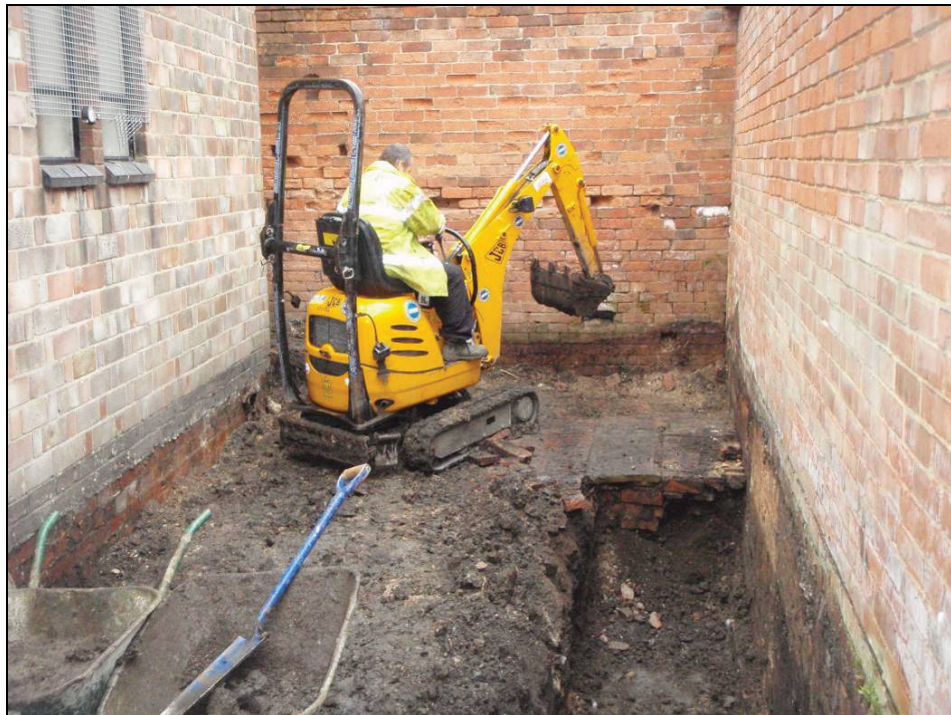
- 6.10 The demolition of the fire place (112) also enabled to establish the nature of its construction, which was built of a veneer of brick wall backfilled with a deposit (118) composed of frequent ceramic building material within a loose silty matrix (Fig. 8).

Figure 8: Foundation trench along garden wall, looking north

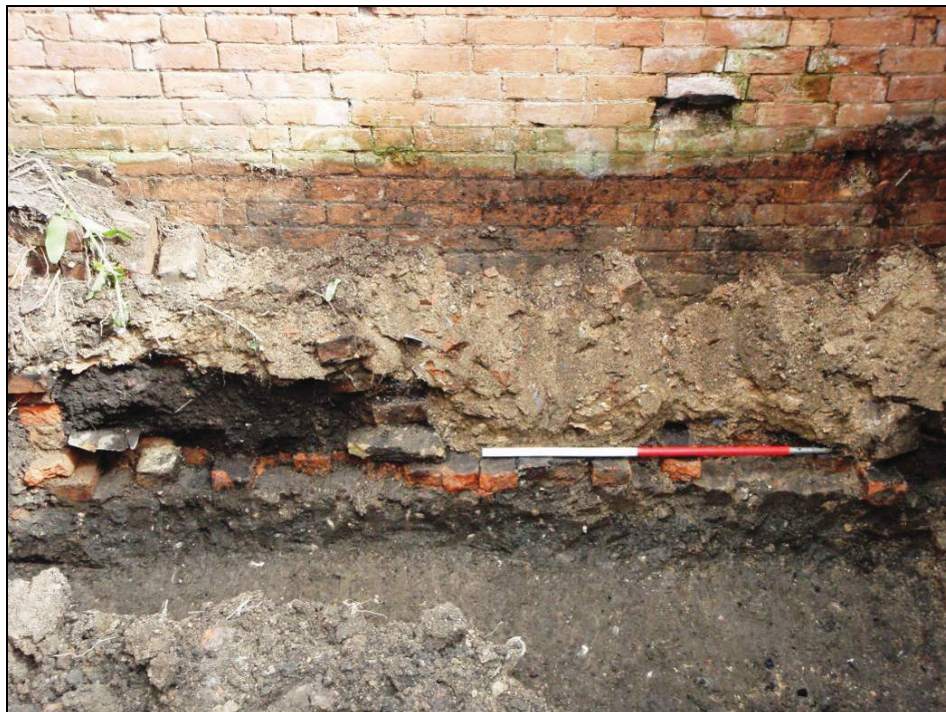
- 6.11 The northern end of the foundation trench revealed an earlier masonry remain, consisting of a brick floor (115) with a possible storage container (114) constructed from two brick walls laid over the floor (Fig. 9). The floor was found at 900mm below the present ground level. The possible container was filled by a dark brownish grey firm clayey silt deposit (113) with occasional small ceramic building material fragments. The floor was heavily truncated and only visible after cleaning the section across the foundation trench. The reason for this truncation is unknown as no cuts were identified. However, a plausible cause is that it may have been made by a robber trench for the dismantlement of a former E/W wall. The upper layer (102) over these masonry remains is completely different from the entire site as it is composed of a mixed demolition material composed of light yellowish brown loose mortar, ceramic building material fragments, slate fragments within a loose mid brown clayey silt matrix. The nature of this deposit may be a backfill of the possible robber trench suggested above.

- 6.12 Floor (115) was made of orange bricks (9¹/₄" x 4³/₄" x 3") bonded with soft brownish grey clayey silt with charcoal flecks. The floor extends towards the north underneath the existing E/W wall of the church northern boundary. The layers below the floor are the aforementioned (116) and the natural substratum (117).

Figure 9: Section 3 across northern end of foundation trench revealing brick floor (115)

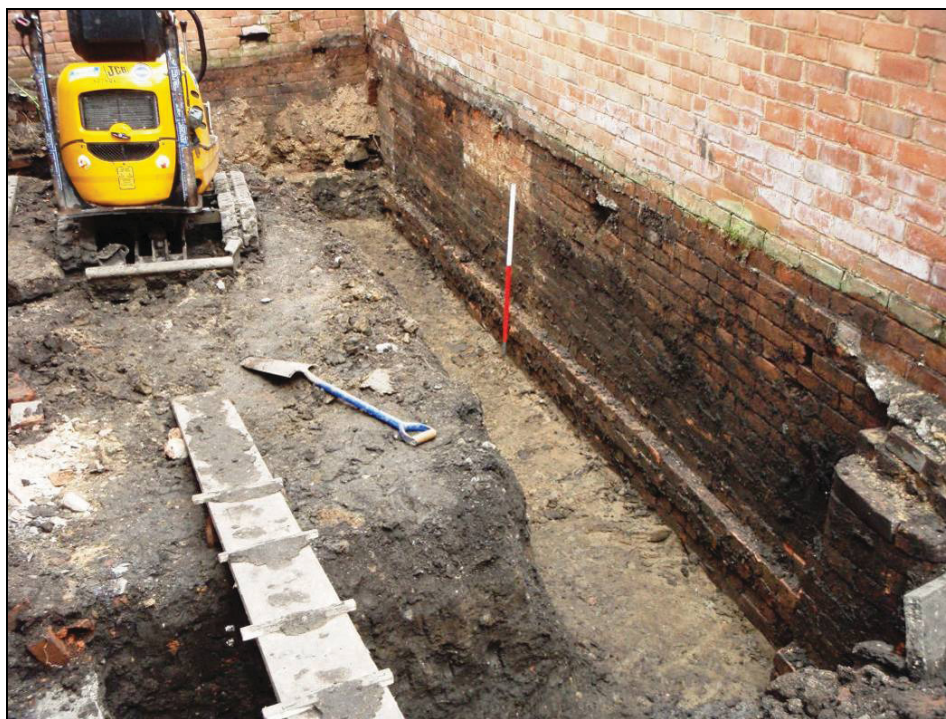
- 6.7 Following the removal of the brick floors (106) and (111) and the uppermost courses of the East/West wall (110), a ‘U’ shaped trench was excavated for the foundation of the proposed extension building. The trench measured 7.10 metres

long (N/S), 1 metre wide and had a maximum depth of c. 1.50 metres below the present ground surface. The northern E/W return measures 3 metres in length and the southern counterpart 2.60 metres (Figs. 8-10).

- 6.8 The excavated deposits consisted of two made-ground layers (119) and (116) which were very similar in character, composed of mid brownish grey firm silty clay with occasional sub-round pebbles. Layer (119) produced two modern glass jars and one clay pipe with no stamps. The natural substratum (117) was also encountered at the base of the trench. This consists of a mid yellowish brown hard silty clay layer and seems to be undisturbed.

Figure 10: Foundation trench fully excavated down to the natural sub-stratum (117)
