**Ireton Home Farm, Kedleston.
Results of an Archaeological Watching Brief.**

ARS Ltd Report 2009/32
12th May 2009

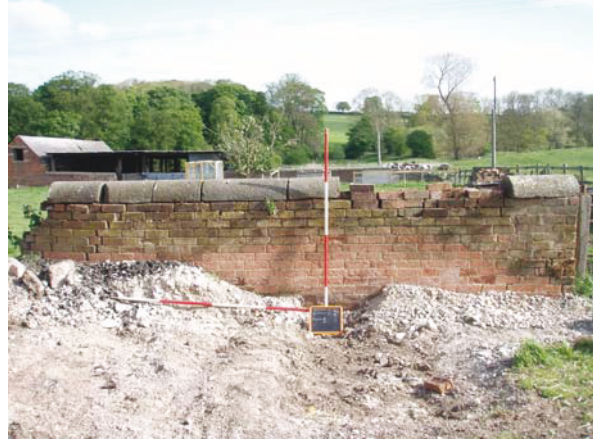
Post medieval wall preserved during
excavation looking North.

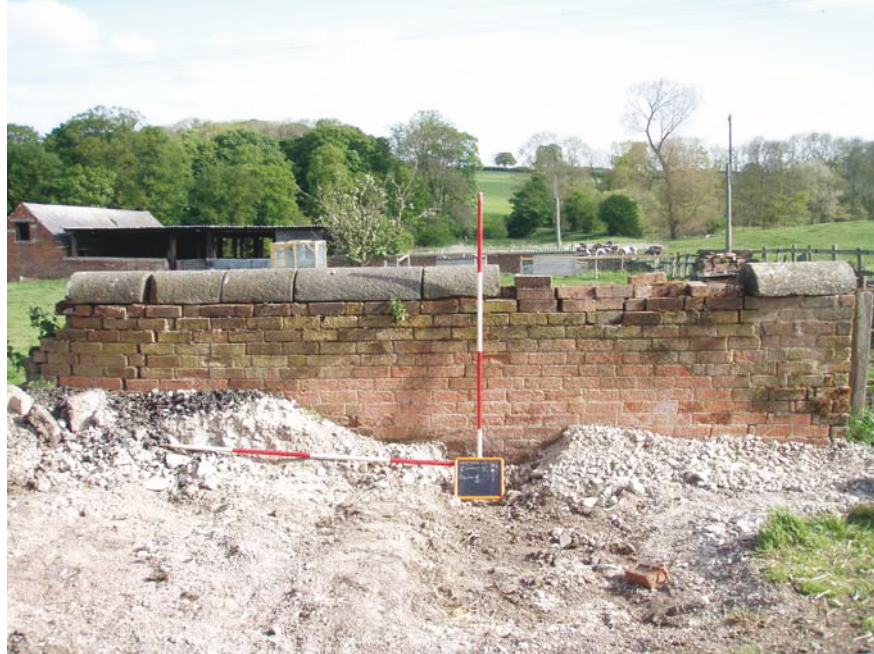
Fig. 3: Wall (001) in situ prior to excavations

- 5.2 The trench was excavated either side of an upstanding post medieval brick wall which was to be preserved as part of the new cowshed. To the north of this wall the excavations measured 7.2m x 28.2m and ran parallel to the existing field boundary. This wall was in poor repair and extremely fragile and so was photographed, measured and assigned the context number (001) in case of any potential damage caused by excavations. To the south of this wall the excavations were smaller measuring 3.1m x 13.4m. The whole of the trench was excavated to a depth of less than 0.5m and so most of what was revealed to the south of the wall was highly disturbed topsoil (002) with large amounts of residual brick, tile, glass, 20th century pottery and plastic sheeting relating to recent farmyard activity.

- 5.7 Wall (001) was left in situ and upstanding once all excavation and backfill of stone hardcore had been completed and will comprise part of the finished cowshed.

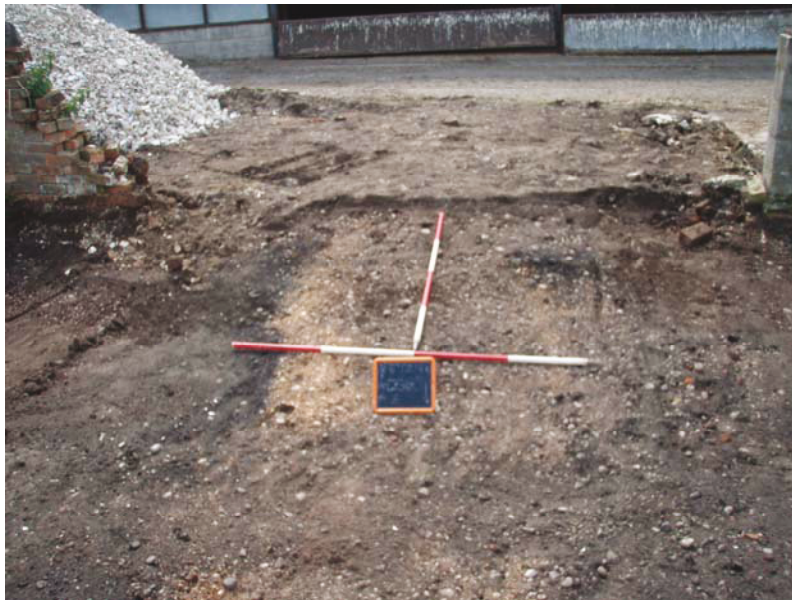
- 5.3 To the north of the wall (001) the disturbed topsoil (002) continued but here was completely removed by excavation. Underneath (002) there was a disturbed layer made up of clay mixed with the same residual pottery and cinders (003). The modern finds from these layers suggest that this relates to repeated dumping of waste material in this area. This was confirmed by the tenants of the farm who can remember this occurring as recently as the 1950s. The foundations of wall (001) appear to be set into this layer and presumably run deeper.
- 5.4 The only archaeological features that were recorded by the watching brief were three possible post medieval track surfaces (004), (005) and (006) which appear to cut through layer (003). All three (004), (005), and (006) are made up of layers of

Fig. 4: Highly disturbed subsoil surface (003)
Relating to dumping and track (004)

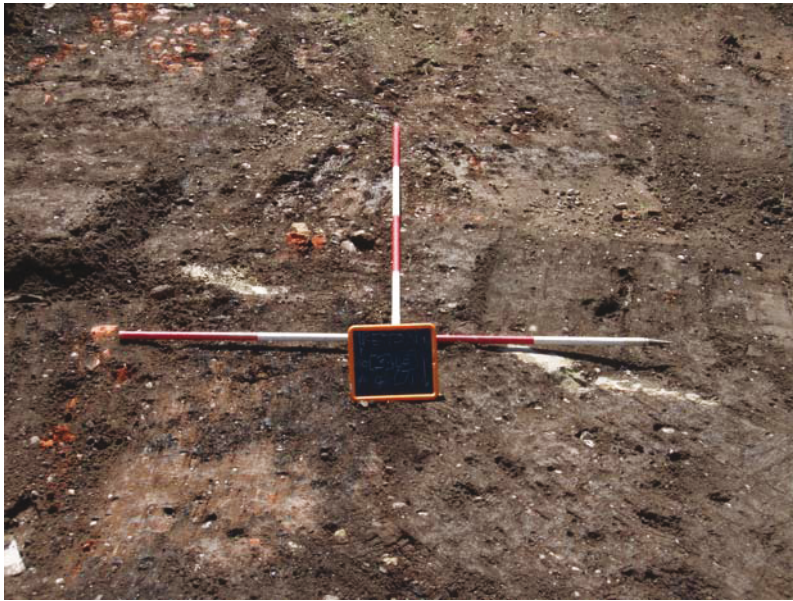
cinders and broken up 19th century brick with residual late 19th and 20th century pottery and modern glass. As with the episodes of dumping the tenant can remember these tracks in use until relatively recently and the surfaces appear to be post medieval or modern. Track (006) had undergone repairs at some point with a layer of half bricks (008) dumped probably as an attempt to backfill a pothole.

- 5.5 The only other features recorded were two drains (007) and (009) that cut diagonally across the trench on the same alignment and (Southeast – Northwest) and cut through the track surfaces of (005) and (006) respectively (Fig 6). These postdate the post medieval tracks and are most likely also 19th or 20th century in origin. Drain (007) appears to be at least partially stone lined with sandstone.
- 5.6 All these features will be preserved under a layer of hardcore and the concrete raft on which the new cowshed will be constructed on as no deeper foundations will be excavated. No artefacts were collected during the watching brief due to the residual nature of the very recent pottery, glass and brick that made up the excavated layers. No complete ceramic vessels or diagnostic artefacts were observed.

Fig. 5: Track (005) showing crushed brick rubble and cinder surfacing and drain (007) cutting through.
