**Alton Towers Resort, Alton,
Results of an Archaeological Watching Brief.**

ARS Ltd Report 2009/49
19th June 2009

**Alton Towers,
Alton, Results of an Archaeological Watching Brief**

ARS Ltd Report 2009/49

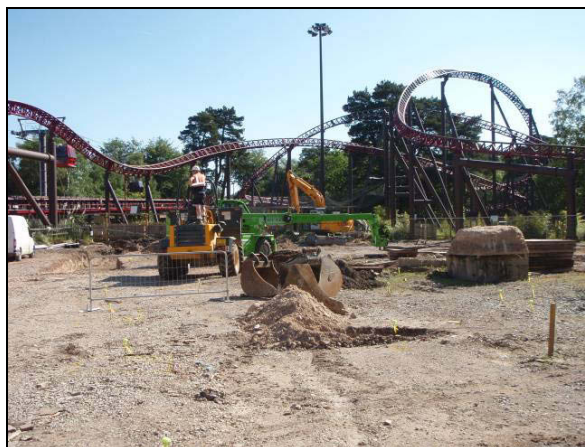
Location of 15 test pits in the vicinity of the
dismantled "Corkscrew"

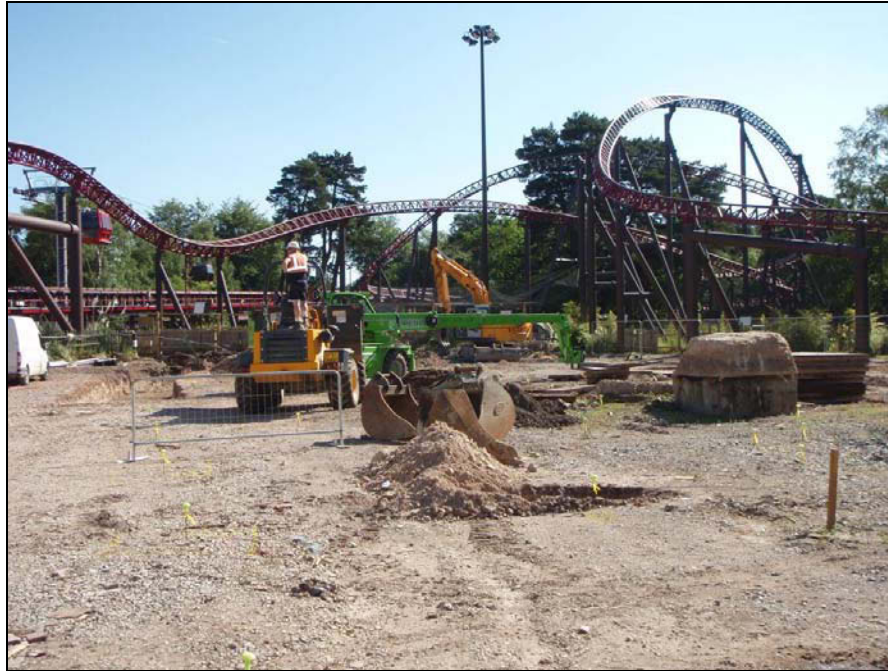
- 5.1 Fifteen initial test pits measuring 2m x 2m in the area of the former corkscrew rollercoaster at SK 073 430 (Area A) revealed no archaeological deposits (Fig. 3). In this area gently sloping sandstone bedrock [004] was overlain by up to 2m of hardcore stone [001] and [002], deposited for the foundations of the corkscrew (Fig.4). If any archaeological remains were ever present in this area they were removed during these works. In two test pits a thin layer of crushed sandstone was observed [003] but this appeared to have been created as a result of the dumping of hardcore rubble and contained modern brick fragments and metalwork debris. Further observations were made of groundworks in this area but no archaeological features were observed.

Figure 3. Location of test pits within the area formerly occupied by the corkscrew pleasure ride.

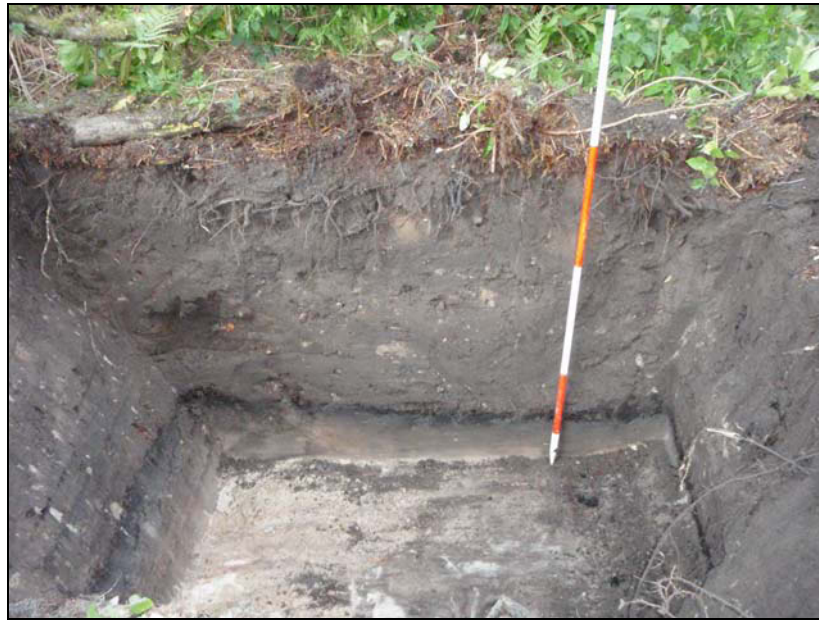
- 5.2 In the woodland (Area B) excavation of small foundation pits for the supports of the new ride were observed (Fig 5.). These measured from 1m² to 2.7m² and the excavations were observed down to bedrock (Fig. 5). All were excavated with a toothless ditching bucket and revealed a deep layer of redposited sandy clay [006] which contained modern brick, glass and other modern debris underneath the leaf mould [009] (Fig. 6). This was apparently the result of bulldozing of the higher ground to create a platform for the corkscrew ride, the resulting spoil being deposited down slope. This layer was consistently disturbed by root action and modern debris and revealed no archaeological features.

Figure 6. Excavation of foundation pit in woodland area.

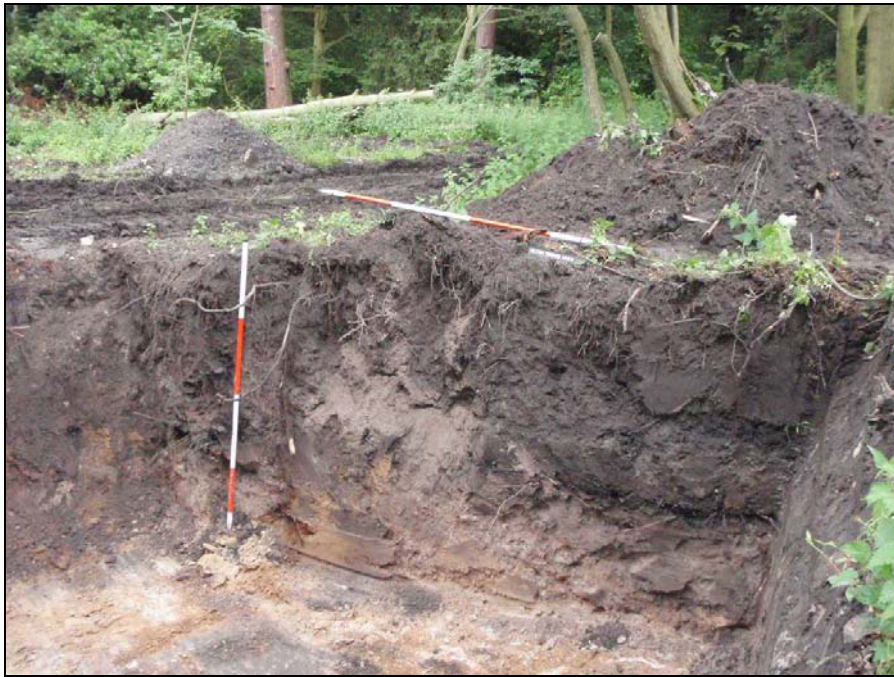
- 5.3 Underneath this re-deposited clay a previous layer of leaf mould [007] was still evident, and contained identifiable organic material such as decayed leaves. This again had modern brick and glass within it and was no more than 0.1m deep at its full extent.

- 5.4 Beneath [007] was a layer of undisturbed natural sandy clay [008] 0.35 -0.50m deep which was identified as the layer with the most archaeological potential. However this layer was cleaned and observed to have no features or finds of any kind in evidence in any of the excavated areas.

- 5.5 The sandy clay layer [008] overlay the sandstone bedrock [004]. Again during this stratigraphic excavation no finds or features were identified.
- 5.6 In the wooded area several temporary tracks had been laid to allow access for the construction of the new ride. Several sections cut through one of these tracks [010] as it would need to be partially excavated in places to allow the new foundations to be put in place. It was found that the track was constructed of two key layers rubble hardcore as a foundation [011] with a metalised surface above. This was then cut [012] into the redeposited clay [009] and the sandy clay [008].

Figure 7. Section of foundation pit in woodland area showing depth of redeposited topsoil.
