**An Archaeological Building Recording
of White House, Grainger Park Road, Benwell,
Newcastle Upon Tyne.**

Archaeological Research Services Ltd Report No. 2009/41
June 2009

Archaeological Research Services Ltd Report 2009/41

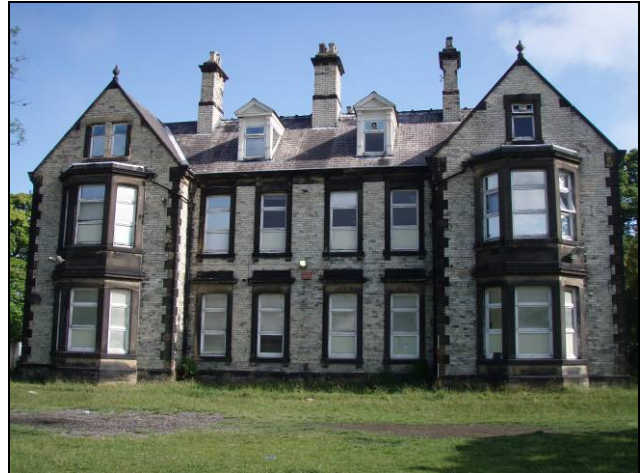
South facing elevation of White House

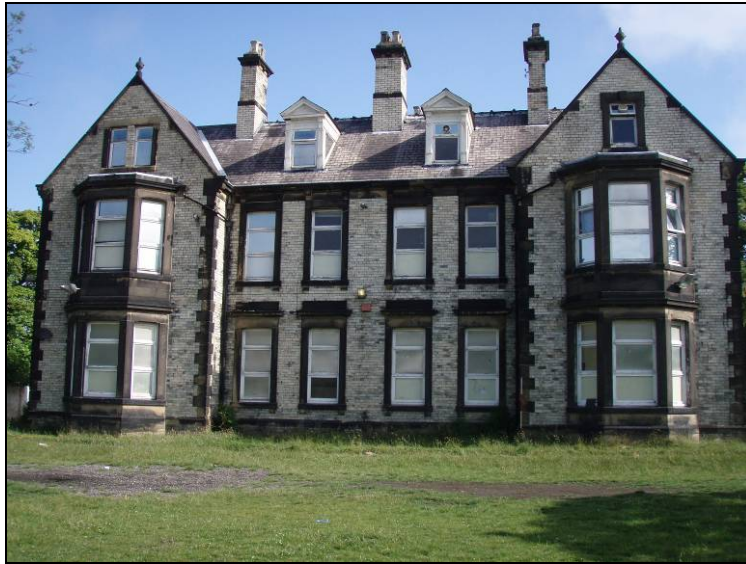
Fig. 10 South facing elevation

This elevation is framed by two quoins to the east and west. There are 25 windows in total, 12 of which exist within the sandstone-framed bay windows. 11 of the windows exist within the brickwork of the building, and two are roof lights for the third floor. Each of the windows to the ground and first floor are wooden framed with wooden transoms separate each pane of glass (3 per window). The windows look to be modern hinged replacements for original sash.

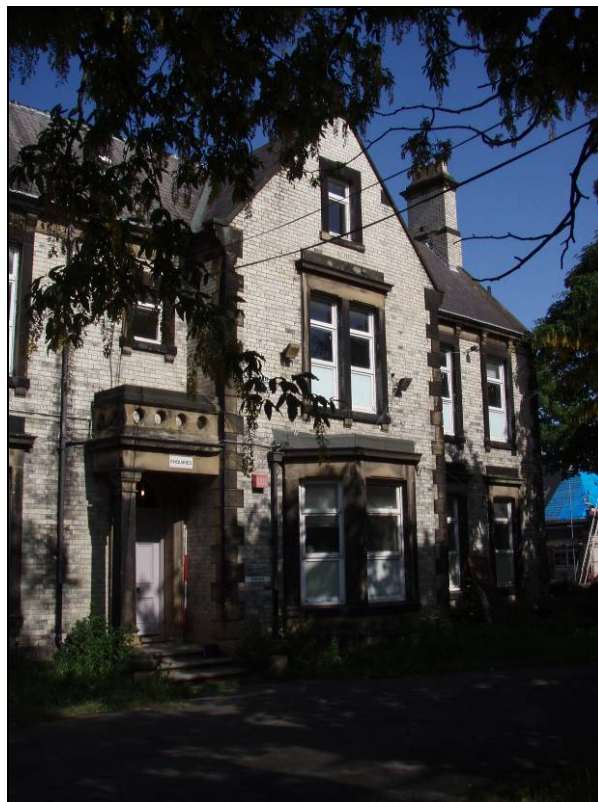
Fig. 11 East facing elevation

This elevation is in the same style as the south facing elevation. To the elevations southern most side are two windows, one to the ground floor and one to the second floor which have been bricked up. The bricks used are the same as the rest of the buildings construction, this may indicate that they were blocked up shortly after the buildings construction or that somebody went to length to find ones which match. A further 11 windows exist on the two floors, three exist within the ground floor, sandstone bay window which is located north of the ornate doorway. This doorway would have been the original entrance to White House and as such is ornately decorated with sandstone mouldings and a large sandstone pillar supporting a canopy above the door.

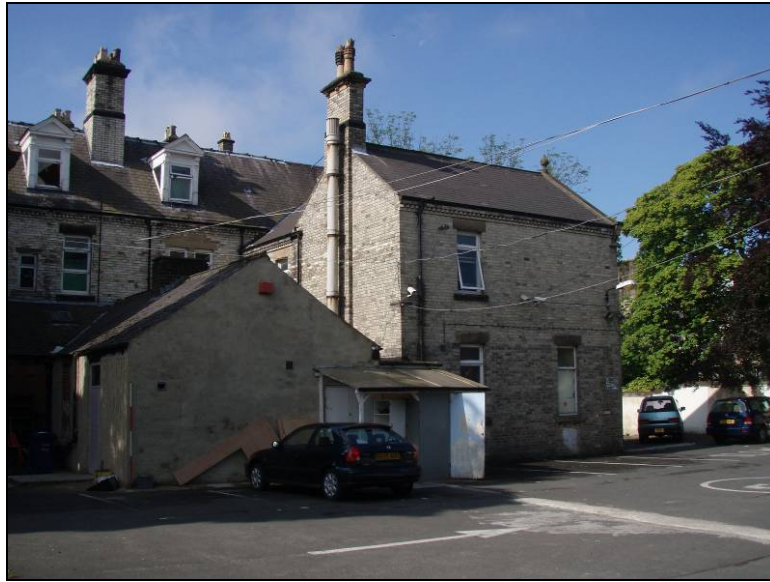
Fig. 12 North facing elevation

This elevation has a mixture of construction techniques. The eastern side of the elevation does not contain any windows and the brick work is covered by a grey render. Centrally, the ground floor has extensions running to the north. The walls are covered with the same grey render as used to the east. There is a door to the elevation but it is a modern replacement. To the west the difference in construction from the other parts of the building are obvious. Being a later addition, a lighter sandstone has been used, carved in a different style, around the three windows.

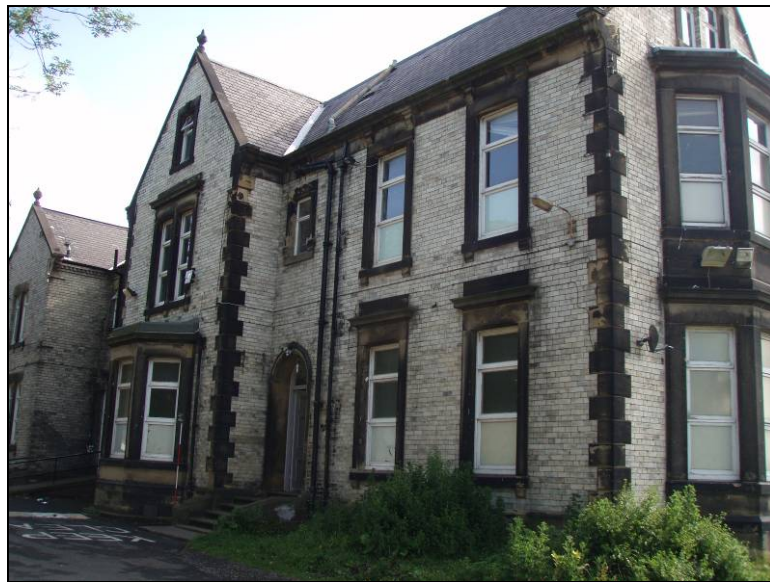
Fig. 13 West facing elevation

This elevation is like the east facing elevation. Unlike the east facing elevation the entranceway does not have an ornate canopy above it and consist of a sandstone arch. All windows are exposed to this elevation, with the addition of four narrow windows to the north (as part of the latest extension).

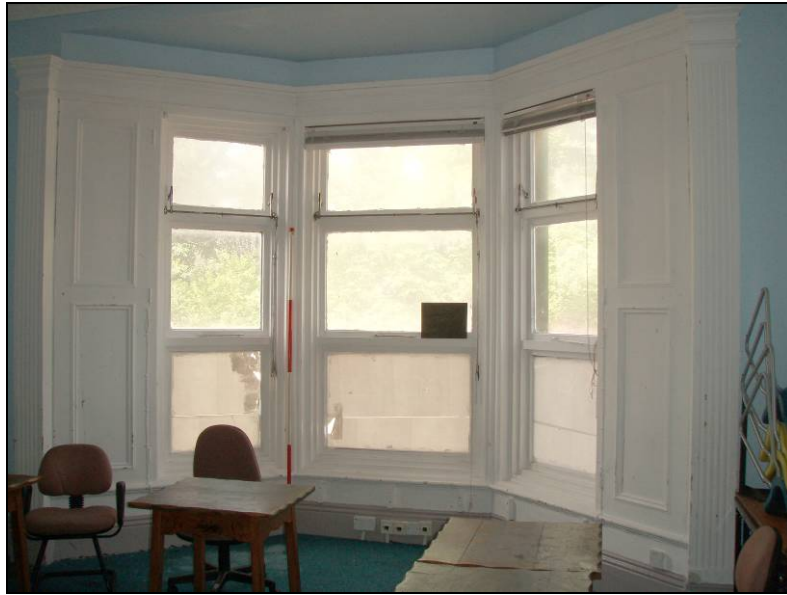
The large bay window is framed with wooden panelling. This style of window is replicated throughout the building unless otherwise stated. The walls have been re-plastered damaging the skirting, but the majority of the ceilings ornate coving is still present. There are two modern doors to this room.

Fig. 14 Internal bay window room 1

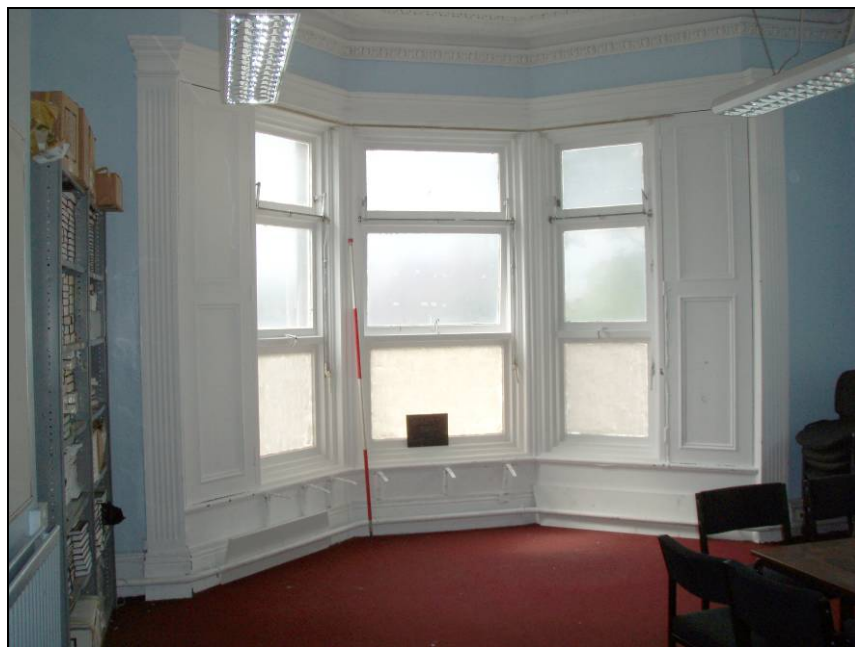
This room has a large wood panelled bay window (in the same design as room 1) on its southern elevation. Two further windows exist on the western elevation. Once again the original ceiling coving exists but other original features, such as the fireplace, have been removed.

Fig. 15 Internal bay window room 2

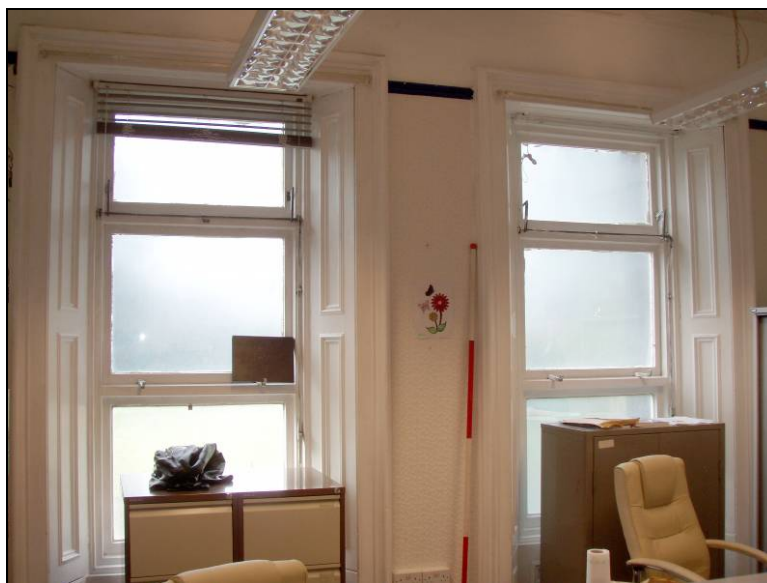
This room has been modernised internally (within the last 50 years). Two windows exist to the south elevation; each window is framed with wooden panels. The ceiling coving in this room is of the style consistent throughout the building

Fig. 16 Internal wood panelled windows room 3

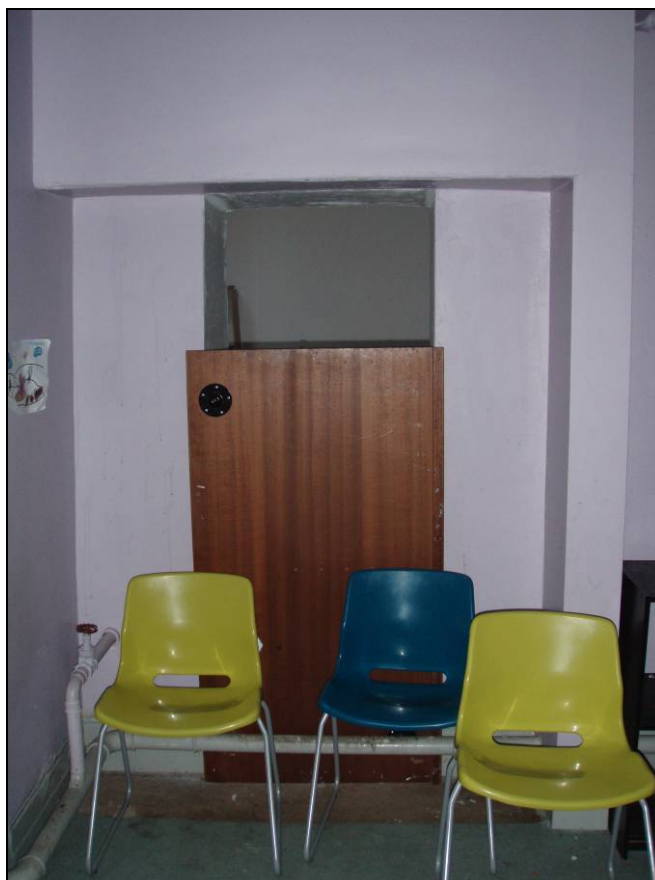
This room is a small interior room located centrally within the building, and has no windows on its walls. It does have a ceiling light which is in considerable

disrepair. There are no noteworthy features in this room other than that a section of wall has been removed to the east, presumably in order to give access between the two houses after they were combined into one.

Fig. 17 Internal partition opening room 4

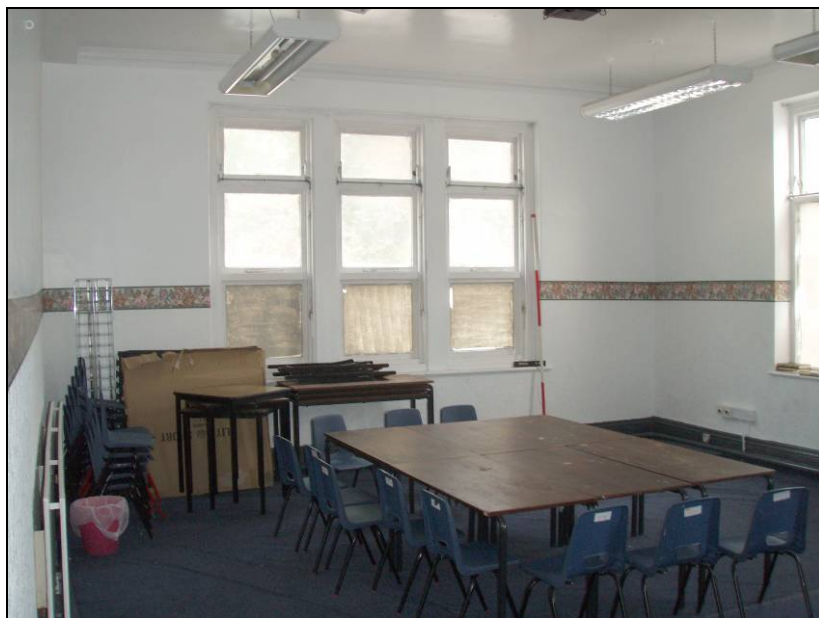
This room is in the later addition to the house and its windows, five in total, are of a plain design with simple wooden frames. There are no other noteworthy features to this room.

Fig. 18 Internal windows of later extension room 5

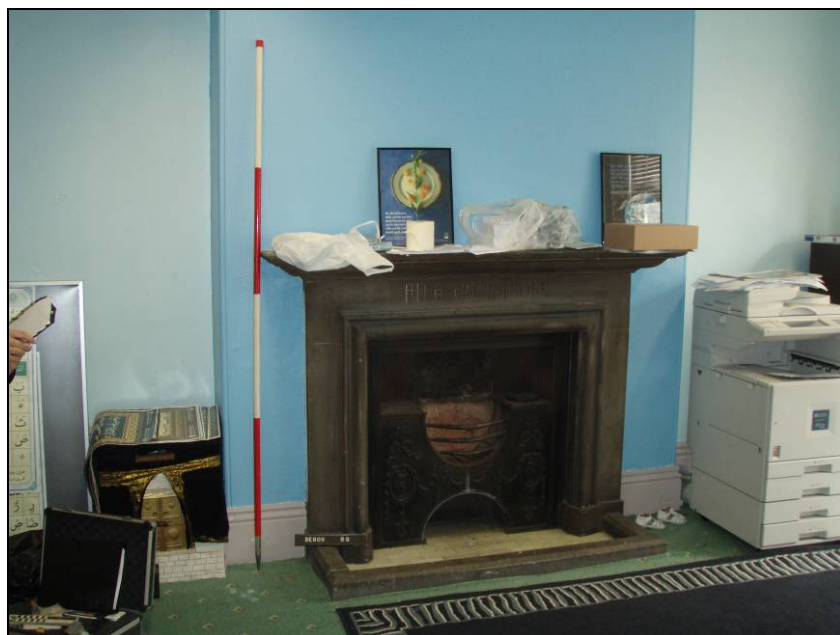
This room contains another large, wood panelled bay window to its eastern elevation. A large ornate fireplace, original to the property exists to the room's northern elevation.

Fig. 19 Original fireplace in room 9

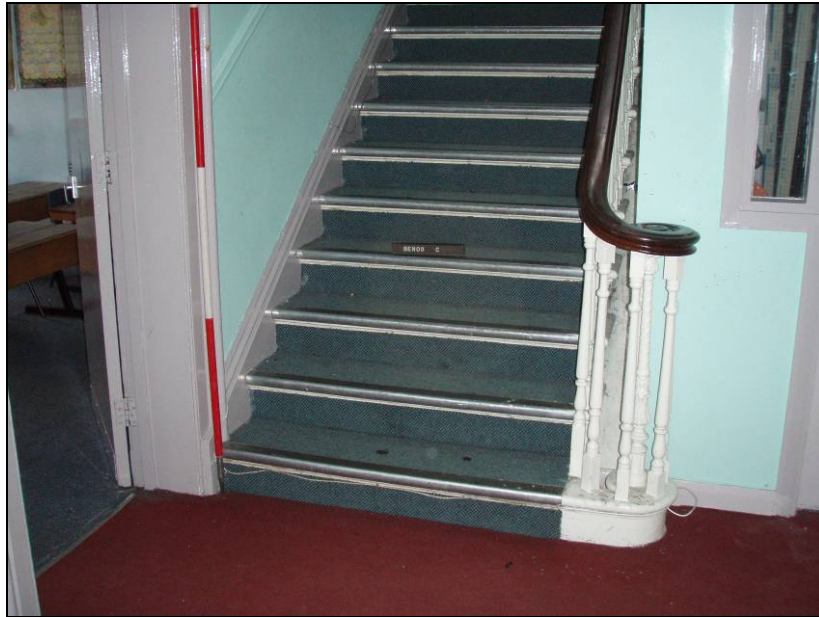
The corridors of the ground floor are plain in design, the walls being largely modern partitioning (most probably at the time of the two houses being made into one). The ceilings have mostly been re-plastered, but within the porches to the external doors and the staircase the moulding has survived.

Fig. 20 Staircase to first floor with balustrade

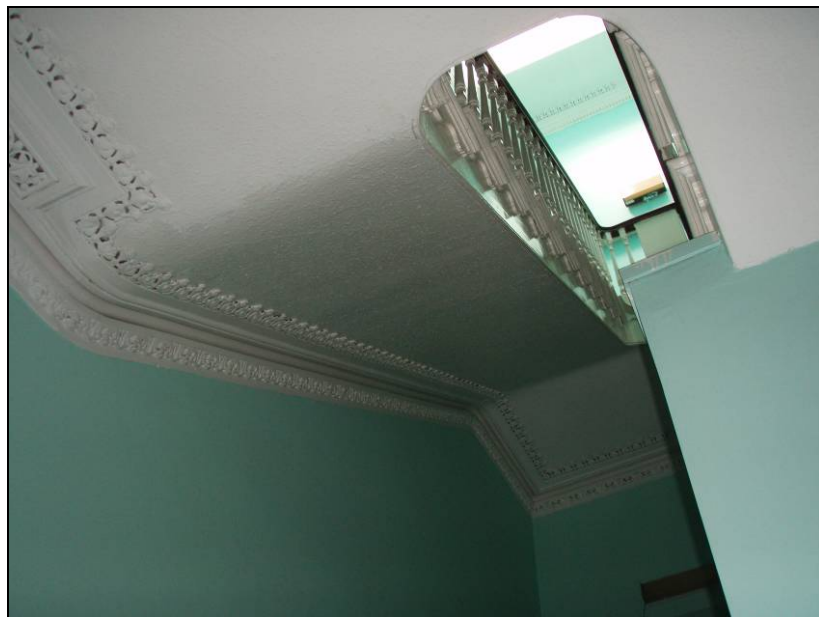
Fig. 21 Ceiling coving above staircase

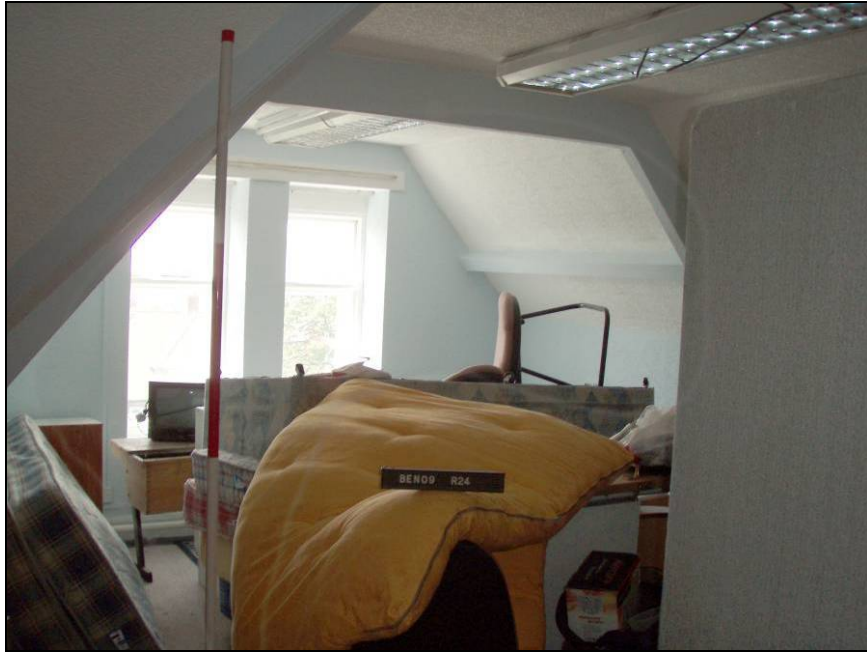
The shape of this room is determined by its sloping ceilings. The original beams are present although covered with a white wash render. Full access was not possible into this room as it is currently used as a store room. The windows looked to be of a plain design in comparison with the other floors.

Fig. 21 Roof beams in room 24

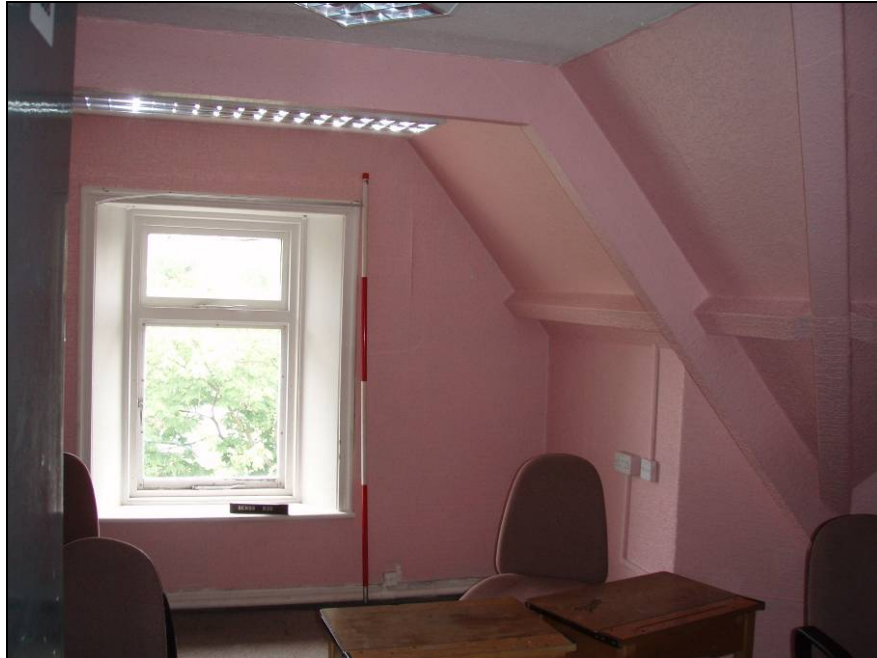
As in rooms 24, 26 and 29, this room is dominated by the roof beams, in this room they emphasise that its location protrudes from the building. There was one window located centrally on the eastern elevation. There were no other features of architectural or historical significance.

Fig. 22 Roof beams in room 30
