Archaeological Watching Brief at Westgate Road, Newcastle Upon Tyne

Westgate Road, Newcastle Upon Tyne

ARS Ltd Report 2009/55
August 2009

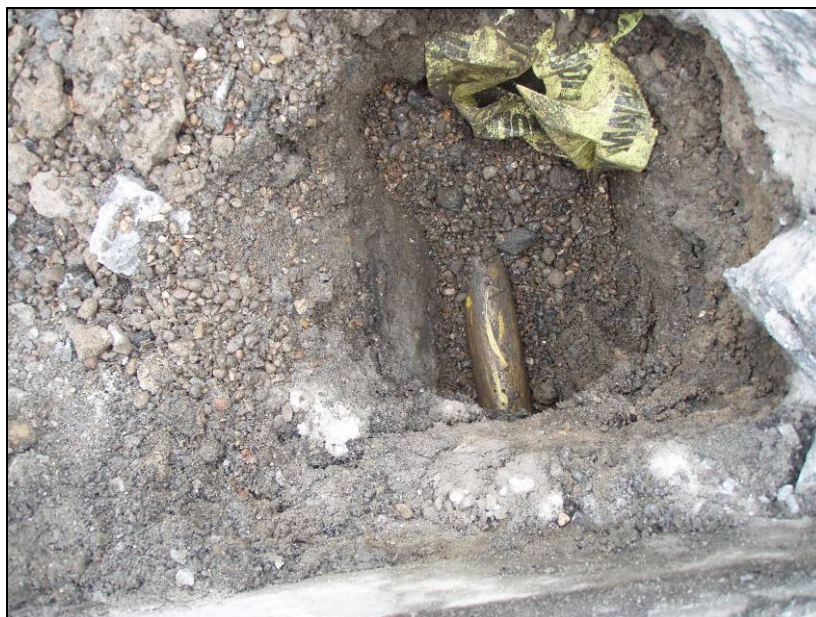
- 4.1. The trench was opened to approximately 2m in length by 1m in width. The tarmac layer was broken up and then removed to a depth of 0.12m to reveal a layer of concrete (Fig. 3). The concrete was then removed from the south east corner, which had a depth of 0.14m, revealing the gas pipe sitting within made ground (which consisted of gravel and hardcore).
- 4.2. The excavation was terminated when the gas pipe was located (Fig. 4). As a result the work did not penetrate any undisturbed layers beneath the tarmac and concrete of Westgate Road.

Fig. 3 Open trench showing tarmac, concrete and made ground.
