**An Archaeological Desk-Based Assessment
off land adjacent to No. 39 Newbold Street,
Rochdale.**

Archaeological Research Services Ltd
Report No. 2009/72
October 2009

An Archaeological Desk-Based Assessment off land adjacent to No. 39 Newbold Street, Rochdale.

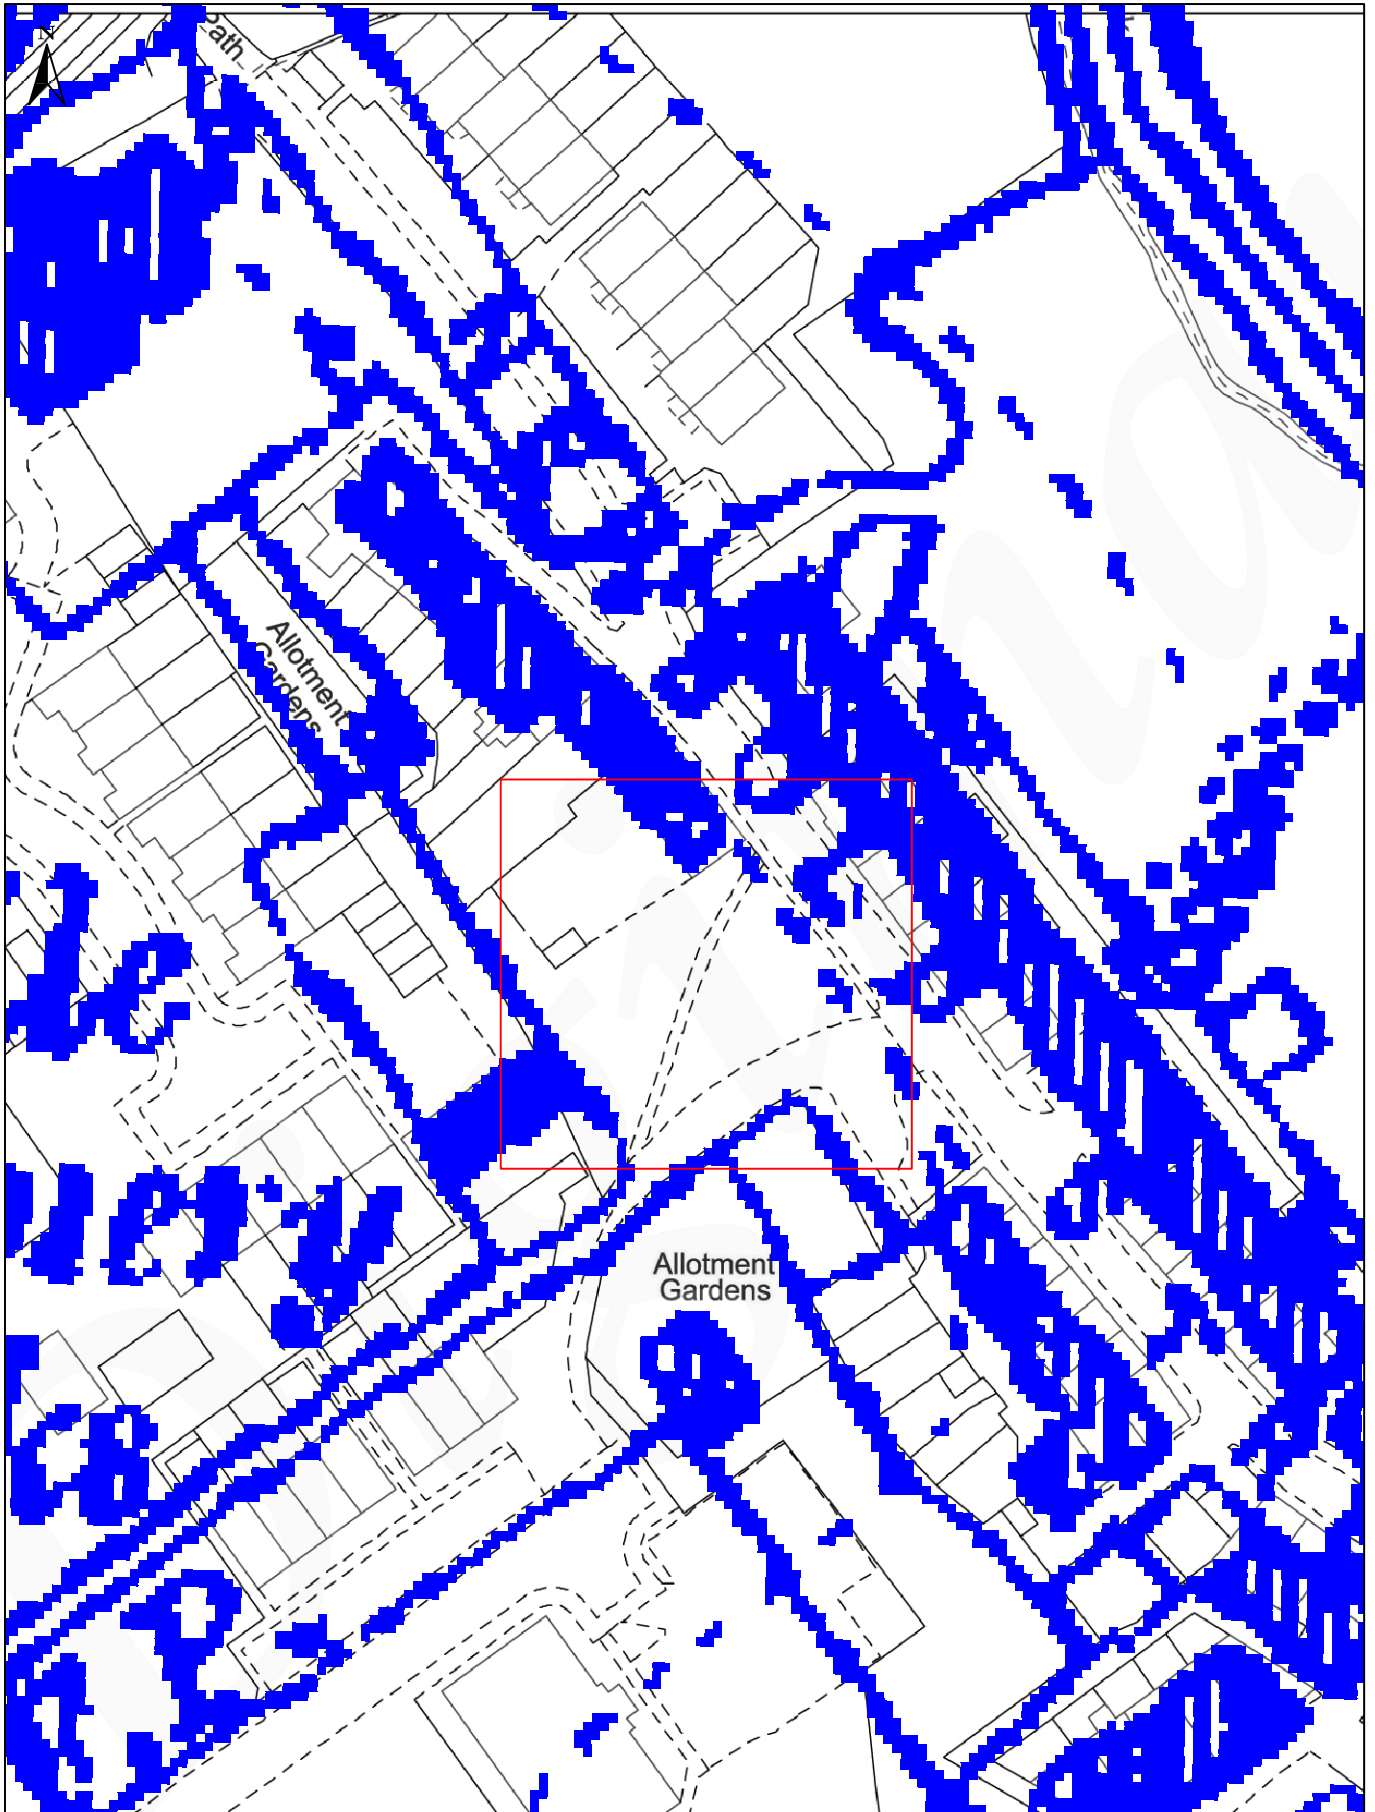
- 4.5. *3rd Revision OS map of 1922 at 1:10560 (Fig. 7)*
A third revision map of the area at 1:2500 could not be found and the larger scaled map of 1:10560 was consulted. Although in lesser detail because of its

scale, this map does show that there have been no changes to the study area or its immediate surroundings since the 2nd Revision OS map of 1906.

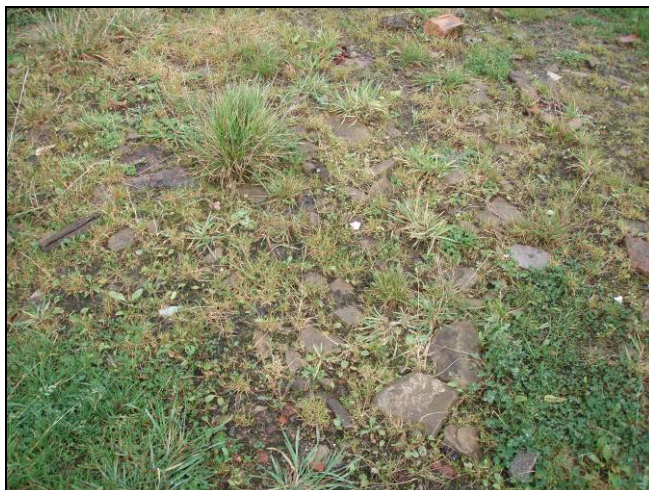
- 5.1 A site visit was made on the 2nd November 2009. The land running from the road (east – west) is barren and sandy. Rubble and stonework are visible through this layer (Figs 8 & 9) which may indicate the location of Newbold Hall but not with any great degree of accuracy (Fig. 13). The land to the westernmost side of the site is largely overgrown, but again stone debris can be made out on the surface. Towards the south-western portion of the site there is a services duct (Fig. 10) which would indicate that, should remnants of the Hall still exist below ground level, a portion of it may have already been disturbed through service works.
- 5.2. A new housing development has been constructed to the immediate west of the development site and holds the name Newbold Hall Drive, which is testament to the now demolished Newbold Hall.

Fig. 8 Stone rubble showing through topsoil

- 7.1. The potential for the survival of archaeological evidence on the site is considered to be high. Given that archaeology is likely to be impacted on during any ground works on the site, it is recommended that trial trenching be used in order to establish the level of preservation of any below ground archaeology which may exist.

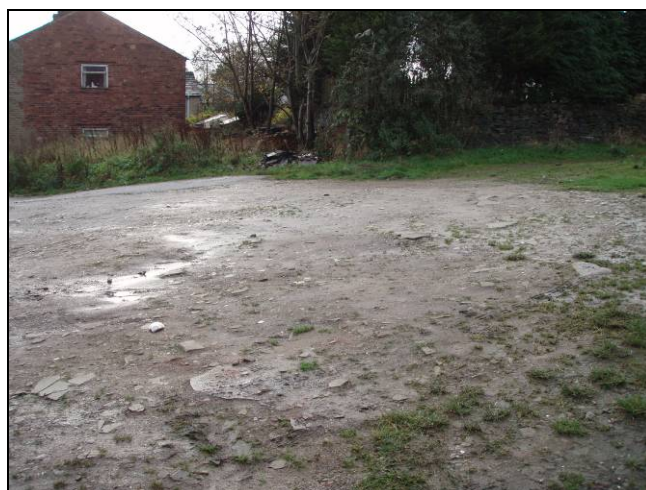
Fig. 9 Rubble visible on bare plot looking south

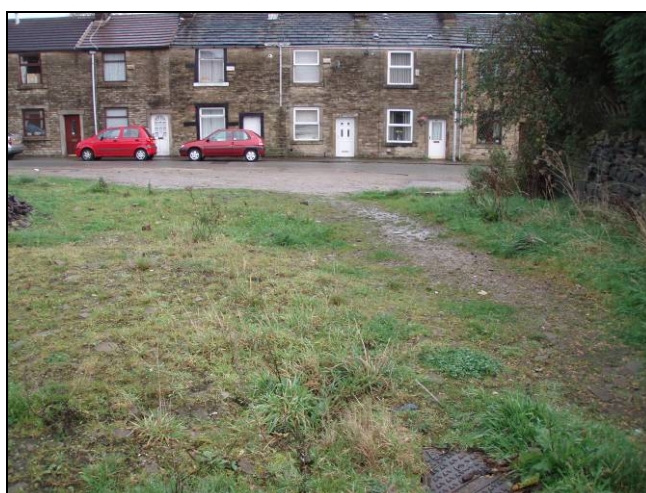
Fig. 10 Drain to south west of site.

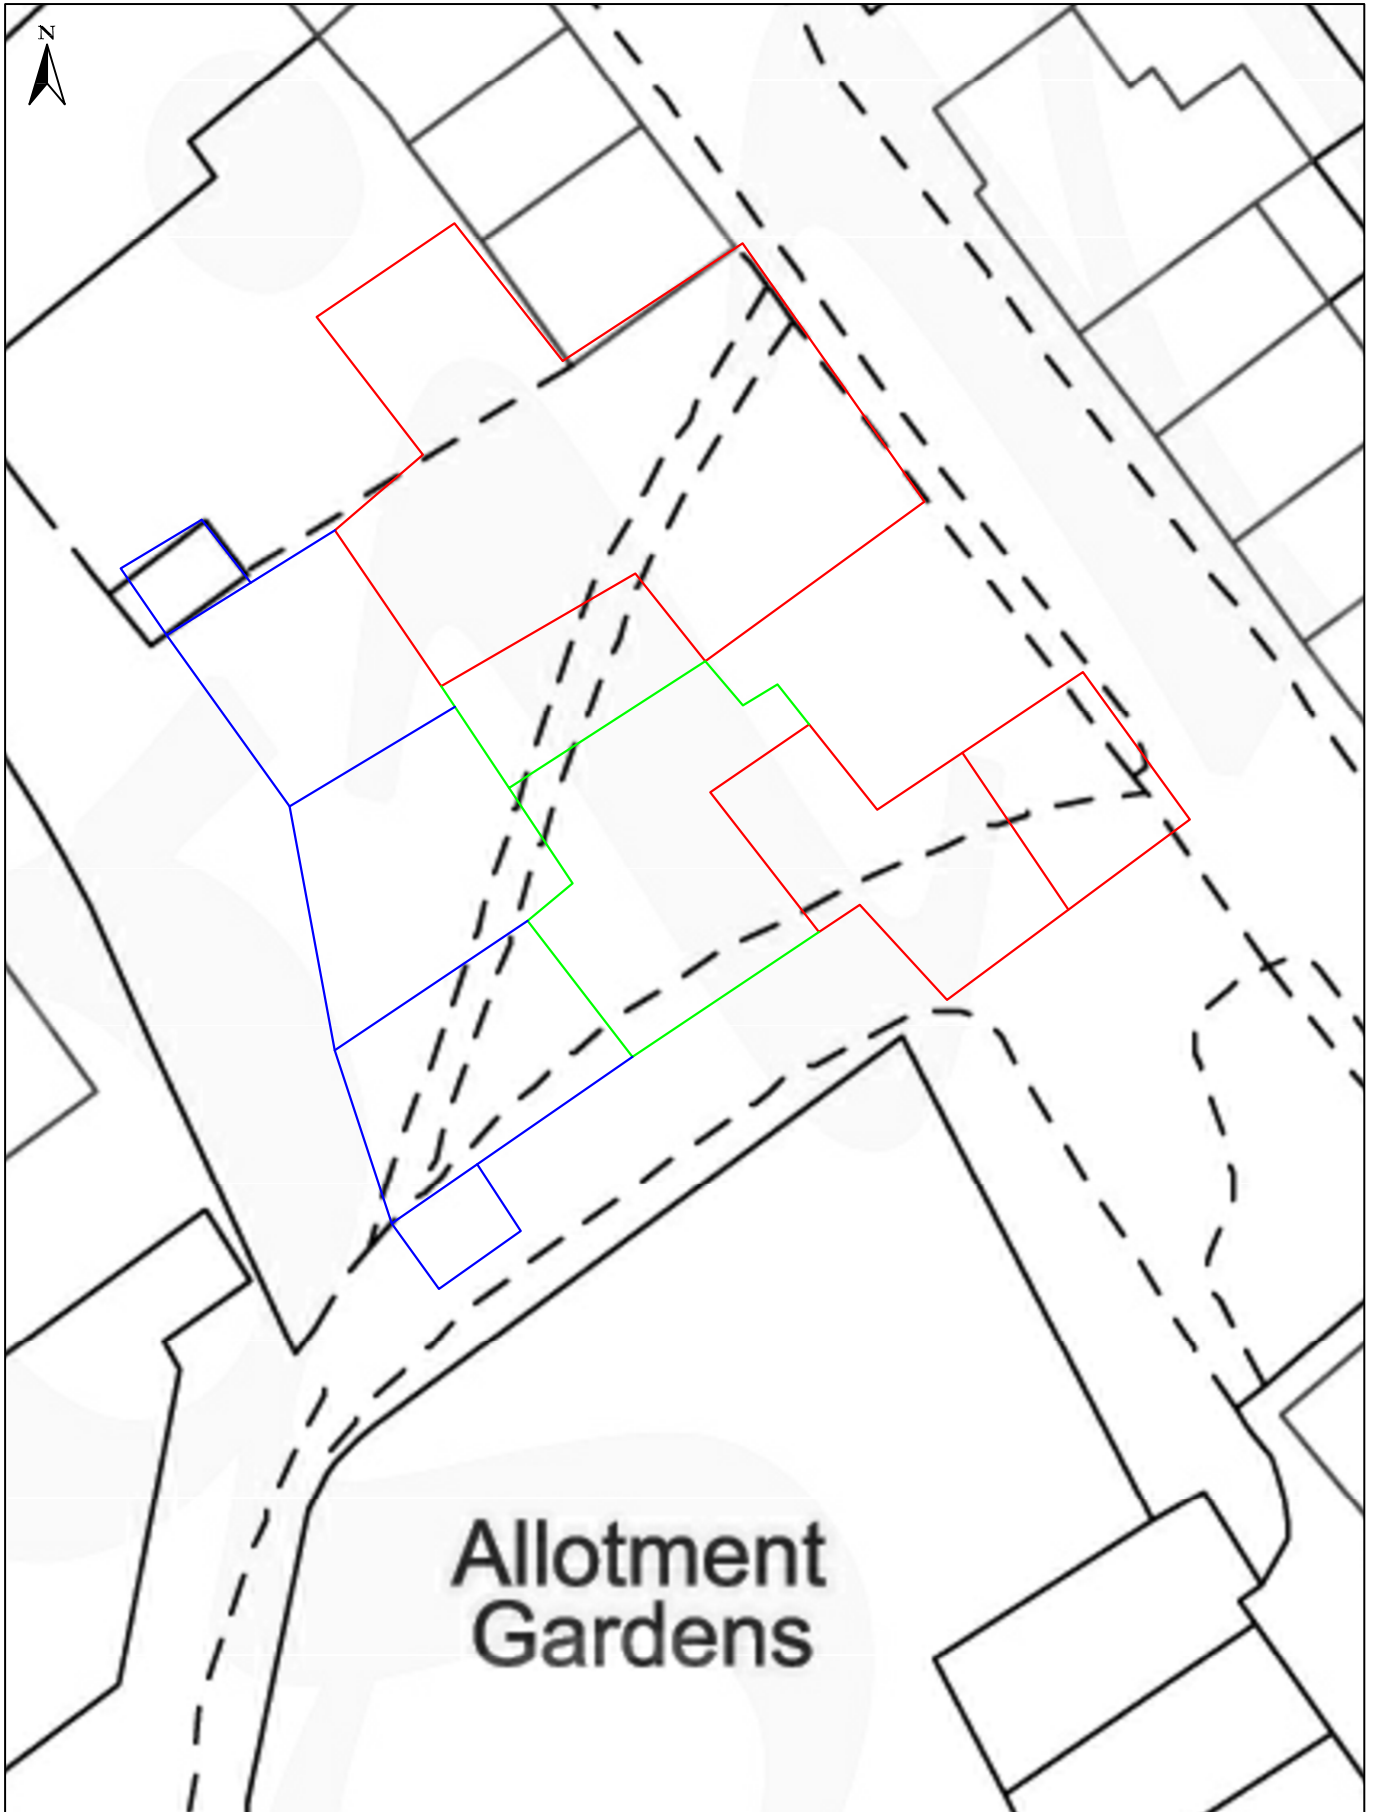
Title:
 Figure 13: Ground condition,
 constraints, and locations of debris

- 6.2. The positioning of the Hall on the OS maps and subsequent site visit, illustrate that the majority of the north-east of the site would have been taken up by the footprint of the Hall, some of which extends to the rear of the adjacent property to No. 39. To the south-west it is unclear to what extent the Hall footprint would have encroached, and although the old maps show this area to be occupied by the lands of the Hall, it is therefore possible that there may have been out-buildings in this area. Observations from the site visit illustrated that parts of the remains of the Hall were still slightly visible on the surface which would make avoidance during groundworks near impossible.
