**Nertherton Hall, Nr. Bradbourne, Matlock,  
Derbyshire.  
Results of an Archaeological Watching  
Brief.**

**Report No. 2010/3**

January 2010

**Netherton Hall, Nr. Bradbourne, Derbyshire.  
Results of an Archaeological Watching Brief.**

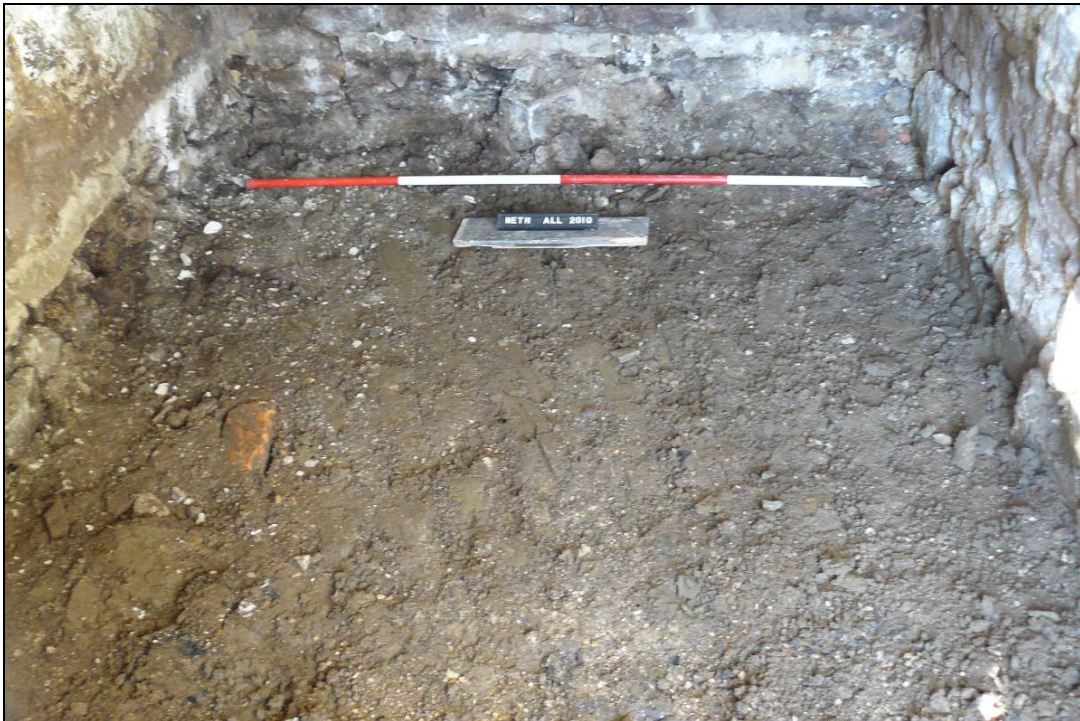
- 6.1.1 Phase one of the groundwork commenced within seven rooms incorporated in the east west orientated range of outbuildings north of Netherton Hall (Fig. 3). Rooms 1 to 6 measured approximately 3.6m north to south and varied in width between 2.4m and 3.75m, room 7 measured 3.6m x 6m. Prior to archaeological involvement solid floor levels of concrete and flooring tiles had been removed from the above rooms revealing a compacted clay surface.

- 6.1.2 The mid to darkish brown compacted clay surface (001) represented made ground which was reduced to facilitate a level surface at a predetermined level below the proposed new floor surface. The maximum depth excavated of (001) in rooms 1 to 4 was no more than 0.15m, with small areas requiring the ground to be built up. Excavation of (001) revealed it to contain small amounts of red brick, tile and stone fragments with the occasional full red brick, remnants still remaining in the levelled ground surface (Fig. 4). Two handmade thin bricks were recovered from within (001) whose measurements varied from  $8\frac{7}{8}'' \times 4\frac{1}{2}'' \times 1\frac{1}{2}''$  to  $9\frac{1}{8}'' \times 4\frac{5}{8}'' \times 1\frac{3}{4}''$ . Although thin bricks of this size may be associated with manufacture prior to the brick tax of 1784 (Lloyd N. 2003), it is not considered these bricks derive from that period. The context from within which they were discovered, along with lack of mortar and evidence of bedding sand on other fragments suggests a modern paving brick.

- 6.1.3 Rooms 5 and 6 did not require any excavation, only the removal of surface debris. With no roof cover on room 7 the ground had a frozen upper surface of 30mm. Below the frozen surface ground conditions were identified as (003), this contained a pocket of yellowish brown sand, possibly deposited during a period of building work. The depth of excavation again was not greater than 0.15m.

Fig. 4: Post excavation ground conditions in rooms 1 to 7.

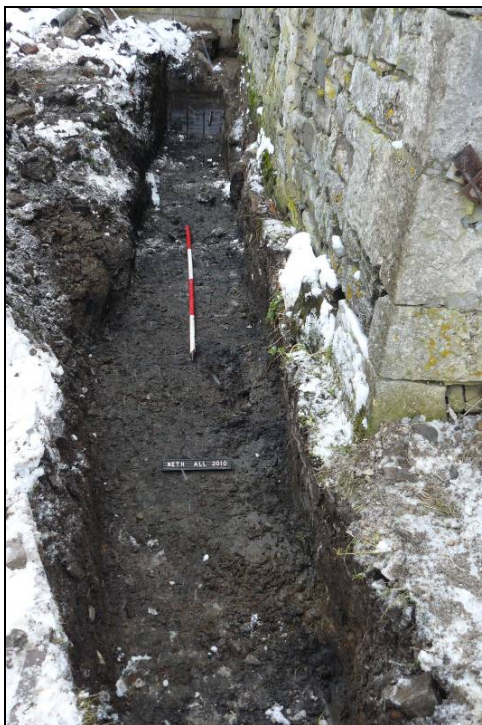
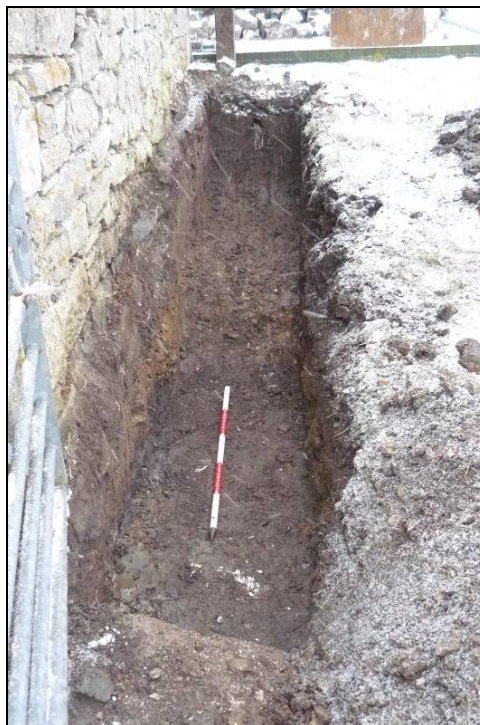
Fig. 5:  
Post-ex of trench 1 running east west.

Fig. 6:  
Post-ex of trench 1 running north south.

6.2.2 Stabilization of the wall foundations to the west and north of room 7 were an element of the planning requirements. To undertake this requirement trench 1 was excavated c. 7m along the external wall of room 7 east west and 5m on the north south external wall, the trench was 0.6m wide and had a maximum depth of 0.8m. Removal of building tumble banked against the walls and excavation of the trench revealed the ground stratigraphy to consist of a layer of dark brown silty clay topsoil (002) 0.18m thick, overlaying mid brown coloured boulder clay (003) with a general depth of 0.5m. At the limit of excavation underlying (003) there was a finer clay deposit without pebble inclusions (004), which contained small areas of black mudstone (figs.5 & 6).

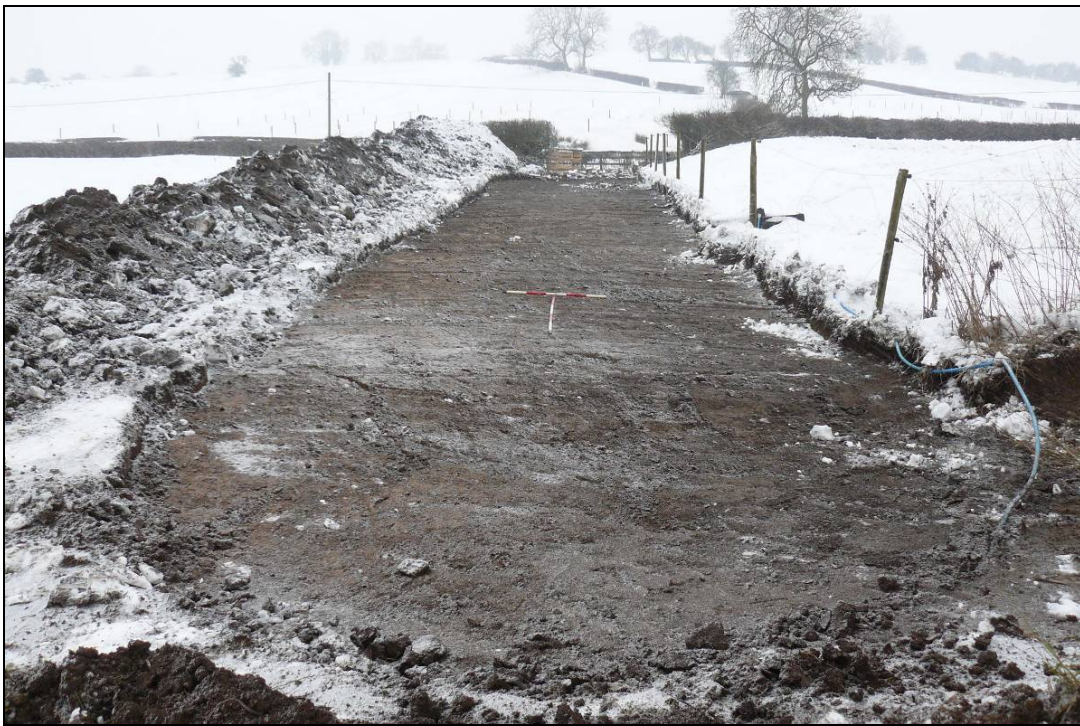
- 6.3.2 Within this area of topsoil strip, topsoil 005 had a general depth of 0.2m. Underlying (005) was a natural deposit of boulder clay (006), mid lightish brown in colour containing rounded pebbles and cobbles <0.15m. Deposits (005) and (006) were consistent throughout the excavated area which continued from the entrance at a width of 4.6m and maximum depth of 0.35m (Fig. 7). A sub circular area of limestone rubble 1.5m in width was located 20m north of Brackendale Lane. The observation of diagonally west to east running land drains close by which then connected to a north south main land drain suggest an area of ground susceptible to waterlogging. Nothing of archaeological interest was exposed within this excavation phase.

Fig. 7: Excavated access road facing Brackendale Lane to the south. Scale 1m & 2m

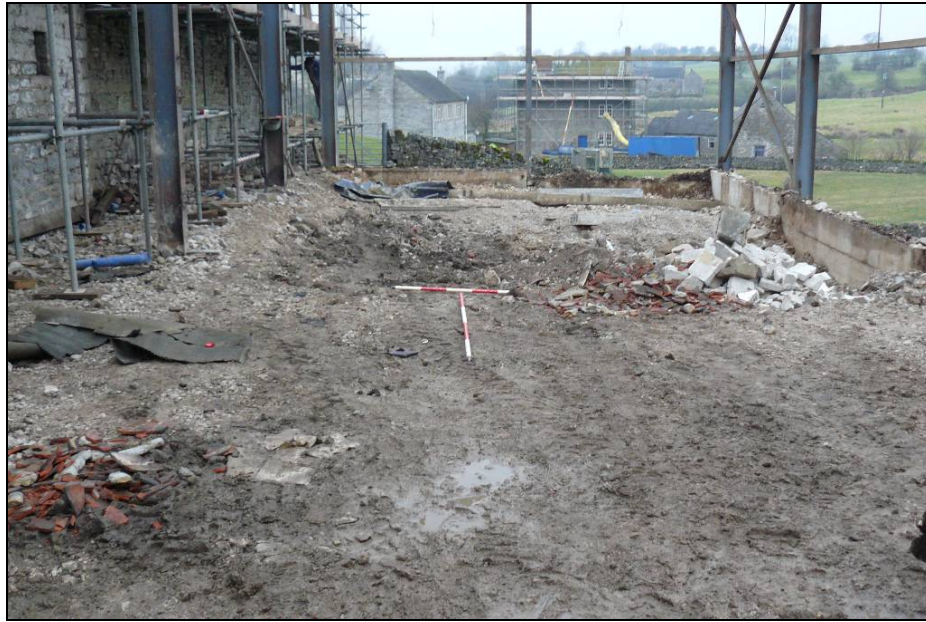
- 6.4.1 The final phase of excavation was undertaken on ground directly to the north of the range of outbuildings (Fig. 3). Prior to the current renovation programme a modern steel framed outbuilding with concrete base had been situated at this location, the steel frame of the structure was to be retained as the footprint for a new swimming pool building. The concrete base was removed prior to archaeological observation.
- 6.4.2 Figure 8 illustrates the nature of the sloping ground which can be seen by the dip of the dry stone wall extending south to north in the background. The first deposit encountered in trench 3 consisted of made ground of hardcore and rubble infill to level the sloping ground.

Fig. 8: Trench 3 swimming pool area prior to excavation. Facing west: Scale 1m & 2m

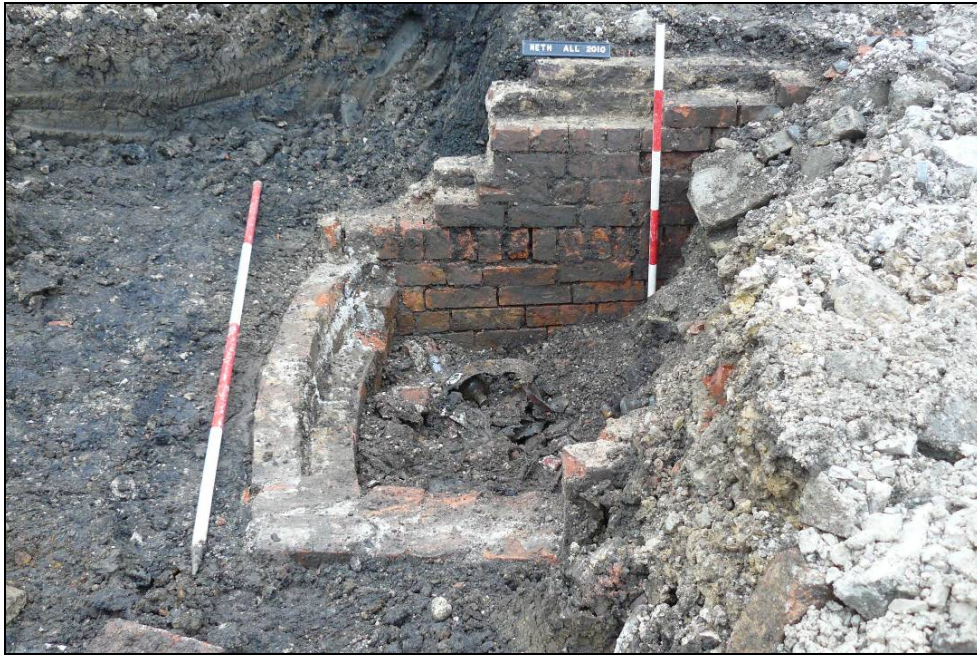
- 6.4.3 Excavation of a trench measuring 13.5m east to west x 6.6m north to south with a maximum depth of 1.5m at its southern extent commenced with removal of made ground (007) from its western extent, this revealed the remains of a red brick structure (008) 1.6m north of its southern extent. Two east west orientated walls extended for 1.9m east from the western extent of the trench, they were connected by a slightly curved north to south orientated brick wall measuring 1.67m in length, this enclosed the eastern extent of the structure (Fig. 9). The walls were two courses in width (0.22m) constructed from orange/red solid machine made brick measuring 9<sup>1</sup>/<sub>8</sub>" x 4<sup>1</sup>/<sub>2</sub>" x 3". The southern wall was exposed at eleven courses in height (the limit of excavation), built with rows of brick at four and three courses high in stretcher pattern and broken by a row of headers, roughly bonded using a firm gritty sand mortar. The structure had its own individual fill (009) which consisted of a dark silty matrix containing modern household debris, this included glass bottles, paint tins, plastics and metal buckets and a pram frame.

- 6.4.4 The exposed components of this structure built into sloping ground are of modern origin. Without further excavation or research of this feature it is not possible to assign a possible function.

Fig. 9: Structure (008) with slightly curved eastern wall and part standing southern wall, at the limit of excavation. Facing south: Scale 1m & 2m

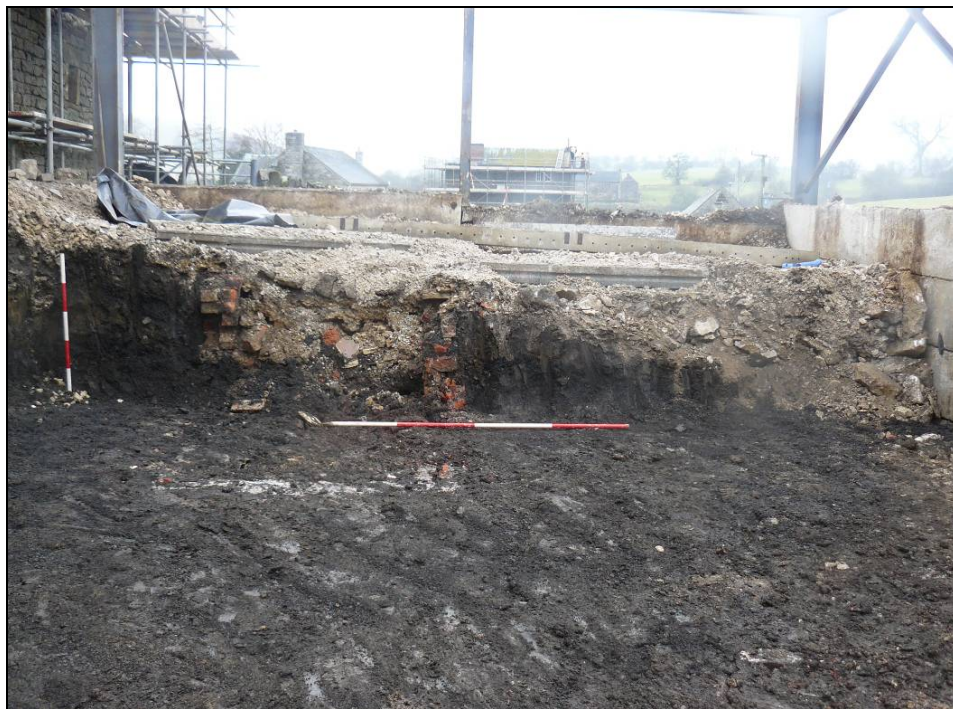
- 6.5.1 Excavation continued east with the removal of natural ground (003) at the southern extent of the trench which sloped downhill to the north for approximately 4.5m where made ground continued the limit of excavation northwards (Fig 10). Natural ground at this limit was heavily made up of laminated black mudstone.

Fig. 10: Western extent of trench highlighting dip of natural ground to the north, overlain by made ground. Facing west: Scale 1m & 2m

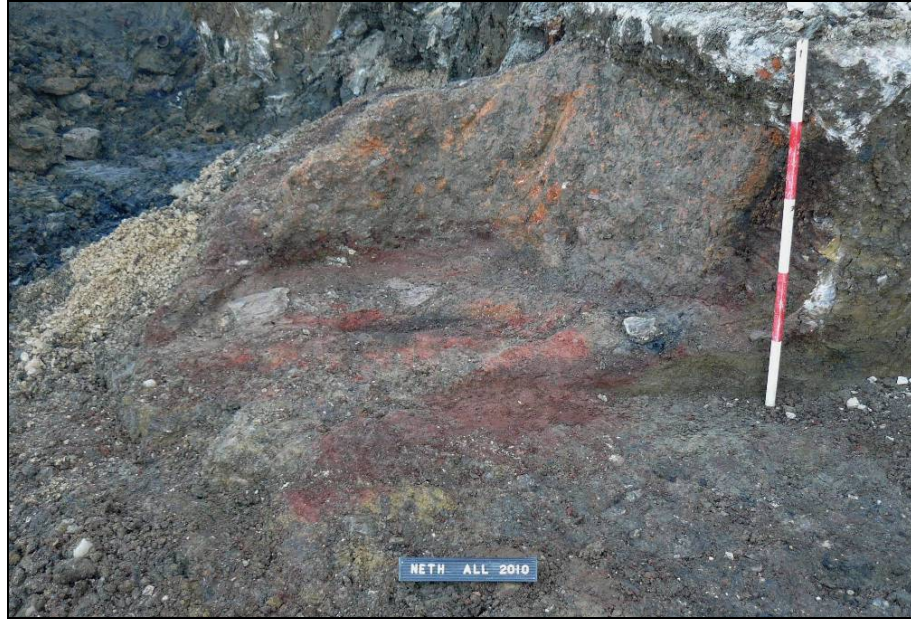
6.5.2 At a point 5.5m east from the western extent of the trench an area of redeposited natural ground (010) was encountered, on removal of (010) feature (011) was exposed abutting a concrete foundation within the southern extent of the trench (Fig. 11). The concrete abutment is one of three located within the trench at its southern extent supporting the modern steel construction. The base of feature (011) was 0.8m below made ground at this point and had also been disturbed by the construction of a modern pipe trench which ran south-east to north-west across its northern extent Fig. 12).

Fig. 11: Feature (011) post-ex condition.  
Facing east: Scale 1m

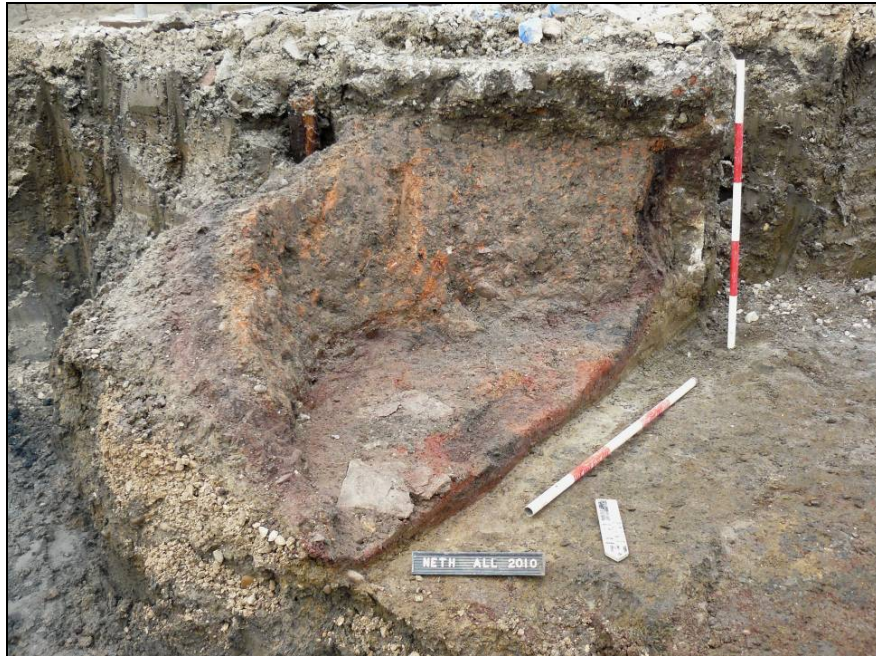
Fig. 12: Feature (011) with base half sectioned. Note gravel from within abutting drainage trench. Facing east: Scale 1m x 2.

- 6.5.4 The partial remains of (011) suggest a circular pit cut to create a level platform within the south to north sloping ground, consisting of shallow very steep sides at the northern extent which rise to very steep sides of 0.65m depth at the southern extent. The base was flat with a probably diameter of 1.26m. Exposed to a depth of 0.11m the base was predominately fine silty red fired clay and was overlain by a few irregular shaped slate tiles <0.2m in width. The outer extent of the base area had changed to a darker red colour which extended up the walls of the pit for a maximum of 0.1m, at this point a transformation of the surface was undertaken where the surface became a solid mass which was irremovable by hand tools. The colouring changed to an orange red with its solid form a conglomerate of the pebble and clay natural ground (003). The conglomerate was 0.09m thick with a band of dark red fired clay extending a further 0.15m thick (Fig 12).

- 6.5.5 The form of this feature is man made with obvious changes to the surface composition through intense heat, although no evidence of in-situ burning directly onto the surface was identified. The evidence of slate tiles overlying the fired base as seen in fig. 12, may suggest a floor surface on which a brazier was placed with the heat produced transferred to the surrounding surfaces.
