Land to the Rear of 5 Old Road, Branston, Burton-upon-Trent, Staffordshire.

Results of an Archaeological Watching Brief.

Archaeological Research Services Report No. 2010/14 March 2010

Planning Application No. PA/15554/012 Oasis No. archaeol5-73554

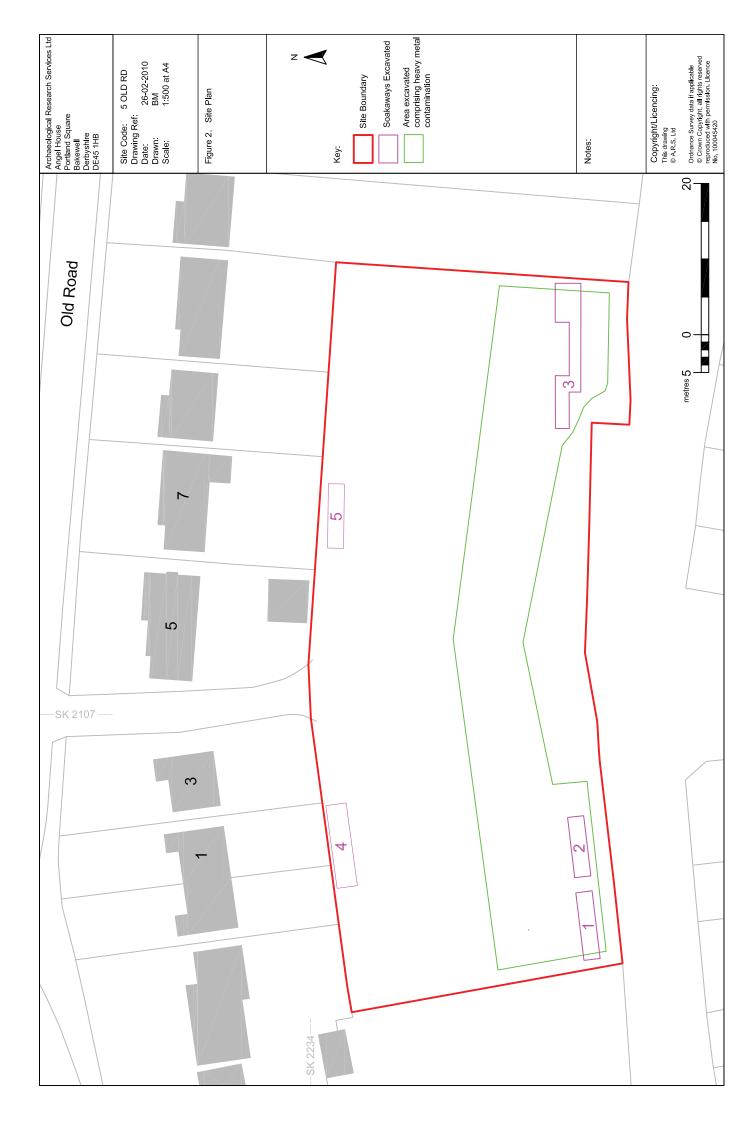
- 6.1.1 Phase one of the groundworks commenced within an area of heavy metal contamination to the south of the site which measured approximately 90m in length with a maximum width of 15m (Fig. 2). The removal of the contaminated material was undertaken to a depth of 0.6m from current ground level, this equated to an ordnance datum level (OD) of 47.4m.
- 6.1.2 The site stratigraphy revealed two contexts. An imported surface deposit of dark brown sandy clay topsoil (001) with a maximum depth of 0.4m overlaid made ground (002), this consisted of numerous lenses of mixed material, red/grey sandy clay, building debris of brick and concrete, fly ash and other coal fired waste; which extended to the limit of excavation for this phase (Fig. 3).

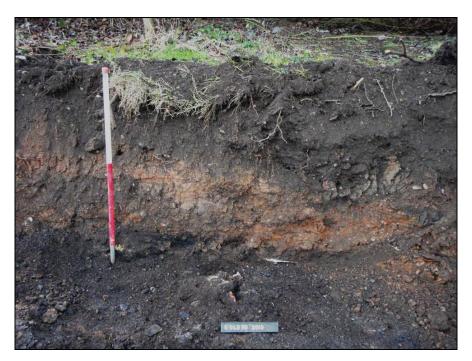
Fig. 3: Exposed stratigraphy Facing South, scale 1m.

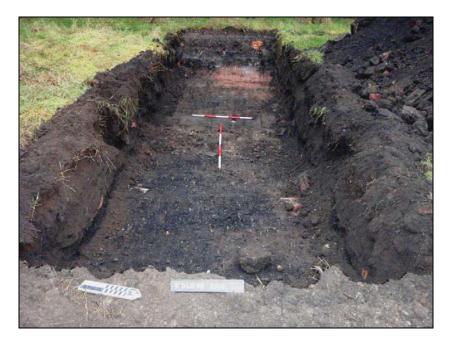
Fig. 4 made ground in the northern area of the development site. Facing West, scale 1m & 2m.

- 6.2.1 Further excavations across the northern extent of the site confirmed the presence of made ground across the site (Fig.4)
- 6.2.2 At the western extent of the site approximately 0.3m below ground level a context of sand and gavel was encountered (003) which was identified as natural ground. The natural ground dropped at approximately a 45° angle towards the east and continued below the water table (Figs 5 & 6). The cut into the natural deposit of sand and gravel suggested the limits of a pit formed by the extraction of sand and gravel on the site as proposed by local knowledge.

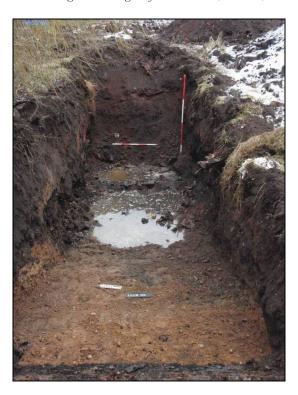
$\label{eq:Fig. 5} Fig. 5: Natural ground \\ to the west and level of the water table. Facing East, scale 1m \& 2m.$

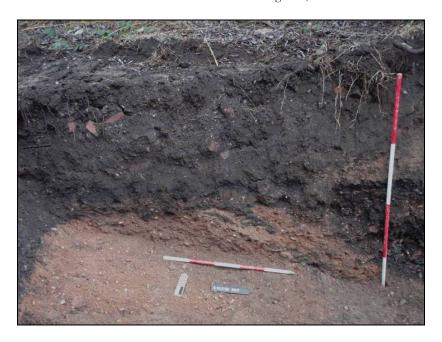
Fig. 6: South facing section revealing natural ground. Scale 1m horizontal & 2m vertical.

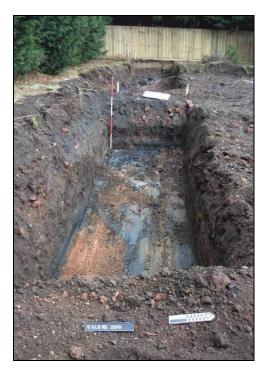
6.3.1 Soakaways 1 and 2 situated in the south-west corner of the site and soakaway 3 situated in the south-east corner were excavated a further 1.3m into an already reduced level of made ground, this equated to 1.9m to 2m below site ground level. The trenches were excavated into made ground to the limit of excavation (Figs. 7 & 8).

F ig. 7: Post excavation of soakaways 1 & 2. Facing West, scale 2m

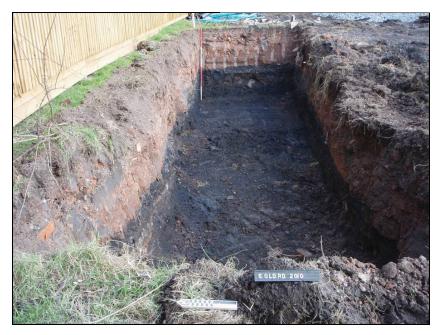
6.3.2 Soakaways 4 and 5 were situated at the northern boundary of the site, on ground slightly lower than that in the south. These were excavated in an area unaffected by the present groundworks. Soakaway 4 measured 11m x 2.8m and soakaway 5 measured 8.5m x 2.1m. Both were excavated until they reached the water table at a depth of 1.9m. In both trenches (001) overlay made ground (002) of imported red clay, rubble and fly ash (Fig. 9).

Fig. 9: Post excavation of soakaway 4, made ground of clay/rubble and fly ash. Facing East, Scale 2m

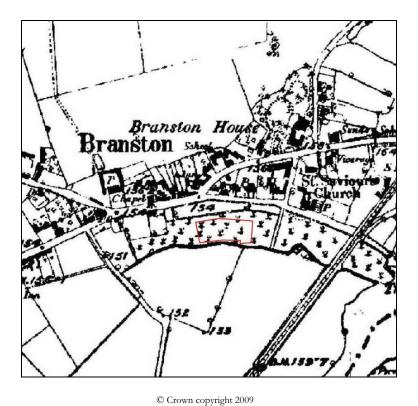
A Map regression identifies the development of the site from open ground (1849-99), to extraction pits (1948-76) and finally enclosed on three sides by housing development (2009) (Figs. 10-13). The projected route of Ryknield Street Roman Road is shown to run north of the site in figures 12 and 13, crossing the modern access road leading to a junction of the A38.

Fig. 10: 1st Edition County Series map 1:10560, 1849 – 1899. Development site seen as open marshy ground

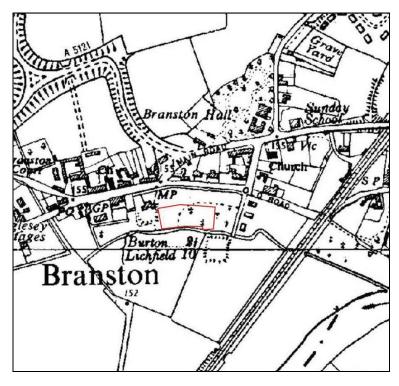
Fig. 11: National Grid map series 1:10560, 1948 – 1976.

Development site seen in an area of possible pits. Post dating the construction of the A38 junction, but prior to the construction of early 1960s housing.

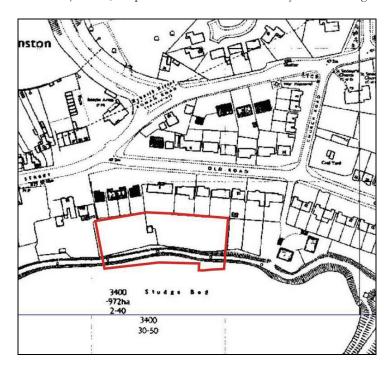
Fig. 12: National Grid map series 1:2500, 1943 – 1995

Development site seen after the construction of housing on Old Road, with its southern extent overlapping an area of sludge beds. Projected course of Ryknield Roman Road to the north.

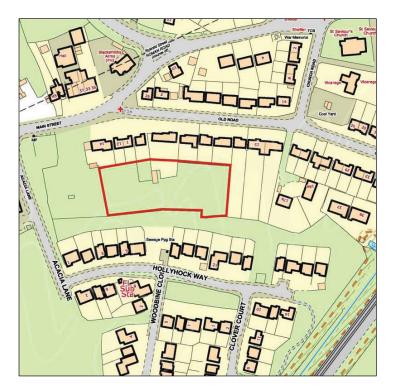
Fig. 13: OS 1:2500 map, 2009.

Development site seen with private housing developed to three sides and open ground to the west. Projected course of Ryknield Roman Road to the north.
