**An Archaeological Building Recording at
Bagots Bromley Farm, Abbots Bromley,
Staffordshire**

ARS Ltd Report 2010/16
February 2010
Oasis I.D. archaeo15 – 73751

In January 2010 Archaeological Research Services Ltd were commissioned by Michael Congreve of Bi Design Architecture Ltd to undertake an Archaeological Building Recording at Bagots Bromley Farm, Abbots Bromley, Staffordshire, prior to the proposed development of the site.

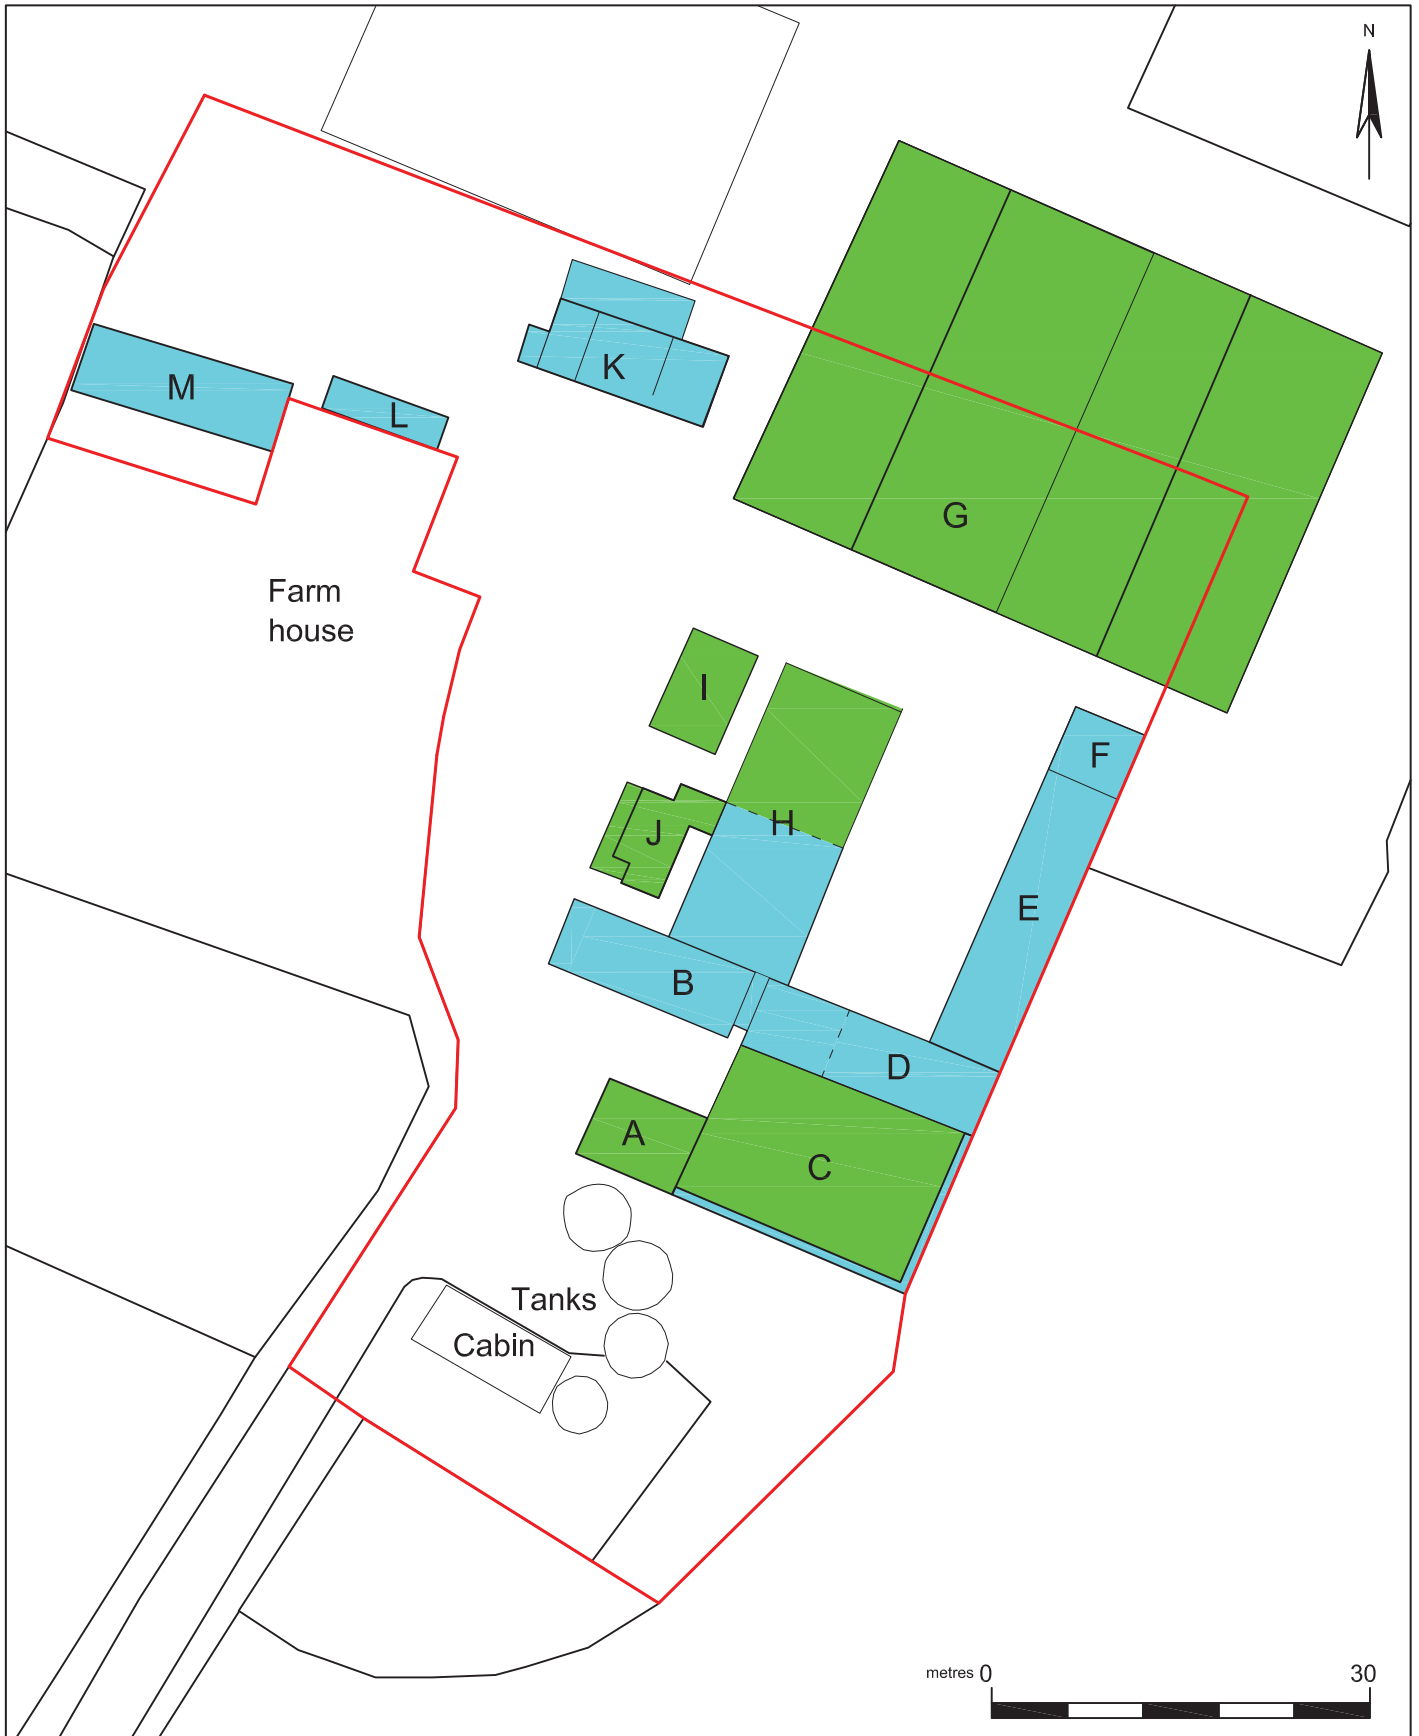
Figure 2
 Site location showing the building codes and their proposed development.

- 4.1 The development site consists of thirteen ranges built parallel or perpendicular to the central lane of Bagots Bromley Farm (Fig. 2).
- 4.2 An archaeological Desk-Based Assessment (DBA) has been produced which examined the historical and archaeological background of the development site (Hunt 2007). This included cartographic regression analysis and discussed the results of documentary studies of the historical evolution of the site based on a compiled document located at the Historic Environment Records held at Staffordshire Historic Environment Records, Staffordshire Records Office, University of Leicester Geology Department and Library (*ibid.*).

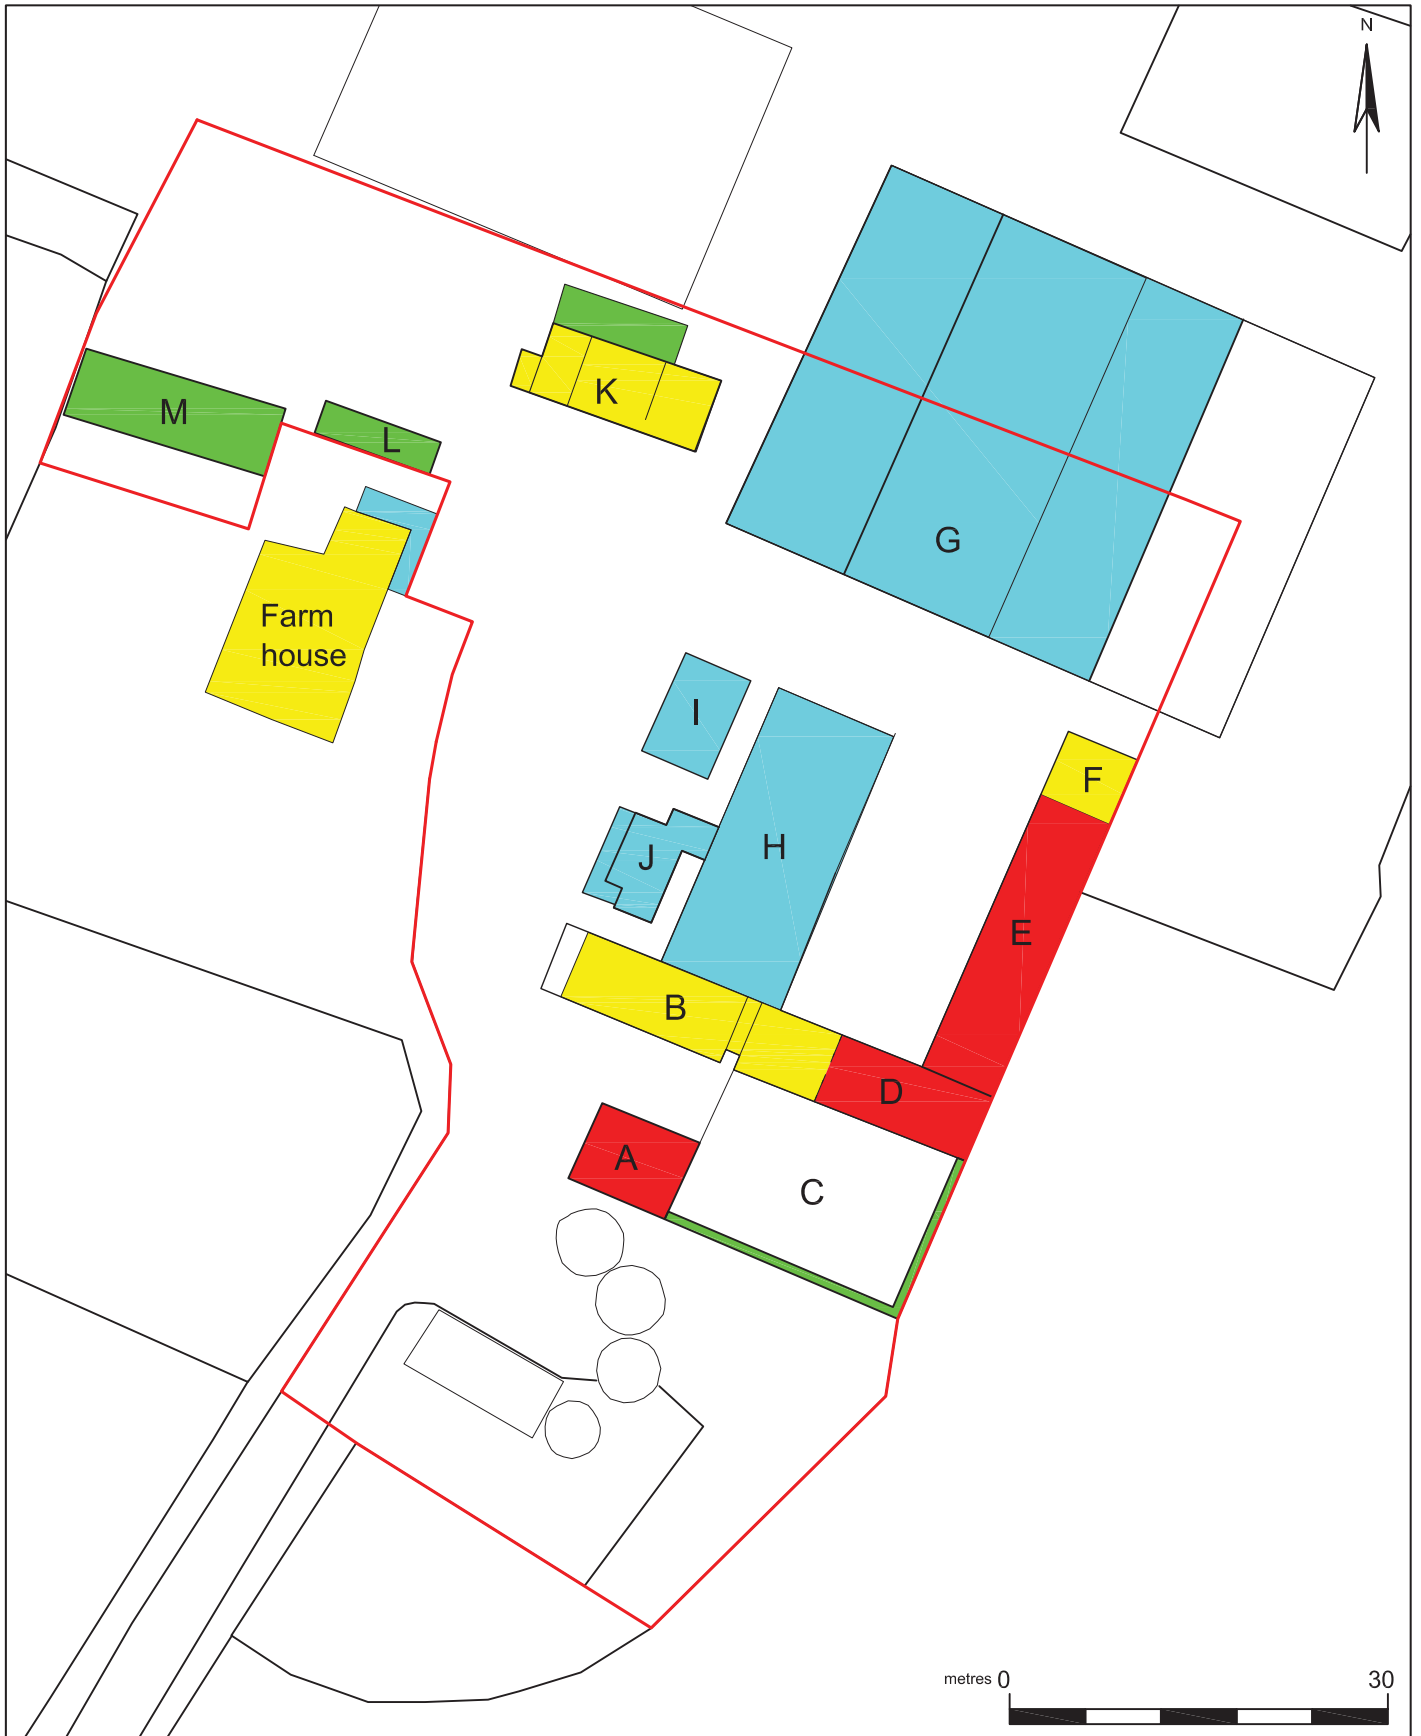
Figure 3
 Phased plan based on cartographic evidence

- 4.3 The DBA has already been submitted as a separate document, and should be consulted in conjunction with this report. The result of the historical research together with the archaeological building assessment successfully identified clear evidence of different phases of construction within the site. A phased plan has been prepared in order to exhibit the surviving sequential development of the farm (Fig. 3). The assessment of the buildings and their sequential developments are considered below. A photographic selection is included in this reports and plotted on a separate plan (Fig. 4).

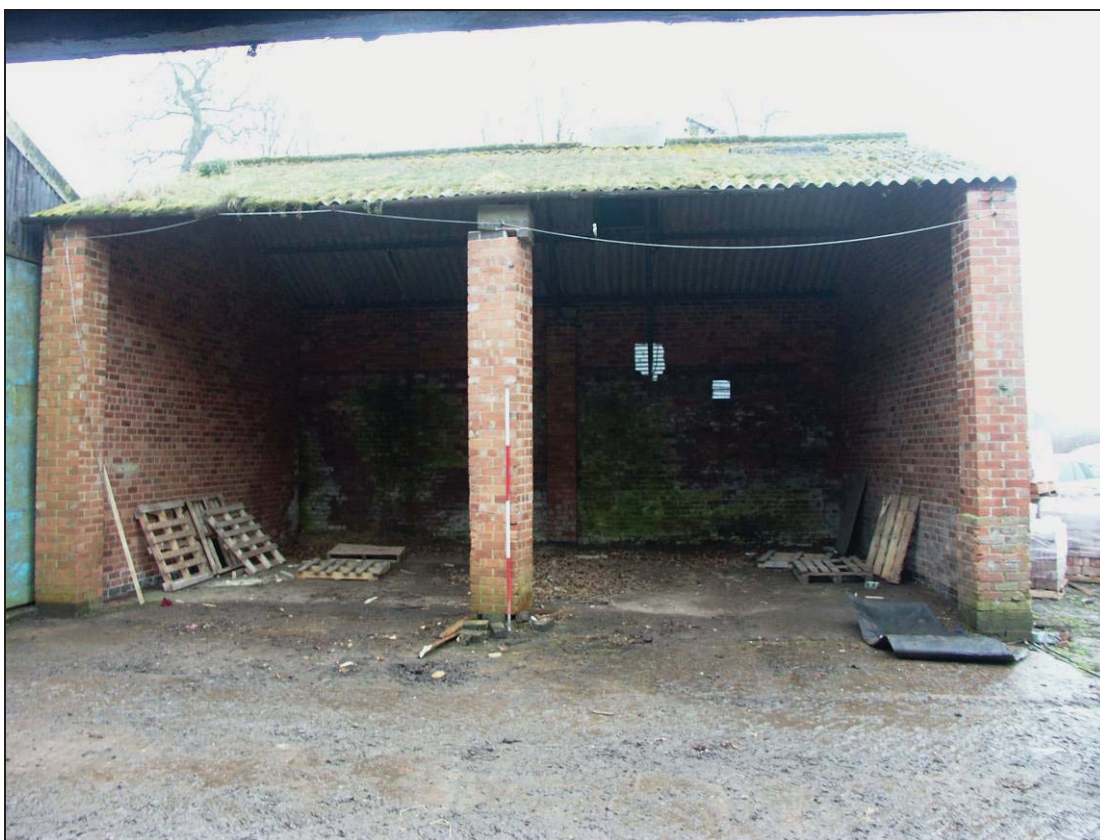
- 4.4 This building is an open-fronted shed which might have been used for storage (Pl. 1). It is a single-storey brick-built range of two bays with a pitched roof with close verge and plain eaves. The roof is made of corrugated asbestos sheeting supported by a central steel 'W-shaped' truss and the eastern and western gable walls. Its overall dimensions are 9 metres in length (east/west), 6.70 metres in width (north/south) and 5.50 metres in height. The northern elevation is the open-fronted side which has a central brick pillar.

Plate 1: North elevation of Building A with open front

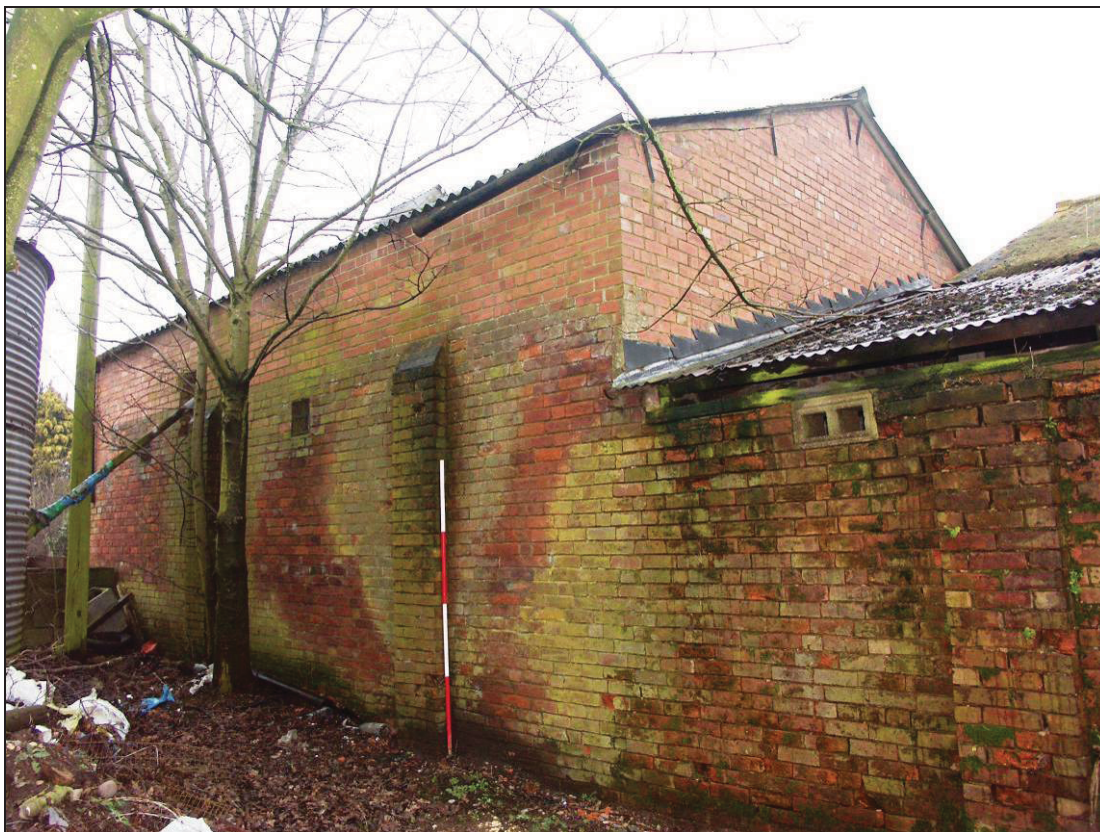
- 4.5 The south elevation appears to have incorporated an earlier wall (up to 2.90 metres high) built with brownish red hand-made bricks (9" x 4 1/4" x 3") bonded with flush medium-coarse pinkish brown lime mortar (up to 10mm thick) and laid to Flemish Garden Wall bond (Pl. 2). This wall has two external pilasters with chamfered top. Between the pilasters there are two small cast-iron vents.

Plate 2: South elevation of Building A incorporating an earlier brick wall with pilasters

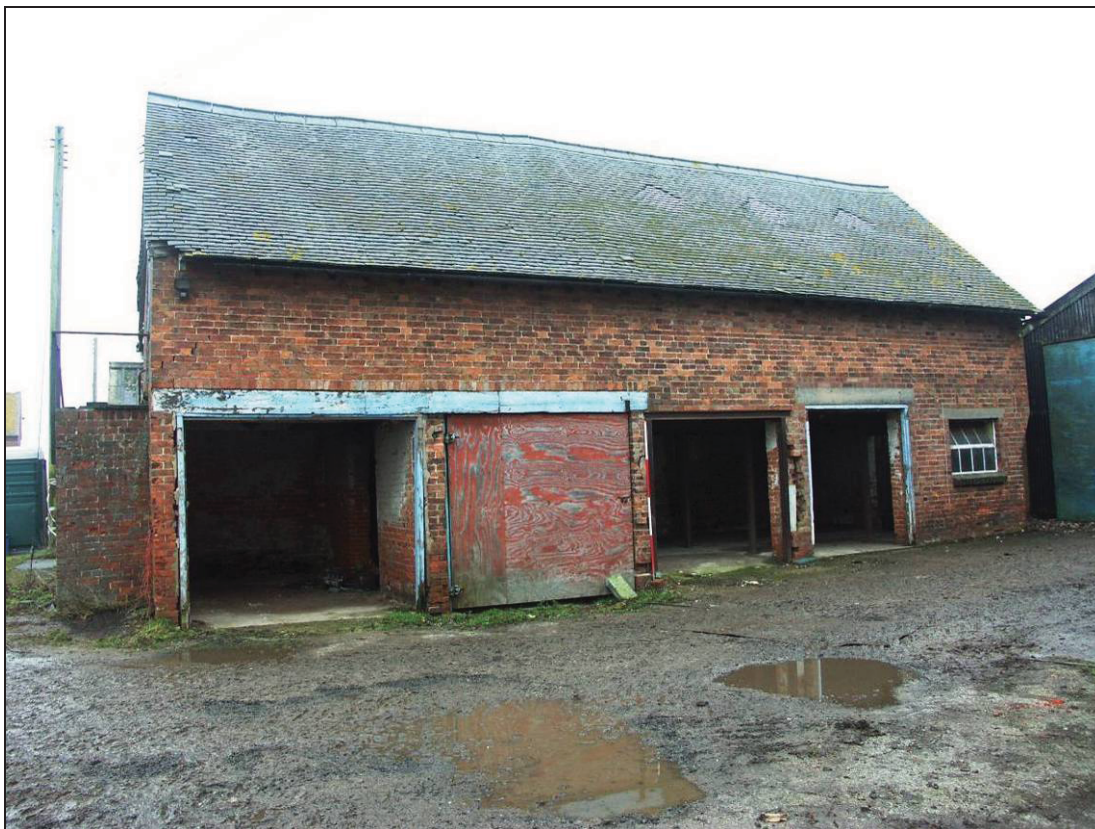
- 4.8 This is a one-and-a-half storeys high brick-built range of five bays with a pitched tiled roof with barged close verge and projecting eaves with cast-iron guttering (Pl. 3). This building was used as a mill, powered by electricity, but the millstones and driving machinery have been removed. Its overall dimensions are 14 metres in length (east/west), 5.60 metres in width (north/south) and 6.70 metres in height.

- 4.10 The main south elevation has four large doorways and a window opening on the easternmost bay of the ground floor. The doorways in the first and second bays from the west have a continuous timber lintel. The third has an RSJ lintel and the fourth a concrete lintel. The doorways are devoid of doors except for the second bay from the west which has a large soft-wood door. There is a window opening on the fifth bay with a concrete lintel and a projecting tapered sill made of blue engineering bricks. The opening has a steel 'Crittall-type' window with an upper inwards hopper opening. The east and west elevations have an oculus on each gable built with chamfered bricks and containing cast-iron vents.

Plate 3: South elevation of Building B

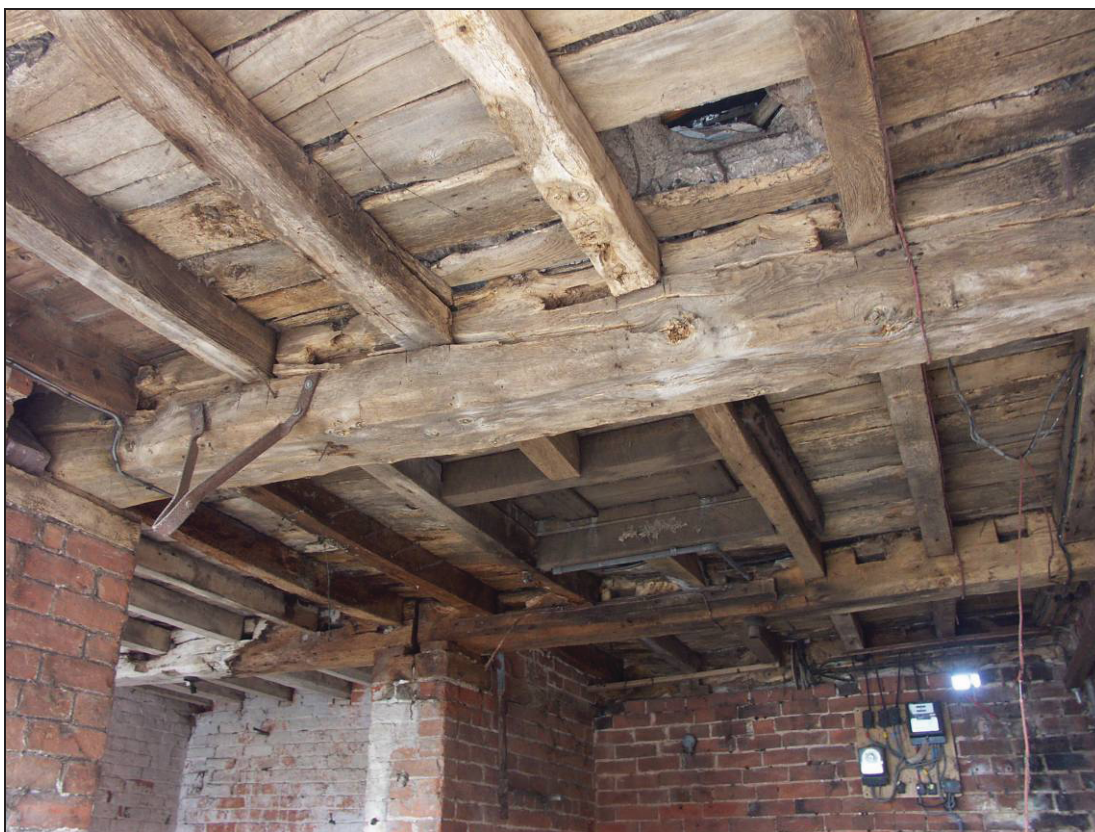
- 4.11 On the ground floor, the first two rooms (from the west) have a different ceiling from the rest of the building. This consists of two east/west timber bridging beams with chamfered edges (2.50m to the underside) carrying exposed joists which bear floor boards for the upper storey (Pl. 4). The walls consist of bricks with partitions and the floor is made of concrete. There is an electric winnower threshing machine inside the second room from the west and above it a boarded-up ceiling hatch from which grain would have been hoisted up to the floor above in sacks (Pl. 5). However, no evidence of a hoist was identified.

Plate 4: Timber ceiling structure in Building B

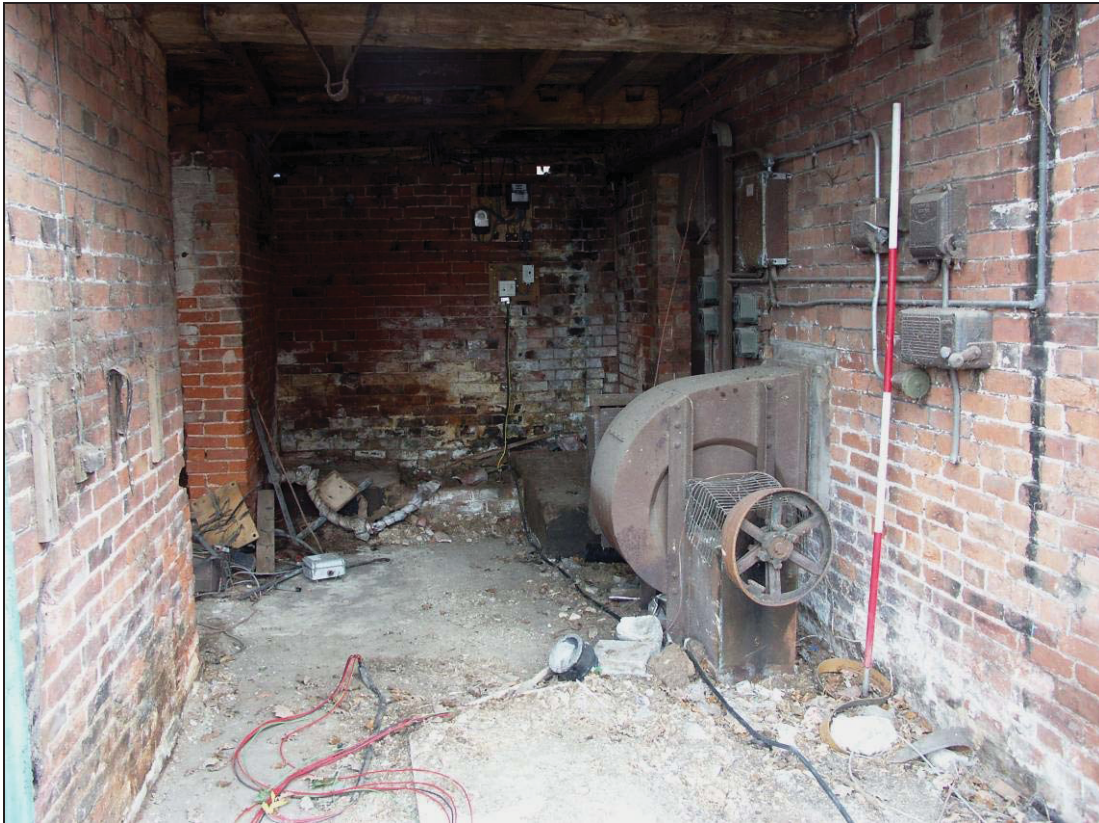
Plate 5: Electric winnower threshing machine on the ground floor of Building B

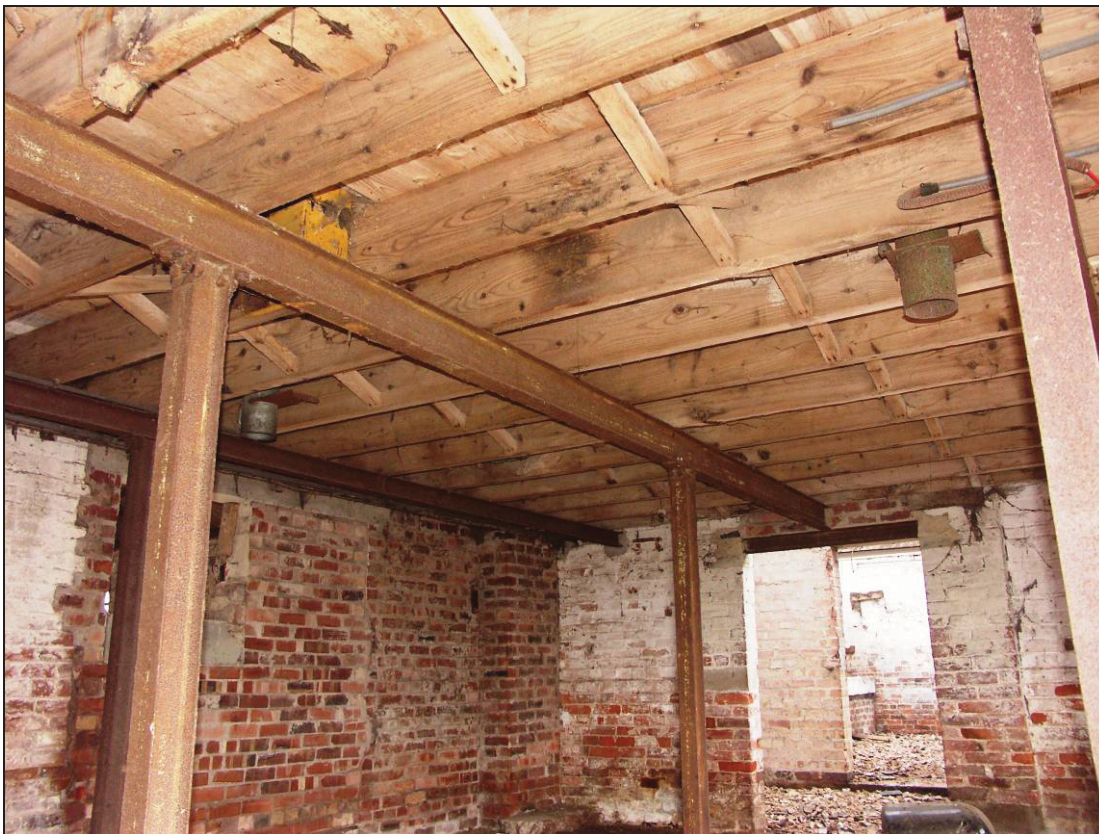
- 4.12 The eastern section of the building is a large room which would have contained mill machinery. The only surviving signs of the machinery are four metal tubular vertical drives protectors placed in the ceiling structure for the upper storey (Pl. 6). The ceiling structure consists of sawn timber joists reinforced with herringbone strutting. The entire structure is supported by an RSJ frame which would have been added at a later stage in order to reduce the vibrations from the millstones in the upper storey. The floor is also made of concrete but is higher than the western side.

Plate 6: Ceiling with circular apertures for former drive of millstone

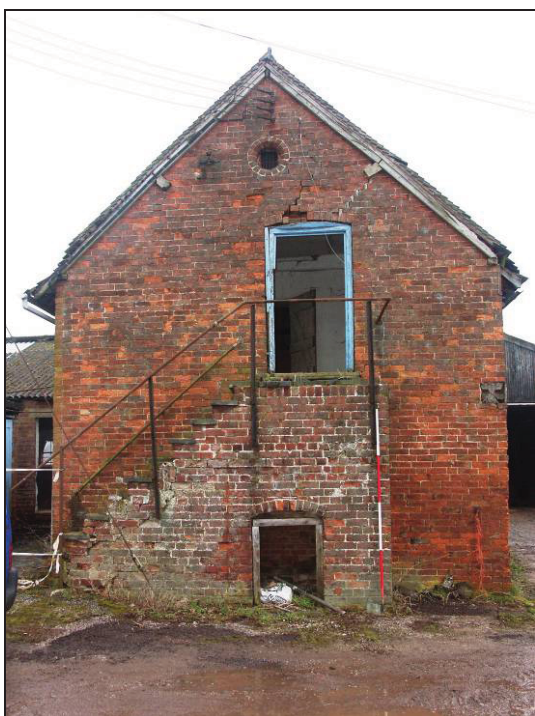
- 4.13 The upper storey is accessed from an external staircase on the west elevation which leads to a doorway with a ledged door (Pl. 7). The staircase is made of bricks and the steps are topped with blue engineering bricks. There is an opening with a segmental arched head which enables access under the stairwell. The interior of the upper floor was only viewed partially due to the unsafe condition of the building. The western section has two sawn timber king-post truss carrying two tiers of trench purlins which extend throughout the entire building (Pl. 8). The western side has a modified truss consisting of a sawn timber tie-beam supporting two raking struts. The principal rafter has been removed.

Plate 7: West elevation of Building B

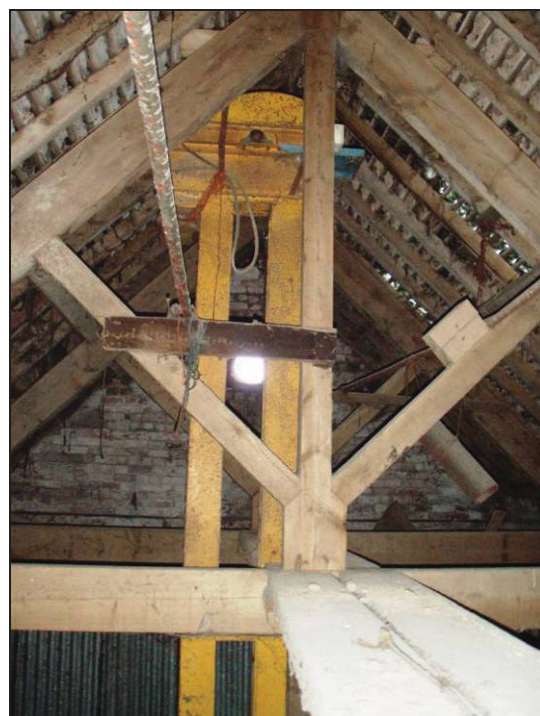
Plate 8: Detail of king-post truss

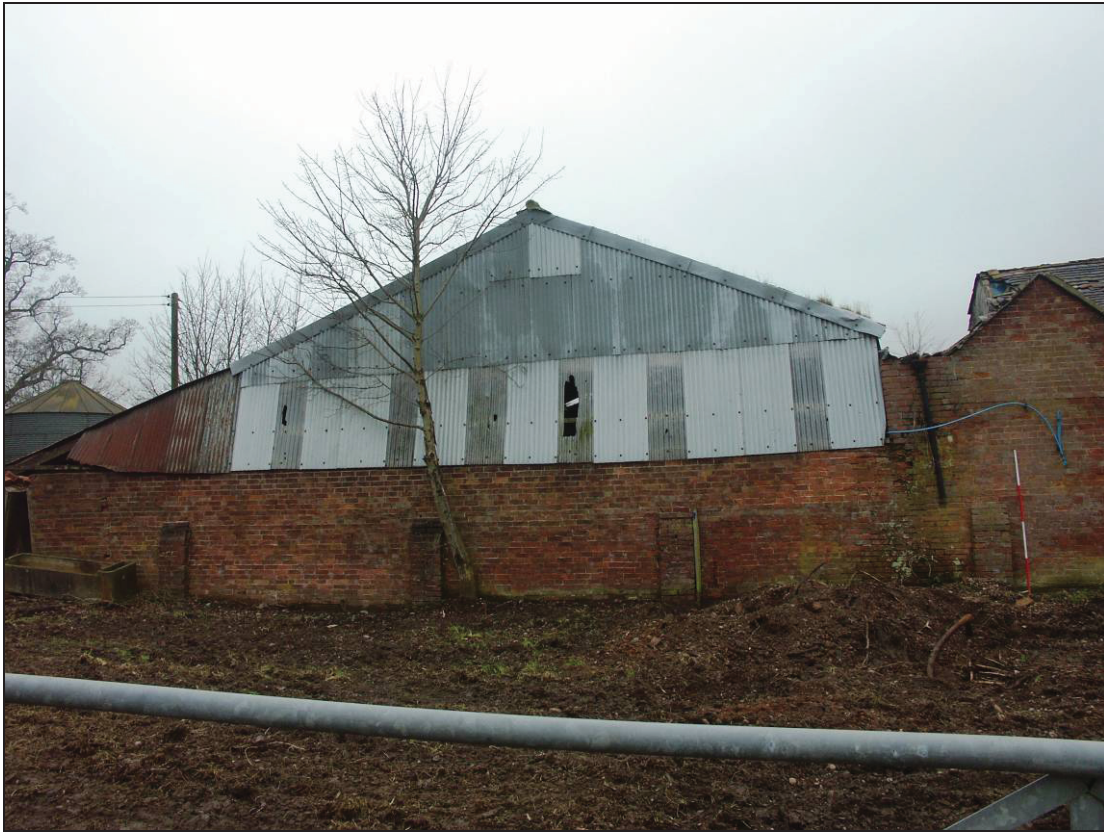
- 4.15 This building is situated on the south-east corner of the development site. It is a long single-storey brick built range with a pitched roof made of corrugated asbestos sheeting with eight (four on each side) corrugated PVC skylights. Its overall dimensions are 18.85 metres in length (east/west), 15.15 metres in width (north/south) and 6.20 metres in height.

Plate 9: East elevation of Building C

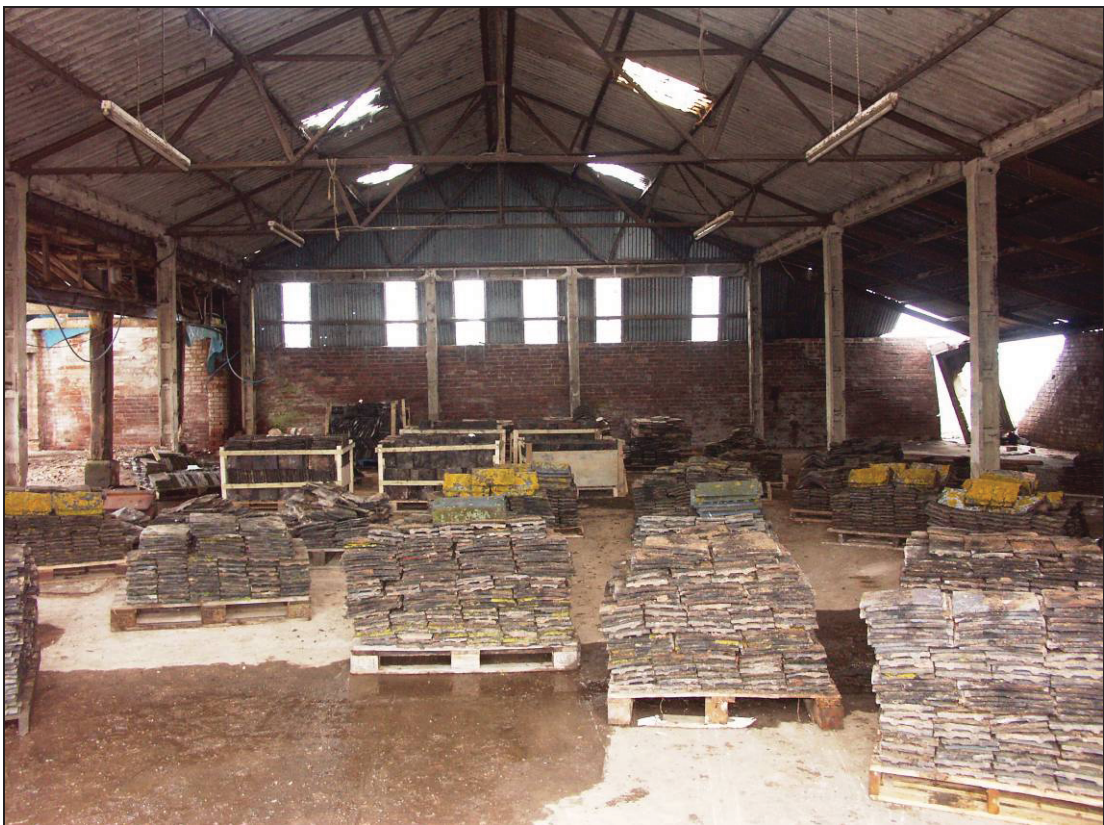
- 4.16 Internally there is a concrete structure composed of twelve posts linked with a continuous wall plate which is supporting five 'W-shaped' steel trusses (Pl. 10). The arrangement of the posts divides the interior into three east/west bays. The main doorway is positioned on the east elevation which consists of a large steel sliding door. The east elevation appears to have incorporated an earlier brick wall with pilasters equivalent to the ones observed in Building A (Pl. 9). The upper section is built with corrugated asbestos sheeting integral with the roof structure.

Plate 10: Inside Building C, looking east

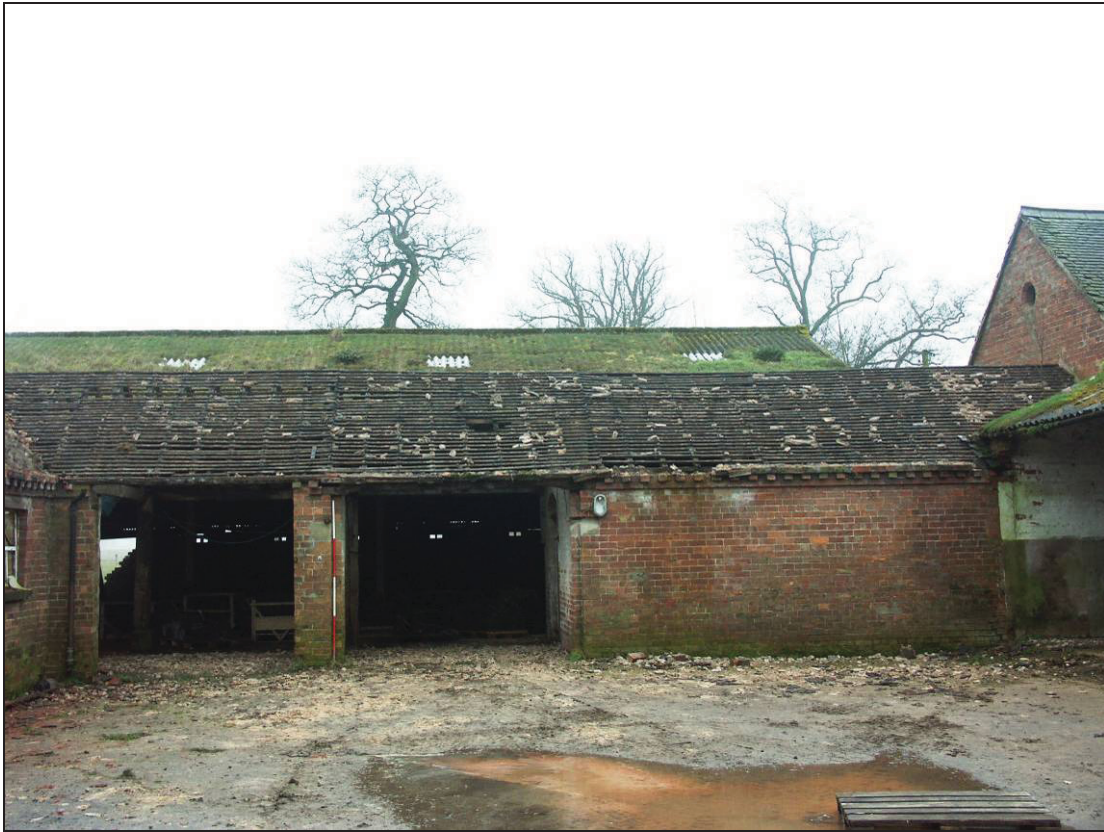
Plate 11: North elevation of Building D

- 4.23 This range dates originally to the mid 19th century and is of local historical importance. The western section seems to be depicted in the 1848 Tithe map and its eastern section, built with similar style and fabrics, is shown in the 1901 OS map. The whole range is in moderate state of preservation but its architectural construction bears noteworthy merits.

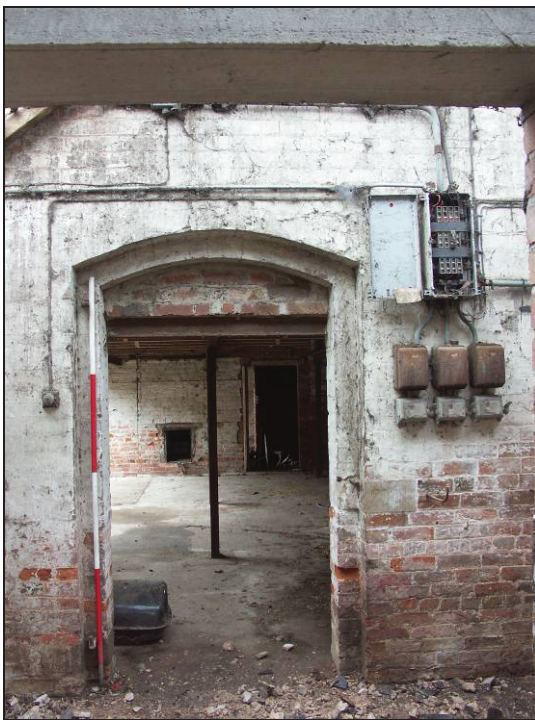
- 4.21 The western elevation has two external doorways with segmental arched heads which lead to Building B on the west and to the central passageway on the east (Pl. 12). The only surviving door is on the eastern side which is a timber ledged-and-brace type with external iron strap hinges (Pl. 14). Internally the building has a continuous trough along the northern wall. The roof structure is of two timber king-post trusses carrying two trenched purlins reinforced with cleats. The king post is bolted to the tie-beam (2.32 metres in height to the underside). The brick walls are lime washed and the floor is made of concrete.

Plate 12: Doorway on the western end of Building D

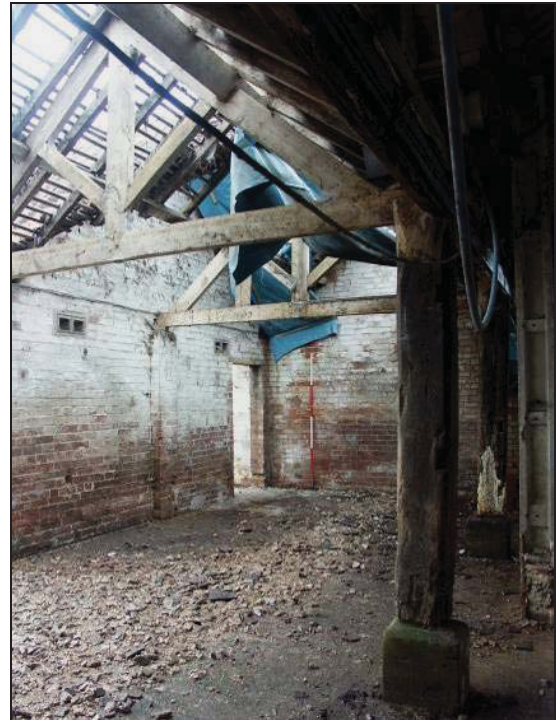
Plate 15: Internal view of the eastern side

- 4.22 The eastern side is similar to its western counterpart except for the roof structure which consists of three king-post trusses built with narrower timber and without cleats (Pl. 15). The interior has a north/south brick partition and an inserted doorway on the north-eastern corner.

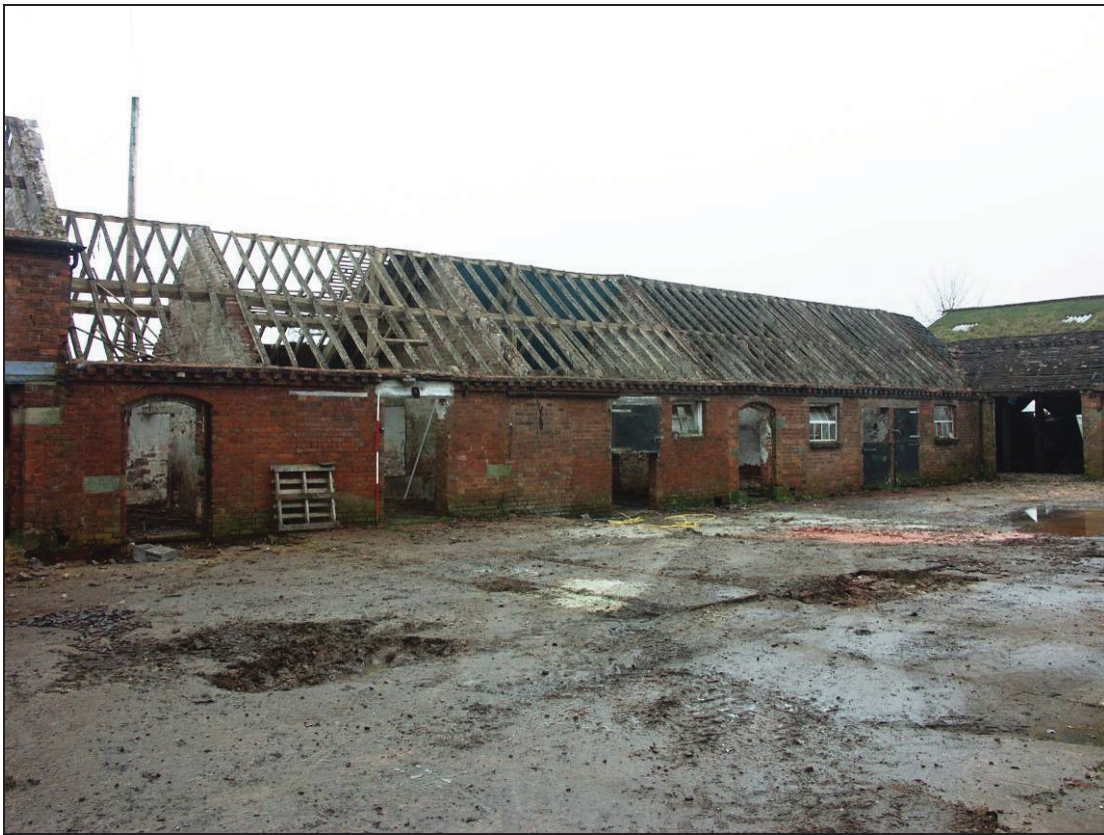
Plate 16: West elevation of Building E, looking south-east

- 4.27 The southern section of the building has a similar roof structure but the timbers are narrower and without chamfered edges (Pl. 23). The brick partitions are built with brown bricks (9" x 4½" x 3") laid to English Garden Wall bond.
- 4.28 This range was probably built during the end of the 19th century as it is shown on the 1902 OS map. Despite unsympathetic insertions such as later doorways, the building has some architectural value.

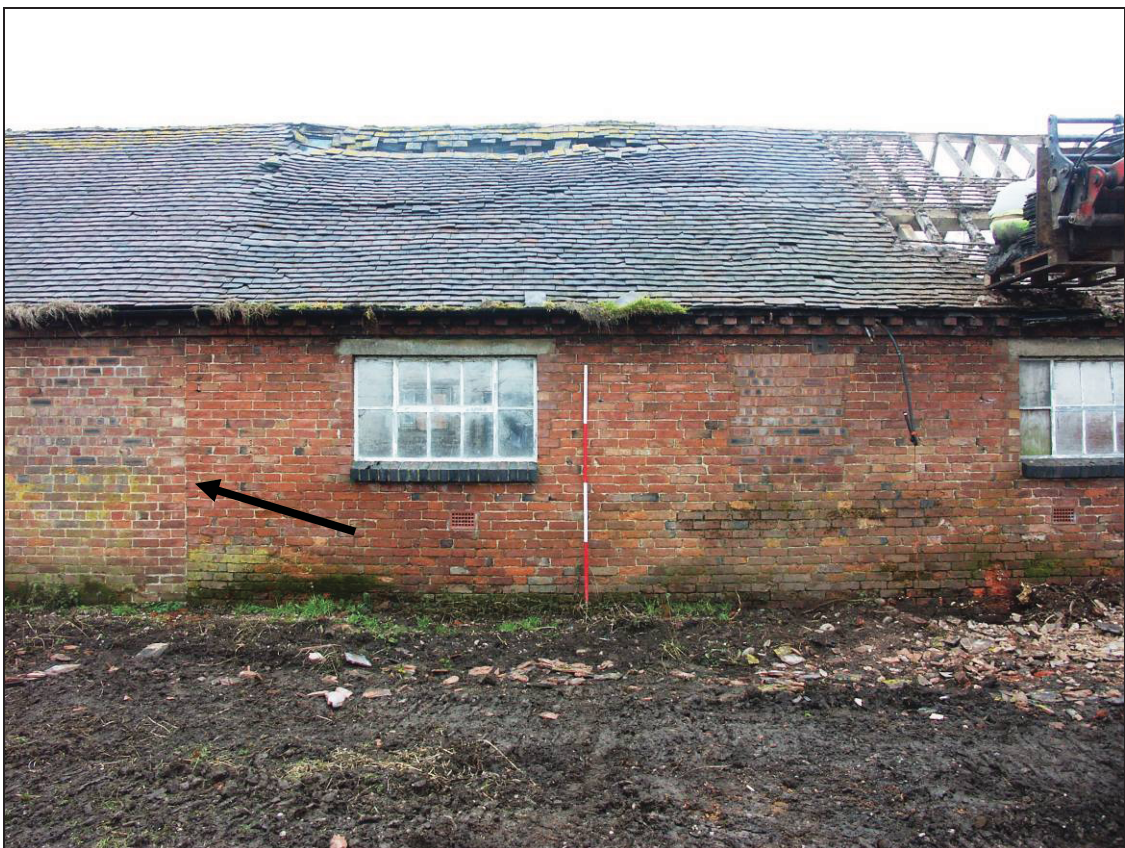
- 4.25 Building E has three original doorways with segmental arched heads on the western elevation of which one is currently blocked with bricks and three later inserted doorways with concrete lintels (Pls. 17, 18 and 19). On the eastern and western elevations there are several inserted window openings with concrete lintels and projecting tapered sills made of blue engineering bricks. Each opening has a steel 'Crittall-type' window with an upper inward hopper opening. On the eastern elevation there is a distinct construction break in the brickwork which may indicate that the building incorporated an existing boundary wall on the southern section which is also part of Buildings C and D (Pls. 21 and 22).

Plate 21: Construction break on the east elevation of building E, indicated with an arrow

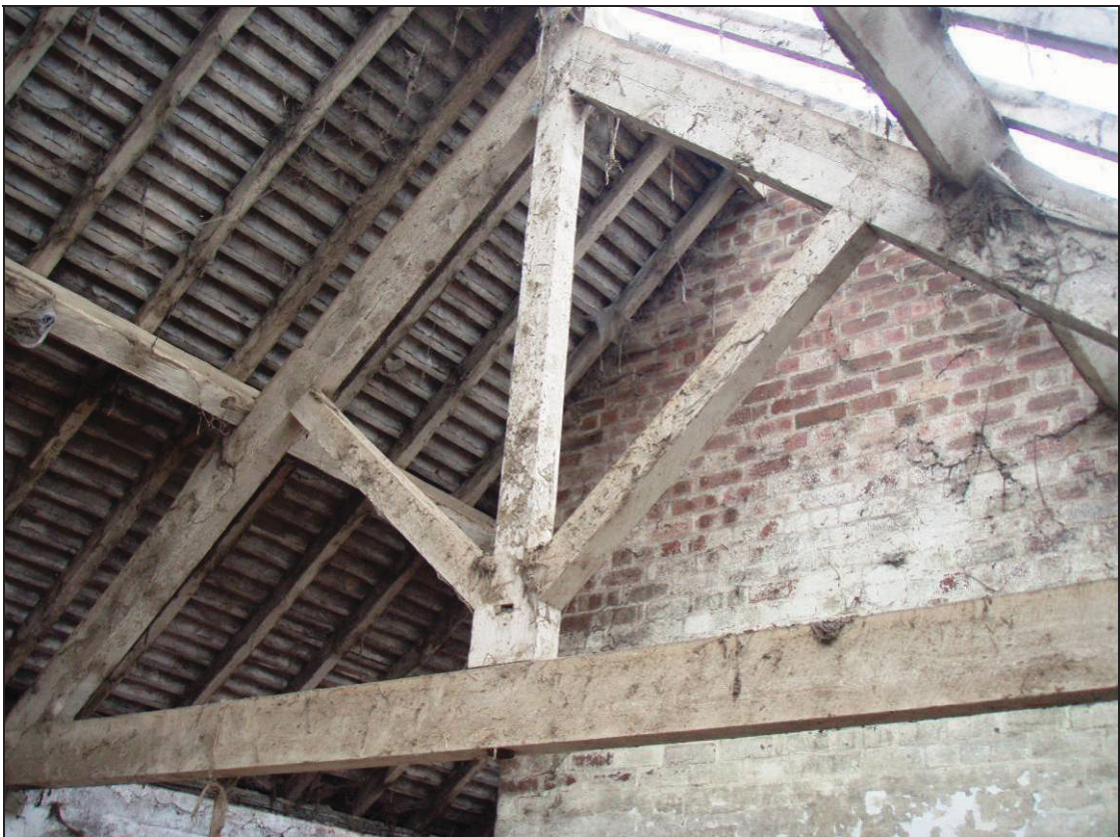
Plate 23: Timber king-post truss within the southern side of Building E

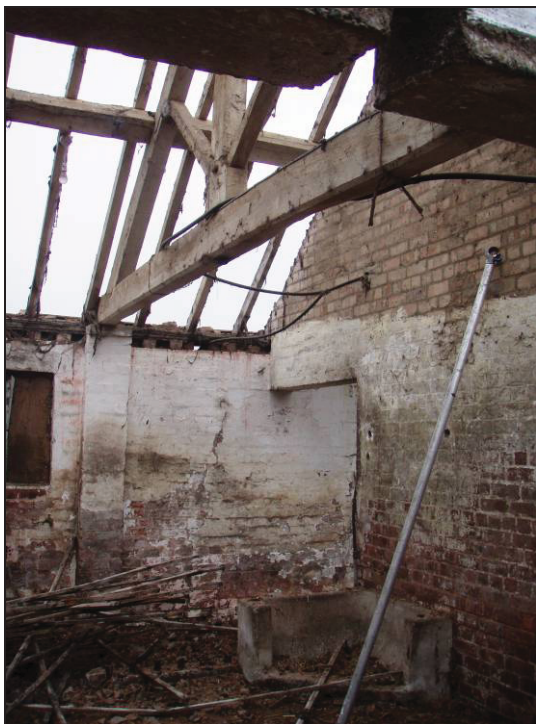
- 4.26 Internally the building has four (9") brick partitions which appear to be later as they are not aligned with the timber trusses. The roof structure of the northern half of the building has two timber king-post trusses supported by brick pilasters (Pl. 24). The trusses carry two tiers of trenched purlins which are fairly thick in nature. The tie-beams have chamfered edges with run-out stops (2.40 metres in height to

the underside) and the king posts are bolted (Pl. 24). The brick walls are lime washed and the floor is made of concrete (Pl. 25).

Plate 24: Northern side of Building E, looking south

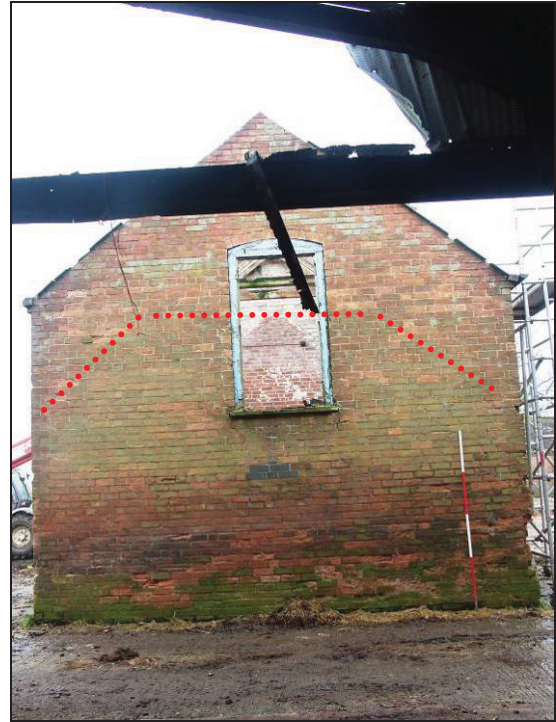
- 4.30 The northern elevation shows signs of having been heightened at a later stage (Pl. 27). There is a large window opening which might have been used as a loading bay. Above the window opening there is an inscribed brick with initials and date (1864) which may indicate the year the upper section was raised (Pl. 28).

Plate 27: North elevation of Building F showing construction break (red dots)

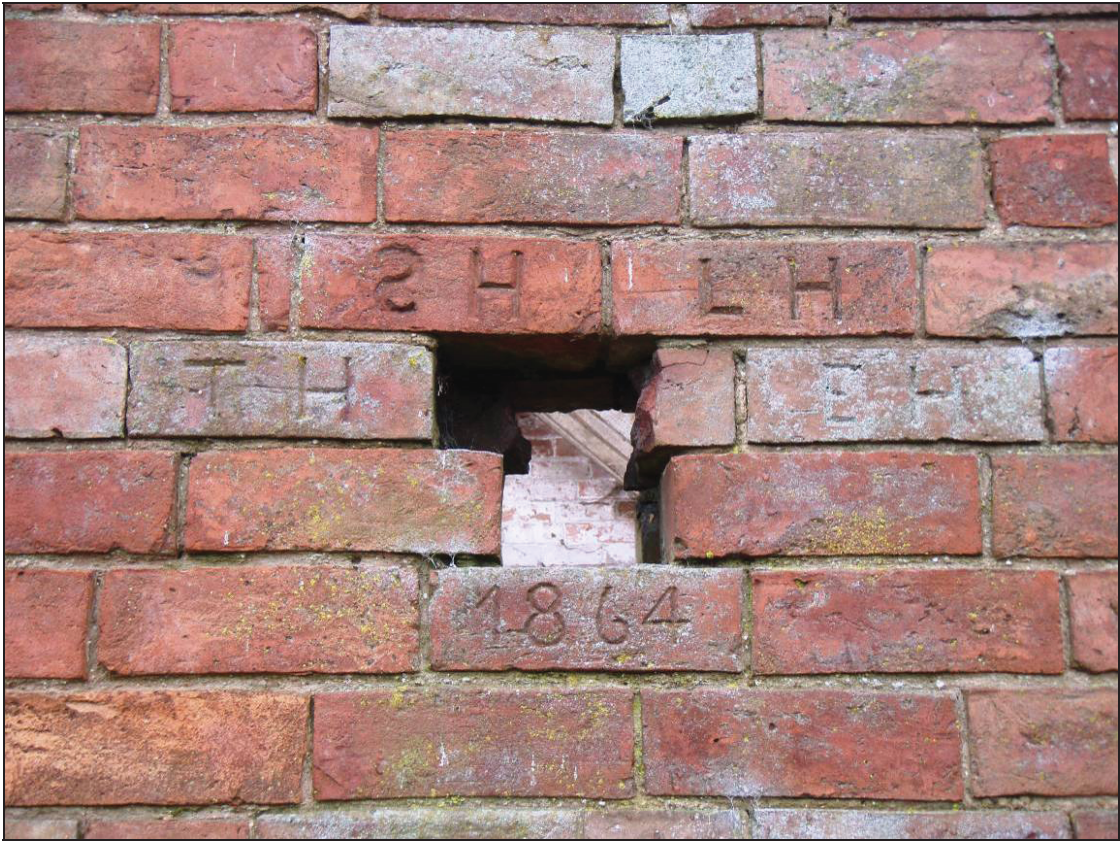
Plate 28: Inscribed initials and date on the north elevation of Building F

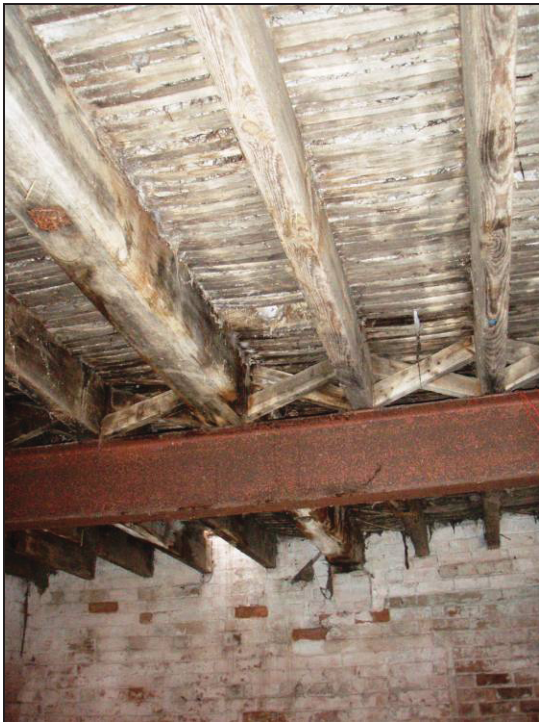
- 4.31 Internally the ground floor has a brick floor and a timber ceiling with a bridging east/west beam with chamfered edges, exposed joists reinforced with herringbone strutting and lath-and-plaster (Pl. 29). This building might have been used as a mill, powered by electricity, as there is a hole in the ceiling and a metal tubular vertical drive protector which is currently on the floor of the building, similar to those recorded in Building B. The whole structure is supported with an RSJ beam which would have been inserted at a later stage in order to reduce the vibrations from the millstone in the upper storey.

Plate 29: Ceiling structure of Building F
