**An Archaeological Building Recording at
Bagots Bromley Farm, Abbots Bromley,
Staffordshire**

ARS Ltd Report 2010/16
February 2010
Oasis I.D. archaeo15 – 73751

In January 2010 Archaeological Research Services Ltd were commissioned by Michael Congreve of Bi Design Architecture Ltd to undertake an Archaeological Building Recording at Bagots Bromley Farm, Abbots Bromley, Staffordshire, prior to the proposed development of the site.

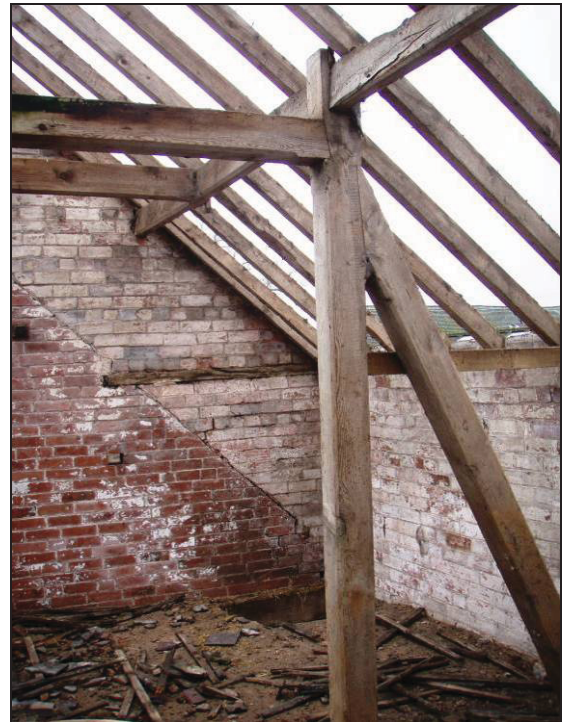
- 4.32 The upper storey was not accessible, however it was partially observed from the northern window opening. The roof structure consists of a central queen-post truss without principal rafters (Pl. 30).
- 4.33 This building is depicted in the 1848 Tithe map and the current upper storey might have been added to the original structure in 1864 as an inscribed brick indicates. It has little architectural merit but is of local historical importance.

Plate 30: Truss structure of Building F

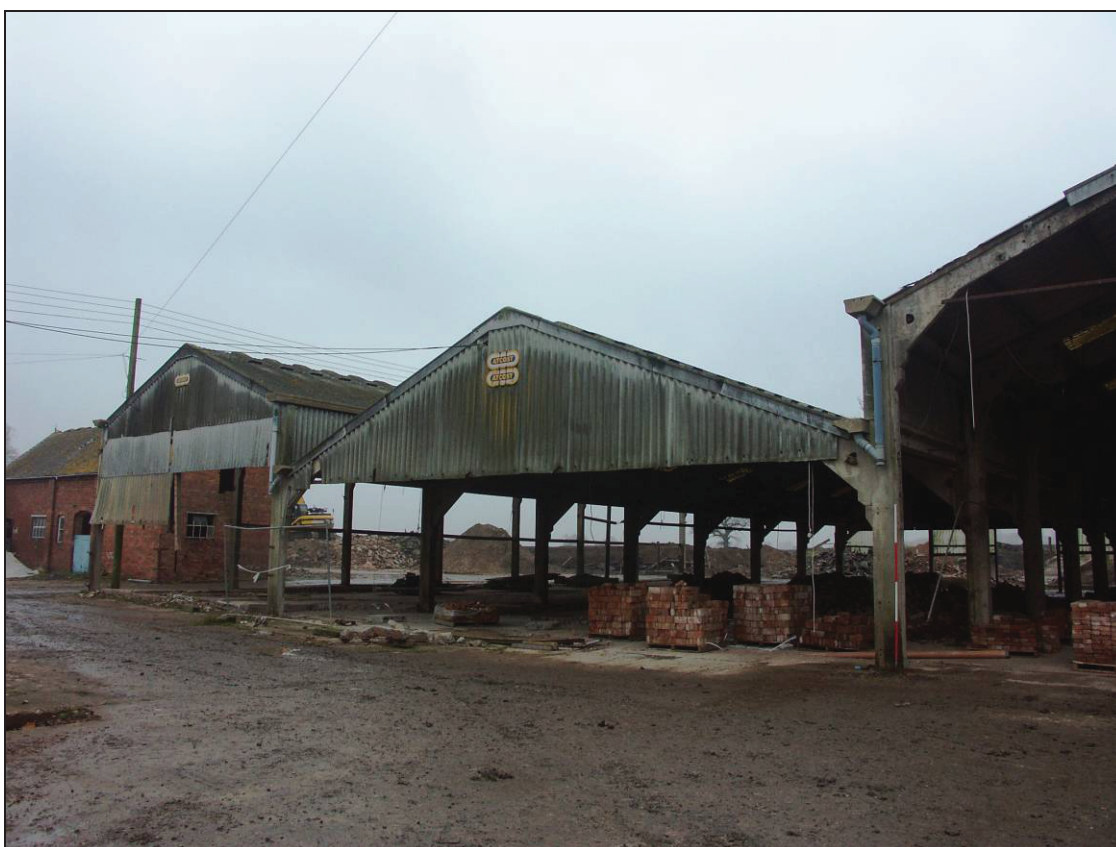
Plate 31: South elevation of Building G

- 4.34 Building G consists of four north/south opened storage sheds made of concrete posts supporting steel 'W-shaped' trusses which carry four pitched roofs with central valleys (Pl. 31). The material of the roofs is corrugated asbestos sheeting and the floor is made of concrete. Its overall dimensions are 42.50 metres in length (east/west), 32.60 metres in width (north/south) and 6.75 metres in height.
- 4.35 This building is modern in date and of no architectural or historical significance.

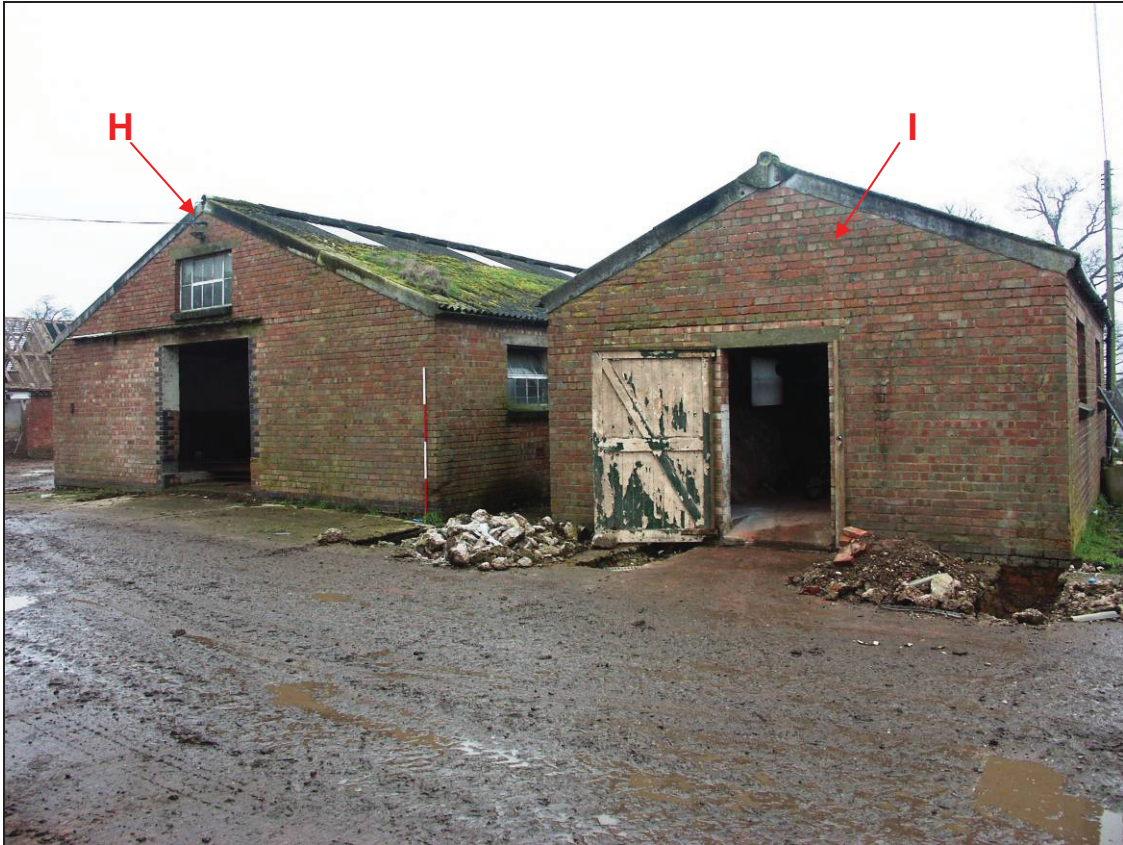
Plate 32: North elevation of Building H on the left and Building I on the right

- 4.36 Building H is a long rectangular single-storey brick-built range of six bays with a pitched roof which has close verge and plain eaves (Pls. 32 and 33). Its overall dimensions are 24 metres in length (north/south), 10.30 metres in width (east/west) and 5 metres in height. The walls are decorated with pilasters which divide it into six bays. Each bay has a window opening with a concrete lintel and a projecting tapered sill made of blue engineering bricks. The window opening has a steel 'Crittall-type' window with an upper inward hopper opening. This range is built with red machine-made bricks ($8\frac{3}{4}'' \times 4'' \times 2\frac{3}{4}''$) bonded with flush medium-coarse light brown lime mortar (up to 10mm thick) and laid to Flemish Garden Wall bond.

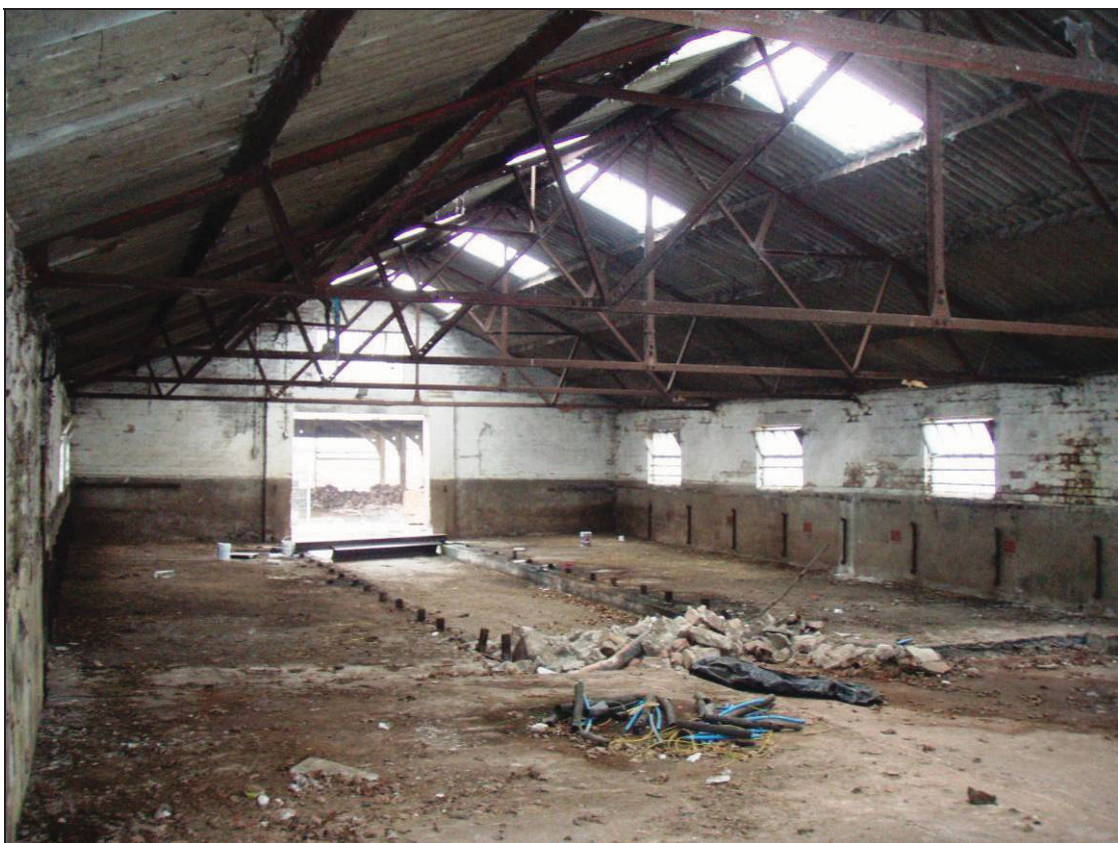
- 4.37 This building appears to have been used as a cow shed (Pl. 34). Internally it has a concrete floor and the roof consists of five steel 'W-shaped' trusses supporting asbestos corrugated sheeting with twelve skylights (six on each side) and cast-iron guttering. On the north elevation there is a large doorway which would have had a sliding door which is no longer present.
- 4.38 This building is modern in date and of no architectural or historical significance.

Plate 34: Inside Building H, looking north

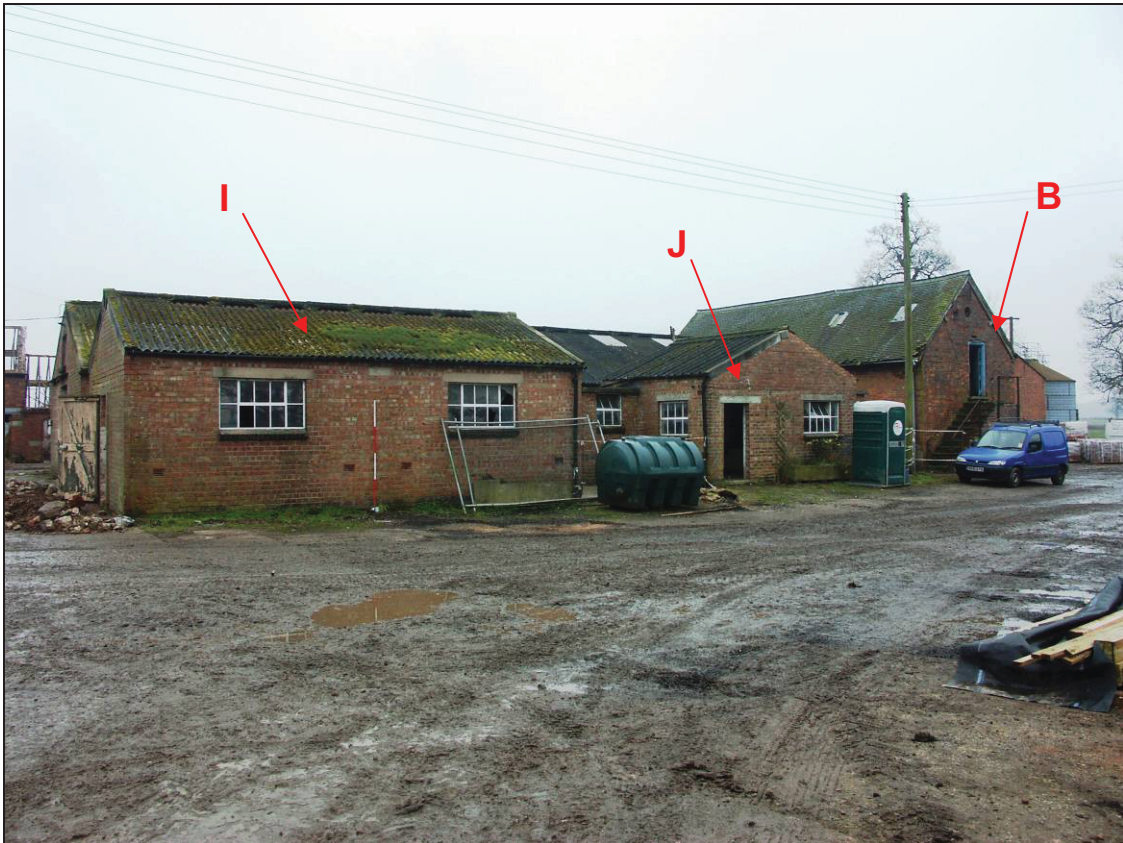
Plate 35: West elevation of Building I on the left and Buildings J and B on the right

- 4.39 Building I is a single-storey brick-built range of two bays with a pitched roof which has close verge and plain eaves (Pl. 35). Its overall dimensions are 9.25 metres in length (north/south), 4.80 metres in width (east/west) and 4.20 metres in height. It is built with similar fabrics as Building H except for the lack of pilasters on the wall. It has two windows on the side walls and PVC guttering which appears to be a later replacement.
- 4.40 Internally the building is accessed from a doorway on the north elevation which has a concrete lintel and a framed ledged-and-brace timber door (Pl. 36). It has a concrete floor and a ceiling composed of a north/south timber bridging beam and exposed joists supporting wooden boards. The roof is supported by a central steel 'W-shaped' truss.
- 4.41 This building is modern in date and of no architectural or historical significance.

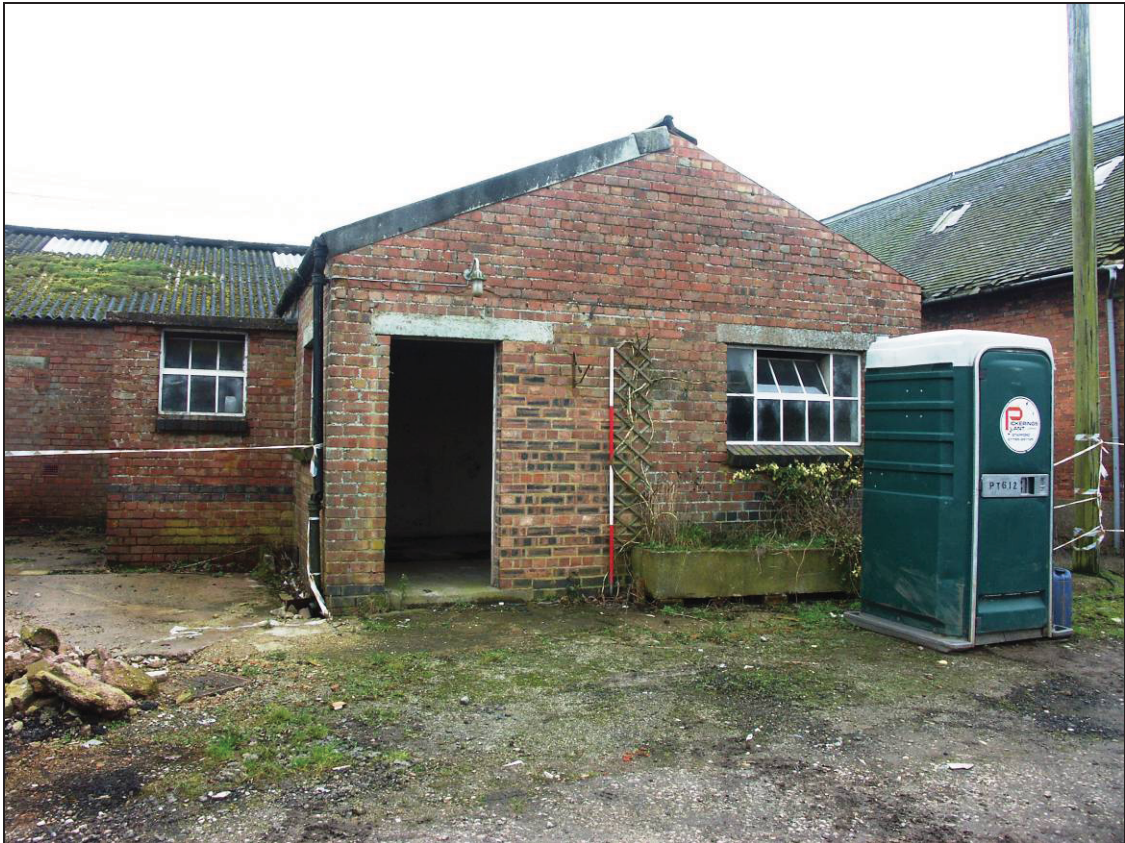
Plate 37: West elevation of Building J

- 4.42 Building J is situated between the south elevation of Building I and the north elevation of building B. It is a single-storey brick-built range of one bay with a pitched roof which has close verge and plain eaves. Its overall dimensions are 5.90 metres in length (north/south), 4.70 metres in width (east/west) and 4.20 metres in height. It is built with similar fabrics as Building I.
- 4.43 The building is accessed from a doorway on the west elevation which has a concrete lintel (Pl. 37). This elevation also has a window equivalent to those in Buildings H and I. Internally it has a raised concrete floor, a false ceiling made with wooden boards and the walls are rendered with cement.
- 4.44 This building is modern in date and of no architectural or historical significance.

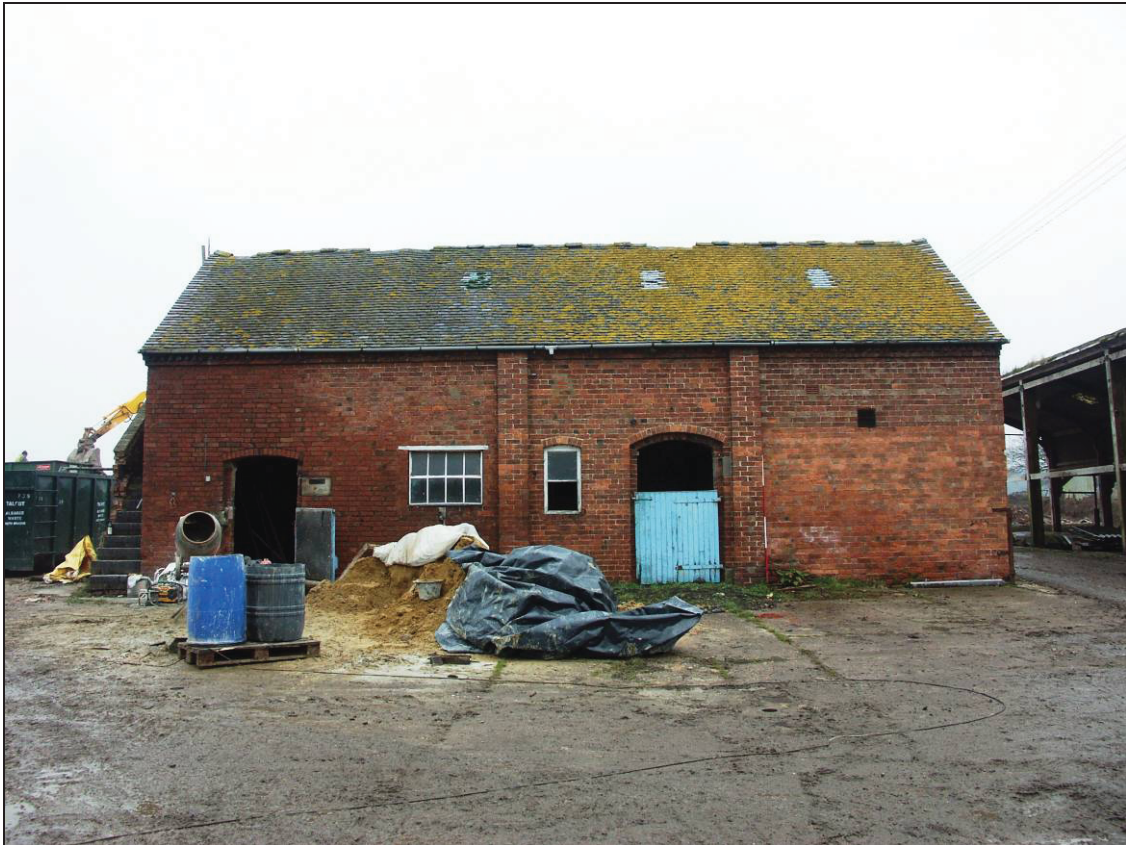
Plate 38: South elevation of Building K

- 4.51 This building may date to the first quarter of the 19th century as it seems to be depicted in the 1848 Tithe map and there is an inscribed brick with the date of 1819. The lean-to northern extension might have been added in the mid 19th century as indicated by the inscribed date on one of the bricks. Moreover, the lean-to is shown on the 1882 OS map. There are signs of repairs and some of the windows might not be original. However, this building can be considered of some architectural merit and is of local historical importance.

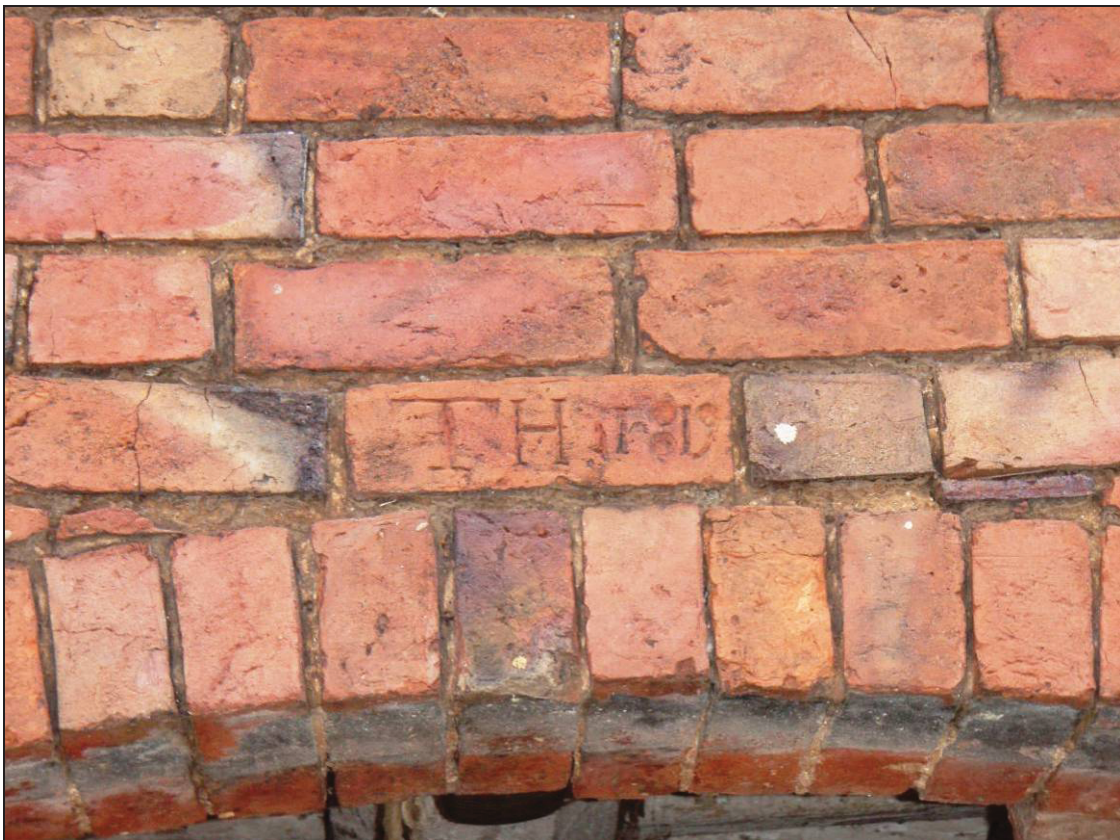
- 4.46 The walls are decorated with dog-toothed brick cornices at the eaves of the side walls and the verge of the western gable. The south elevation has two doorways and windows on the western and central bays. The doorways have segmental arched heads and stable timber doors with iron strap hinges (Pl. 43). There is a brick with inscribed initials and date (1819) over the western doorway (Pl. 39).

Plate 39: Inscribed initials and date over the doorway head on the western bay of Building K

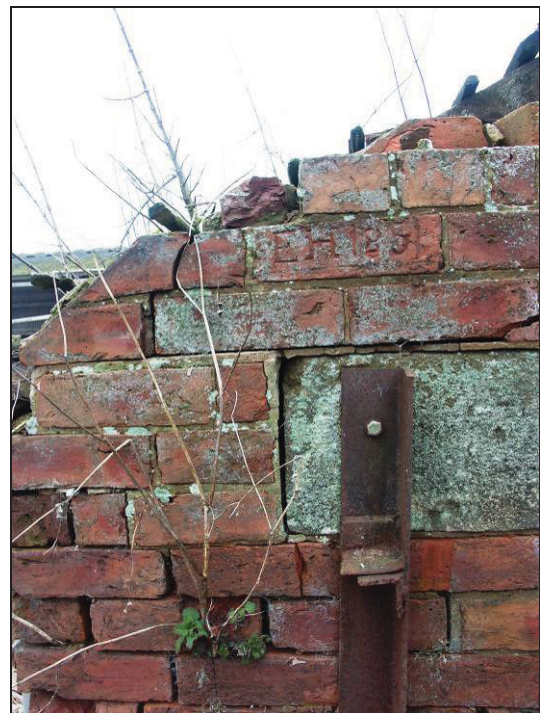
- 4.48 There is a lean-to extension along most of the northern elevation built with similar fabrics to the main building (Pls. 40 and 44). It is accessed from the western side which has a brick wall containing another brick with initials and date (1851). This date may indicate the year the lean-to extension was erected (Pl. 45).

Plate 45: Detail of inscribed initials and date

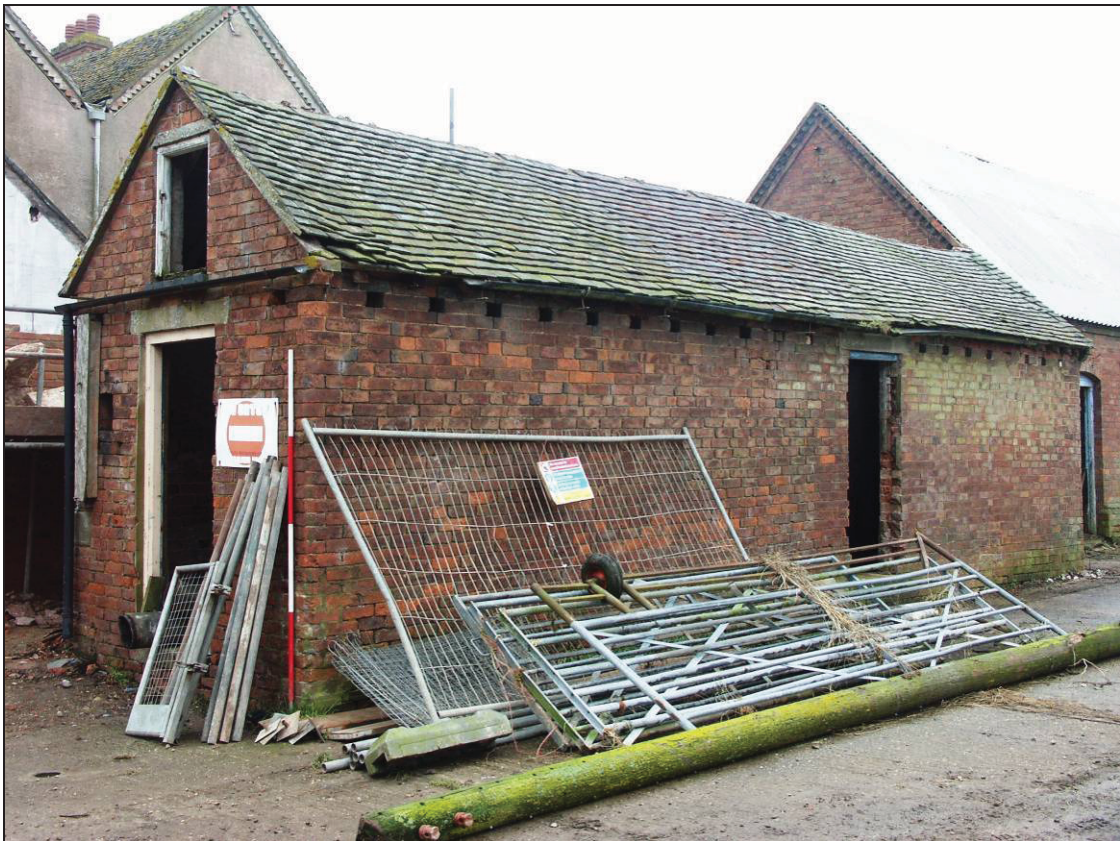
Plate 48: North elevation of Building L

- 4.54 This building appears depicted in the 1882 OS map and although is not of architectural merit, it is of some local historical importance.

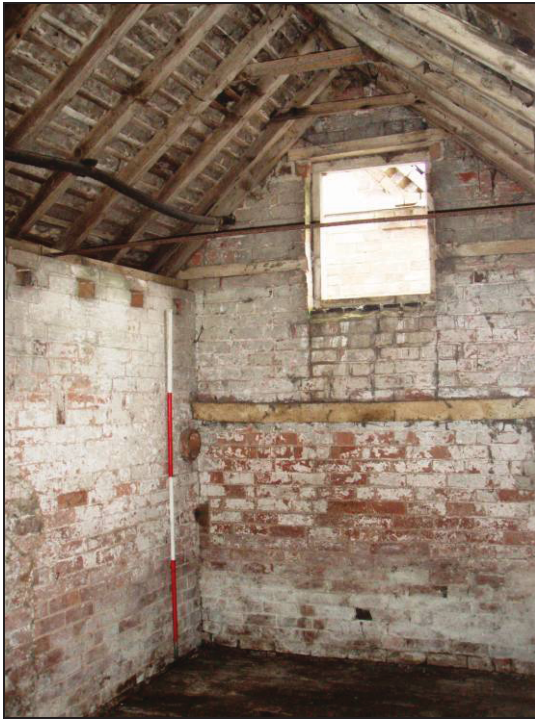
Plate 49: Internal view of Building L

- 4.53 Internally the building is divided by an inserted brick wall. The floor is considerably raised (350mm high) and is built with bricks laid on edge. The roof structure consists of timber common rafters with upper collars (Pl. 49). This building might have originally contained ovens for burning, baking and/or drying as there are four apertures with semi-circular heads blocked with bricks on the south wall which resemble ovens or similar features and the brick floor is slightly stained with charcoal (Pl. 50).

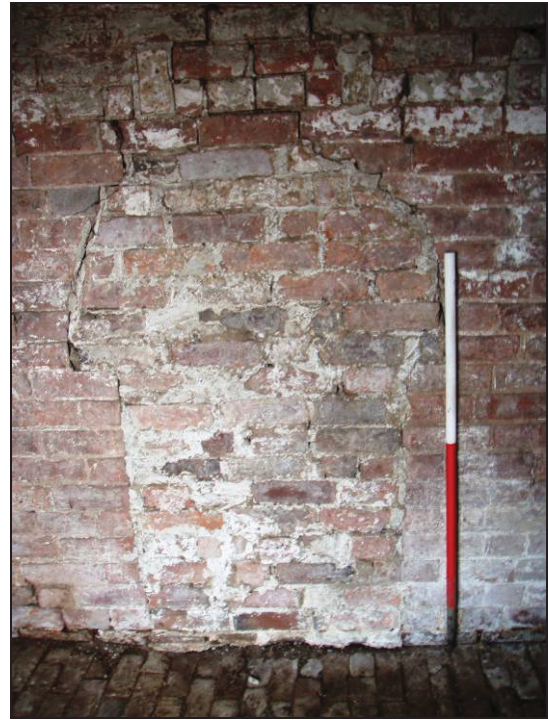
Plate 50: Detail of former oven blocked up

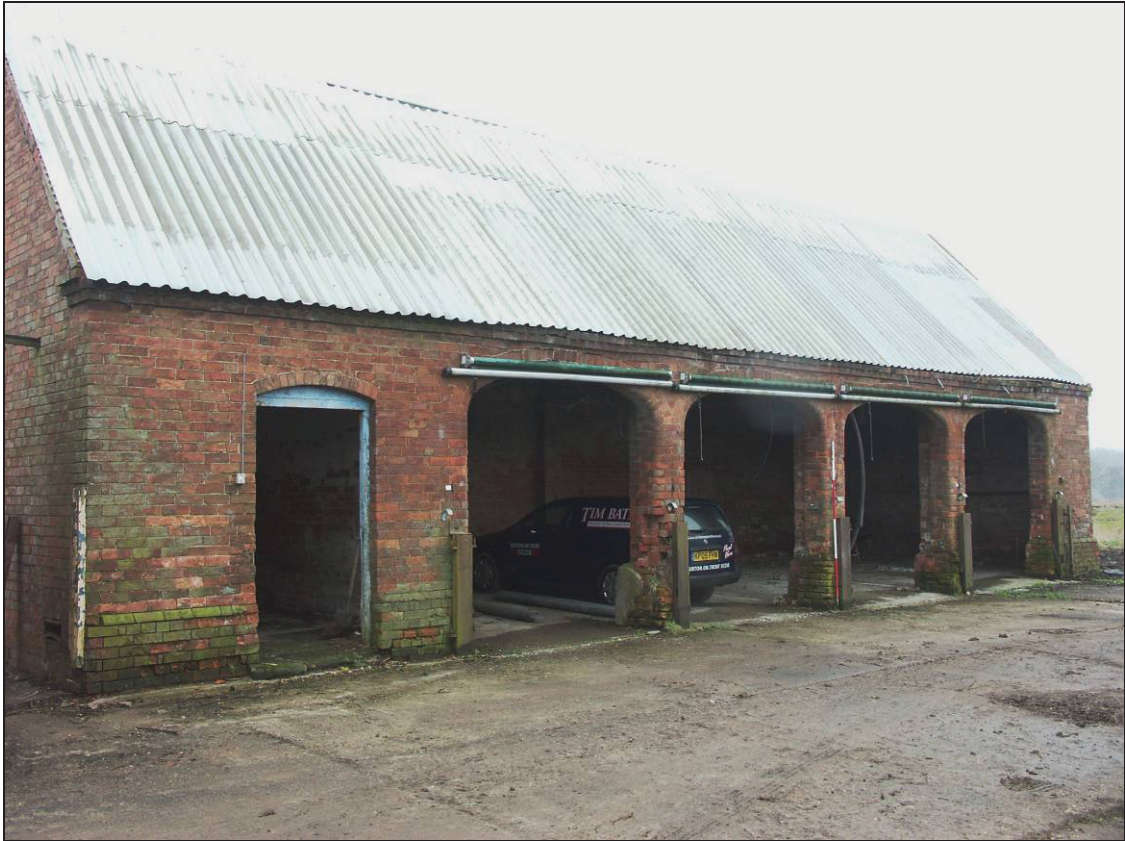
- 4.56 The northern elevation is an open-fronted arcade composed of four large doorways with elliptical arched heads and elegant pillars with bullnose jambs (Pl. 51). The eastern bay has a common doorway with segmental arched head and a ledged timber door which leads to a room latterly used as a stable.

Plate 51: North elevation of Building M, looking north-east

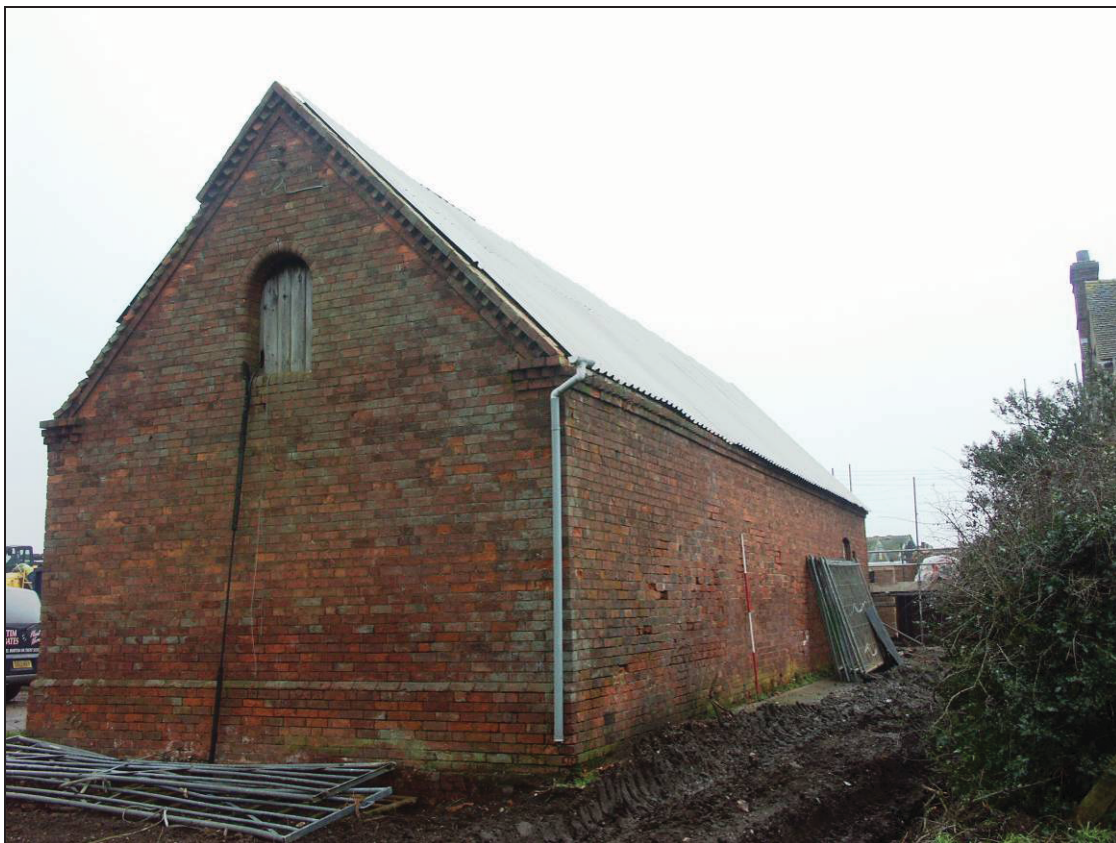
Plate 52: West and south elevations of Building M

- 4.59 This is an elegant range which, although the roof has been replaced with metal sheeting, bears particular architectural merit. The building was probably built during the mid 19th century and is exhibited in the 1882 OS map. Thus it is of local historical importance.

- 5.14 Building M is a tall single storey brick built range which was used as a coach house/cart shed. The brickwork is decorated with dog-toothed brick cornices at the eaves of the side walls and the verge of the gable walls. It has an elegant open-fronted arcade supported by pillars with bullnose jambs. There is also a semi-circular window with bullnose jambs and *intrados*. The roof structure is well-preserved and consists of three king-post trusses carrying two tiers of trencled purlins. Although its original tiled roof has been replaced by modern metal sheeting, the majority of the building bears particular architectural merit. The building was probably built during the mid 19th century and is exhibited in the 1882 OS map. Thus it is of local historical importance.

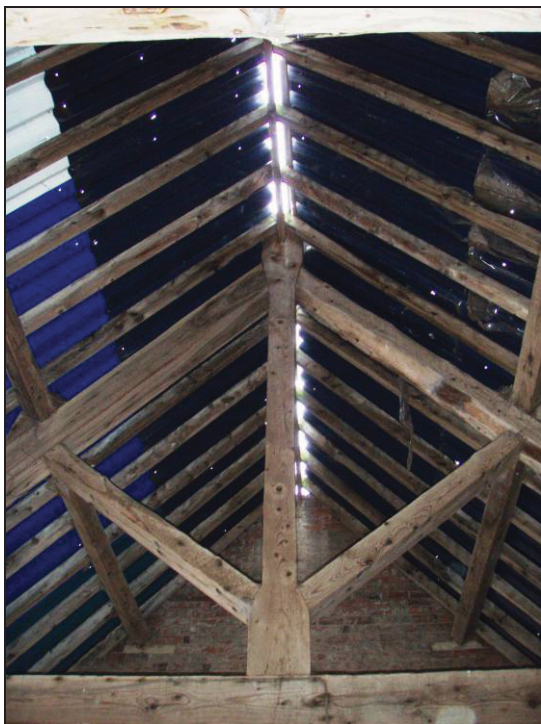
- 4.58 Internally the main area was used as a coach house/cart shed. The floor is made of concrete at the same level as the farmyard. The walls have a brick plinth with chamfered tops. The roof structure consists of three king-post trusses carrying two tiers of trenched purlins reinforced with cleats (Pl. 54). The king posts are bolted to

Plate 54: King-post truss

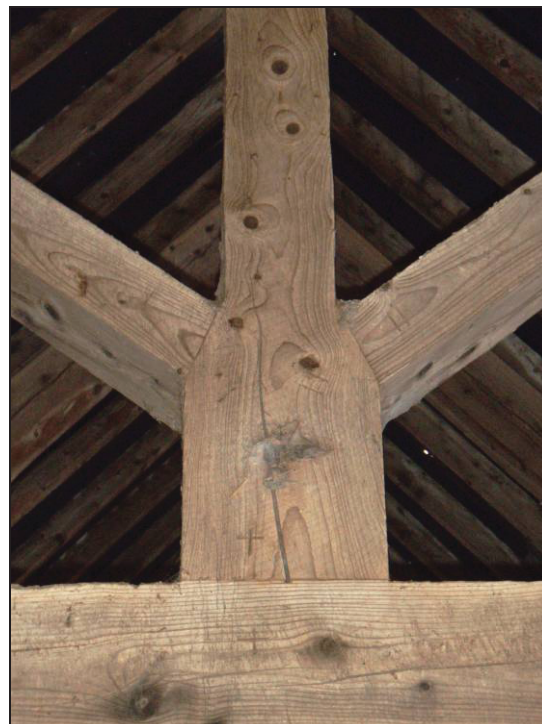
the tie-beam which is 2.95 metres in height to the underside. The trusses are the only example within the entire farm which have carpenter's marks (Pl. 55).

Plate 55: Detail of carpenter's marks on king-post
