**An Archaeological Desk-Based Assessment and
Photographic Building Recording
at Summer House Farm, East Rainton,
Houghton-le-spring, Sunderland.**

Archaeological Research Services Ltd
Report No. 2010/31
May 2010

An Archaeological Desk-Based Assessment and Photographic Building Recording at Summer House Farm, East Rainton, Houghton-le-spring, Sunderland.

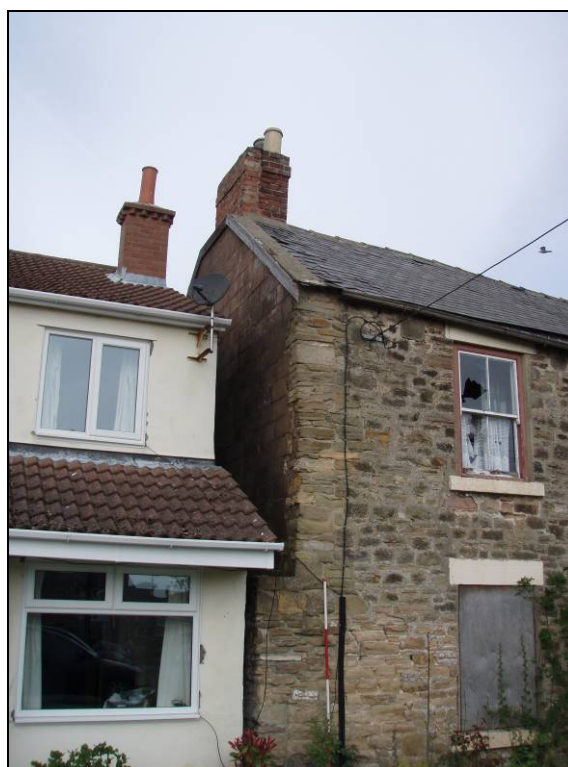
Figure 10. Farmhouse, south facing elevation

5.1.4. *Farmhouse Exterior, South Facing Elevation (Fig. 10)*

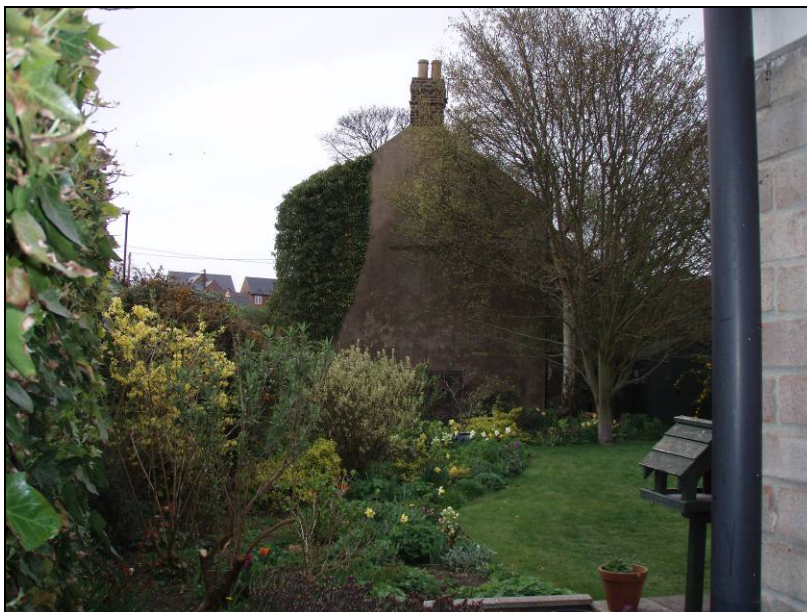
Figure 11. Farmhouse, north facing elevation

5.1.5. *Farmhouse Exterior, North Facing Elevation (Fig. 11)*

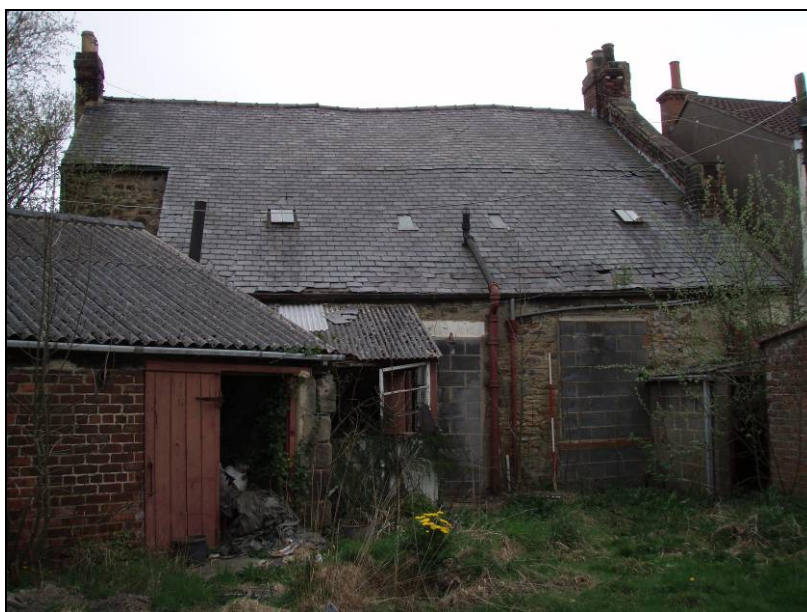
Figure 12. Farmhouse, west facing elevation

This elevation is in a poor state of repair. The irregular shaped roof has 4 small lights. There are two blocked up doors to this elevation as well as a small lean-to. The lean-to has a wooden frame and corrugated metal panels. The frame is in a poor state of repair. The interior shows that the lean-to is constructed to the edge of the building in between it and the attached shed. There are two windows within the interior showing into the farmhouse. A small breezeblock shed is attached to, and obscures, the southern end of this elevation

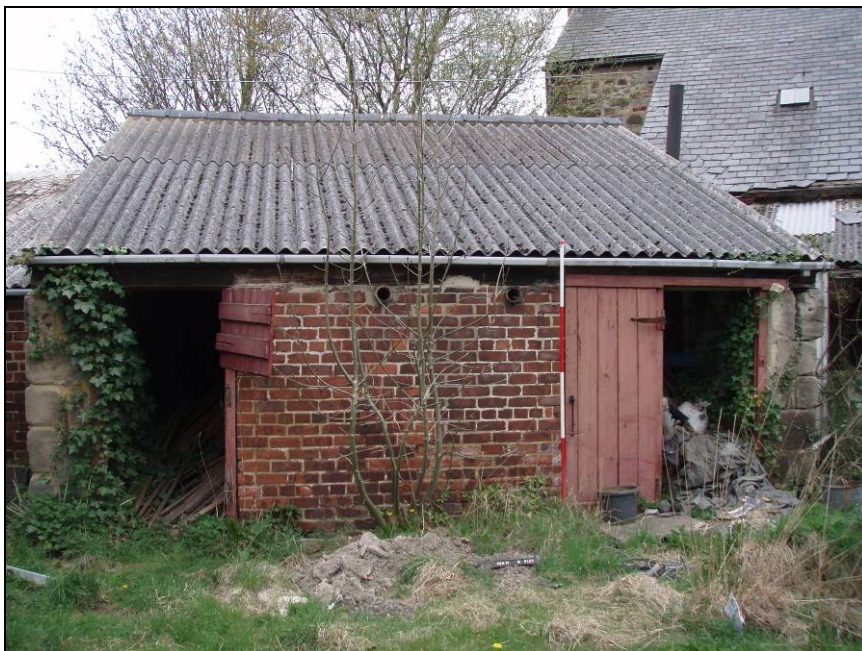
Figure 15. Sheds attached to farmhouse

This building appears on the Tithe plan of 1839. The frontage has two wooden doors and sandstone quoins. In-between the two doors is a modern brick replacement wall, with two drainage pipes protruding from under the roof. The roof is made from corrugated asbestos sheets. The interior of the sheds consists of sandstone walls, indicating that they are older than the brick frontage, with timber beam roof supports.

- 5.2.2. The sheds attached to the farmhouse have been extensively repaired by reconstructing in brick leaving no significant archaeological or architectural features. The east barn has also been extensively repaired with the majority of the first floor having been rebuilt in brick, and the roof completely replaced. This building (possibly due to the extensive repair work) showed no features of archaeological or architectural significance. The west barns also showed no significant features to the exterior. The interior of the smaller barn contained the original stable flooring. The west barns are in a more original state, having less alterations or repair work to them, as such access into the larger barn would be beneficial.

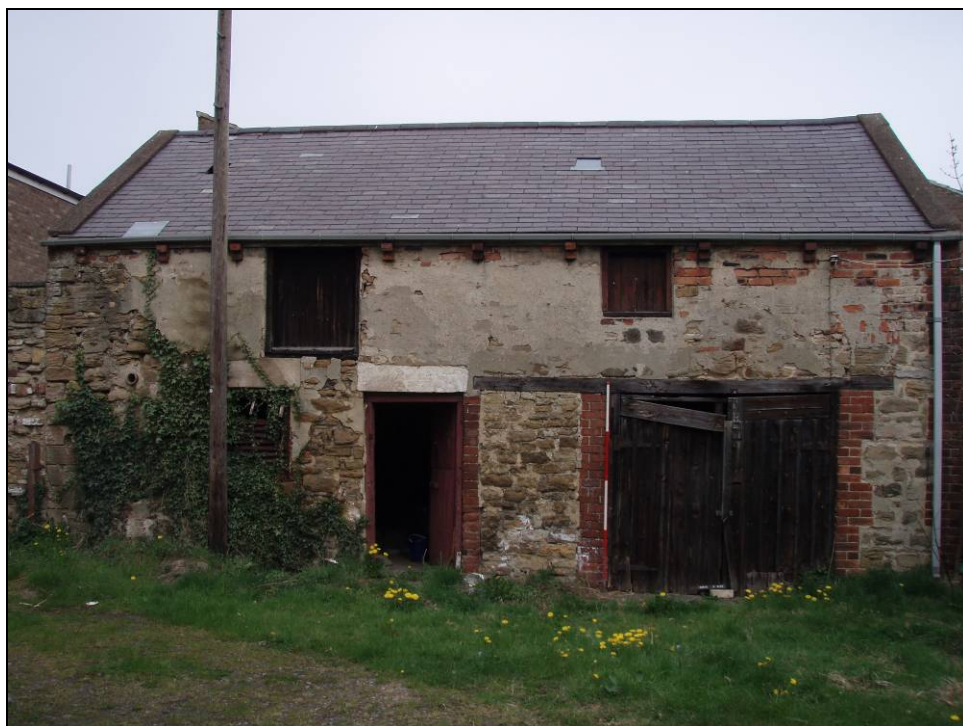
Figure 17. East barn, South facing elevation

This shed shows two phases of construction. This elevation has a mix of sandstone and brick walling. The building appears to have been constructed from stone with later brickwork patching. The first floor is mostly constructed of brick, covered by a grey render. This is obvious repair work to the structure of the building and is keyed into the sandstone work below. There are two windows to the first floor, the one to the west providing an access hatch. These are wooden framed openings, both of which are blocked. The ground floor has a single window to the western side. Although the window is obscured by vegetation it can be seen to have a large sandstone lintel. A narrow door is positioned centrally on the building, also with a sandstone lintel. To the east of this elevation there is a large double door into the barn. This has brick jambs and a wooden frame. There has also been a long wooden lintel inserted which stretched to the centre of the building.

- 5.1.9. The roof is in relatively good condition when compared with the rest of the buildings and consists of slate tiles with two small glazing lights. This is probably due to it having been replaced/ repaired shortly before the farm became unoccupied. The interior to this building shows heavy modification/ reconstruction as did the exterior. The walls have been rendered but where it has come away, it is possible to see the original sandstone walls with brick insertions.

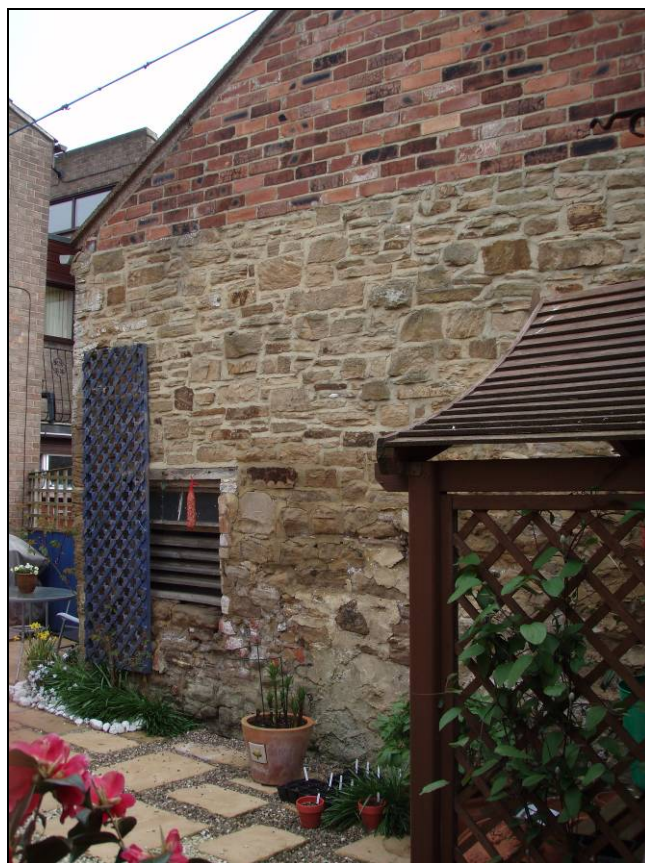
Figure 19. East barn, west facing elevation

- 5.1.10. *East Barn, West Facing Section (Fig. 19)*
This elevation was only visible over the wall of a neighbouring property. The solid sandstone wall could be seen until reaching the roof level of the building. From this level upwards it had been replaced by modern brickwork, probably built at the time of the roof being refurbished. A small window exists to the ground floor but this has brick surrounds inserted into the sandstone.

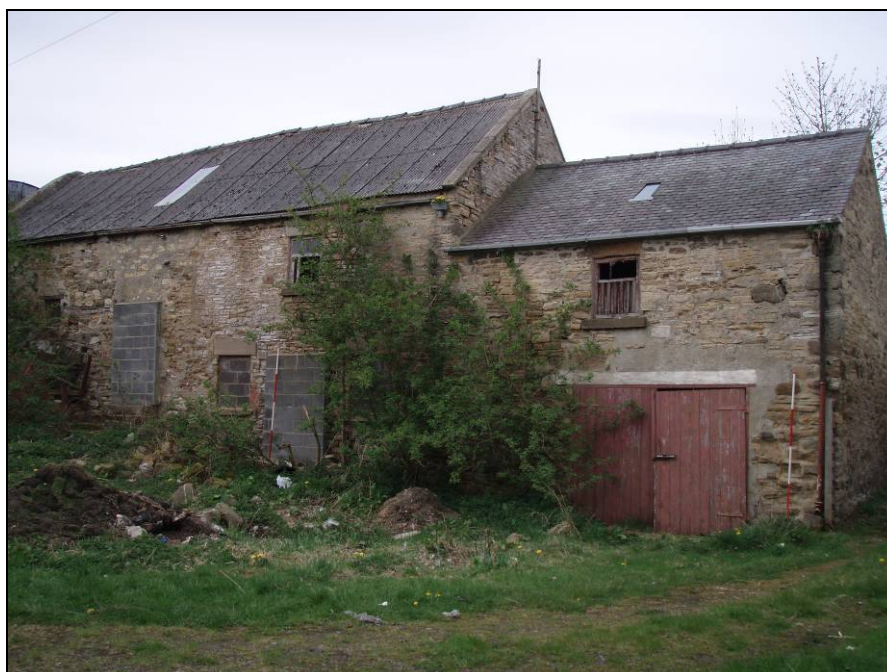
Figure 20. West barn, east facing elevation

- 5.1.11. *West Barn, East Facing Elevation (Fig. 20 & 30)*
This building consists of a large two story barn with a smaller northern extension, with no internal access to one another. The southern barn was not accessible to the interior and could only be viewed from this elevation. Two blocked up doorways are present within the sandstone walling. The doorway located centrally on this elevation is raised, having four concrete steps to reach it. There are also two windows to the ground floor (both blocked up) which have sandstone lintels and cills. This elevation exhibits signs of poor repair work within the sandstone blocks. There is one window (also blocked) to the first floor. The roof is made from corrugated asbestos, with one panel removed and replaced by a corrugated plastic (as a light). The join between this larger part of the barn and the smaller barn to its north could not be viewed due to the vegetation attached to it.

- 5.1.12. The northern extension of the barn, although mostly obscured by vegetation, was of the same sandstone design as the other barns on the site. To the ground floor there was a large double door with a wooden frame and long wooden lintel, the re-pointing and obvious alterations around the door would suggest that the lintel is a later replacement for the earlier doorway. The first floor has one window located centrally. This has a wooden frame without any glass fill. The roof is slate tiled with a single small light in its centre.

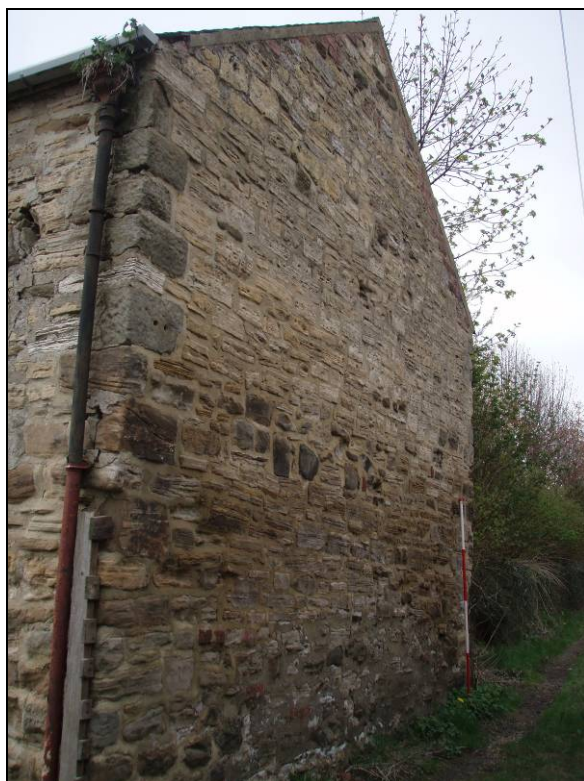
Figure 21. West barn, north facing elevation

- 5.1.13. *West Barn, North Facing Elevation (Fig. 21)*
This elevation shows the same sandstone design as the east facing elevation. Sandstone quoins run up to the pitched roof, which has had some repair work done to it in the form of brick replacements below the apex.

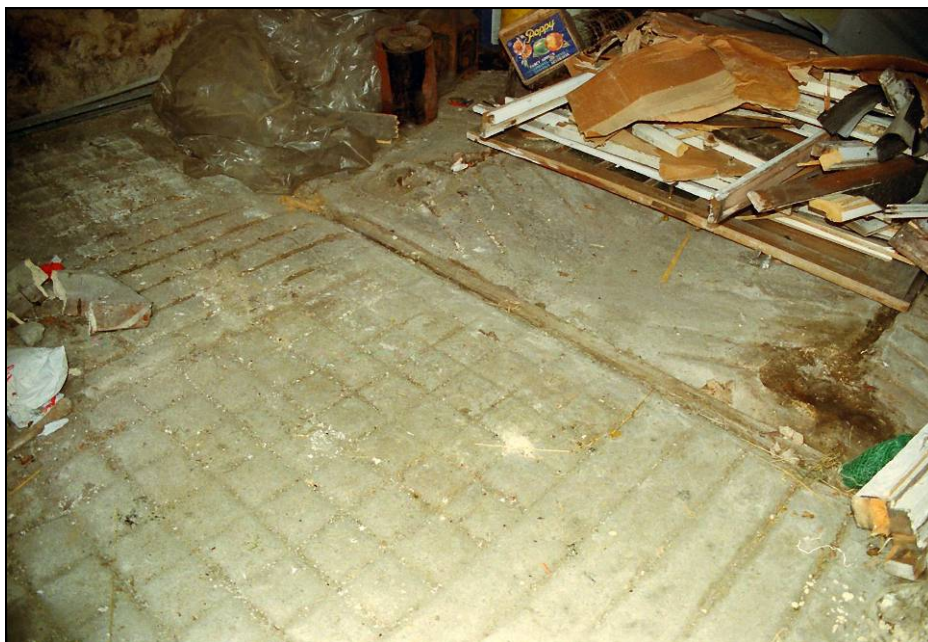
Figure 22. West barn, interior floor

- 5.1.14. *West Barn, Interior (Small barn Fig. 22)*
The walls of the interior were rendered so the stonework behind was not visible. The flooring was concrete with scored drain-away patterns consistent with those found in generic farm stables. Like the other buildings this barn is in a very poor state of repair, this was mostly evident in the ceiling of the floor above. An access hatch leading to the first floor was without ladder, but it was evident that it was unsafe to access.

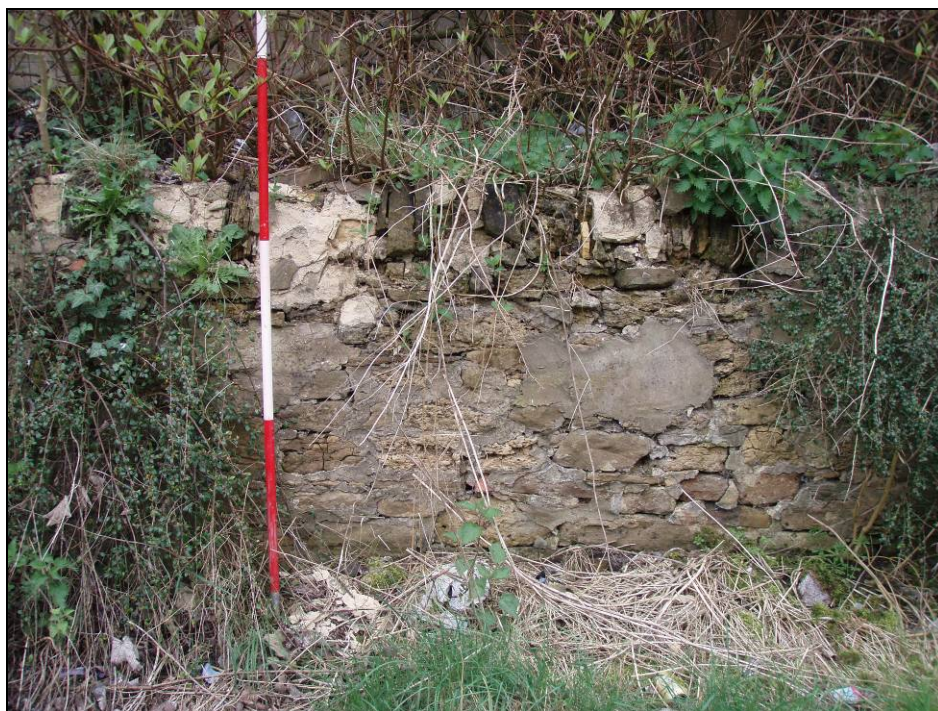
Figure 23. East – west wall

- 5.1.15. *Wall running East – West Along Access Road (Fig. 23)*
This wall, measuring 45 metres long, is made from small sandstone blocks, with some brick replacements. Along its length are areas of repair and rendering.
