An Archaeological Watching Brief at Fairview Farm, Adlington, Chorley

ARS Ltd Report 2010/62
October 2010

Planning ref: 09/00714/FULMAJ
Oasis no: archaeol5-83640

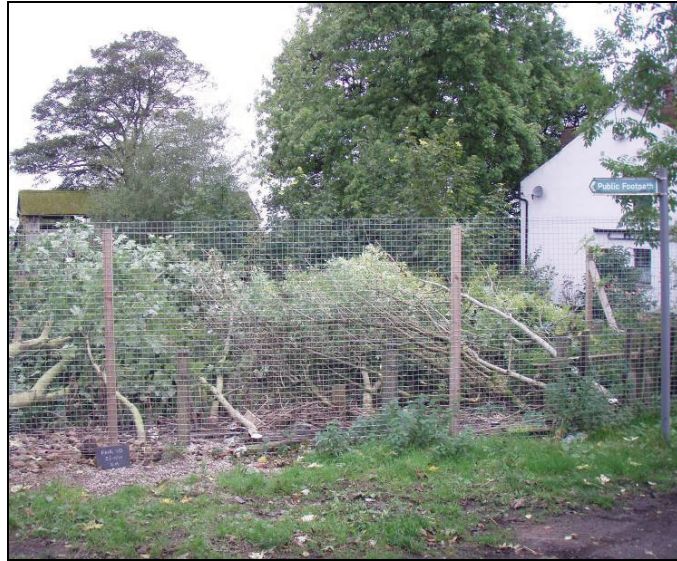
Area of plots 22-25 prior to excavation

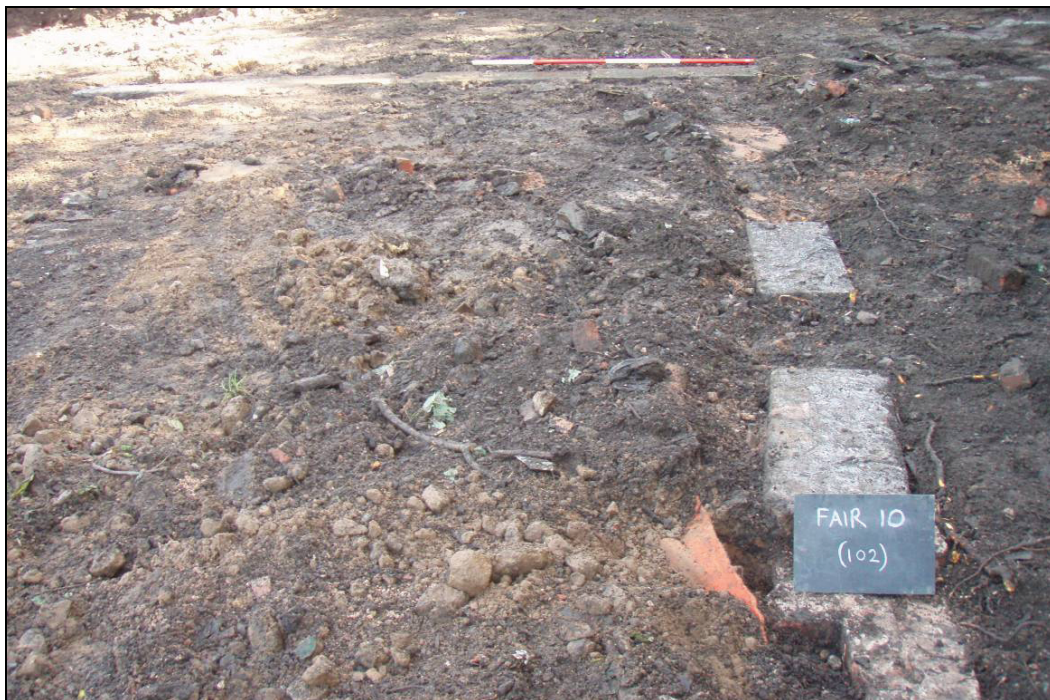
- 4.1.2. At the western limit of (101) 6m from the eastern boundary, stone blocks were encountered. Partial remains consisting of two blocks and sandy bedding material were orientated south-west to north-east for 5m where they returned at a right angle to the north-west for 4.7m before termination (Fig. 5). The worked rectangular blocks, which measured <math><1.3\text{m} \times 0.34\text{m} \times 0.1\text{m}</math>, were extant for one course only, set onto the sandy bedding layer, and probably represent kerbstones for the footpath.

Fig. 5: Kerbstones 102 abutting 103 in the bottom right hand corner. Facing NW. Scale 2m

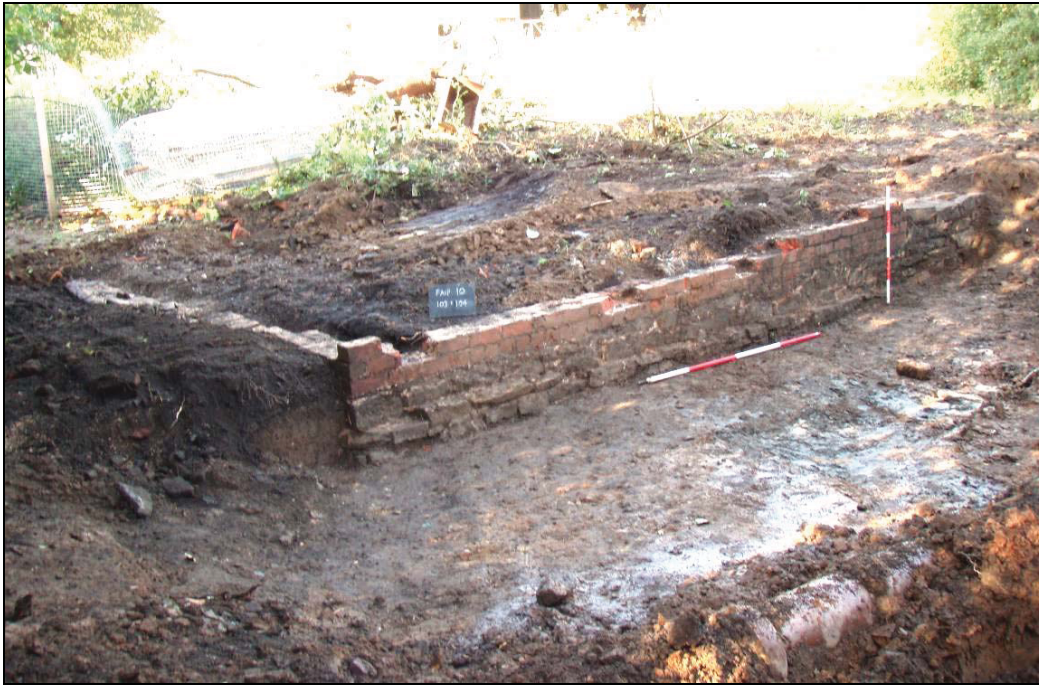
- 4.1.3. The kerbstone at the southern extent of the alignment abutted the corner of a double skin brick wall (103), which continued on the same alignment for 4.8m to the limit of excavation. From the corner (103) continued at a right angle to the north-west and was uncovered for 7m, to the limit of excavation (Fig. 6).
- 4.1.4. The brick wall (103) was constructed as double skin with a cavity of 15mm and existed to a maximum height of four courses. The lower course of bricks was laid as headers

with the upper courses in stretcher bond, the plain hand made bricks measured 9¼" x 4½" x 3⅜" and were bonded with pinkish, friable, sandy-lime mortar.

Fig. 6: Remains of brick wall 103 and stone plinth 104. Facing W. Scale 2m & 1m

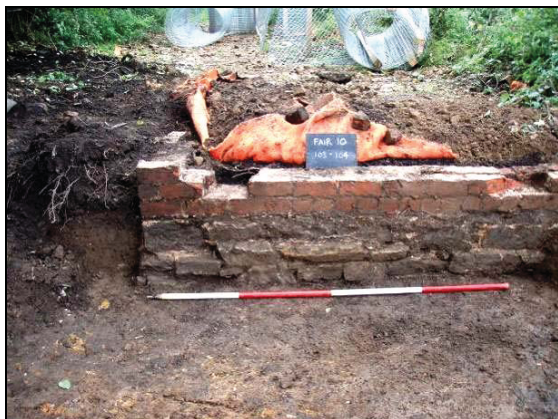
4.1.5. Wall (103) was constructed onto a stone plinth (104) which measured up to 0.6m in width and 0.35m in height (Fig. 7). Constructed of roughly hewn stone of various sizes (104) was initially flush with (103) on the outer face to a depth of 0.2m, it then stepped out a further 0.1m forming a larger plinth. The north-east facing walls of (103) and (104) extended north-west for 5.4m where (103) abutted a stone wall (106), and (104) appeared to have been tied into (106). Large roughly hewn blocks <0.48m x 0.15m x 0.47m comprised the upper course of (106), with the stonework generally decreasing in size towards the lower section of the wall (Fig. 8). Random areas of stonework had been bonded with pinkish, sandy-lime mortar. The vertical outer face of (106) existed to a height of 0.68m, while the inner face appeared to be of uneven construction, but the excavation did not extend into this area and it was not exposed.

Fig. 7: Walls 103 and plinth 104. Facing SW. Scale 2m

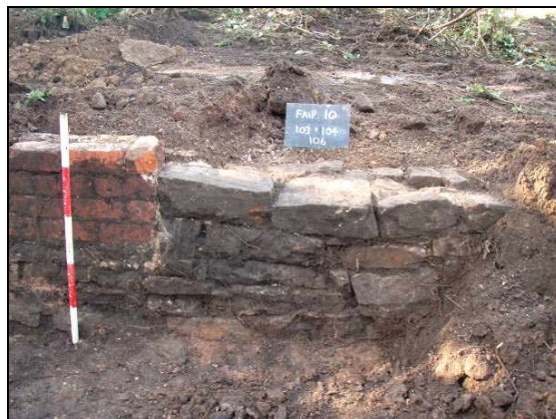
Fig. 8: Junction between walls 103, 104 & 106 Facing SW. Scale 1m

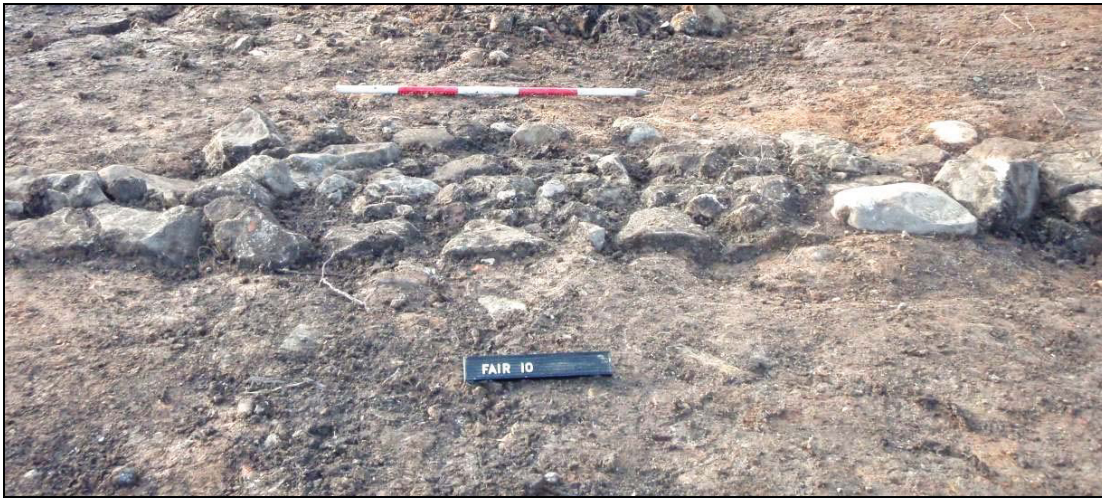
- 4.2.4. The north-west facing wall of (117) continued 4.5m to the south-west and then returned at a right angle to run 6m south-east, it then returned at a right angle and ran 4m north-east to terminate 1m short of (119). The break between (117) and (119) again probably represents an access point. The 'U'-shaped form of (117) defined the southern limit of area B within the structure. Positioned centrally within the north-west to south-east connecting wall of (117), an area of smaller angular stone cobbles extended beyond the 0.6m width of the foundation walls (Fig. 9). This may indicate the floor level of an access point between areas B and C within the structure. A 1m long

sondage was excavated at the point of difference between the wall and possible floor; this revealed the stone block foundation of the wall to be laid into natural ground (105) to a depth of 0.3m while the smaller angular cobbles were at a depth of only 0.12m.

Fig. 9: Probable floor level of entrance in connecting wall of (117). Facing south-west. Scale 1m

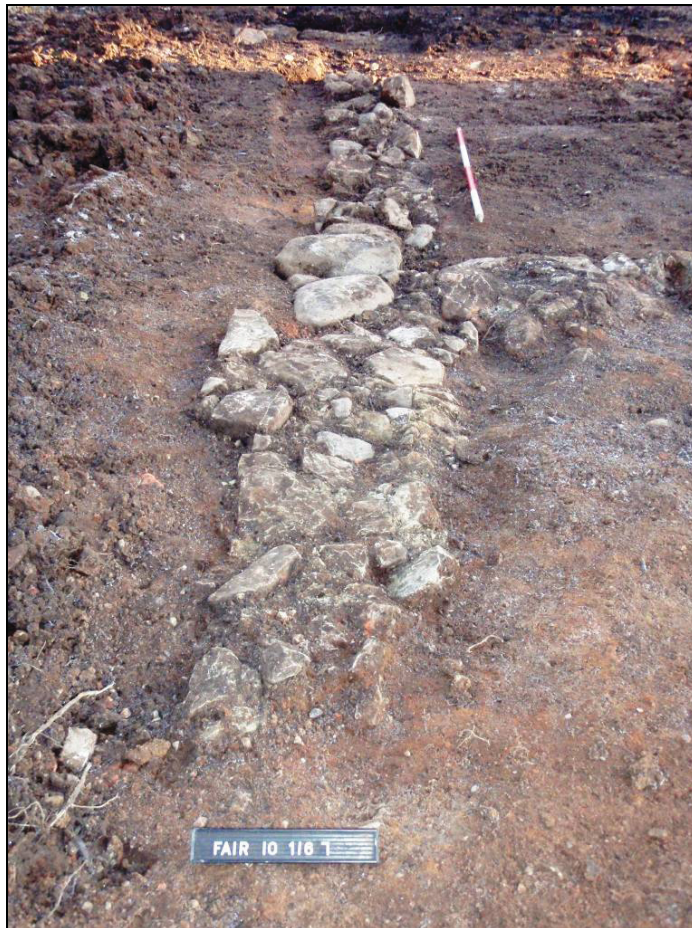
Fig. 10: Wall foundation of (116) & (117) to the north west of the site. Facing north-east. Scale 2m

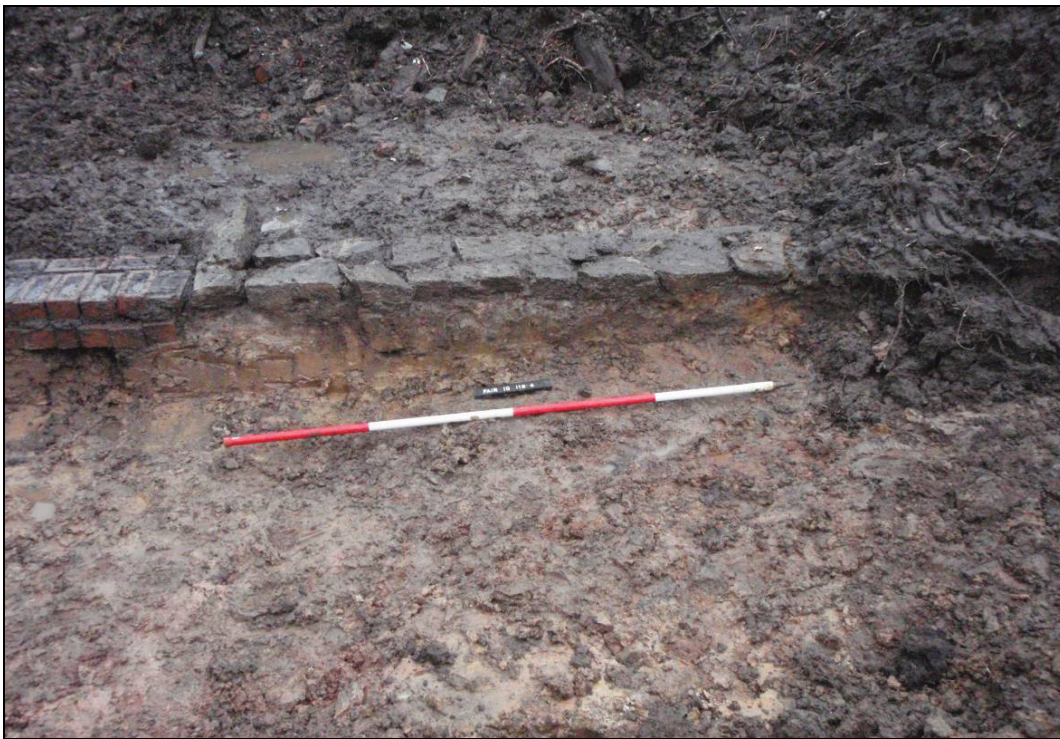
4.2.5. Two sections of wall foundations extended to the south-west of (117). (116) was tied into the north-west facing wall and extended 1.5m; (114) was tied into the south-east facing wall and extended 1m. Both (116) and (114) terminated at the above points and resumed after a break of 3.8m (Fig. 4). To the east (114) extended south-west 4.7m where the evidence of disturbed stone suggested that the wall returned at a right angle northwest. To the west (116) extended south-west 4.6m to return at a right angle south-east for 3.1m, at which point it terminated to leave a break of 2.3m between (116) and (114). This break was interpreted as the construction of an entrance into a later brick built structure which abutted a probable thrashing barn within area C. The foundations of (114) and (116) were built with irregular sized angular stone <0.55m x 0.4m x 0.12m with no apparent bonding material and to a width of 0.45m, a disparity to the 0.6m width for the abutting foundations walls of (117). A sondage excavated against the south-east face of (114) revealed it to be standing at only one course, and laid directly onto natural ground (105) (Fig. 11).

Fig. 11: South-east facing wall (114) and brick wall (113) laid onto natural ground.
Facing north-west. Scale 2m

4.2.6. A red brick wall (113) which abutted (114) to the south-west was set into natural ground (as seen in Fig. 11). It extended for 5.7m where it returned at a right angle to the north-west for 6.6m (Fig. 4). The south-west run of (113) was stepped down in two locations to accommodate the slight dip in the natural substratum (105), with two possible positions for buttresses identified. The foundations of (113) extended to a width of 0.48m and stepped up two courses to support the double skin width of the wall observed at excavation level. Wall (113) was constructed using frogged bricks which measured 9¼" x 4½" x 3" bonded by firm black sandy mortar, laid either as headers or two skins of stretcher bond. The south-west facing wall of (113) was the limit of the structure and directly opposed the north-west to south-east alignment of (114), (116), situated 5.7m to the north-east. A red brick wall (115) was contemporary

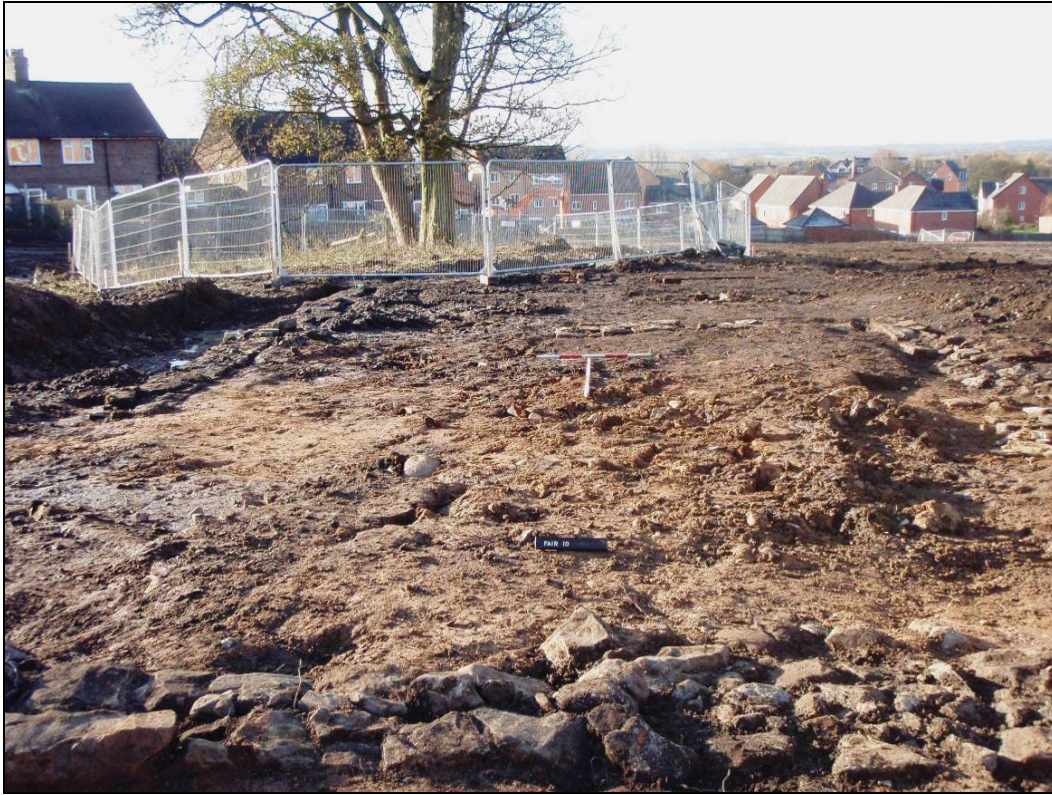
Fig. 12: Condition of site after ground reduction down to natural ground.
Facing South-west. Scale 1m & 2m

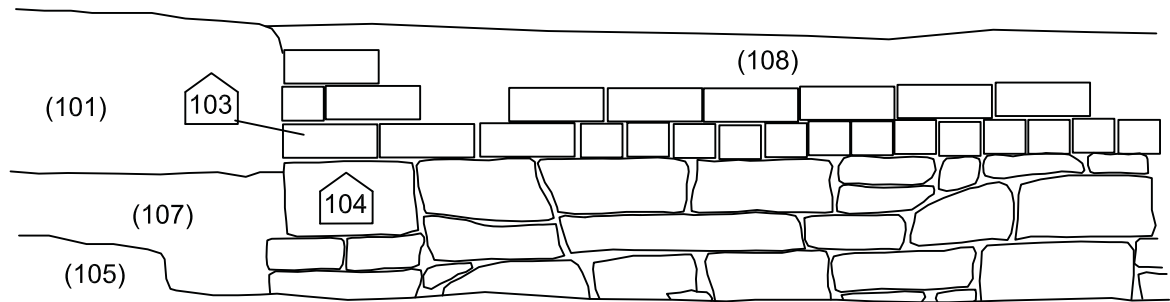
DRG 2 North facing section of 103 & 104

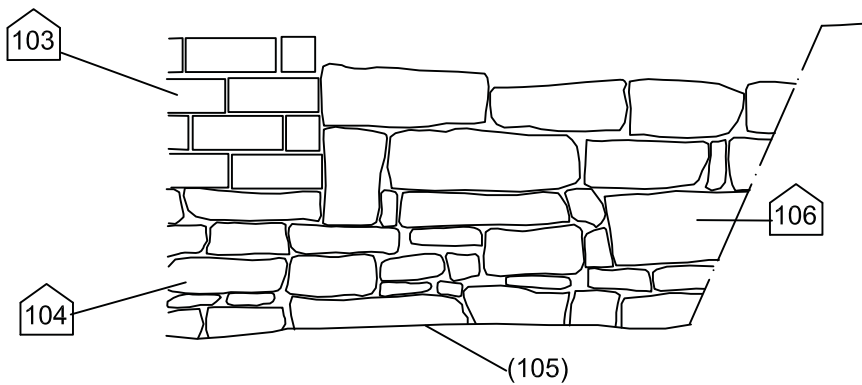
DRG 3 North facing section of 103 & 106

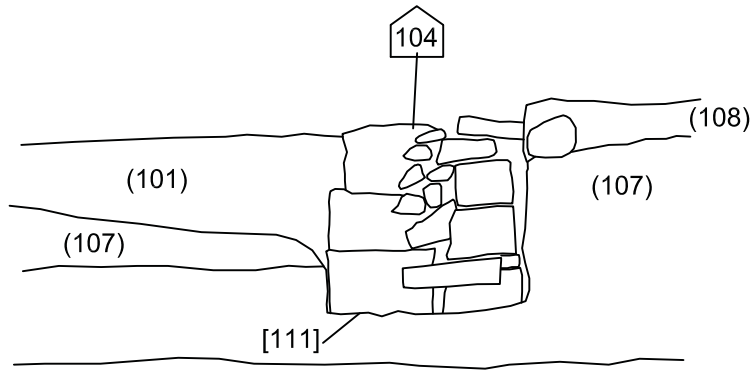
- 4.1.6. Excavation of walls (103) and (104) exposed a foundation trench cut into the section of the north-east facing trench wall. Cut [111] was straight edged with a flat base and cut into greyish brown clay subsoil (107) with a maximum depth of 0.32m and continued into underlying natural ground (105) for a further 0.1m (Appendix 1, Drawing 4).

DRG 4 North facing section of 104 & [111]

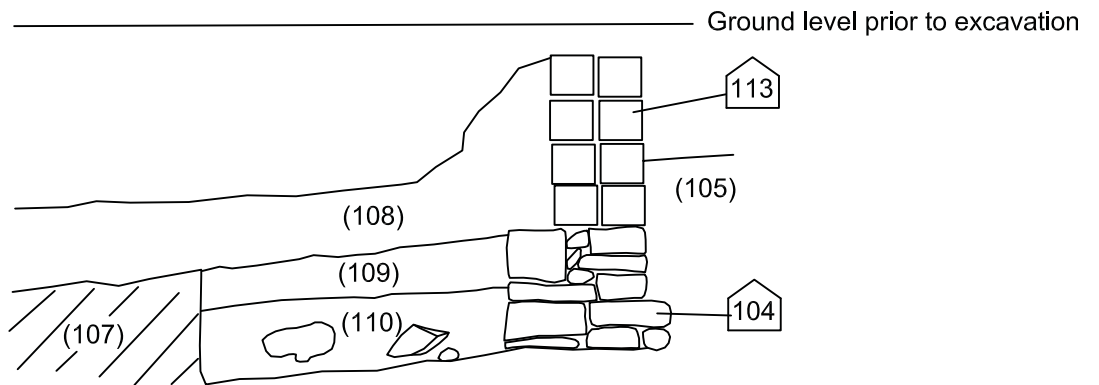
- 4.1.7. Demolition of (103) and (104) for 3.8m to the north-west exposed the south-east facing section of the trench. This revealed (103) had been constructed into (105) which was then redeposited against the outer face of the wall. At this point a section of wall existed to four courses in height with made ground consisting predominately of dark brown silty clay soil and demolition rubble (108) filling the internal area to the depth of these four courses. Underlying (108) a layer of compacted clay (109) 0.12m in depth had been redeposited over a compacted layer of clinker material (110). At 0.18m in depth (110) had been deposited directly onto subsoil (107), and (110) and (109) probably represent the sub-base and surface of a floor level.

DRG 5 East facing section of demolished wall 103 and associated context
