# An Archaeological Building Recording of The Eureka Public House, Frederick Street, South Shields

**Archaeological Research Services Ltd**  
**Report No. 2010/61**  
October 2010

# An Archaeological Building Recording of the Eureka Public House, Frederick Street, South Shields

*In October 2010 Archaeological Research Services Ltd were commissioned by South Tyneside Council to undertake an archaeological photographic building recording of the Eureka public house, Frederick Street, South Shields prior of the buildings demolition.*

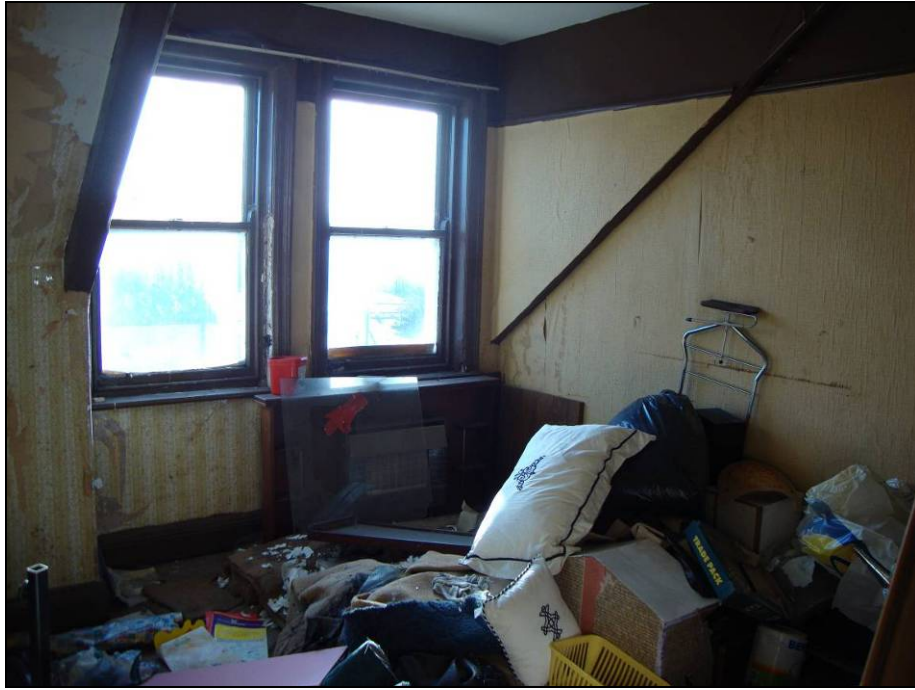
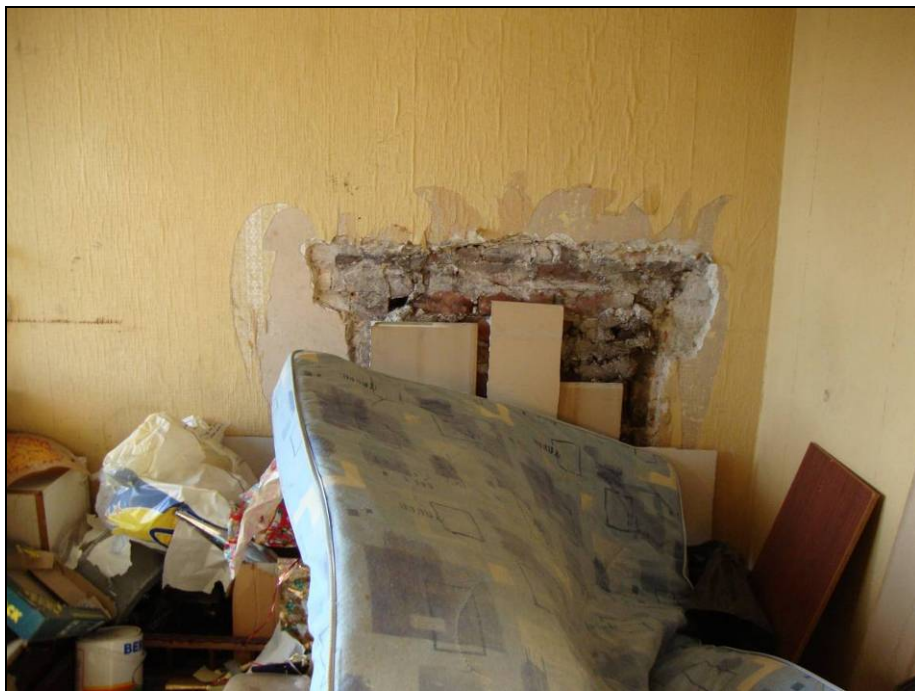
#### *5.1.1. Room 1 (Figs. 9 & 10)*

This second floor room had two wooden framed sash windows to the south eastern elevation and a blocked off fireplace visible on the southwest. The gable beams are visible within the ceiling.

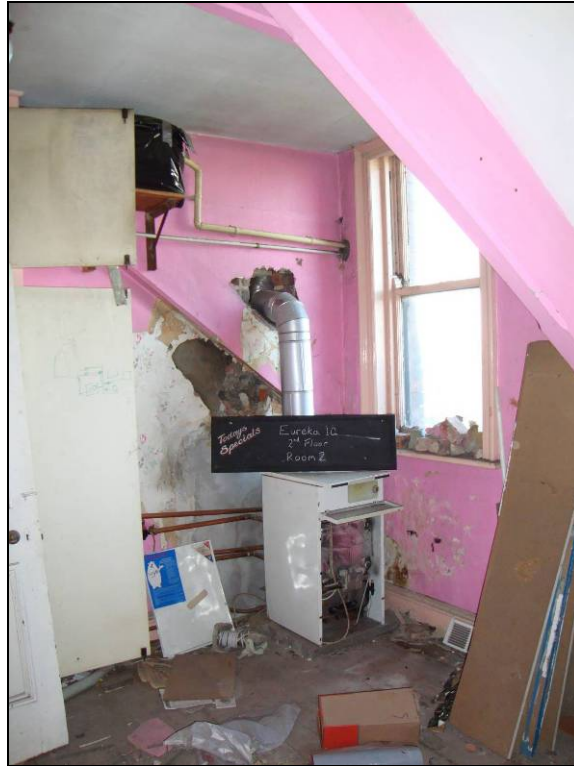
Fig 11. Room 2

#### *5.1.2. Room 2 (Fig. 11)*

This room had a sash window to the northwest elevation as well as a small square replacement window. The southeast wall had had extensive damage and modifications caused by heating works and ducting.

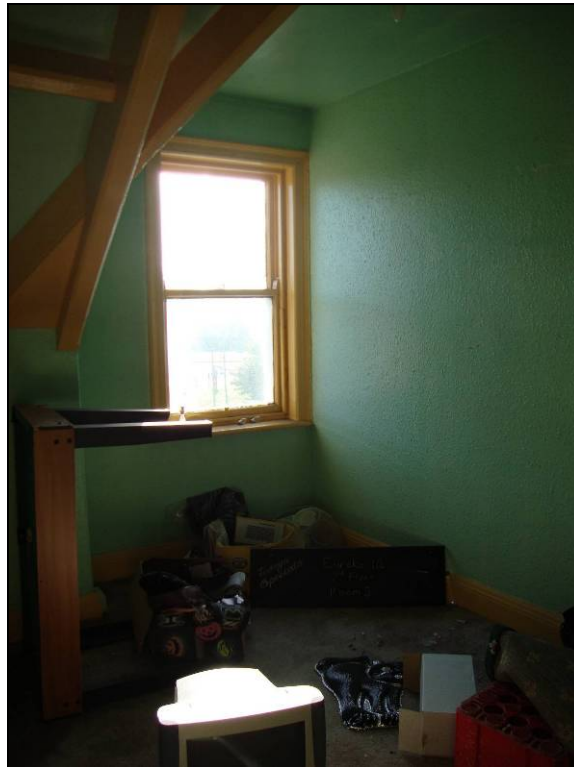
Fig 12. Room 3

#### *5.1.3. Room 3 (Fig. 12)*

This room had a single sash window and, like Room 1 had exposed ceiling beams.

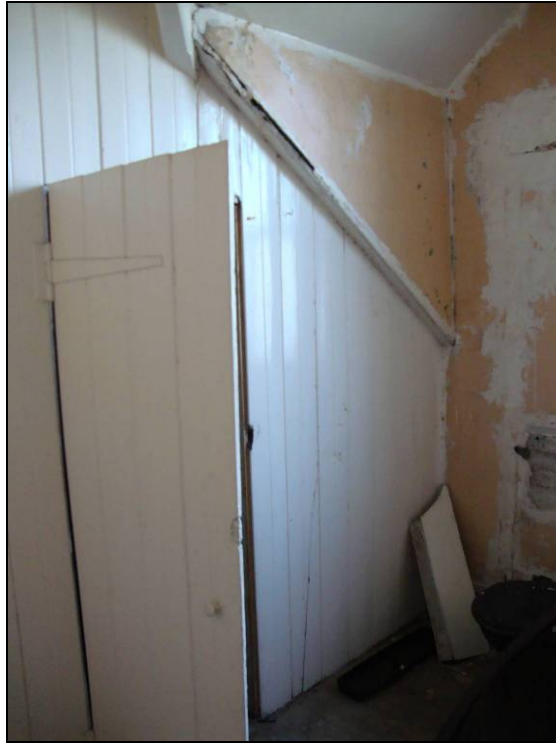
Fig 13. Room 4

#### *5.1.4. Room 4 (Fig. 13)*

This Room had been used as a bathroom with a single sash window to the northwest elevation. The southeast elevation consisted of a wood panelled partition with a doorway, creating Room 5.

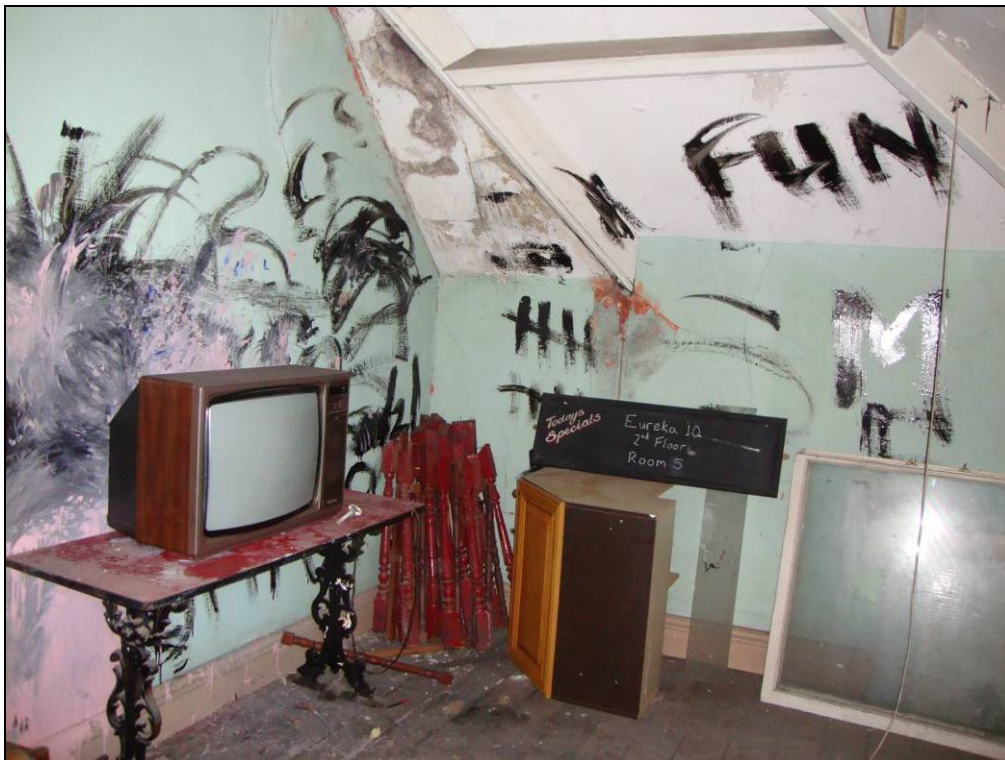
Fig 14. Room 5

#### *5.1.5. Room 5 (Fig. 14)*

This small room was situated in the eaves of the gable end of the building, and all beams associated with the roof are visible in the ceiling.

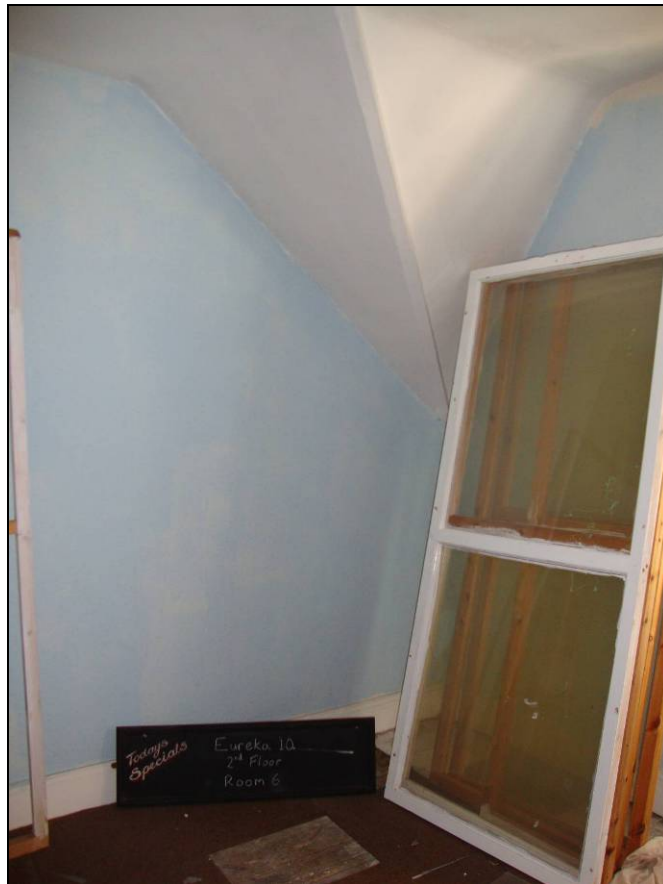
Fig 15. Room 6

#### *5.1.6. Room 6 (Fig. 15)*

This room had a single sash window and was framed at each side of its southwest elevation by the gable ends of the roof.

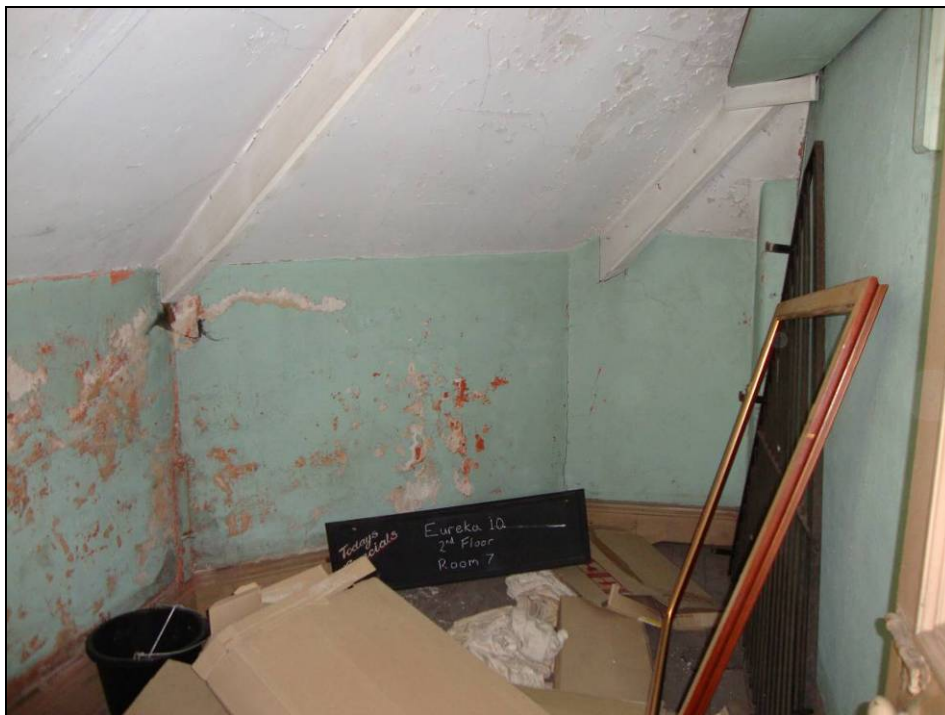
Fig 16. Room 7

#### *5.1.7. Room 7 (Fig. 16)*

This room was a mirror image of Room 5. A small ceiling light had been boarded over near the room's doorway.

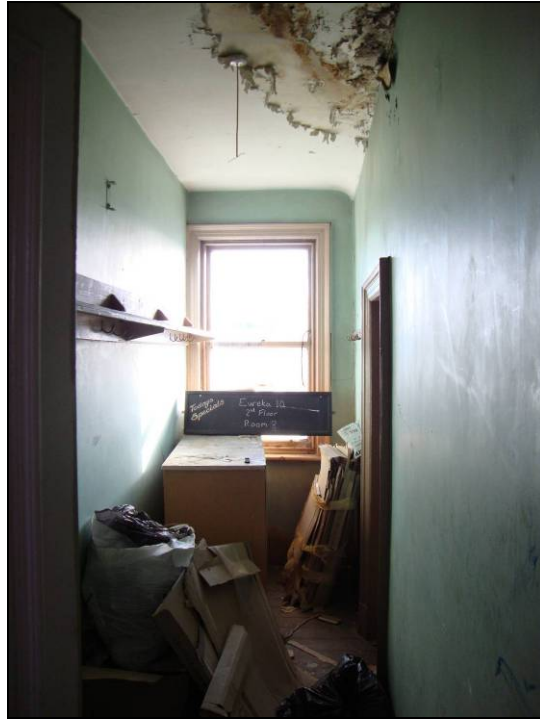
Fig 17. Room 8

#### *5.1.7. Room 8 (Fig. 17)*

This room had been partitioned off from Room 3, creating more of a narrow corridor than a room. On the southeast elevation was a single sash window, the frame of which was cropped on one side by the partition wall. A door, similar to that in Room 4, leads into Room 7.

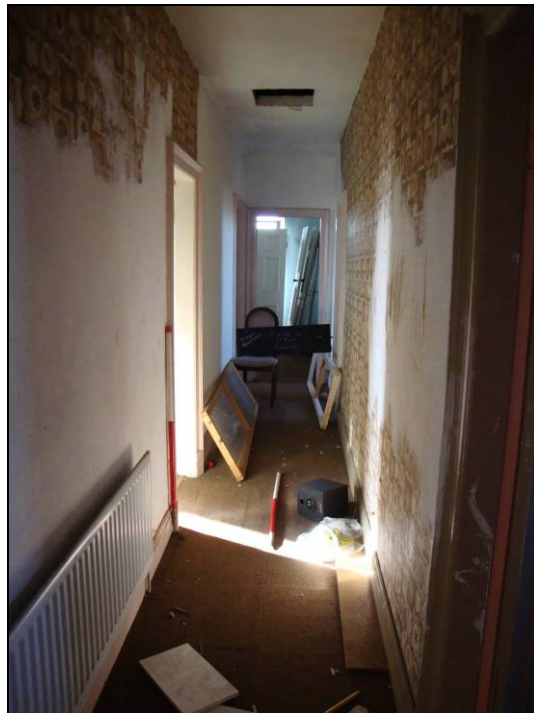
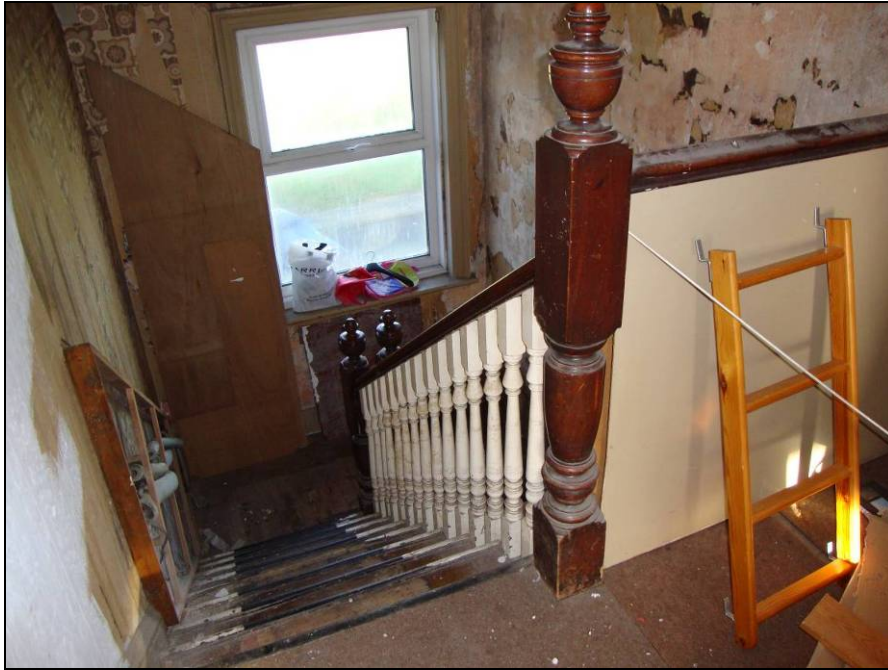
5.1.8. *Room 9 (Figs. 18 & 19)*

This room was the main corridor for this floor. It serves as access to rooms 1, 2, 3, 4, 6 & 8. The staircase was framed by wooden spindles and banisters. A modern replacement window was present on this floor.

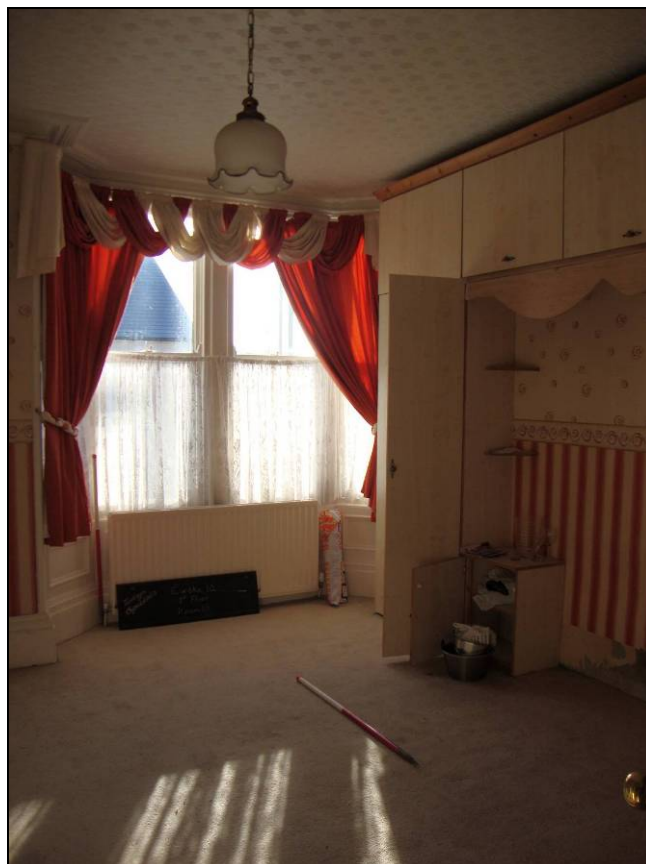
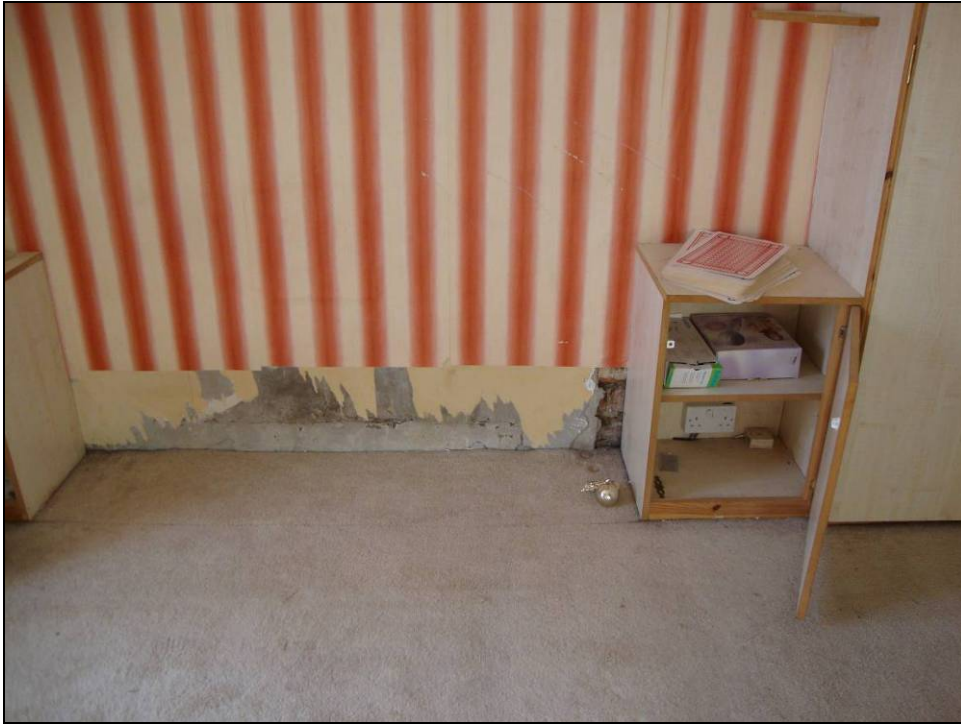
5.2.1. *Room 10 (Figs. 20 & 21)*

This room had a large, wood-panelled bay window to the southeast elevation; the north east elevation was concealed by fitted wardrobes. Although covered with wallpaper, the southwest elevation shows signs of a covered fireplace towards its base.

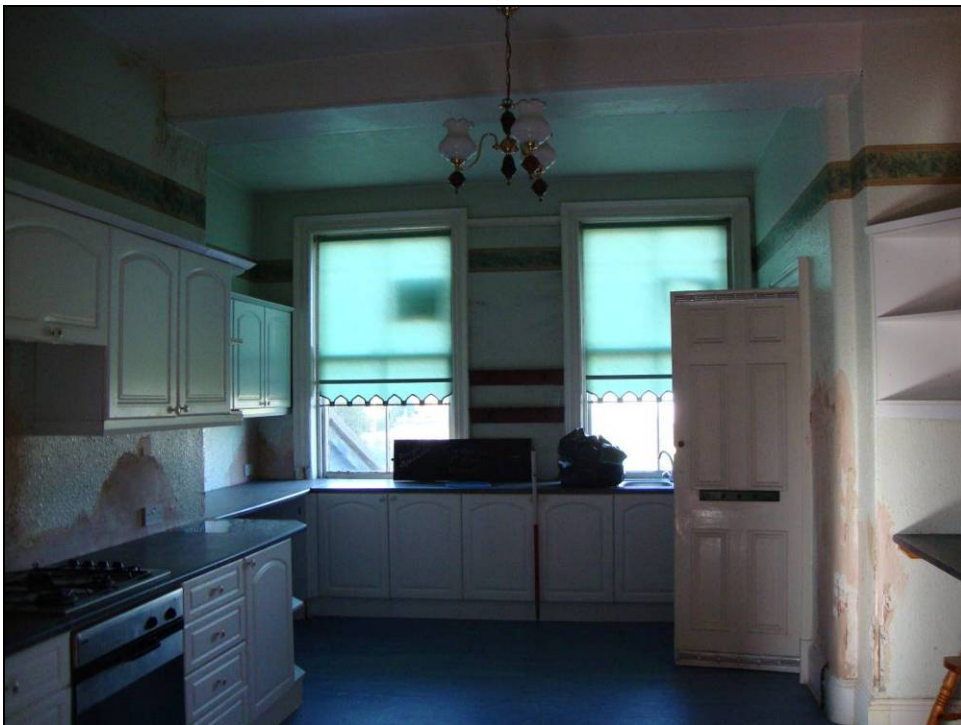
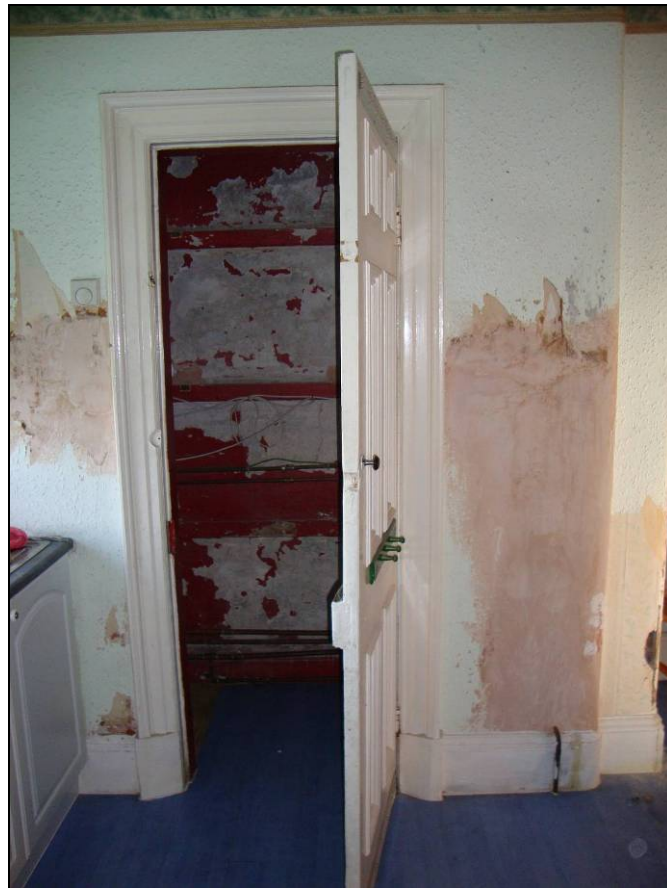
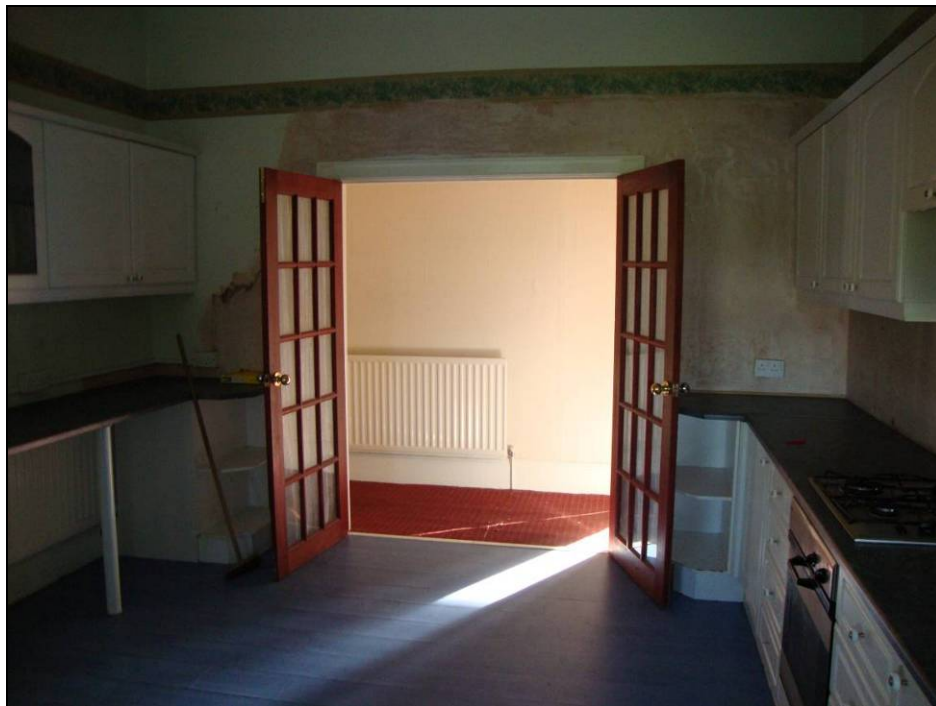
5.2.2. *Room 11 (Figs. 22, 23 & 24)*

This large kitchen area had two large sash windows to the northwest elevation. A small partitioned room on the northeast elevation houses a water boiler. The southeast elevation had a large double doorway into the passage area.

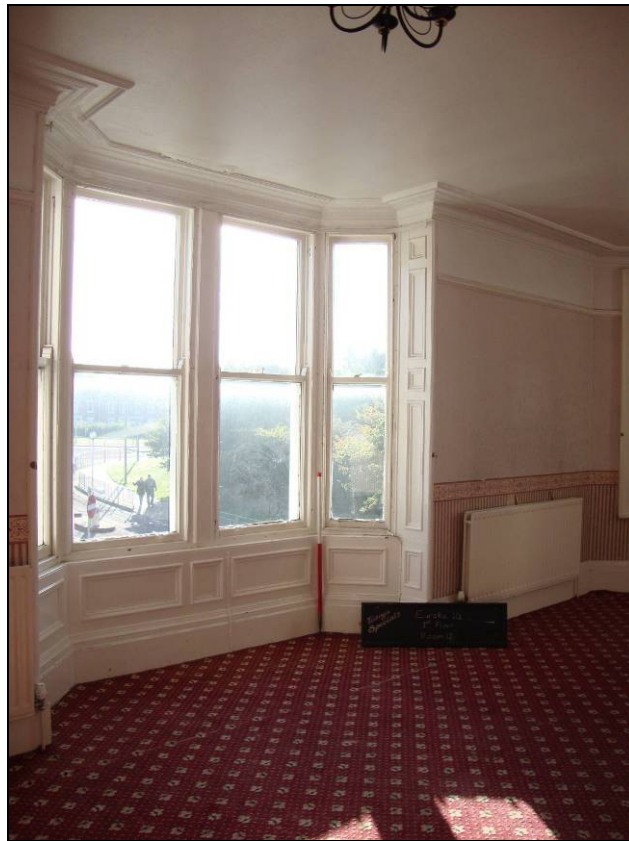
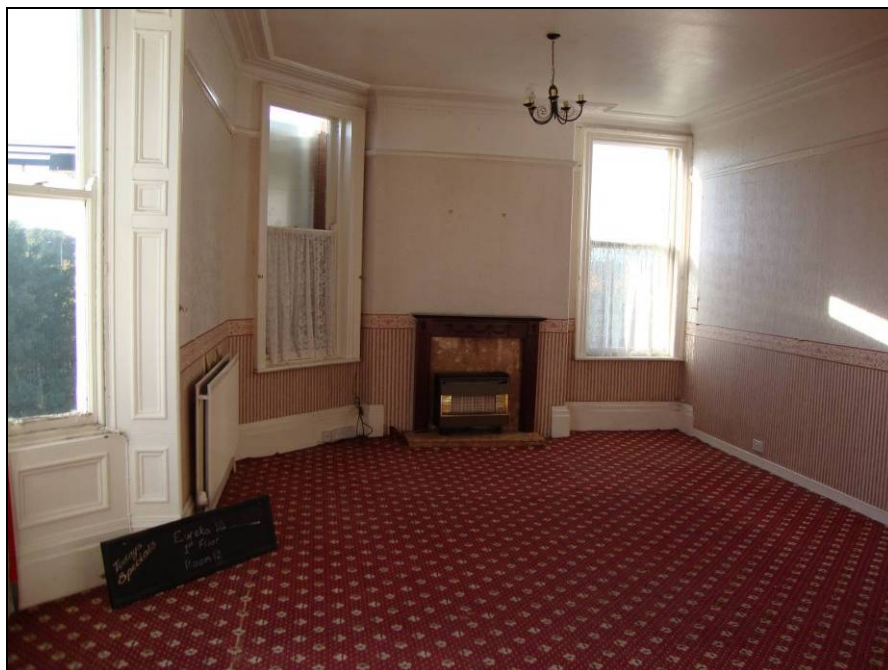
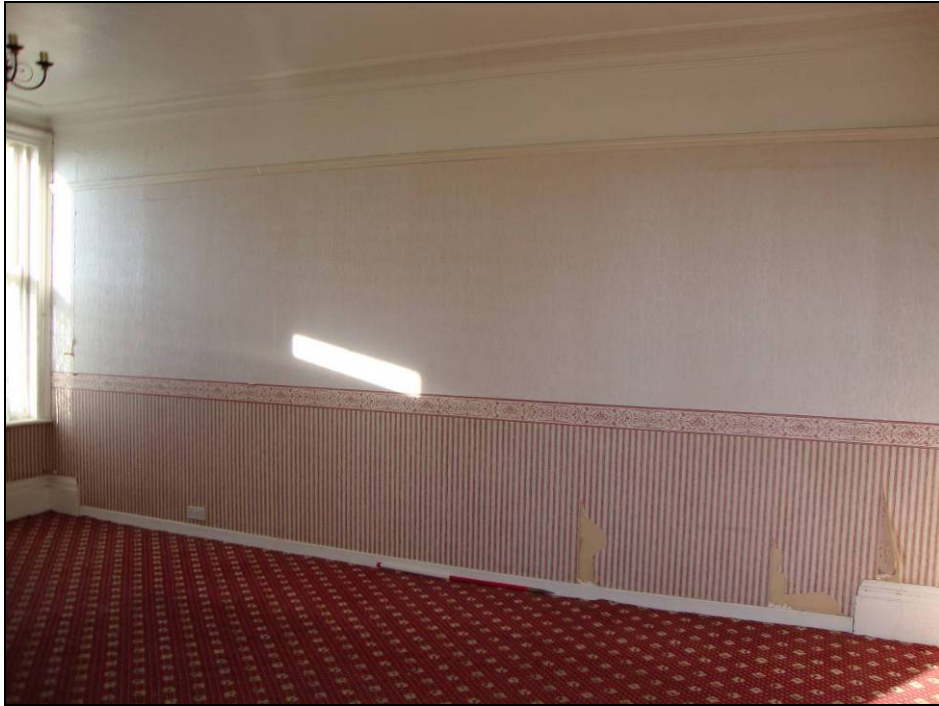
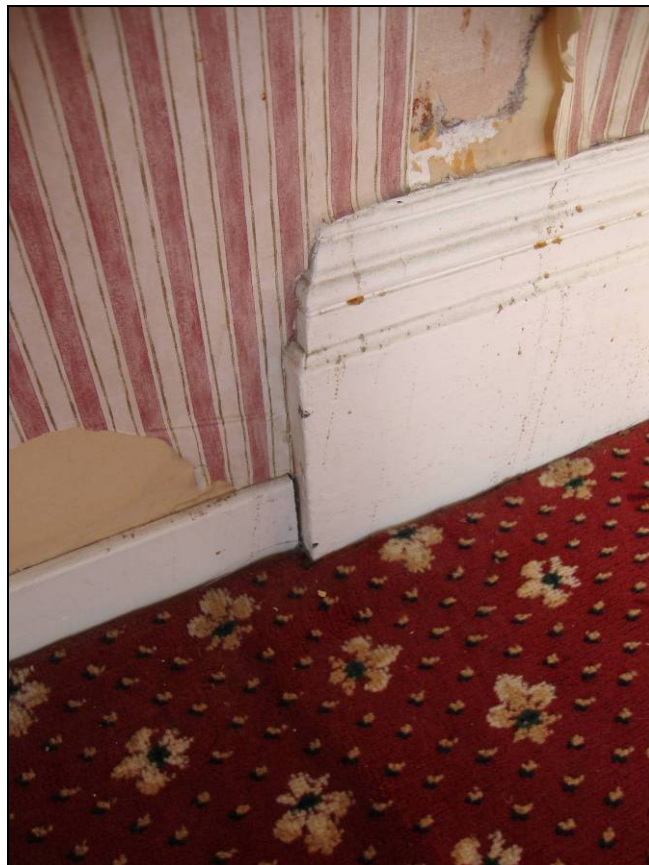
5.2.3. *Room 12 (Figs. 25, 26, 27 & 28)*

This large room had a large bay window to the southeast elevation. The southwest elevation had two sash windows as well as a fireplace located centrally. The northwest elevation appears to have been once an open area, effectively making Room 12, 13 and 14 one large room. Although the ceiling coving and picture rail exist along this elevation, they are modern replacements; the skirting board on the other hand, has a return at either side of the wall, showing where a gap would have been.

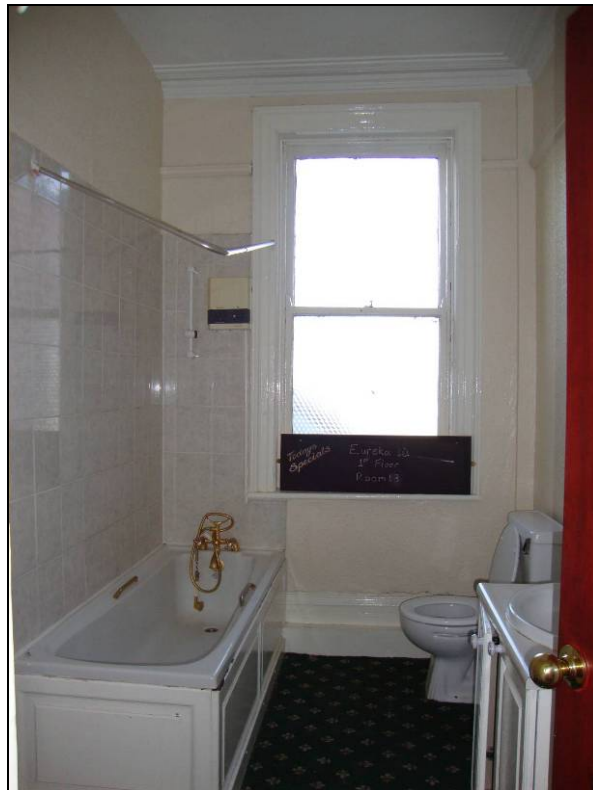
Fig. 29. Room 13

5.2.4. *Room 13 (Fig. 29)*

This room (currently a bathroom) has been partitioned from Room 14. It has a single sash window. The ornate coving disappears to the southwest into the partitioned wall.

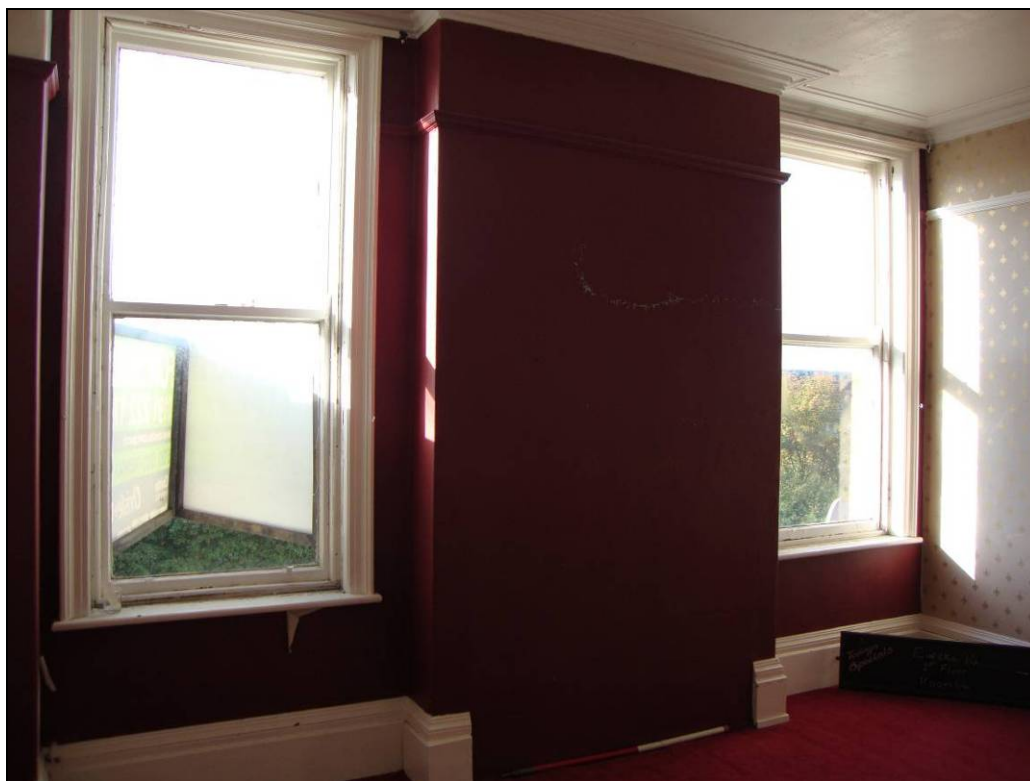
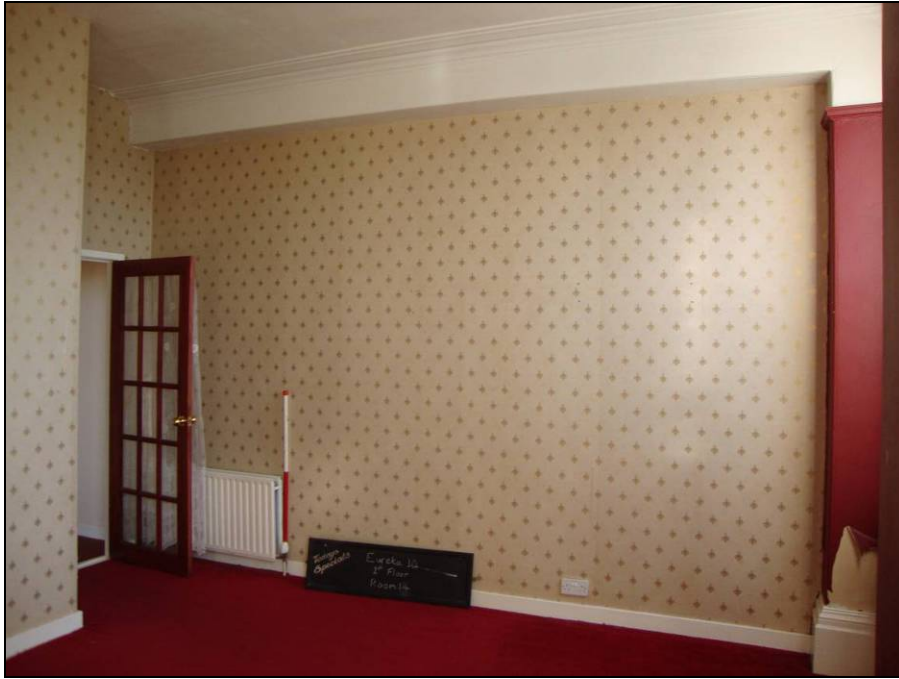
5.2.5. *Room 14 (Figs. 30 & 31)*

The southwest elevation of this room had two large sash windows, either side of a blocked off fireplace. The ornate coving carries on into this room from Room 13. The southeast elevation is indented beneath a ceiling beam. This beam is likely to have been the roof support for the open plan area before they were sectioned into smaller rooms.

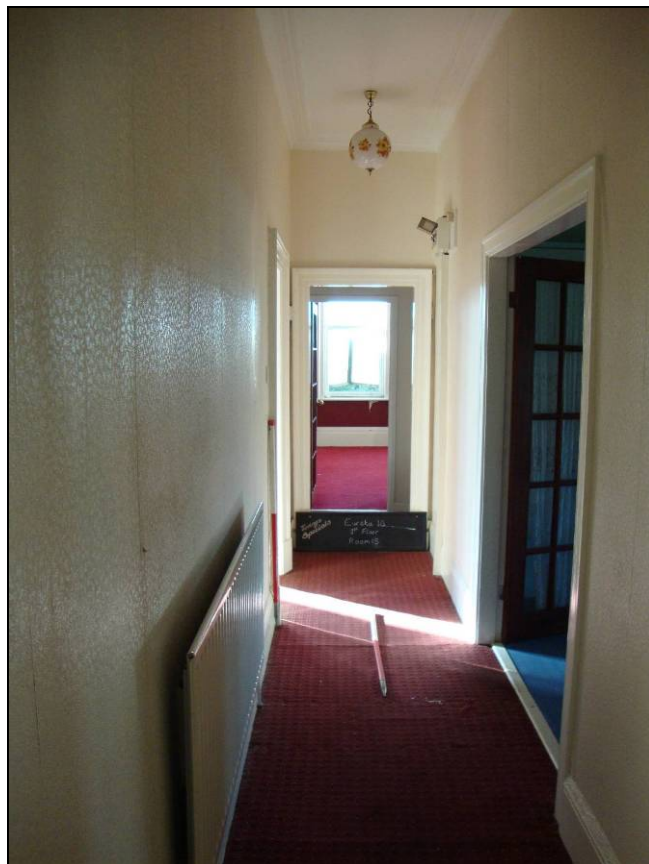
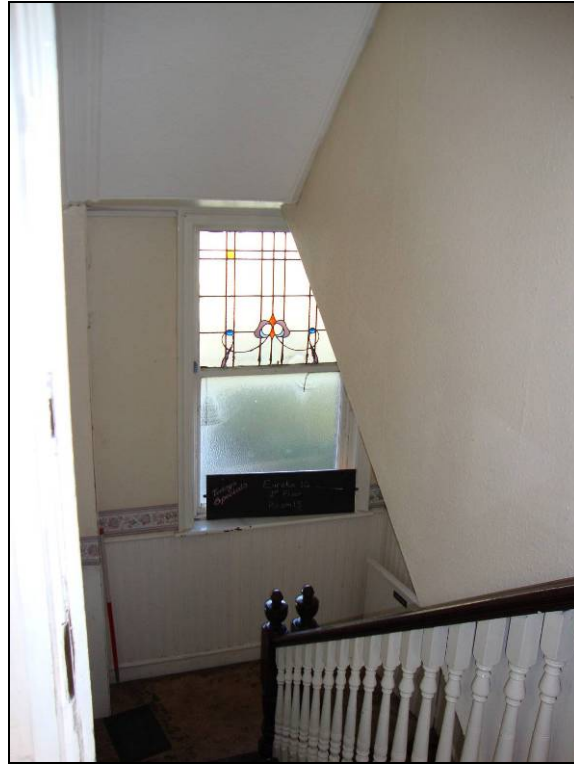
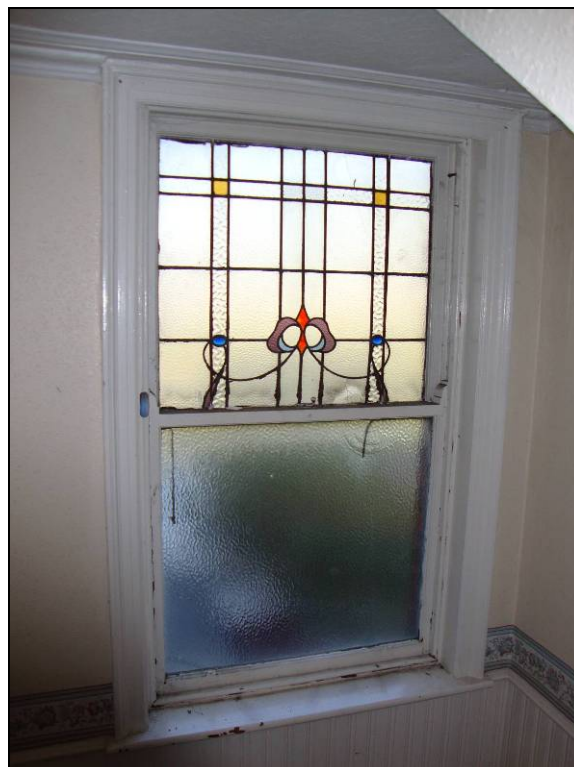
5.2.6. *Room 15 (Figs. 32, 33 & 34)*

This room was the main corridor serving as access to Rooms 10, 11, 12, 13 & 14. The staircase to this area has carved wooden spindles in the same style as the second floor. The window to this elevation had a stained glass design likely to be original to the building.

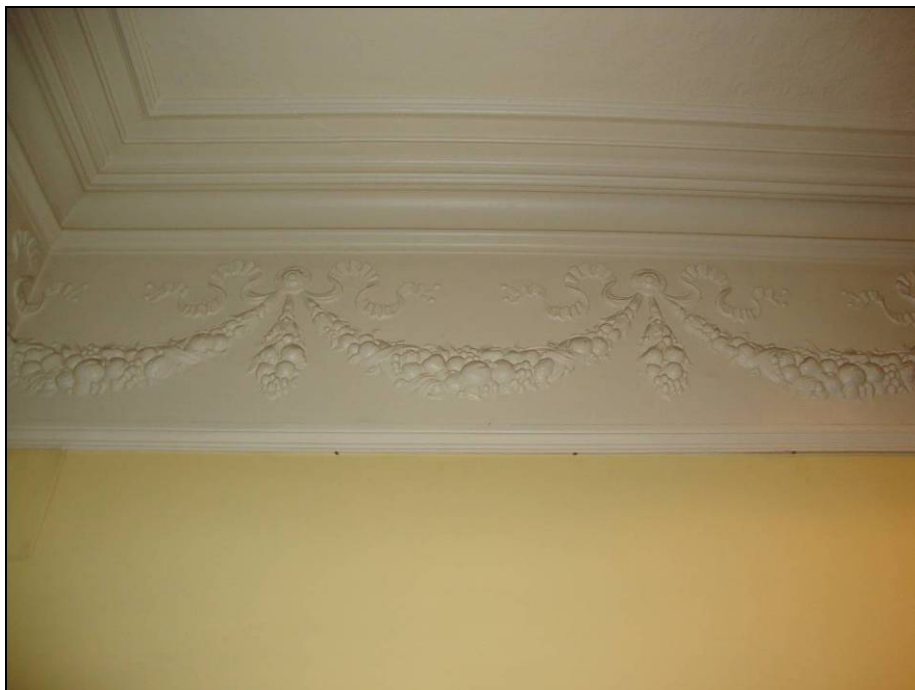
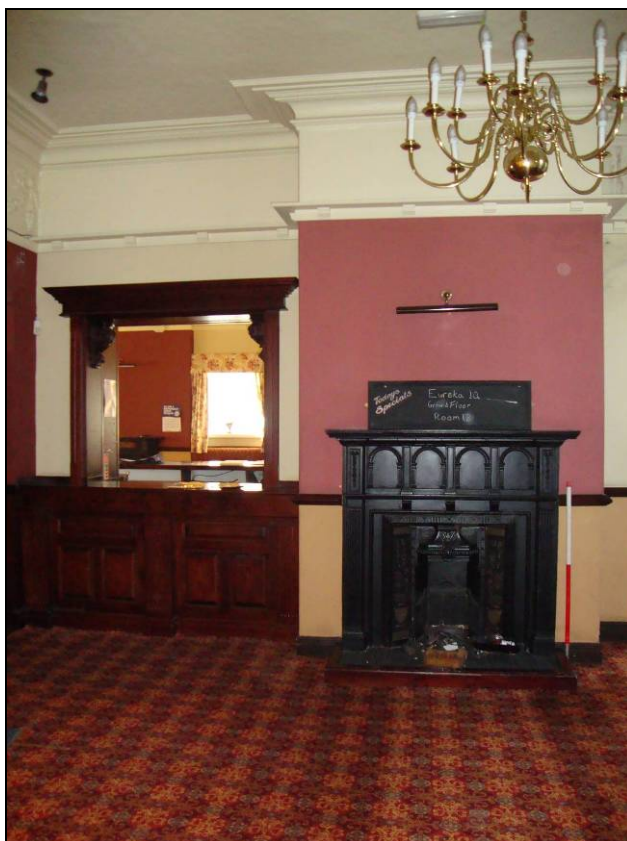
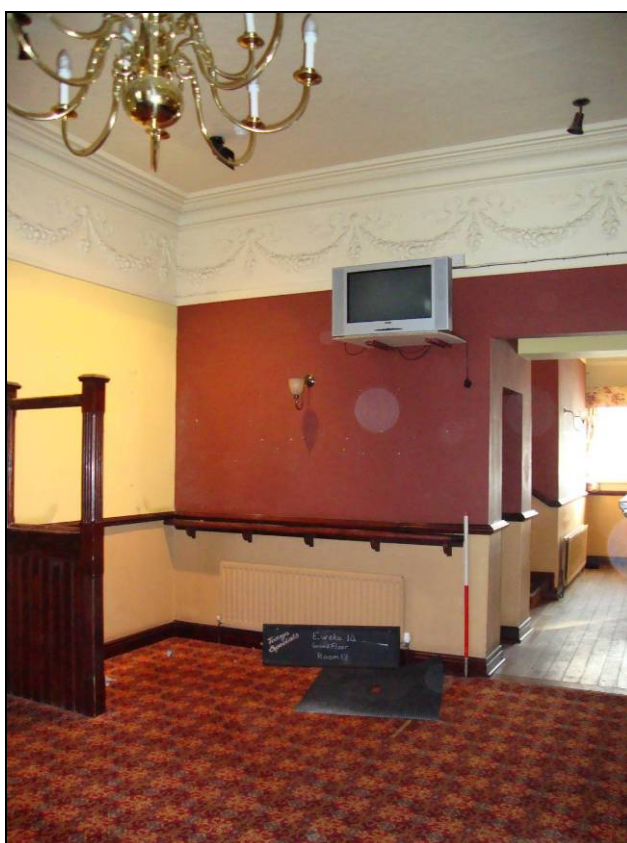
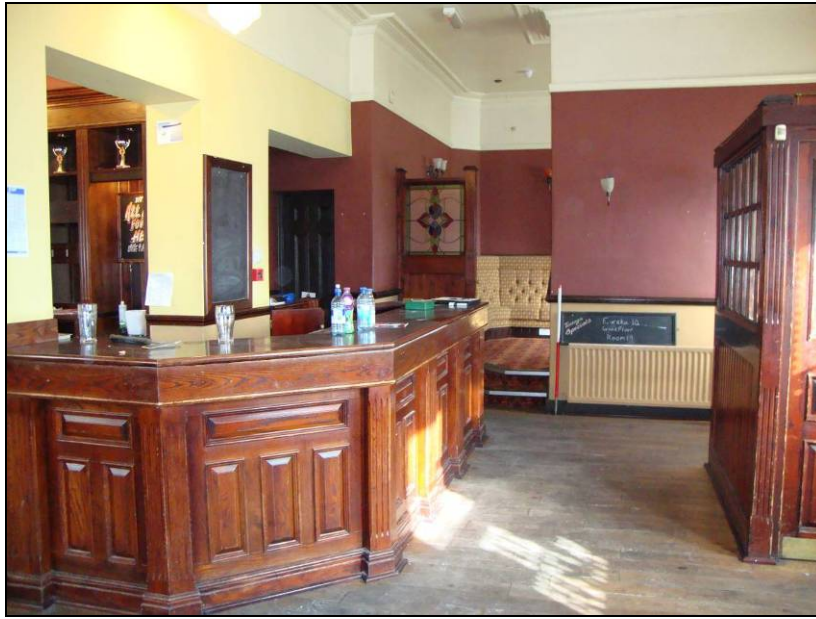
5.3.3. *Room 18 (Figs. 37, 38, 39 & 40)*

This room had access to the bar, as well as to Rooms 16, 19 and 20. Two large stained glass windows were situated on the northwest elevation. The southwest elevation had an original fireplace (although with a modern insert). The northeast and southeast elevations had a decorative frieze below the moulded coving.

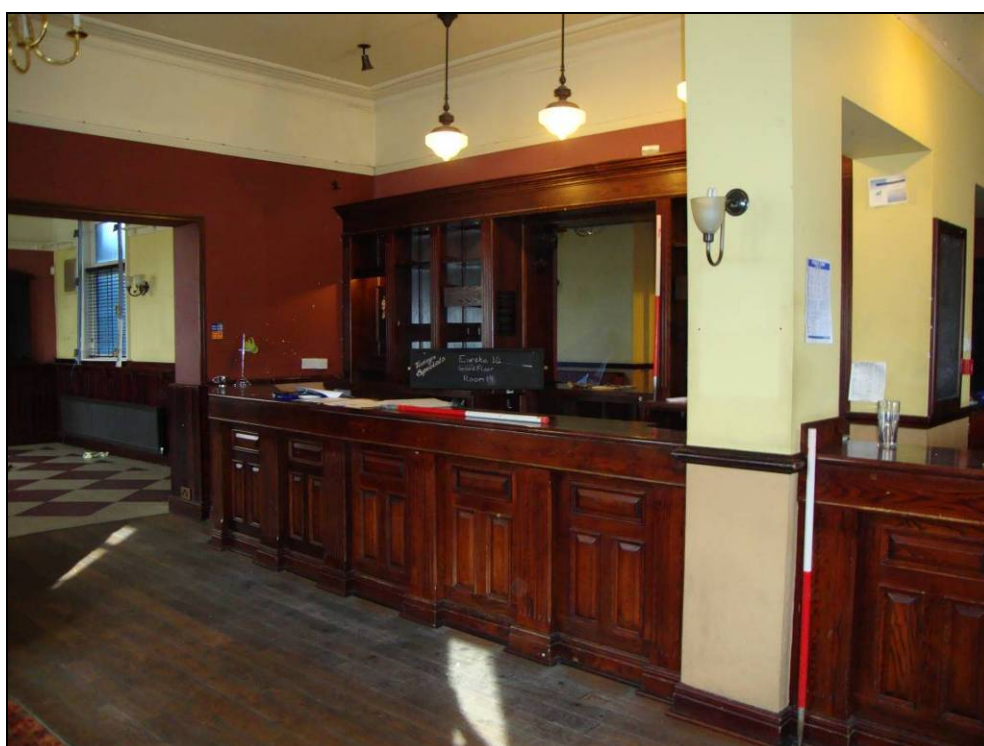
Fig. 44. Bar, Room 19

The bar was dark oak, wood panelled, and gave access to Rooms 18, 19 and 20. The bar was in good condition, but was possibly part of the 1980's renovation (as mentioned above) and therefore not original to the building.

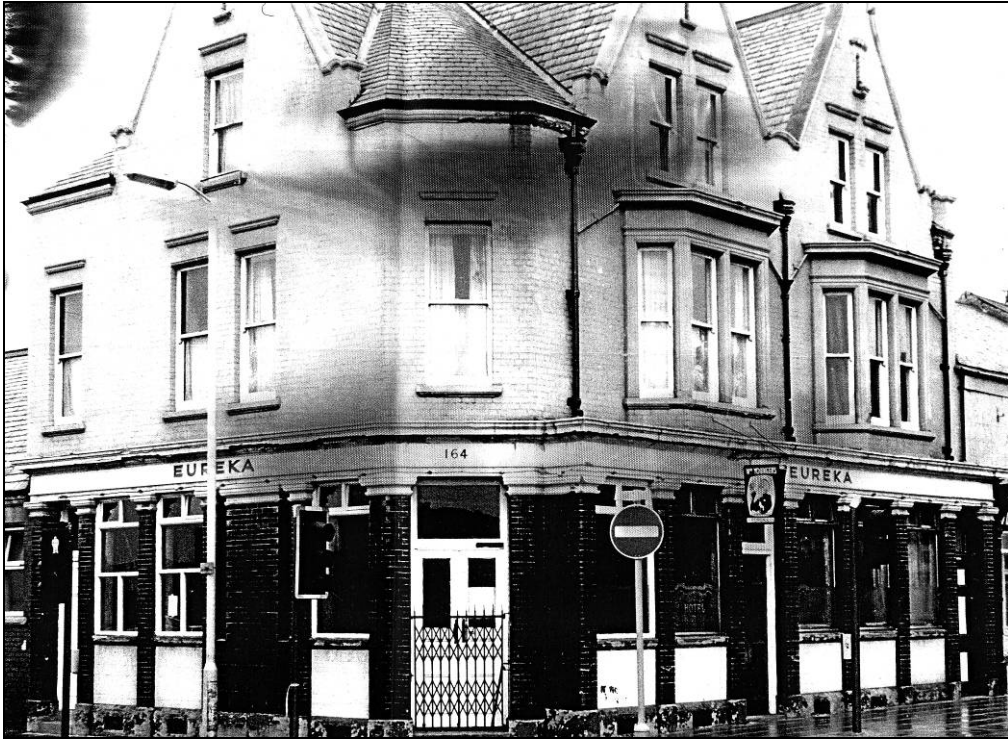
Fig. 61. Eureka photograph dated 22/02/1984

3.1.1. Another picture, dated 22/02/1984 shows the building has been stripped back to its original frontage, with the main entrance still in the southern corner of the pub (Fig. 61). An article in the South Shields Gazette, dated 16/03/1989, has two
