**An Archaeological Building Recording at
Scholes Mill Manager's House, Tansley,
Matlock, Derbyshire**

View of the Manager's House, Scholes Mill, Tansley, Matlock

ARS Ltd Report 2010/45
July 2010

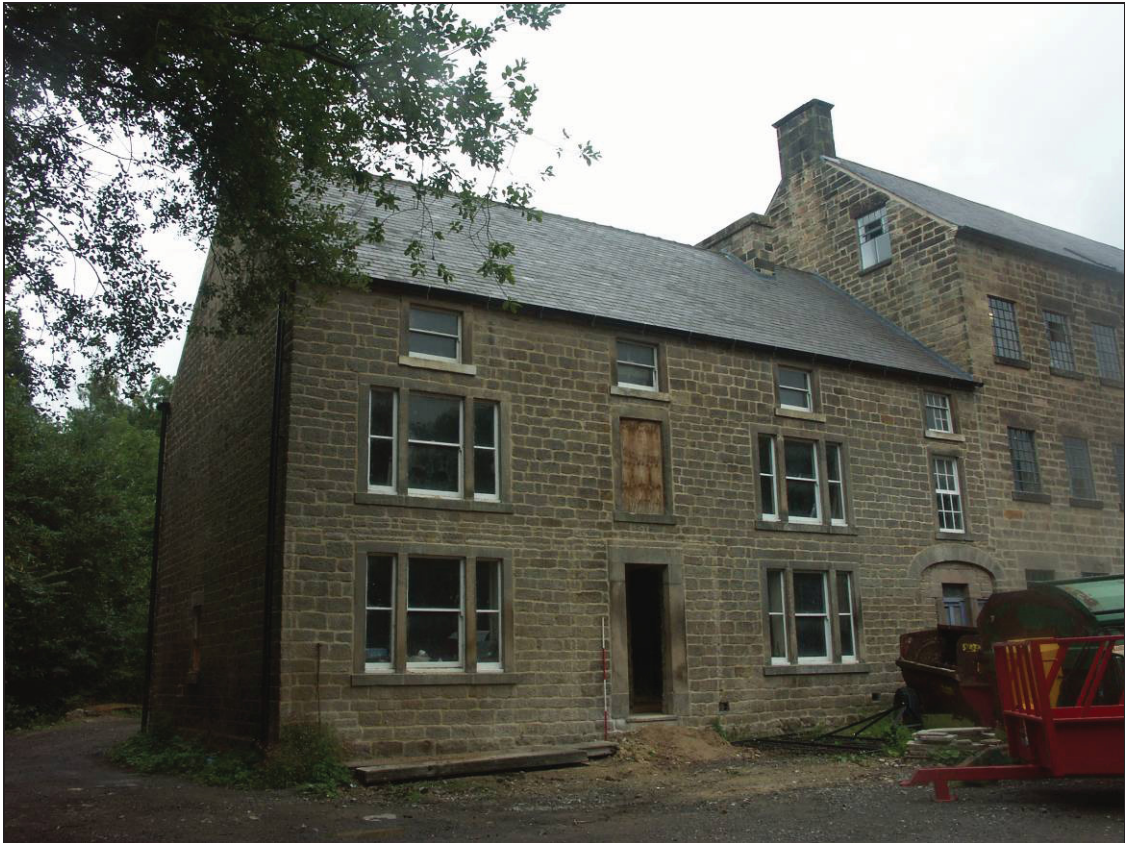
Figure 2: General view of the southern elevation (scale 2m)

- 4.3 The building is a three-storey range of four bays with a pitched slated roof and two chimney stacks. The house is built with gritstone square blocks laid to regular courses. The southern elevation has two tripartite sash windows and a doorway (with rectangular overlight) in stone surrounds on the ground floor (Fig. 2). The first floor has a similar arrangement with a central and narrower window opening instead of a doorway between the tripartite windows. The second floor has small window openings with stone surrounds comparable to the openings of the floors below.

- 4.4 There is a large archway with an elliptical head on the western end adjoining the mill. The archway is now blocked up with stones containing a secondary doorway. Above the archway there are two window openings on each floor which are different from their corresponding type on each floor.

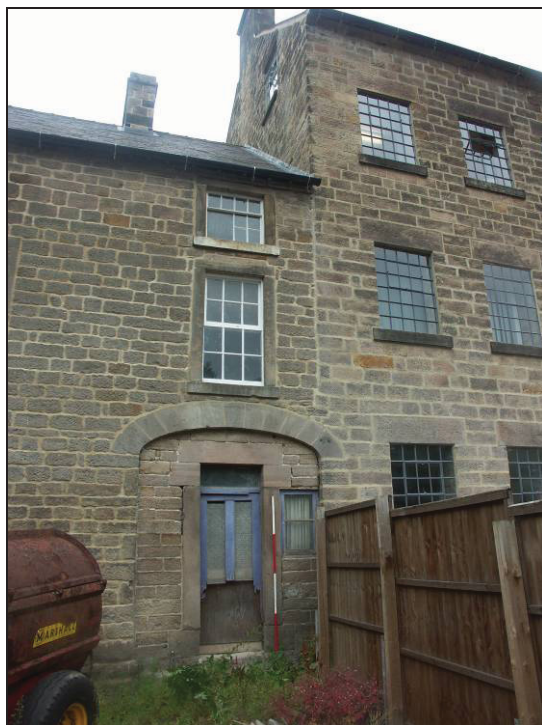
Figure 3: Joint between the house and the mill (scale 2m)

- 4.5 The joint between the mill and the house is irregular in places and when the information obtained from the interior of the building is considered (see below) this suggests that the house would have originally extended further east and thus predates the mill (Figs 3 and 4).

- 5.4 The blocked archway of the Manager's House would have originally been used for loading and unloading supplies carried by a cart. The building survey identified that the current joint between the house and the mill is not straight and instead there are several masonry remains indicating that the wall of the house would have extended towards the mill structure. Therefore, the house itself would have been a larger building with a central cartway whose eastern side was dismantled in order to enable the erection of a new and larger structure, the present mill. The Manager's House thus, might have been an earlier mill built in the late 18th century which was adapted into a house for the manager of a later mill constructed adjacent to it around the early to mid 19th century.

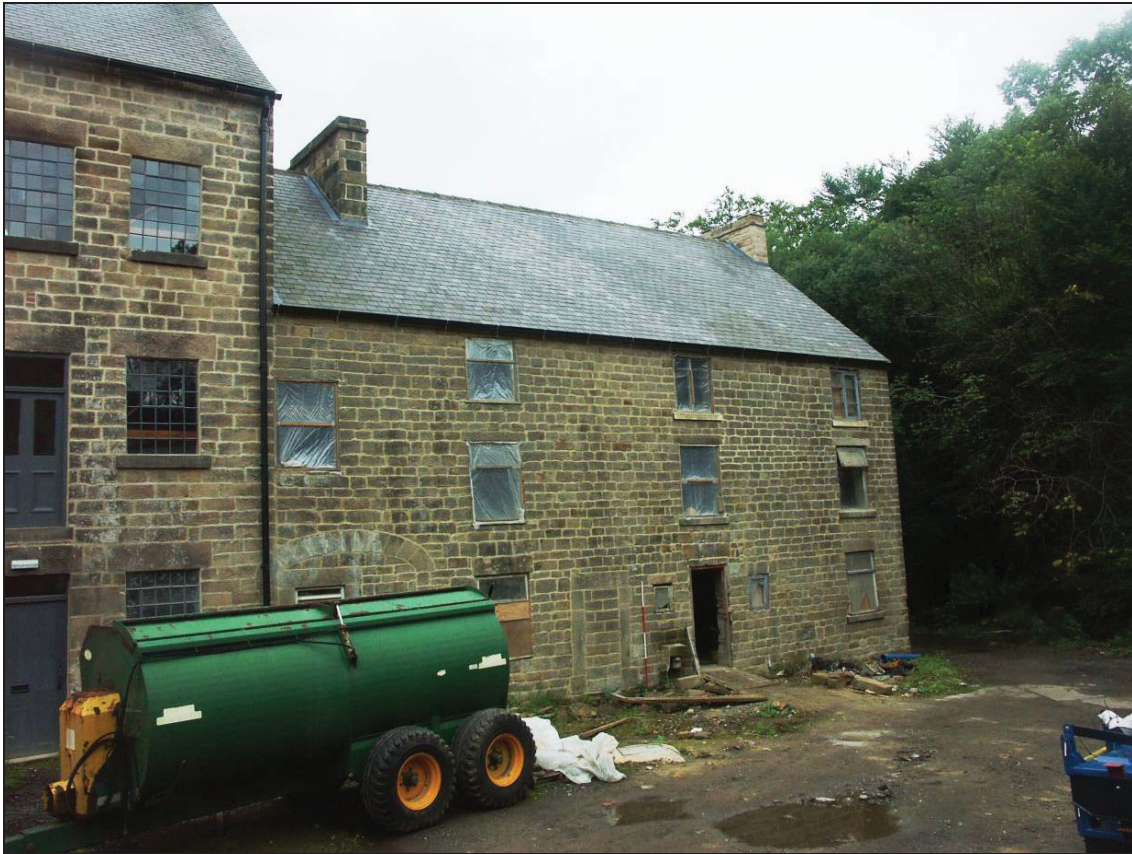
Figure 5: General view of the northern elevation (scale 2m)

- 4.6 The northern elevation is different from the southern elevation and, although it has similar window arrangements, the window openings are different types (Fig. 5). There is a doorway in the second bay from the west which appears to have replaced an original window opening. There is another doorway with stone surrounds which is now blocked with stone and is situated between the central bays. This elevation has an equivalent archway with stone infills and a later doorway within it. The doorway has stone surrounds comparable with the blocked doorway in the centre.

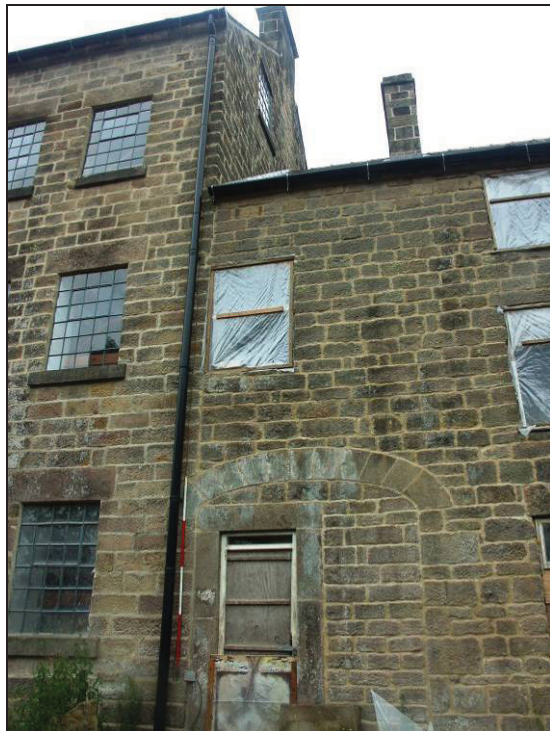
Figure 6: Joint between the house and the mill

- 4.7 The joint between the mill and house is also slightly irregular and again indicates that the house would have originally extended further east (Figs 6 and 7).

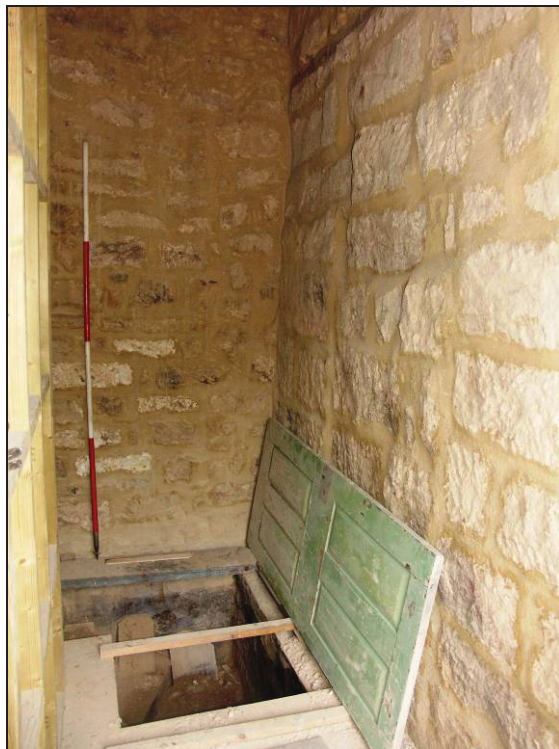
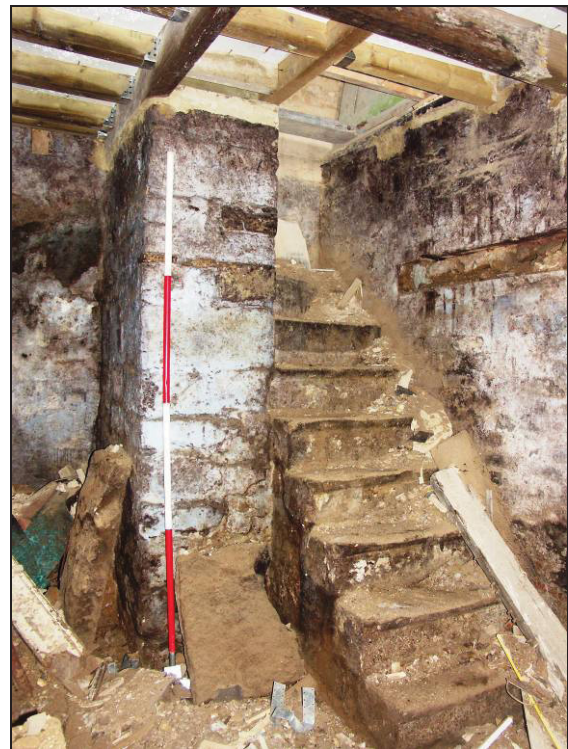
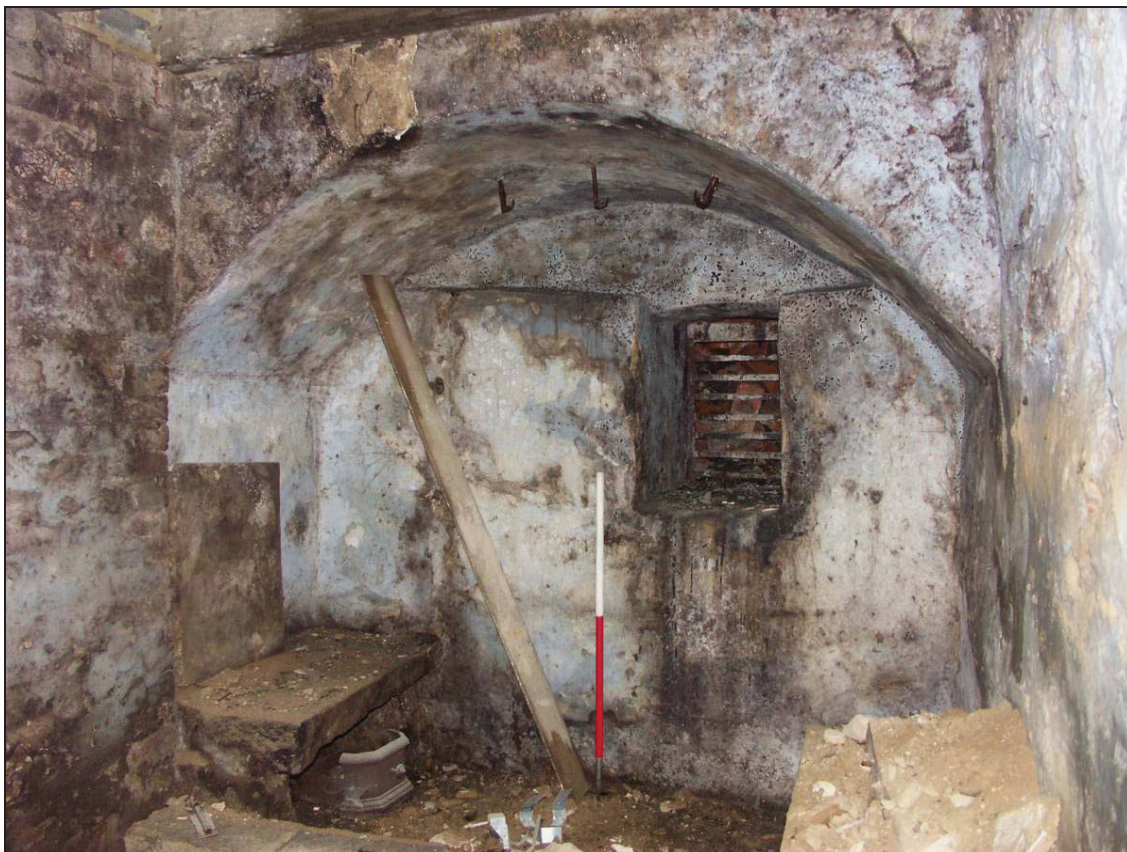
- 4.10 There is a quarter-turn stone staircase with winders which leads to a cellar beneath (Figs. 8 and 9). The cellar consists of a small cell underneath the hallway although it extends slightly westwards yielding a total of *c.* 3 metres in width. The cellar has a segmental brick vaulted area adjacent to the main southern wall strengthening a coal chute opening which is now blocked up (Fig. 10). The total height of the cellar is 2.30 metres.

Figure 8: Hallway G-1 with stairs down to the cellar

Figure 9: Staircase of the cellar (scale 2m)

Figure 10: General view of the cellar with former coal chute blocked up, looking south (scale 1m)

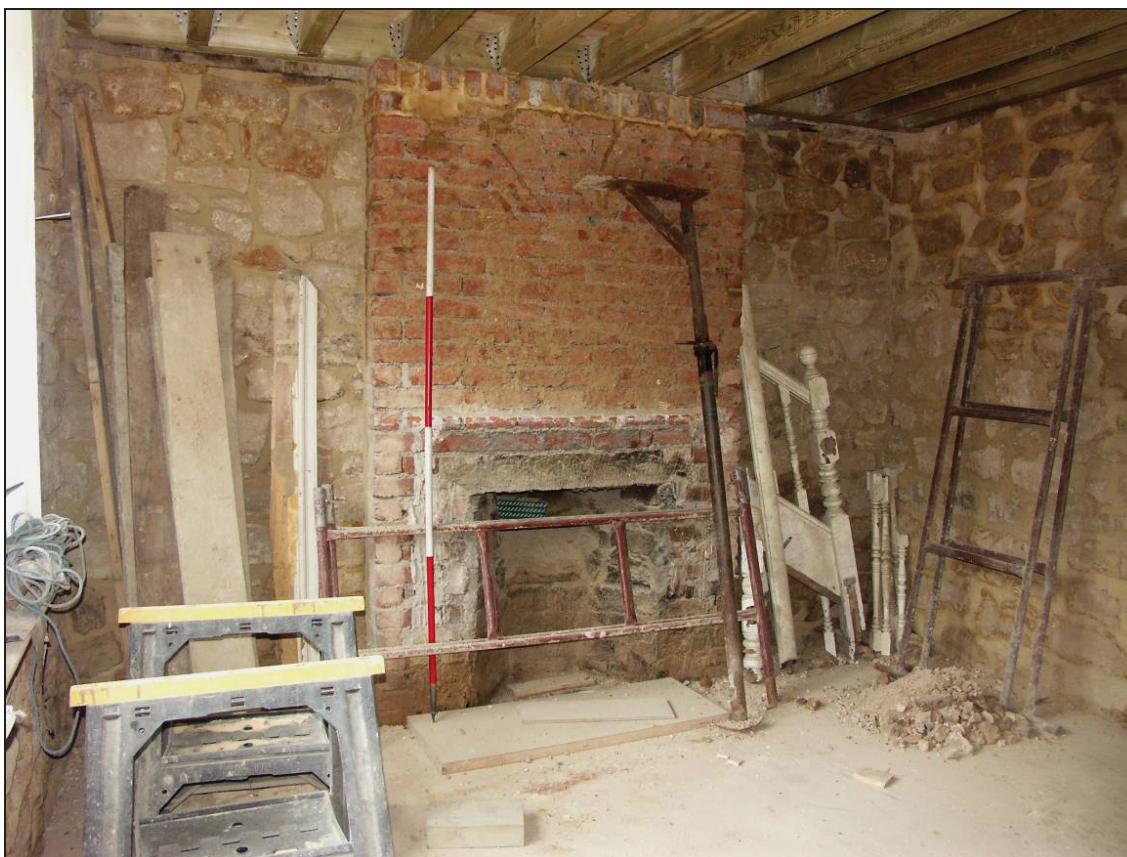
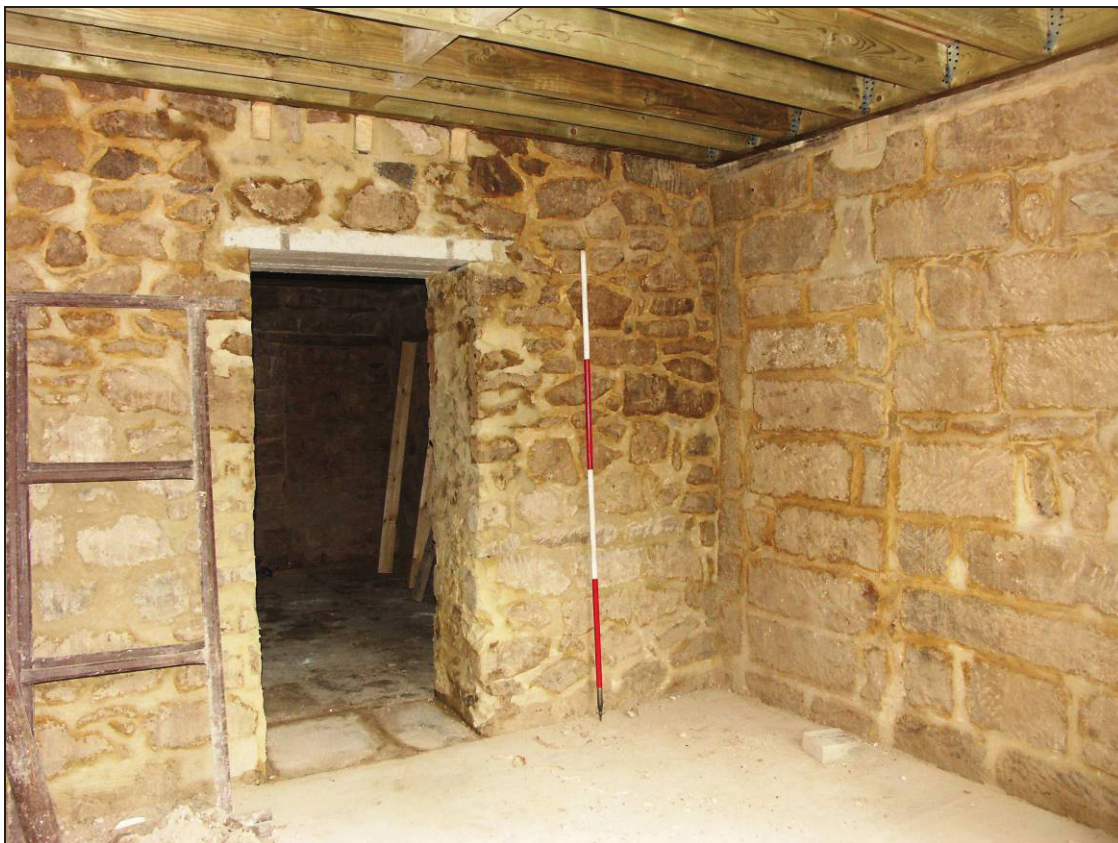
- 4.11 Room G-2 has an inserted brick chimney breast containing a fire place made of sandstone blocks (Fig. 11). The east/west partition wall adjoining room G-4 is built with uncoursed sandstone rubble. This wall appears to be a later insertion as is not properly keyed in and the character of the masonry does not match the main structure of the house. Moreover the wall abuts the north/south partition of the adjacent hallway (Fig. 12). This room has new timber boards over the original flagstones.

Figure 11: Fire place in room G-2, looking west (scale 2m)

Figure 12: Room G-2, looking north (scale 2m)

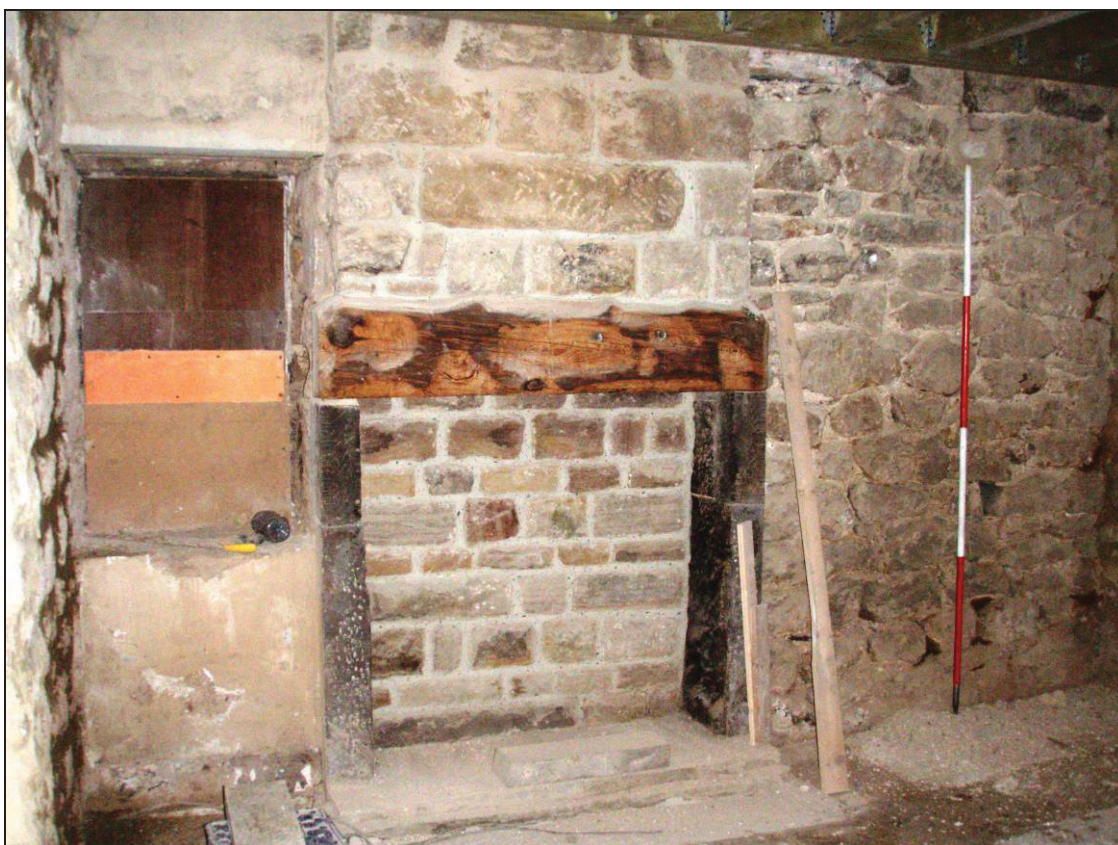
Figure 13: Fire place in room G-3, looking west (scale 2m)

- 4.12 Room G-3 also has an inserted chimney breast made of regular sandstone blocks containing a fire place with a timber lintel (Fig. 13). The fire place is currently blocked with stones.
- 4.12 There is a blocked doorway within the partition wall adjoining room G-4. There is sign of repair/rebuild within the northern wall although this may be the result of blocking a former doorway with stones matching the main masonry structure.

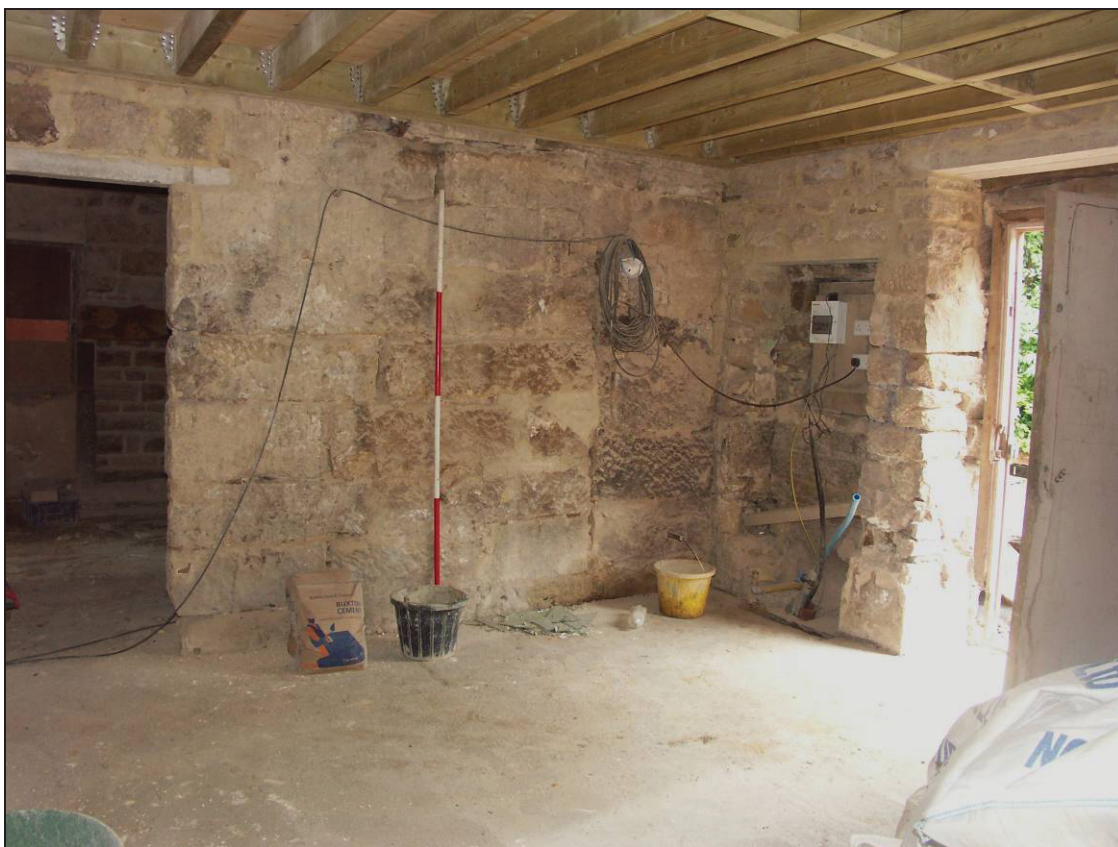
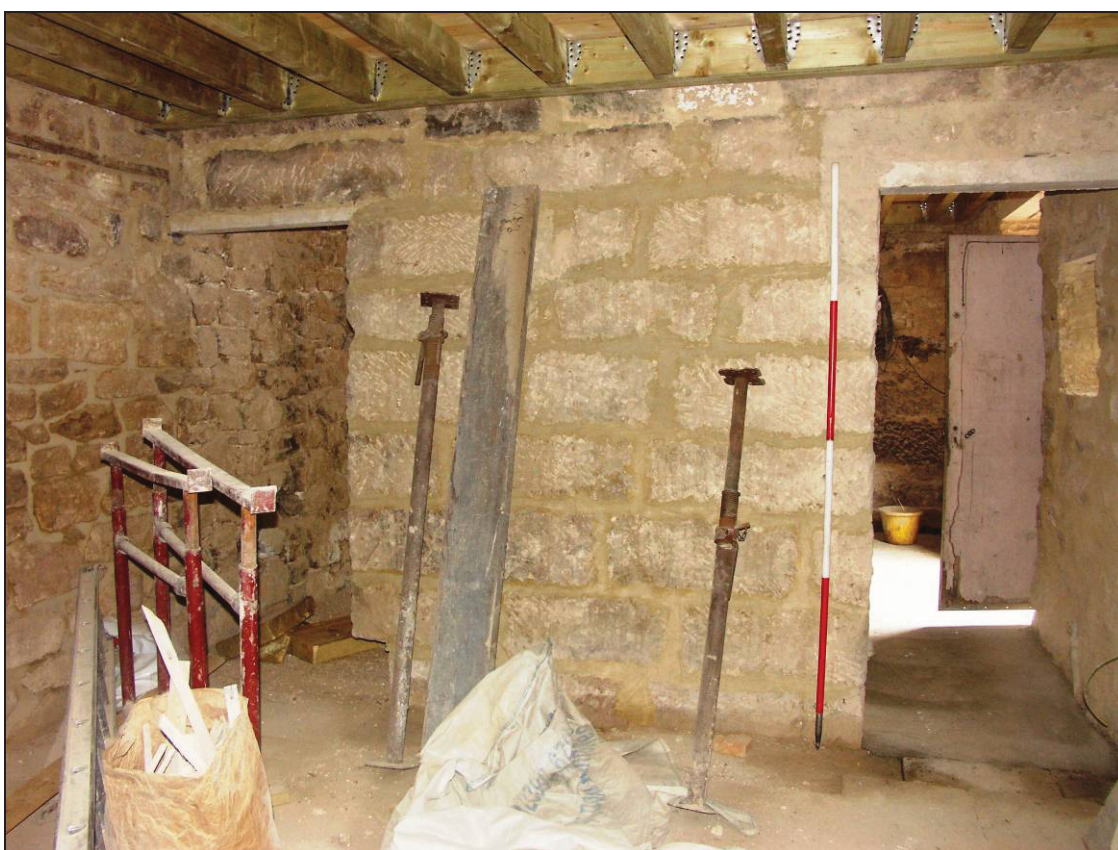
- 4.13 Room G-4 has similar fabrics to the adjacent room G-3 including the eastern partition wall adjoining room G-5 which is made of large roughly hewn gritstone blocks (Figs 14 and 15). The north/south partitions appear to be later additions to the main structure of the house. The floor of this room consists of a thin layer of cement over the original flagstone.

Figure 14: Room G-4, looking north-west (scale 2m)

Figure 15: Room G-4, looking east (scale 2m)

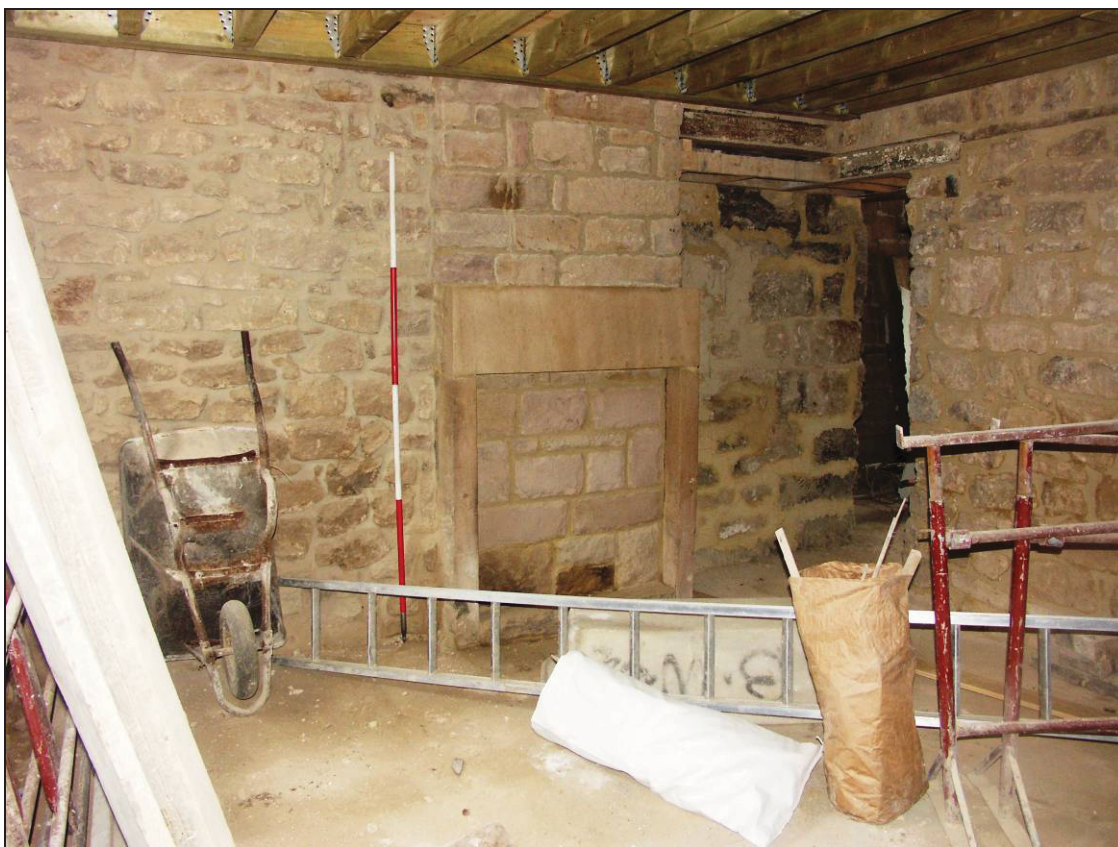
Figure 16: Blocked fire place in room G-5, looking east (scale 2m)

- 4.14 Room G-5 has an inserted chimney breast containing a fire place made of dressed sandstone which is currently blocked with stones (Fig. 16). The partition wall adjoining room G-6 consists of a veneer of roughly hewn gritstone blocks facing room G-6 and another veneer of uncoursed rubble facing this room.

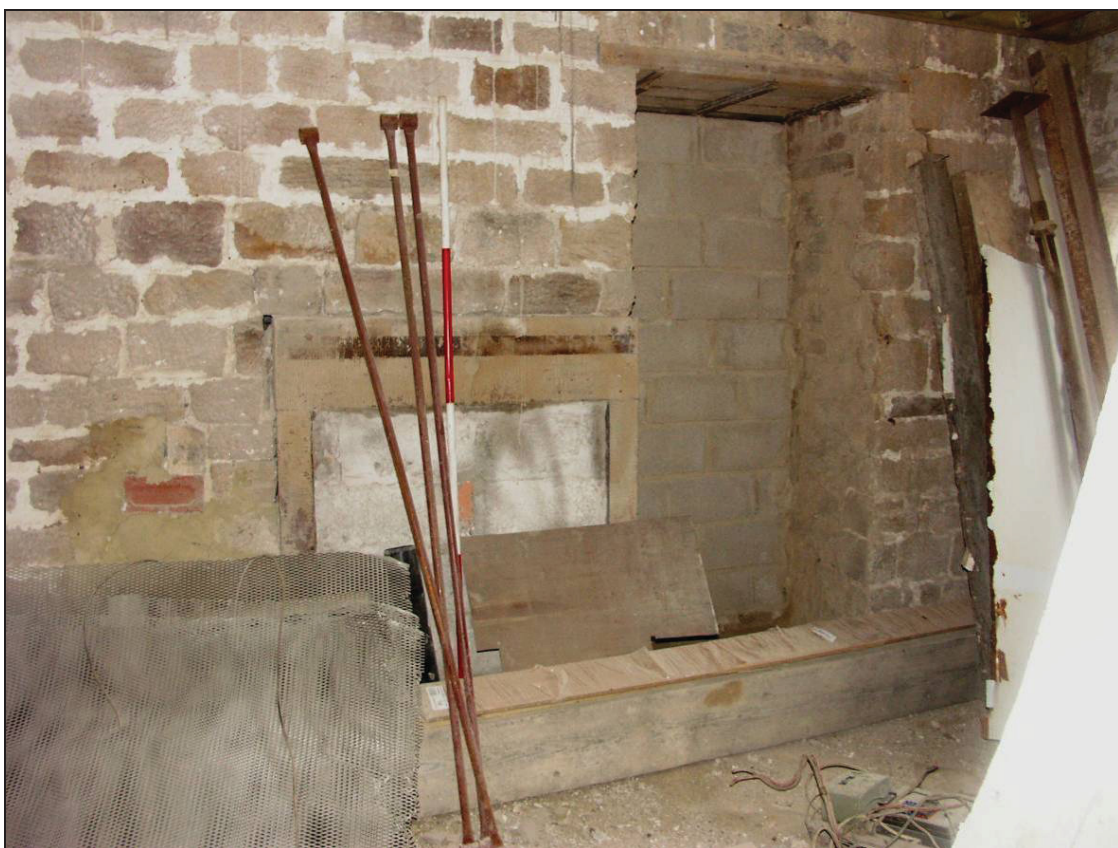
Figure 17: Blocked fire place in room G-6, looking east (scale 2m)

- 4.15 Room G-6 is a former north/south passageway with modified original doorways. It has a blocked fire place and a recessed doorway in the eastern wall of the adjacent mill (Fig. 17).

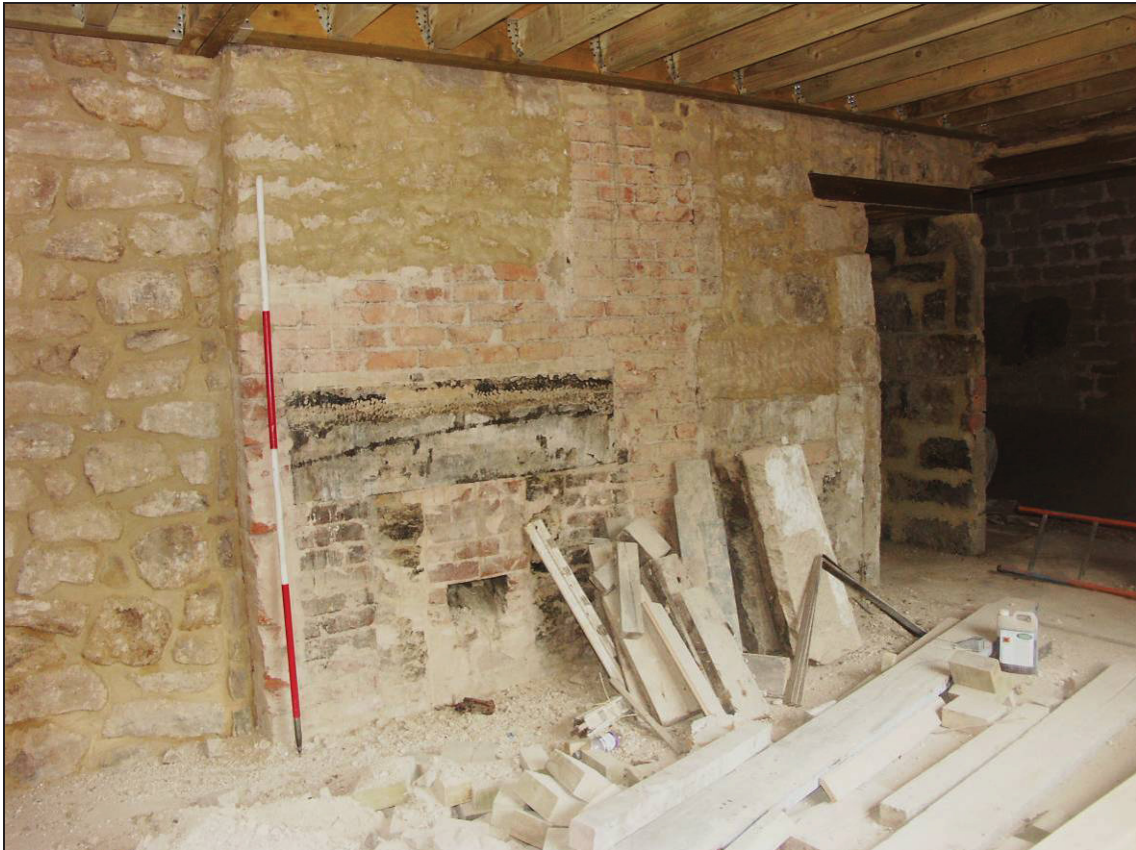
Figure 18: Blocked fire places in room G-7, looking north-east (scale 2m)

- 4.16 Room G-7 has an inserted chimney breast made of bricks and stones, which contains two blocked fire places built with sandstone lintels (Fig. 18). The room has new floor boards over the original flagstones. The north/south partition walls are made of rectangular roughly hewn sandstone blocks whereas the east/west partition adjoining rooms G-4 and G-5 consists of an uncoursed rubble wall.

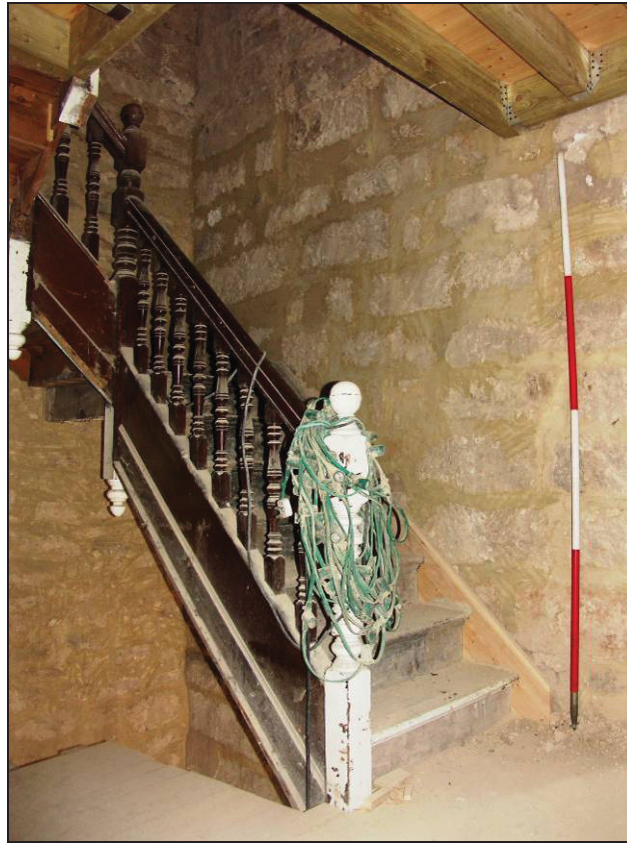
Figure 19: Staircase in hallway F-1, looking north-east (scale 2m)

- 4.18 Room F-1 is a hallway above G-1 containing a timber dog-leg staircase with open strings, moulded newel posts with ball finials and pendants, turned balusters and moulded handrails (Fig. 19). The partition walls and doorway arrangements are equivalent to room G-1 below.

staircase appears to have been added even later as in order to make it functional, former doorways which would have allowed access through it were blocked up creating a coherent stairwell. This suggests that the original access to the upper floors might have been within the eastern side of the central cartway.

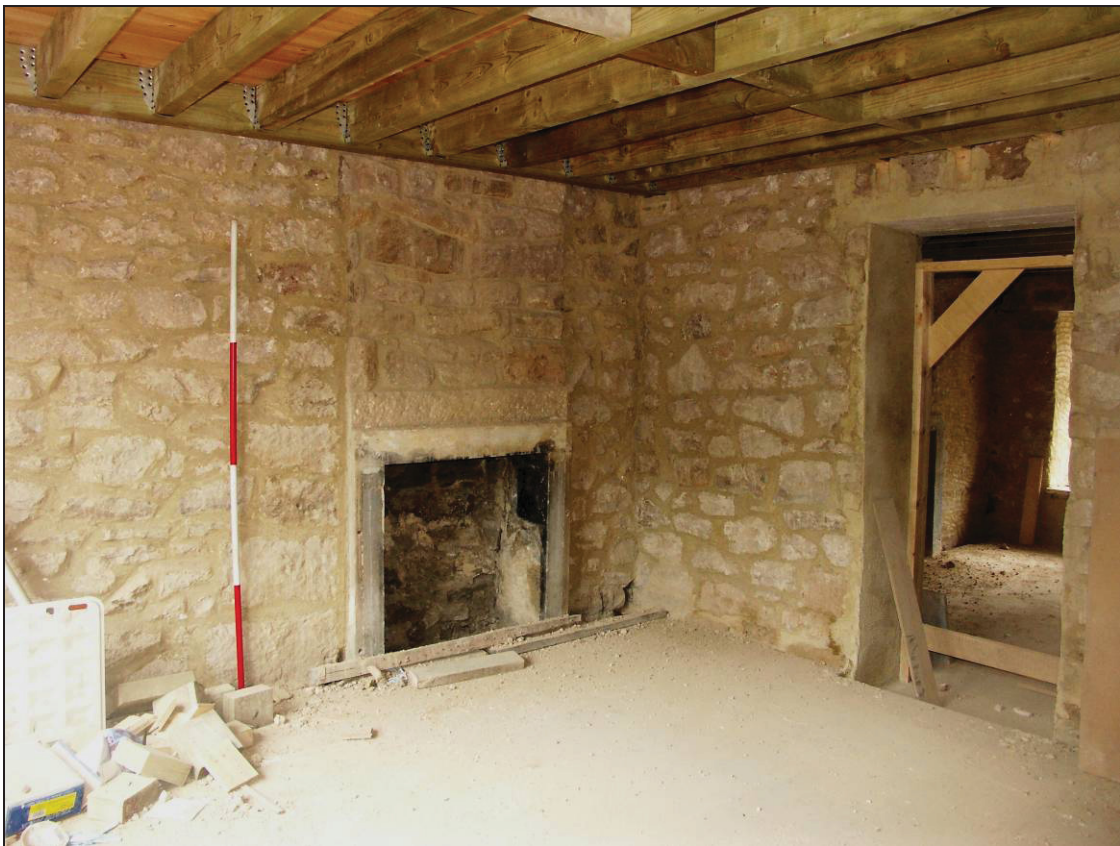
Figure 20: Fire place in room F-2, looking west (scale 2m)

- 4.19 Room F-2 has an inserted chimney breast containing a fire place made of sandstone blocks (Fig. 20). The east/west partition wall adjoining room F-3 is built with uncoursed sandstone rubble. This wall appears to be a later insertion as is not properly keyed in and the character of the masonry does not match the main structure of the house. Moreover the wall abuts the north/south partition of the adjacent hallway.

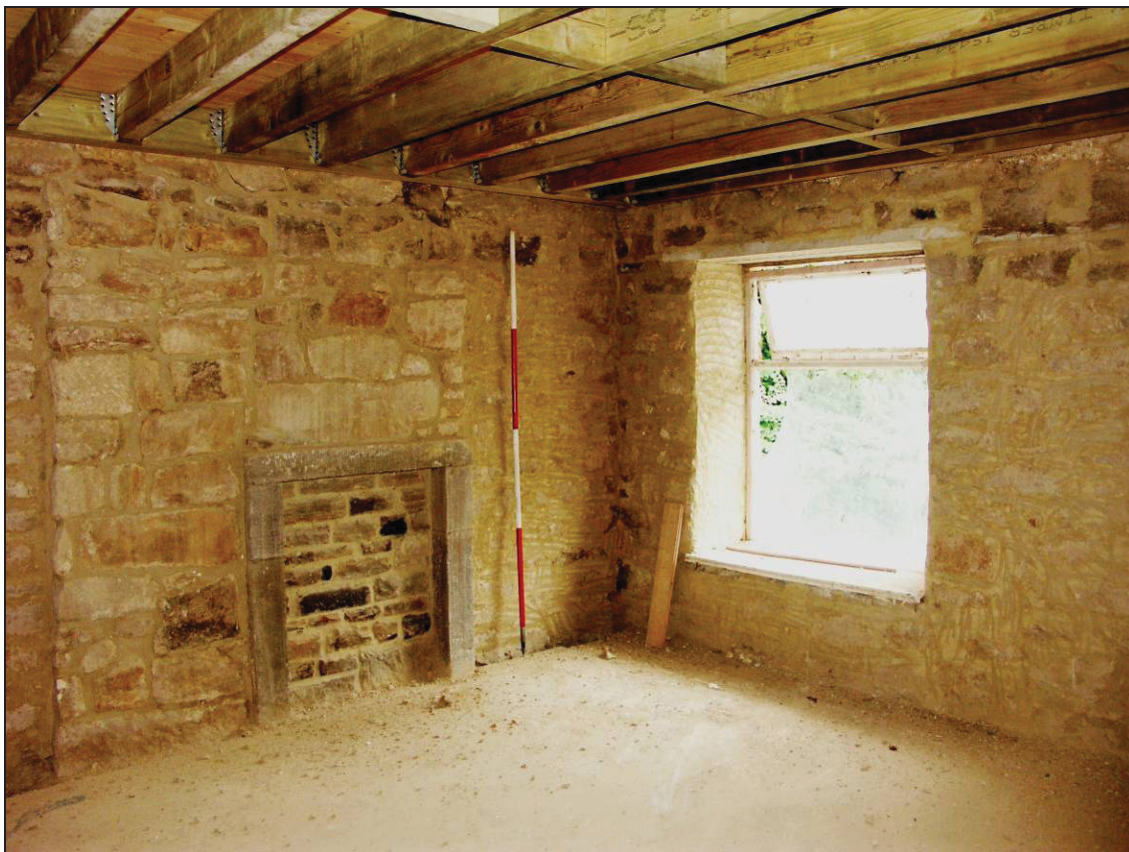
Figure 21: Blocked fire place in room F-3, looking west (scale 2m)

- 4.20 Room F-3 also has an inserted chimney breast made of sandstone blocks containing a fire place built with dressed sandstone (Fig. 21). The fire place is currently blocked with stones. There is a blocked doorway within the partition wall adjoining room F-4. The partition walls are equivalent to room G-3 below.

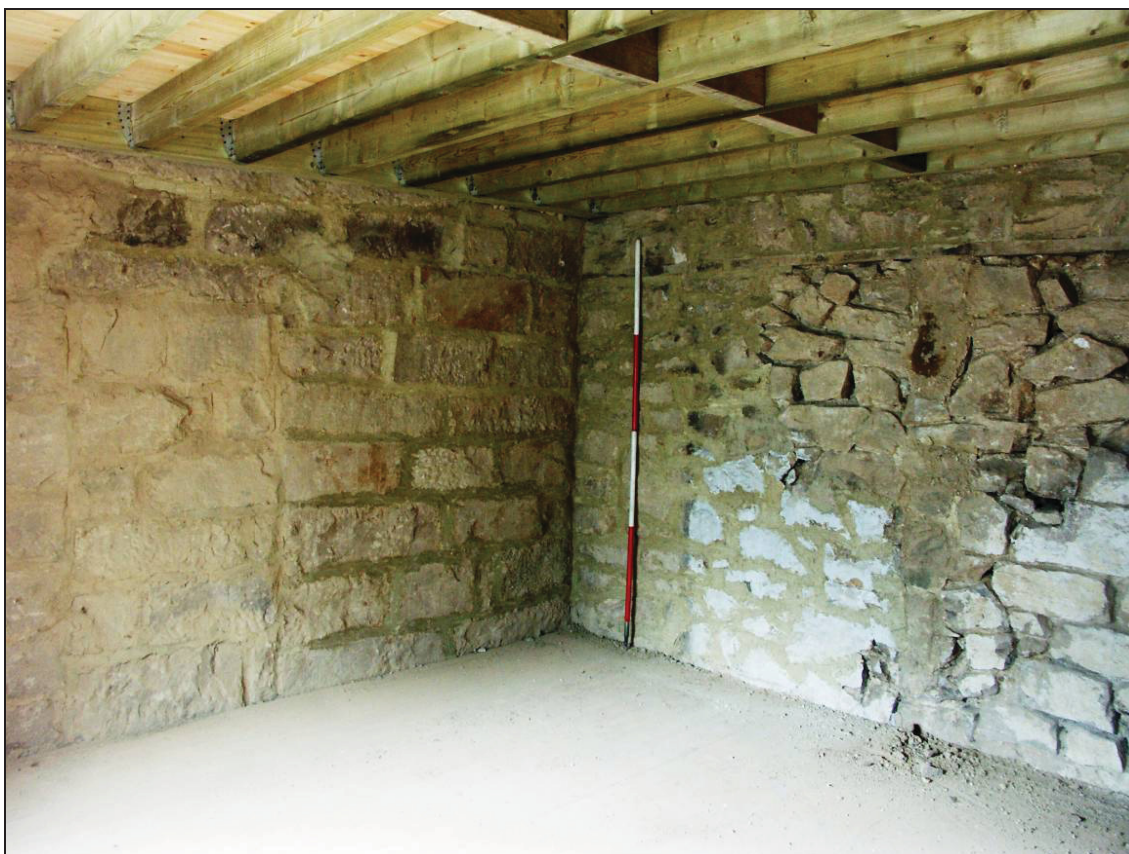
Figure 22: Room F-4, looking east (scale 2m)

- 4.21 Room F-4 is similar to its counterpart G-4 below except that there is a blocked doorway within the partition wall adjoining room F-5 (Fig. 22). The southern wall is in moderate state of disrepair.

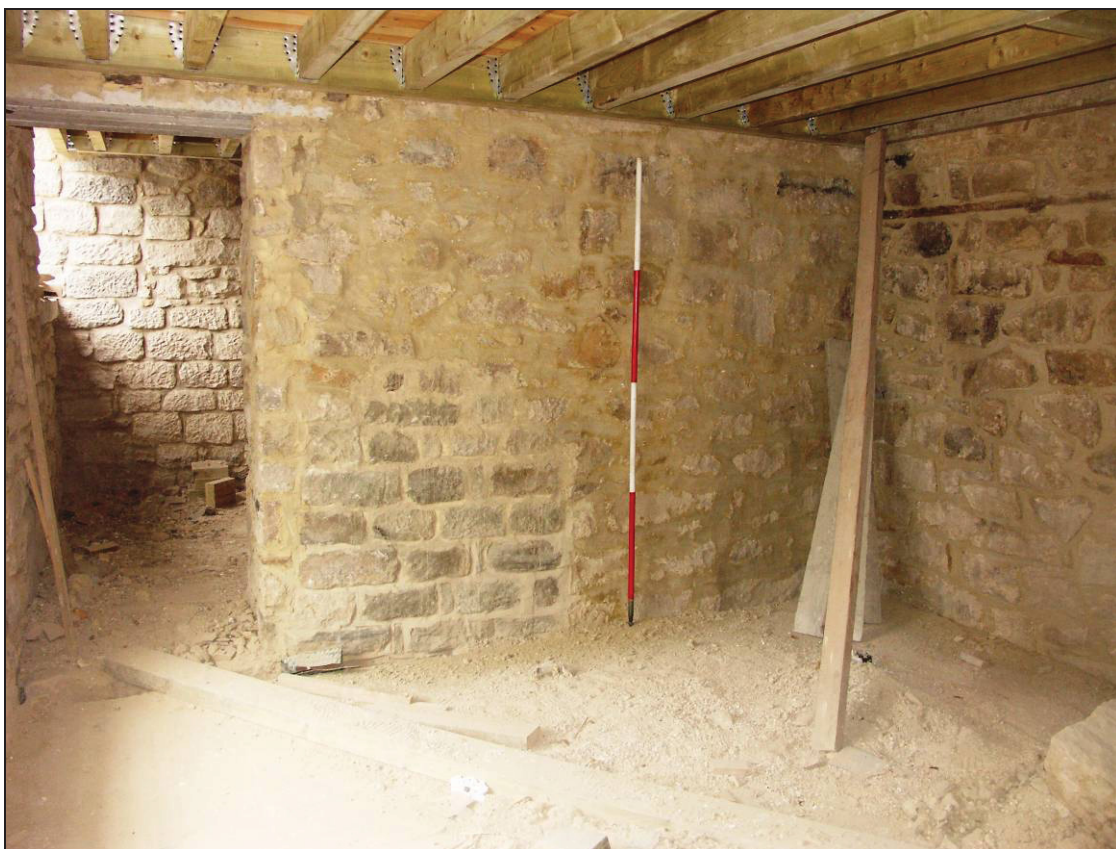
Figure 23: Room F-5, looking east (scale 2m)

- 4.22 Room F-5 has a north/south partition wall adjoining room F-6 which is built with sandstone blocks of which some are regularly laid with roughly square blocks and others are random uncoursed rubble (Fig. 23).

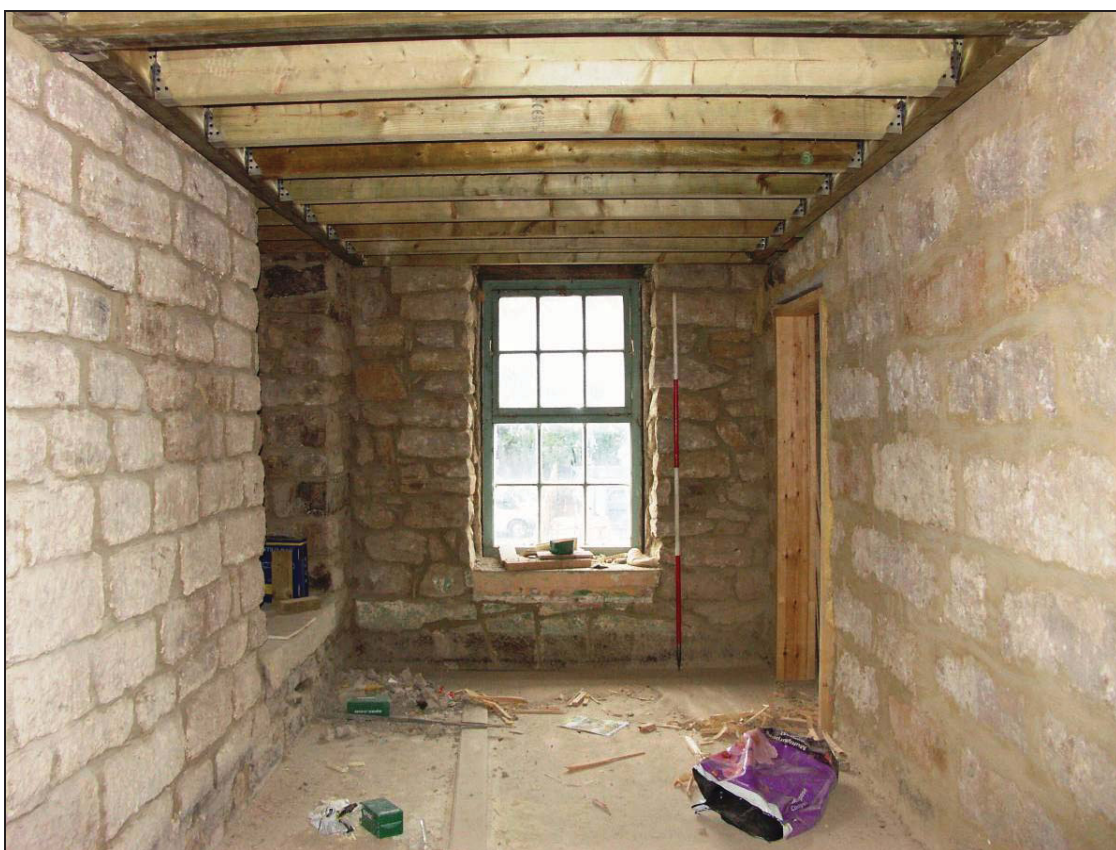
Figure 24: Room F-6, looking south (scale 2m)

- 4.23 Room F-6 is a north/south passageway which has two recessed openings in the eastern wall of the adjacent mill (Fig. 24). The long north/south partition wall adjoining F-5 and F-7 is built with large roughly hewn gritstone blocks which appear to be a later addition to the main structure of the house.

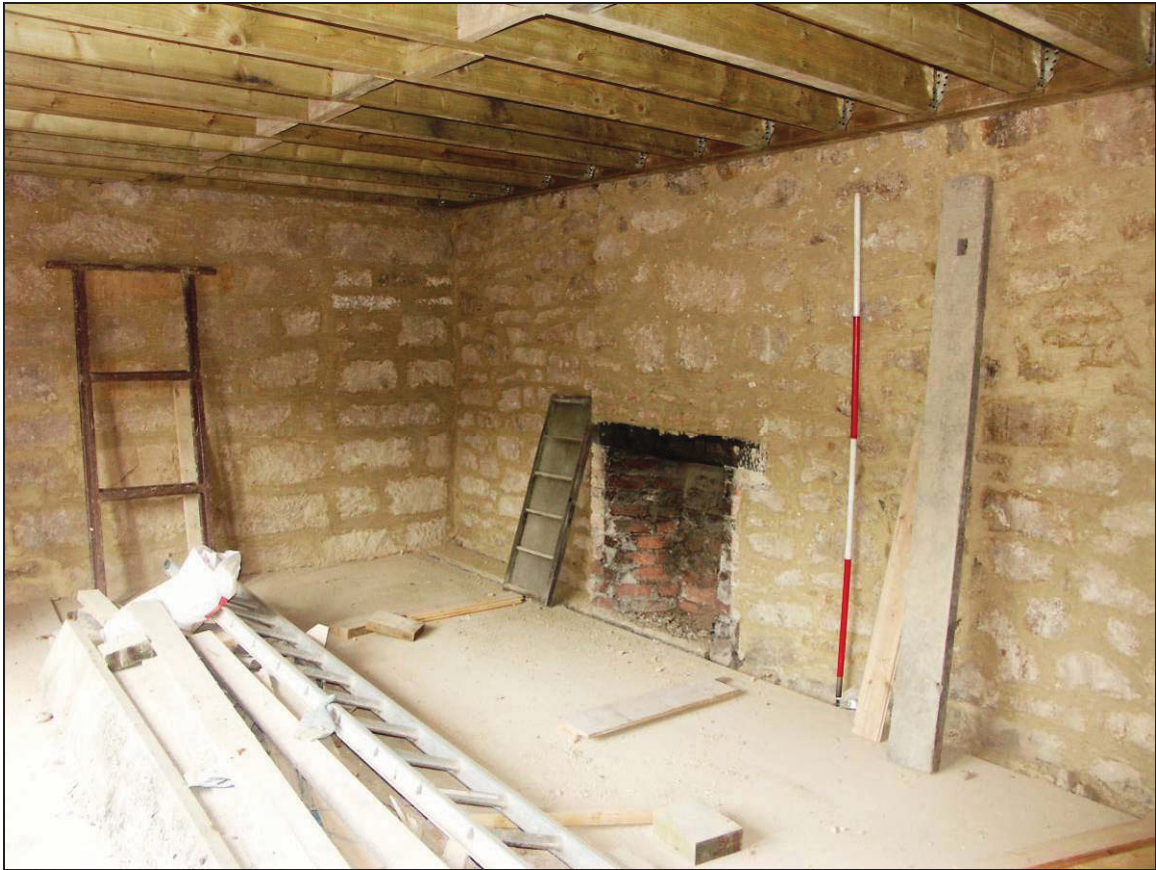
Figure 25: Fire place in room F-7, looking north-west (scale 2m)

- 4.24 Room F-7 has an inserted chimney breast made of stone, which contains a blocked fire place with a timber lintel (Fig. 25). The east/west partition wall adjoining rooms F-4 and F-5 is built with uncoursed rubble stones.

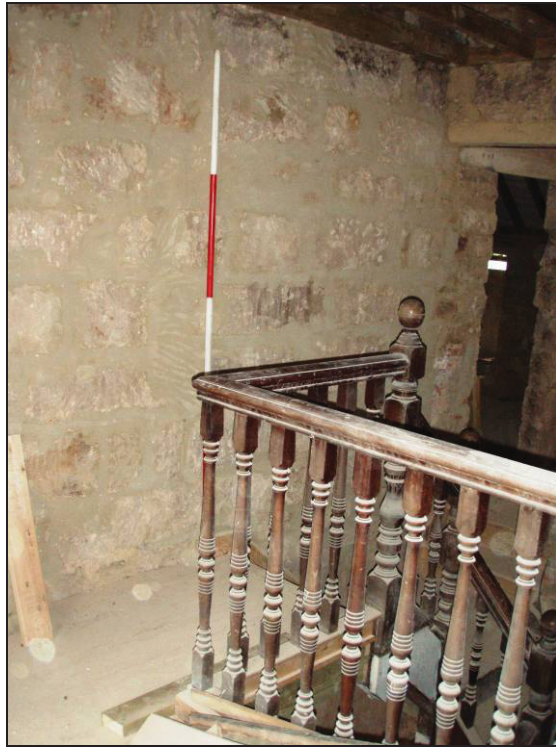
- 4.26 Room S-1 is a hallway above F-1 containing the top of the staircase's balustrade (Fig. 26). The partition walls and doorway arrangements are equivalent to room F-1 below. However, there is a blocked doorway in the eastern partition wall of the staircase which would have previously contained a door (Fig. 27). The existence of a doorway in such a place is somewhat abnormal as it would have led to the middle of the present stairwell rather to a landing of the stairs.

Figure 26: Top of balustrade, looking north

Figure 27: Blocked doorway in staircase S-1

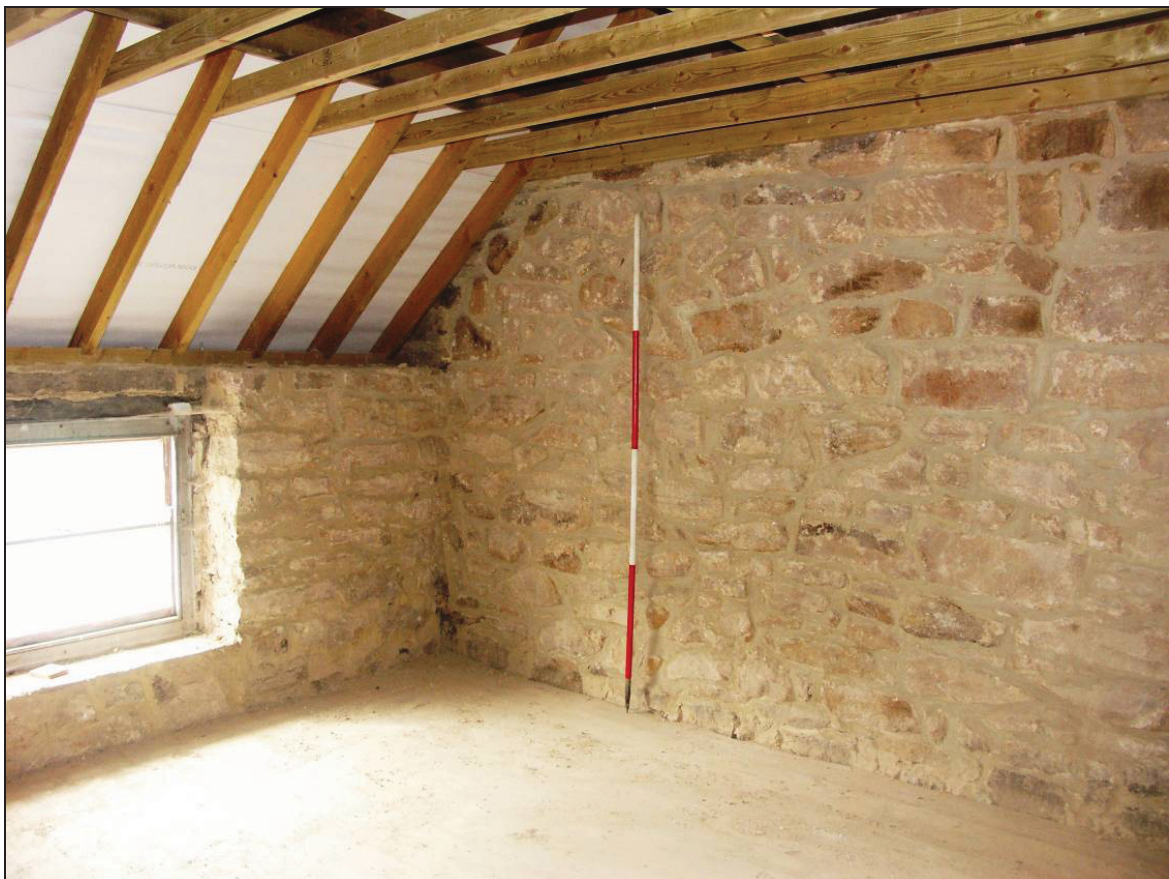
Figure 28: Room S-2, looking west (scale 2m)

- 4.27 Room S-2 is comparable to F-2 below except that it lacks of fire place. However the scars of the chimney breast are partially perceivable (Fig. 28). The east/west partition wall adjoining room S-3 is built with uncoursed sandstone rubble. This wall appears to be a later insertion as is not properly keyed in and the character of the masonry does

not match the main structure of the house. Moreover the wall abuts the north/south partition of the adjacent hallway.
