**An Archaeological Building Recording at
Scholes Mill Manager's House, Tansley,
Matlock, Derbyshire**

View of the Manager's House, Scholes Mill, Tansley, Matlock

ARS Ltd Report 2010/45
July 2010

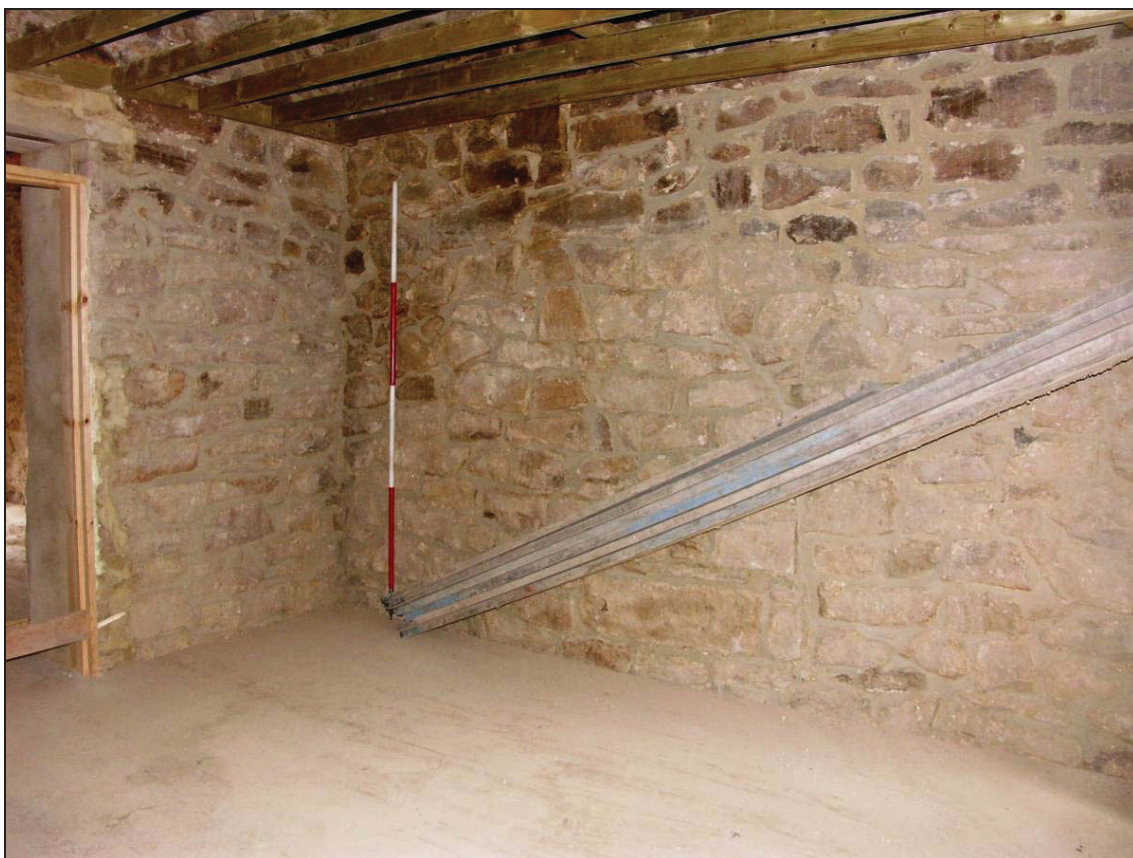
Figure 29: Room S-3, looking west (scale 2m)

- 4.29 Room S-3 is comparable to F-3 below except that it lacks a fire place. However the scars of the chimney breast are partially perceivable (Fig. 29).

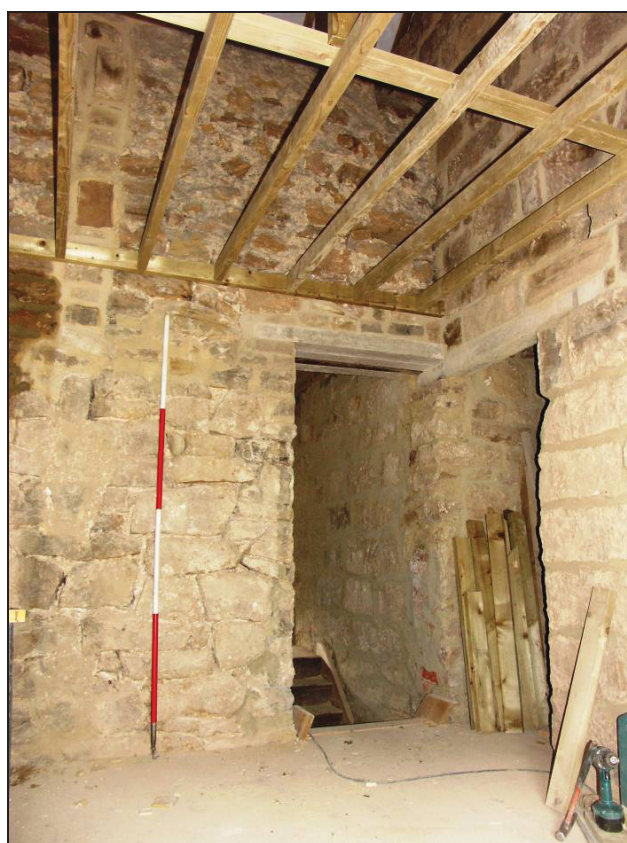
Figure 30: Room S-4, looking south (scale 2m)

- 4.30 Room S-4 is similar to its counterpart F-4 below except that there are no blocked doorways within the north/south partition walls. The scars of a former north/south partition wall can be seen in the centre of the southern wall which would have extended further north (Fig. 30).

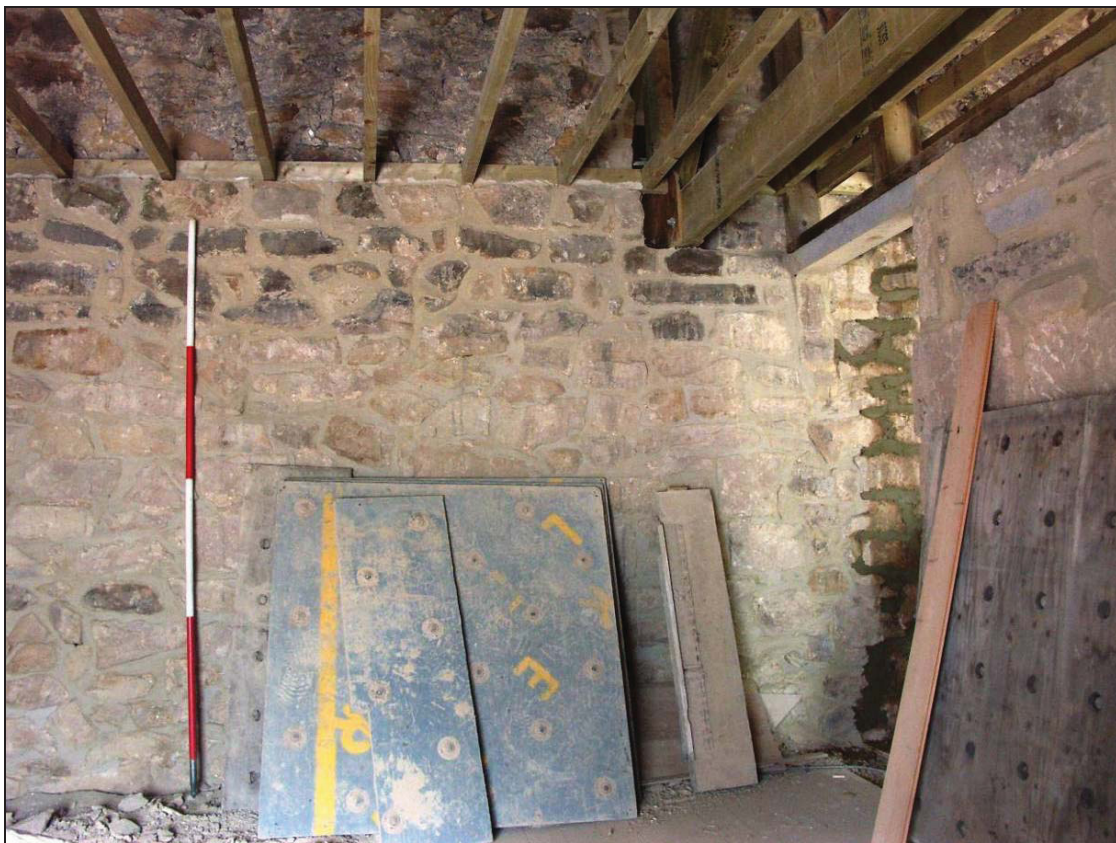
Figure 31: Room S-5, looking south (scale 2m)

- 4.31 Room S-5 is similar to F-5 below although there is no doorway to the adjoining room on the eastern side (room S-6). There is a timber truss which is a recent replacement of an original one. The truss is set across the entire building and its underside is c. 2 metres high from the floor. The large partition east/west wall adjacent to room S-7 has a slot accommodating the tie-beam through the wall itself (Fig. 31).

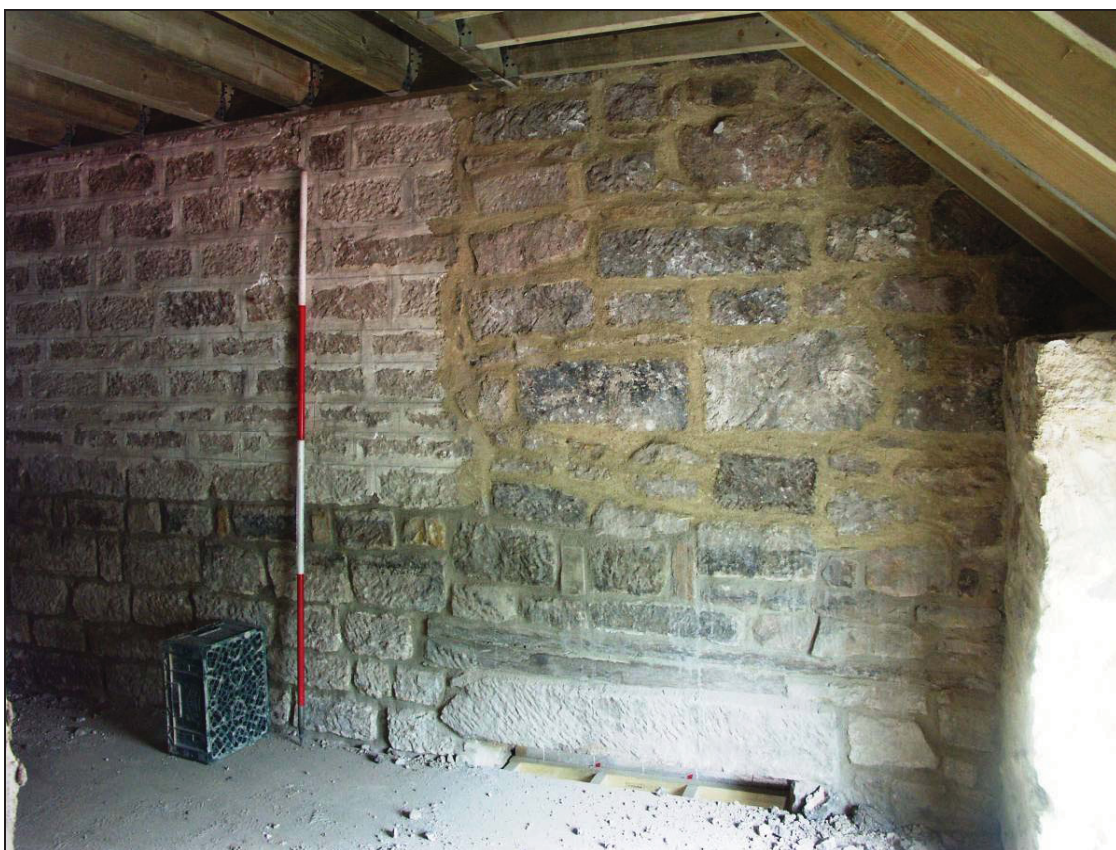
Figure 32: Room S-6, looking east (scale 2m)

- 4.32 Room S-6 is similar to F-6 below and although it has not openings linking the mill, there are various scars of repair/rebuilt along the eastern wall adjoining the mill (Fig. 32). The north/south partition wall adjoining rooms S-5 and S-7 extends upright acting as a truss which supports the side purlins of the roof structure.

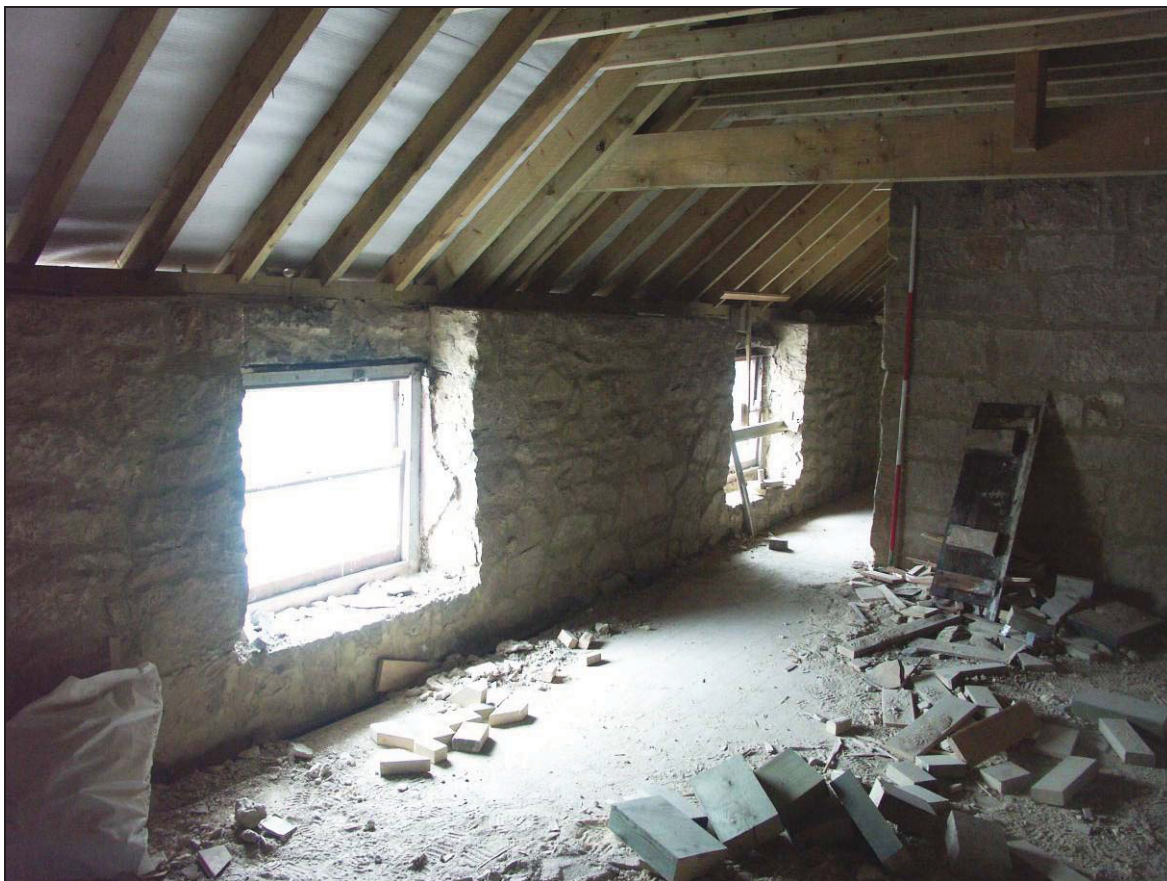
Figure 33: Room S-7, looking east (scale 2m)

- 4.33 Room S-7 is similar to F-7 below however without fire place. There is a chimney breast is situated on the north-east corner of the room which extends up to the roof. The new truss and the slot in the east/west wall which accommodates the tie-beam of the truss are present (Fig. 33).

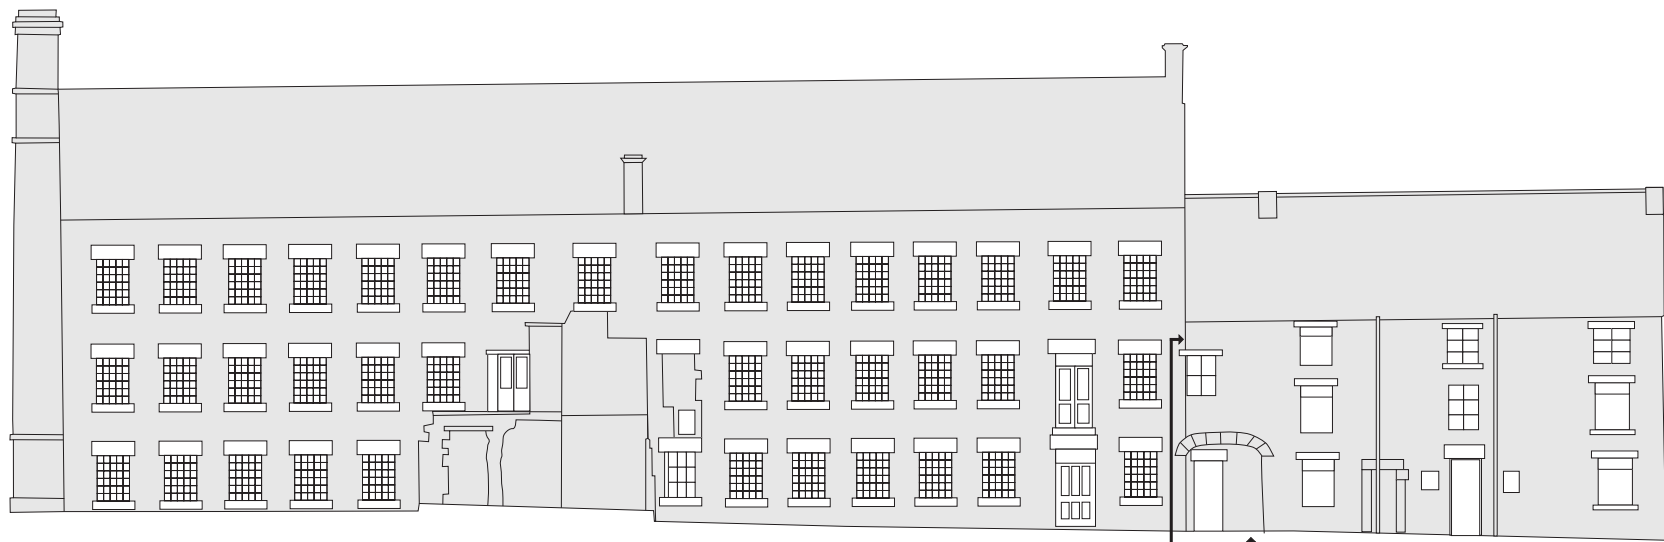
North East Elevation

Jagged joint of later mill
incorporating earlier building
(current Manager's House)
