# An Archaeological Building Recording of Annstead Farm, Chathill, Northumberland

**ARS Ltd Report No. 2011/30**  
March 2011

**An Archaeological Building Recording  
of Annstead Farm, Chathill, Northumberland**

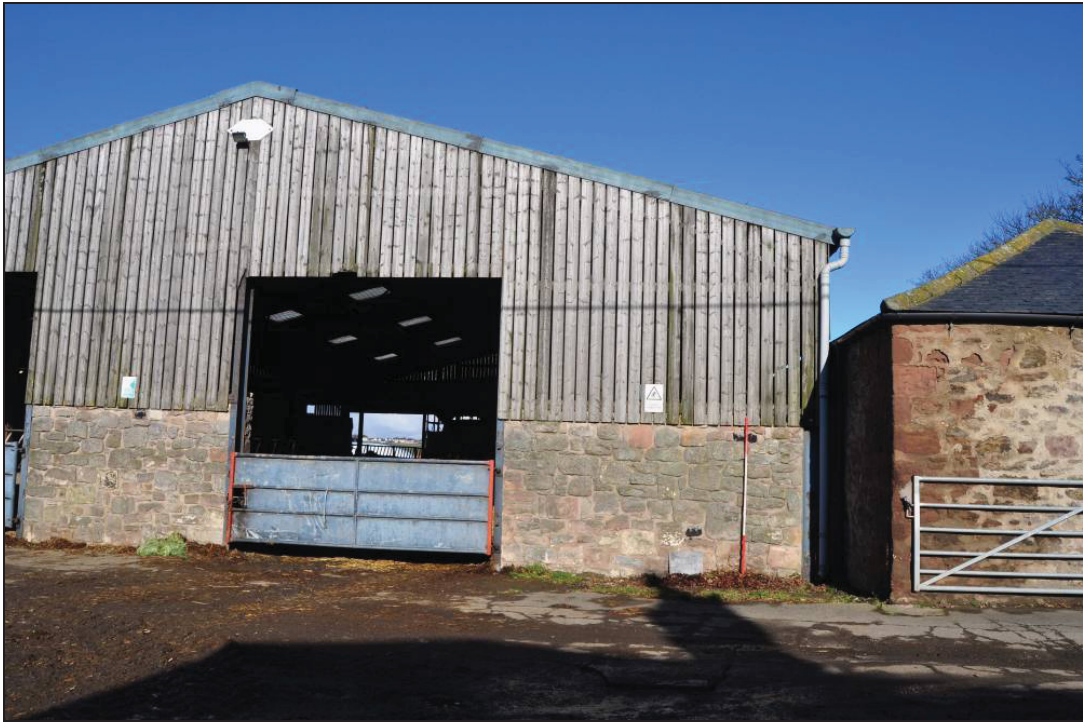
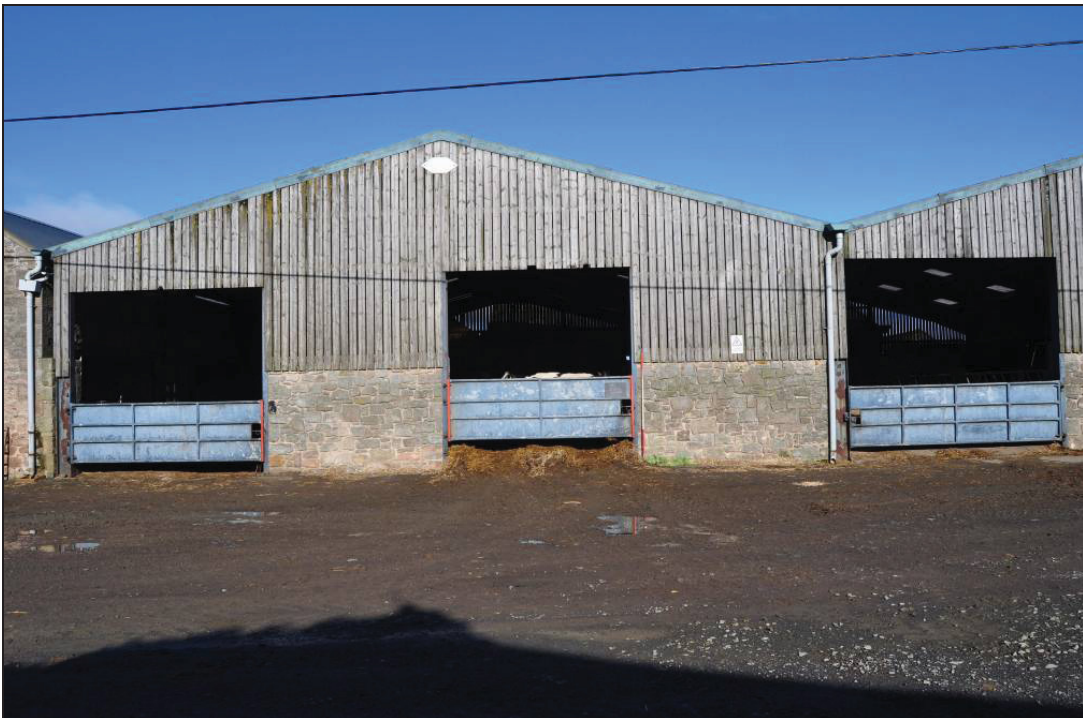
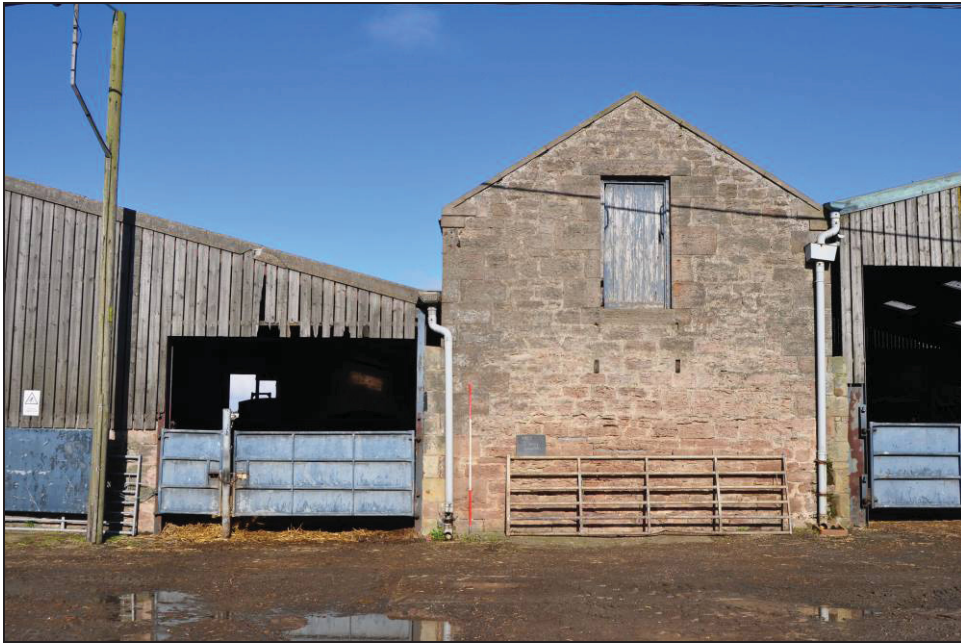
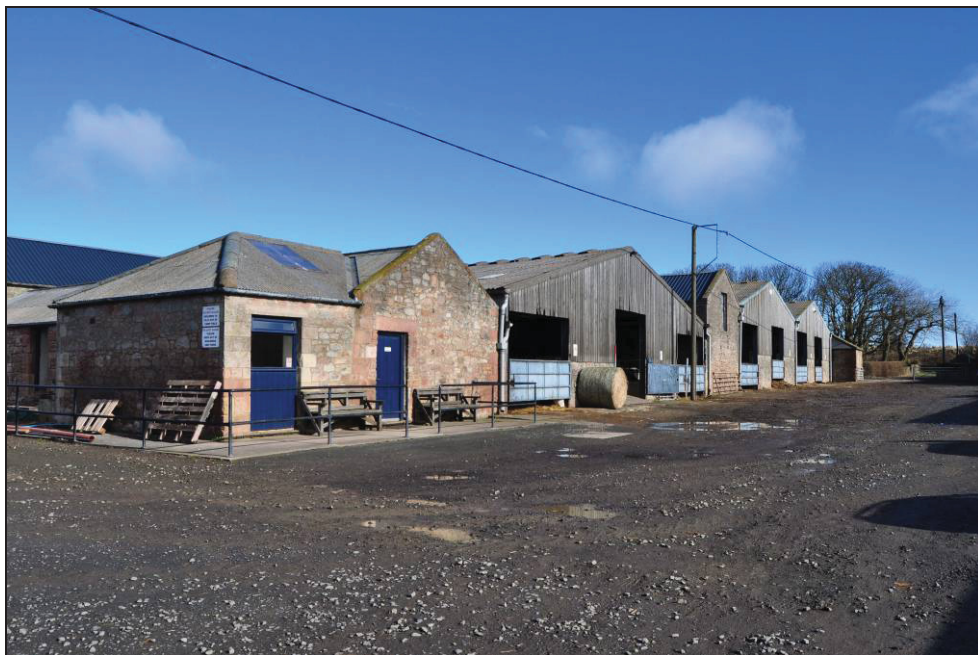
- 4.2. *External southeast facing elevation (Figs 5 – 8)*  
This elevation mainly consists of a modern barn frontage. A low course is topped by a wood panelled frontage up to a corrugated roof. There are seven openings into the various inner sections of the barn, these are closed via a modern gate. Centrally to this elevation is one of the original barn elevations. The masonry frontage of this elevation has a central floating doorway to the first floor, framed by large blocks. This section of building is of a typical mid 19<sup>th</sup> century design, giving a range of barns in an 'E' shape, in plan. The sandstone is more weathered than the rest of the barn.

Figure 5. Southeast facing external elevation

Figure 6. Southeast facing external elevation

Figure 7. Southeast facing external elevation

Figure 8. Southeast facing external elevation

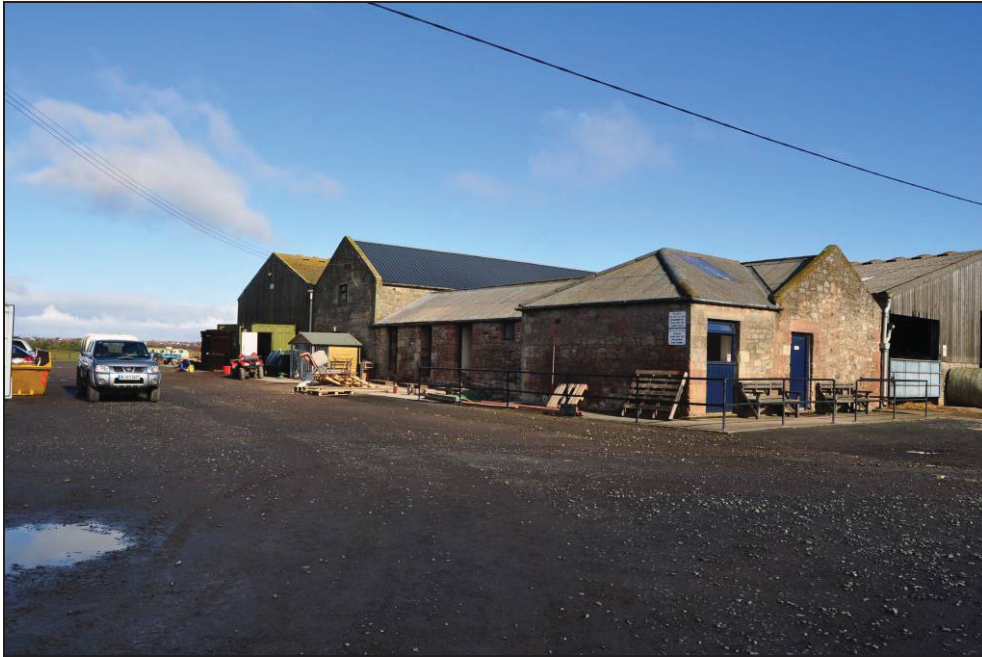
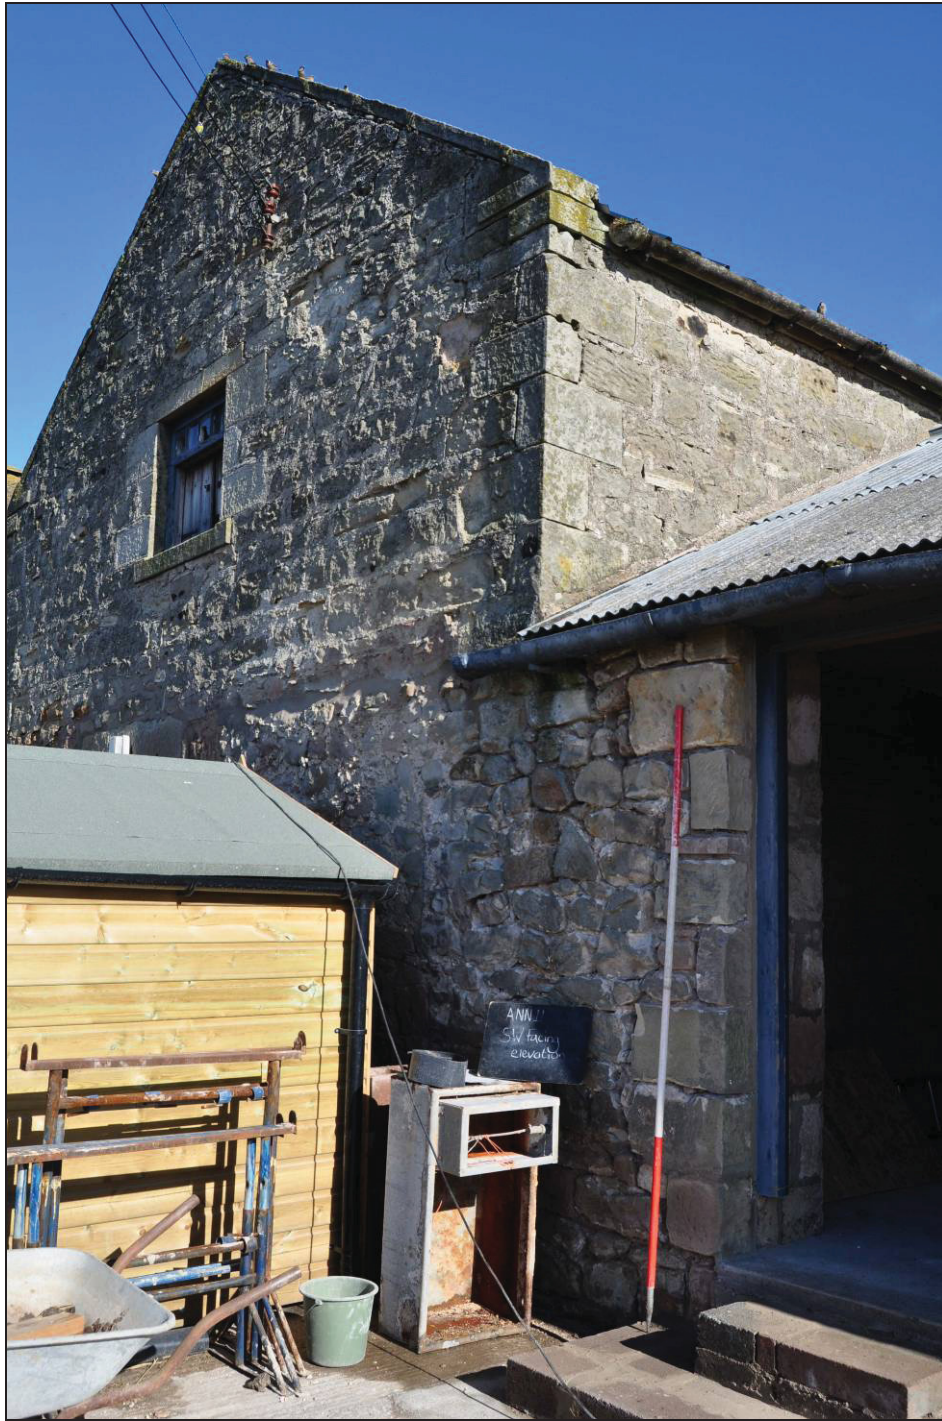
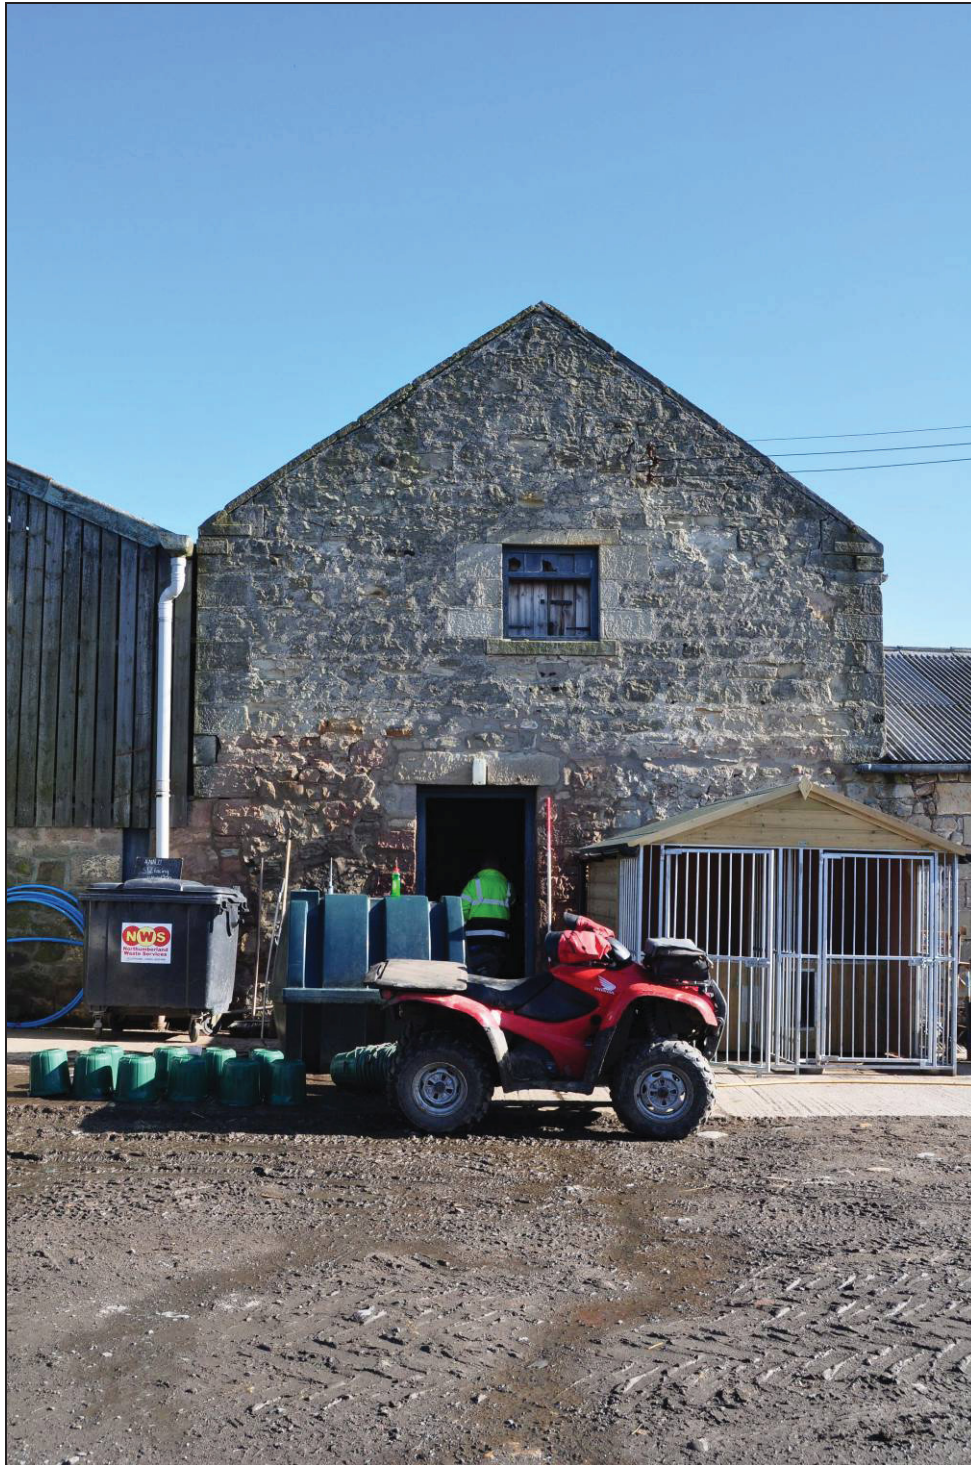
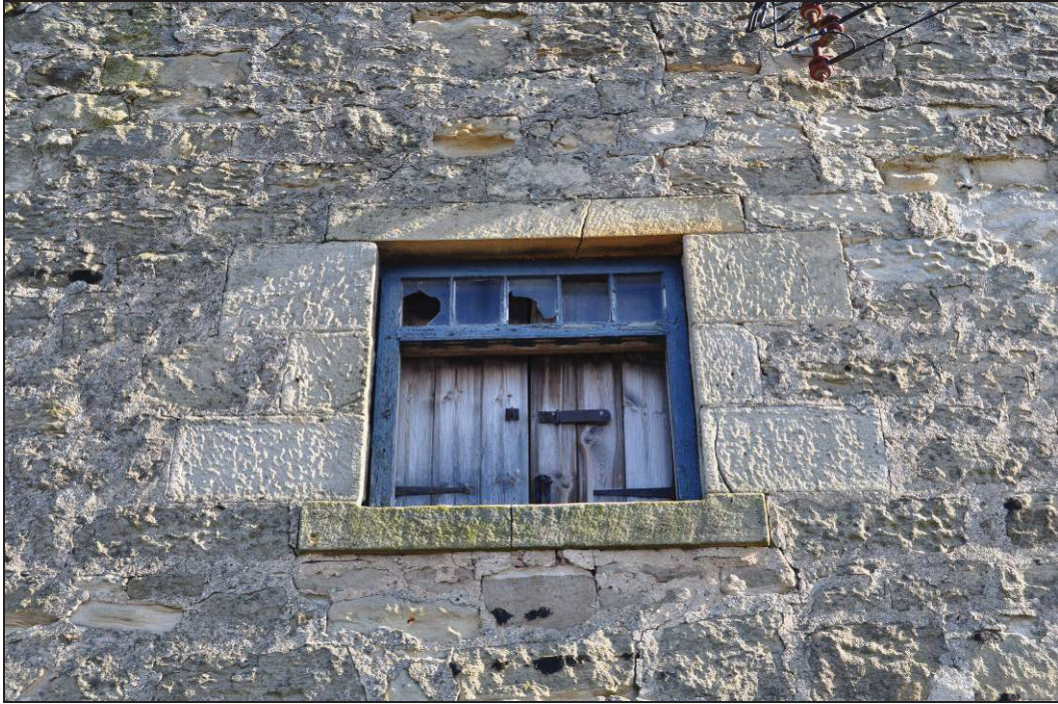
- 4.3. *External southwest facing elevation (Figs 9 – 12)*  
This range of buildings is original to the barn complex. The central section of the elevation is a two storied elevation, with an original doorway to the ground floor and a single original window to the first floor. The building to the southeast of this section was not required for study, and the building to the northeast consists of a modern wood panelled barn.

Figure 9. Southeast facing external elevation

Figure 10. Southeast facing external elevation

Figure 11. Southeast facing external elevation

Figure 12. Southeast facing external elevation

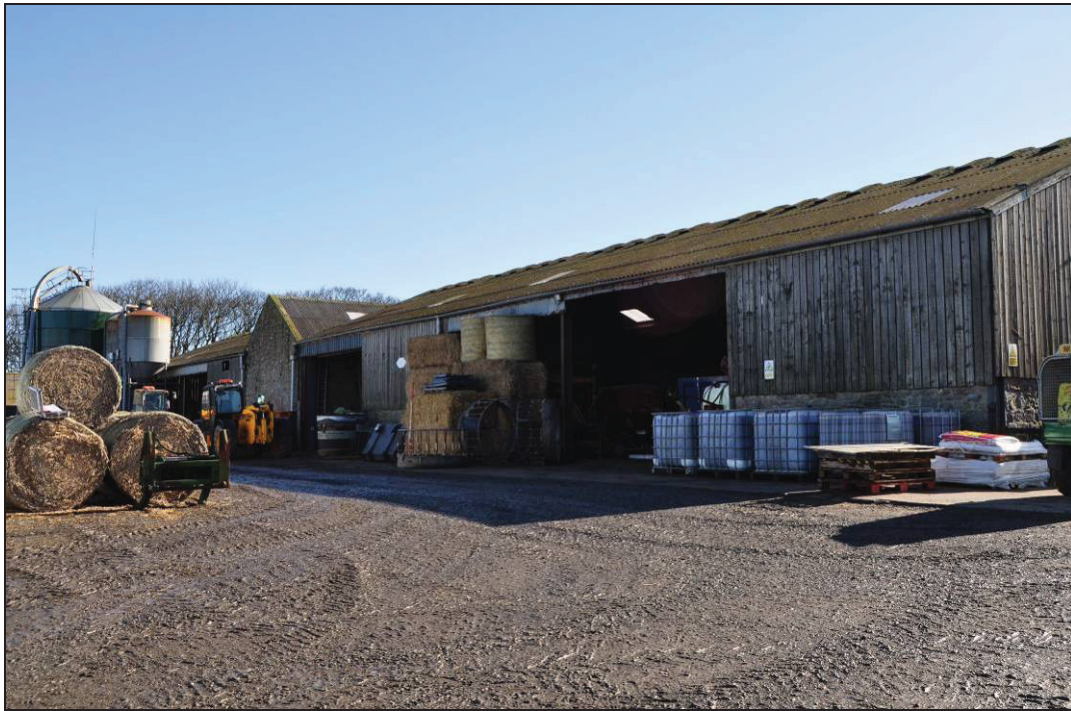
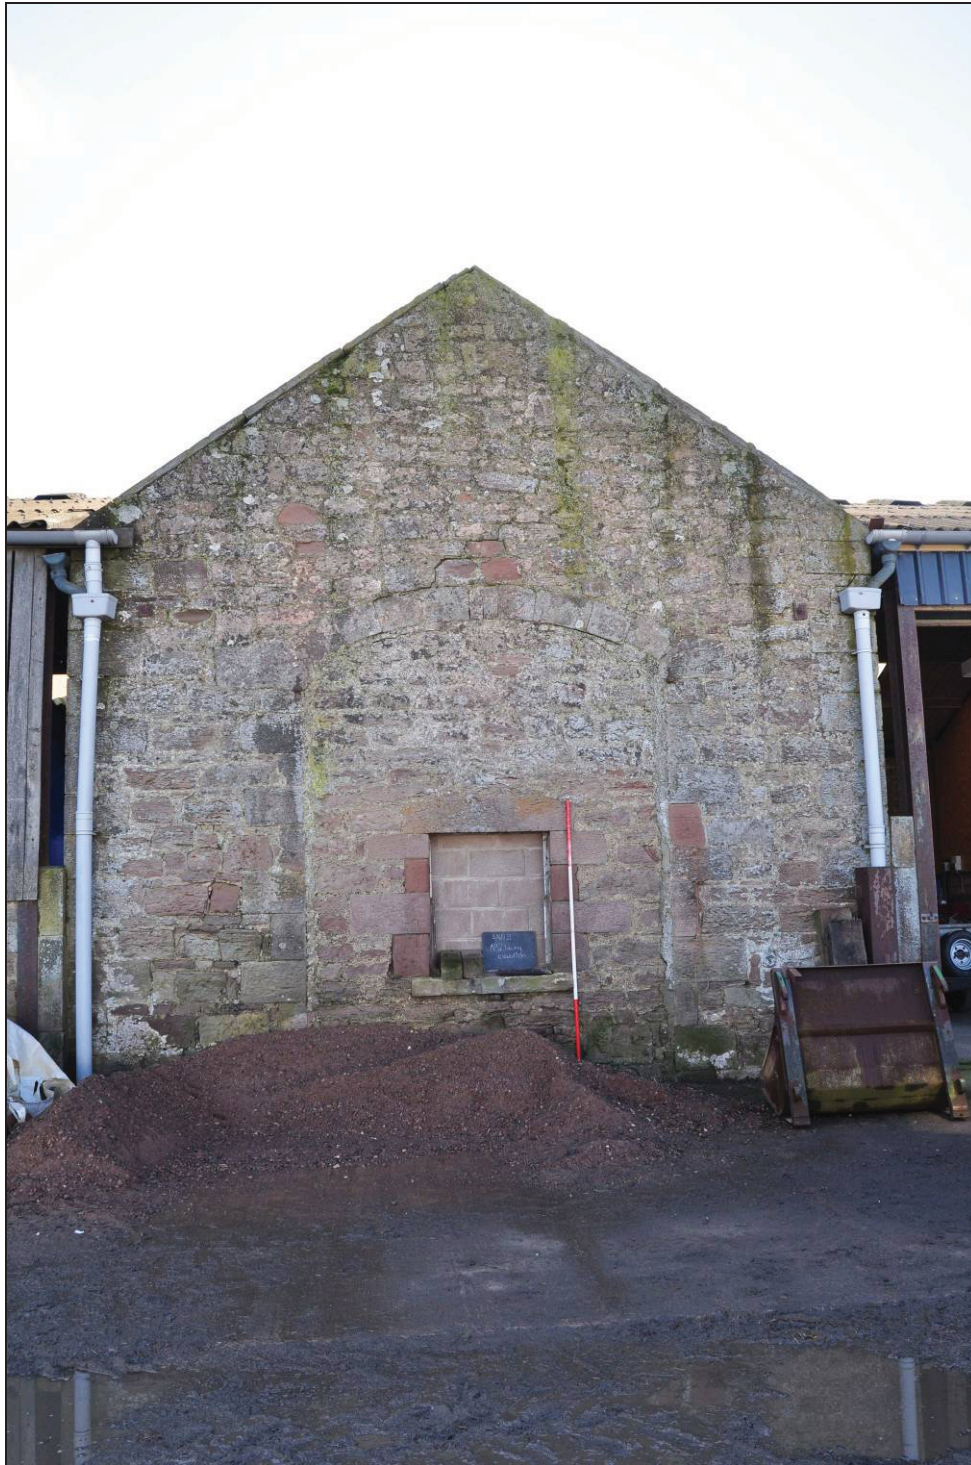
- 4.4. *External northwest facing elevation (Figs 13 – 14)*  
This elevation carries the same architectural design as the southeast facing elevation, in that a low masonry course is topped by the wood panelled barn structure. There are three openings across its length, and like the southwest facing elevation, an older, original part of the mid 19<sup>th</sup> century build exists. The masonry wall is broken up on the first floor by a large sandstone arch, the opening of which had been blocked off. Below this arch is a window which has been inserted into the blocked off arch, and also been blocked off at a later date.

Figure 13. Northeast facing external elevation

Figure 14. Southeast facing external elevation

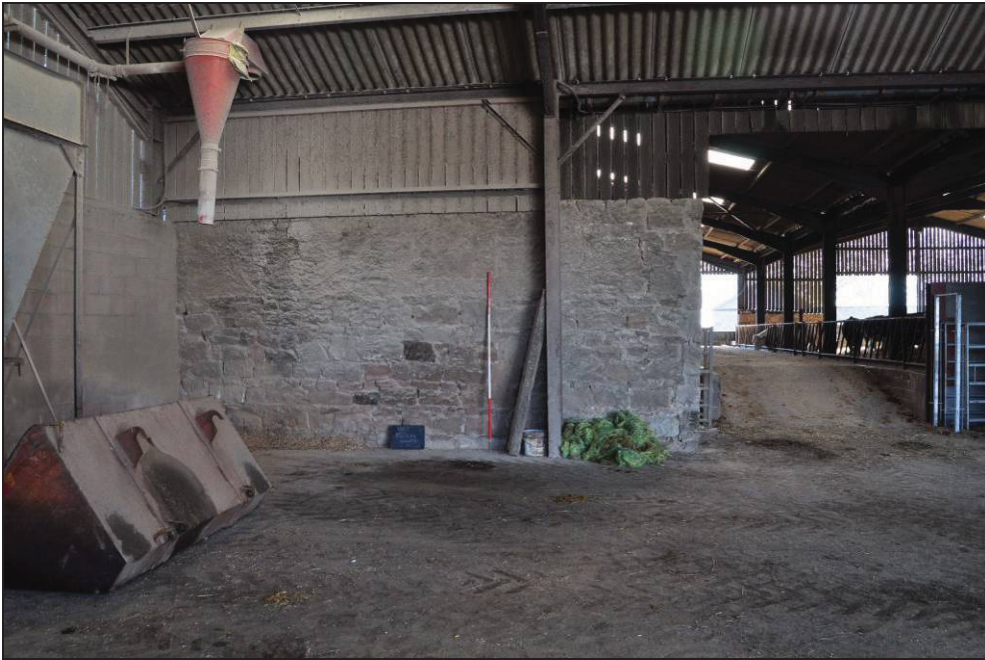
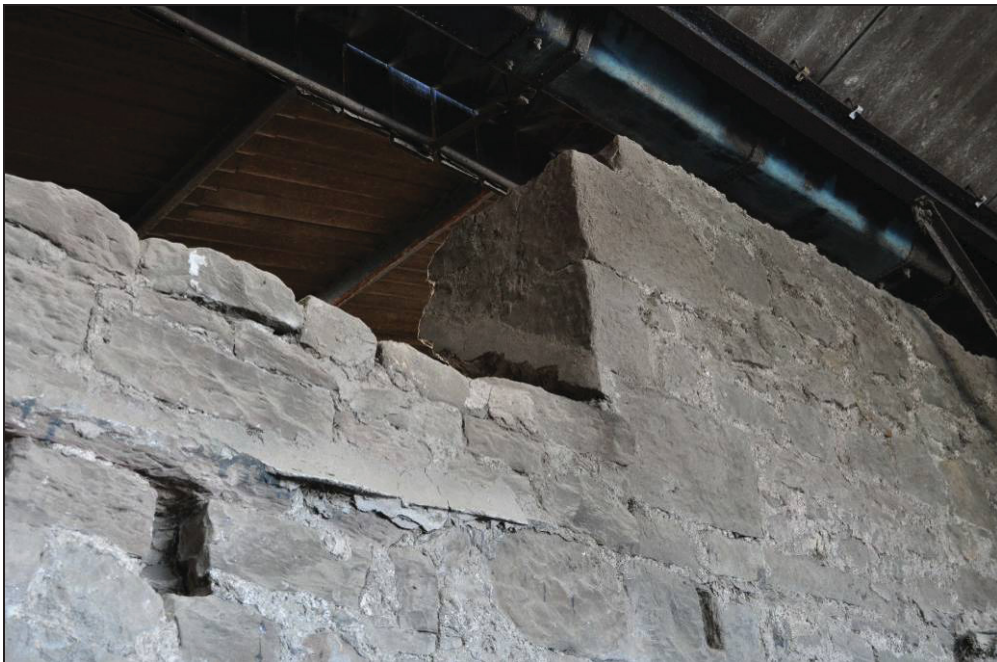
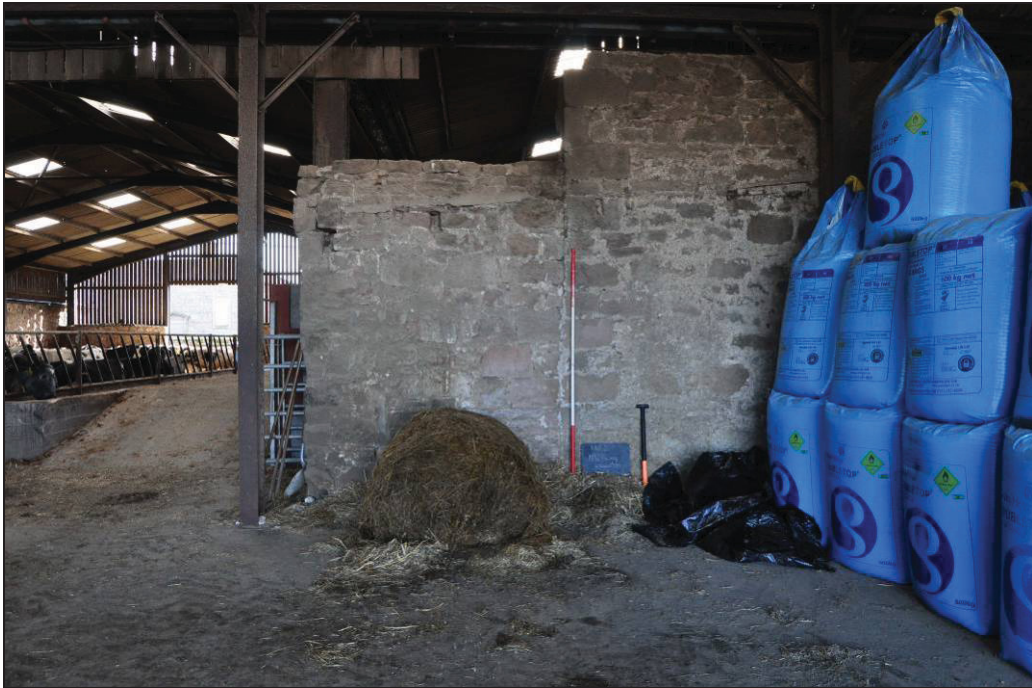
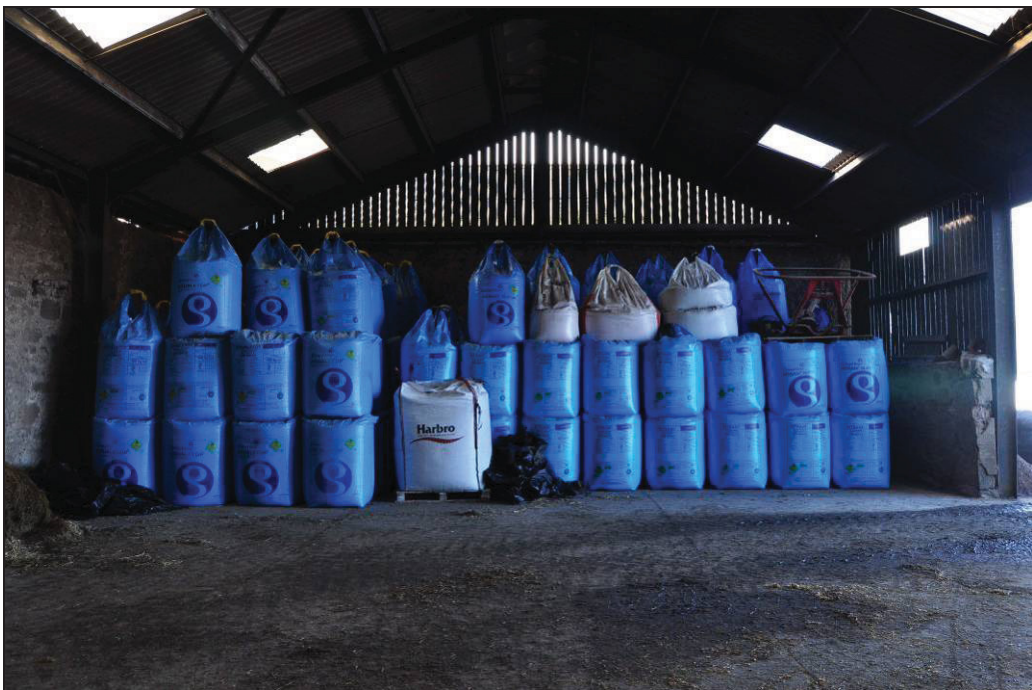
- 4.7. *Room 3 (Figs 15 – 18)*  
This room is situated to the northwest of Room 3. The northwest elevations are modern, supporting the barn roof. Reflecting Room 1, the southeast partitioning wall shows evidence of modification around the opening between rooms. There is also evidence on the higher portion of wall which indicates the original roof level. There is a trace line of another former roof level protruding from the north west of this wall, but no other traces of this structure exist.

Figure 15. Room 3

Figure 16. Room 3

Figure 17. Room 3

Figure 18. Room 3
