# An Archaeological Building Recording of Annstead Farm, Chathill, Northumberland

**ARS Ltd Report No. 2011/30**  
March 2011

**An Archaeological Building Recording  
of Annstead Farm, Chathill, Northumberland**

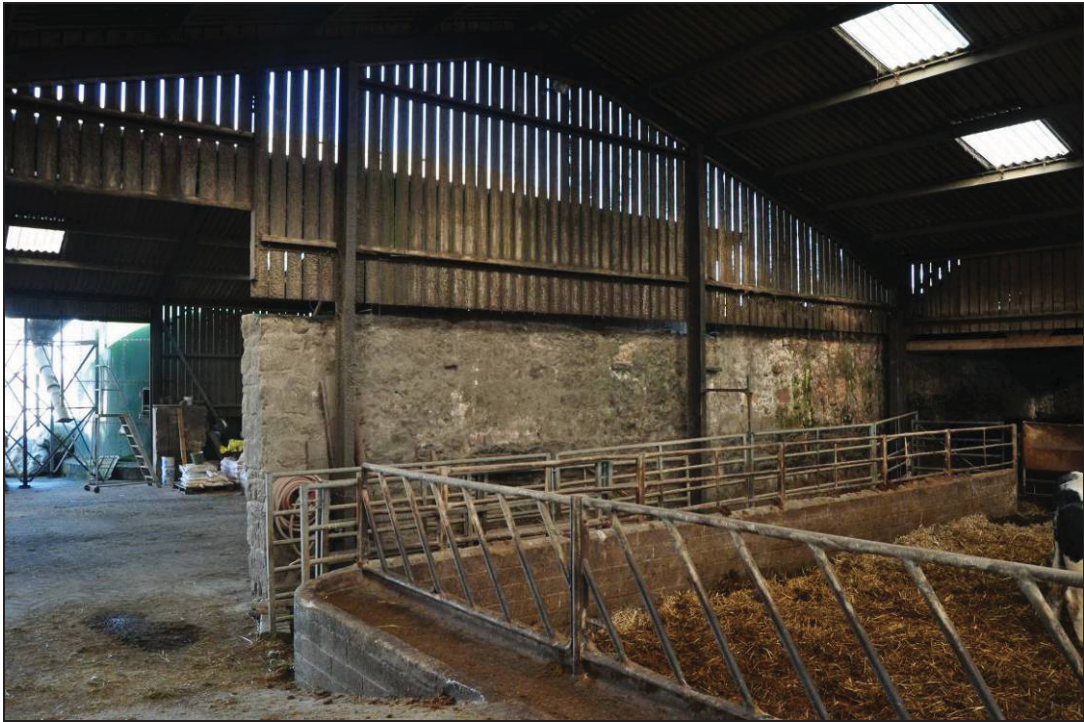
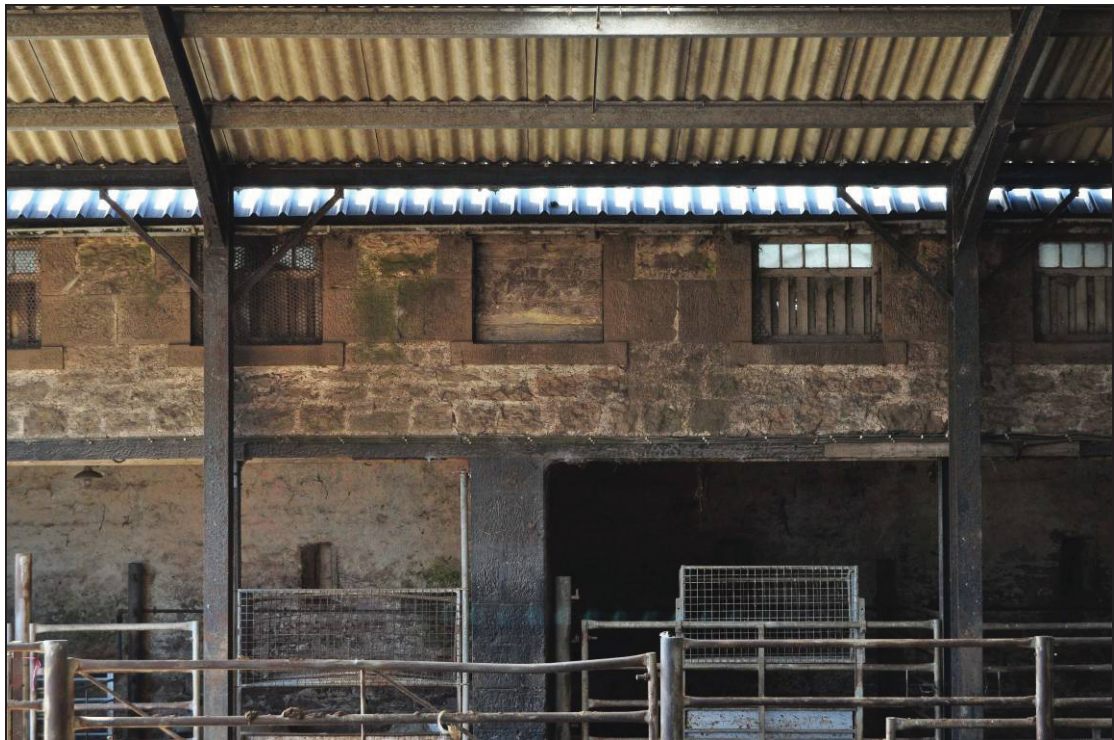
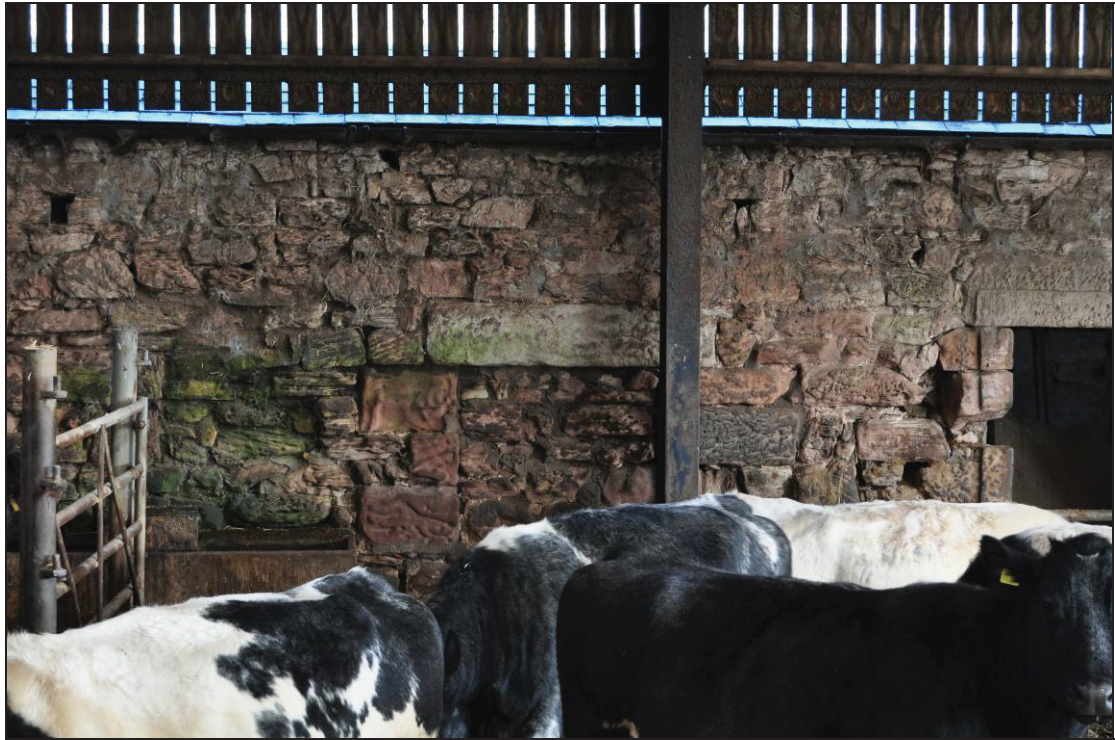
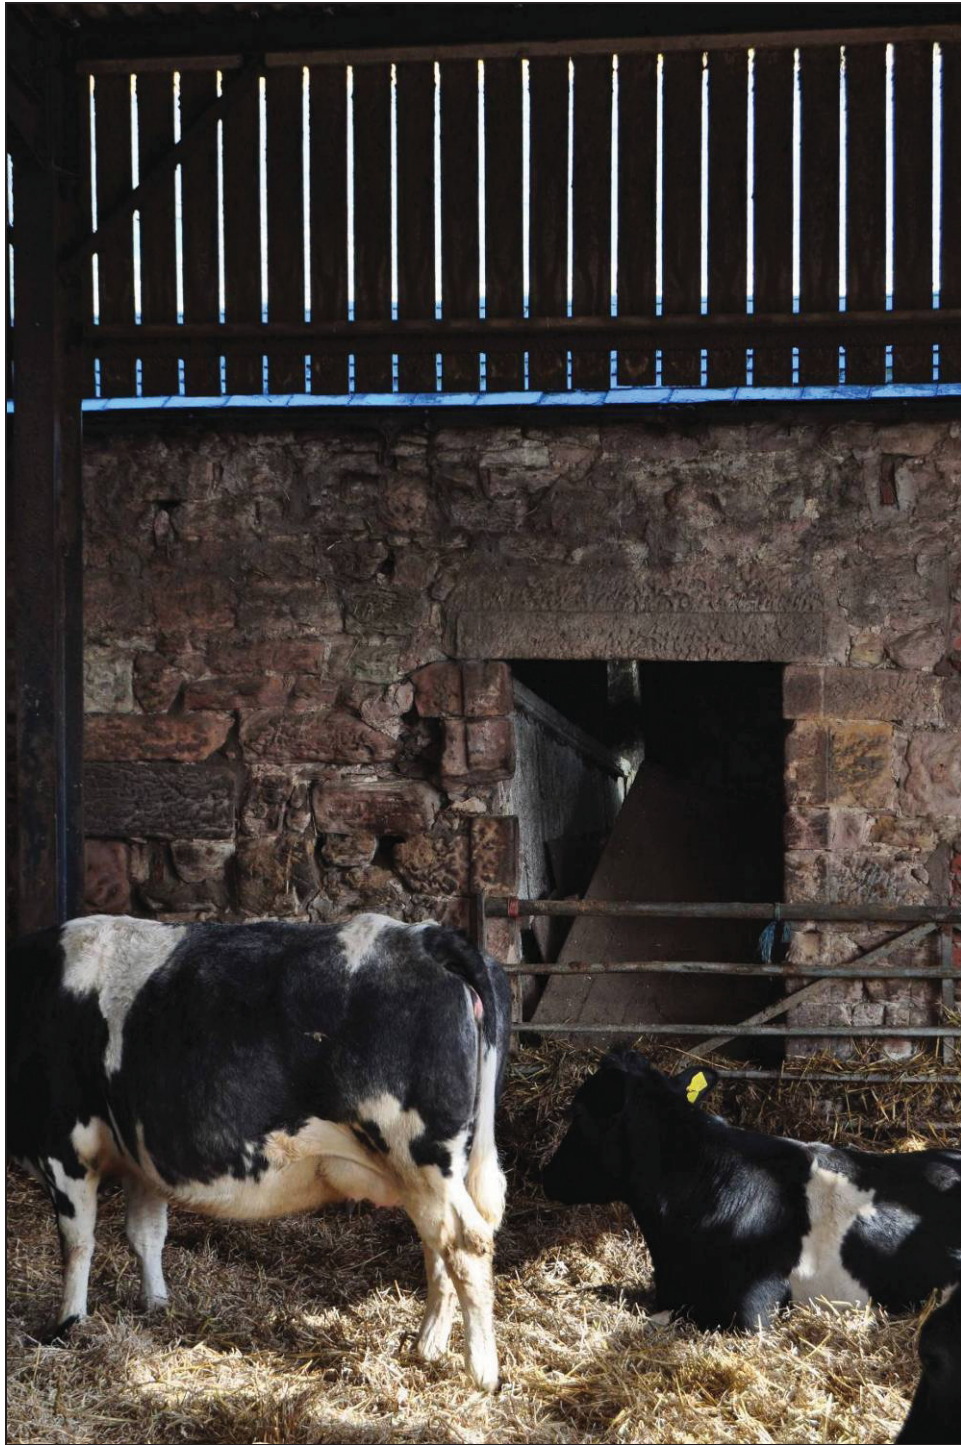
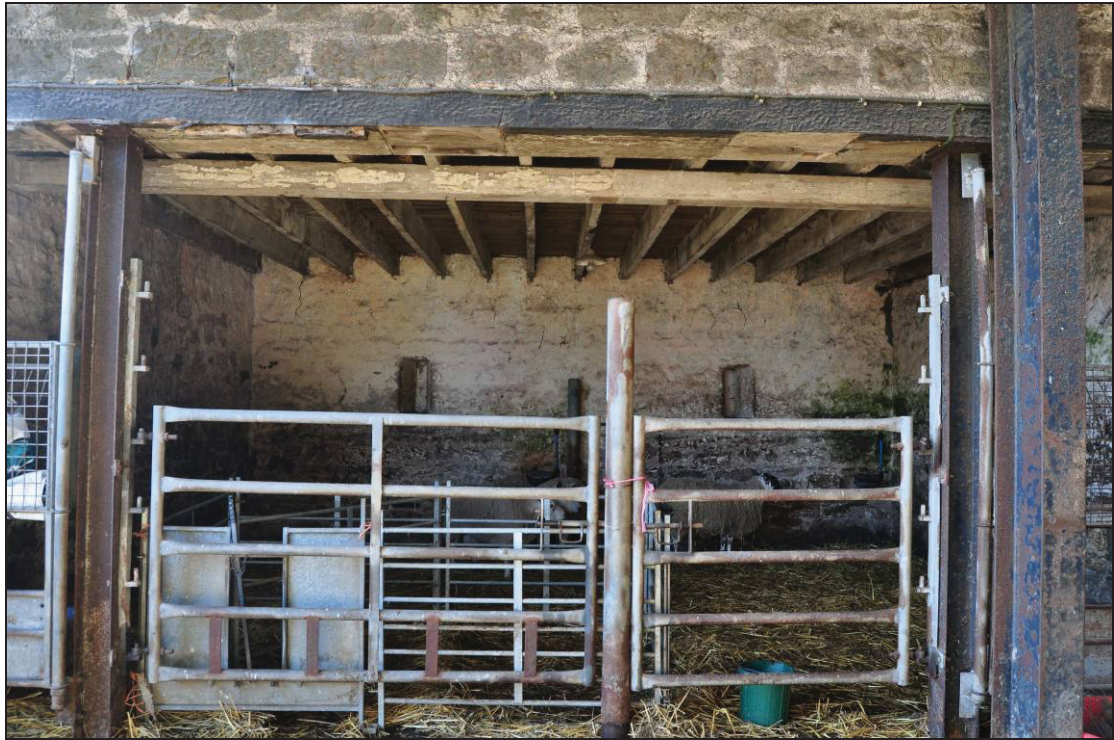
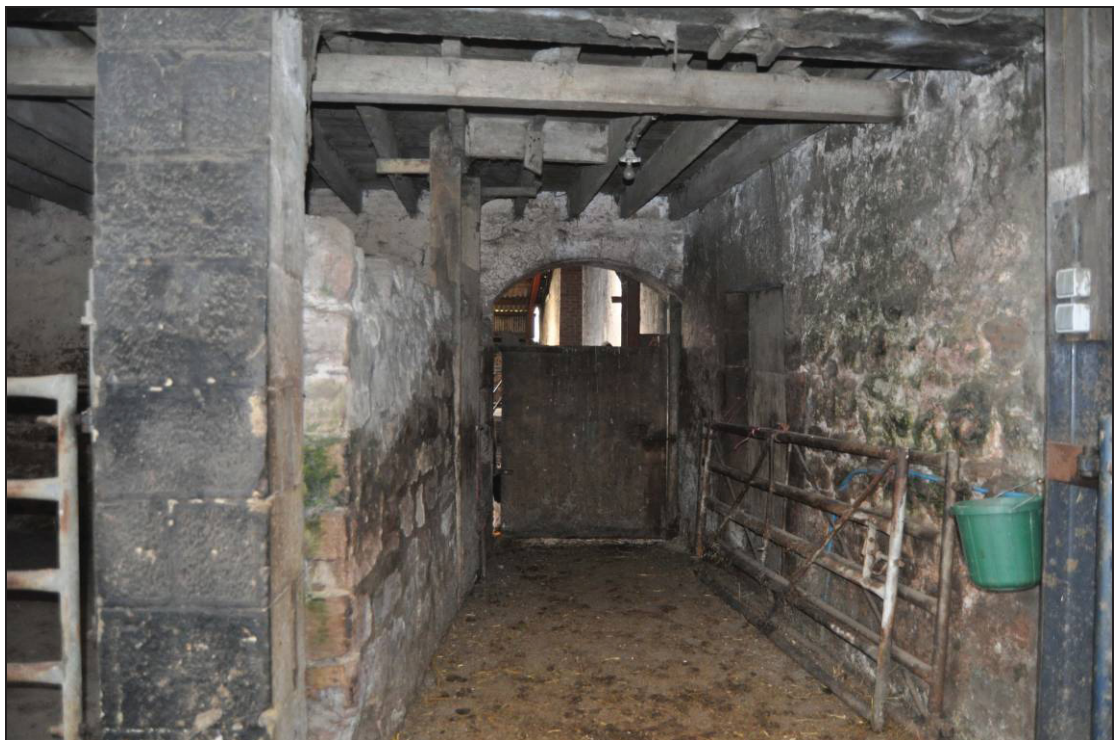
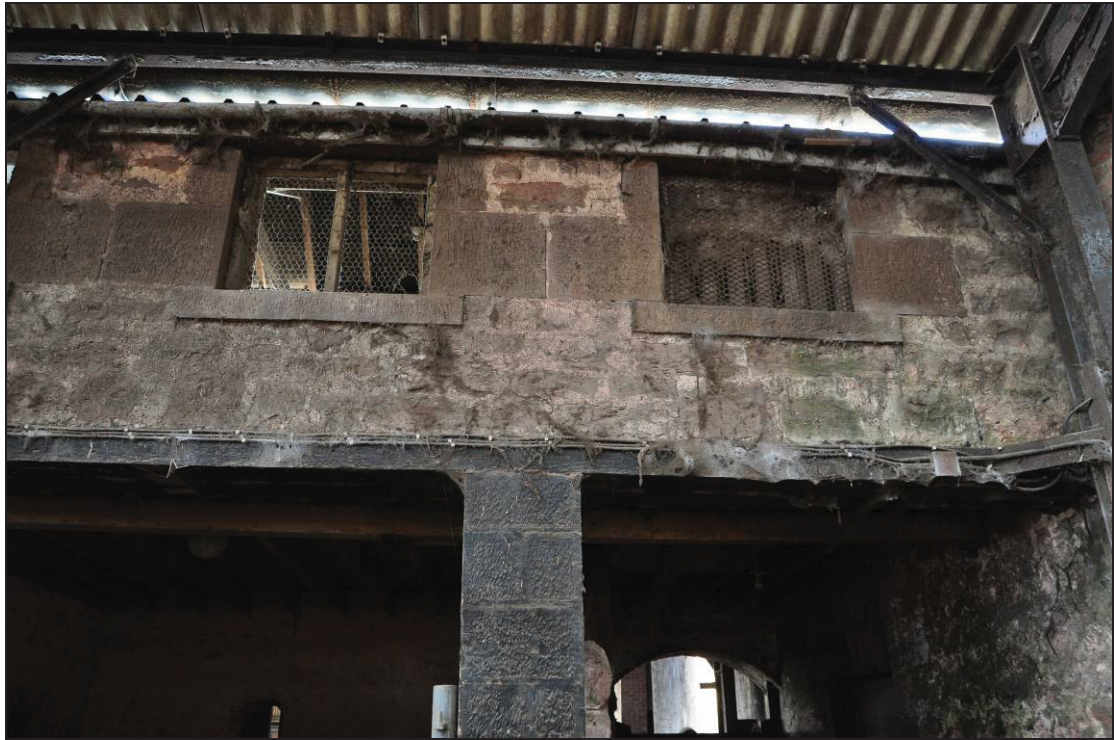
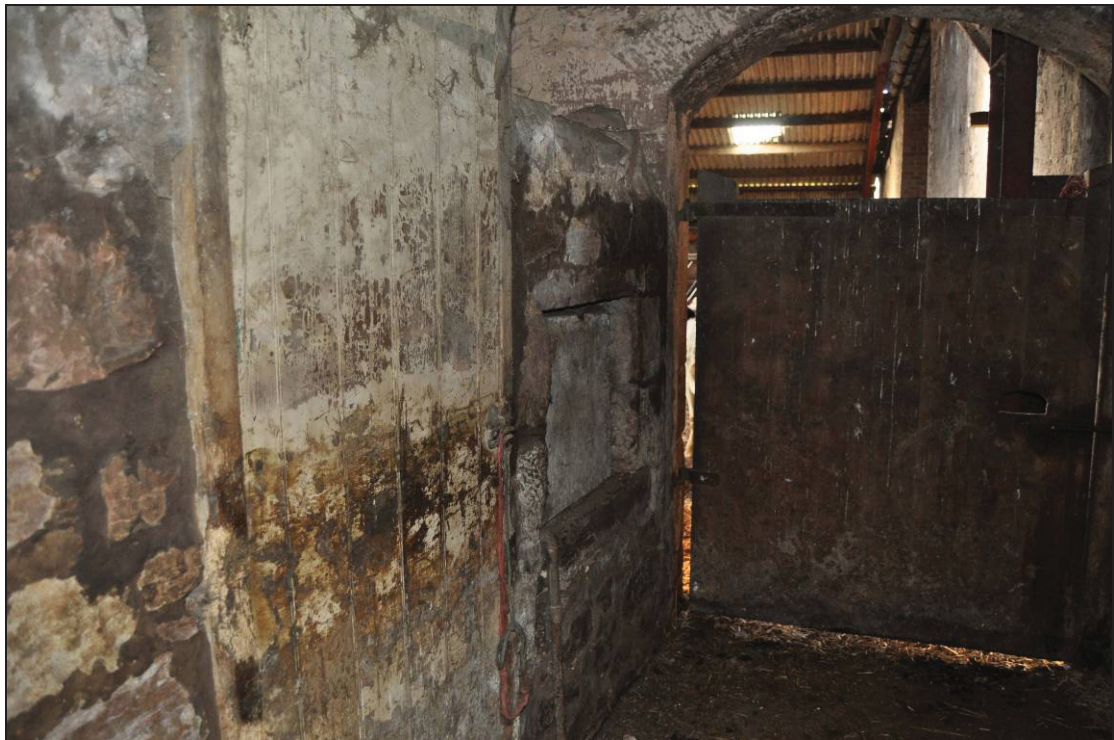
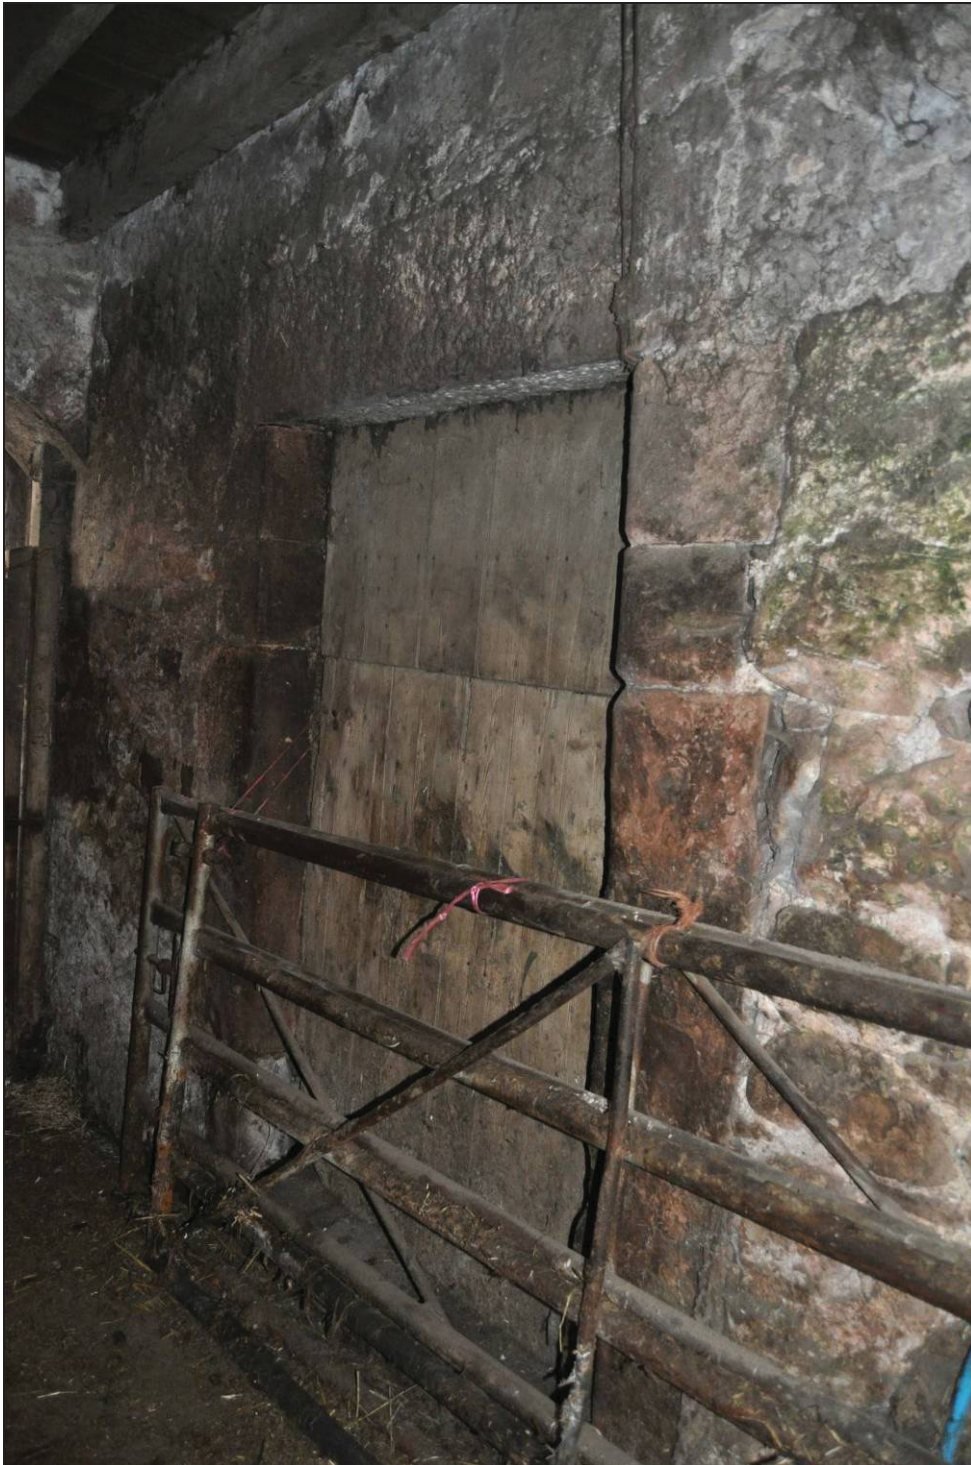
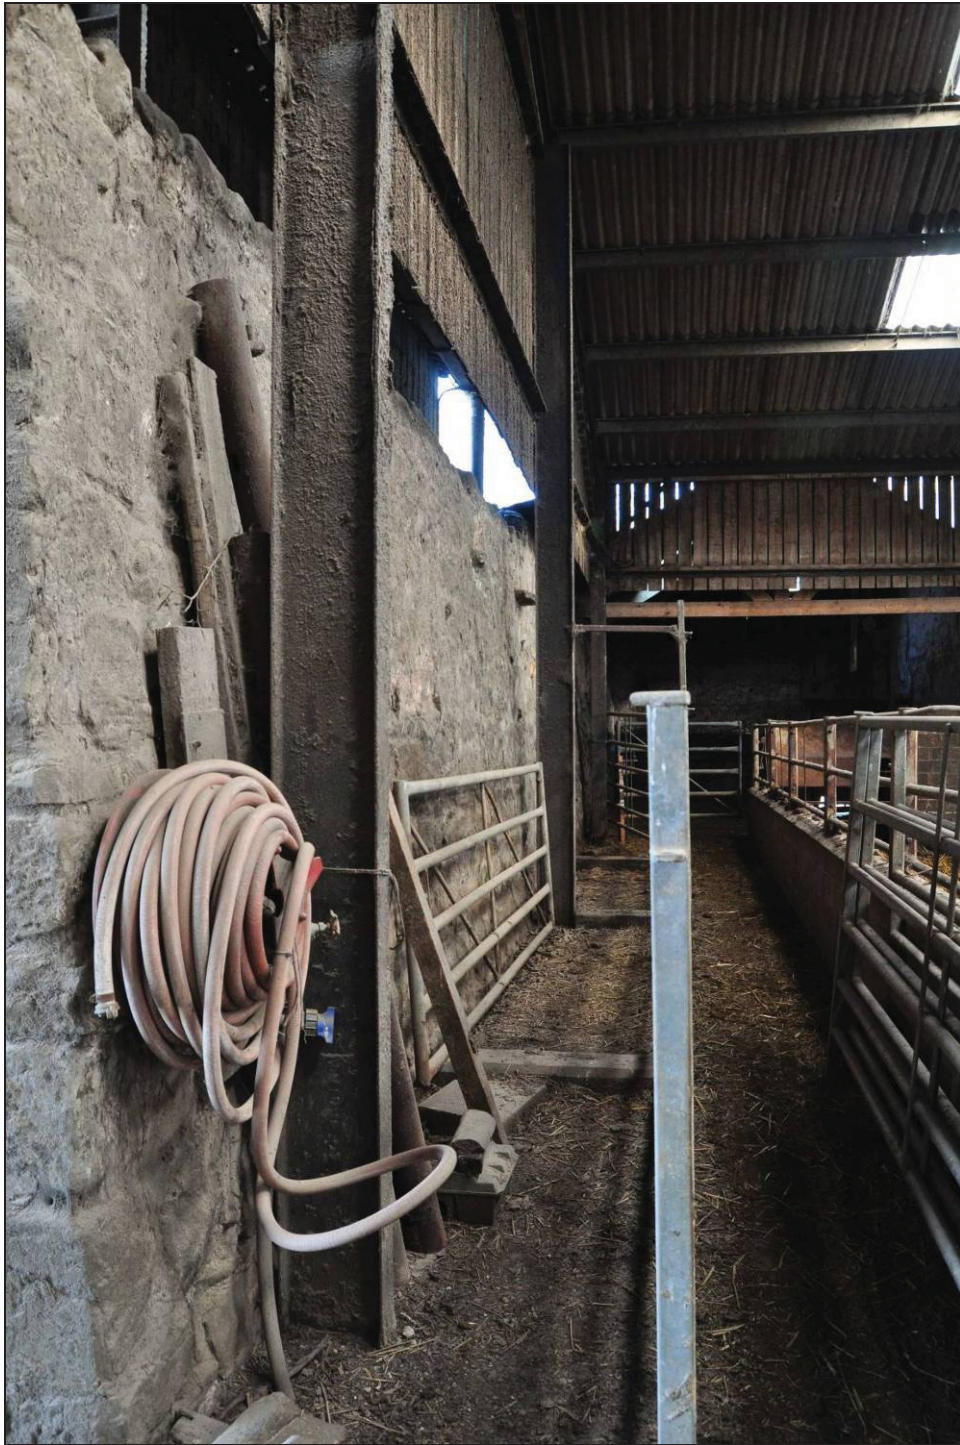
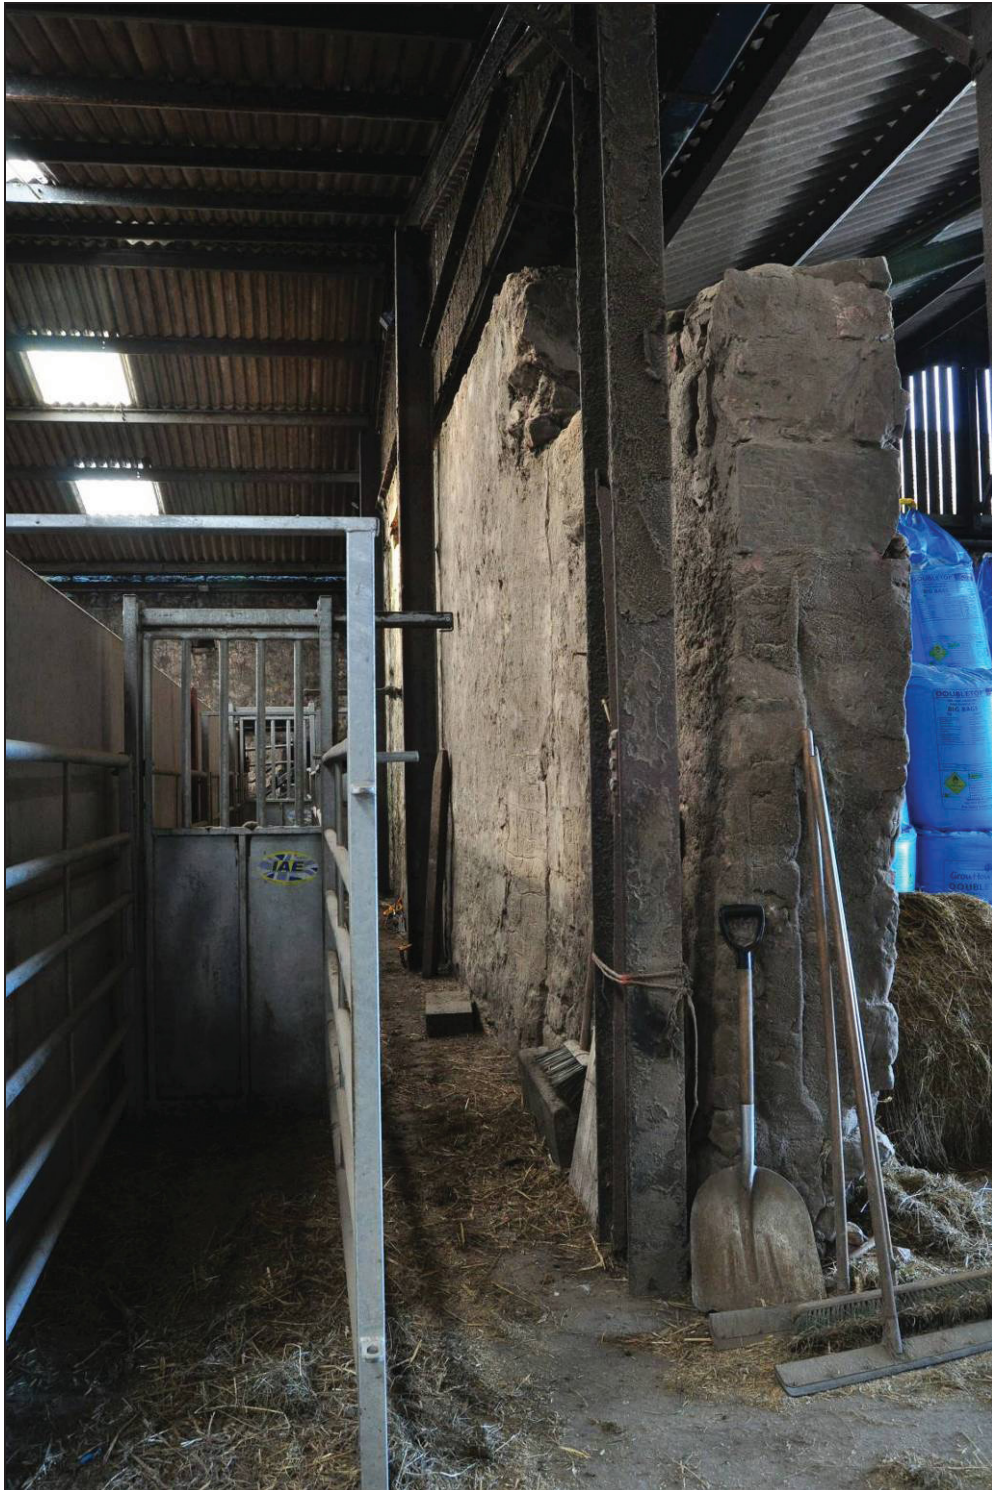
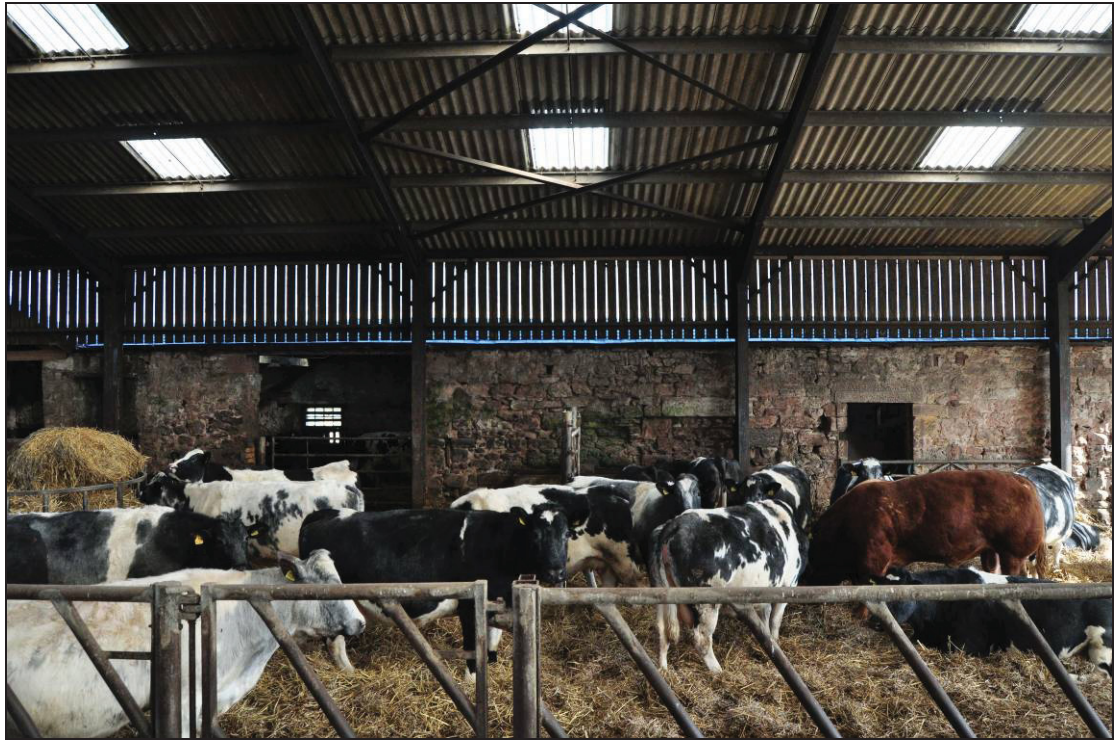
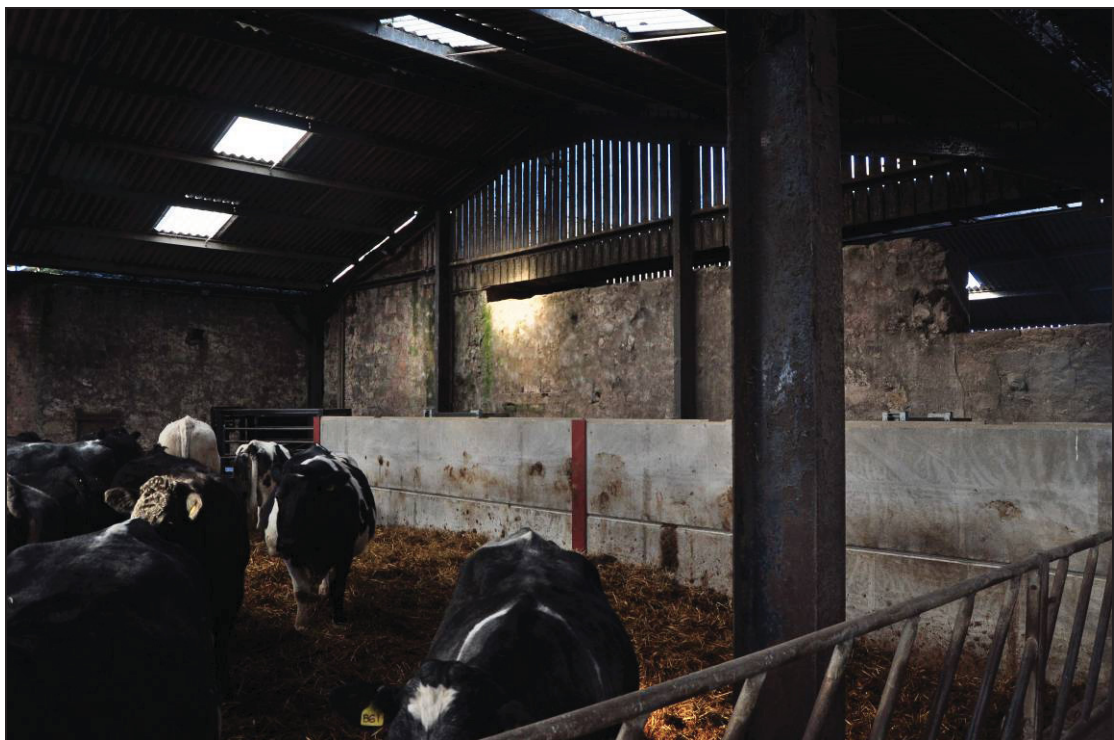
- 4.5. *Room 1 (Figs 19 – 31)*  
The southeast elevation of this room comprises of the modern built up area of the barn as seen from the external elevations. The northeast elevation consists of a single storied elevation, original to the farm complex. The construction style matched that of the other original parts of the building, and is built in the same rubble masonry style. A series of openings exist along its length including a doorway, and two blocked off windows, each framed in sandstone. The southwest elevation consists of three bays to the ground floor

- 4.5.1. The northwest elevation, formerly one solid wall, has been cut centrally to create an opening into Room 3. This work is evident from the brick work used to reconstruct the wall ends.

Figure 19. Room 1

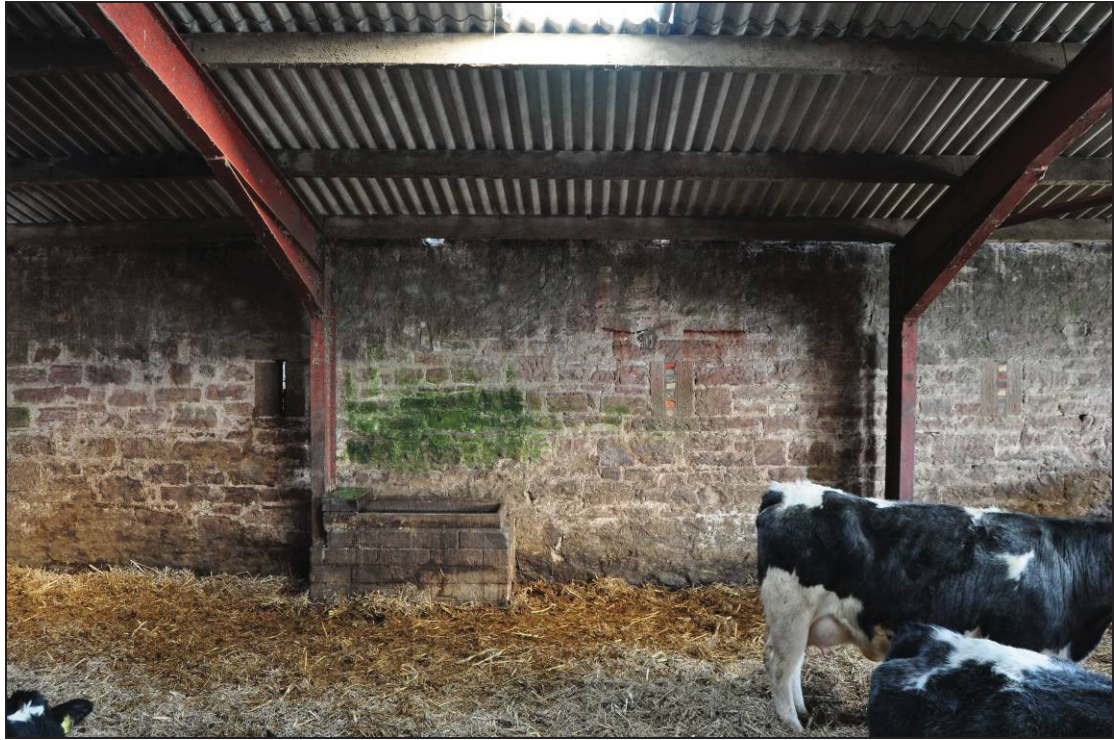
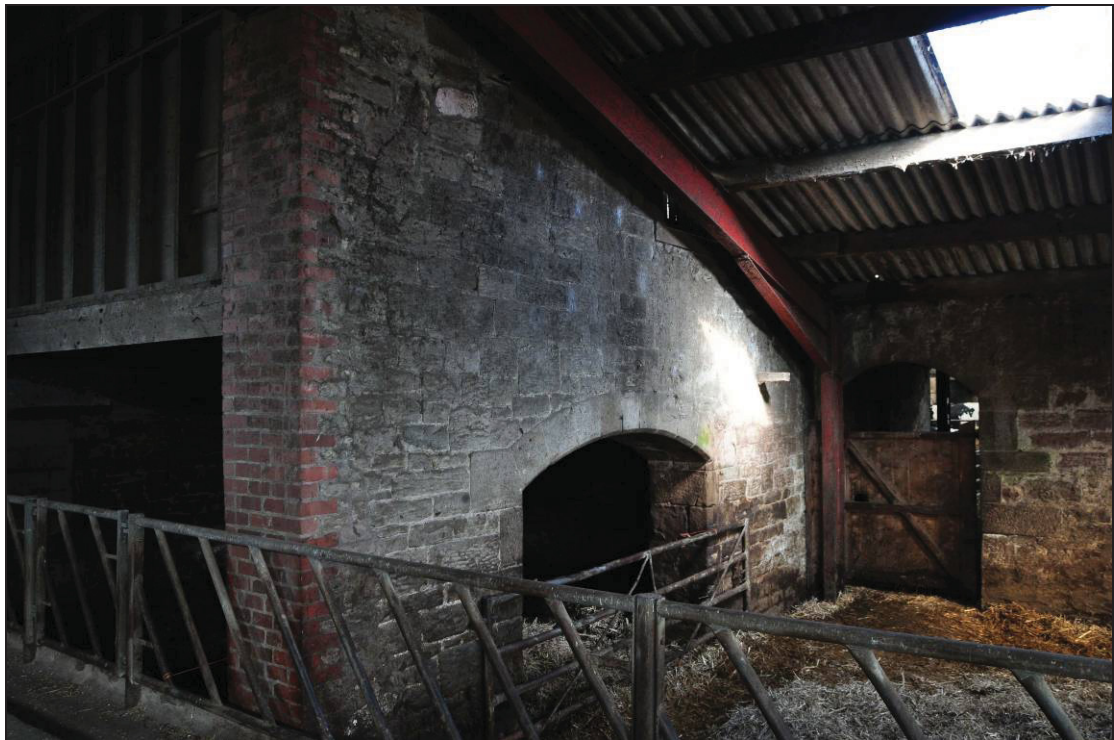
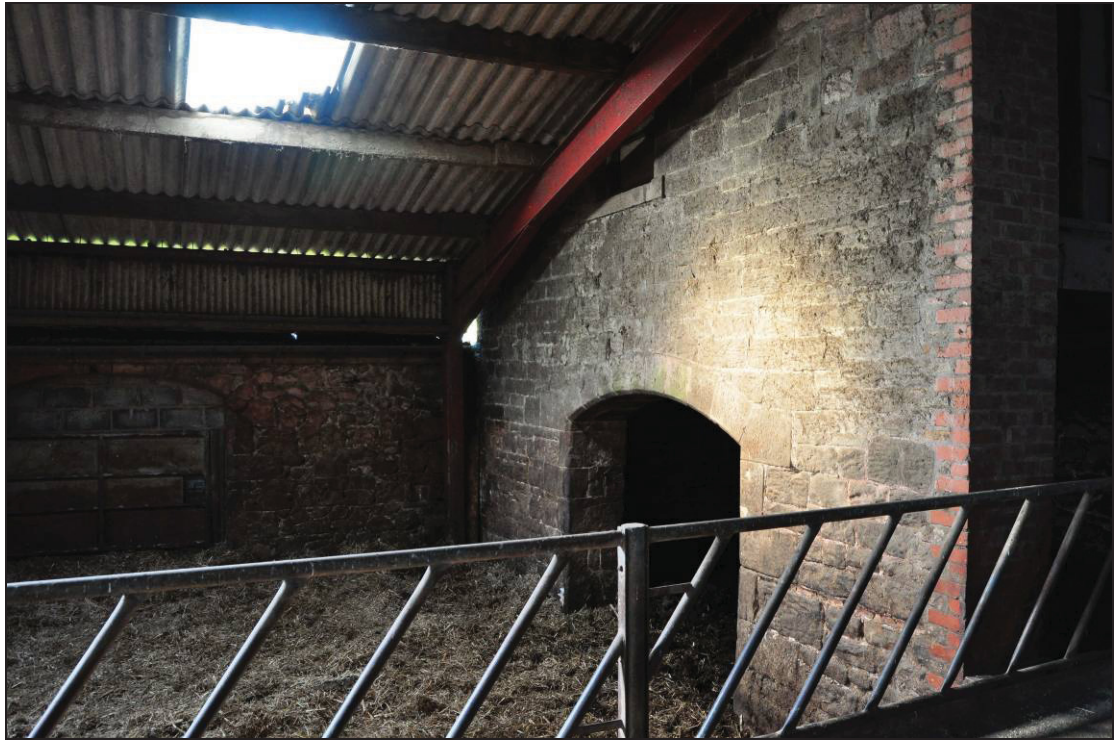
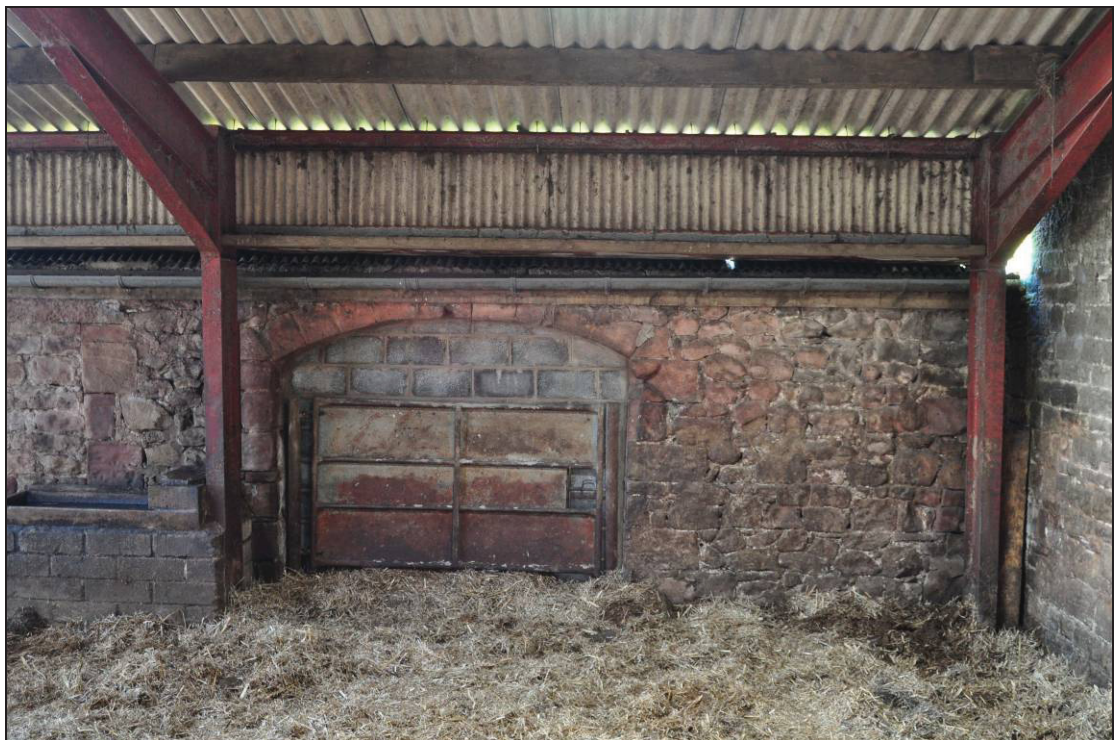
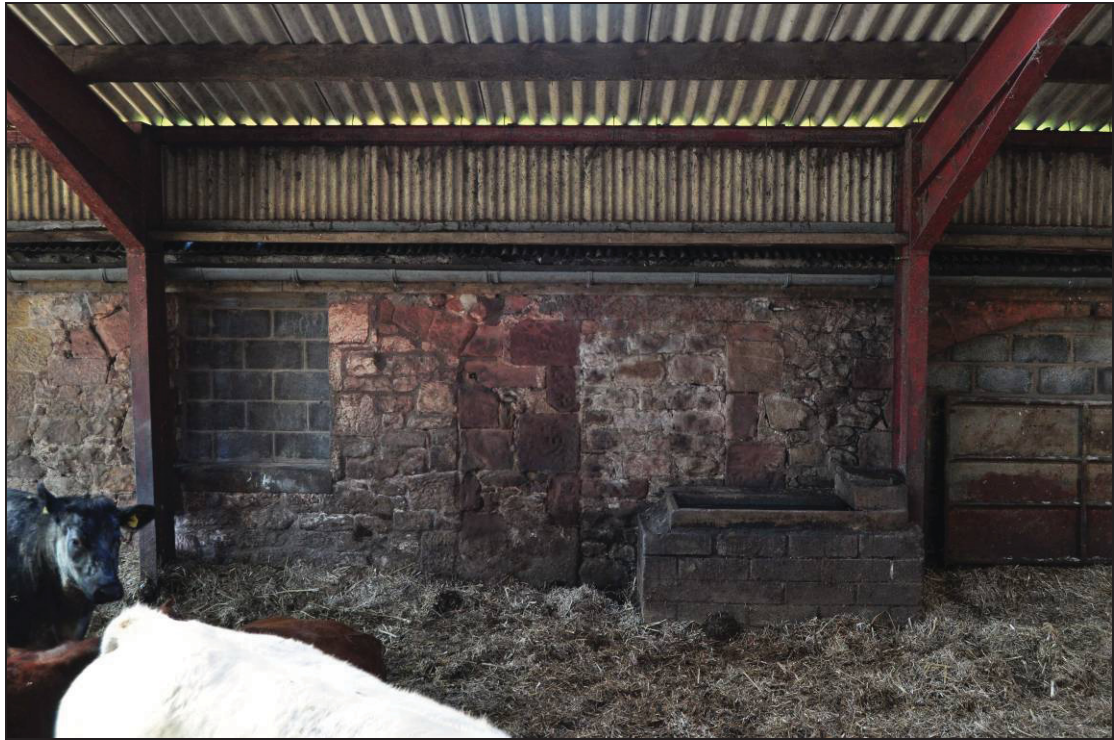
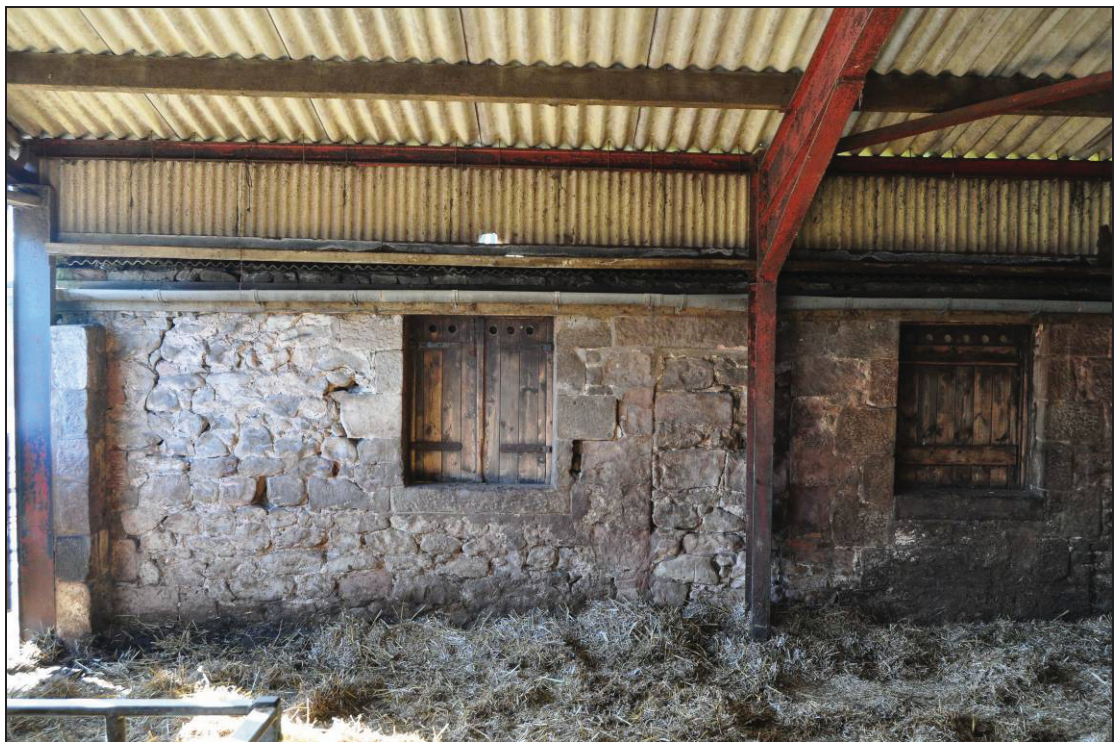
- 4.15. *Room 11 (Figs 32 – 37)*  
This barn was originally an open courtyard area. The northwest elevation consists of two walls, previously one elevation, which is evident from the brick reconstructive work where the central section of wall has been removed to create the opening providing access into Room 12. Either side of this opening there is a sandstone arch which is original to the building. Above each arch, to the first floor, is a window which has been halved by the modern corrugated roof. The northeast elevation has three narrow blocked off lights, which would have looked out from the stalls in Room 1. The southwest elevation consists of two blocked off doorways and 4 blocked of window openings.

Figure 32. Room 11

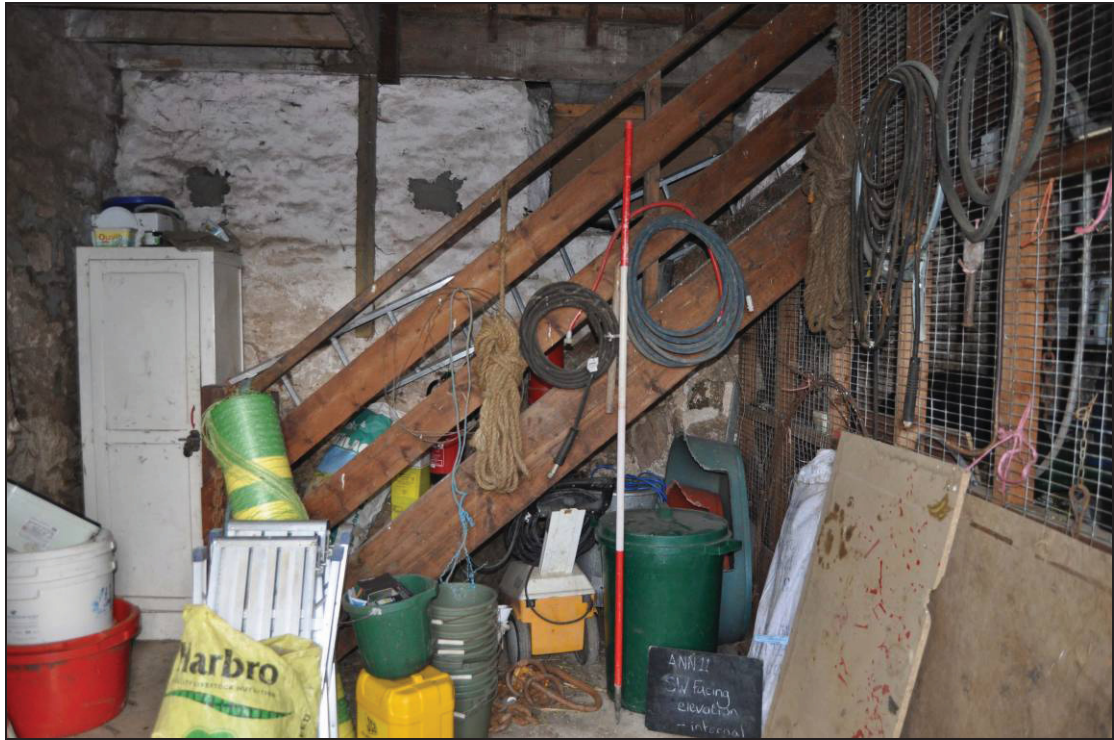
Figure 38. Room 2

- 4.6. *Room 2 (Fig 38)*  
This room serves mainly as a staircase to the first floor loft room. Part of the original barn structure, the room currently holds a chemical store. There is a window to the northeast elevation that has been blocked off. The doorway to the southwest elevation has a modern wooden lintel inserted above it, although the exterior retains the original sandstone. The stone work mimics the style of the exterior.

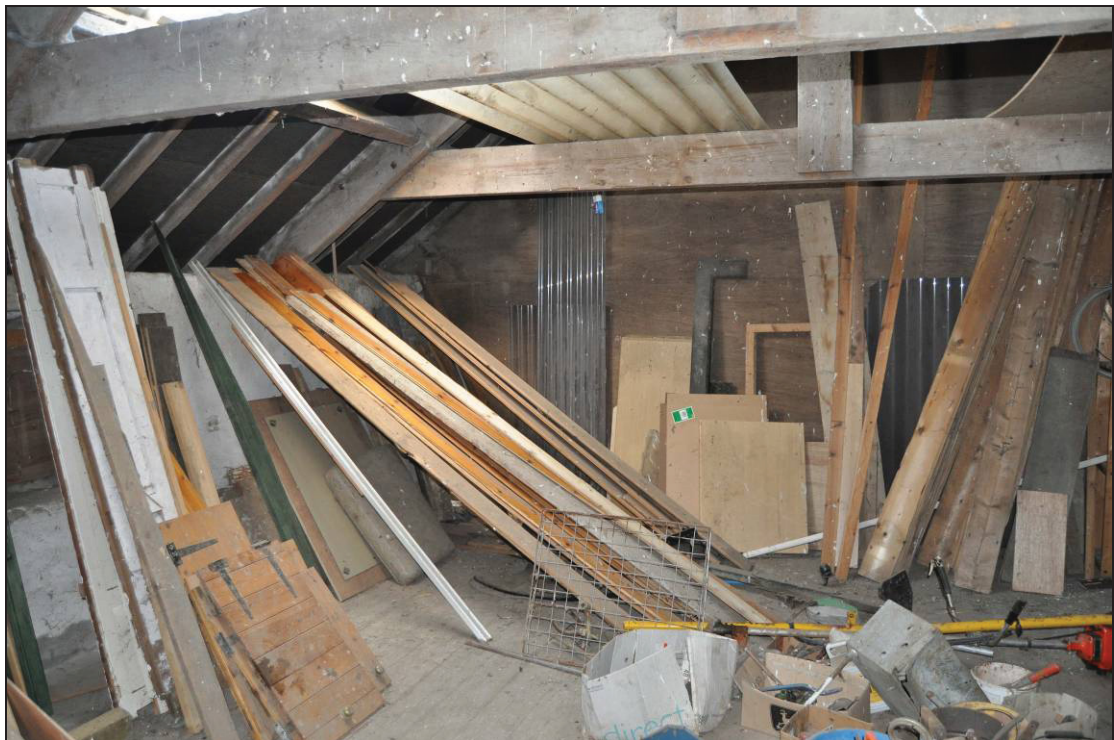
Figure 39. Room 6

- 4.10. *Room 6 (Figs 39)*  
The walls of this room are plaster clad, which covers all of the construction and fabric, and each of the five windows is blocked off. The roof looks to be a later replacement.

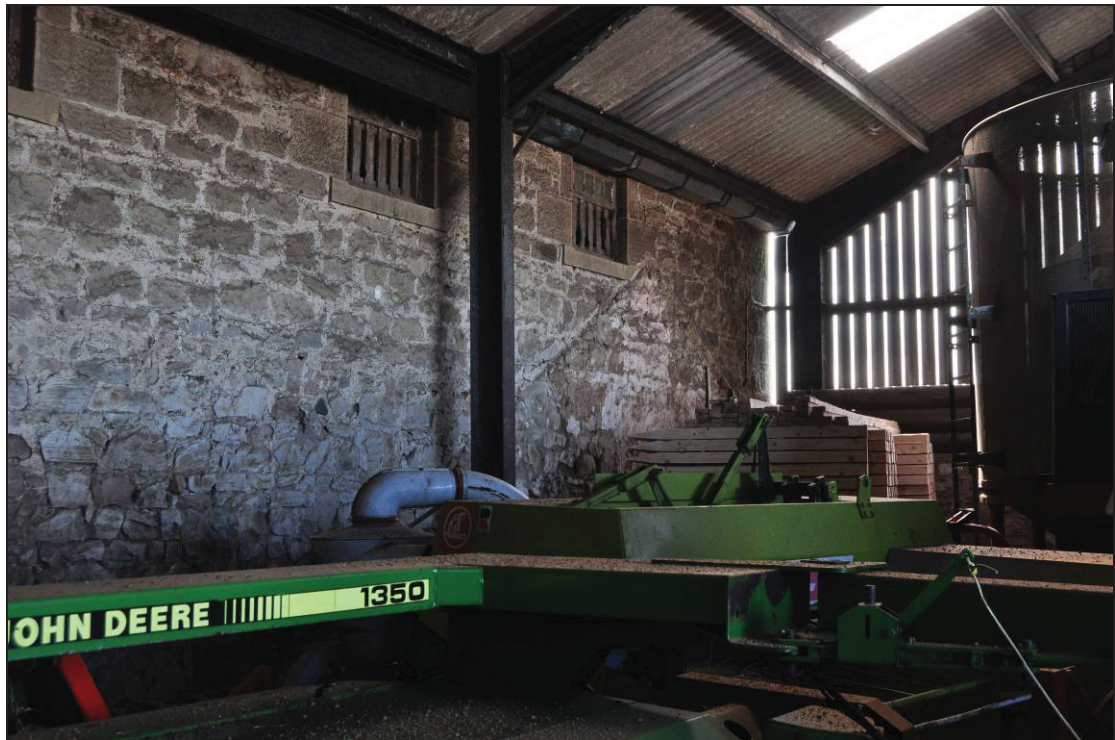
Figure 40. Room 12

- 4.16. *Room 12 (Fig 40)*  
The only original wall in this room is the southeast elevation. Access was difficult into this room due to the heavy amount of farm machinery. The work performed to create the central opening is as evident from the brickwork in this room as it was from Room 11. Towards the southwest of the wall, there are traces of a former pointed roof line, protruding to the northwest. The building which was situated here was likely to have been associated with the original farm complex. Evidence for this can be seen in the chamfered window cill of the farthest southwest, first floor window. This sandstone cill has been cut purposefully before being built into the structure.

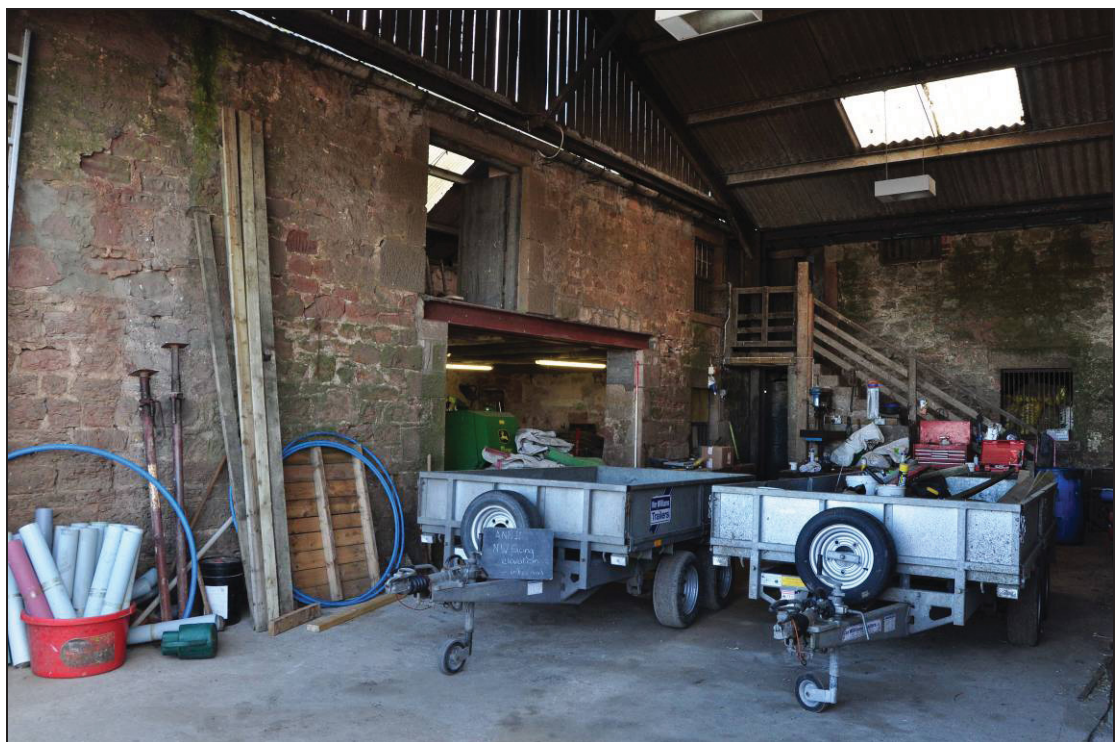
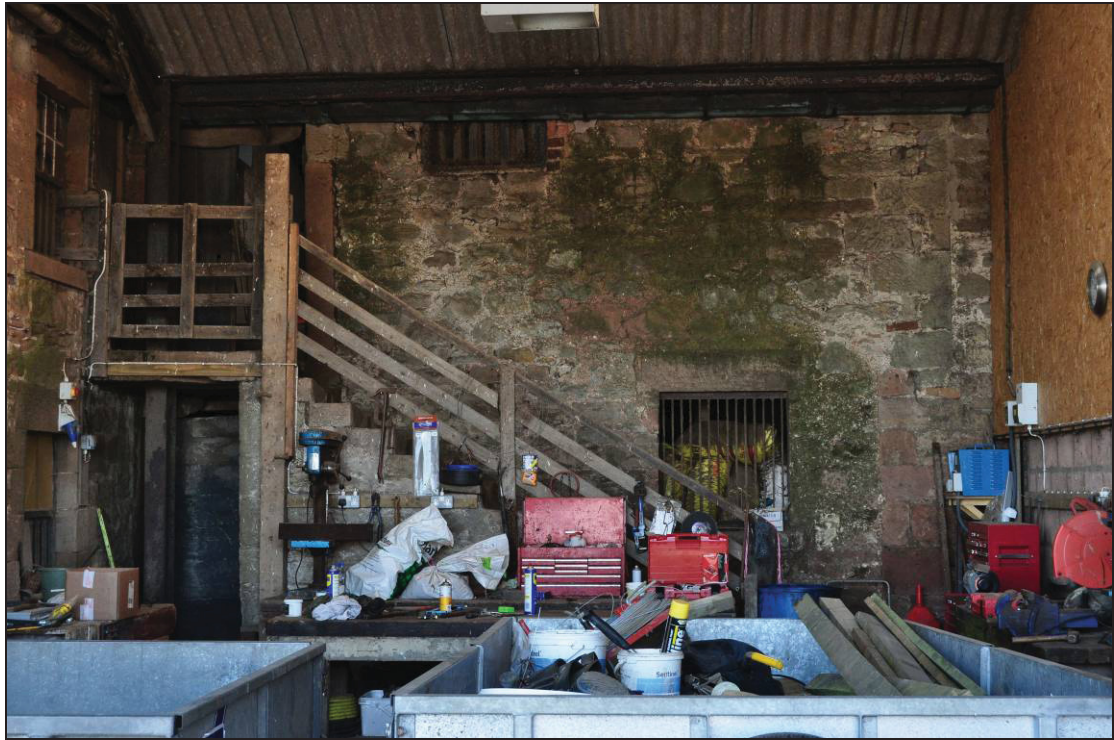
- 4.8. *Room 4 (Figs 41 & 42)*  
This room has been partitioned off from Room 12, using modern breeze blocks and wooden panels, to create a wall to the southwest. The southeast elevation consists of the same sandstone walling as is consistent with the rest of the buildings. The ground floor comprises a window and a doorway, between the two is an original stone staircase leading to the first floor. The first floor consists of a doorway (leading to Room 9) and a small window. The window has been halved by the modern corrugated roof so that only the lower half is visible.

- 4.8.1. The north east elevation comprises part of the original barn structure. The ground floor of this elevation consists of a large modern, inserted opening, topped by a steel lintel. A small original window opening exists to the south east of this. The first floor consists of an original door opening, and small window.

Figure 41. Room 4

Figure 42. Room 4
