# An Archaeological Building Recording of Annstead Farm, Chathill, Northumberland

**ARS Ltd Report No. 2011/30**  
March 2011

**An Archaeological Building Recording  
of Annstead Farm, Chathill, Northumberland**

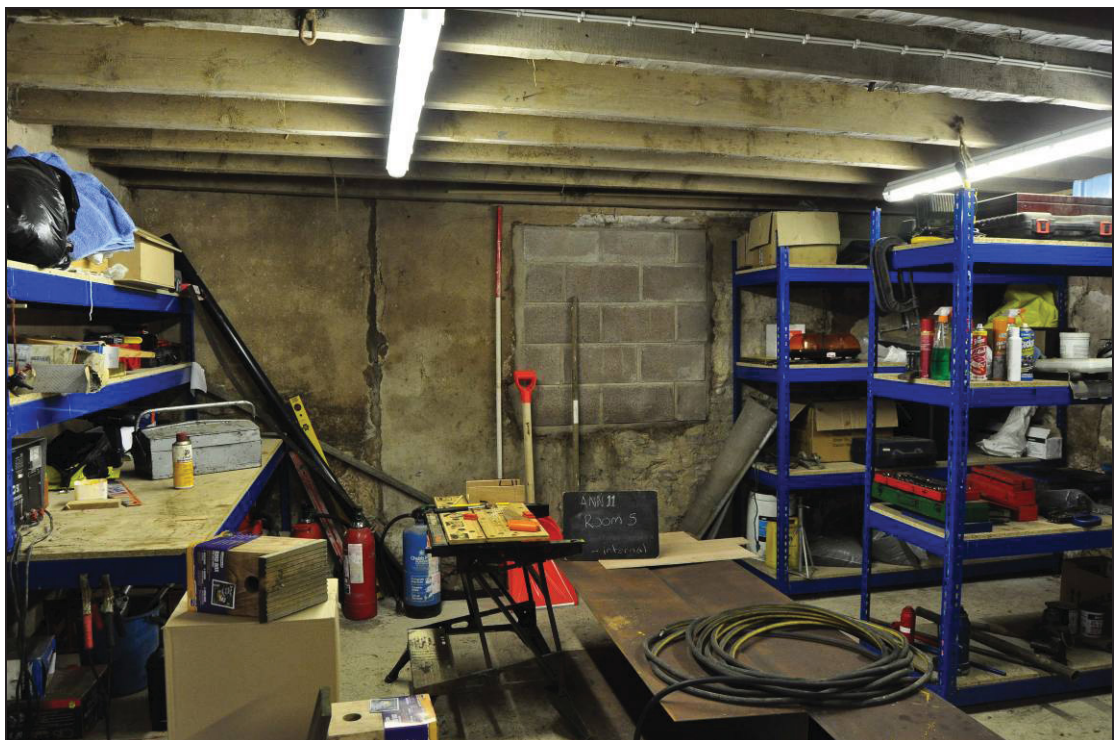
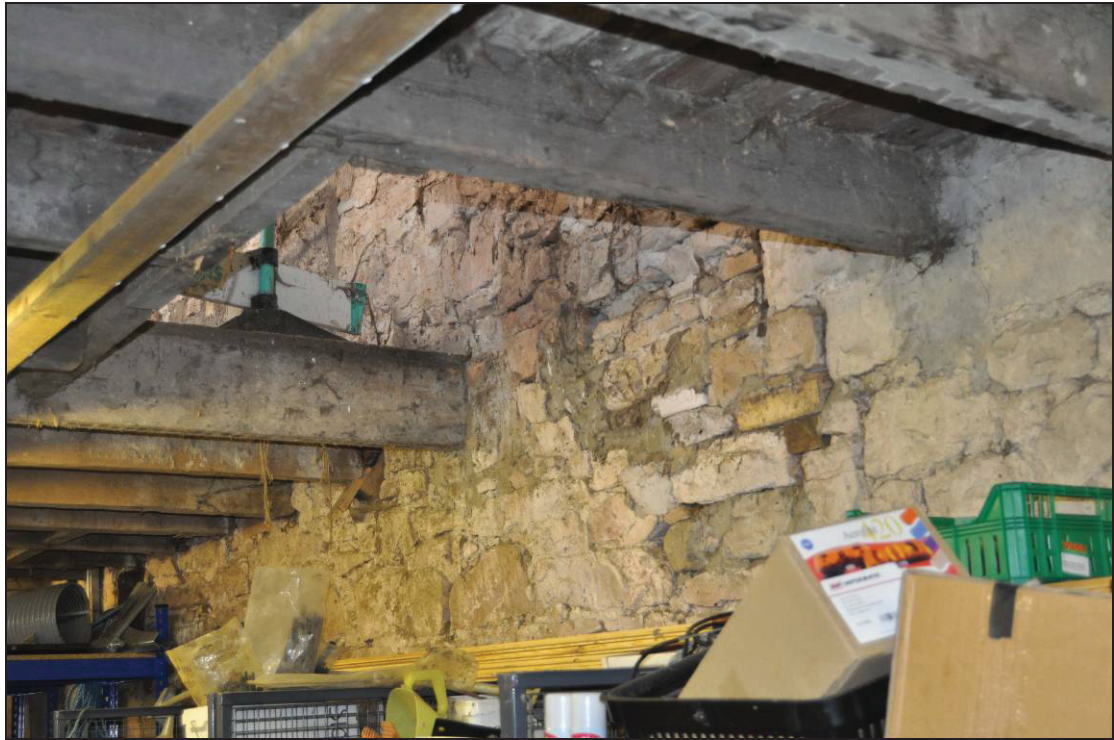
- 4.9. *Room 5 (Figs 43 & 44)*  
The Walls of this room have been clad so that the stone work is not visible. The northwest elevation has a blocked off window, with modern breeze blocks. The southeast elevation consists of a doorway and a window both blocked off using modern breeze blocks. The northeast elevation has traces of a former staircase left in the fabric of the wall, along with a cavity in the ground floor ceiling.

Figure 43. Room 5

Figure 44. Room 5

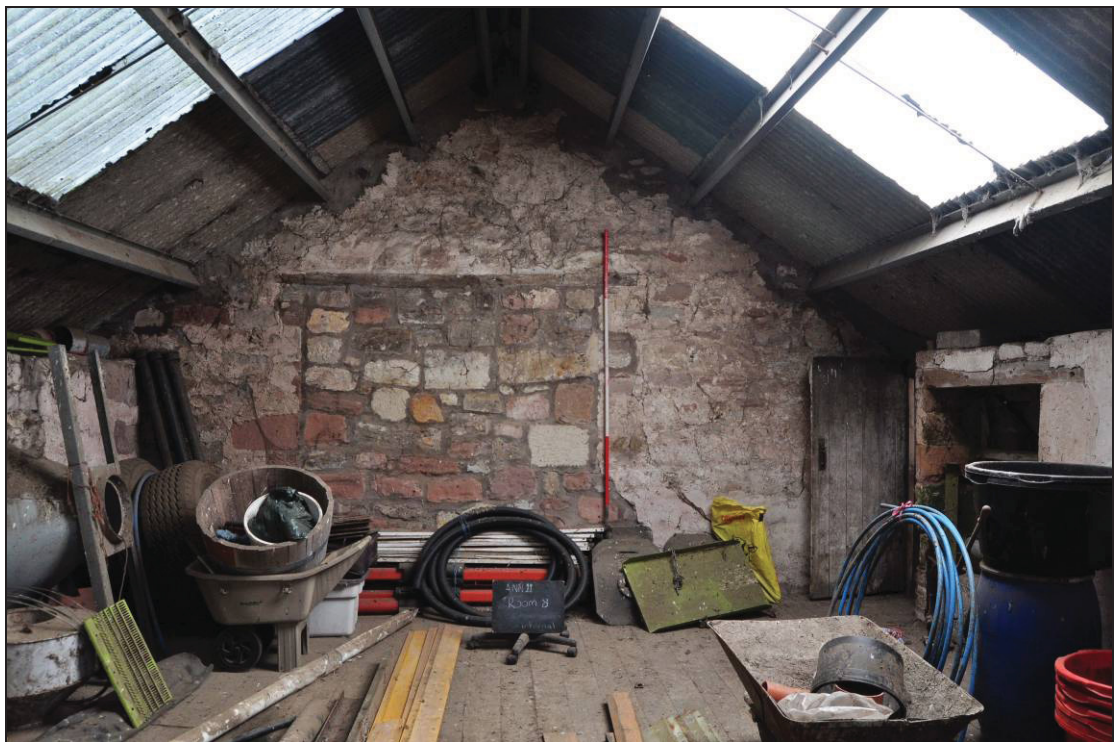
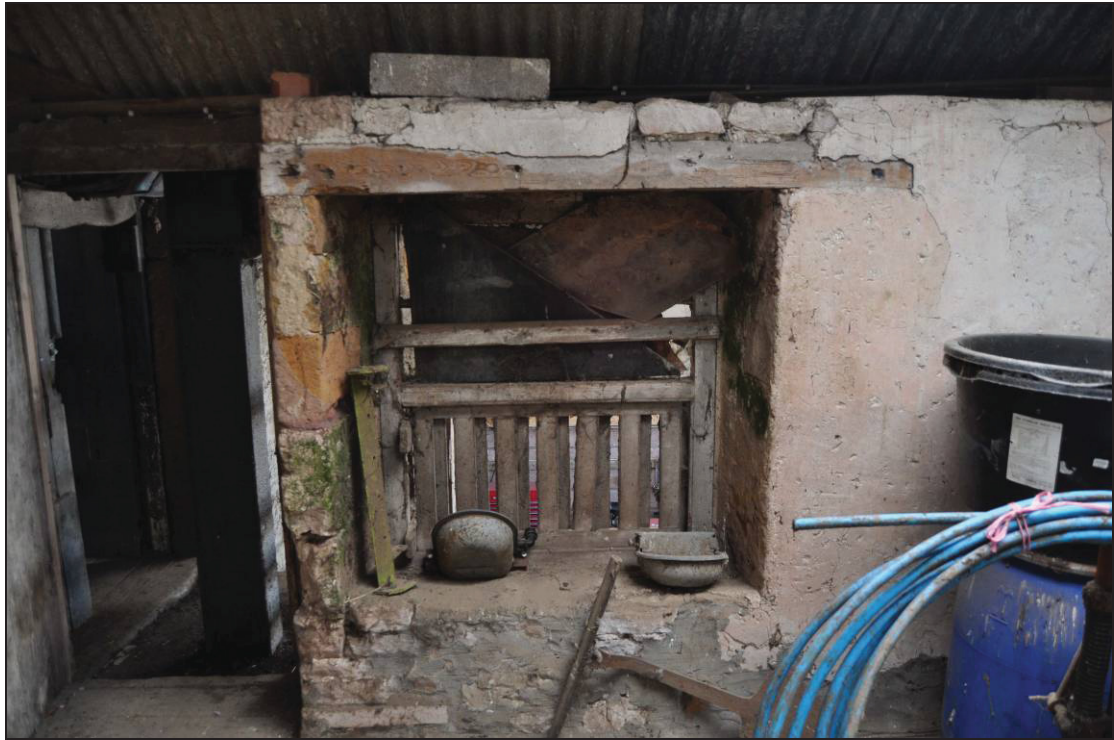
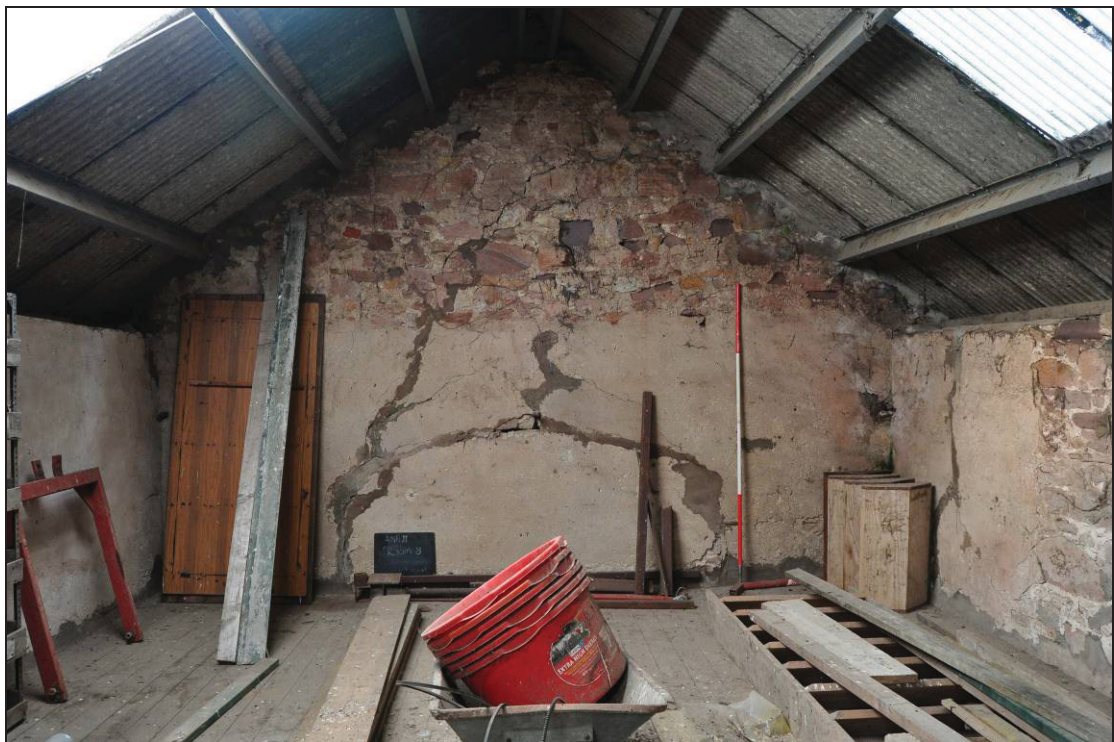
- 4.12. *Room 8 (Figs 45 – 47)*  
This room is situated directly over Room 5. The southeast elevation has a central, large blocked off opening. The roof is a modern replacement, and cement fixings to it can be seen on the apex of this elevation. An attempt has been made at plastering the northwest elevation. Cracking of the plaster has revealed the line of the original archway which is still visible on the external elevation.

Figure 45. Room 8

Figure 46. Room 8

Figure 47. Room 8

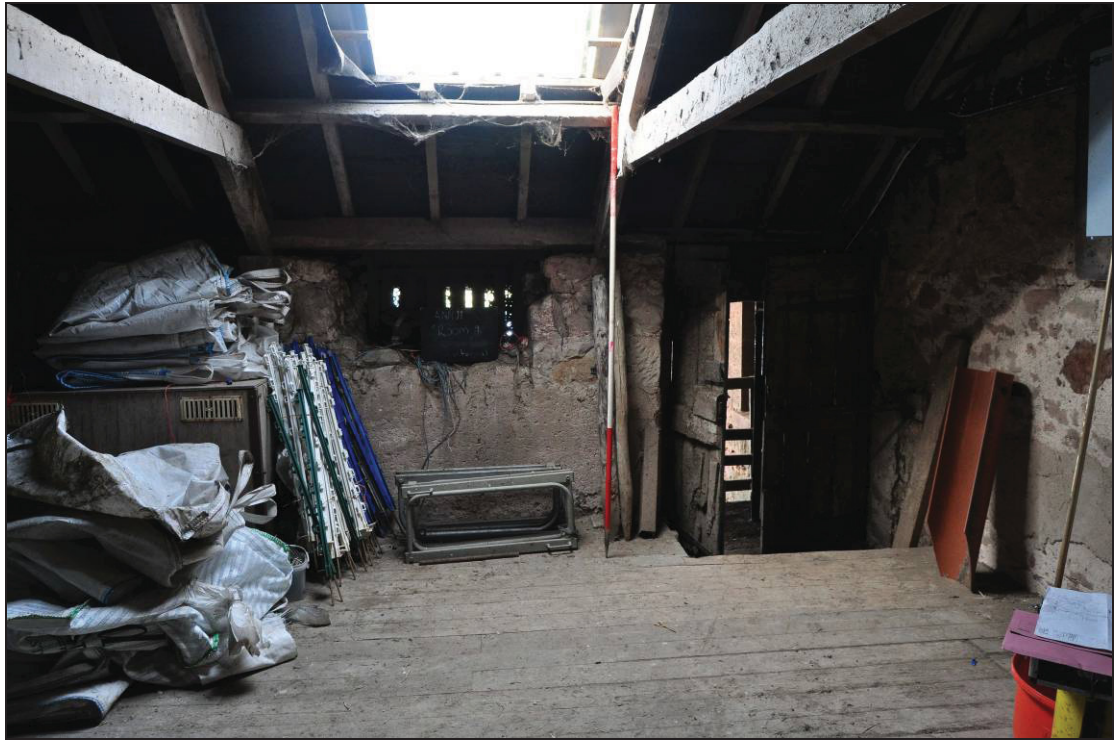
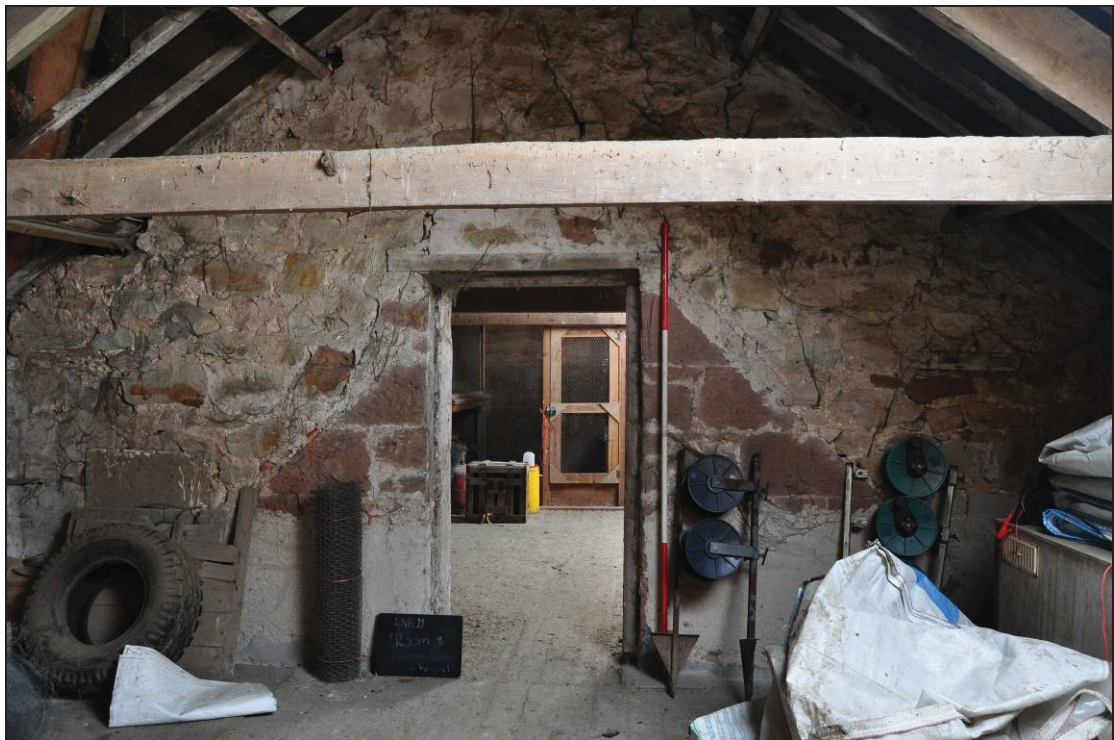
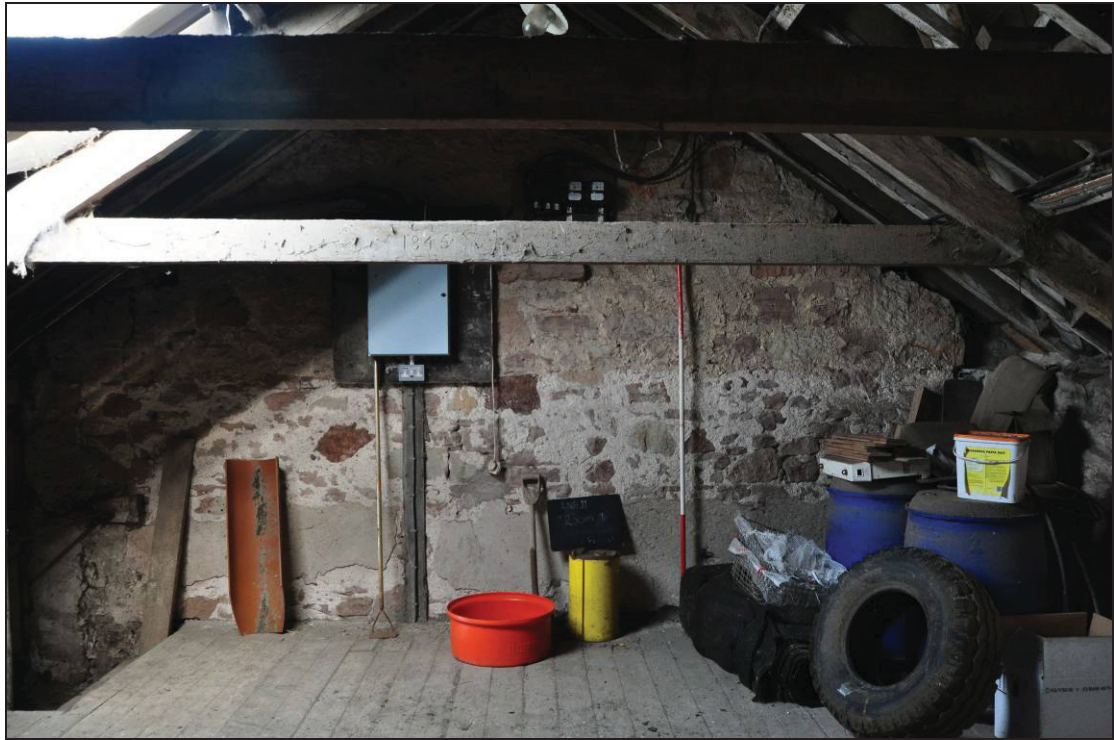
- 4.13. *Room 9 (Figs 48 – 50)*  
The northeast elevation of this room has had various additions made to it, in the form of electrical junction boxes. The southwest elevation retains the markings of a former roof line, indicating that the walls of this building have been built up to raise the roof height. The door on this elevation has also been constructed during the heightening works.

Figure 48. Room 9

Figure 49. Room 9

Figure 50. Room 9

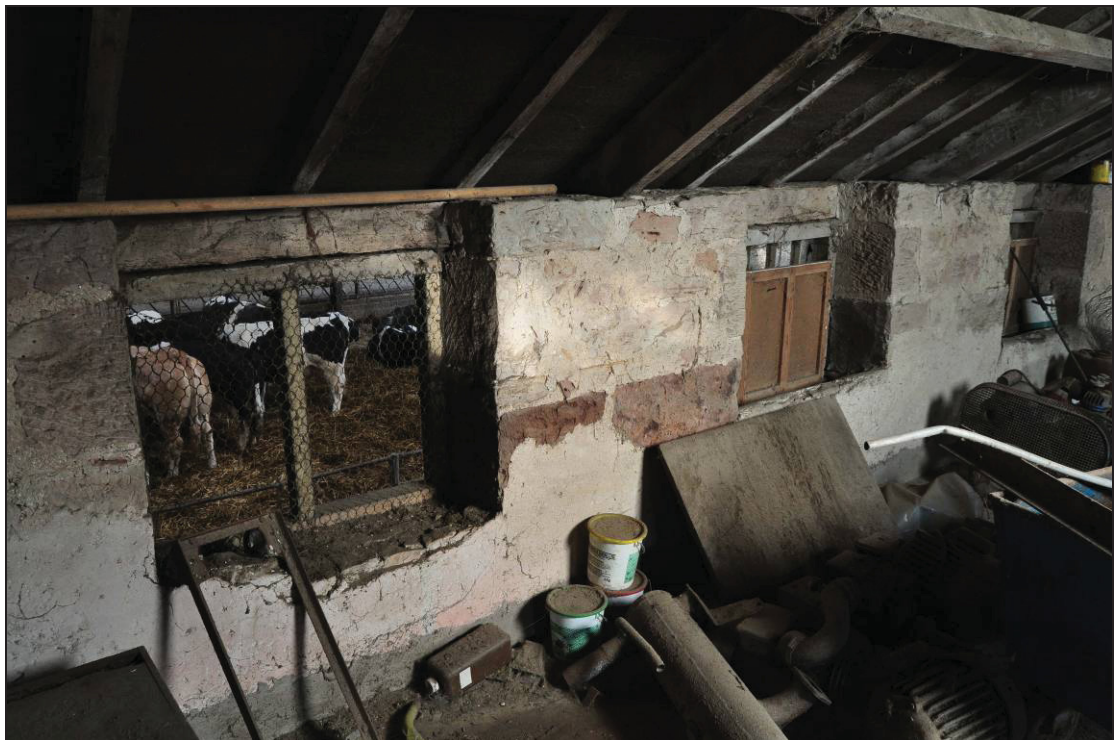
Figure 51. Room 10

- 4.14. *Room 10 (Figs 51)*  
The walls in this room are covered with cladding. The southwest and northeast elevations are lined with windows, the northeast ones overlooking Room 11. The southeast elevation has a doorway, the opening of which is original to the building.

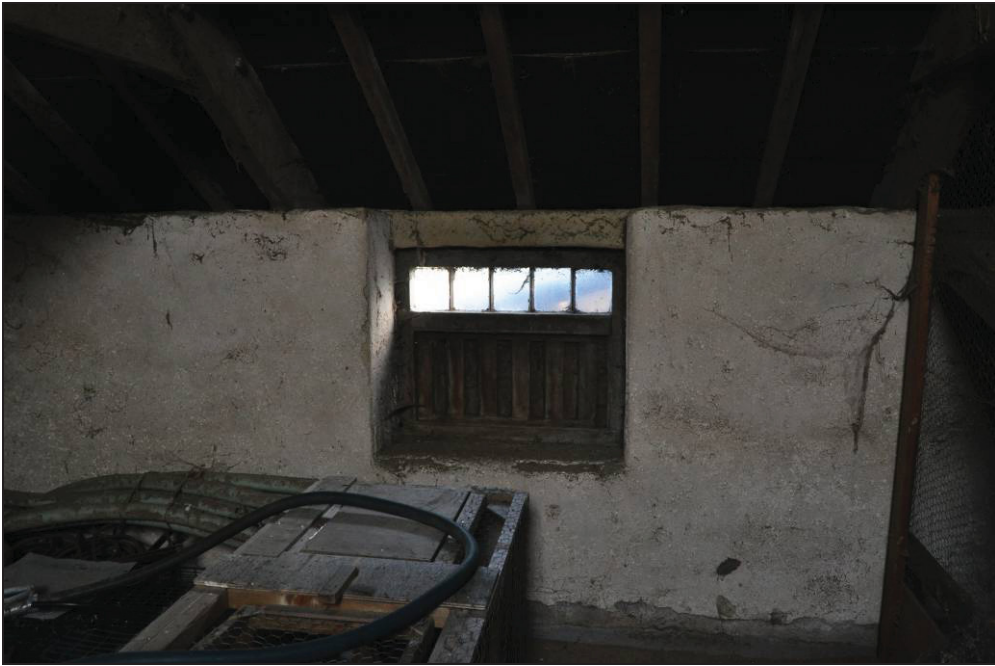
Figure 52. Room 7

- 4.11. *Room 7 (Fig 52)*  
Like room 6, the walls of this room have been clad, leaving two window openings, one to the southeast and one to the northwest. A large aviary hides any features which may be present to the southwest elevation
