# An Archaeological Watching Brief on the B6318 near Halton Shields, Northumberland

ARS Ltd Report 2011/35 April 2011

In April 2011Archaeological Research Services Ltd were commissioned by BT Openreach to undertake an archaeological watching brief on the B6318 near Halton Shields in Northumberland. The Watching Brief was carried out while a small trench was dug, by hand, between two existing junction boxes prior to the installation of an armoured copper cable

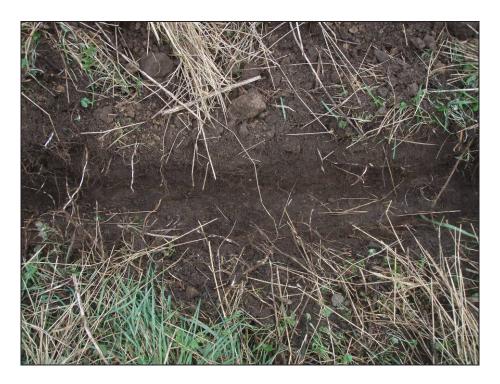
- 4.1. The trench was dug through turf and undergrowth to dark brown/black topsoil (001) with a depth of around 0.25m. Below this, at the base of the trench was orange/pale brown subsoil with small sandstone inclusions (002).
- 4.2. Neither Hadrian's Wall, nor any of its associated features, were encountered during the watching brief.

Figure 3. Small section of the trench.

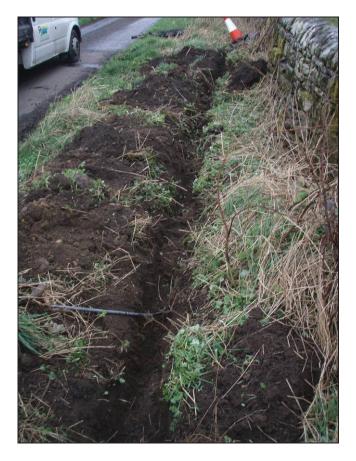
Figure 4. Trench with armoured copper cable installed.
