St Laurence's Churchyard, The Forbury, Reading, Berkshire

Archaeological Watching Brief Report

Ref: 87990 01
February 2013

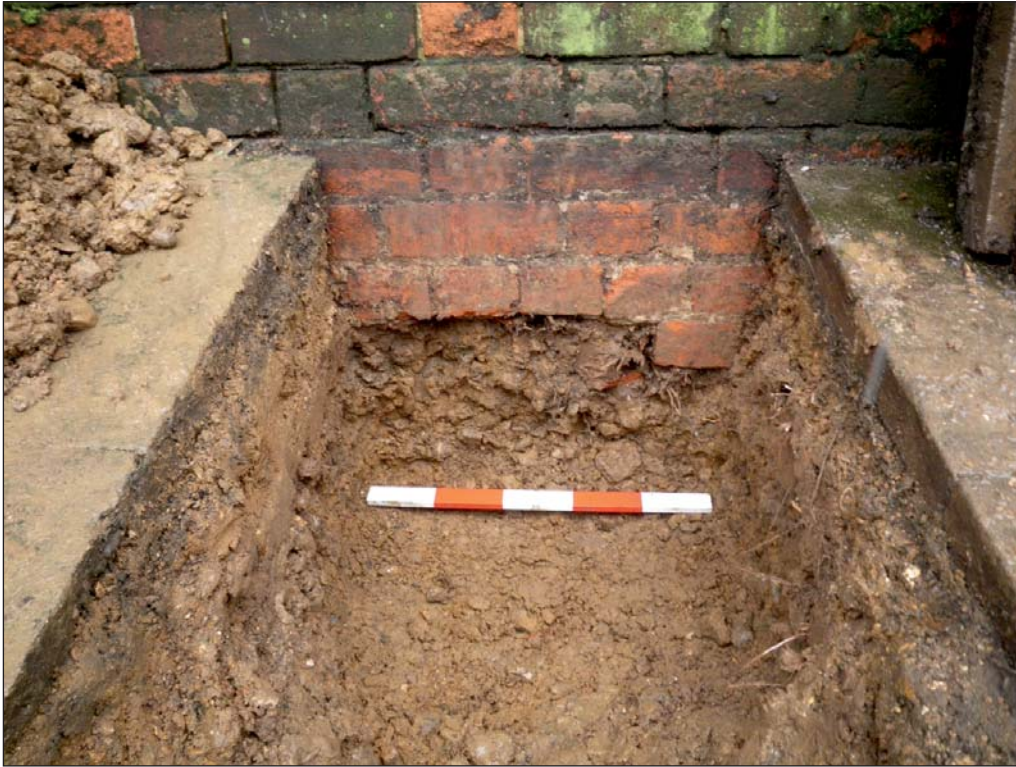
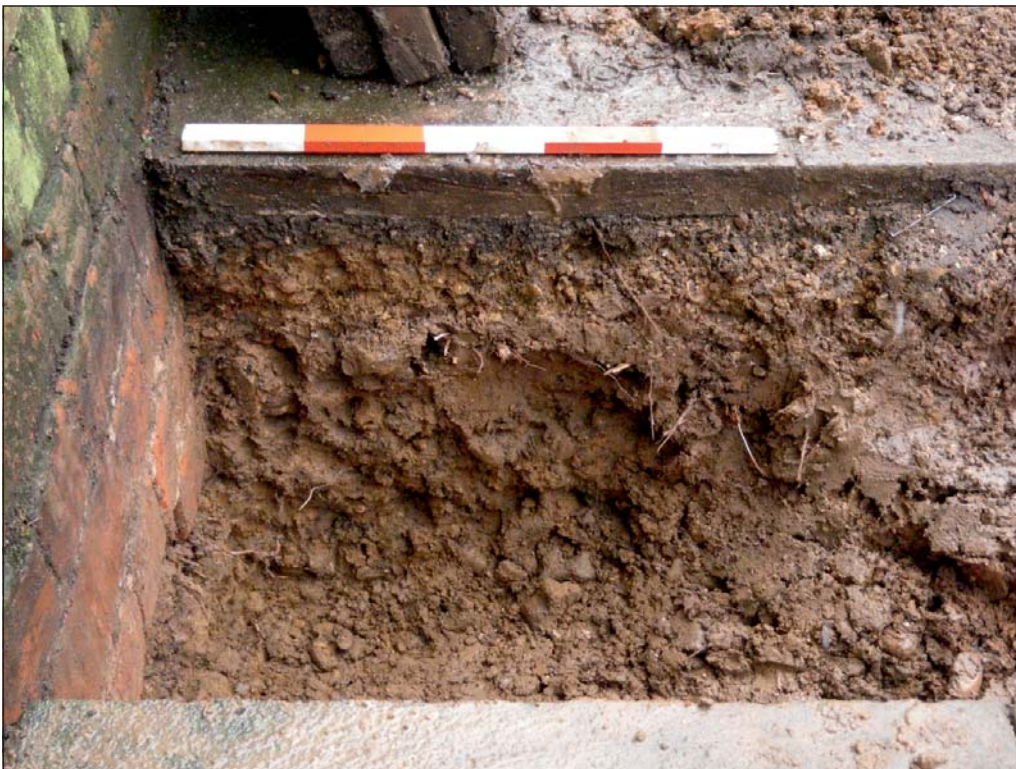
- 5.2.1 Test Pit 1 (**Figure 1, Plates 1 and 2**), was located on the north-east side of the wall, and recording demonstrated that wall (**105**) continued for four courses beneath the current ground surface. The wall was a continuation of the current red brick wall that encompasses the current churchyard and is of 18th century date. This was built upon a foundation layer of mixed sand and clay deposit (**103**) and contained abundant flint fragments with occasional brick. The natural gravel was encountered at a depth of 0.50m. No flint footings were seen.

Plate 1: North-east facing section of Test pit 1

Plate 2: South-west facing section of Test pit 1

- 8.1.5 No earlier foundations were noted beneath the current red brick wall in Test Pit 1, although it is thought that earlier wall foundations may lie further to the west (seen in earlier watching brief, Wessex Archaeology 2005, Test Pit 7). It was not clarified at the time, if the flint rubble represented the foundations of an original medieval wall or the re-use of original material following the extension of the churchyard.

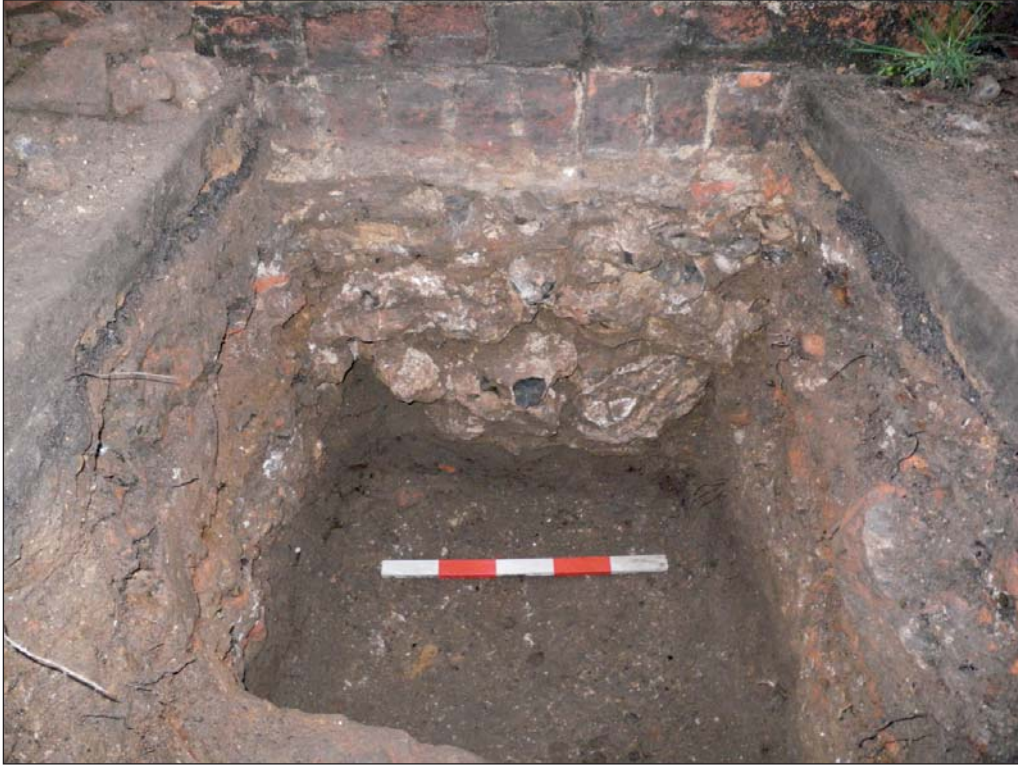
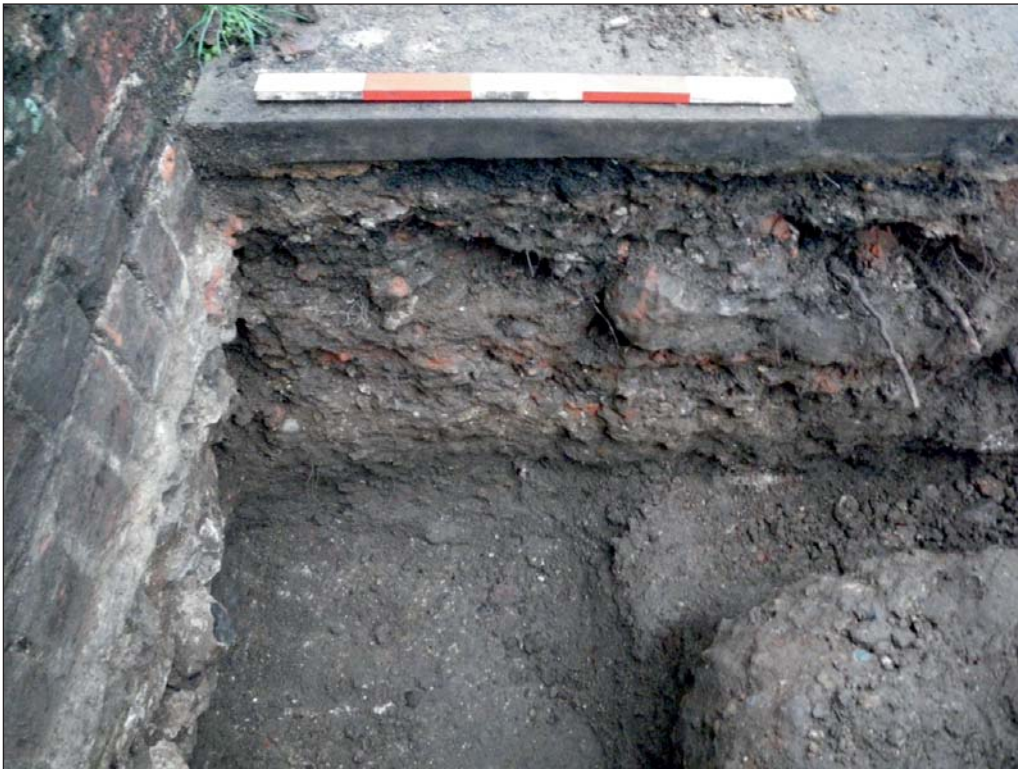
- 5.3.1 Test Pit 2 (**Figure 1, Plates 3 and 4**) was located on the south-east side of the wall. Below the foundation layer (**202**) for the current pavement was a layer of made-ground (**203**) to a depth of 0.52m. This deposit contained an abundant quantity of ceramic building material and post-medieval pottery. This in turn overlay a further layer of made-ground (**204**) that reached a depth of 0.68m. These layers abutted flint wall (**208**) and contained flint rubble that formed five rough courses to a depth of 0.60m. This may represent an earlier wall or may have formed the foundation of for the current/18th century wall (**207**).

- 5.3.2 Flint wall (**208**) sealed a friable greyish brown silty clay layer (**205**) that appeared to be the foundation deposit upon which the wall was built. This deposit was 0.18m thick and overlay a further layer of dark greyish brown silty loam (**206**). This deposit contained patches of mortar, common charcoal and occasional medieval tile fragments.

Plate 3: East facing section of Test pit 2

Plate 4: South facing section of Test pit 2

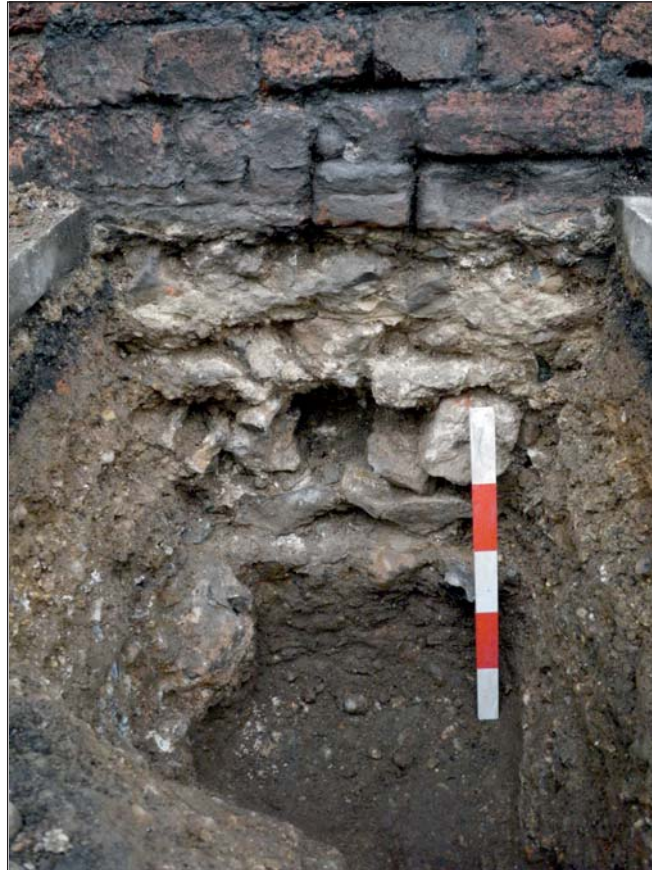
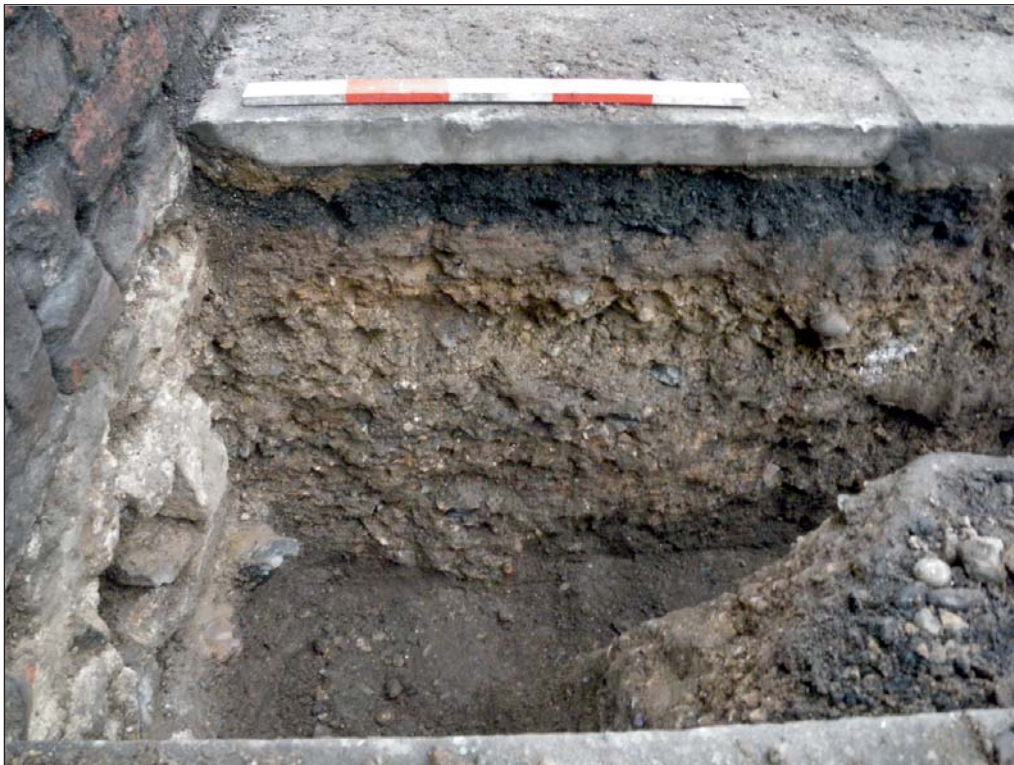
- 5.4.1 Test Pit 3 (**Figure 1, Plates 5 and 6**) was located to the south-west of Test Pit 2 on the south-east side of the wall. It was stratigraphically very similar to Test Pit 2. It comprised of the remnants of a flint coursed wall (**307**) that was sealed by the retaining red brick wall (**306**). The remnant flint formed five courses and was joined by a lime mortar. The flint wall

may represent an earlier wall or was the foundation for the 18th century wall (307). This flint wall sealed a greyish brown silty clay layer (305) and was very similar to layer (205) within Test Pit 2. Layer (305) contained medieval tile fragments.

- 5.4.2 The flint wall courses (307) were abutted in section by two layers of made-ground (303) and (304). Layer (303), 0.07m in depth, represented a light greyish brown loam with abundant gravel inclusions and occasional tile fragments. This in turn sealed a further compacted layer (304) that was 0.22m thick and contained common tile and flint/gravels. It is likely that this layer represented the initial backfilling against the wall.

Plate 5: South-east facing section of Test pit 3

Plate 6: South-west facing section of Test pit 3

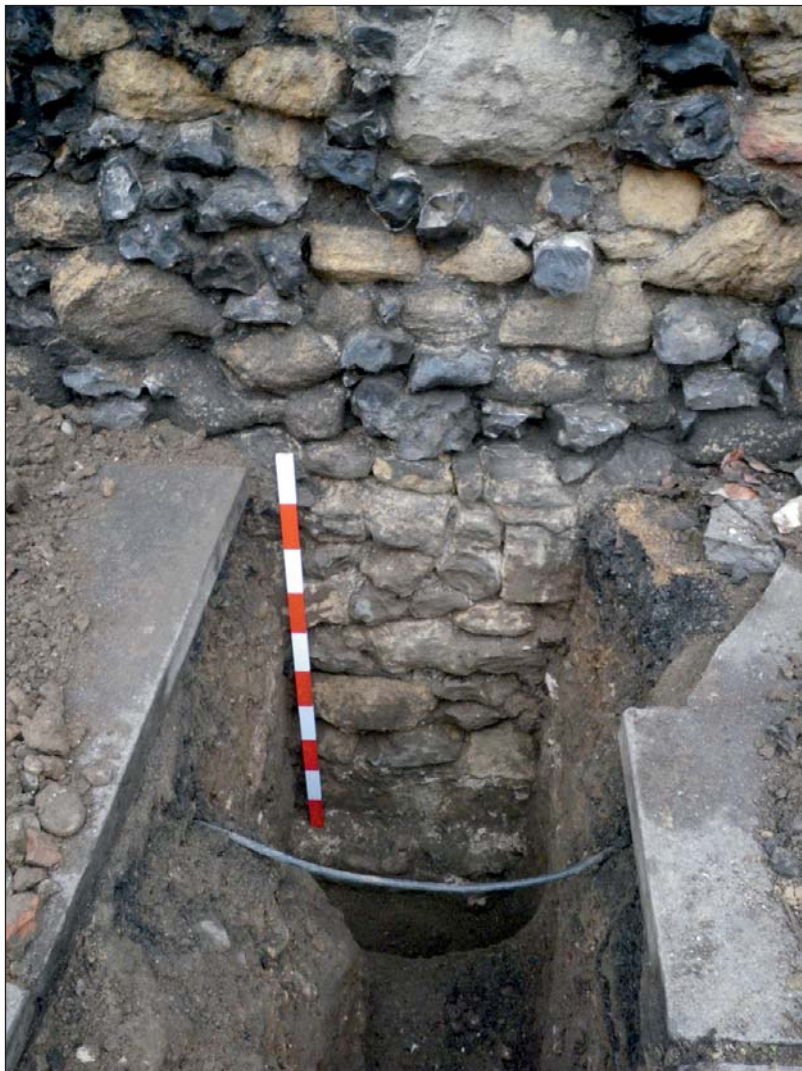
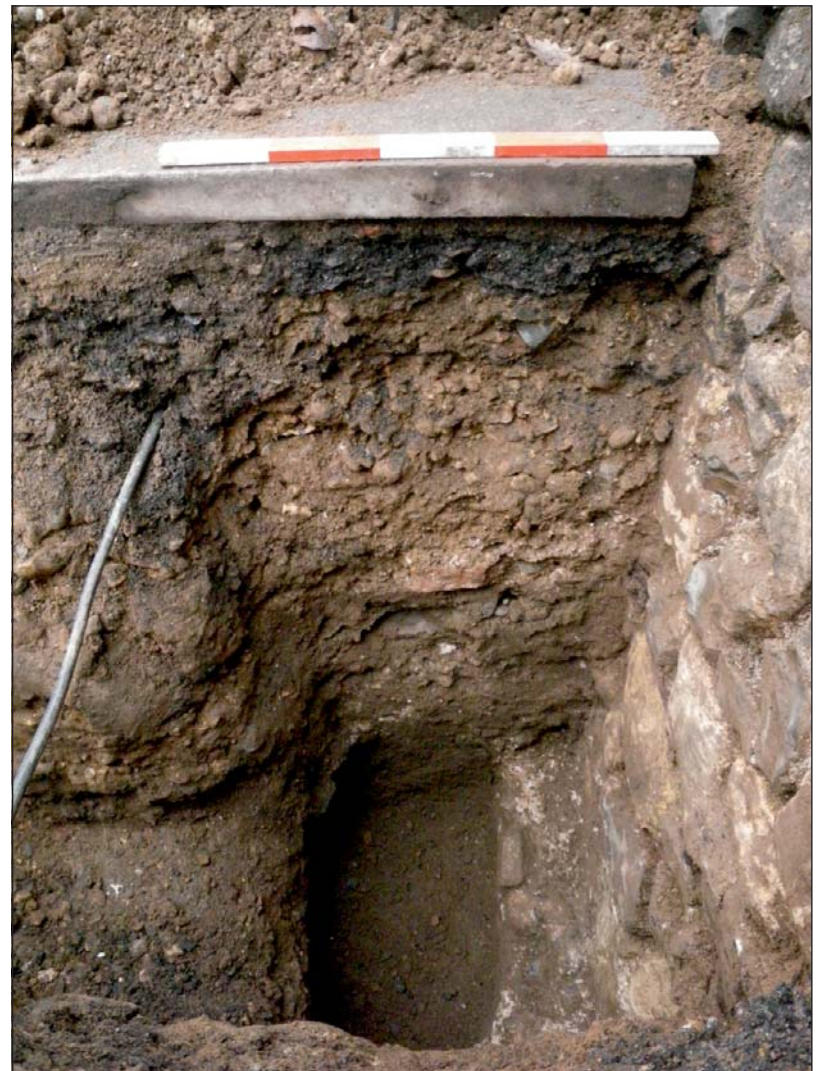
- 5.5.1 Test Pit 4 (Figure 1, Plates 7 and 8) was located on the southern perimeter of the churchyard. Wall (406) comprised of a mixture of stone and flint and was thought to represent the oldest part of the wall (CgMs 2013, 4). This wall was seen to overlay the footings of a substantial wall (possibly sandstone) (407), at least nine courses to a depth of 1.24m. A foundation stone (408) was encountered at a depth of 1.24m and protruded from the wall by 0.12m. It is likely that walls (407) and (408) represent the original medieval wall. It is possible that later wall (406) (the extant wall forming the southern boundary of the churchyard) used some of the stone from the original wall and was supplemented with flint.

- 5.5.2 A number of made ground layers were encountered abutting the walls. Layer (403), a fairly loose deposit with abundant gravel inclusions (0.34m thick), is thought to be modern deposition caused by modern service disturbance. This sealed layer (404) which was identical to layer (304) within Test Pit 3. This was a light yellowish brown silty clay with abundant gravel and tile fragments, 0.19m thick. Layer (405) was a loose greyish brown friable layer that contained common medieval tile fragments; it was very reminiscent of layer (205). The bottom of the deposit was not found and it seems likely the deposit was a deliberate back fill against the wall foundations when it was initially constructed, although the layer is undated. Medieval tile fragments were recovered from layer (405).

- 5.5.3 A possible foundation cut associated with the construction of the wall was noted during the excavation of Test Pit 4. However, due to the limitations of the investigation and the presence of modern services, this could not be clarified.

Plate 7: South-east facing section of Test pit 4

Plate 8: North-east facing section of Test pit 4

- 8.1.2 Test Pit 4 recorded very substantial stone footings beneath the current wall on the southern edge of the churchyard. The excavations reached a depth of 1.2m, although the base of the wall was not reached. A step, possibly representing the foundations of the wall, was seen towards the base of the test pit at a depth of 1.10m and was noted to continue into the lowest deposit. Medieval roof tile and a single fragment of floor tile was recovered from the base of the test pit.

- 8.1.3 The southern wall is formed of both large stone blocks and supplemented with flint nodules - this section of retaining wall is thought to be older than the red brick wall dated to the late 18th century. The results from Test Pit 4 suggest that the large stone blocks represent the remains of the original medieval wall. The findings appear to confirm the 'Plan of Forbury at the Dissolution' from 1816, which showed the land being extended to the east. Such deposits would not have been encountered within the other test pits as the remainder of the earlier wall would be expected within the churchyard.
