Kennet Building Marlborough College, Wiltshire

Programme of Archaeological Monitoring and Recording

Planning Ref: 19/04481/FUL
Accession Code: DZSWS:09-2019
Ref: 225931.03
March 2021

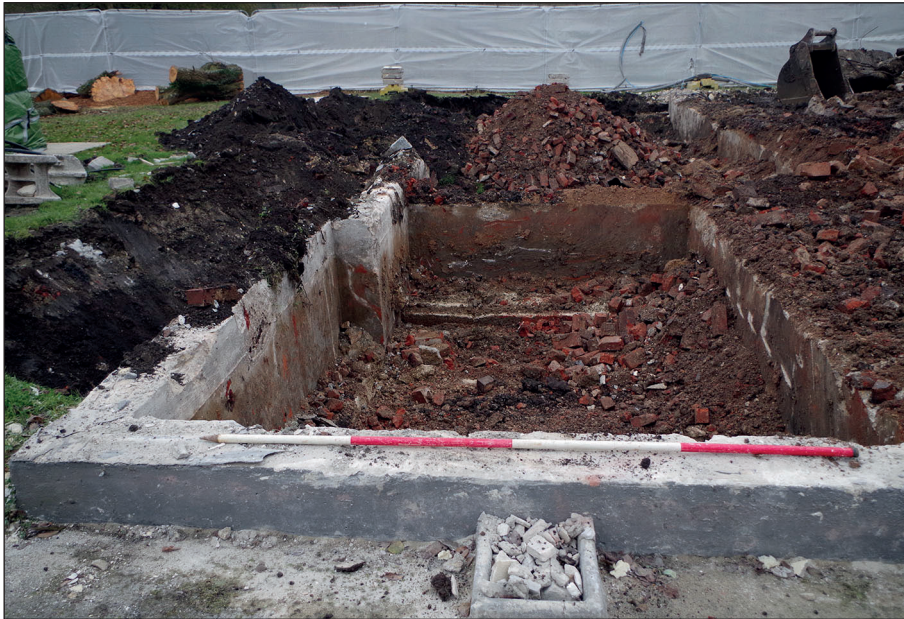
Plate 1: View of foundation walls from the north-east, 2 m scale

foundations only, a photographic record was made (**Plate 1**). The footprint of the new building, Trench 2, was then stripped and the area, which included the location of Trench 1, was fully recorded. The results detailed below therefore focus on Trenches 2 – 8.

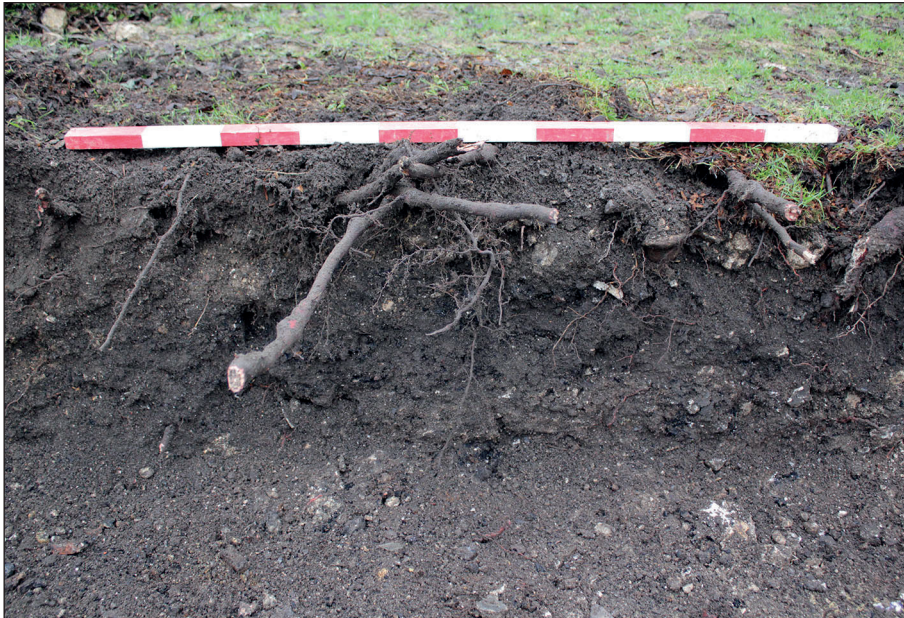
Plate 2: North-west facing representative section of Trench 2, 1 m scale

- 5.2.1 The soil sequence across the site was variable. Across the footprint of the new building (Trench 2; **Fig. 1**), a silty clay loam topsoil (201) was found to overlay a modern road surface (202) sealing a bedding layer comprising Type 2 hardstanding (204) and various dumped deposits (203) containing broken brick, glass, concrete and modern ceramics (**Plate 2**). Excavations within this area reached 0.40 m in depth and did not reach natural geology.

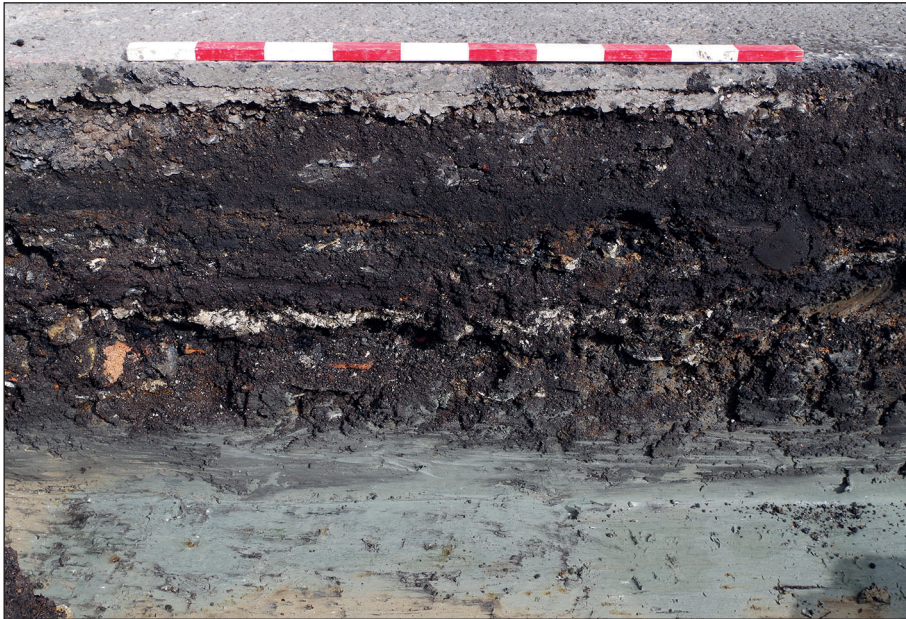
Plate 3: South-west facing representative section of Trench 3, 1 m scale

Trench 3		35.68 m x 1.35 m		NGR	m OD
Context	Interpretation	Fill of	Description	Depth bgl (m)	
301	Road		Tarmac	0-0.07	
302	Bedding		Gravel bedding/hard standing. Frequent 80% SA and SR gravel <20mm, light grey in colour.	0.07-0.18	
303	Layer		Fine silty black tail (?) sandy layer. Part of road make up (?).	0.18-0.23	
304	Made ground		Silty sandy clay with 5% med coarse gravel and rare flint, SA to R. Rare CBM and broken bricks.	0.23-0.42	
305	Layer		Thin layer of redeposited CBM, brick and degrade chalk.	0.42-0.45	
306	Made ground		Compact dump material, mid-dark grey silty sandy clay with occasional charcoal, 5% med coarse gravel, rare SA flint <50mm, rich in finds.	0.45-0.62	
307	Natural		Clay, waterlogged med blueish grey, clean clay. Occasional patches of iron panning and manganese flecks. Towards N end a few patches of light yellowish brown clay.	0.25-0.90/1.20+	
308	Pit		Possibly machine dug cut of a large pit. Level base from mid-way to S end. Concave N side in section.	0.25-0.75

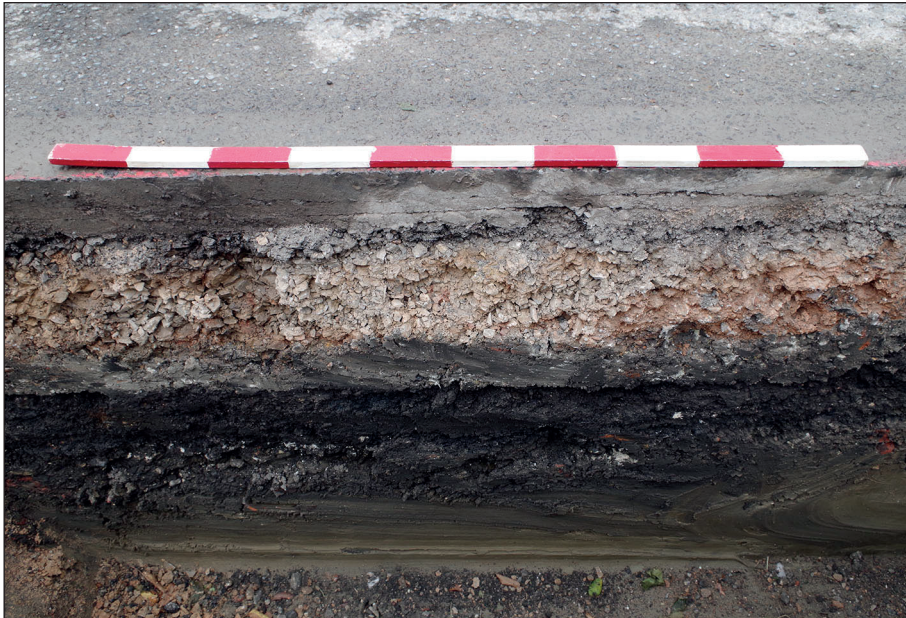
Plate 4: South-west facing representative section of Trench 7, 1 m scale

- 5.2.2 Trenches 3, 6, 7 and 8 were excavated through tarmac road surface/car parking area. The upper soil sequence was fairly consistent across the trenches with tarmac (301, 601, 701 and 801) found to overlie bedding layers (302, 602, 702 and 802) comprising crushed and/or gravel. In trenches 3 and 6 these bedding layers sealed a very dark deposit with tarmac inclusions (303 and 603). Further layers of made ground were then encountered within Trench 3 (304, 305 and 306) beneath which the natural geology was located (**Plate 3**). Comprising a waterlogged mid-bluish grey clay deposit, the natural was seen to naturally rise within the central area of the trench where it was encountered 0.25 m below the current ground surface. Elsewhere within the trench the deposit was located between 0.90 m and 1.20 m below the existing surface.

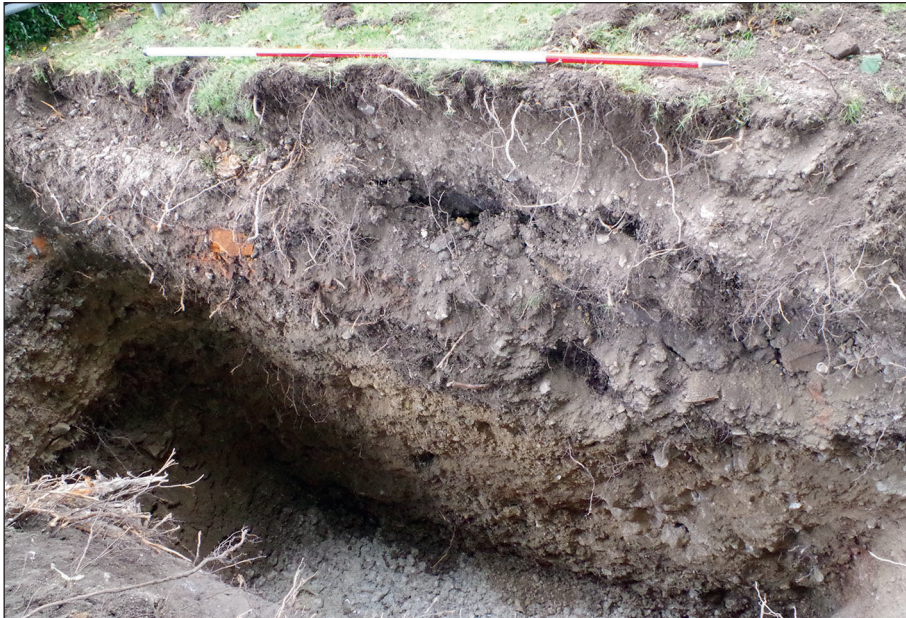
Plate 6: East facing representative section of Trench 4, view from north-east, 2 m scale

- 5.2.6 Trench 4 within the east was excavated through topsoil (401) which overlay a subsoil of light greyish brown silty clay (402) (**Plate 6**). In turn overlaying a made ground deposit containing CBM, metal piping remains and other modern debris (403). This made ground deposit was seen to seal a buried ground surface (404) comprising a silty clay loam with evidence of rooting and burrowing. Beneath 404, 405 comprised a further deposit of made ground comprising a matrix of loose silty sand and chalky gravel which in turn overlay a second buried soil (406). Located at approximately 2.60 m bgl the deposit appeared a mid-greyish brown silty clay loam and overlay the natural chalk geology (407).

Trench 4		3.5 m x 1.6 m		NGR	m OD
Context	Interpretation	Fill of	Description	Depth bgl (m)	
401	Topsoil		Mid greyish brown silty clay loam, soft with wel defined horizon. Frequent rooting, rare SA and R flint and chalk inclusions.	0-0.15	
402	Subsoil		Light greyish brown, loose chalky silty clay, sparse 4% SA chalk <20mm. Rooting.	0.15-0.35	
403	Made ground		Light geyish brown silty clay loam, loose to failry compact with moderate CBM and building rubble.	0.35-0.90	
404	Buried soil		Buried ground surface, mid greyish brown silty clay loam with sparse SA and SR chalk. Visible on south side but distrubed	0.90-1.05

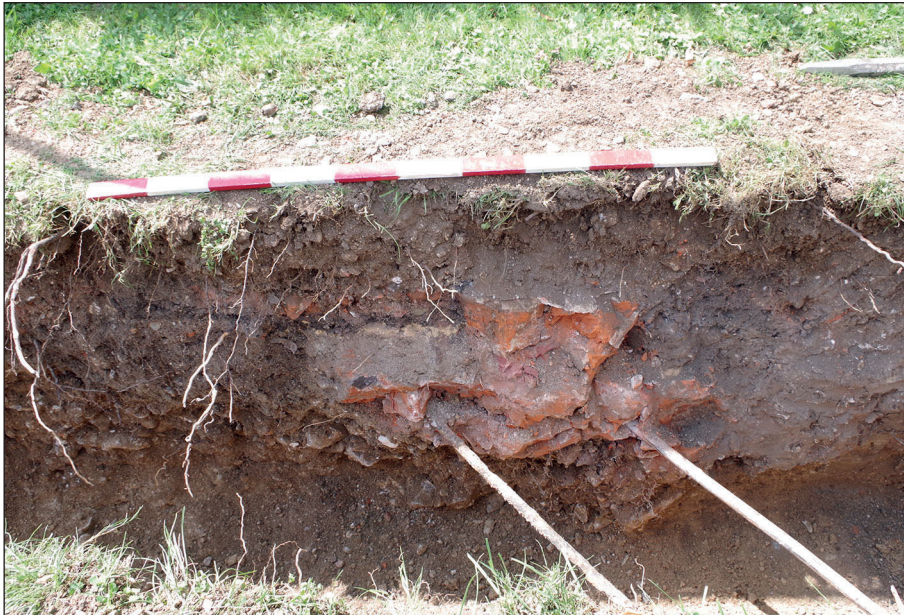
Plate 8: Modern brick wall and metal piping 507, view from east, 1 m scale

- 5.3.2 A modern manhole was located within Trench 4 and a modern utility trench located within the southern extent Trench 5. A linear cut was also identified within Trench 5 (509). The feature was orientated approximately east to west and is believed to be associated with the construction of the nearby building and/or road (**Fig.1**). Further to the north in the same trench, a construction cut (510) contained the remains of a possible wall foundation (507). Aligned north-east to south-west, the upper part of the likely foundation comprised mortar and bricks with the lower portion comprised of a mix of broken brick, mortar and metal piping (**Plate 8**).

507	Fill	510	Upper fill of 510. Possible foundation for a brick wall. Broken brick mixed with mortar. With this are two metal pipes possibly for anchor or possibly for reinforcement.		0.18-0.63
508	Made ground	509	Mid to dark brown firm silty clay loam. Frequent brick fragments, occasional modern glass and pottery, sparse chalk <30mm. Possibly landscaping.		0.15-0.48
509	Cut		For the made ground possibly associated the construction of the modern road and nearby building. Straight cut.		0.40-0.75+
510	Foundation		Possible wall foundation. Irregular shape cut.		0.12-0.84+
511	Deliberate backfill	510	Mide brown silty clay mixed with brick fragments and sparse tarmac fragments.		0.12-0.84+
