# Wapsbourne Manor, Sheffield Park Uckfield, East Sussex

Archaeological Watching Brief

Planning Ref: Lewes LW/22/0188 Ref: 272360.03 June 2023

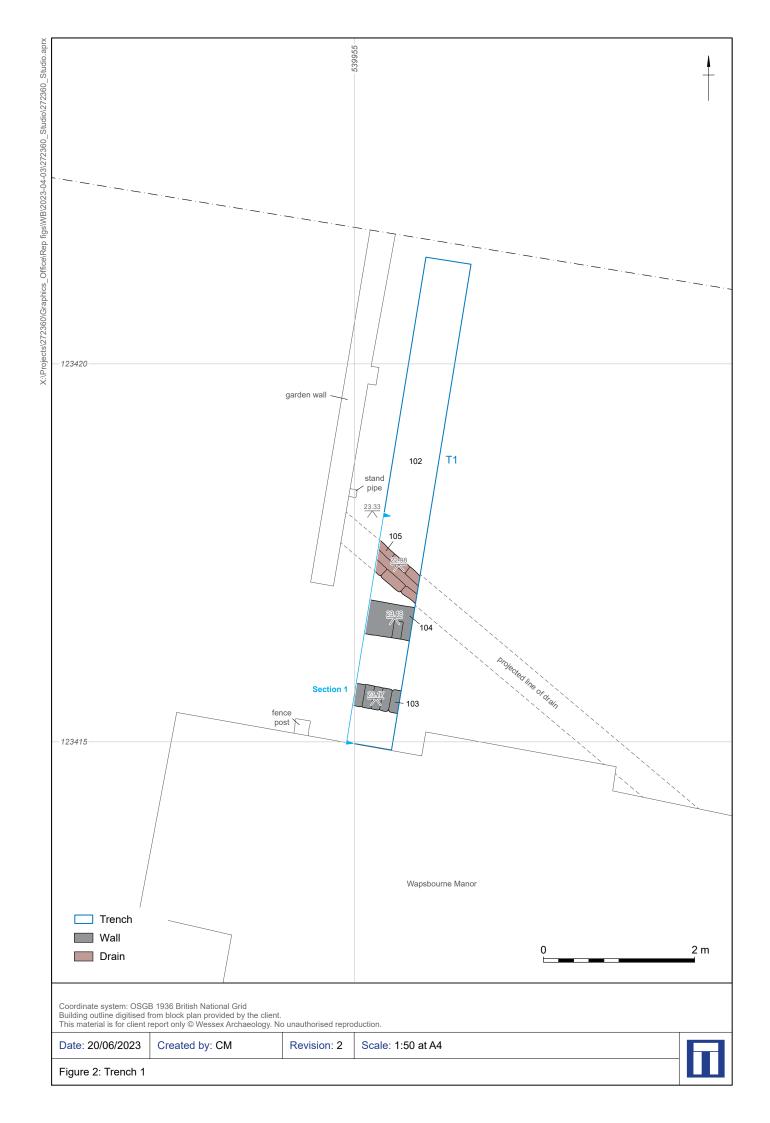
Figure 7: House foundations (right) and walls 103 (centre)  $\,$  and 104 (left), 1 m scale, looking east  $\,$

- 5.3.2 The trench revealed the foundations of the house itself (Figs 3, 5, 6). The courses of stretcher bond brickwork continue below the current ground level with a further five courses visible beneath those described above. There appears to be little bonding visible between the bricks, although the face of the foundations is abraded, possibly caused by fine rooting and a damp atmosphere. The cut for the foundation was not clear in section, due to the reworked soils and disturbed natural geology. It appeared that the cut may have been wider at the top tapering to meet the face of the wall at the base.

Wall 103 (Figs 2, 3, 6, 7, 8) was located 0.50 m north of the wall of the house. It consisted of a single course of roughly handmade bricks, observed directly under the overburden (0.2 m below current ground level) and laid onto the underlying natural. The wall had a width of 0.30 m, an observed length of 0.60 m and a thickness of 0.20 m. The bricks were laid in a header bond formation, unlike the foundations on the house wall, but may present a single course of English cross brickwork. Assessment of the brick suggests they date to the late 18th or early 19th century, this date aligns with the likely period in which the eastern wing of the house was demolished.

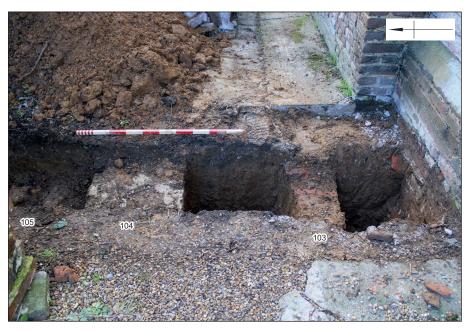
Figure 6: Walls 103 (right) 104 (centre) and drain 105 (left), 1 m scale, looking east

- 5.3.4 Approximately 1.45 m north of the wall of the house and 0.60 m to the north of wall 103 was a slightly more substantial wall 104 (Figs 2, 3, 6, 7, 8, 9). This had a width of 0.55 m and a thickness of 0.20 m, and ran for an observed length of 0.60 m. The wall comprised of roughly handmade bricks, appearing to be the same as those seen in wall 103, and were laid upon a bed of grey mortar (Figs 2 and 3). The brick pattern was unclear as a layer of mortar was present across the bricks, one brick was visible with the header forming the face of the wall.

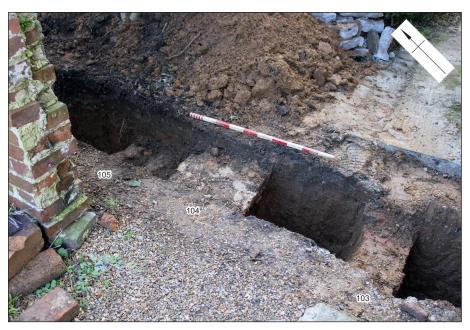
Figure 8: Walls 103 (right) 104 (centre) and drain 105 (left), 1 m scale, looking north east

- 5.3.6 Immediately to the north of wall 104 and 1.95 m north of the house was a south-east to north-west orientated brick lined drain 105 (Figs 2, 3, 8, 9). The drain consisted of two single brick courses laid end to end and had an overall width of 0.40 m. The alignment of this drain may suggest it was not contemporary with walls 103 or 104, although drainage typically runs where necessary to move water, rather than respecting other structures. The relationship with wall 104 is not clear. The drain may have aided the movement of ground water away from the house and garden and/or may have been associated with the standpipe located against the garden wall approximately 0.70 m north-west of the drain. It is possible that the drain diverted rainwater from the roof to feed a below ground cistern which in turn fed the standpipe, but without opening a wider area around the trench it is not possible to determine the relationship and function of these features.
