Church View Barn Denchworth, Wantage, Oxfordshire

Archaeological Watching Brief Report

Ref: 108940.01
June 2015

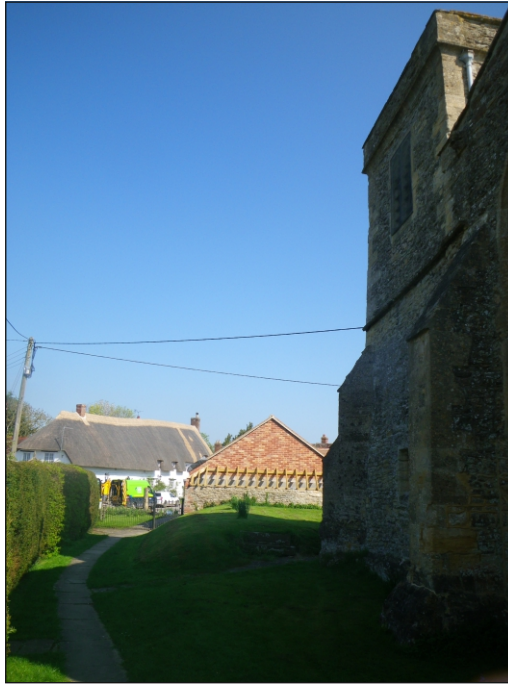
Plate 1: View of the village green and Church View Barn from the south showing the close proximity of the churchyard

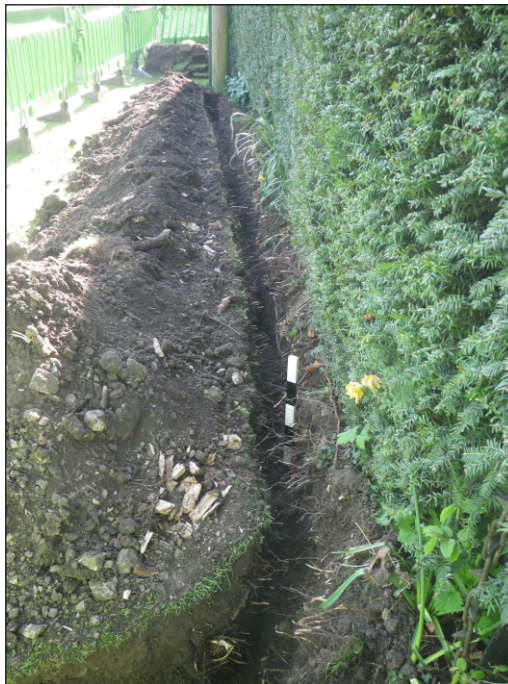
- 3.1.2 The 6.50m length of hand-excavated trench, located along the hedge-line from the support pole to the road at the south end of the village green, cut (to 0.50m below ground level) through a heavily bioturbated (roots) mid-brown, silty clay loam garden soil (**03**; **Plate 2**). The layer contained occasional fragments of late 19th–20th century material, including pottery, brick and an iron nail.

Plate 2: Southern section of trench from support pole to road; garden soil (03)

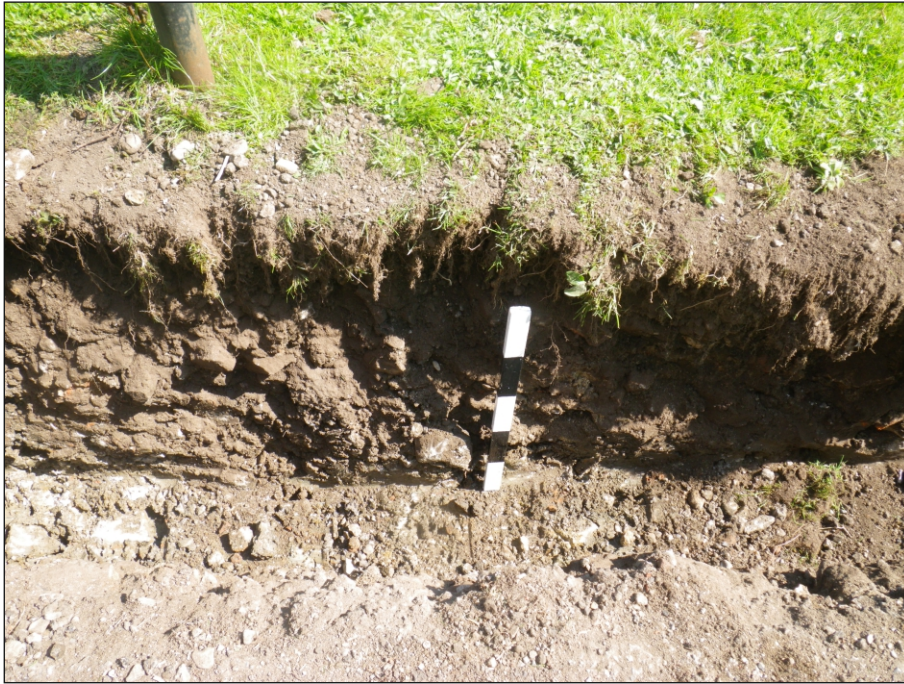
- 3.1.4 The make-up layers (**04/05/06**) comprised mid and dark greyish brown silty clay matrices, with common small subangular gravel in the upper 0.15-0.20m depth, and moderate-occasional small-medium subangular stone (sandstone) in the lower 0.20-0.30m (**Plate 3**). In places these two levels were separated by lenses of yellow gritty sand and black silty clay with charcoal flecks (**Plate 4**). Fragments of unfroged modern brick and tile were recovered at all levels, with occasional fragments of 19-early 20th century pottery, iron nails and a 1921 penny (base of **05**).

Plate 3: West facing section through road-side trench showing variations in road make-up (04); 2.75m from south end

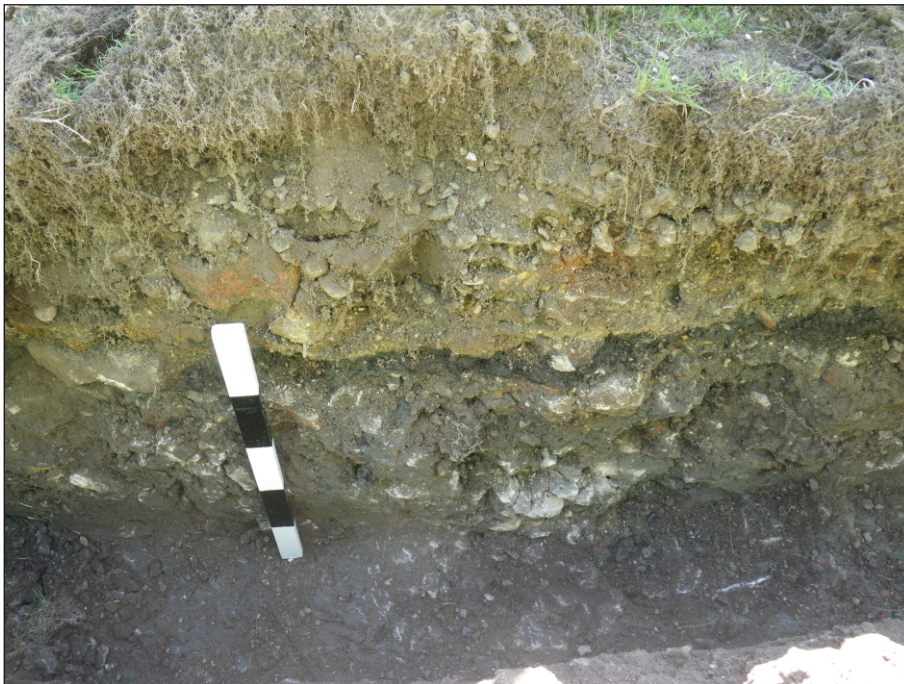
- 3.1.5 Where bottomed, the make-up layers overlay the natural clay (**07** and **08**) with the exception of a 0.50m width comprising a dense stone 'outcrop' situated 8.50m from the south end of the trench. The fractured stone was of the same type (sandstone) seen in the make-up layers and may have been natural (no well-defined edges to 'outcrop'; **Plate 4**).

Plate 4: West facing section through road-side trench showing variations in road make-up (04) and band of compact stone across base; 4.50m from south end

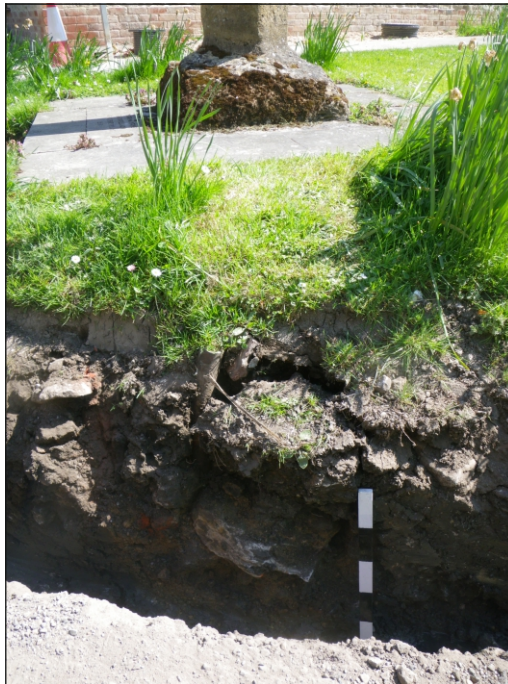
- 3.1.6 At the north end of the village green, adjacent to the relocated village cross, an upright metal post-pipe, with a large stone apparently acting as packing, was observed in the west-facing section (**09**). At the same level, within the trench itself, the remnant of a wooden post were also encountered (**Figure 2**; **Plates 5 and 6**). The location of these features, evident from the turf line and 20th century in date, corresponded with the point at which ground-water began to rise from the base of the trench. Anecdotal evidence suggests this may have been the former location of a water pump.

Plate 5: Metal post-pipe and stone packing (09) at north end of village green with village cross in background

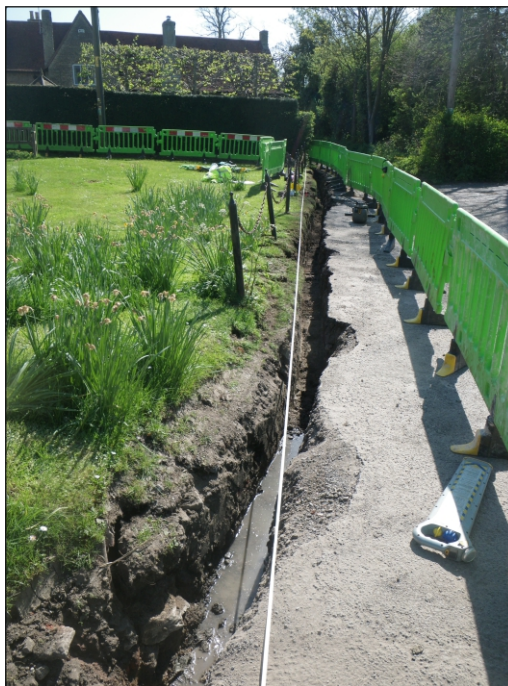
- 3.1.8 For a c. 3m length of the road-side trench, at the north end of the village green adjacent to **09**, the clay is dark grey with an organic content indicative of former/extant waterlogging. Some of the natural to the south in the road-side trench had a similar appearance. No finds were recovered from the clay.

5.1.2 The presence of ground-water at the north end of the road-side trench, in conjunction with implied waterlogging of the natural clay, suggests the presence of a former water-source and possibly a waterlogged area. The potential presence of a water pump is also suggested but was not investigated.

Plate 6: View of road-side trench from north showing post-pipe and packing (09) and ground water

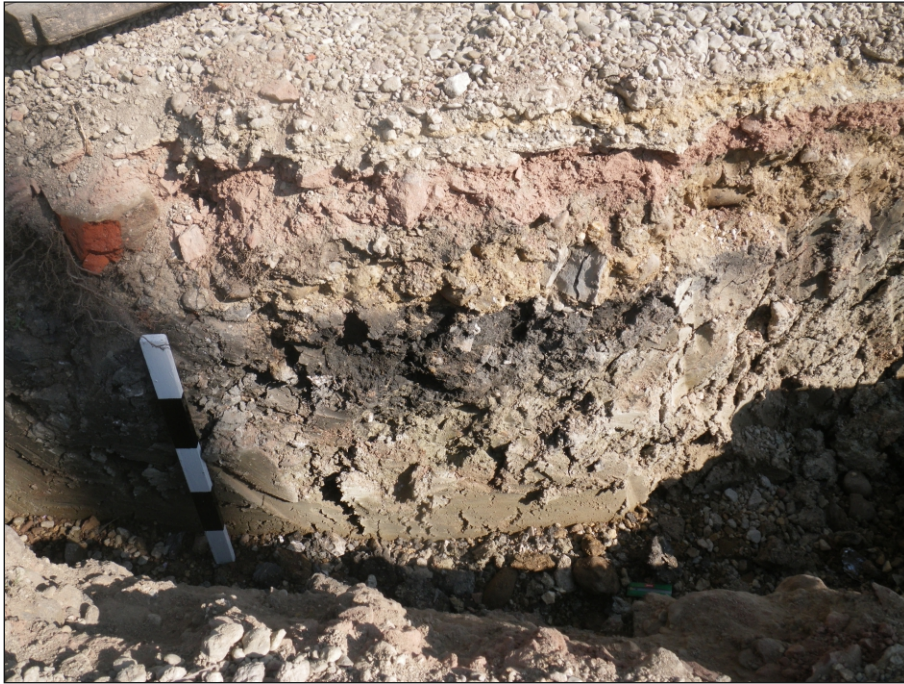
paths/hard standing overlay a small pit (**02**) with a fill of dark grey slightly silty clay from which a few animal bones were recovered (**Plate 7**).

Plate 7: South-facing section through the trench on the northern property boundary of Church View Barn showing pit **02**
