# Army Basing Programme (ABP) Salisbury Plain Camps

2016 Phase Historic Building Record: Bulford Camp

Ref: 104783.02  
October 2016

This report deals with the building recording works at Bulford Camp, where 13 buildings were recorded to Historic England Levels 1-3. A separate report details the building recording at Larkhill Camp. No buildings were recommended for recording at Perham Down Camp.

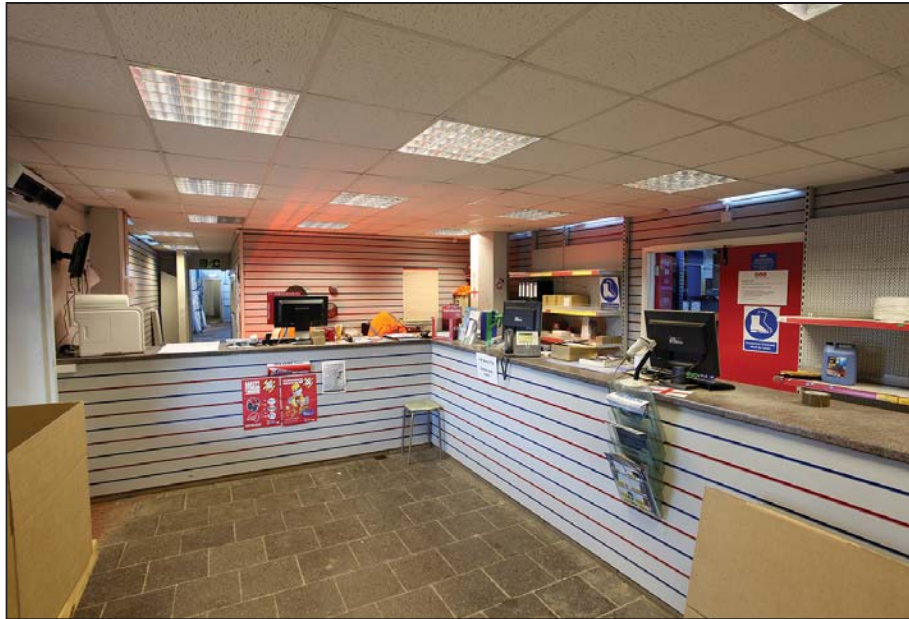
Plate 5: WD 0 040 ground floor reception area viewed from the north showing the later partition walls and ceiling around the original concrete column framework.

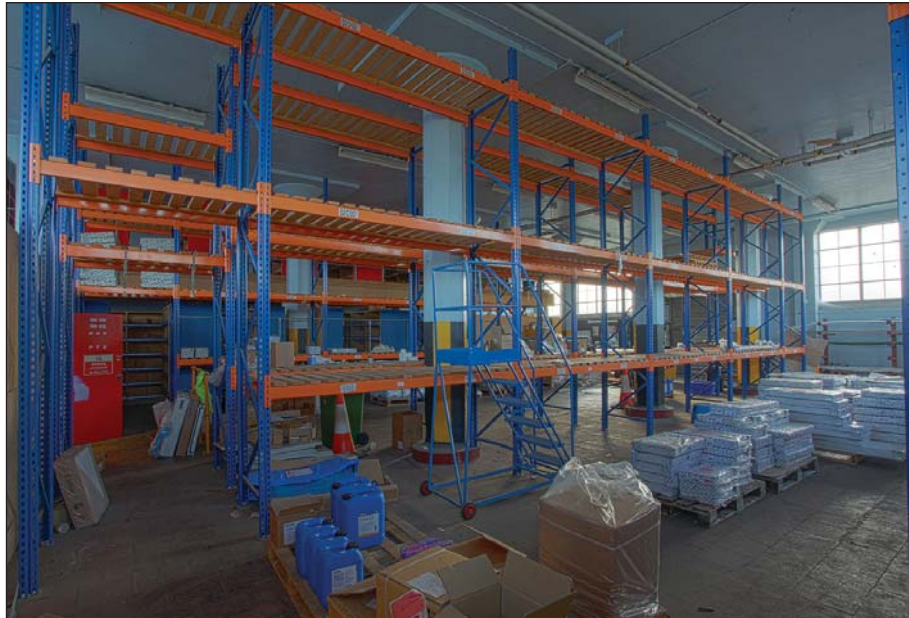
Plate 6: WD 0 040 ground floor storage space with concrete column framework viewed from the north.

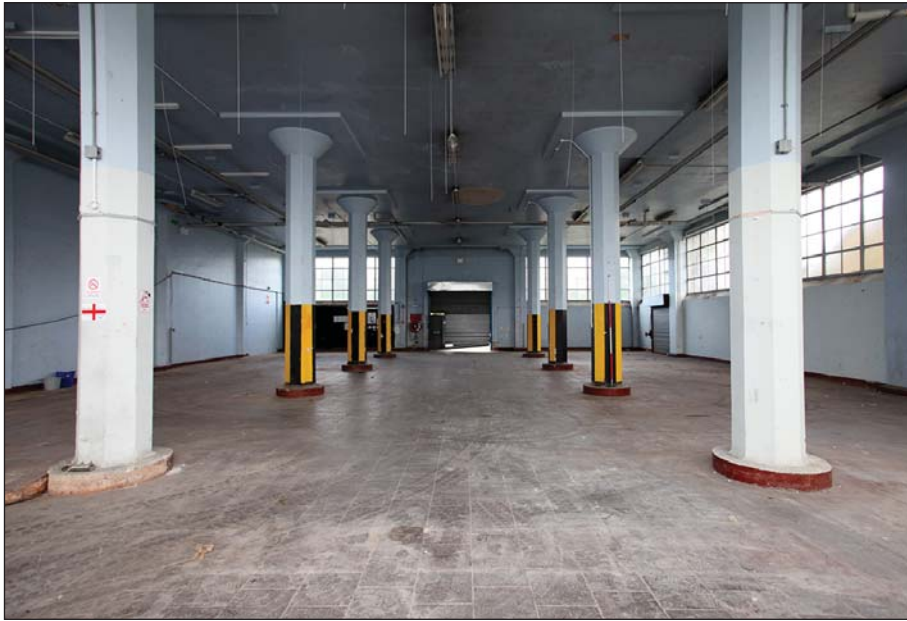
Plate 7: WD 0 040 ground floor. Original bread store after the later phase reception area had been removed and store room cleared.

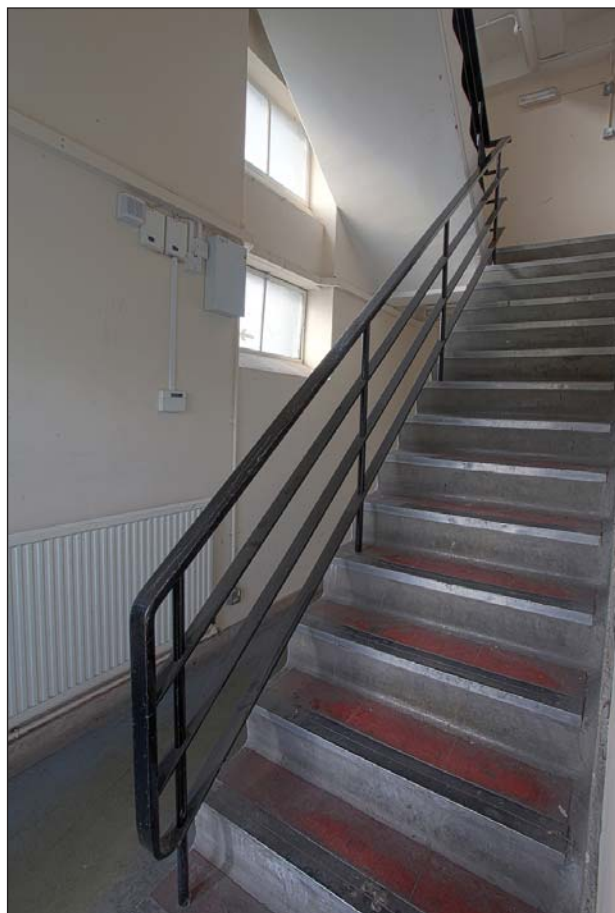
Plate 10: WD 0 040 ground floor. South corner stairwell. It contains its original staircase and column of windows.

- 4.2.18 Stairwells (**Plate 10**) at the east and south corners of the building provide access to the mezzanine and first floor levels. The mezzanine level is located at the south-east end of the building. It is divided in two by the boiler house, which has a high ceiling and high level platform with a chimney breast on it at the north-west end. The boiler is located on a raised concrete platform but the equipment is clearly a later replacement - the flues pass through the ceiling rather than into the high level chimney breast (**Plates 14-15**). As with the ground floor, the mezzanine level has been subdivided since its initial construction. It originally contained the male and female rest rooms, with the boiler house between, but the rest rooms have since been converted and subdivided into three offices (**Plates 16-17**).

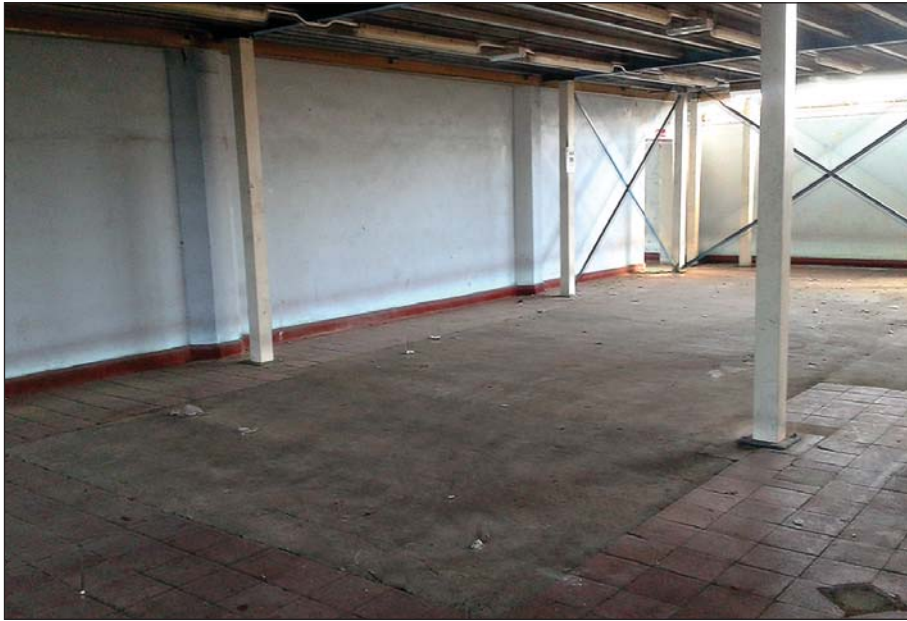
Plate 13: WD 0 040 ground floor. Oven room untiled floor surface that marks the location of the oven.

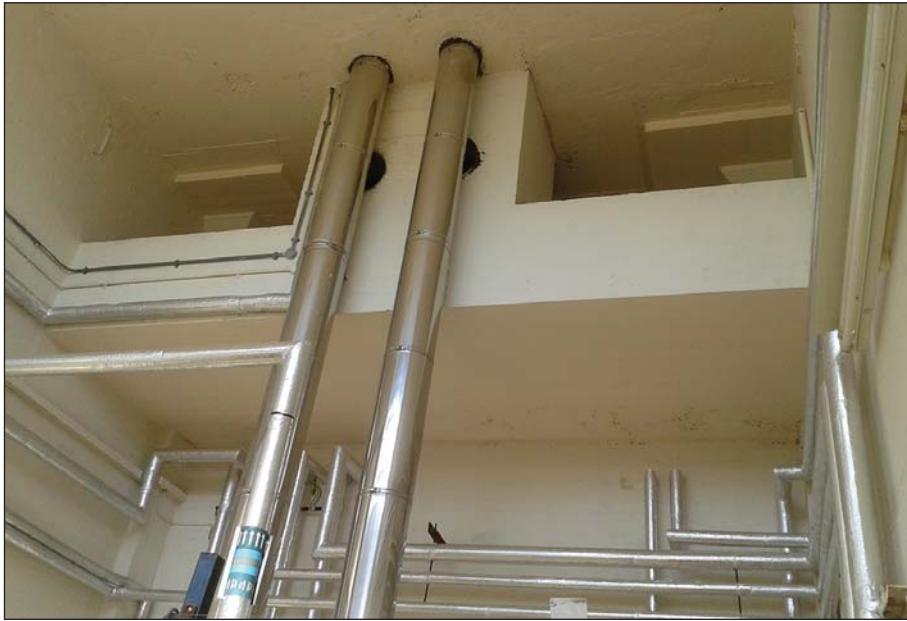
Plate 15: WD 0 040 ground floor. Boiler house high level platform and chimney breast at the north-west end.

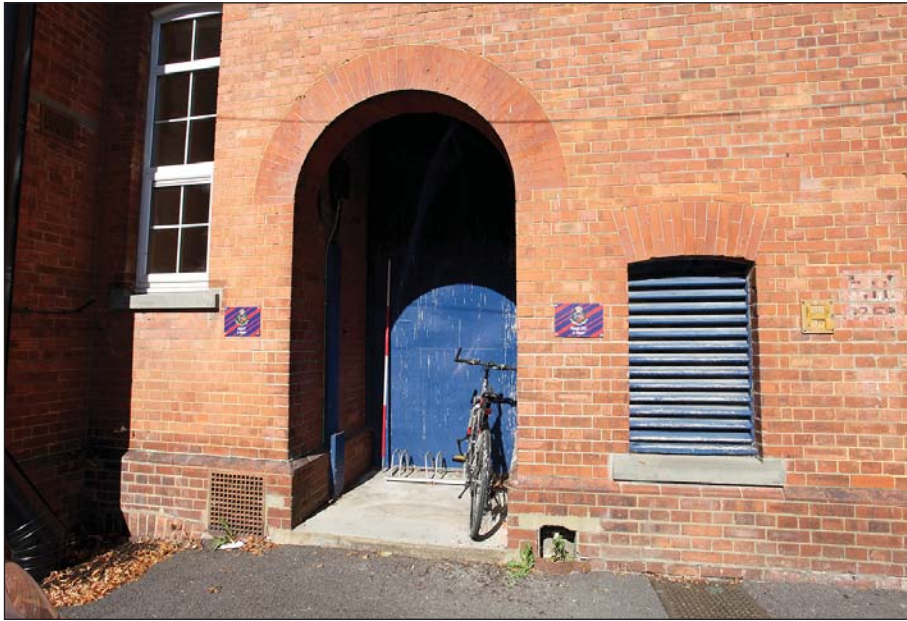
Plate 33: WI 0 082 blocked door on the south-east side of the building. Note the blocked window with its arched head visible to the left of the door and shuttered window and painted fire hydrant sign to the right.

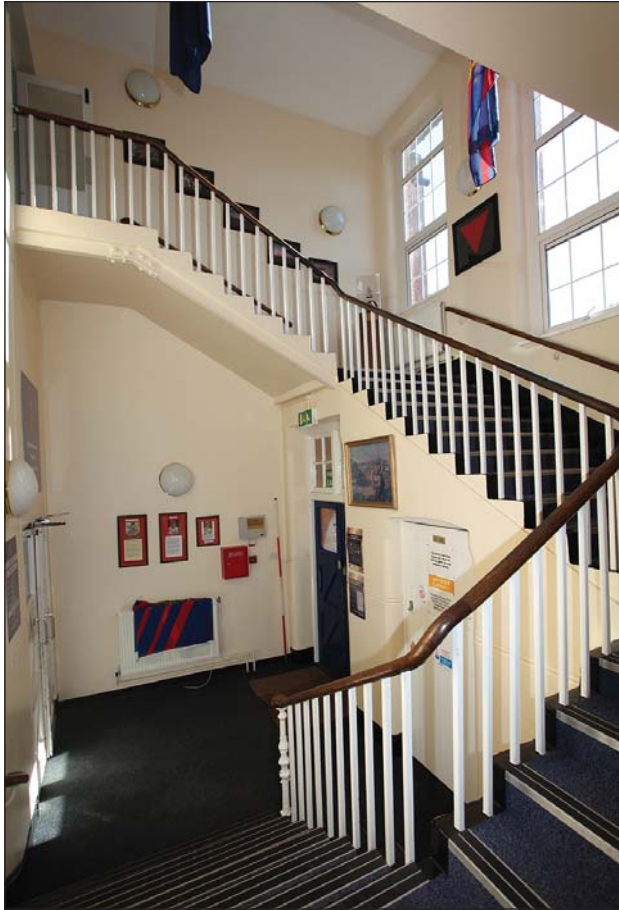
Plate 37: WI 0 082 lobby and stairwell (0.1). The I-beam that supports the upper flight of stairs is visible (top left).

- 4.4.28 The open well staircase (**Plates 36-38**) has a simple stick balustrade and timber handrail but a more elaborate floral motif metal newel post at the base of the stairs; probably cast-iron (**Plate 38**). The stairs themselves appears to be concrete. The upper flight which spans to the first floor is supported by bolted I-beams (**Plate 37**). Floors throughout the building including the stairs are carpeted, except for the kitchen and toilets, which have a hard-wearing plastic floor surface.

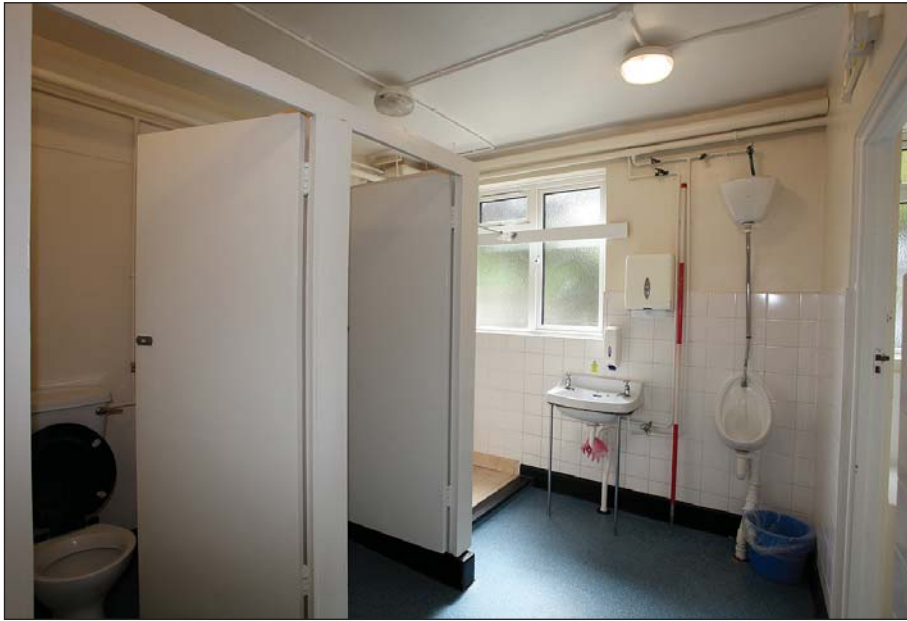
Plate 81: WI 0 216 ablutions room viewed from the north.

- 4.10.15 The ablutions room (**Plates 81-82**) retains the same layout as shown on the architect's drawings except one of the two baths has been replaced by two showers. The majority of fixtures and fittings within the ablutions room have been updated but the toilet cubicles and seat within the bathroom appear to be original. The wall finishes and floor surface also appear to be updated. The walls are partially painted, partially tiled and the floor surface is a mixture of tiles in the shower areas and hard plastic sheeting.

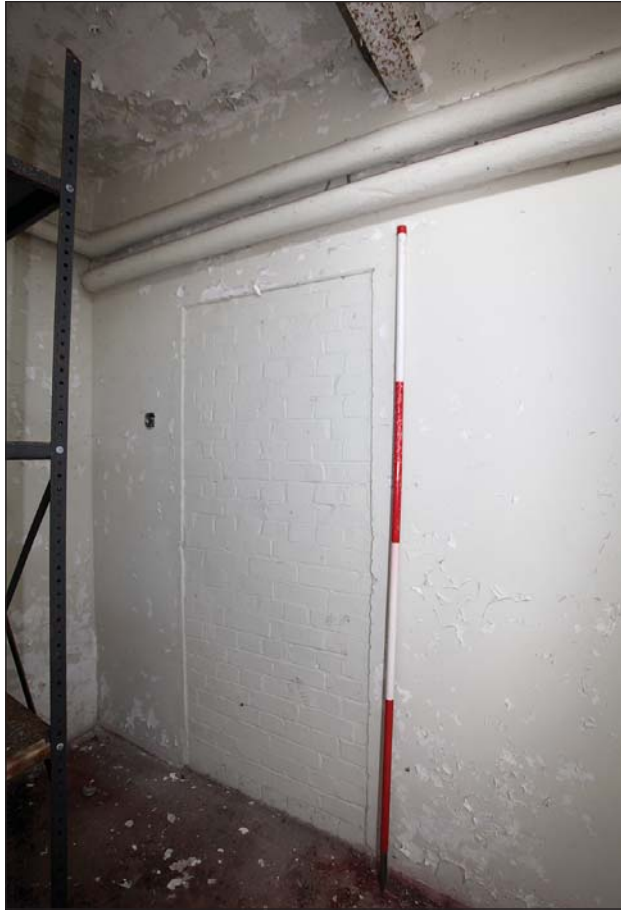
Plate 101: WI 0 235 the blocked door opening between the north and south areas

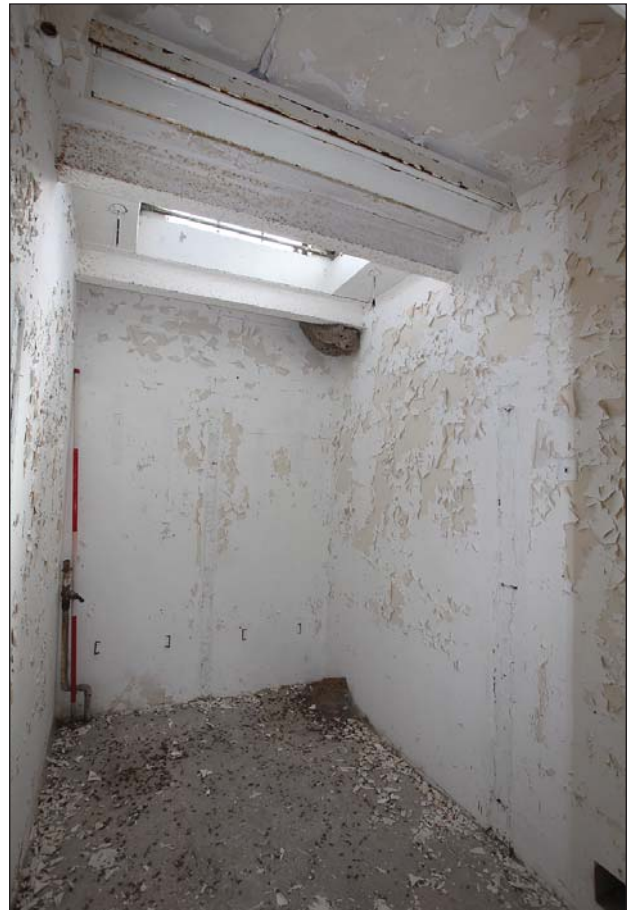
Plate 104: WI 0 235 smallest store room in the south area. Note the vertical scars on the walls that mark the position of removed shelving partitions.

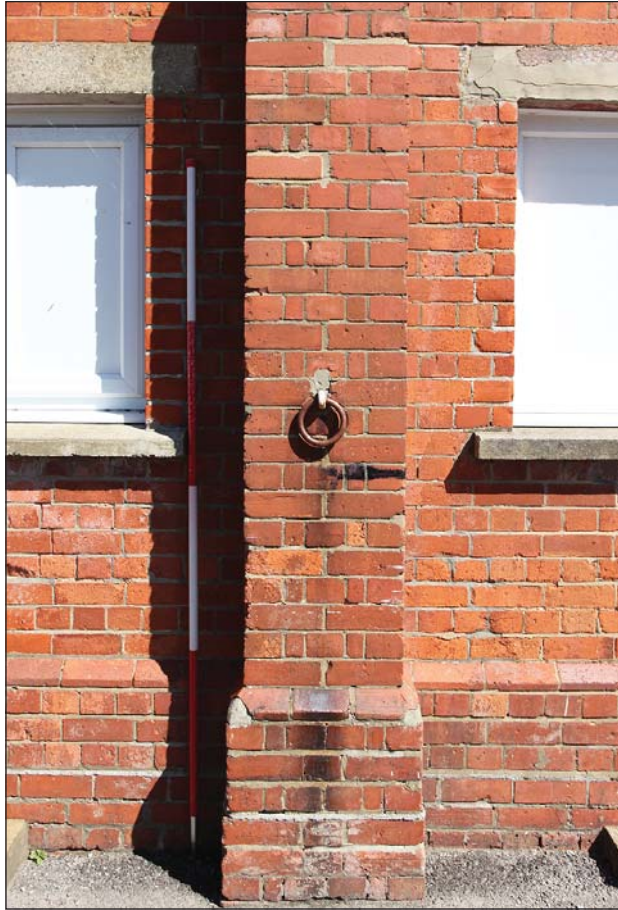
Plate 109: KW 0 415 riding school iron ring fixed to the south-west elevation.

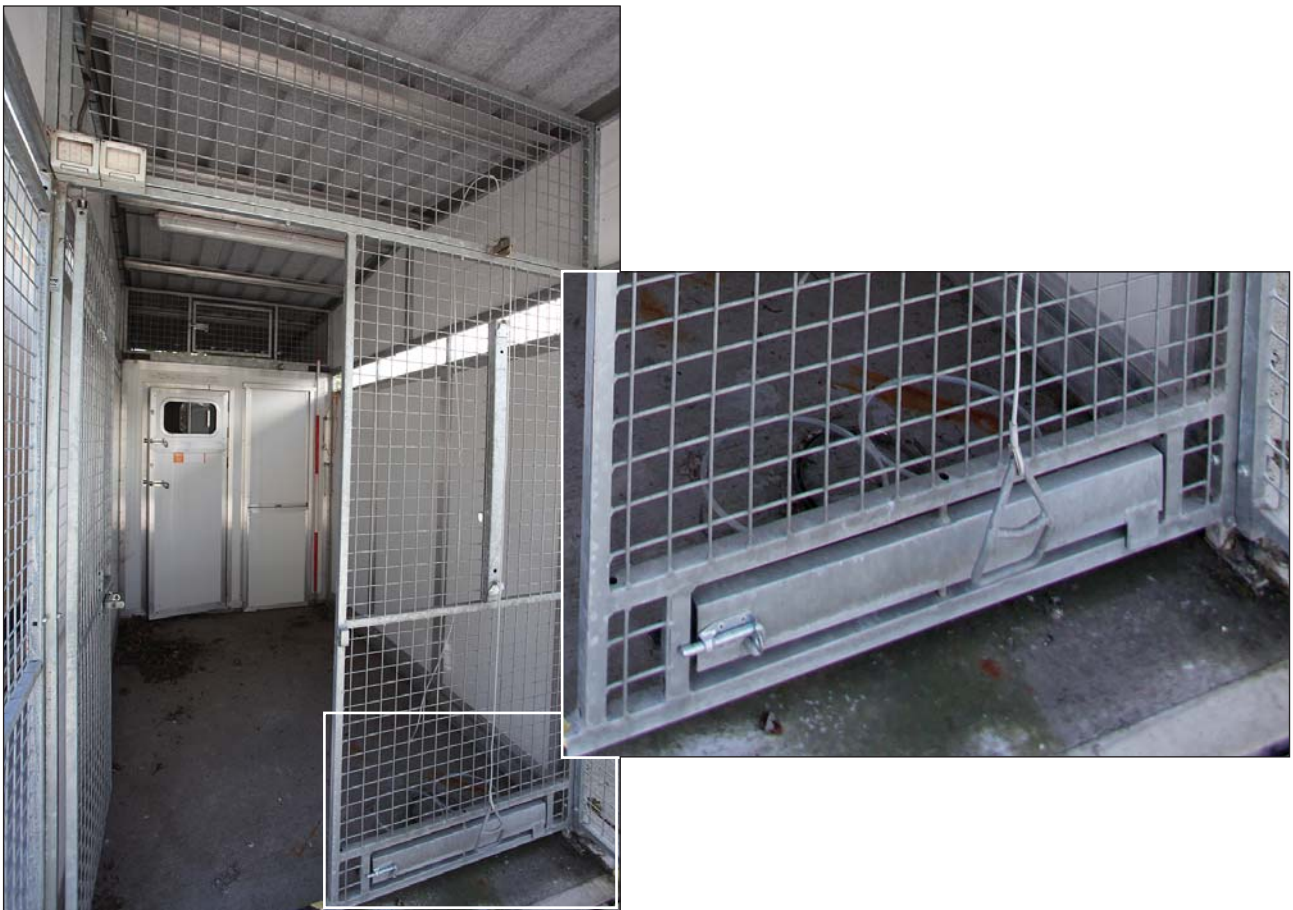
Plate 124: PC A 707 kennel bay. Note the rotating food hatch (inset) and pulley system for the sleeping enclosure hatch (right).
