Milepost on Boreham Road Warminster, Wiltshire

Conservation and Refurbishment Works

Planning Ref: 13/06783/LBC
Ref: 115070.02
March 2017

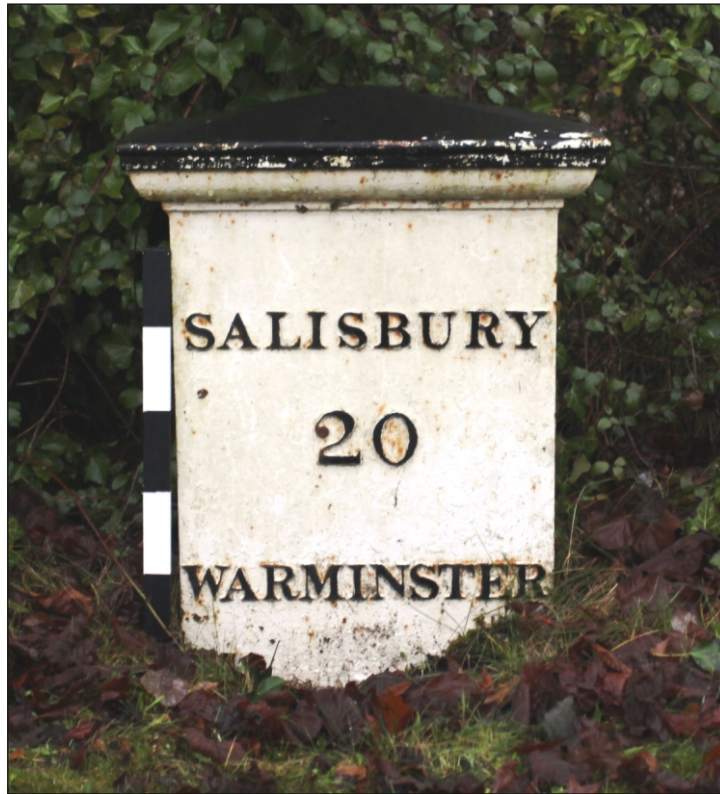
Plate 1: The cast iron milepost on Boreham Road prior to conservation

- 5.2.6 Compared to other, much more corroded examples nearby, the Boreham Road milepost was in reasonable condition having been occasionally painted by a local resident (**Plate 1**), although upon initial inspection there were sporadic small areas of corrosion, as well as blistering and flaking paint visible on the upper part of the milepost exposed above ground. Following its excavation, the damaged paintwork and corrosion to the previously buried lower section was much more extensive where it had been in direct contact with the soil (**Plate 6**).

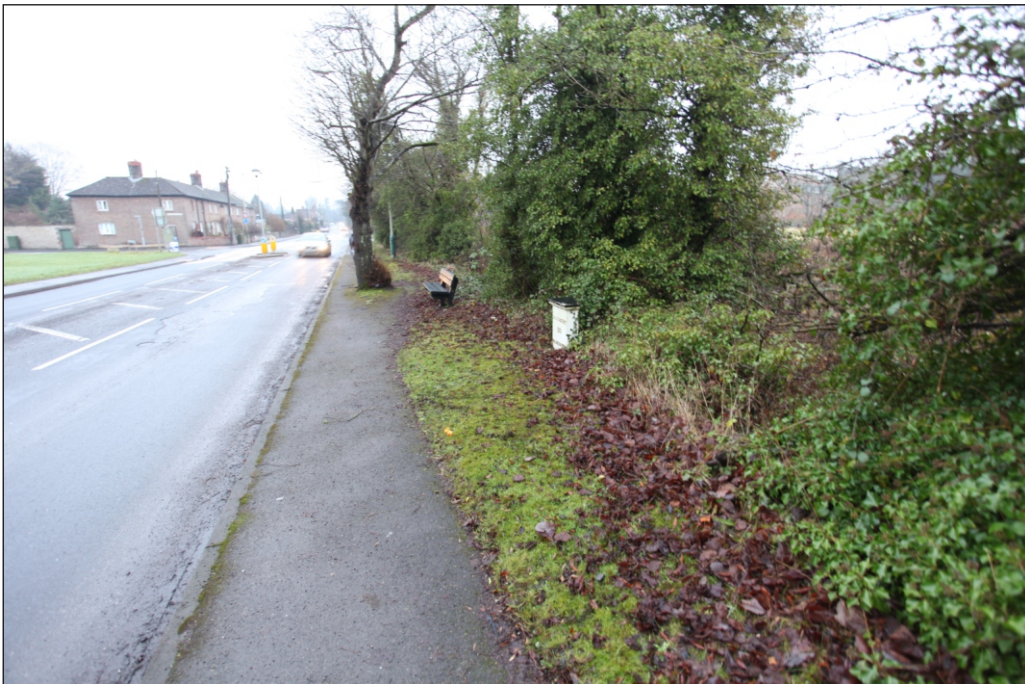
Plate 2: The milepost on Boreham Road prior to conservation showing its position in relation to the Woodcock Road junction (left)

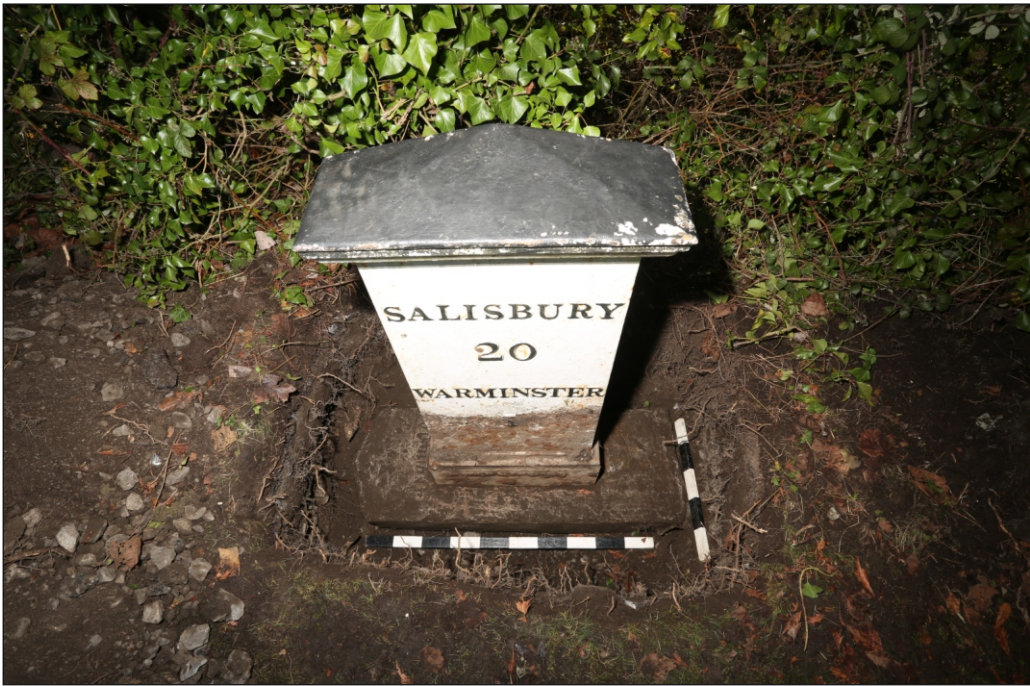
Plate 3: The milepost and milestone beneath it fully exposed prior to lifting

- 5.2.7 Interestingly, when excavated it was found that the cast iron milepost had been deliberately set into an earlier milestone laid horizontally beneath it as a base. To enable stability, two protruding feet at the base of the milepost had been fitted into sockets cut in the face of the milestone beneath. In order to avoid any movement, and to prevent later splitting of the stone following expansion of the corroded iron feet, the remaining space around the feet had been filled with poured molten lead forming a solid and stable joint between the milepost and milestone. In addition to the leadwork, corrosion of the iron milepost base meant a very tight joint, so that it would have been very difficult to separate the two entities without causing severe damage to the milestone or breaking off the feet of the milepost.

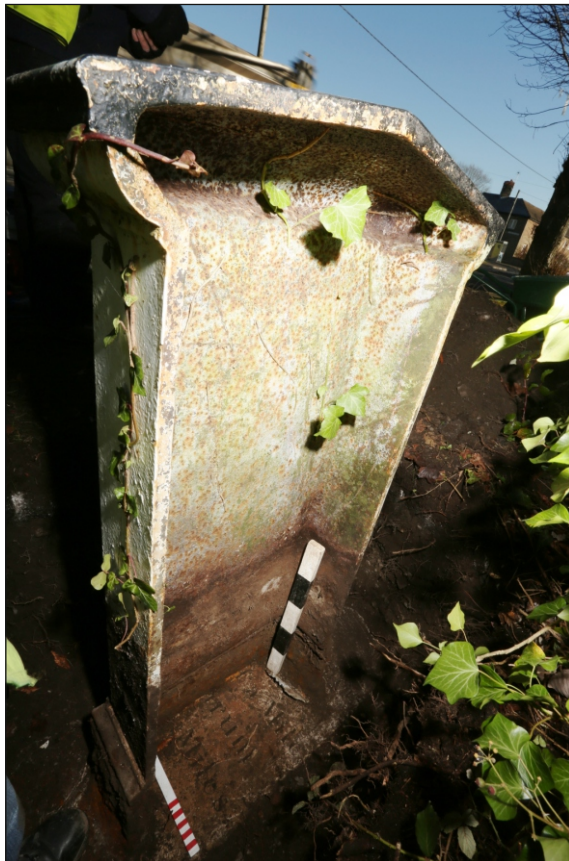
Plate 4: The rear of the milepost and the milestone beneath it prior to lifting

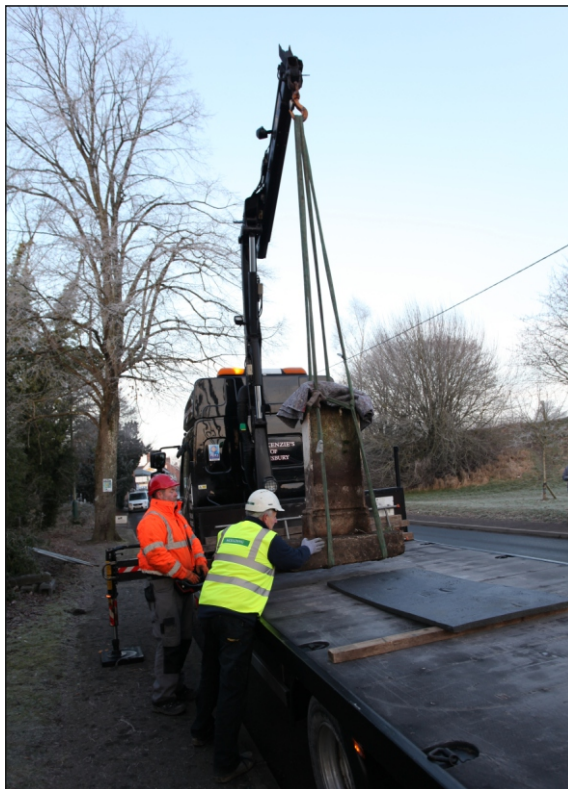
Plate 5: Lifting of the milepost and milestone

- 4.2.3 In order to lift the milepost and attached stone, the two were gently rocked back and forth in order to pass strops beneath the stone. The strops were tied around the post which was padded with blankets to cushion it. The strops were attached to a hoist arm of the lorry and the milepost and stone were carefully lifted onto the flat bed. More blankets and foam pads were used to cushion the milepost and stone and it was strapped securely to the lorry. At the WA Salisbury office, the hoist was used to transfer the milepost and stone to a wooden pallet before being transported into the workshop for conservation and refurbishment.

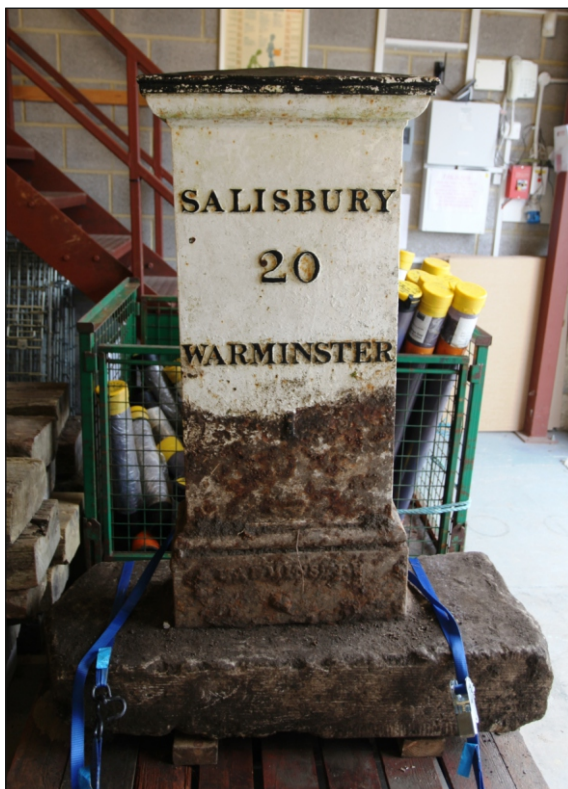
Plate 6: The milepost and milestone prior to conservation

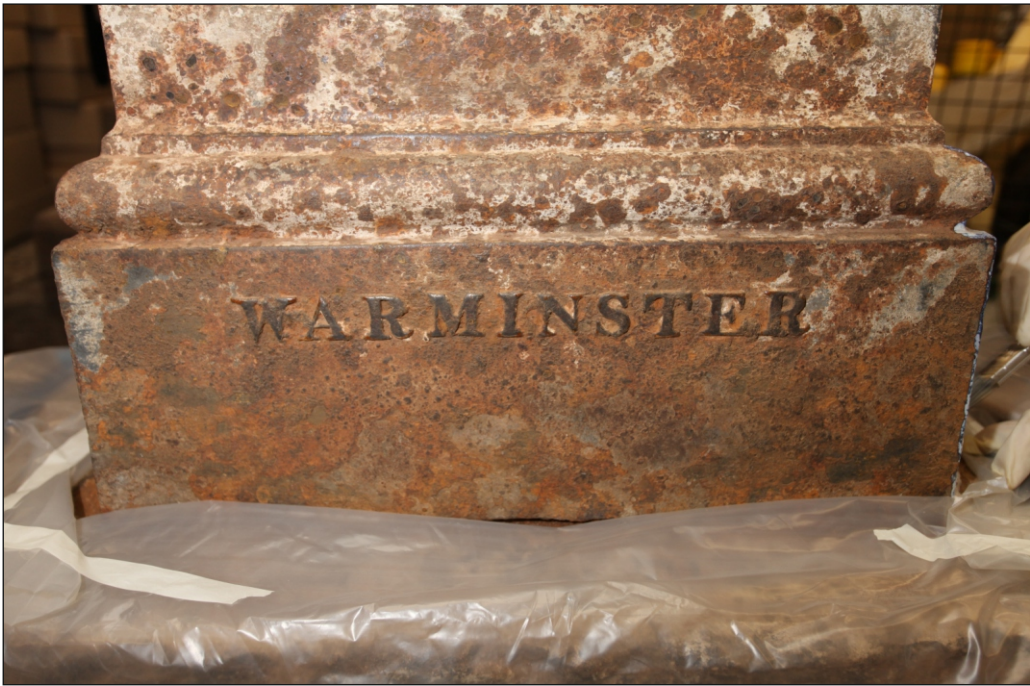
Plate 7: Detail of the base of the milepost after removal of ferrous concretions showing the raised text 'WARMINSTER'

- 4.4.4 After drying, loose and excess paint was removed from the milepost using soft metal tools and specialist aluminium oxide sandpaper. Ferrous concretions and loose rust were removed in the same way.

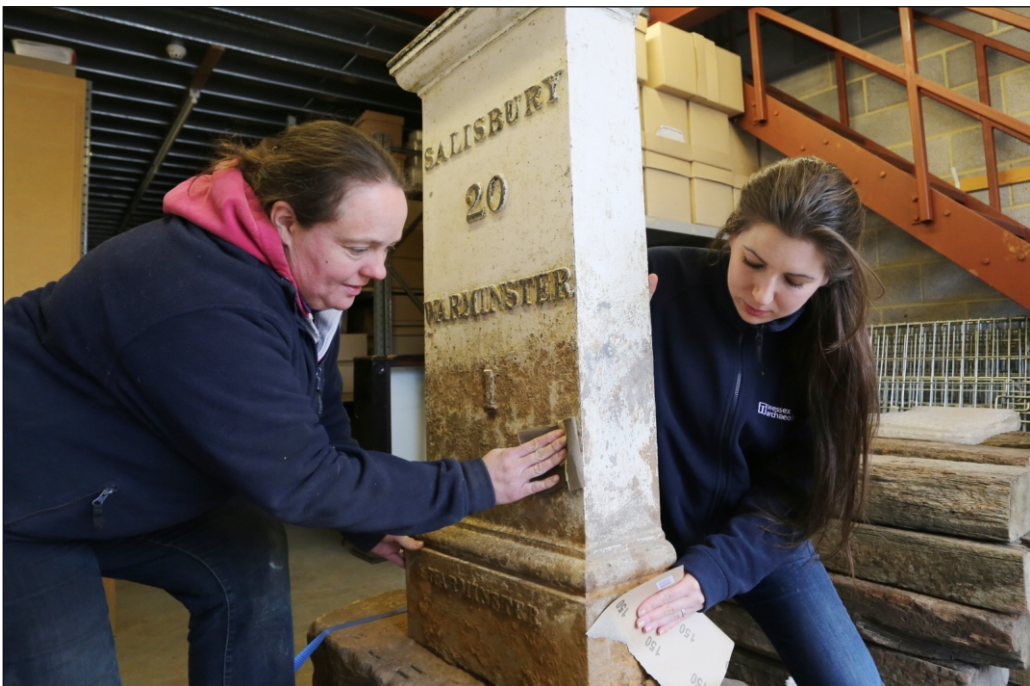
Plate 8: Removal of ferrous concretions prior to treatment with rust converter

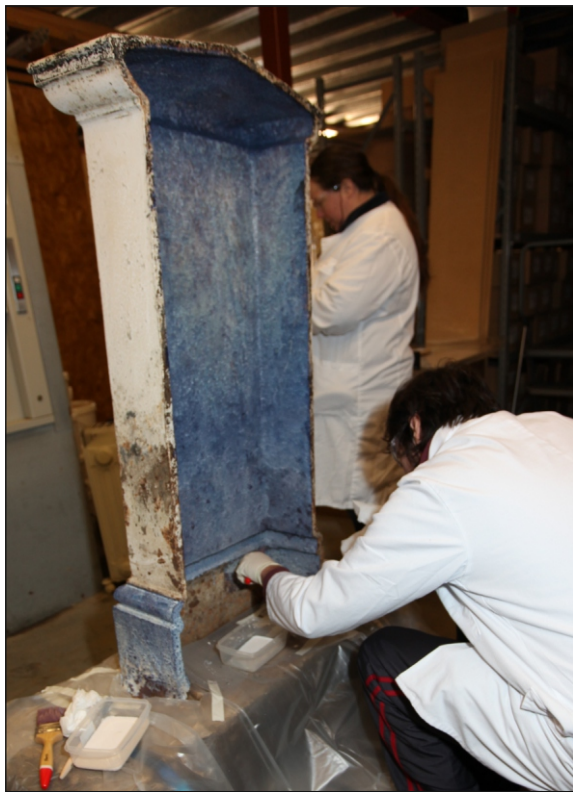
Plate 9: Treating the milestone with rust converter

- 4.4.5 The exposed iron surfaces of the milepost were treated with Hammerite 'Kurst' (an emulsion of tannic acid, 1-methoxy-2-propanol and ammonia), applied with a soft paintbrush. The 'Kurst' was left to convert the iron corrosion products on the surface to passive iron corrosion products.

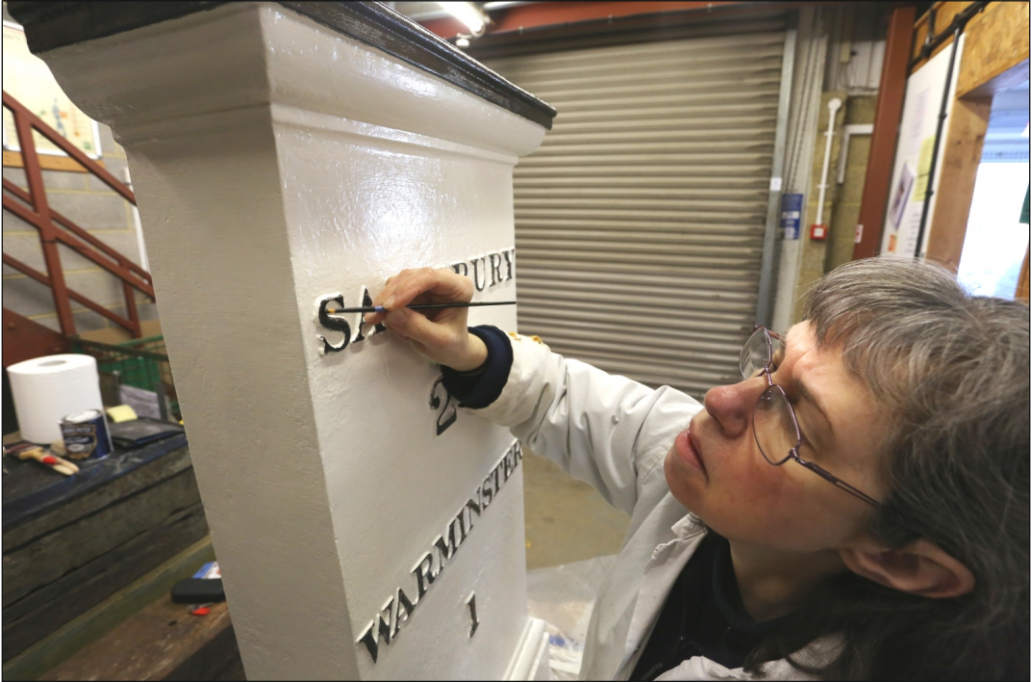
Plate 10: Repainting the milestone

- 4.4.7 The milepost was painted with specialist Hammerite metal paint. Three coats of black paint were applied to the top and three coats of white elsewhere. The lettering was also hand painted with the same black paint.

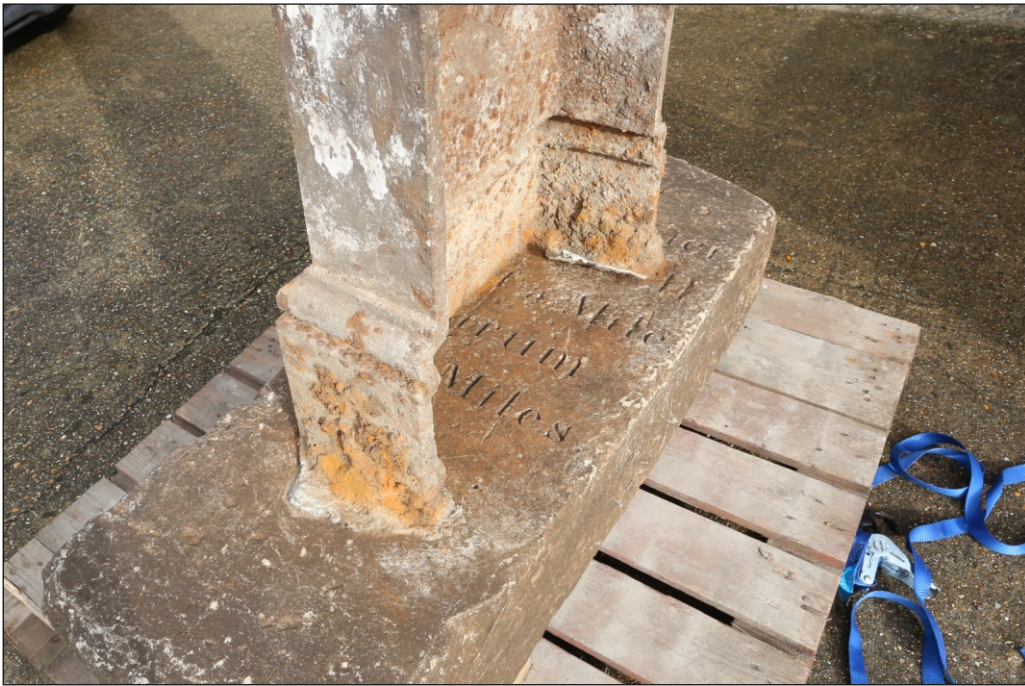
- 5.2.8 The base milestone measured 1.15 m in length, 0.41 m in width and 0.23 m in depth. The head of stone formed a pointed arch. The upper face had an inscription carved into the surface in late 18th – early 19th century style script, with no long/medial 's'. **Plates 11-12** show the inscription from different angles. Although it was partially obscured by the milepost above, the milestone was in good condition with writing clearly legible. It read:

Plate 11: View of the milestone inscription from the bottom right, prior to conservation

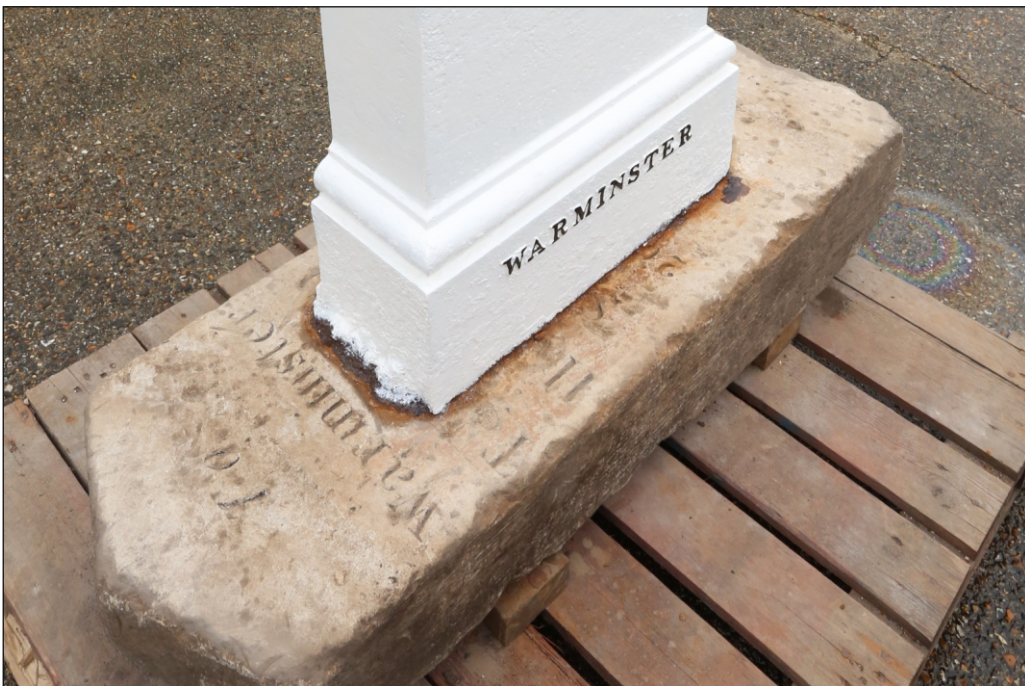
Plate 12: View of the milestone inscription from the top left, after conservation

- 4.4.3 In order to create a stable surface, the milepost was first washed with a solution of 'Sugar Soap' to remove grease and dust. Soil was removed from the top surface of the base milestone using soft brushes and water. As the stone appeared in good condition, there was no further treatment of the milestone.

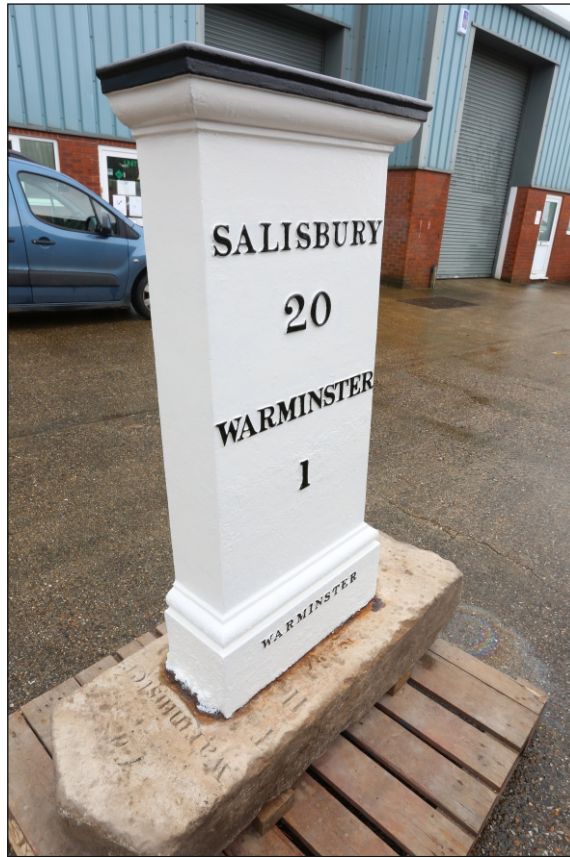
Plate 13: The milepost and milestone after conservation

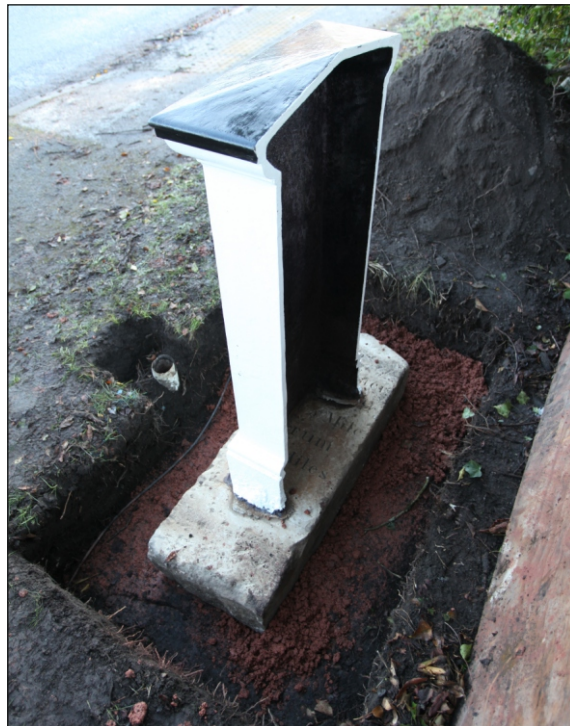
Plate 14: Reinstatement of the milepost and milestone in progress

- 4.2.4 Following conservation and refurbishment of the milepost, it was lifted and transported to site by HIAB lorry. Prior to the reinstatement, a small trench was excavated in the agreed new location using hand tools. The works were monitored by WA staff. The excavated trench was partially filled with scalpings (a compactable mixed matrix of limestone chippings and dust) to provide a foundation for the refurbished milepost and stone. The stone was packed round with more scalpings to stabilise it and the top of the trench backfilled with topsoil.

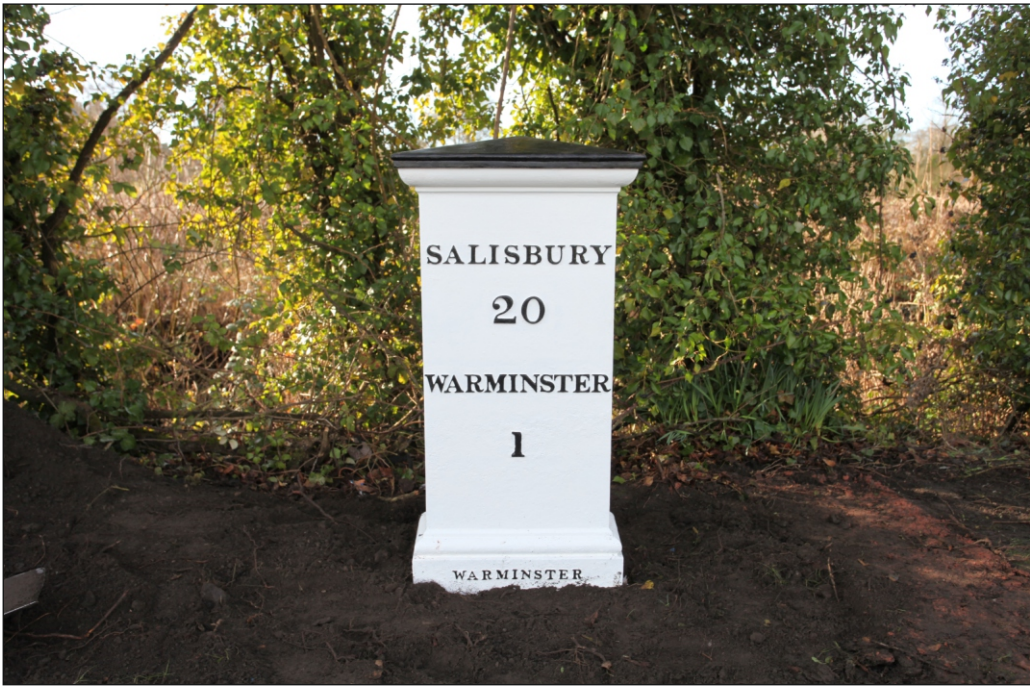
Plate 15: The milepost reinstated

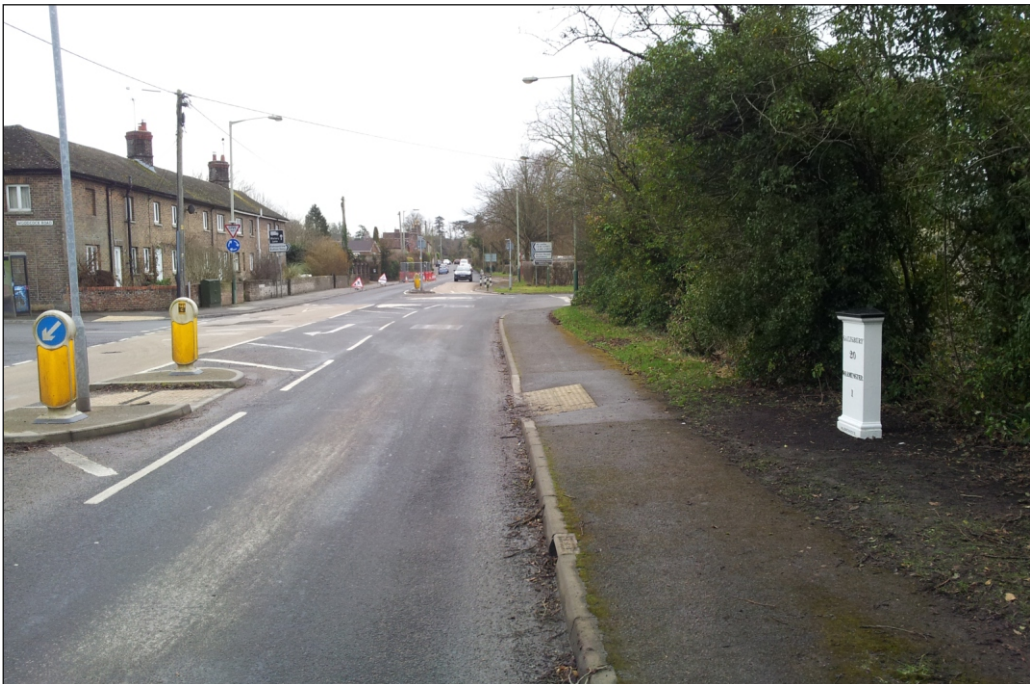
Plate 16: The milepost in its new position relative to the Boreham Road-Woodcock Road and Bishopstrow Road junctions
