Marshalls Mills Leeds

Post-excavation Assessment and Updated Project Design

Document title	Marshall's A&B Mills, Holbeck, Leeds, West Yorkshire
Document subtitle	Post-excavation Assessment and Updated Project Design
Document reference	210750.04
Client name	ECUS Limited
Address	3 Blackburn Road Sheffield South Yorkshire S61 2DW
On behalf of	CEG
Address	Number One, Great Exhibition Way, Kirkstall Forge, Leeds, LS5 3BF
Site location	Globe Road, Holbeck Leeds
County	West Yorkshire
National grid reference (NGR)	429466 432956 (SE 29466 32956)
Statutory designations	None
Planning authority	Leeds City Council
Planning reference	17/0645/FU
Museum name	Leeds Museums
Museum accession code	TBC
WA project code	210750
Date(s) of fieldwork	12 March to 03 June 2019
Fieldwork directed by	Emily Eastwood
Project management by	Milica Rajic
Document compiled by	Emily Eastwood
Contributions from	Lorraine Mepham (finds), Lorrain Higbee (animal bone), Fiona Eaglesham (environmental), Inés López-Dóriga (environmental), and Liz Chambers (environmental).

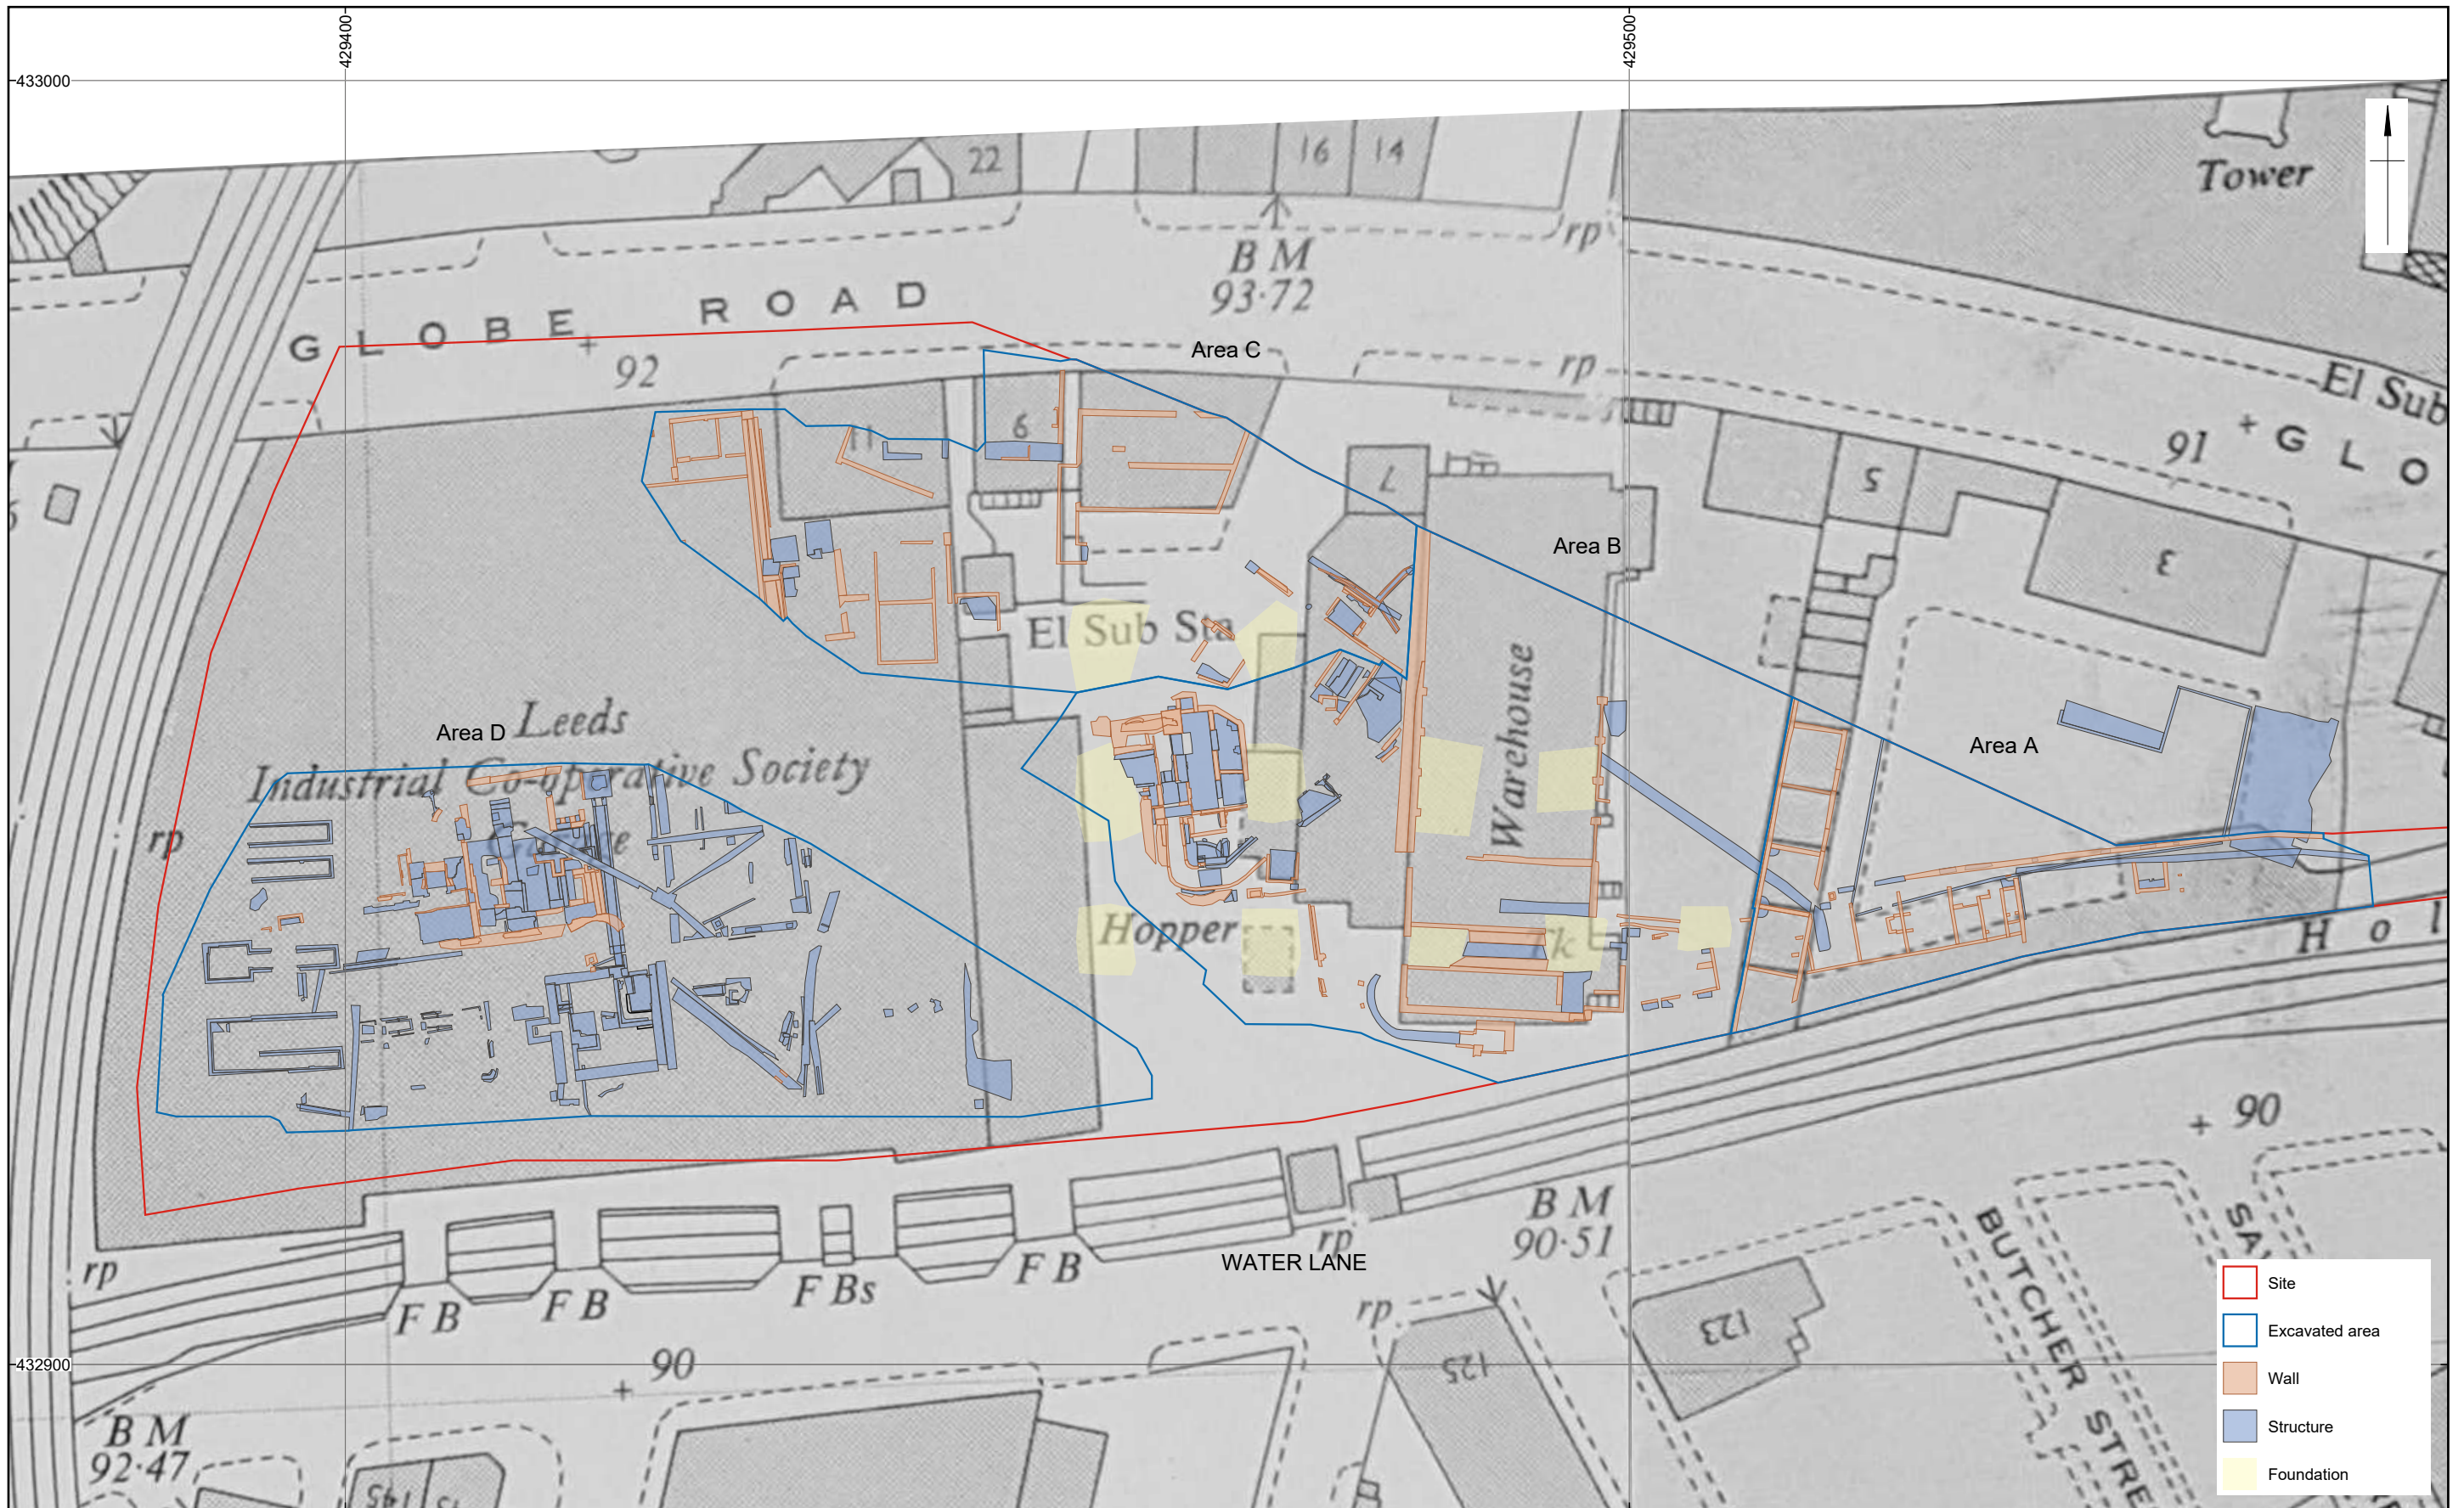
Figure 7

- 5.4.7 The western end of Area A was delineated by the west wall of a north to south running building (1040; **PI. 2**) and associated cobble surface (1446). The structure correlates to buildings on the 1901 Goad Fire Insurance plan (**Fig. 7**) labelled as stables, specifically 'loose box' stalls (a secure space to keep one untied horse). An associated east to west running cobbled surface (1446) correlates with a cart access depicted on a historic map (**Fig. 7**). The machine-made brick foundations of the loose boxes (1040) truncated building 1008 leaving it unclear as to whether the western walls 1106 and 1112 (see Area B below) are a continuation of 1008 or a separate structure.

Site plan overlay on 1901 Goad map

By 1901, a stables complex had been constructed at the far east of the site, spanning the entirety of Area A. The excavated remains of the stables included a series of loose boxes for keeping horses, and a cart track as labelled on the 1901 Goad plan of the area.

- 5.1.11 The eastern end of the site had been developed into a stable complex following demolition of mill buildings in this area. Structure 1040 and associated cobbled surfaces excavated in Area A correspond with loose boxes and a cart track shown on the 1901 Goad Fire Insurance plan.

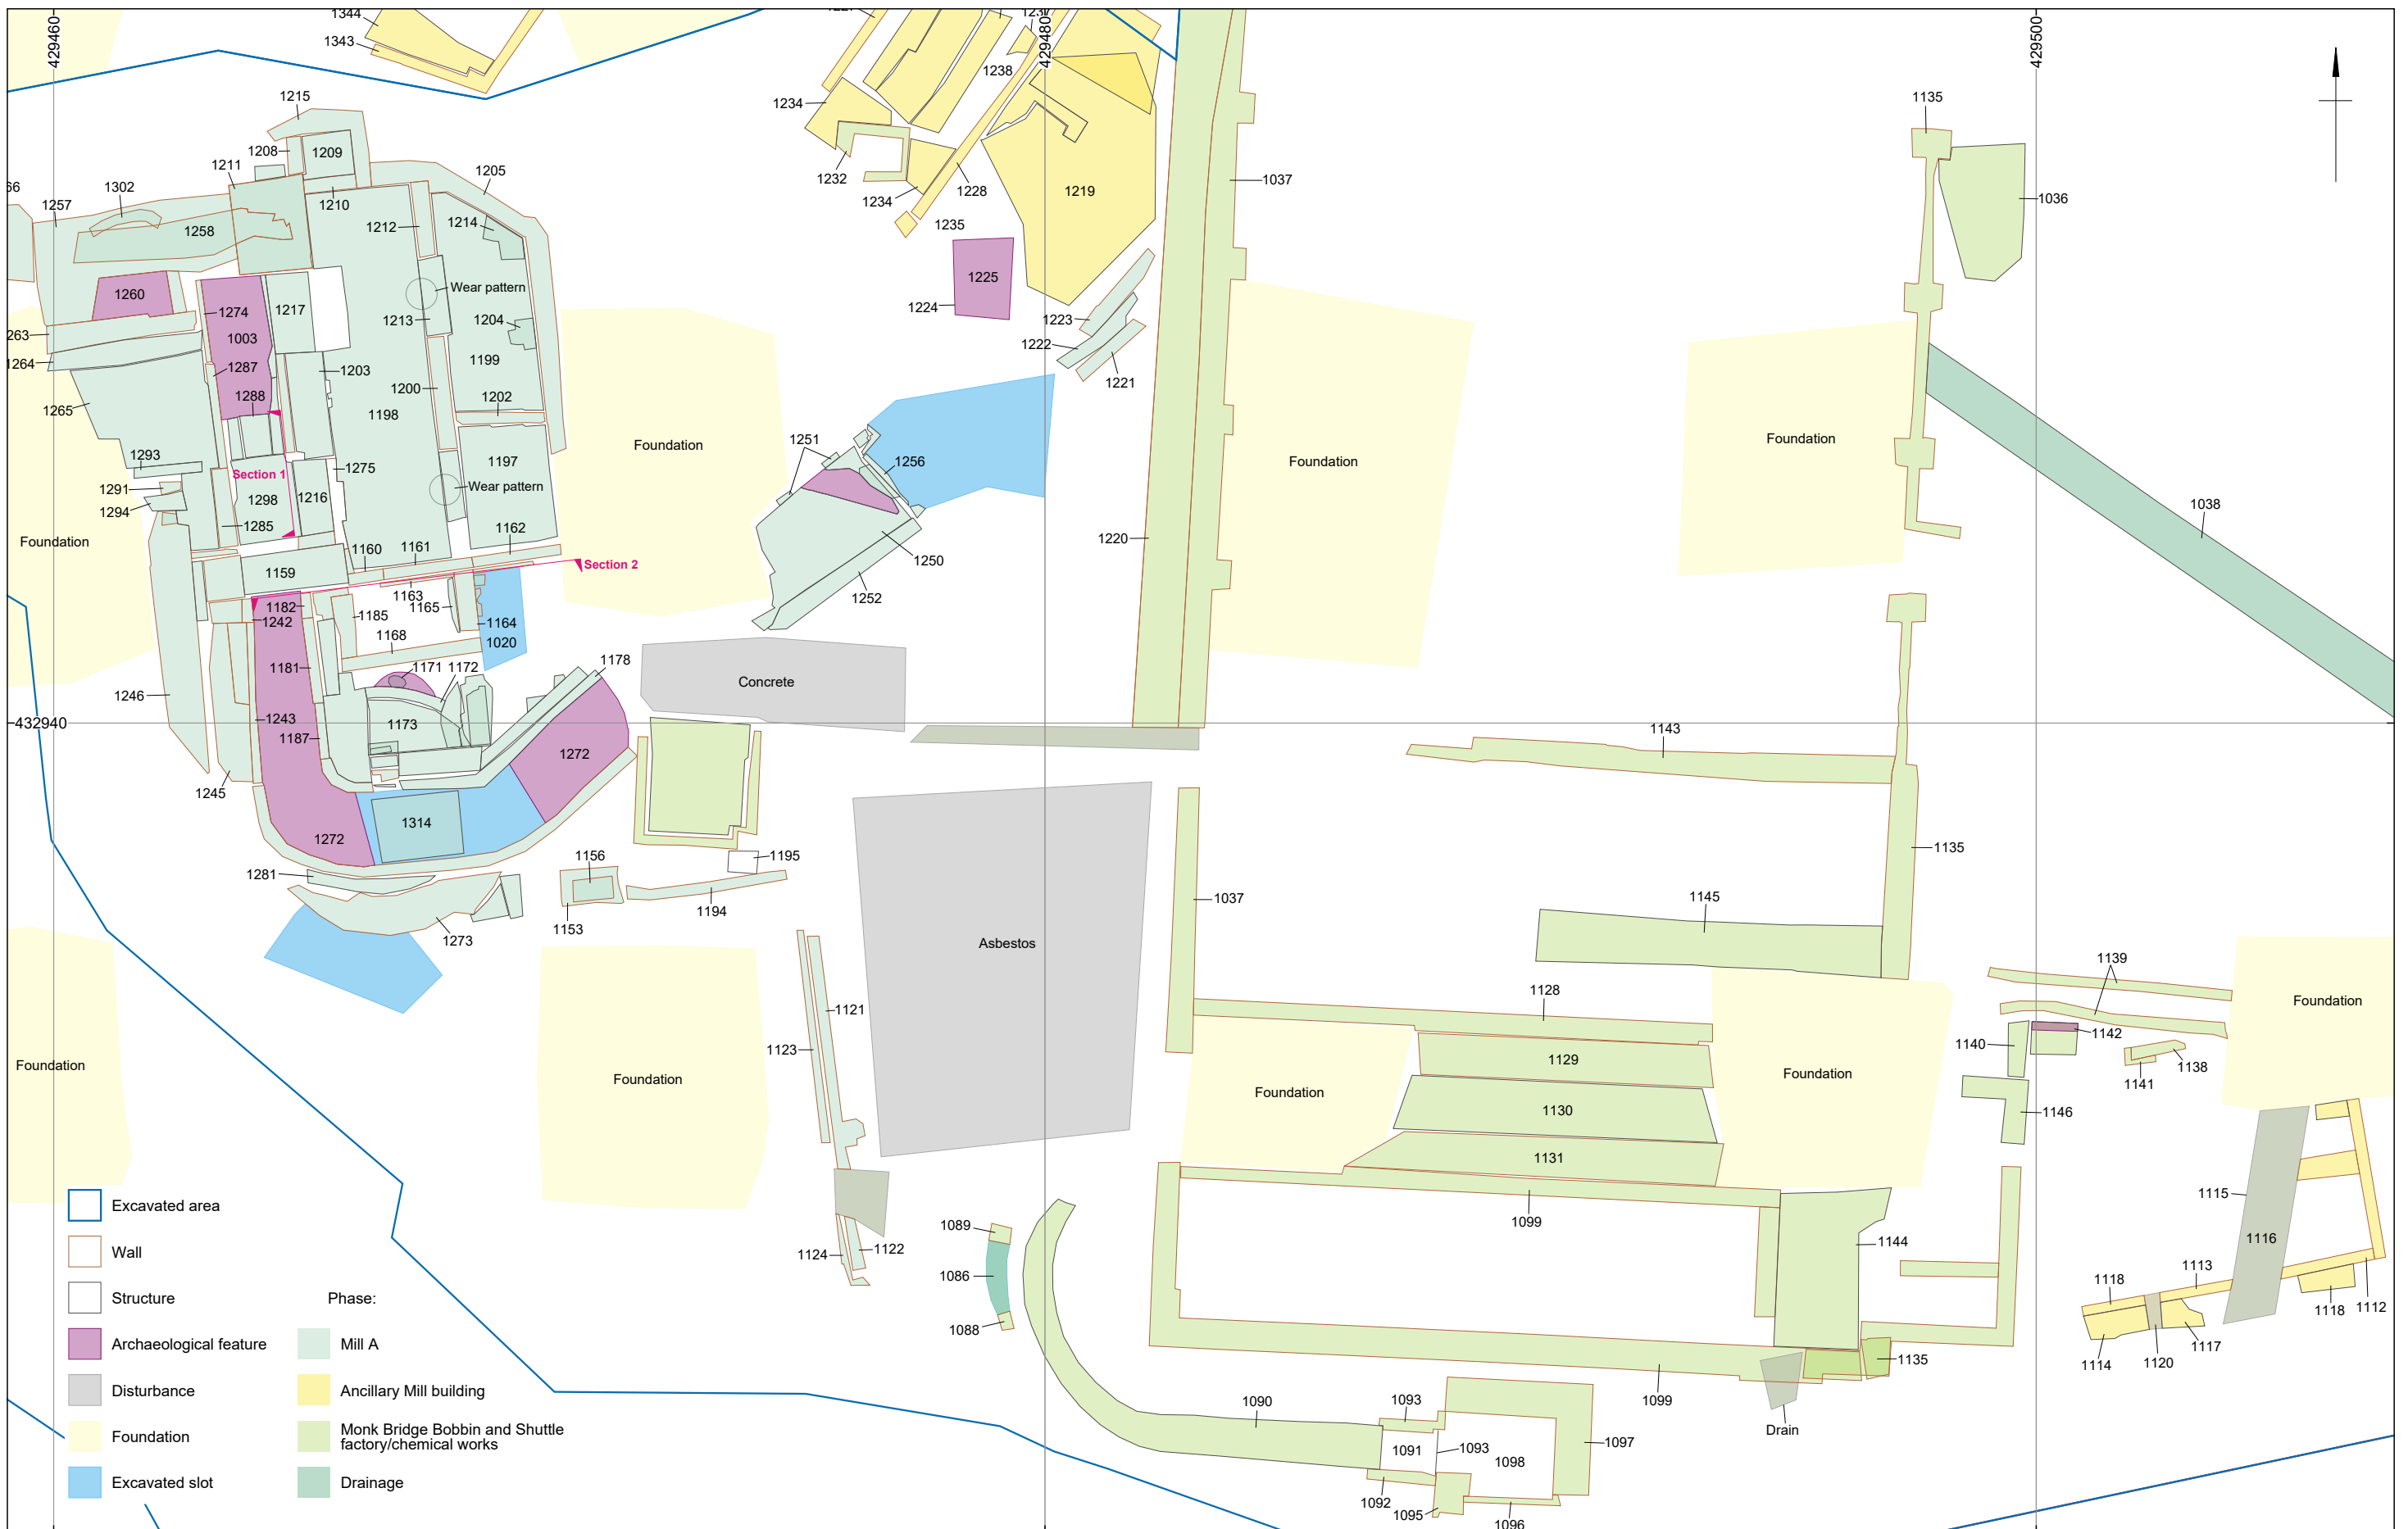
Figure 9

5.4.2 The earliest feature in Area A was a substantial sandstone wall (1010) which ran from the south-eastern limit of excavation for 27 m from east to west. This wall consisted of six courses with larger blocks at the base and was previously interpreted as a retaining wall (NAA 2016). It formed a significant barrier between the mills and the river. Undisturbed natural alluvium (described above) was recorded south of wall 1010 with no obvious cut for the wall. Wall 1010 was butted by a small later structure (1085, see below) and the sandstone foundations of building 1008.

Area A

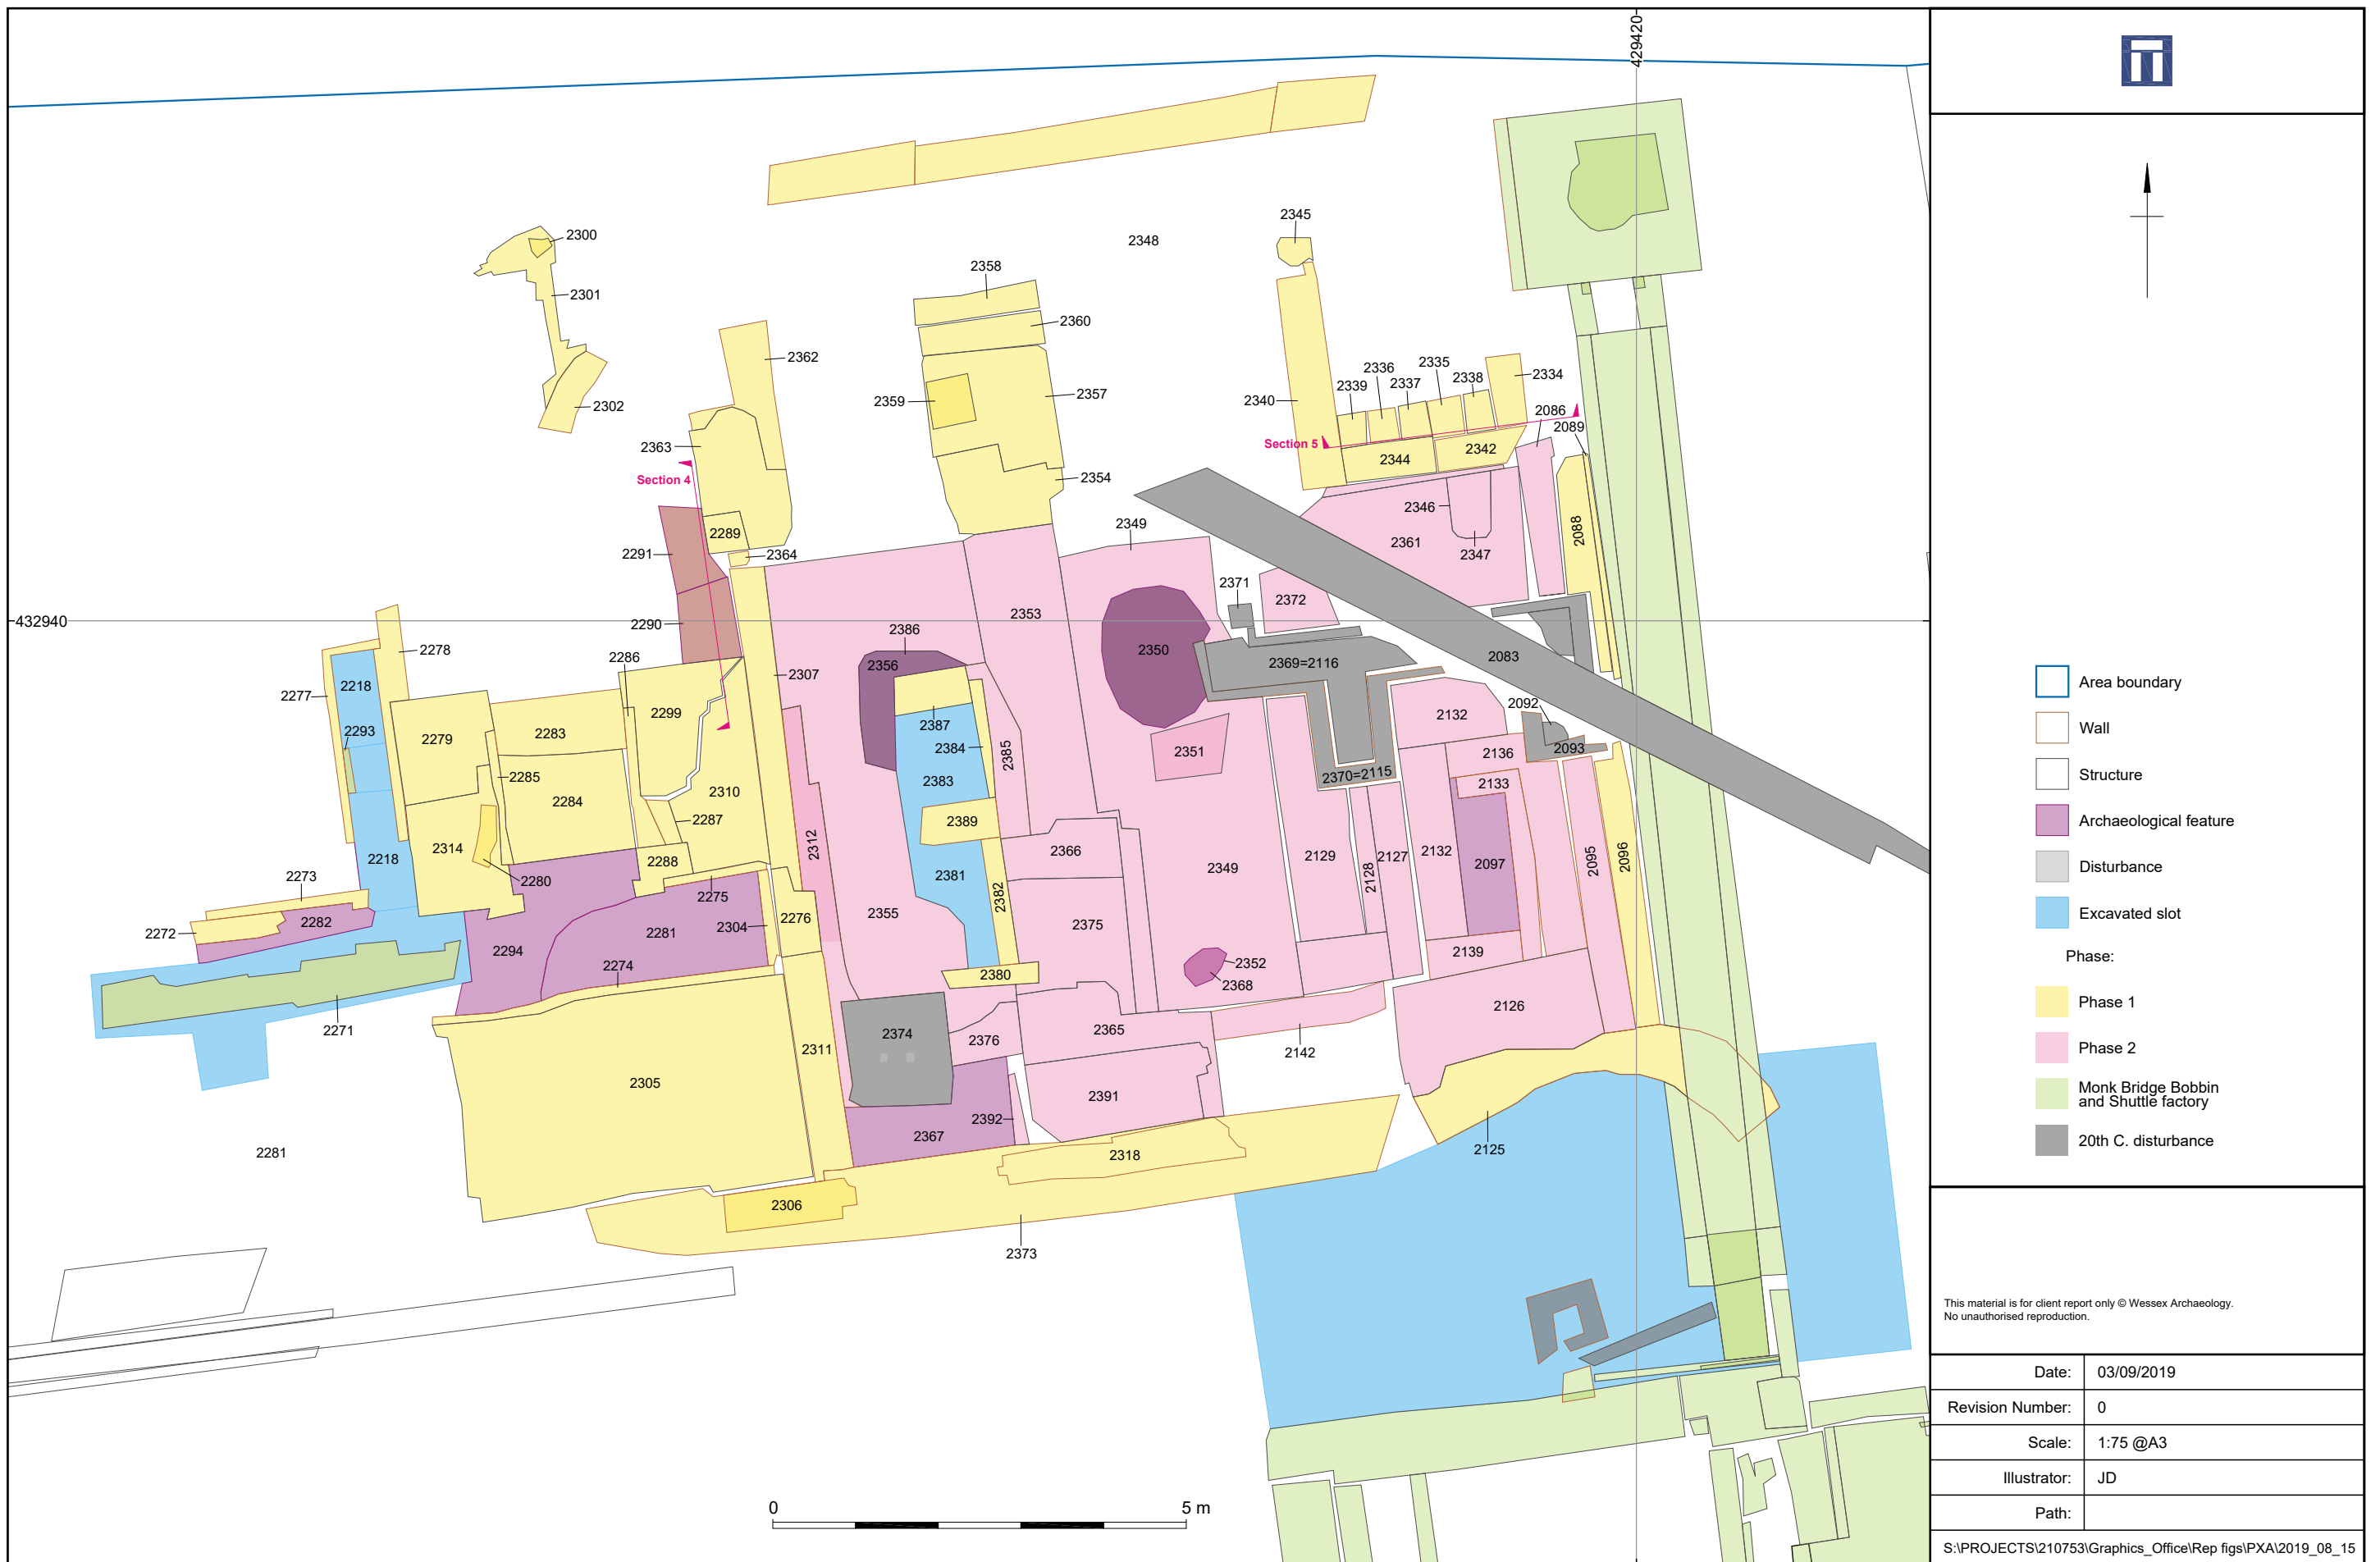
Figure 13

- 5.7 Area D**
- 5.7.1 Area D comprised a 1785 m² parcel of land (**Fig. 13**). Asbestos-bearing materials were found in several locations at the western edge of the area, and multiple diesel tanks were found on the northern edge. These areas were left unexcavated for health and safety reasons and it was agreed with David Hunter that we would leave the area to the north unexcavated due to the modern intrusions and risk of further contamination.

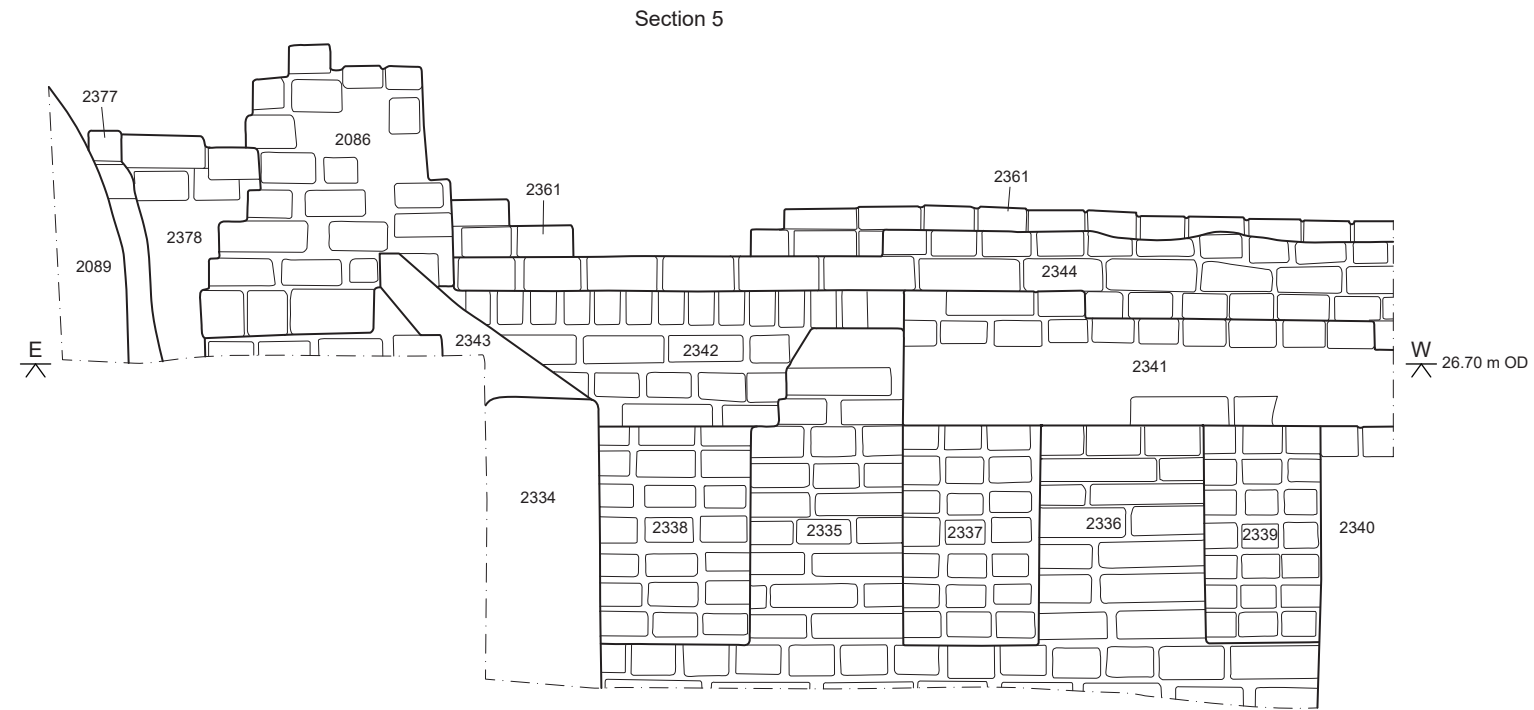
North facing elevation of chutes 2337, 2338, 2339 and associated structures

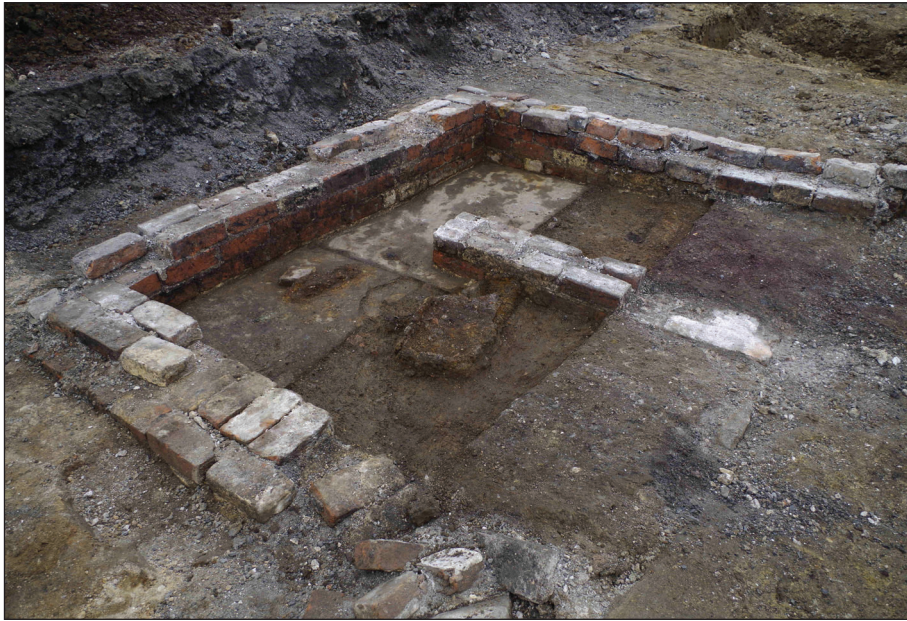
Plate 1: Room group 1085 from North East

- 5.4.4 Two distinct structures occupied the southern extent of Area A. The smaller (1085) was a single room with a central brick partition which butted retaining wall 1010 (**PI. 1**). The line of the walls survived in places as a single course of brick without a substantial foundation suggesting it was a minor building.

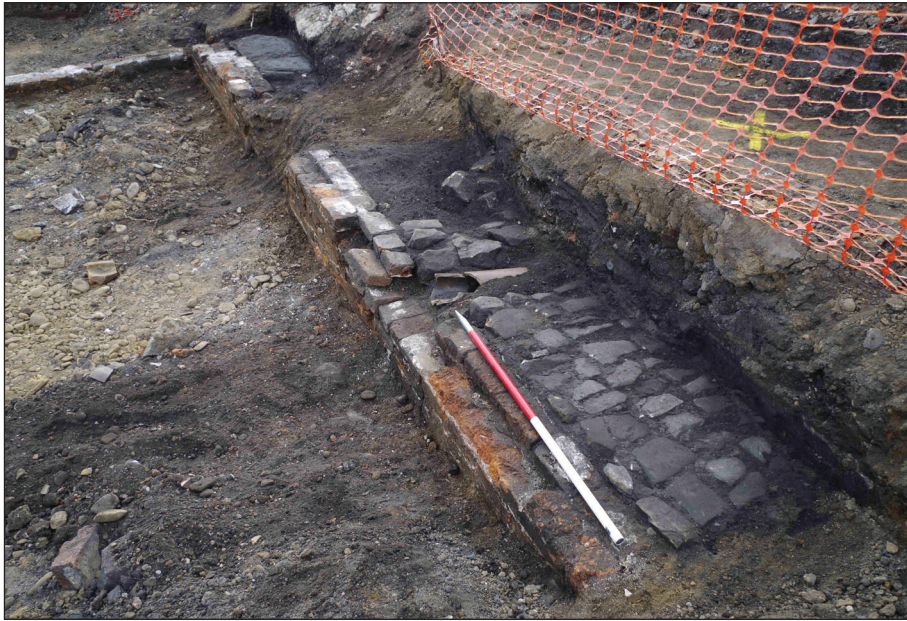
Plate 3: Wall and surfaces 1113, 1115, 1117-1119 from North West

- 5.5.3 The heavily truncated remains of a building (1106, 1113 etc.) were excavated in the south-east corner of Area B. The walls were similarly constructed to 1008 with handmade brick on foundation of a single course of sandstone (1108). The walls (1106, 1113 etc) were intermittently preserved and were accompanied by a short section of drain (1104). Building

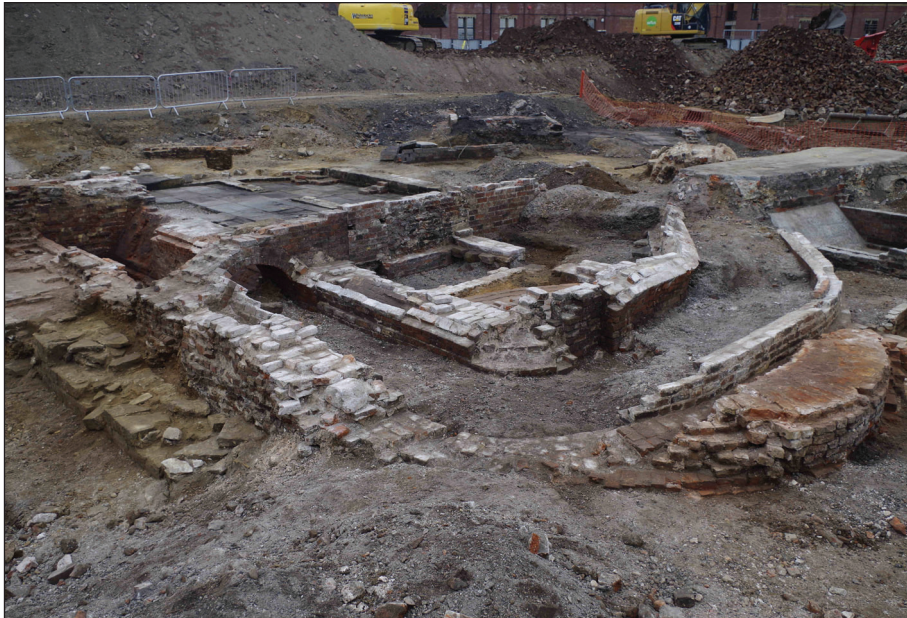
Plate 4: Overview of passage 1217 truncating chimney 1282 from West

- 5.5.4 Several phases of structural remains were excavated in the western half of Area B (**Fig. 11, Pl. 4**).
- 5.5.5 The earliest was a truncated circular brick structure (1282) 6 m in diameter and surviving to a depth of 0.9 m (eleven courses). The structure consisted of two elements; a circular brick base (1281) topped with a wide circular wall (1273). The base consisted of a mix of red brick and firebrick and formed a solid foundation capable of supporting a larger superstructure. The circular wall was eight skins wide, the inner two skins comprised firebrick forming the edge of an interior chamber approximately 3 m in diameter, with the outer six being unfrogged handmade red brick. The use of firebrick and a sooty staining of the interior face of the upper structure support interpretation of the structure as a chimney.

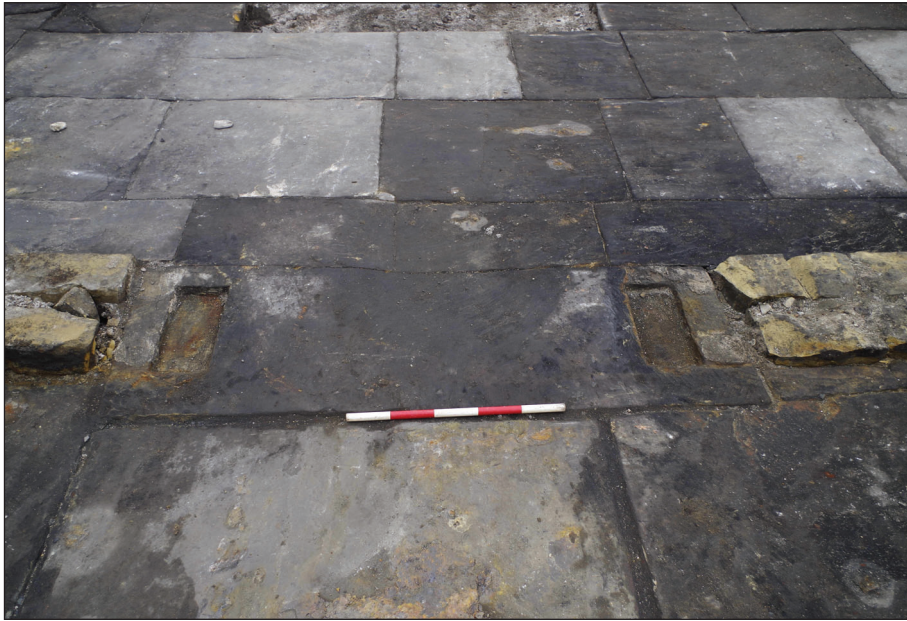
Plate 5: Wear pattern in floor 1196 from East

- 5.5.11 The north-eastern room (1196 etc) had a flagstone floor (1197, 1198 and 1199) with internal stone kerbs indicating partitions (1200, 1212 etc) and two circular wear patterns (**Pl. 5**) which corresponded with possible machine fixings (1201 and 1213) in the centre of the room. This room initially communicated with the south-eastern room (1168 etc) until the opening was bricked up (1160 and 1162) (**Fig. 10**). This probably coincided with the change of use in south-eastern room.
