**BOSTON BARRIER ARCHAEOLOGICAL
CONTRACTOR**
Boston, Lincolnshire

Level 1 Hulk 5 Recording

Document Ref.: 206950.02
February 2021

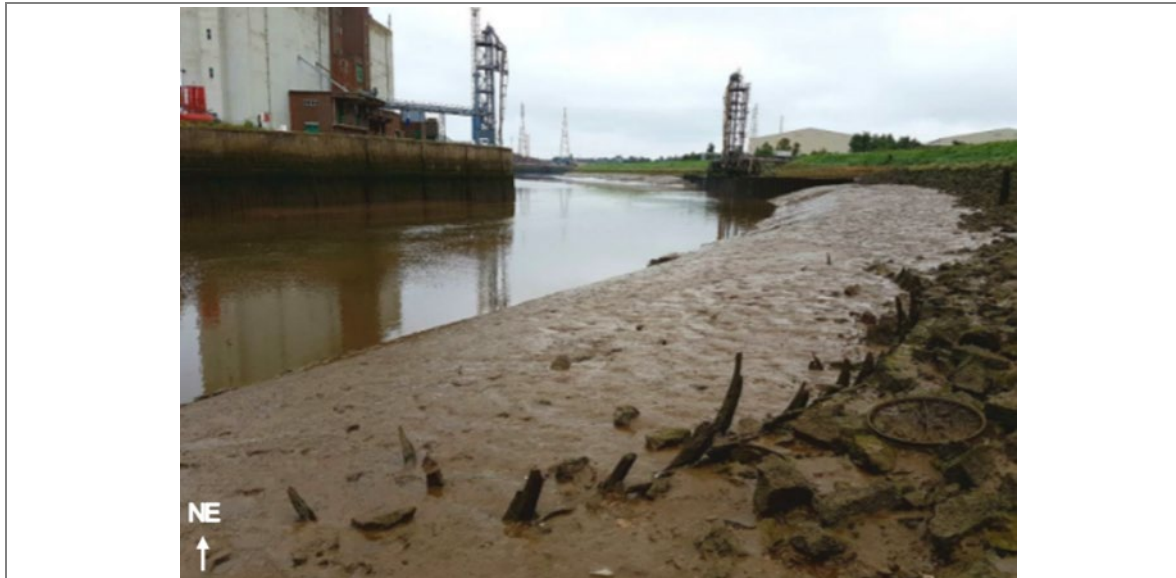
Hulk 5 taken from the south west (Wessex Archaeology 2017)

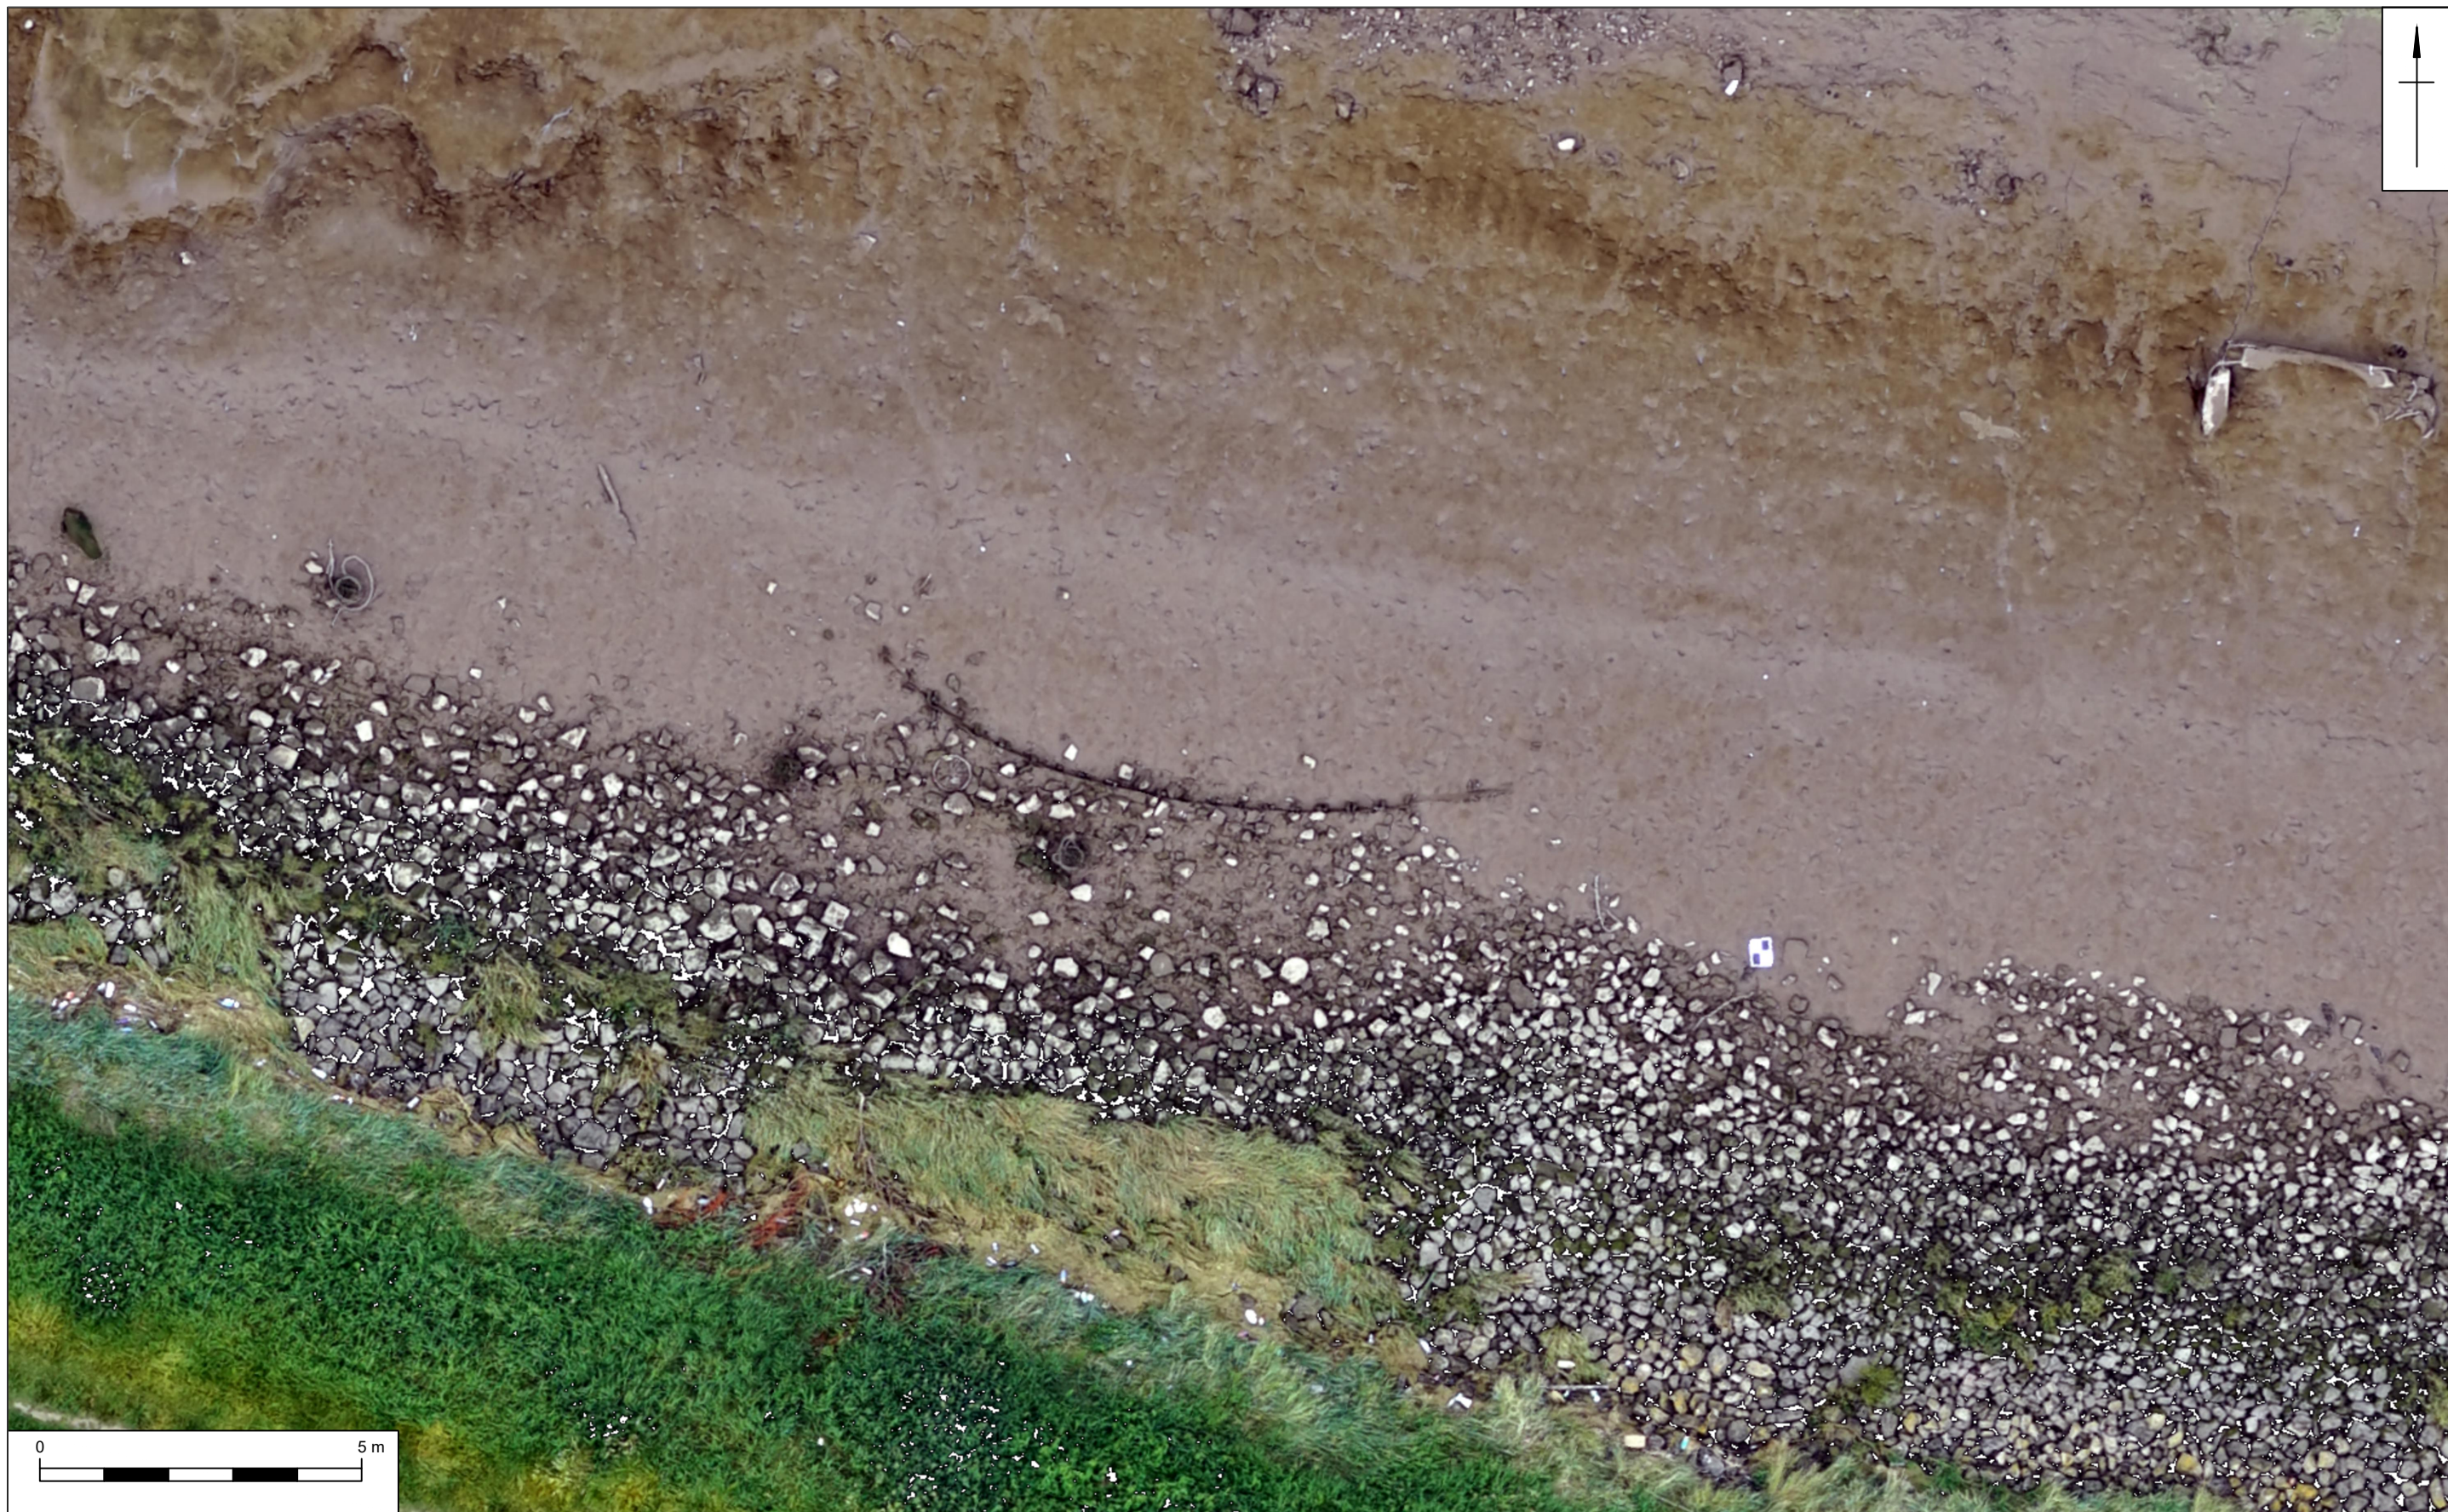
Figure 2

206950 Boston Barrier. Orthophoto of wreck remains

- 2.2.7 Wessex Archaeology was commissioned by the Environment Agency to undertake a programme of archaeological works including UAV survey, hulk recording and geoarchaeological auger survey in 2017, to be carried out in advance of dredging activities required for the construction of a new flood barrier in Boston, Lincolnshire (Wessex Archaeology 2017). A report was produced as a result of this work, including photographs of the hulk described below (Figure 2).

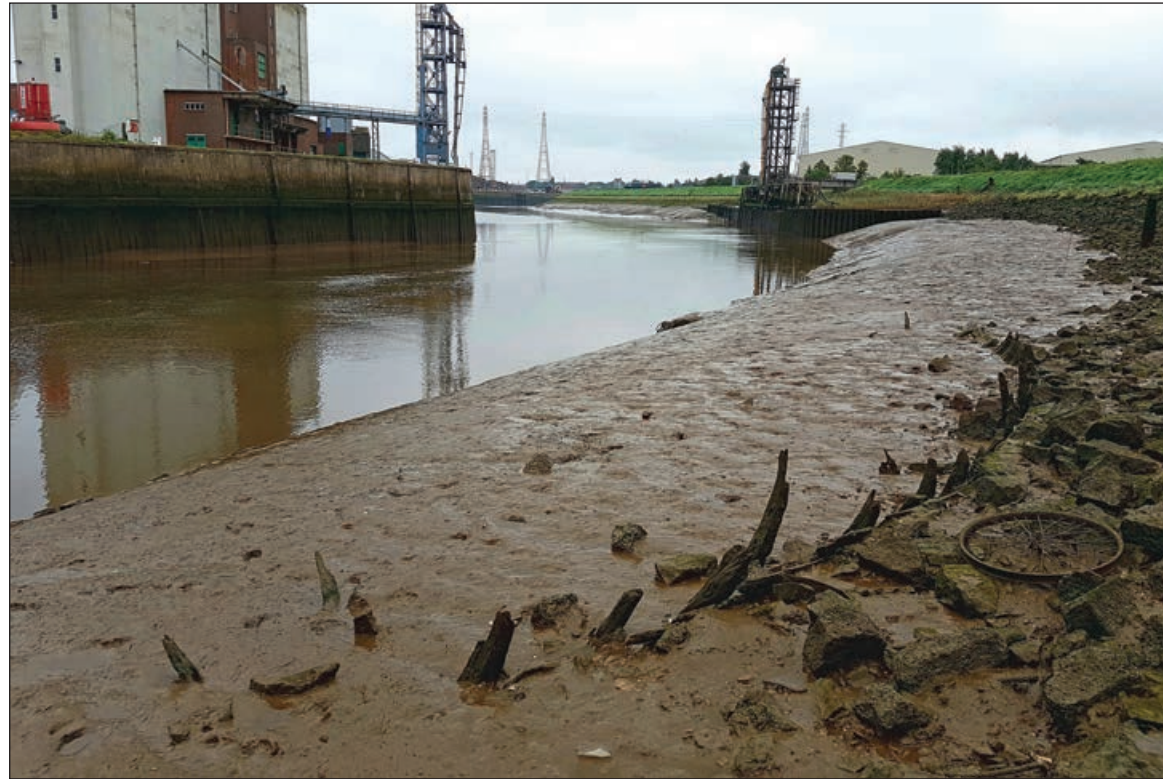
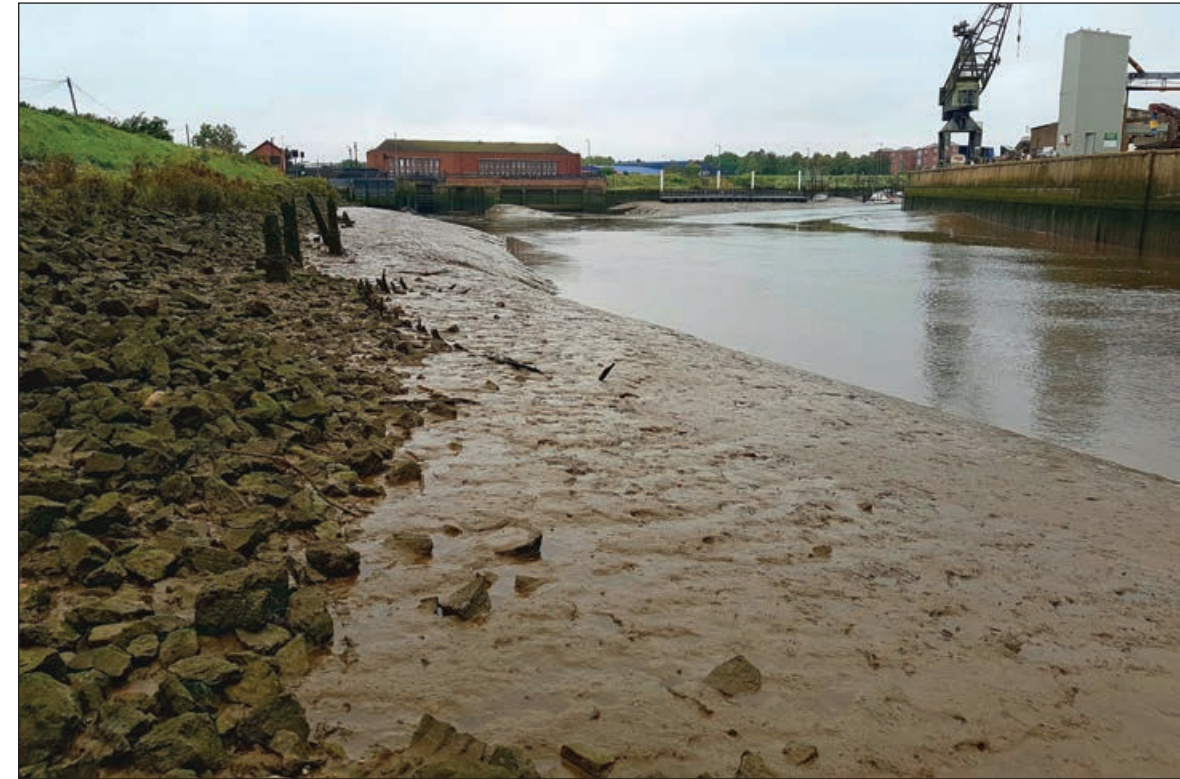
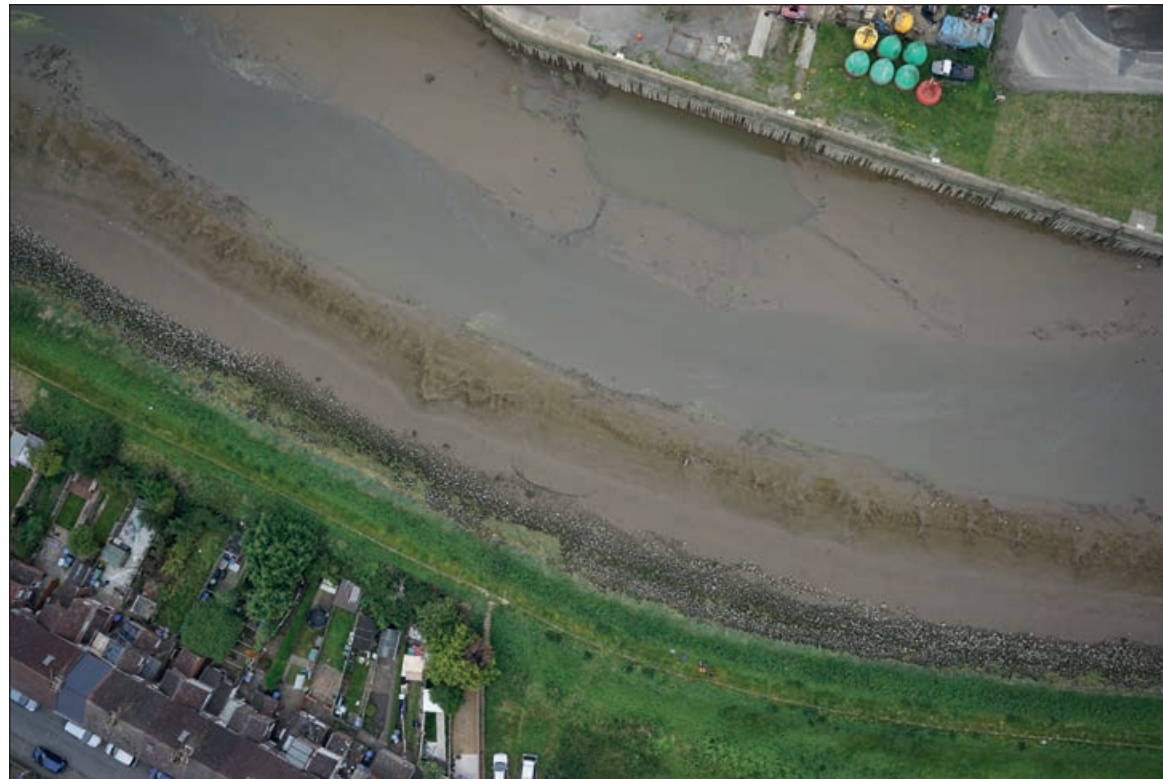
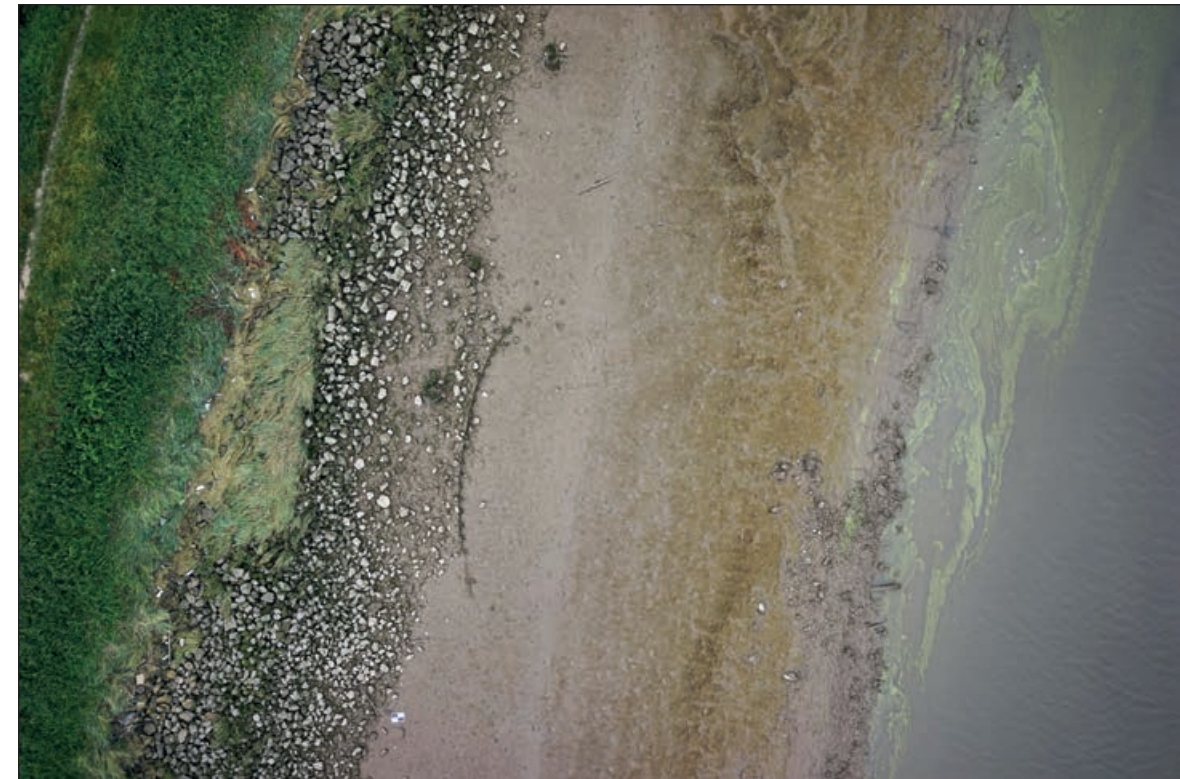
Figure 1	Location Plan
Figure 2	Orthophoto of wreck remains
Figure 3	Detail of Wreck
Figure 4	Outline of Wreck with mesh and measurements
Figure 5	Profile of hulk
Figure 6	3D view showing extent of wreck and modern disturbance
Plates 1-4	Photographs from Wessex Archaeology 2017 UAV Survey
Plates 5-16	Photographs supplied by the client showing the hulk both in situ and dislocated
Plates 17-20	Wessex Archaeology recording the remaining timber of Hulk 5 in 2018

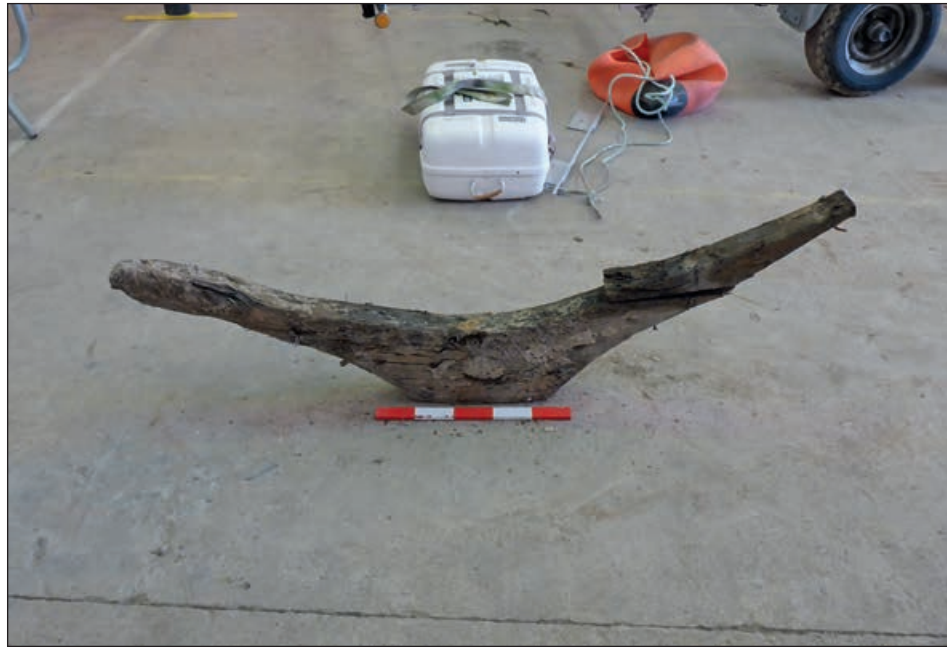
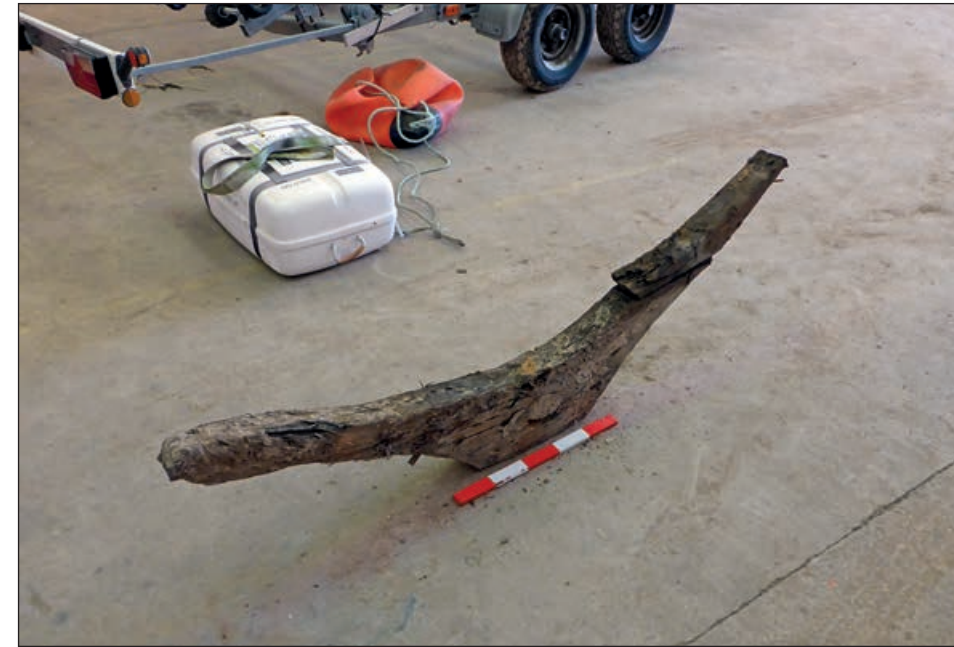
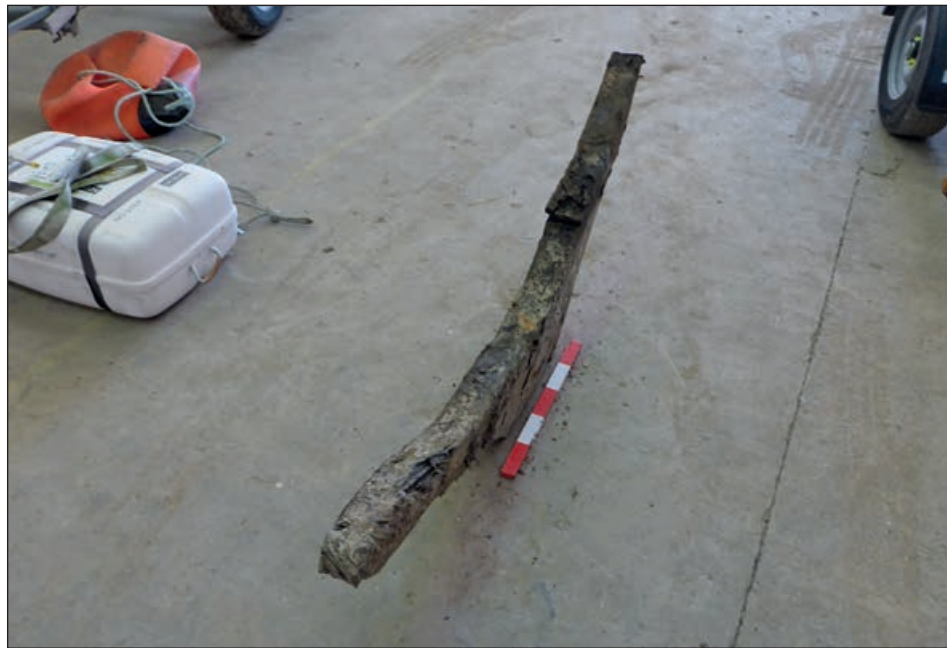
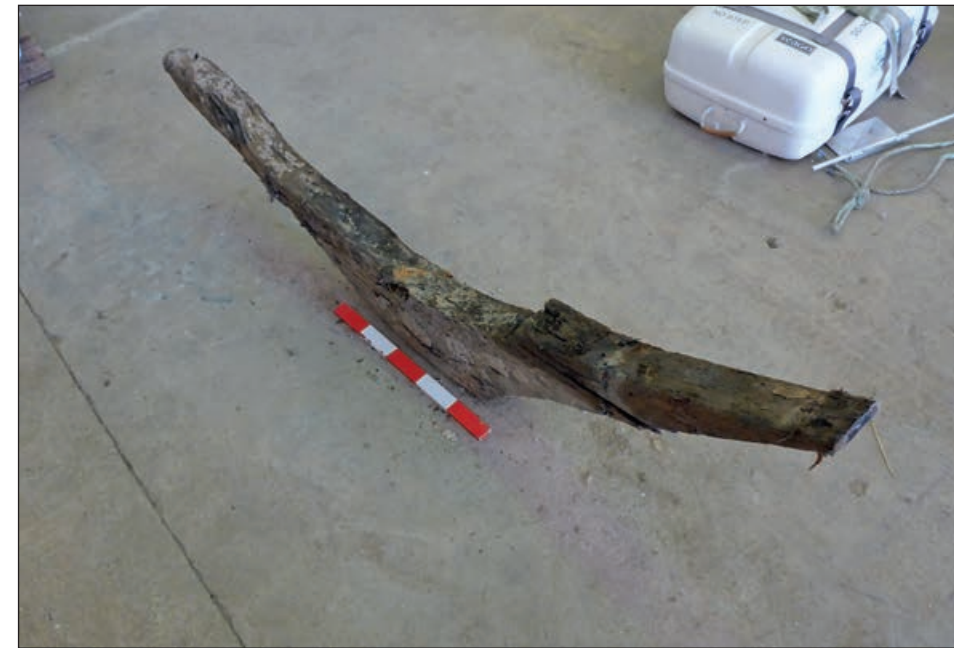
- 3.3.3 The one recovered timber of Hulk 5 was recorded as being a floor timber measuring 1400 mm long by 100 mm wide. A treenail was recorded on the top surface with a diameter of 15 mm as well as an iron fastening between the floor and futtock, and on the outer surface for to attach planking. The sides of the timber angled approximately 45 degrees from the floor before curving to be around 30 degrees. The angles of both sides were not completely even, however whether this is from the time of build or damage that occurred later is unclear.

PE21 7PJ and was recorded by Wessex Archaeology in October 2018. Photographs, measurements and observations were made of the timber (Plates 17-20).
