Lowfield Street, Dartford Kent

Archaeological Watching Brief Summary Report

Document Ref.: 218580.03
May 2019

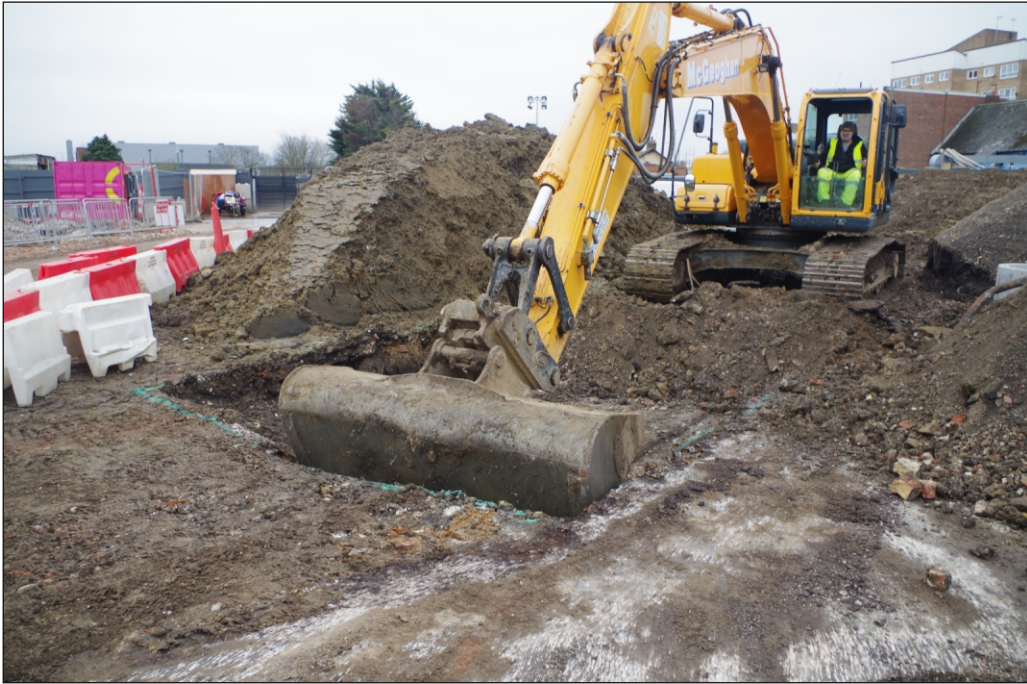
Plate 1: Working shot of WB area 1 – note access constrained by spoil heaps and access road

- 2.1.1 **WB area 1** was approximately east-west aligned and bounded on three sides by spoil heaps and on the fourth side by the site access/haul road. When excavated, an unknown service pipe precluded the length of the area exceeding 4m; however the width of the area was extended to 4m in width to account for the loss of length (**Plate 1**).
- 2.1.2 A modern concrete pad was recorded at the east edge of the area. The natural geology of Taplow gravels was present at a depth of 2-2.1m+ BGL.
- 2.1.3 These were sealed by an alluvial deposit of 1.6m thickness from 0.4m-2m BGL. The alluvial deposit was of a mid brown grey silty clay with occasional chalk flecks from 0.5m – 1.7m BGL and of a dark grey silty clay with rare roots from 1.7m – 2m BGL (**Plate 2**).
- 2.1.4 There were no archaeological features or deposits within WB area 1.

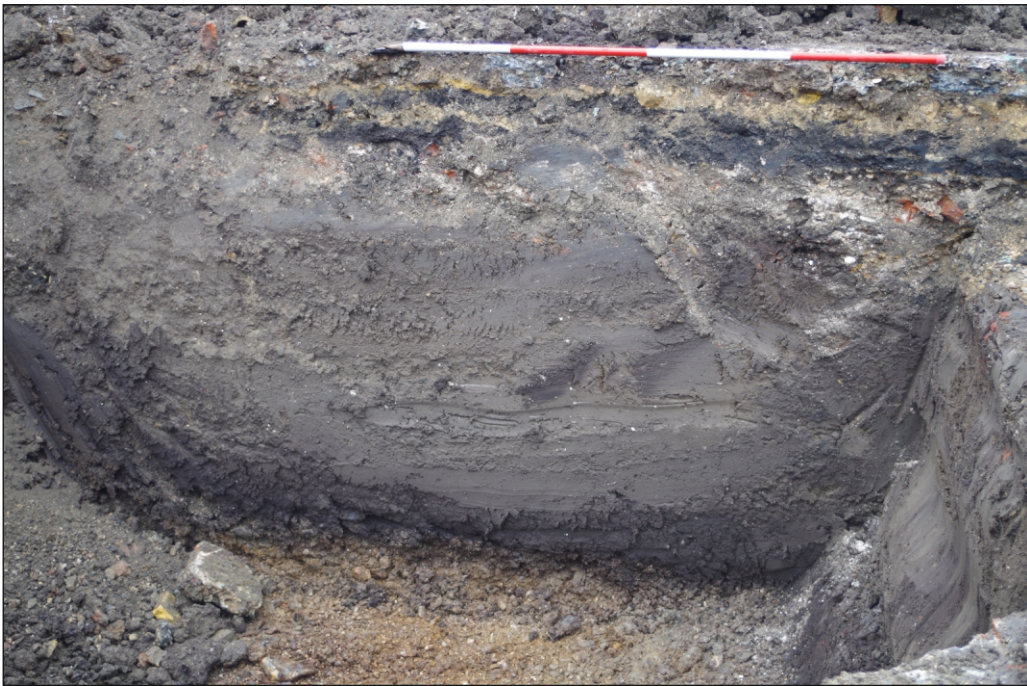
Plate 2: Section of WB area 1, 2m scale, looking north

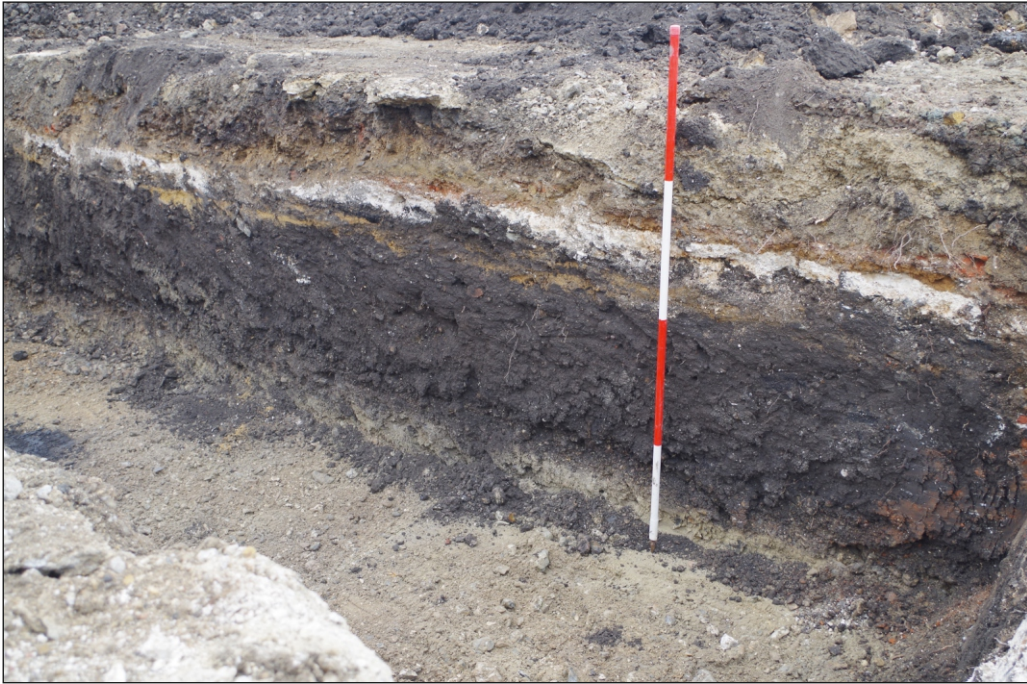
- 2.3.4 The alluvial deposit was sealed by 0.8m thickness of made ground deposits from 0m -0.8m BGL, consisting of yellow crushed brick from 0.7m-0.8m BGL, redeposited chalk from 0.5-0.7m BGL, and concrete, brick, and yellow hardcore/demolition debris from 0m-0.5m BGL (**Plate 3**).

Plate 3: Section of WB area 3, 2m scale, looking northeast

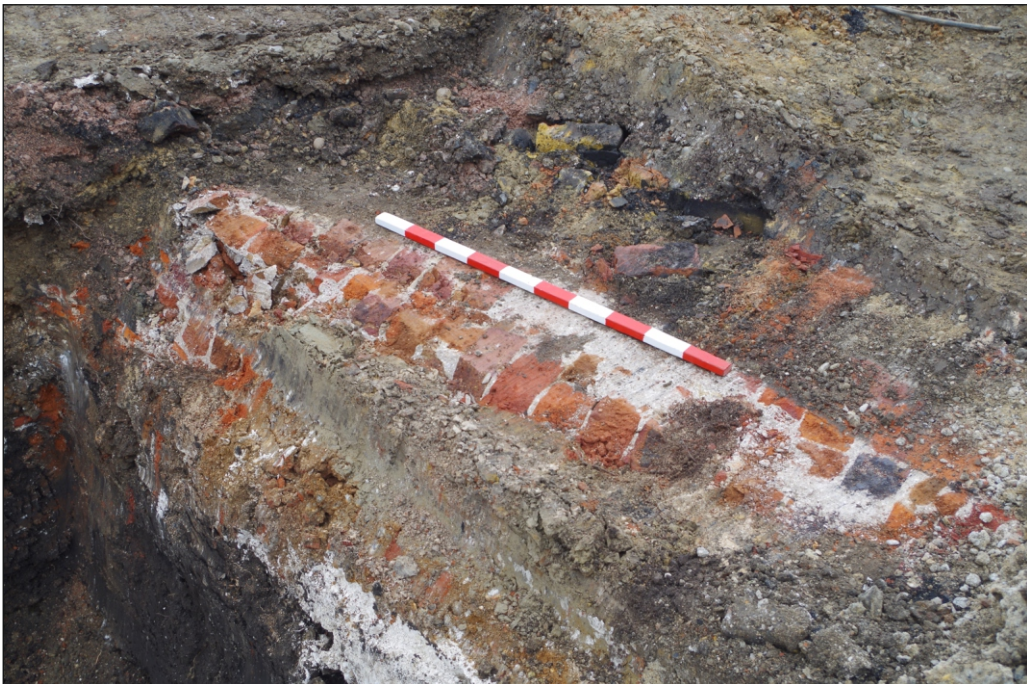
- 2.3.5 Adjacent to the south end of the area, a concrete slab at ground level was broken up and lifted out, which partially covered a recently demolished modern wall running west-east. The wall was constructed from red stock bricks of 0.2mx0.1mx0.07m of which 10 courses were present. The bricks were bonded by a grey cement mortar. The construction cut for the wall was of 1m depth and cut the alluvial layer. The wall was abutted by the modern made ground layers. Research suggests that the wall may be associated with the Parcel Sorting Office on the 1961 historic mapping (**Plate 4**).

Plate 4: Modern wall 1706, 1m scale, looking southeast

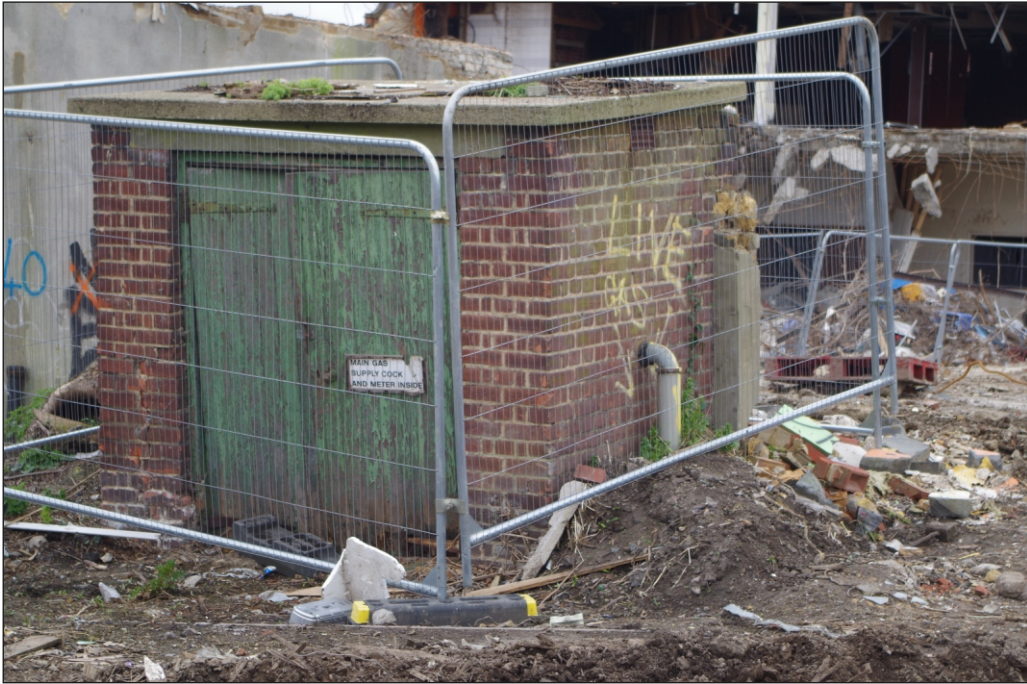
- 2.2.1 **WB area 2** was abandoned due to the presence of a live gas main (**Plate 5**).
- 2.2.2 This area was later monitored as **WB area 7** on 9th May 2019. Excavation occurred to a maximum depth of approximately 2.5m with the stratigraphy formed of multiple layers of made ground. At 2.5m the remains of a former basement associated with the former building located in this area was identified. The basement was constructed from reinforced concrete (**Plate 9**). No archaeological features or deposits were identified.

Plate 5: Live gas main warning – location of WB area 2 inside partially demolished building in background

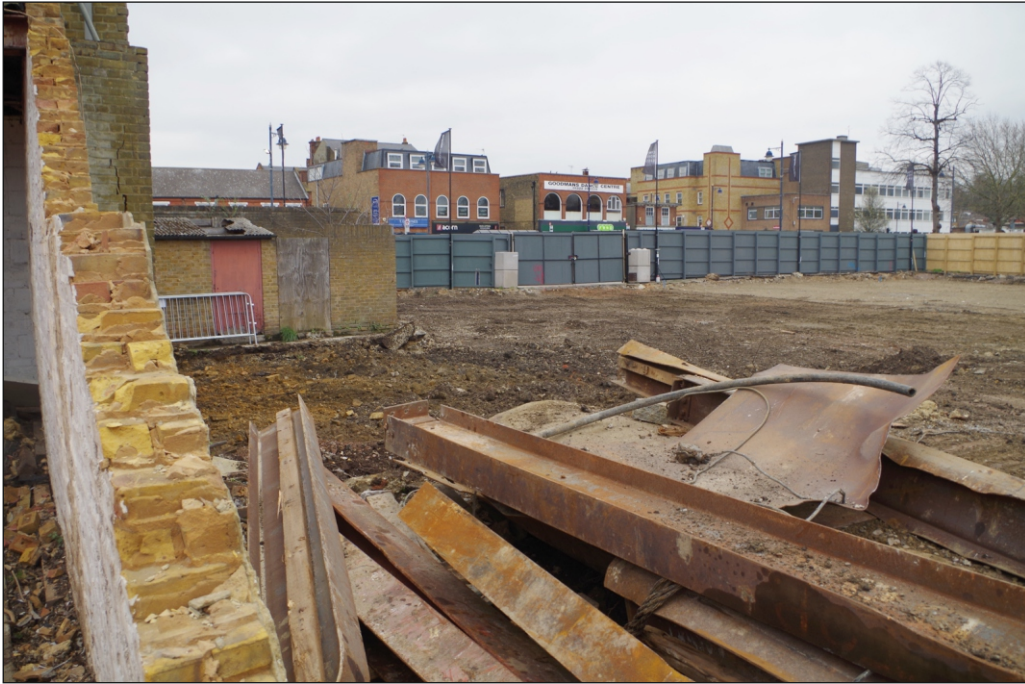
Plate 7: Area at north of site – madeground levelled ready for piling

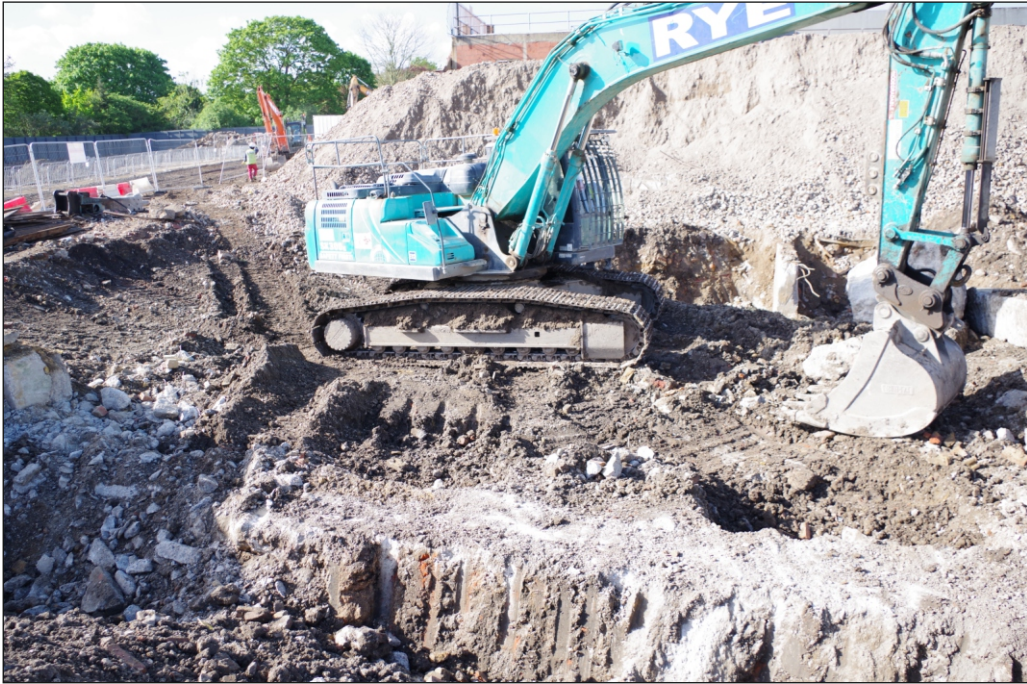
Plate 9: General shot of WB area 7, facing south

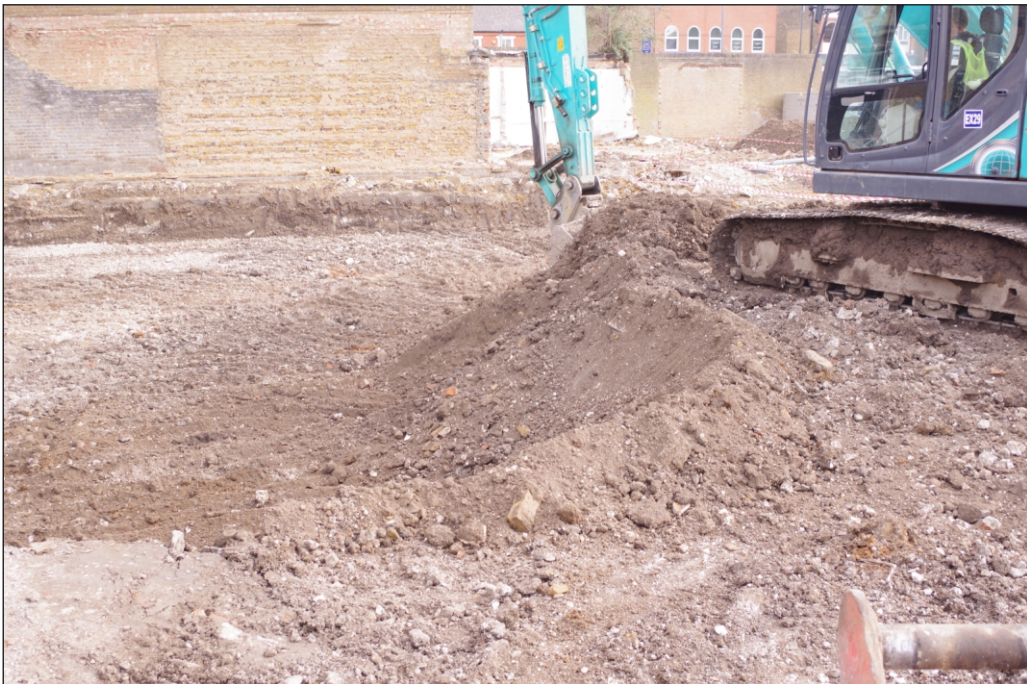
- 2.3.7 Ground reduction occurred to a maximum depth of approximately 2.5m (**Plate 10**). This area had been heavily disturbed by past use. Re-deposited chalk mixed with demolition debris consisting of crushed red and London stock brick was identified from 1.4-2m BGL. Below the made ground, alluvial deposits of similar consistency to that which was recorded in WB area 3 and were encountered to a depth of approximately 2.5m BGL. Modern CBM and brick were identified in the initial 0.25m that were interpreted as intrusive, mixed in during the demolition and re-deposition of made ground.

Plate 10: General shot of WB area 4, facing northeast

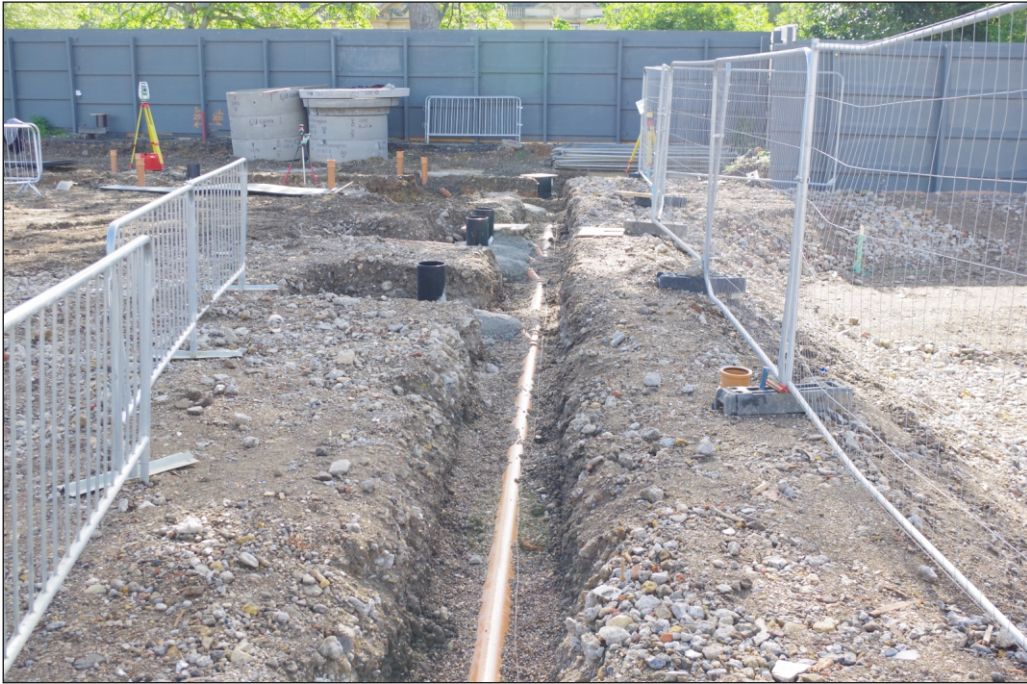
2.4.1 WB area 5 was located in the northeast corner of the site. Monitoring was conducted during the construction of drainage runs, a conduit system and section of strip foundations (**Plate 11** and **Plate 12**) The area had previously been investigated during the 2018 archaeological evaluation (WA 2018). The same made ground deposit identified in trench 1 was found to the maximum depth of works in this area of 0.8m BGL. No archaeological features or deposits were identified. Watching brief area 6

Plate 11: View of the drainage runs in WB area 5, facing east

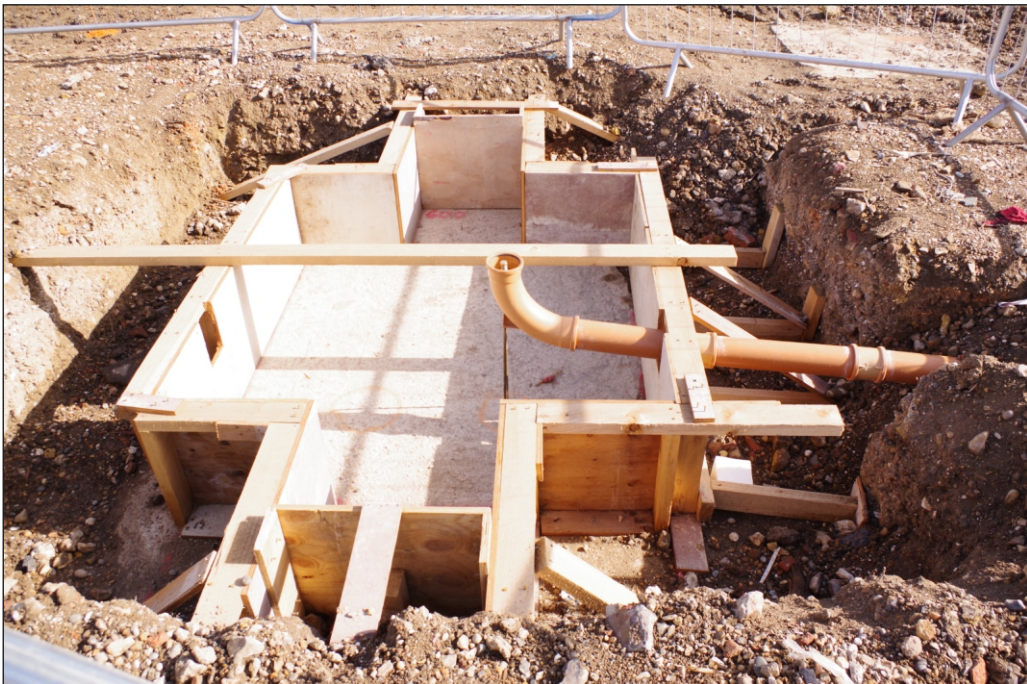
Plate 12: View of conduit system in WB area 5, facing north

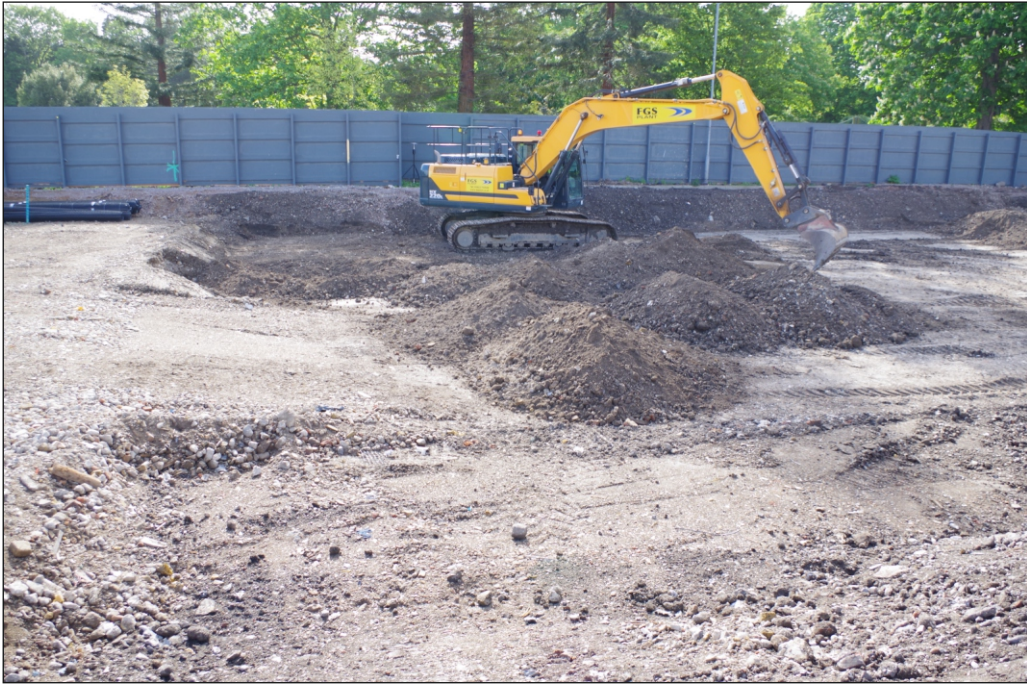
2.4.2 WB area 6 was located on the eastern site boundary (**Plate 13**). The area had previously been investigated during the 2018 evaluation which encountered made ground to 2.05m BGL with a reinforced concrete floor 1m in thickness located at the base of the trench, which inhibited further investigation. The ground level had been raised to the required construction level using material from areas previously excavated within the site.

Plate 13: General shot of WB area 6, facing east
