Boundary Walls at Cross Cottage, Barford St Martin, Wiltshire

Historic Building Record

Document Ref.: 259330.03
Planning Refs.: PL/2021/09605 and PL/2021/09933
February 2023

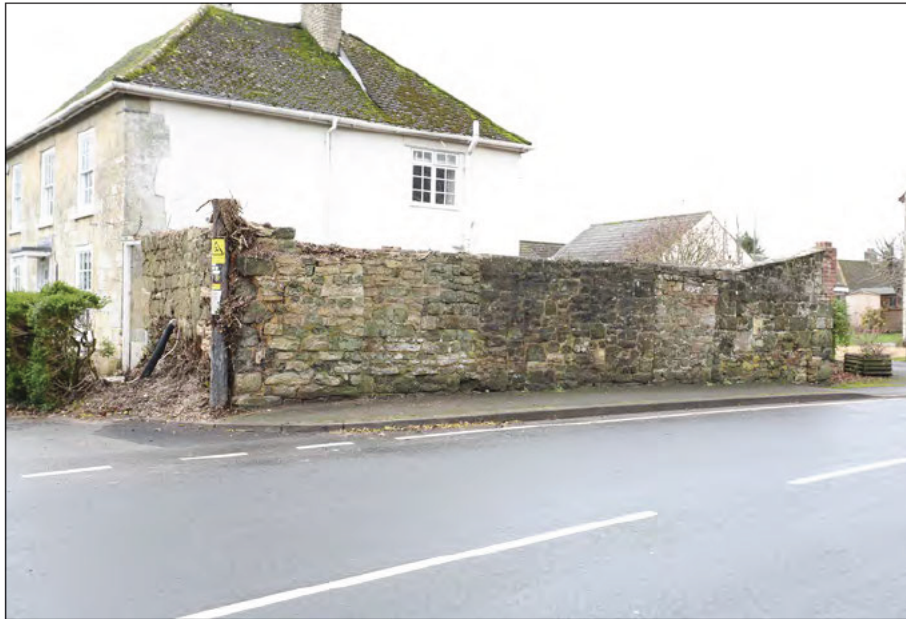
- 4.2.2 **Figure 2** shows the layout of the walls in plan. The boundary wall along West Street and Duck Lane formed an L-shape in plan, orientated north-west to south-east and north-east to south-west respectively. In addition, an angled wall, orientated approx. west-east, joined the West Street wall at its western end (**Photographs 1-2**).

Photograph 1: The boundary walls of Cross Cottage on Duck Lane and West Street viewed from the east

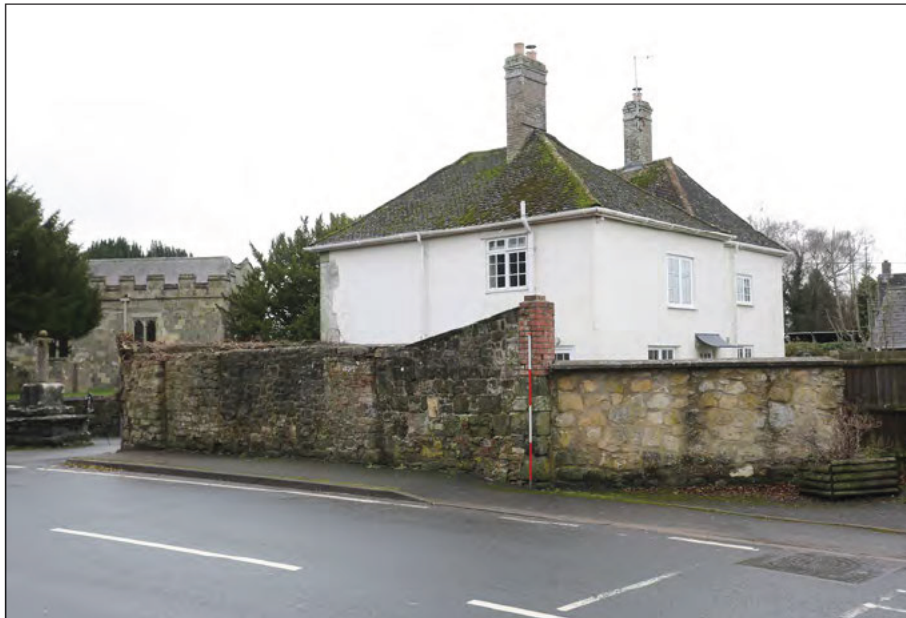
Photograph 2: The boundary walls of Cross Cottage viewed from the north on West Street

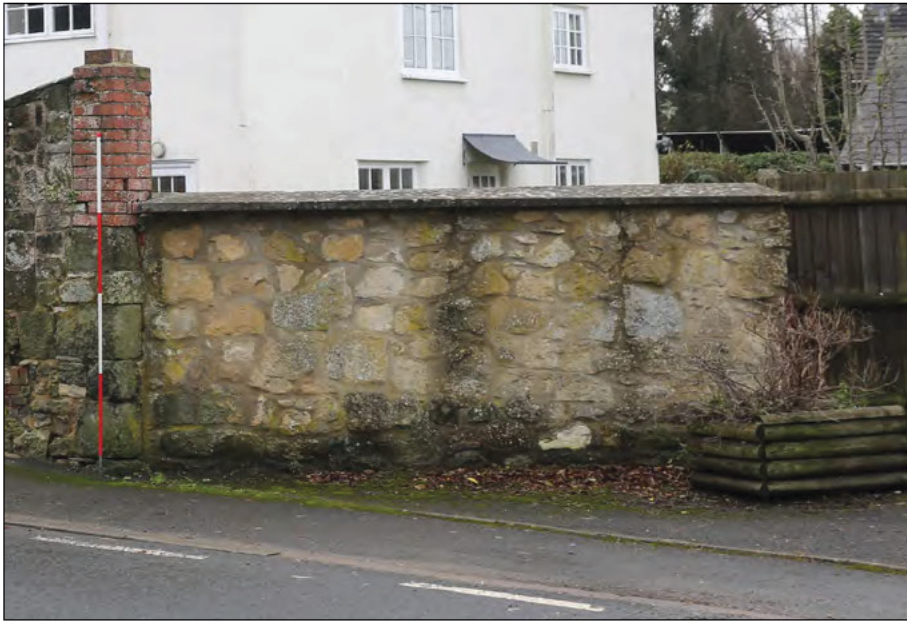
- 4.2.3 The angled wall was a later extension to the boundary wall. It was constructed of regularly coursed limestone blocks and measured 4.0 m long by 0.35 m wide and 1.73 m high (**Photograph 3**).

Photograph 3: The angled wall added as a later extension to the West Street boundary wall

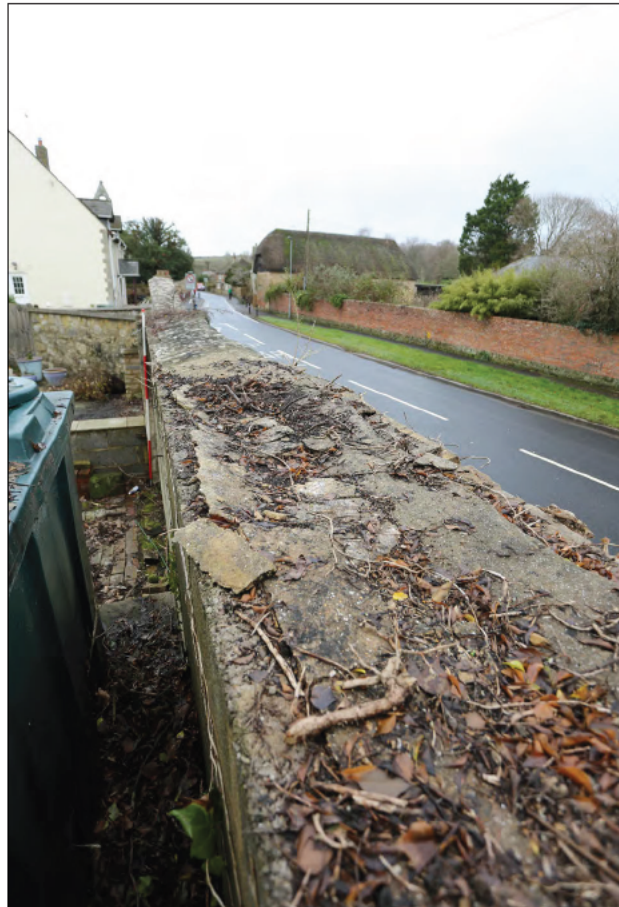
- 4.2.5 Most of the boundary wall was flat-topped but irregular and uncapped, suggesting it was once taller and had been reduced (**Photograph 4**). The flat-topped sections measured 2.2 to 2.3 m in height on Duck Lane and 1.96 m on West Street. On West Street, the western end of the wall was sloped rising to a height of 2.56 m.

Photograph 4: The irregular top of the West Street boundary wall

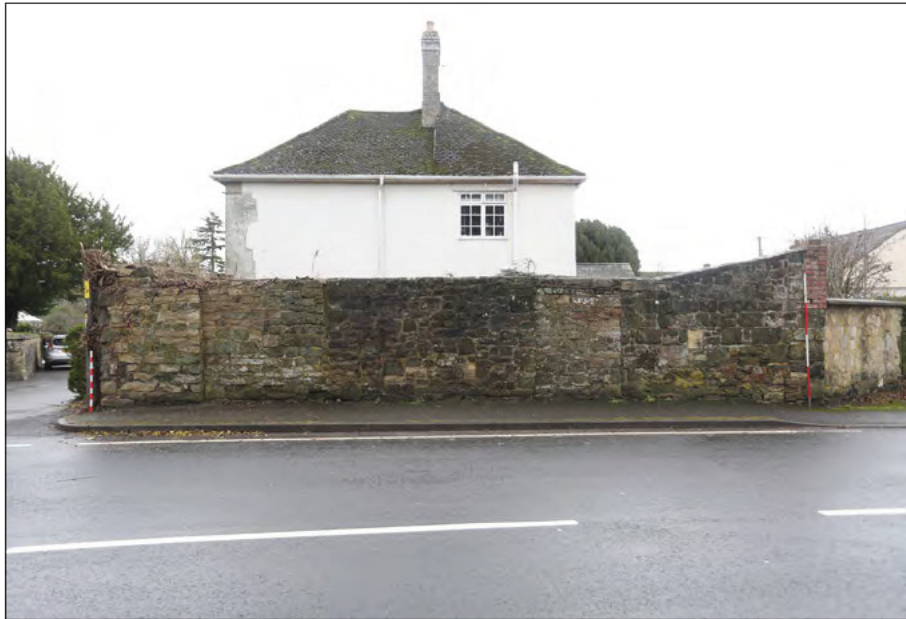
- 4.2.7 The West Street (north-east facing) elevation was sub-divided into five parts (**Photograph 5**). The western end of the wall sloped up to the west where the top part of the wall had been rebuilt in red brick forming a pier. The south-west face of this pier was covered in concrete render with a decorative moulding of a stylised tree (**Photographs 6-7**). This sloping part of the wall probably represents the location of a former lean-to outbuilding that existed on the garden side of the wall.

Photograph 5: The West Street boundary wall north-east elevation

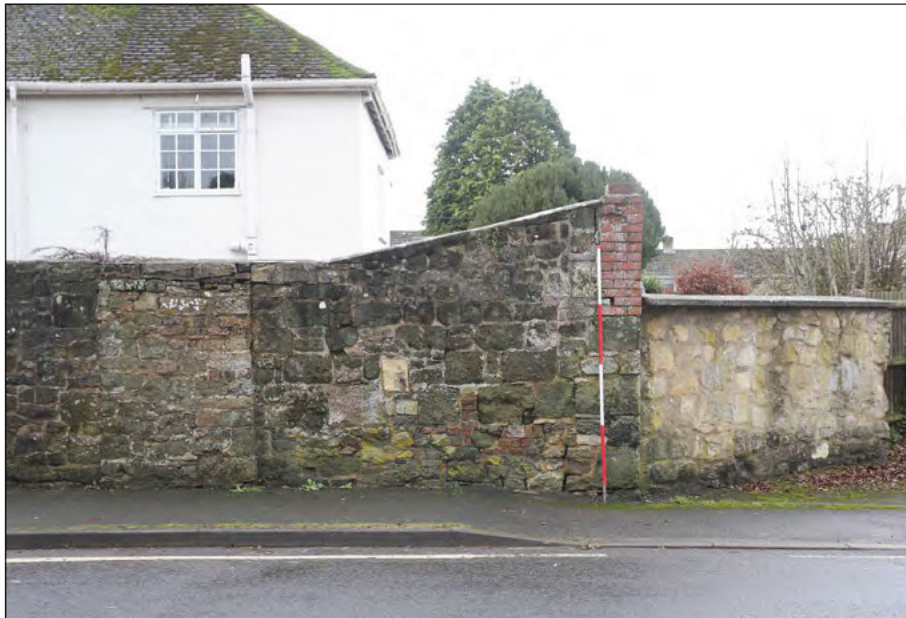
Photograph 6: The sloping section at the western end of the West Street boundary wall

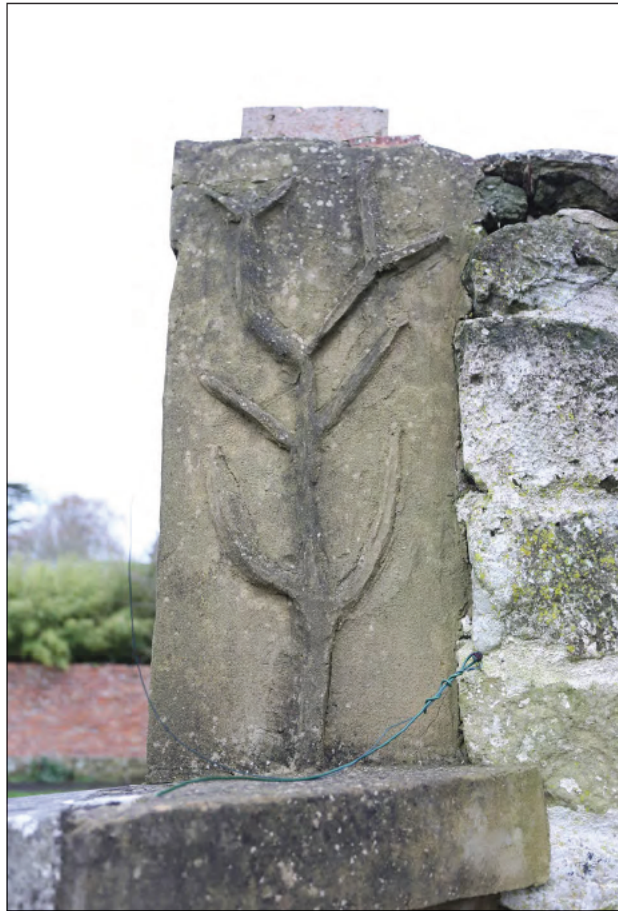
Photograph 7: A decorative stylised tree design in the render on one side of a brick pier (at the western end of the West Street boundary wall)

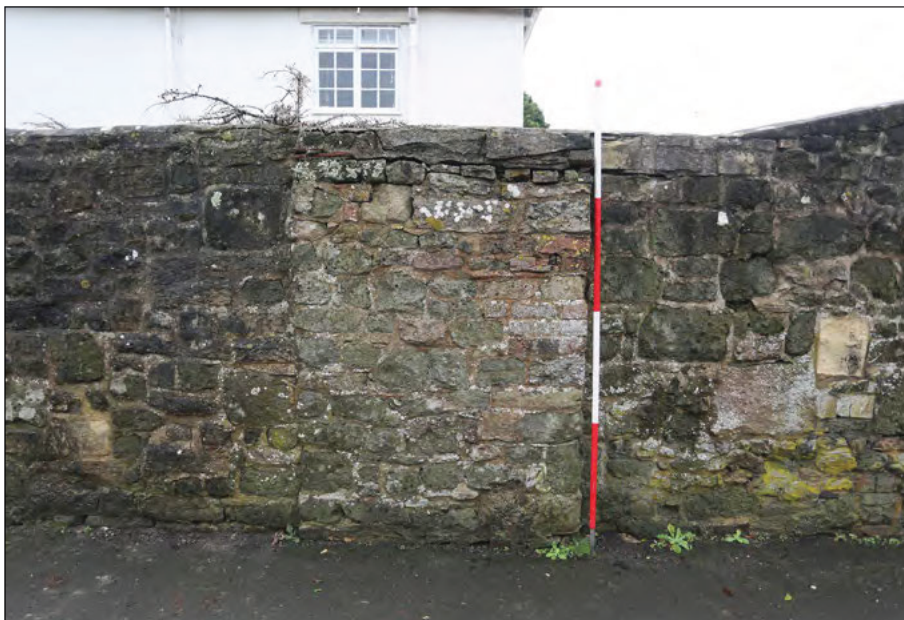
- 4.2.8 To the east of the sloping section there was a 1.38 m long section defined by straight joints, which is interpreted as a blocked entrance (**Photograph 8**). Further east were two sections, both 2.70 m in length, separated by an irregular joint. At the eastern end, the remaining 1.62 m long section of wall projected forward of the rest by 0.18 m (**Photograph 9**).

Photograph 8: A blocked door indicated by two straight joints and changes in the coursing and patina of the stone

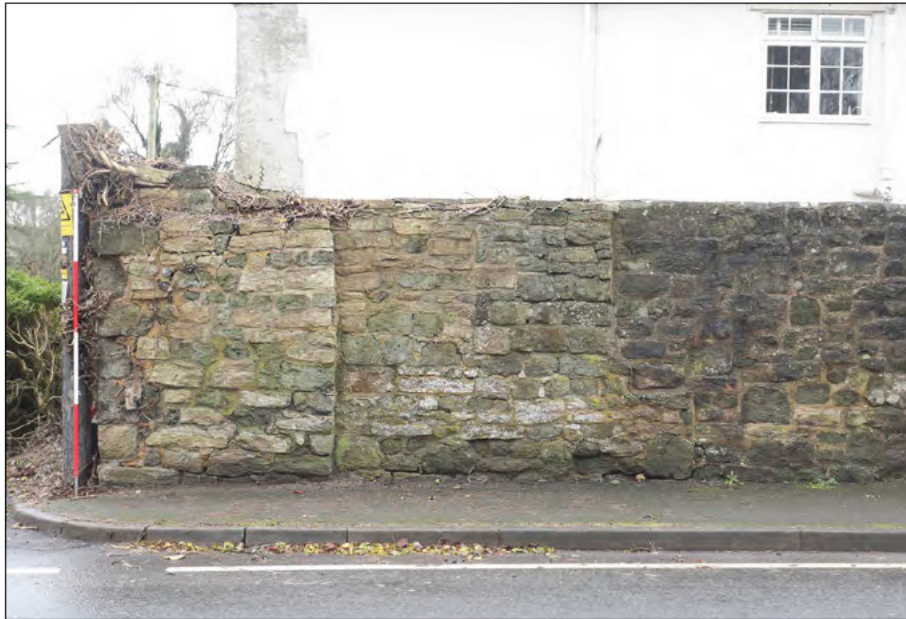
Photograph 9: The sections that form the east end of the West Street boundary wall

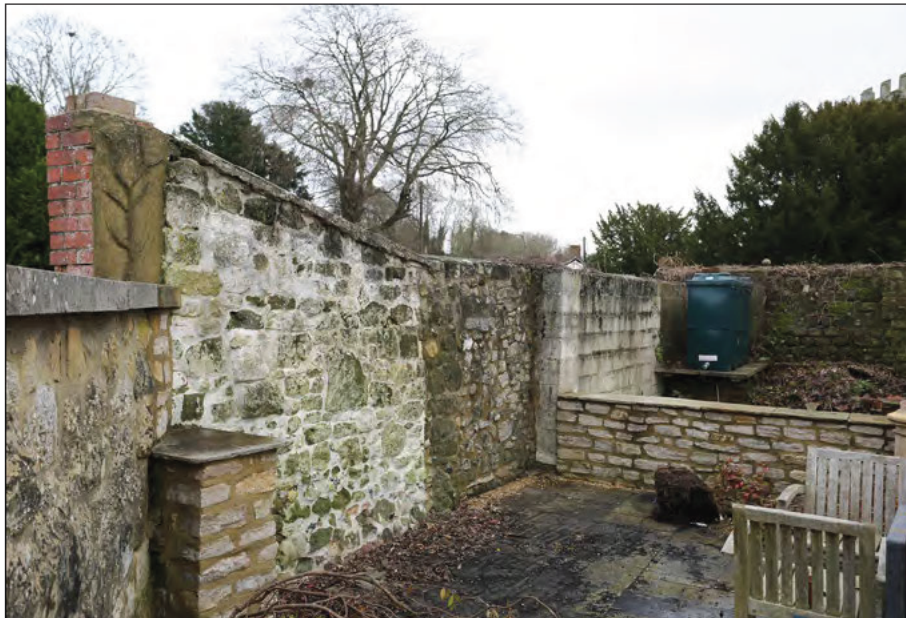
- 4.2.9 On the south-west facing elevation (along West Street) the sloping west end of the wall was painted, suggesting that this area was once part of a lean-to structure. At the eastern end of the elevation and round the corner onto the north-west elevation the wall had been reinforced by construction of an inner skin of concrete blockwork. The western end of the concrete blockwork terminated in a pier adjacent to the blocked door (**Photographs 10-13**).

Photograph 10: The south-west side of the West Street boundary wall, viewed from the west

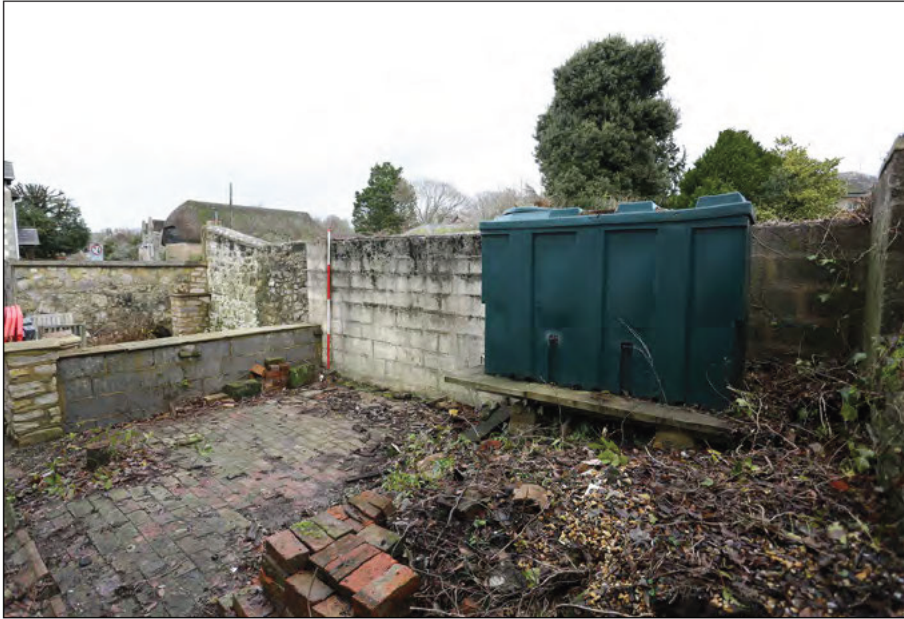
Photograph 11: The south-west side of the West Street boundary wall, viewed from the south

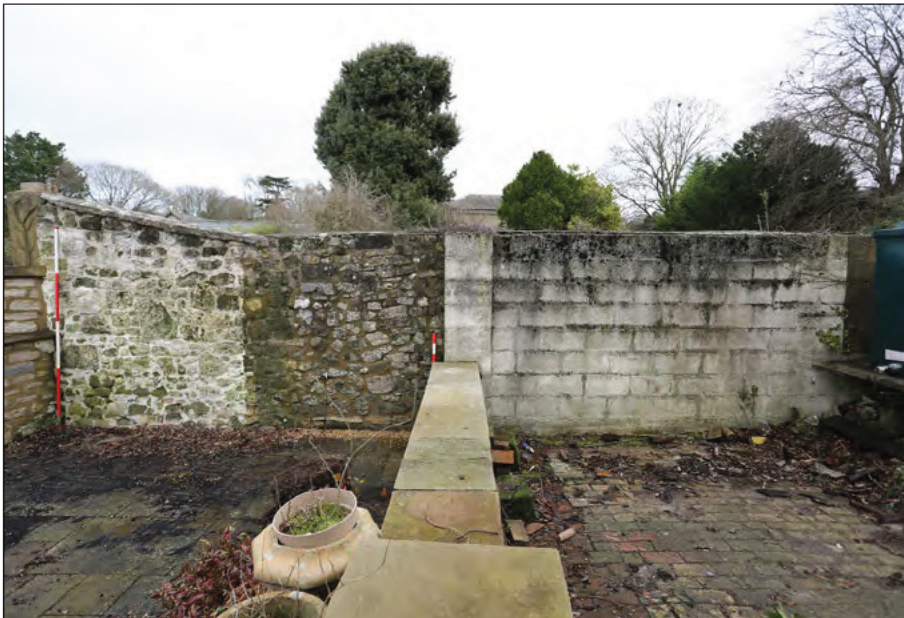
Photograph 12: The south-west elevation of the West Street boundary wall

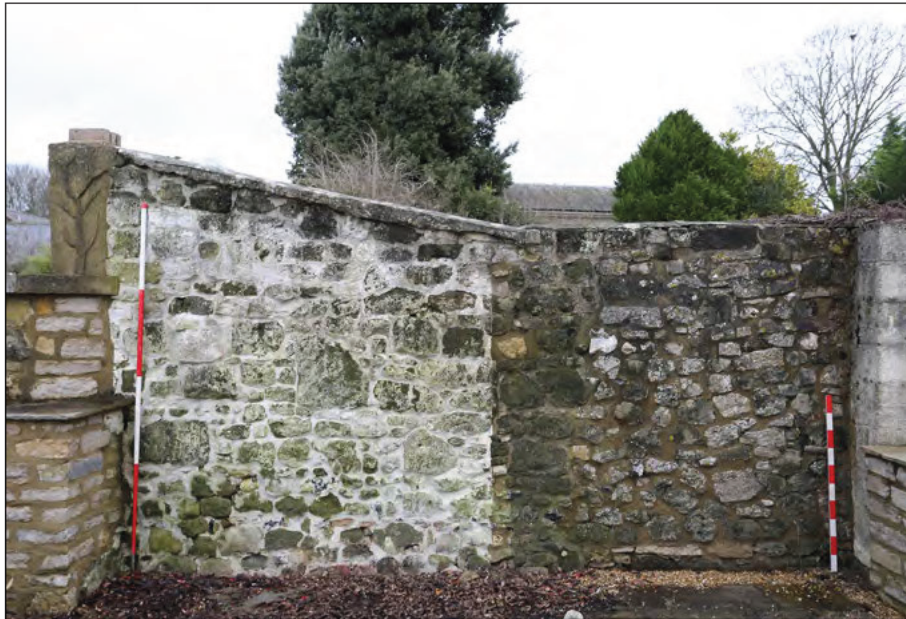
Photograph 13: Remnant paint on the sloping section of wall suggests this was part of a lean-to or mono-pitched structure

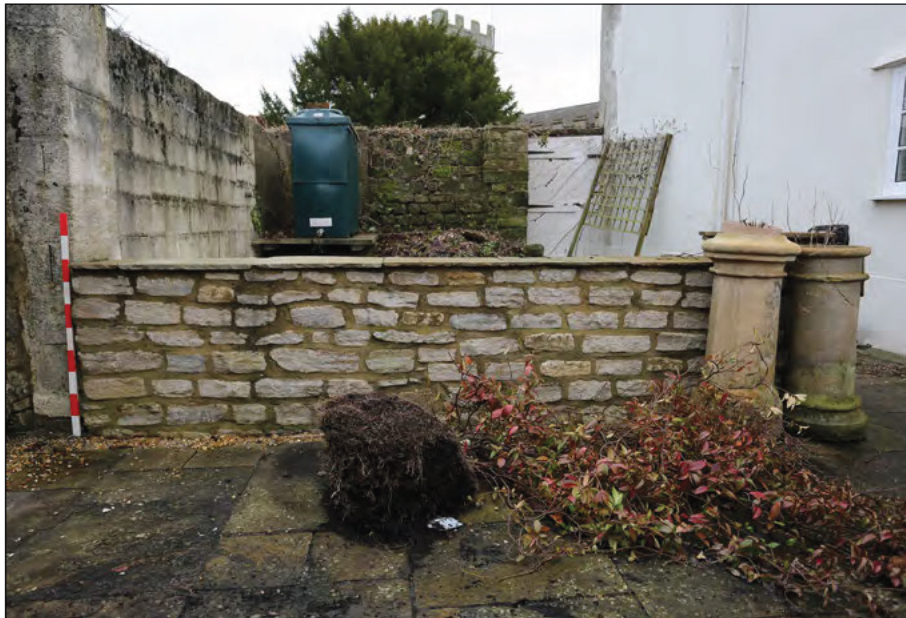
- 4.2.10 A modern stub garden wall measuring 3.4 m in length extended perpendicular from the boundary wall towards the cottage. It consisted of concrete blocks with a stone cap which was faced on the north-west elevation in regularly coursed limestone rubble. A pier of similarly buff coloured stone was located at the junction of the boundary wall and the angled limestone extension (**Photographs 14-16**).

Photograph 14: The north-west side of the garden wall faced in stone

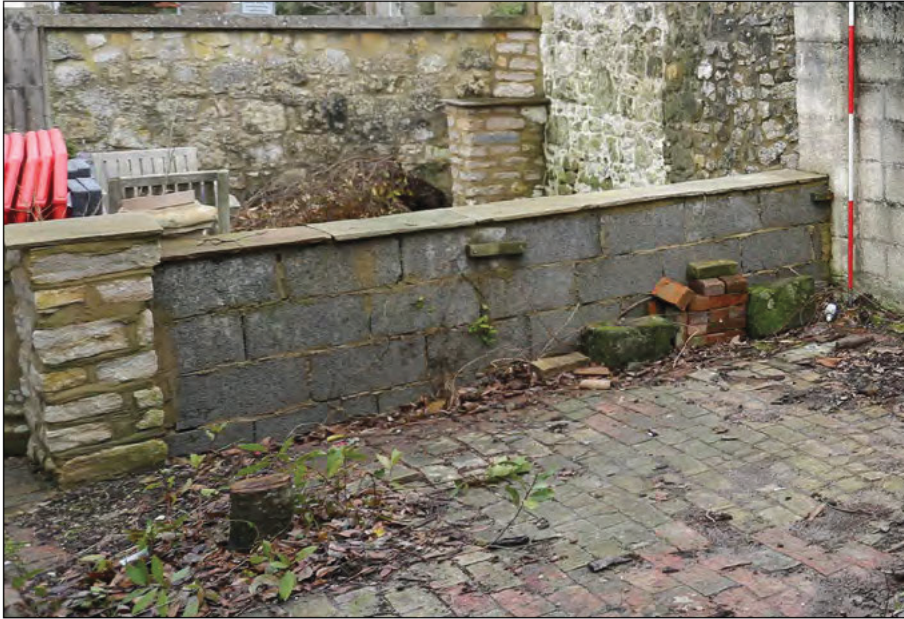
Photograph 15: The south-east side of the garden wall showing exposed concrete blockwork

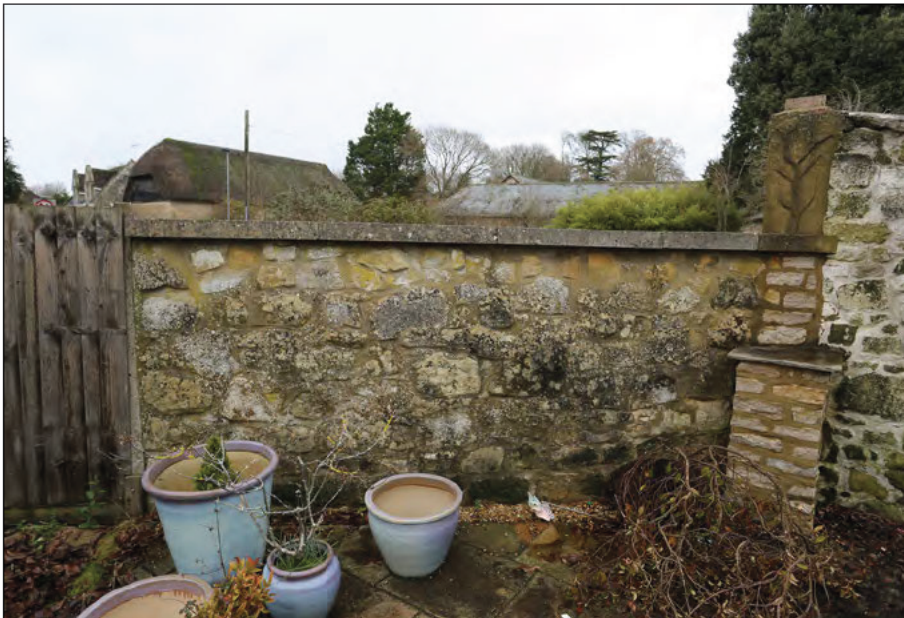
Photograph 16: The angled wall viewed from the south. Note the stone pier at the junction between the angled wall and the older West Street boundary wall

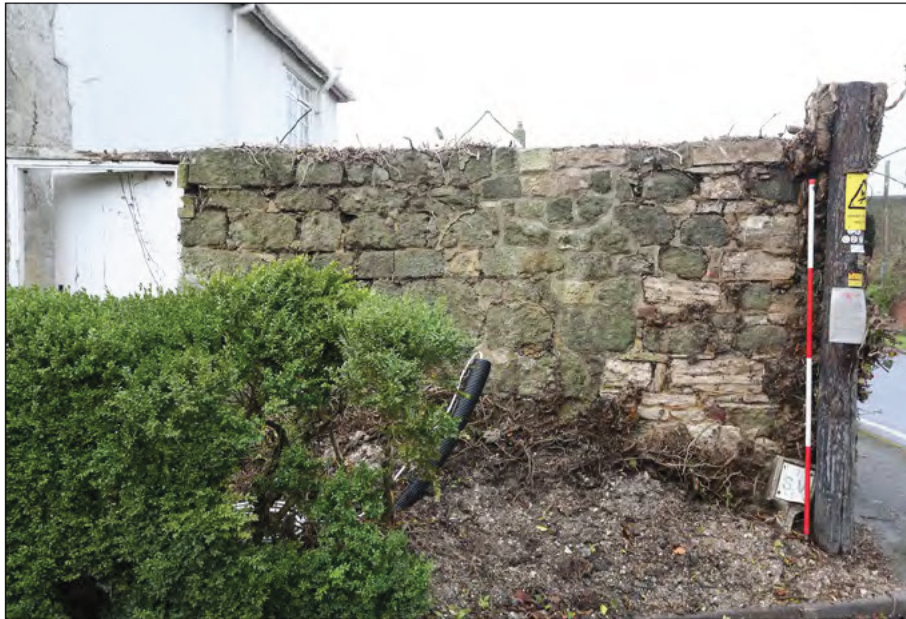
- 4.2.11 The boundary wall along Duck Lane also contained some evidence of phasing, with some red brick and pale buff coloured blocks inserted in the predominantly greensand wall. A timber door providing access into the garden was located in the southern end of this wall, adjacent to the cottage (**Photograph 17**).

Photograph 17: The Duck Lane boundary wall south-east elevation

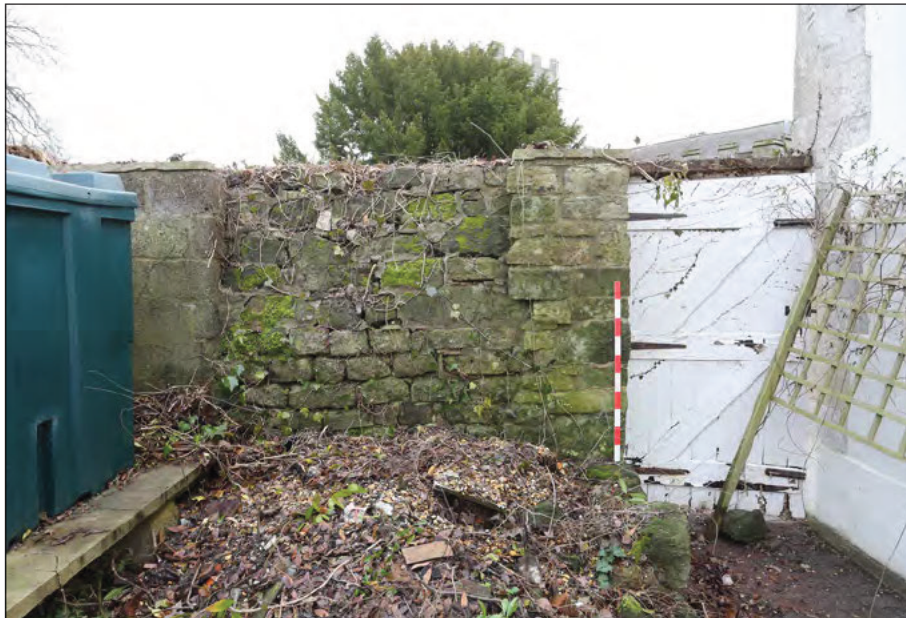
Photograph 18: The Duck Lane boundary wall north-west elevation

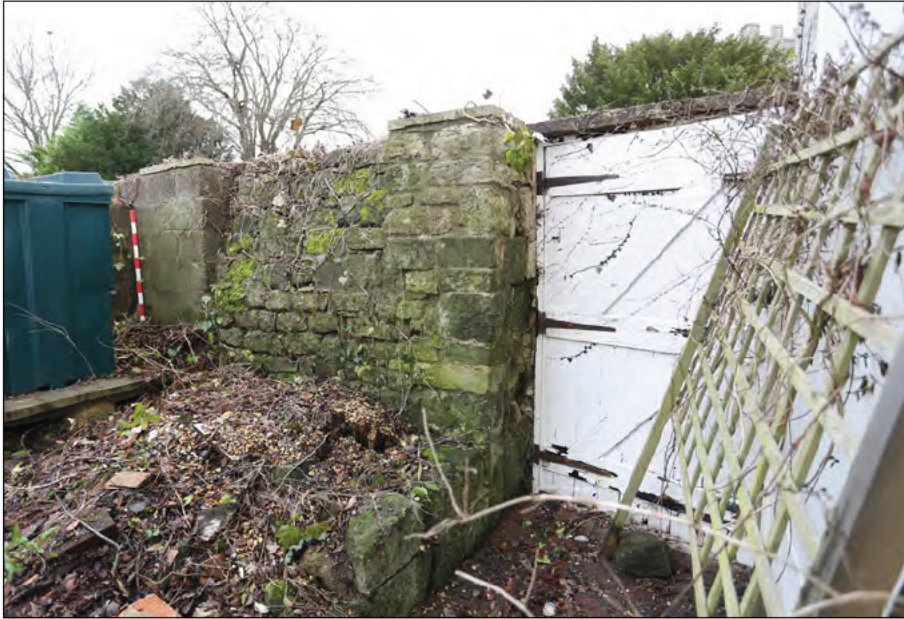
Photograph 19: The Duck Lane boundary wall and short return wall showing the extent of the building that once stood here

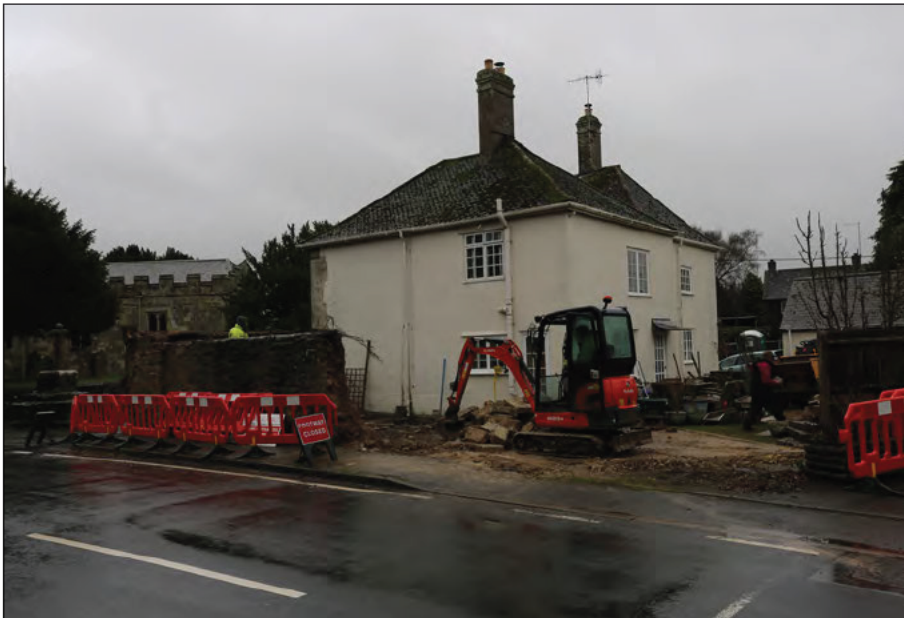
Photograph 20: The demolition of the walls in progress

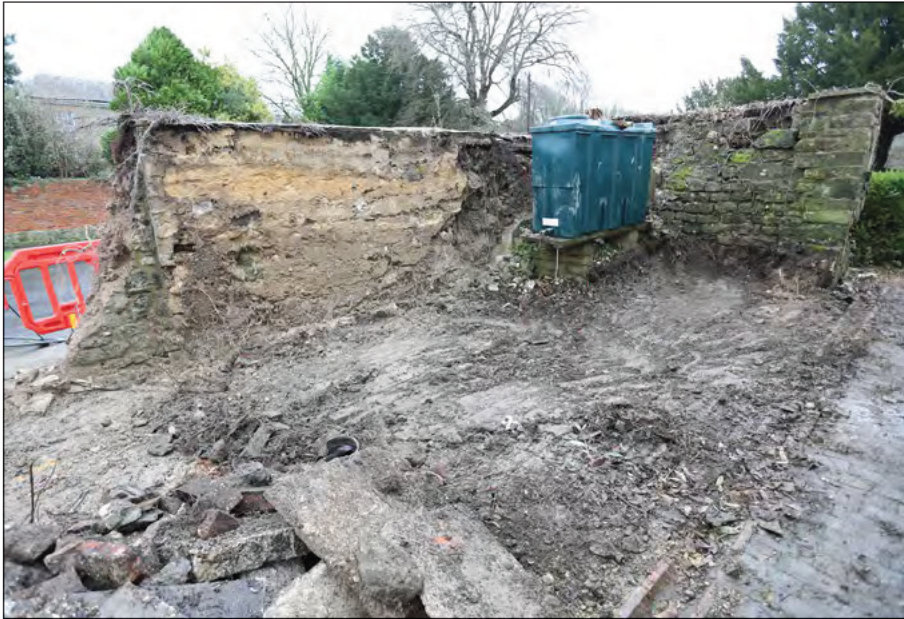
Photograph 21: The partially demolished walls viewed from the west

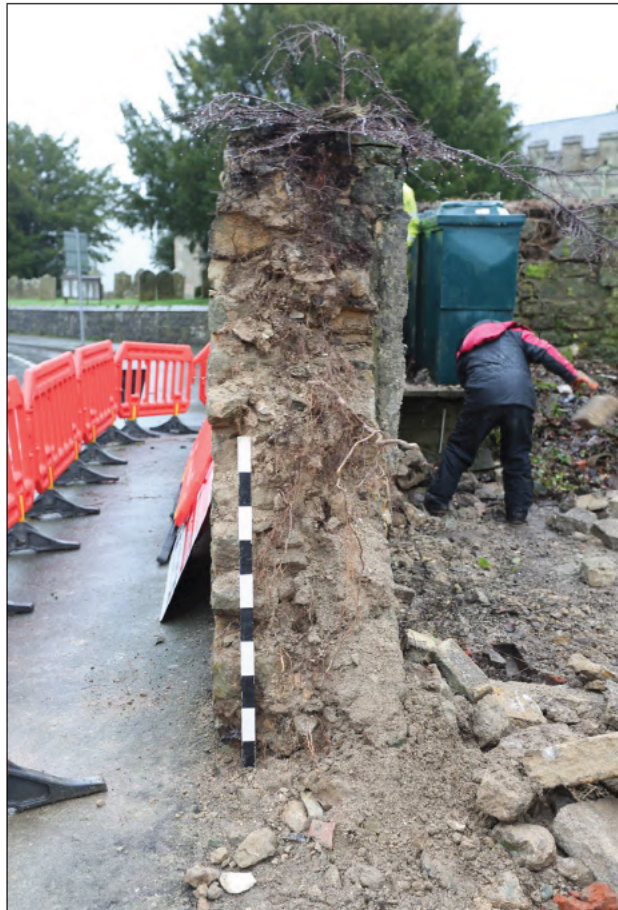
- 4.2.13 Observations during demolition revealed that the older sections of boundary wall had a loose rubble core with no evidence of stones tying through from one side to the other. A large moulded piece of limestone was found ex situ in the demolition material from the western end of the West Street boundary wall. It was L-shaped in profile measuring 1.10 m in length by 0.30 m in width by 0.27 m in depth and appears to represent a former window sill or jamb.

Photograph 22: Cross-section through the blocked doorway in the West Street boundary wall

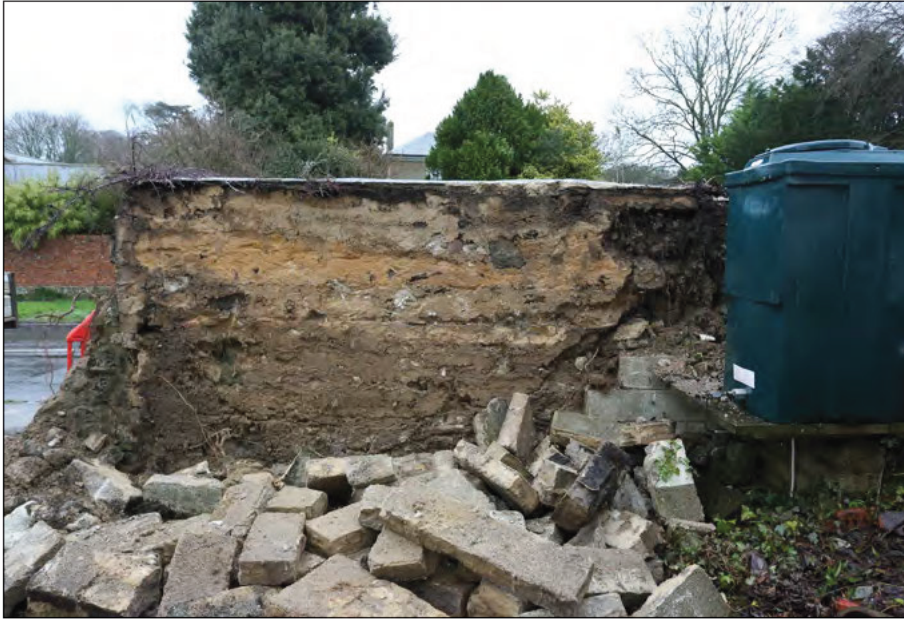
Photograph 23: The south-west elevation of the West Street boundary wall after the removal of the concrete block skin

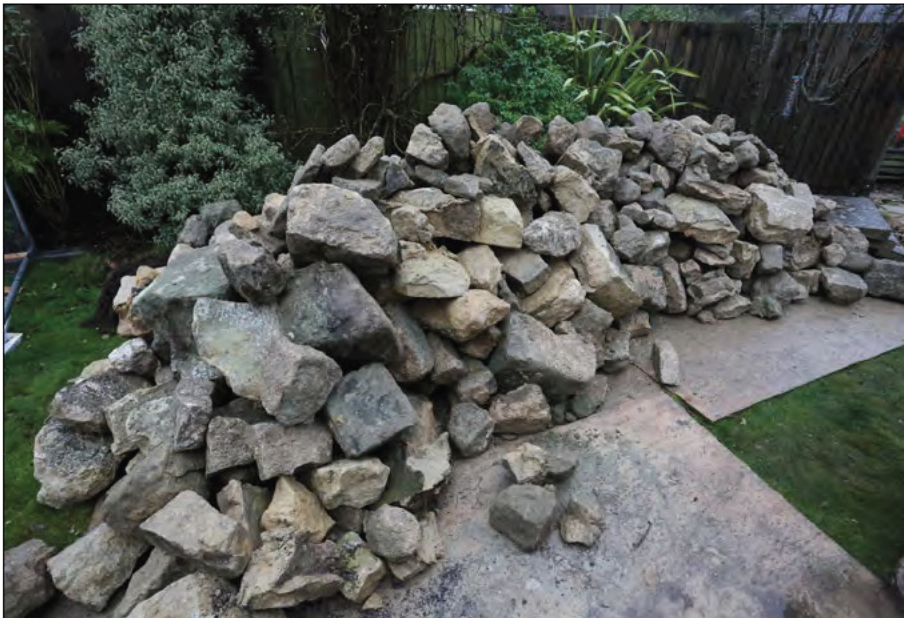
Photograph 24: Stones set aside for reuse

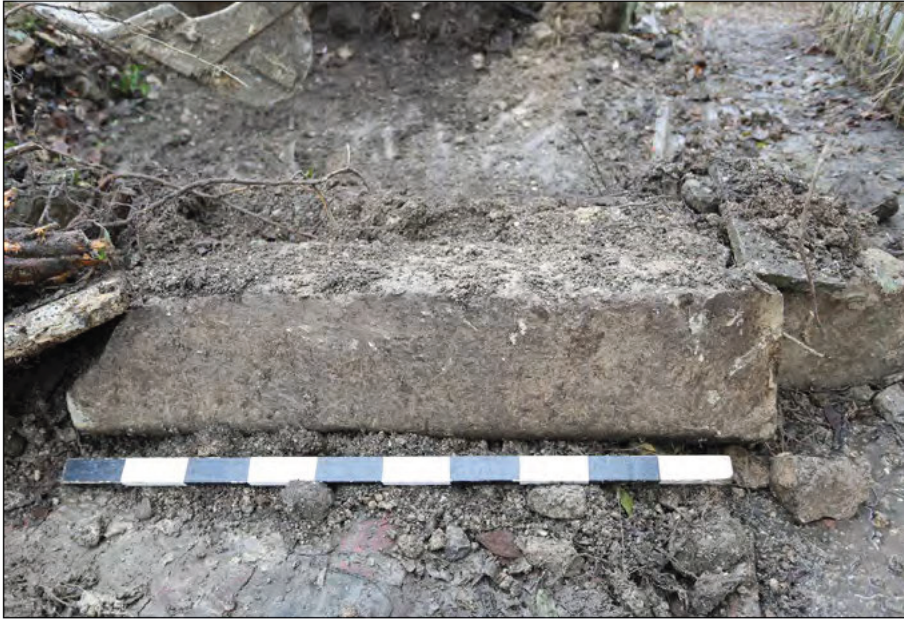
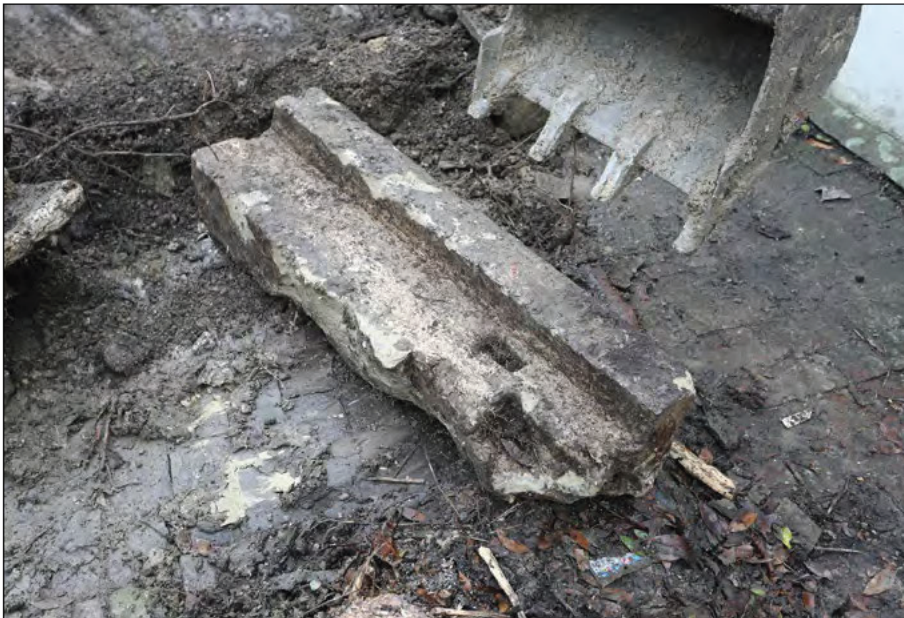
Photograph 25: The moulded L-profile limestone block interpreted as a lintel which was found during demolition

Photograph 26: The moulded L-profile limestone block interpreted as a lintel which was found during demolition
