Sofia Offshore Wind Farm: Investigation of Anomaly 7266 at Turbine Location T15

Archaeological Report

Ref: 211051.06
May 2021

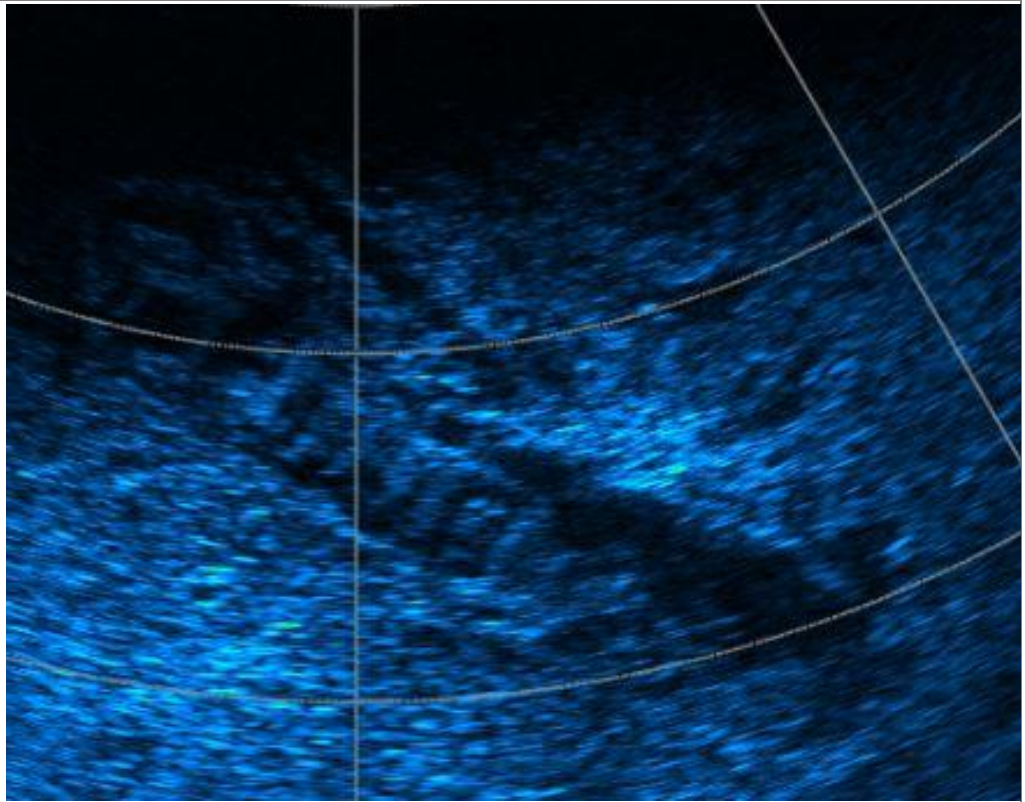
| UID | Easting | Northing | Description | Image |
|---|---|---|---|---|
| WP08 | 465988.71 | 6093524.1010 | Edge of wooden structure. Sonar image shows edge of hull structure with frames, ceiling and outer planking (north approximately up) | |

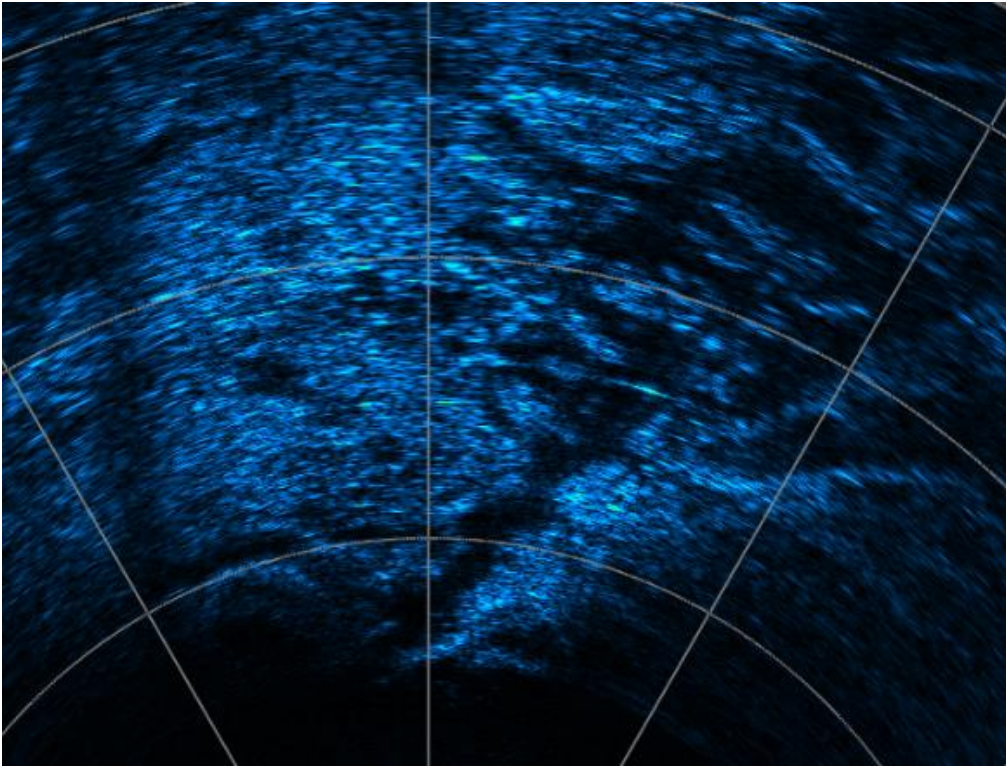
| UID | Easting | Northing | Description | Image |
|---|---|---|---|---|
| WP11 | 465989.46 | 6093523.6780 | Ditto, east end of same. Frames and planking become buried at this point. | <p data-bbox="1081 1018 2085 1101">Looking approximately south-west. WP11 approximate centre of image. The line of ceiling planks and eroded frame ends along the south edge of Area 1 can be seen from centre bottom to top right.</p> |

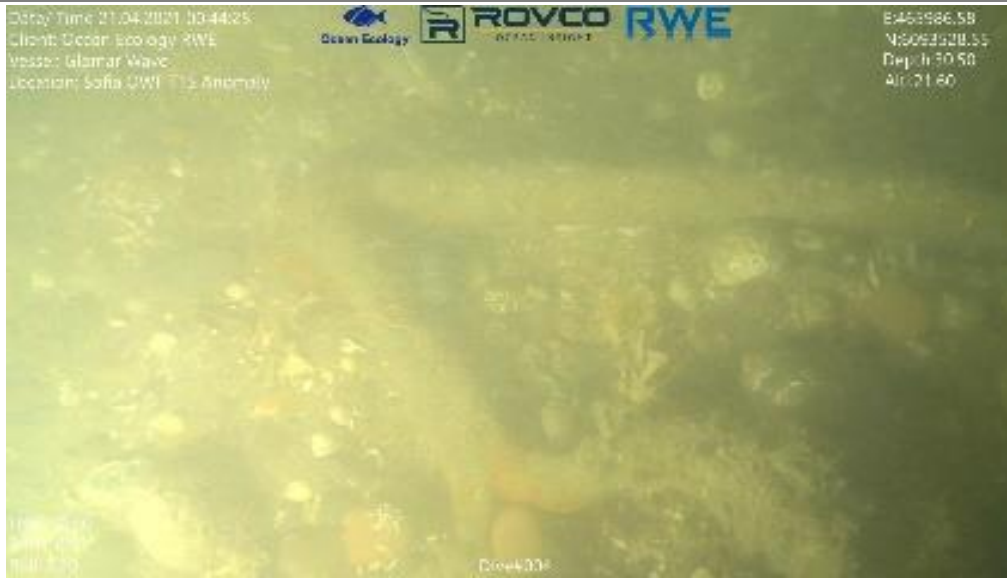
| UID | Easting | Northing | Description | Image |
|---|---|---|---|---|
| WP12 | 465986.31 | 6093528.7810 | Small, ferrous knee. Detached and lying on the seabed. The narrow angle between the arms and the pronounced curve of the lower arm suggests that it is from a position in the vessel where the floor was rising towards the deck, i.e. near the bow or stern. The upper arm is shaped to fit around a longitudinal deck beam or carling. | |

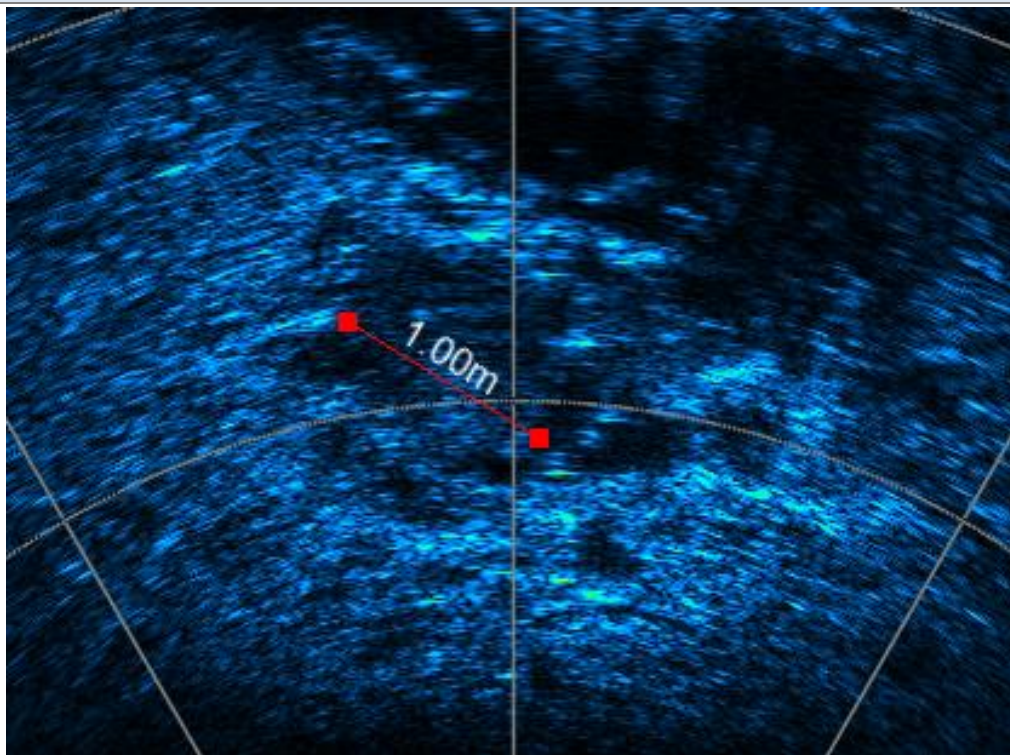
| UID | Easting | Northing | Description | Image |
|---|---|---|---|---|
| WP23 | 465992.12 | 6093520.52 | Planking in Area 2. Small section jettted to clear of sand and small cobbles. Lying horizontally. Orientated approximately west-south-west to east-north-east. Flush laid. Concave, with supporting transverse timber. Likely to be ceiling planks with eroded frame. Light coloured hard surface overlying planks in places (see image) may be concretion formed due to the corrosion of iron fasteners of fixings. | <p>Date/ Time 21.04.2021 21:04:40 Client: Ocean Ecology RWE Vessel: Glomar Wave Location: Sofia OWF T15 Anomaly E:466000.64 N:6093521.44 Depth:30.30 Alti:34.40 Hdg: 268.60 Pitch: -1.58 Roll: 0.28 Dive#009</p> |

| UID | Easting | Northing | Description | Image |
|---|---|---|---|---|
| WP25 | 465988.96 | 6093519.14 | South edge of Area 2 | Jettied area of structure on northern edge of Area 2 (WP23 & 24) |

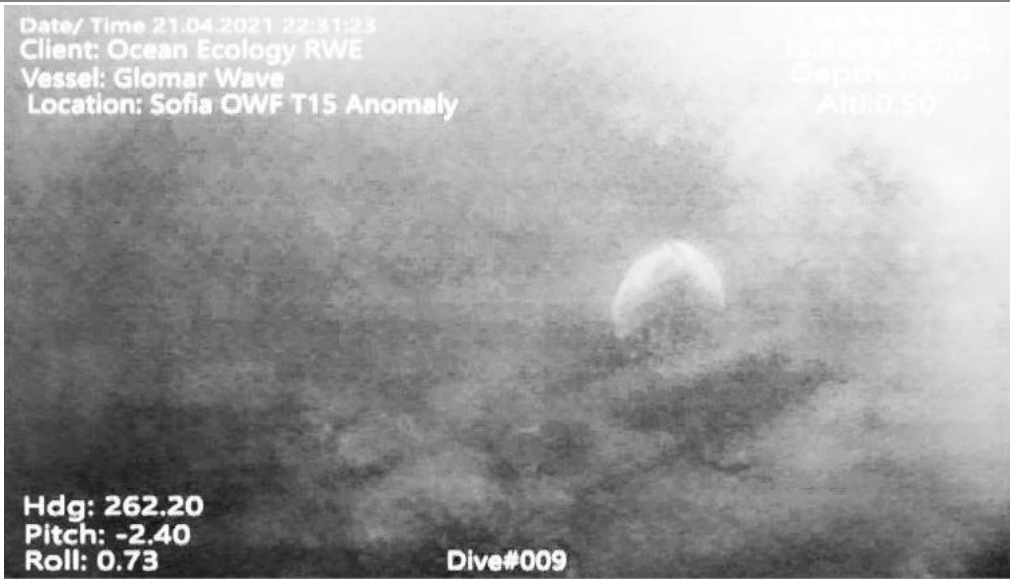
| UID | Easting | Northing | Description | Image |
|---|---|---|---|---|
| WP29 | 465985.52 | 6093527.18 | Studded chain within Area 1. The link in the image has a bar that divides the link internally into two. | <p>Date/ Time 21.04.2021 22:31:23 Client: Ocean Ecology RWE Vessel: Glomar Wave Location: Sofia OWF T15 Anomaly</p> <p>Roll: 0.73 Pitch: -2.40 Hdg: 262.20</p> <p>Depth: 30.60 Alt: 0.50</p> <p>Dive#009</p> <p>Studded chain link in centre foreground. The low-light B&W video still has been adjusted to improve contrast.</p> |

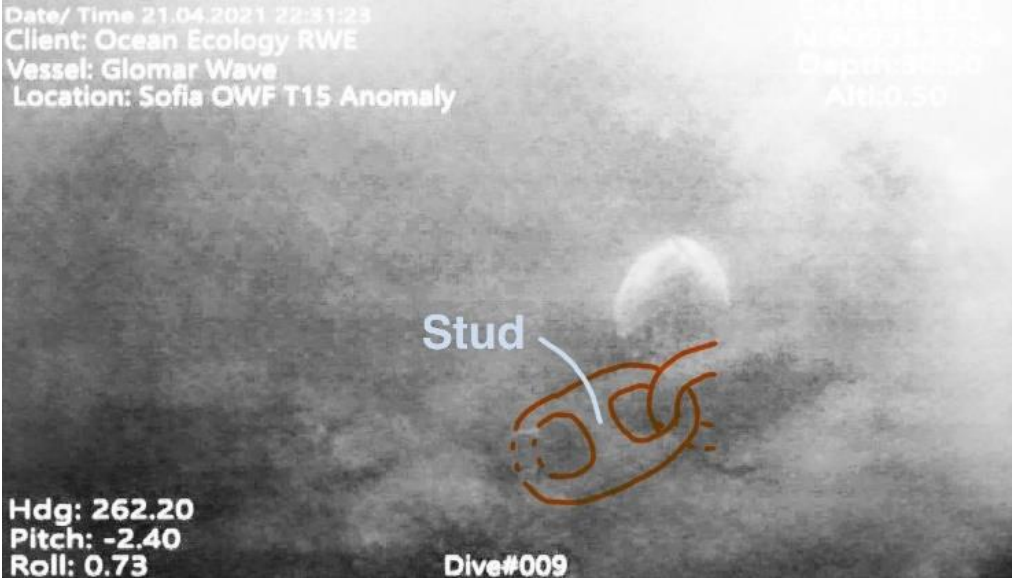
| UID | Easting | Northing | Description | Image |
|---|---|---|---|---|
| | | | | <p>Date/ Time 21.04.2021 22:31:23 Client: Ocean Ecology RWE Vessel: Glomar Wave Location: Sofia OWF T15 Anomaly</p> <p>Number: 7266 Depth: 30.50 Alt: 0.50</p> <p>Hdg: 262.20 Pitch: -2.40 Roll: 0.73</p> <p>Dive#009</p> <p>Interpretational sketch superimposed</p> |

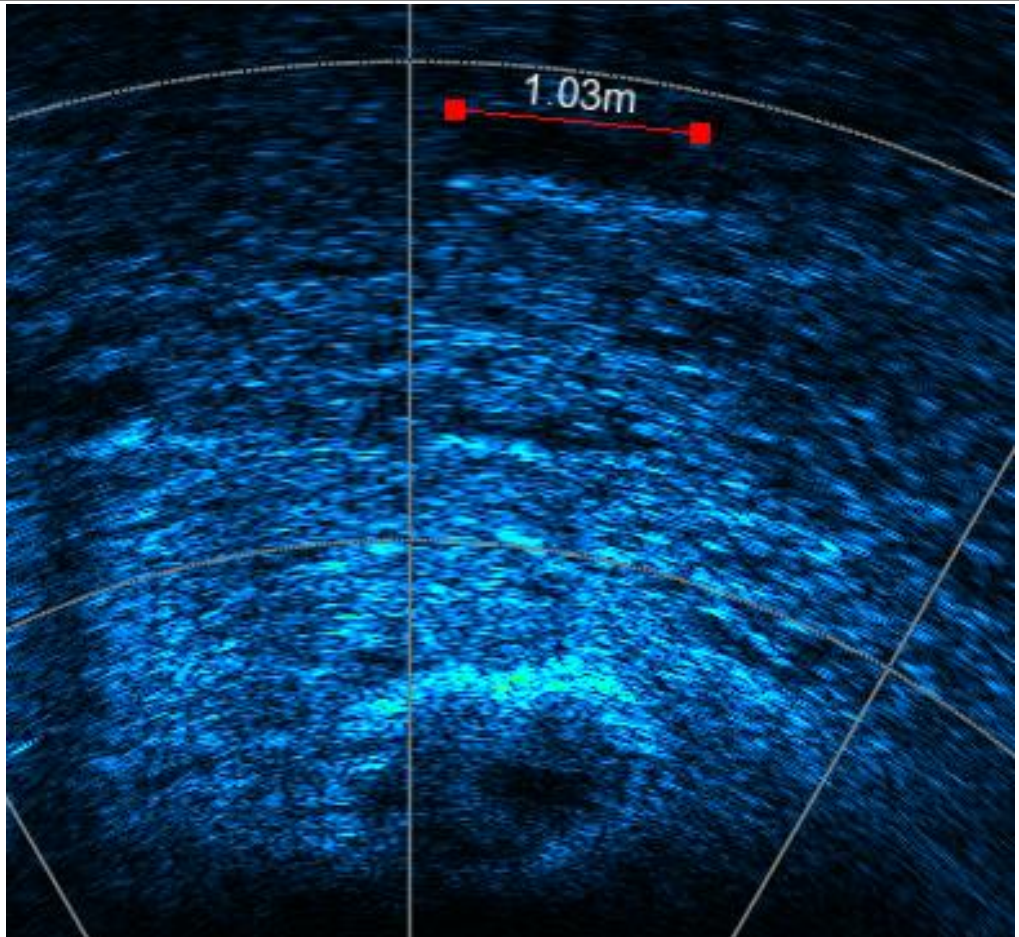
| UID | Location | Description | Image |
|---|---|---|---|
| 31 | 3.6m from east edge of Area 1 | Small linear object observed in SSS data approximately 2.0m east of Trench 3 and 3.6m from the east edge of Area 1. Approximately 1.03m long. Not observed visually, probably due to poor visibility. | The image is a Synthetic Aperture Sonar (SSS) scan showing a seabed with a complex, textured appearance in shades of blue and cyan. A small, bright, linear object is highlighted in red in the upper right quadrant. A red double-headed arrow with the text '1.03m' above it indicates the length of this object. The scan is overlaid with a grid of white lines, including a vertical line that passes through the object and several curved lines representing the scan's geometry. |

- 5.2.3 The ROV imaging sonar picked up a small linear object approximately 3.6 m from the east end of Area 1 in the general direction of the proposed turbine location, but this was not seen when overflown, probably due to the very poor visibility (**Appendix 2: 31**). The presence of a small fragment of timber in TP2 suggests that there is a likelihood of a very sparse buried debris field extending in the direction of the main flow of current, probably aligning with dominant current flow and for an unknown distance. It is unlikely that this can be confirmed or further defined, other than by extensive excavation.

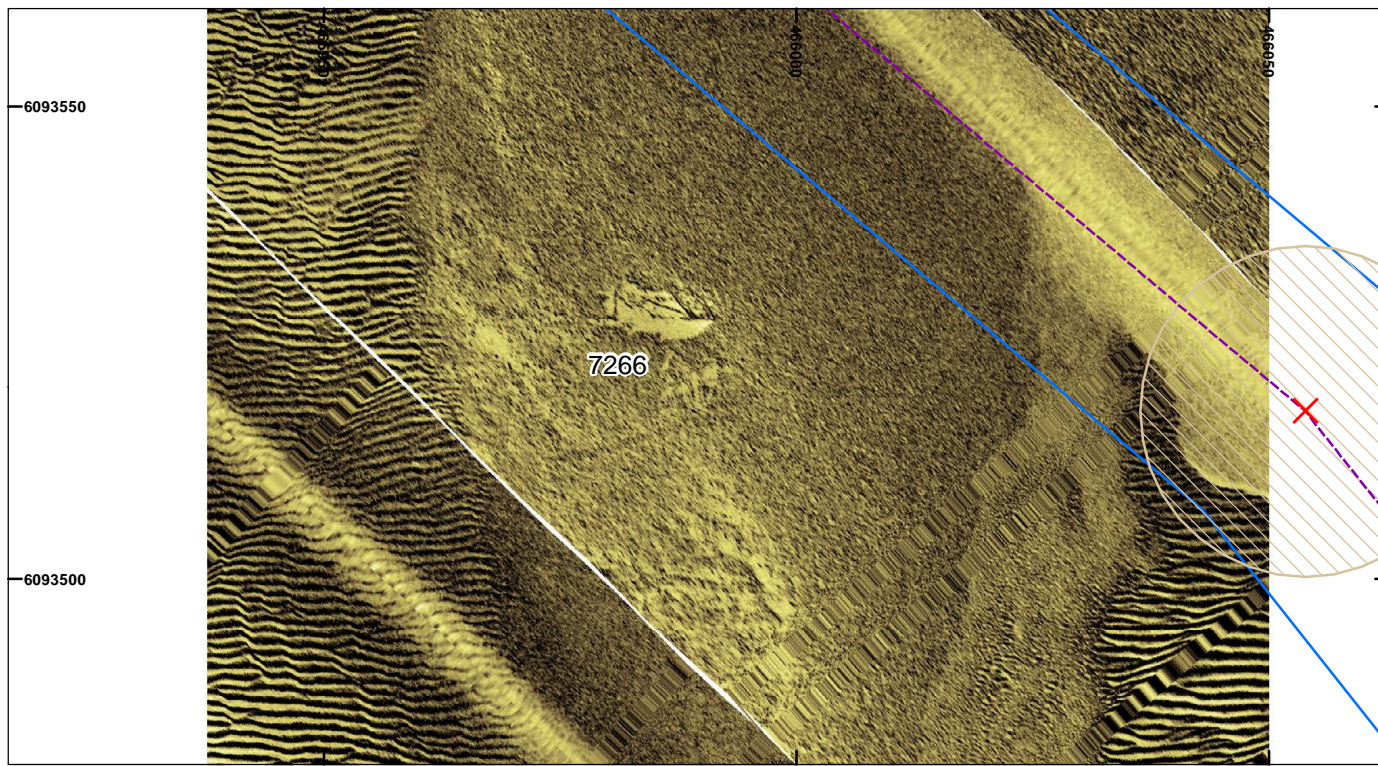
A. Sidescan sonar image of Anomaly 7266

The anomaly was found by geophysical survey. The sidescan sonar and MBES data indicated that it was approximately 19.0 m x 13.5 m x 0.3 m high above bed level. It had a magnetic amplitude of 154 nT, suggesting ferrous content.

- 2.1.1 Although it was believed to be anthropogenic, prior to the investigation the anomaly was not identified or archaeologically characterised. It was observed in sidescan sonar (SSS) and multibeam echosounder (MBES) datasets as a mound-like feature 19.0 m x 13.5 m x 0.3 m high at 465989 6093527 (WGS84 UTM Z31N), with a magnetic amplitude of 154 nT (**Figures 2a-c**).
- 2.1.2 The anomaly as defined by the datasets was approximately 14 m west-south-west of the centre point of the proposed turbine base location.

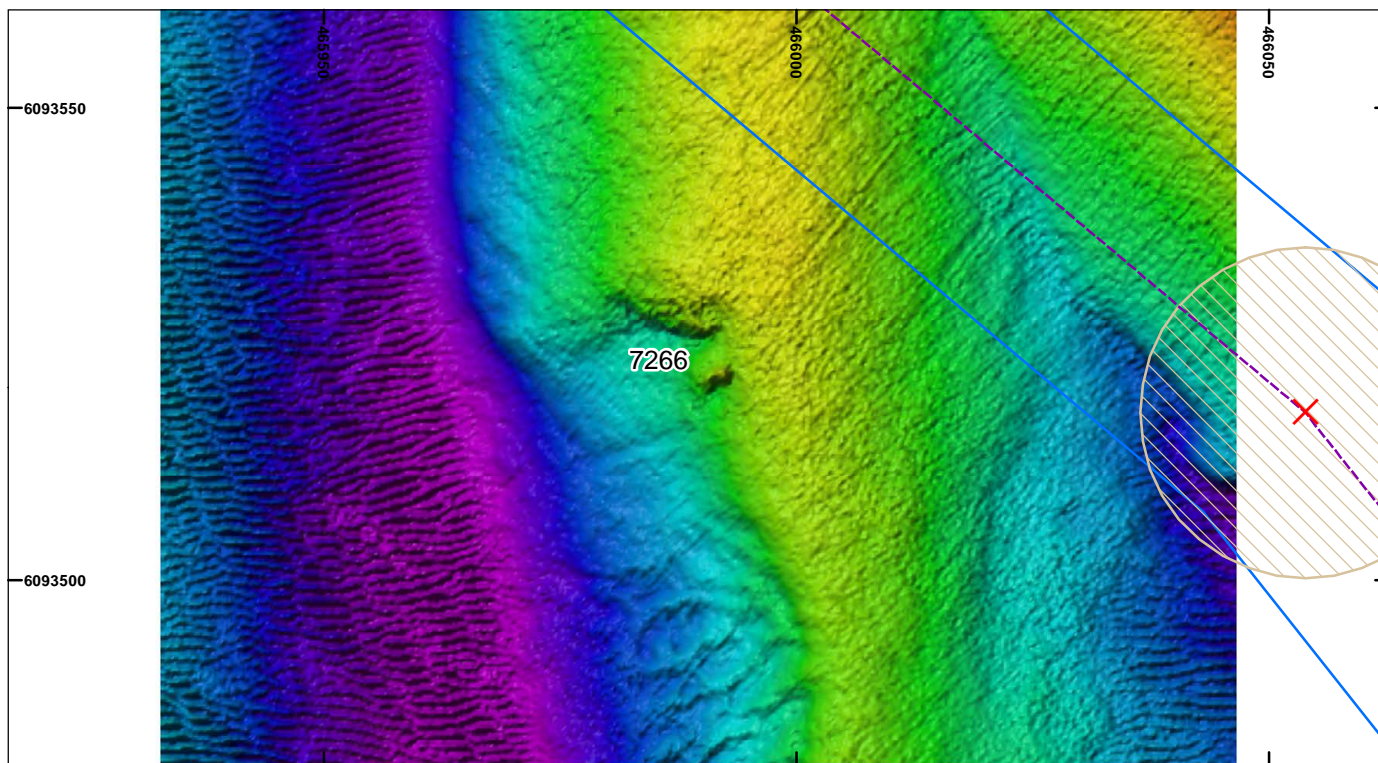
B. MBES image of Anomaly 7266

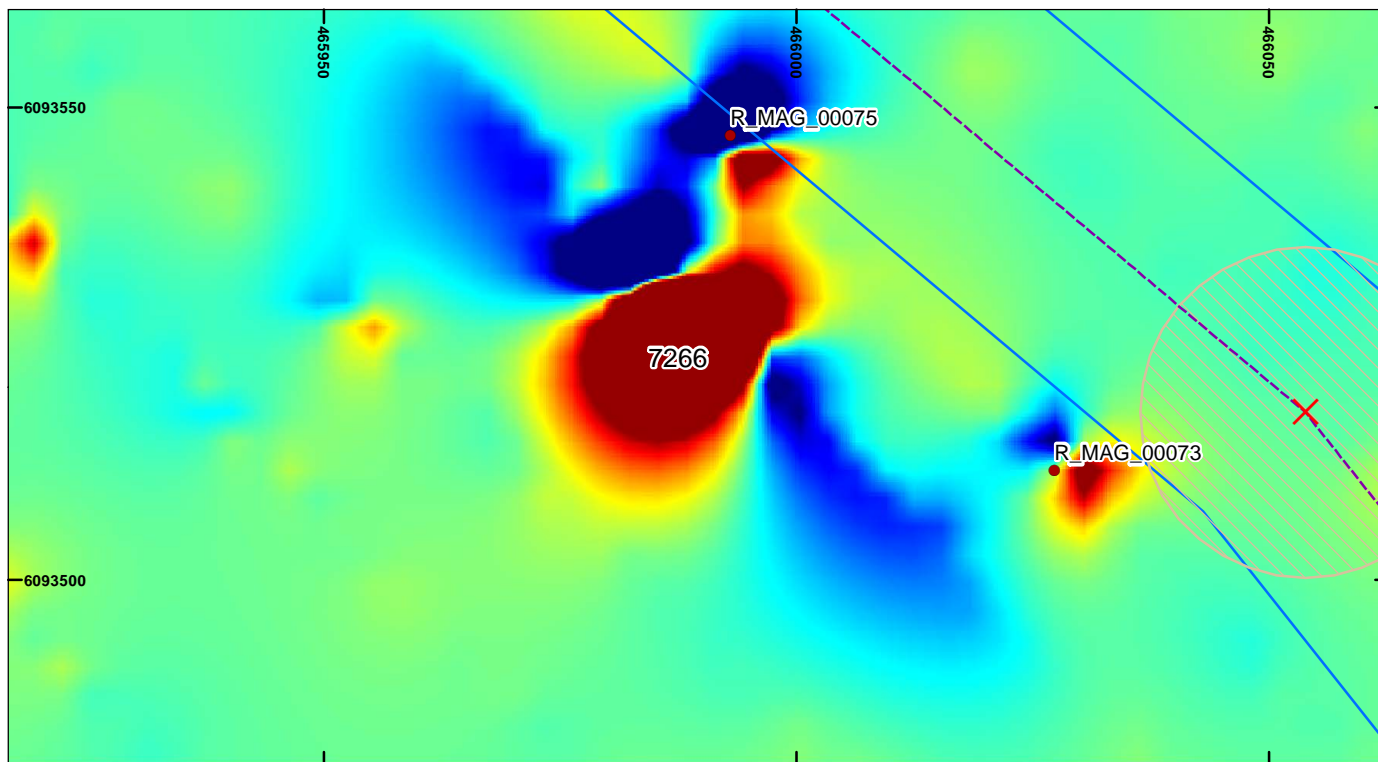
C. Magnetometer data for Anomaly 7266
