SOFIA **OFFSHORE** **WIND FARM**

ARCHAEOLOGICAL ASSESSMENT

**FOR OFTO UXO INVESTIGATIONS AND
CLEARANCE, AND POTENTIAL ARCHAEOLOGY
INVESTIGATIONS: CAMPAIGN 2**

Document reference 004546647

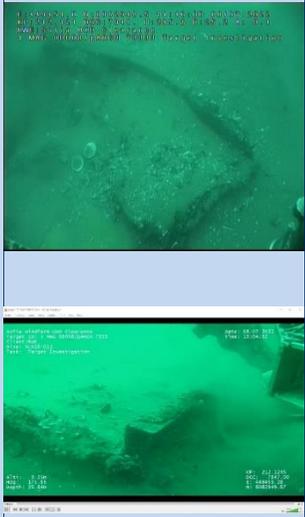
TARGET ID	WA ID	EASTING	NORTHING	EASTING (AS MOVED)	NORTHING (AS MOVED)	DESCRIPTION	REPORT	ACTION	IMAGE
F_MAG_00501	7674	422781.91	6079519.4	422782.76	6079545.52	Wire rope 0.3 m diameter	Modern / non-arch.	No Action	
F_SSS_00190		402637.38	6080899.5			Boulder	Natural	No Action	
F_SSS_00257		412858.05	6080258.42			Boulder	Natural	No Action	
ECR_FABM_SSS_175906		403090.1204	6080866.402			Boulder	Natural	No Action	
H_MAG_00016	7050	434646.8	6095360.7			Nothing Found	Nothing Found	No Action	
J_MAG_00008 / (pARCH)	7333	449453	6082950			Steel metal frame like structure L 1.02 x W 0.5 H 150mm. Metal object	Modern / non-arch.	Recommend avoiding as may present navigational hazard

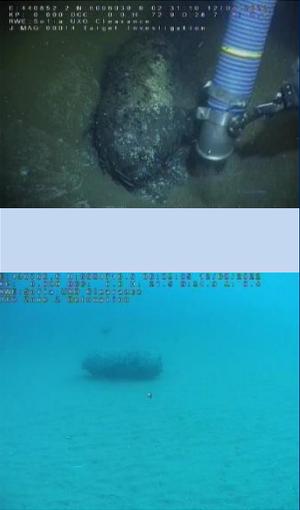
TARGET ID	WA ID	EASTING G	NORTHING	EASTING (AS MOVED)	NORTHING (AS MOVED)	DESCRIPTION	REPORT	ACTION	IMAGE
J_MAG_00014	7326	440855	6096030			German airdropped weapon (bomb) dating to WWII	UXO	UXO requirements take precedence. No further action is required

- 3.1.10 J_MAG_00014 was initially identified as a German SC 500 kg Bomb. However, this was later confirmed to be a British 10000lb Medium Capacity Bomb. The as found position was within the wind farm array area, however the bomb required relocation to an area of deeper sediment to reduce impacts on Dogger Bank Special Area of Conservation. Detonation was conducted via two unsuccessful Low Order deflagrations and a third HO detonation, which was successful.

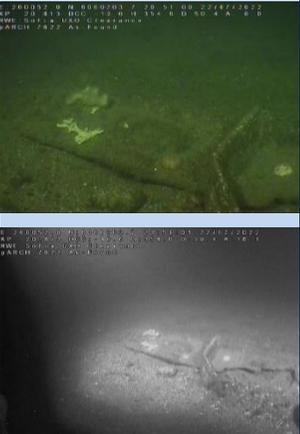
TARGET ID	WA ID	EASTING	NORTHING	EASTING (AS MOVED)	NORTHING (AS MOVED)	DESCRIPTION	REPORT	ACTION	IMAGE
(pARCH)	7622A-D	260054	6060206			Metal debris	Modern / non-arch.	Recommend avoiding as may present navigational hazard

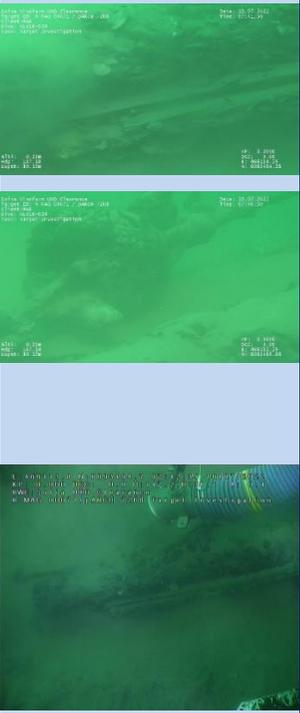
TARGET ID	WA ID	EASTING	NORTHING	EASTING (AS MOVED)	NORTHING (AS MOVED)	DESCRIPTION	REPORT	ACTION	IMAGE
R_MAG_00048						Nothing Found	Nothing Found	No Action	
R_MAG_00050		460949	6098879	460975	6098866	Wire rope	Modern / non-arch.	No Action	
R_MAG_00054		460958	6098834			Nothing Found	Nothing Found	No Action	
R_MAG_00071 / (pARCH)	7268	466111	6093495			Target identified as wood/metallic mixture with small length of steel wire rope, depth burial - 1.0m. Target dimension 4.5 x 0.4 m. Possibly ships mast made of wood and steel components.	Archaeology	Reported via PAD

- 3.1.4 Two targets have been identified as being of archaeological interest.
- 3.1.5 Target 7268 (R_MAG_00071) was reported via the PAD and described as consisting of a mixture of wood and metal with a small length of steel wire rope. Due to its proximity to Anomaly 7266 (wreck of an unidentified wooden ship) target 7268 was recommended by the Retained Archaeologist as requiring further investigation. The target was initially left *in-situ*, however, following agreement with Historic England, has since been recovered, reported to the Receiver of Wreck and is being wet stored at the Wessex Archaeology’s Salisbury office for further assessment (Wessex Archaeology 2022).

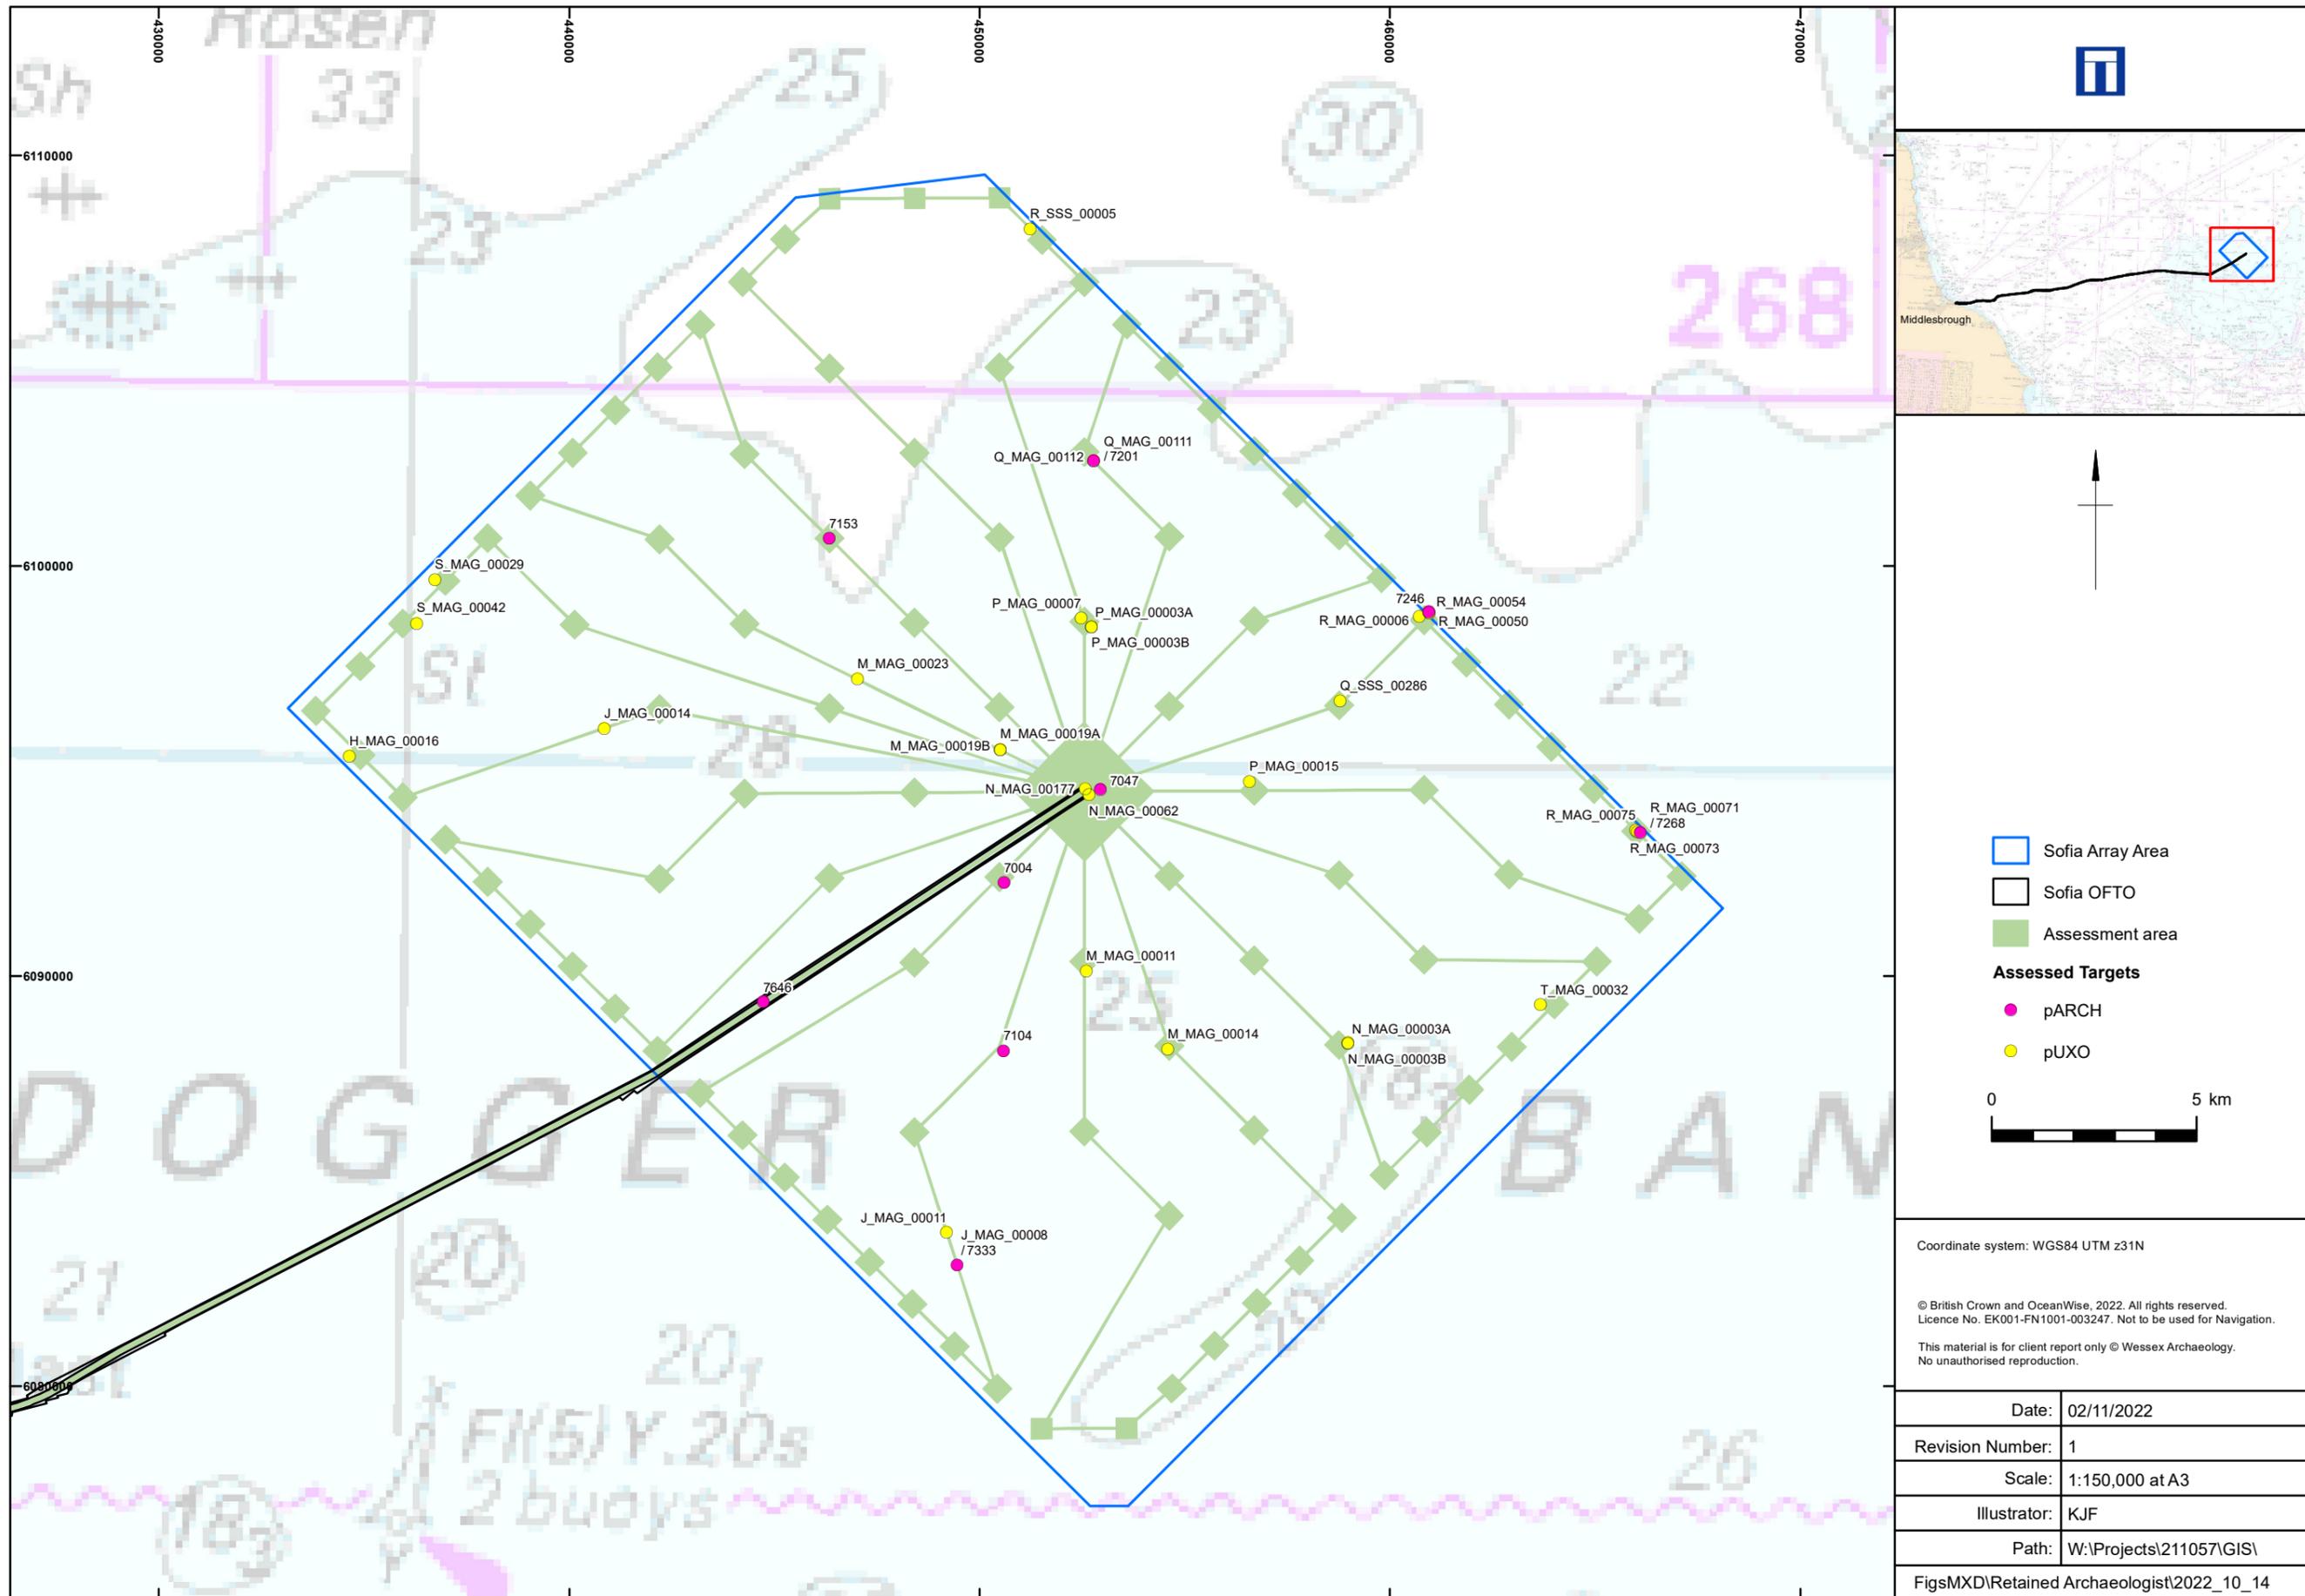
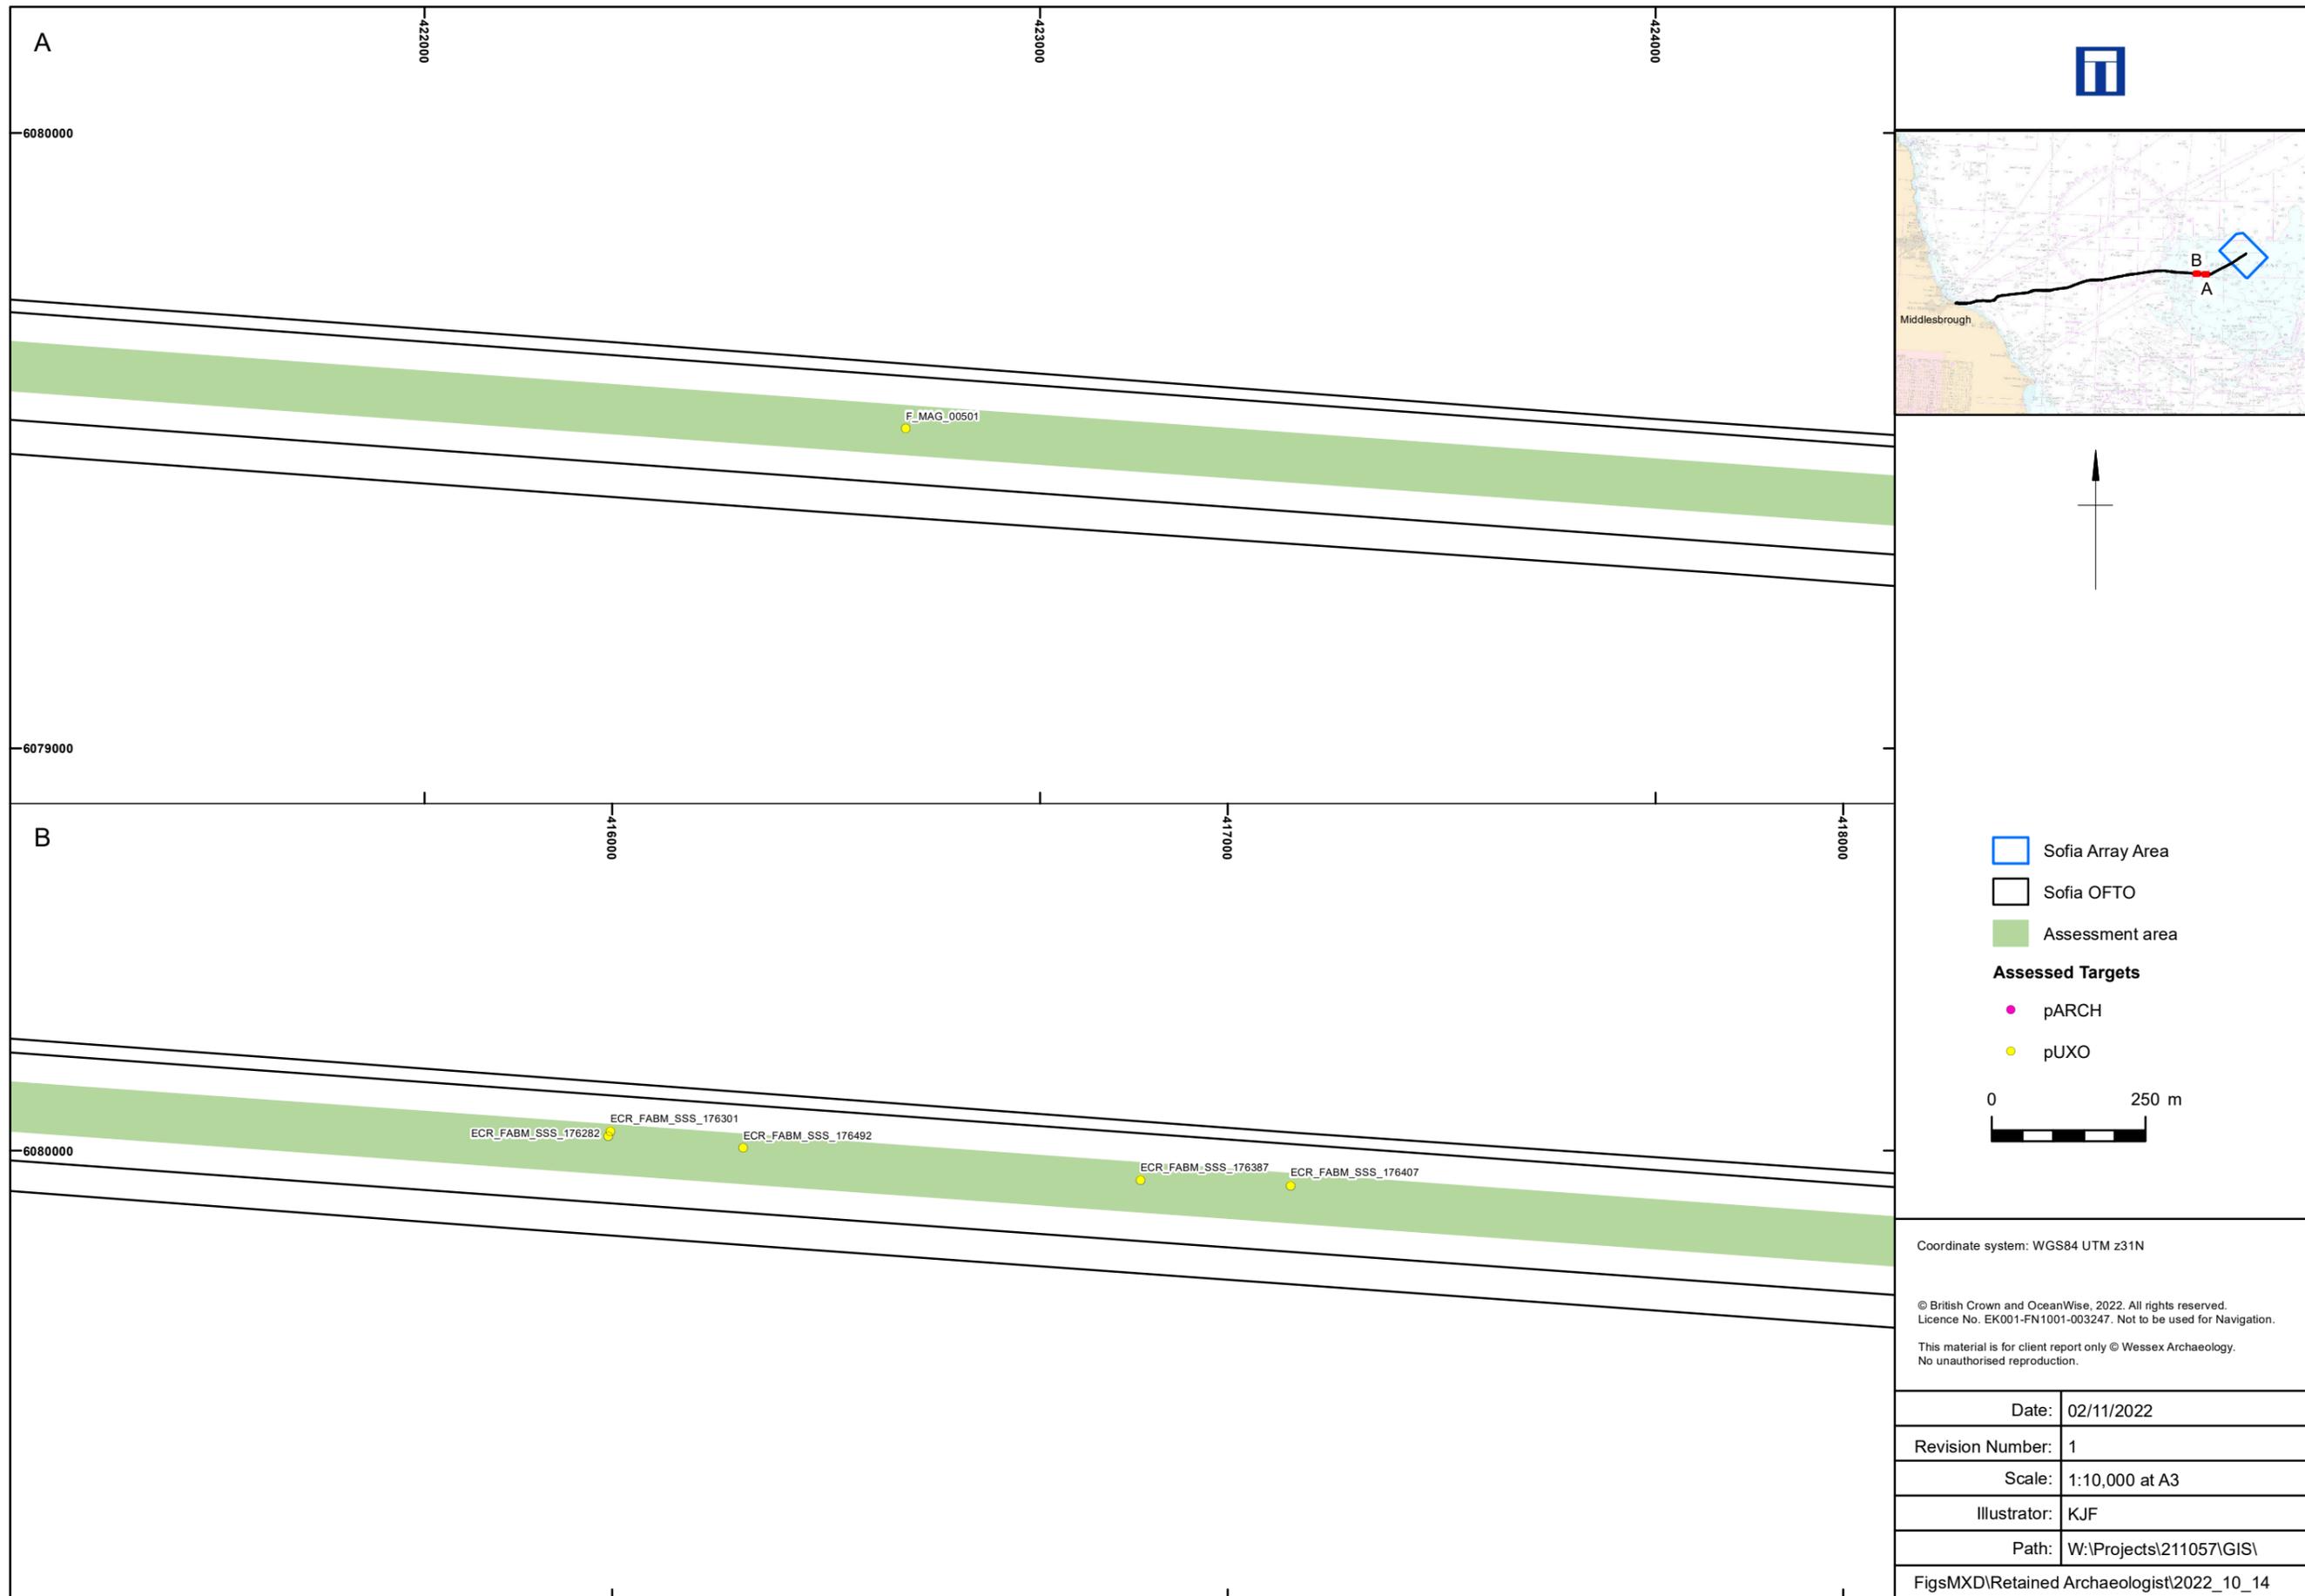
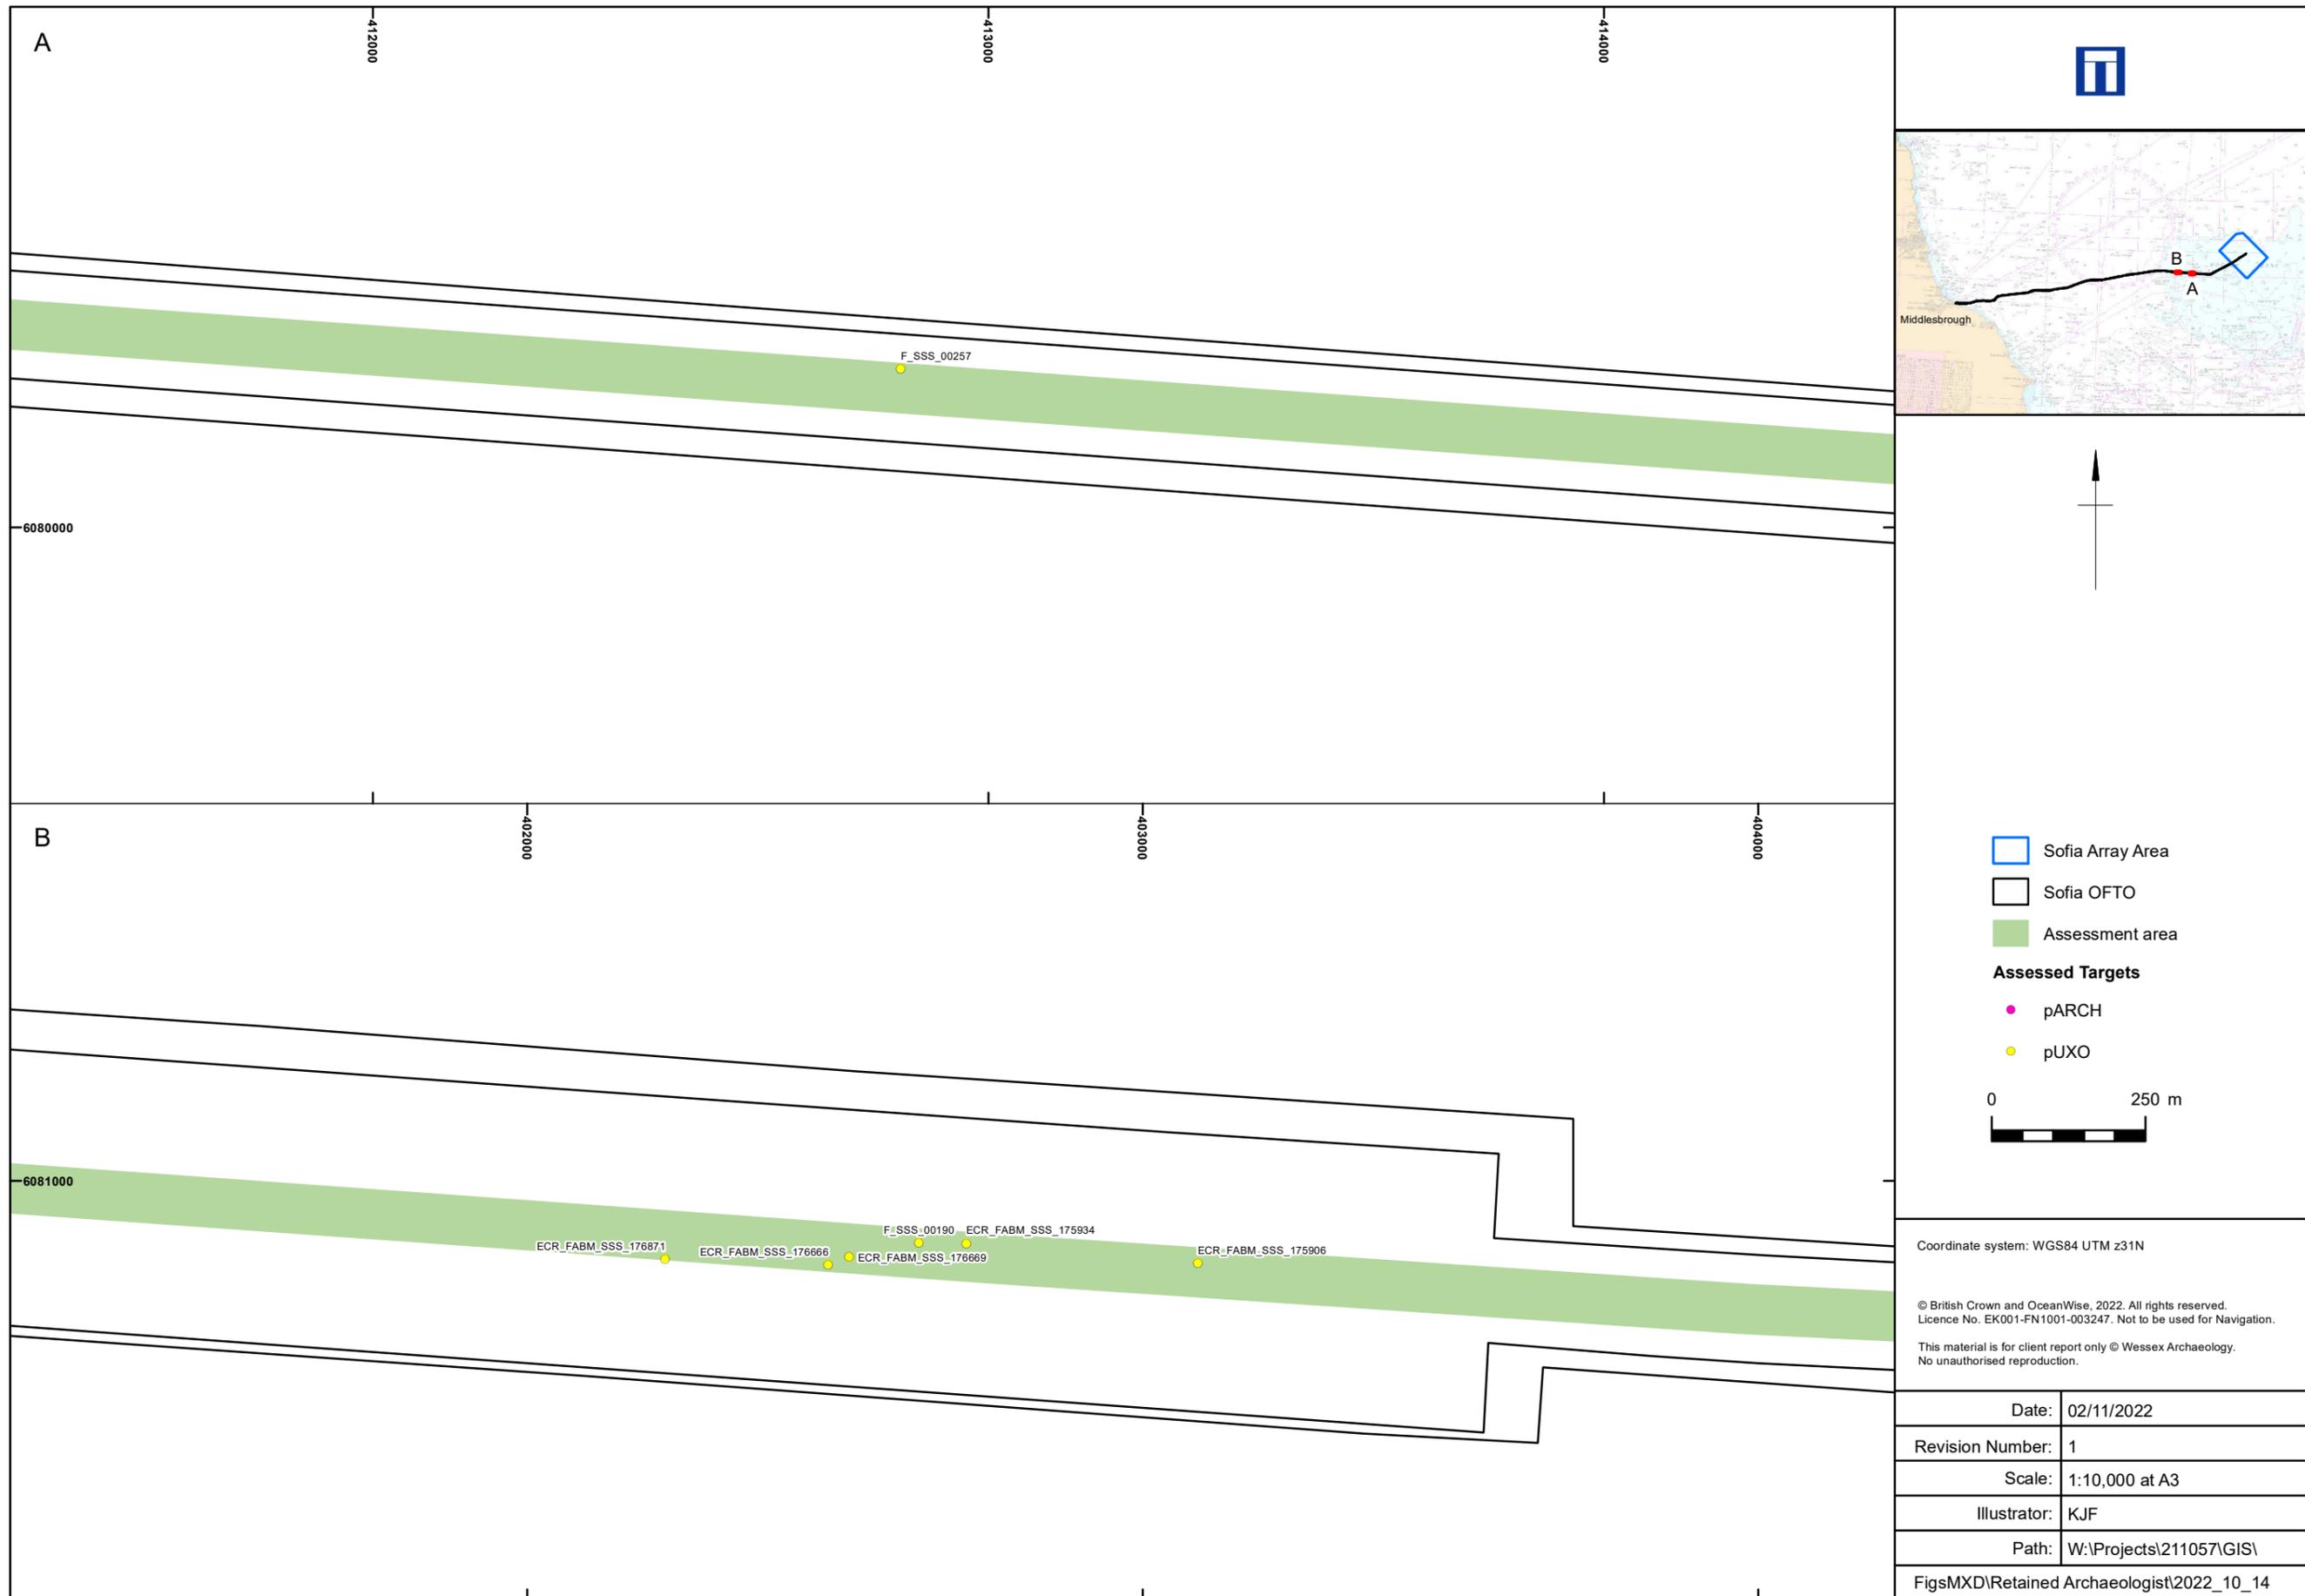
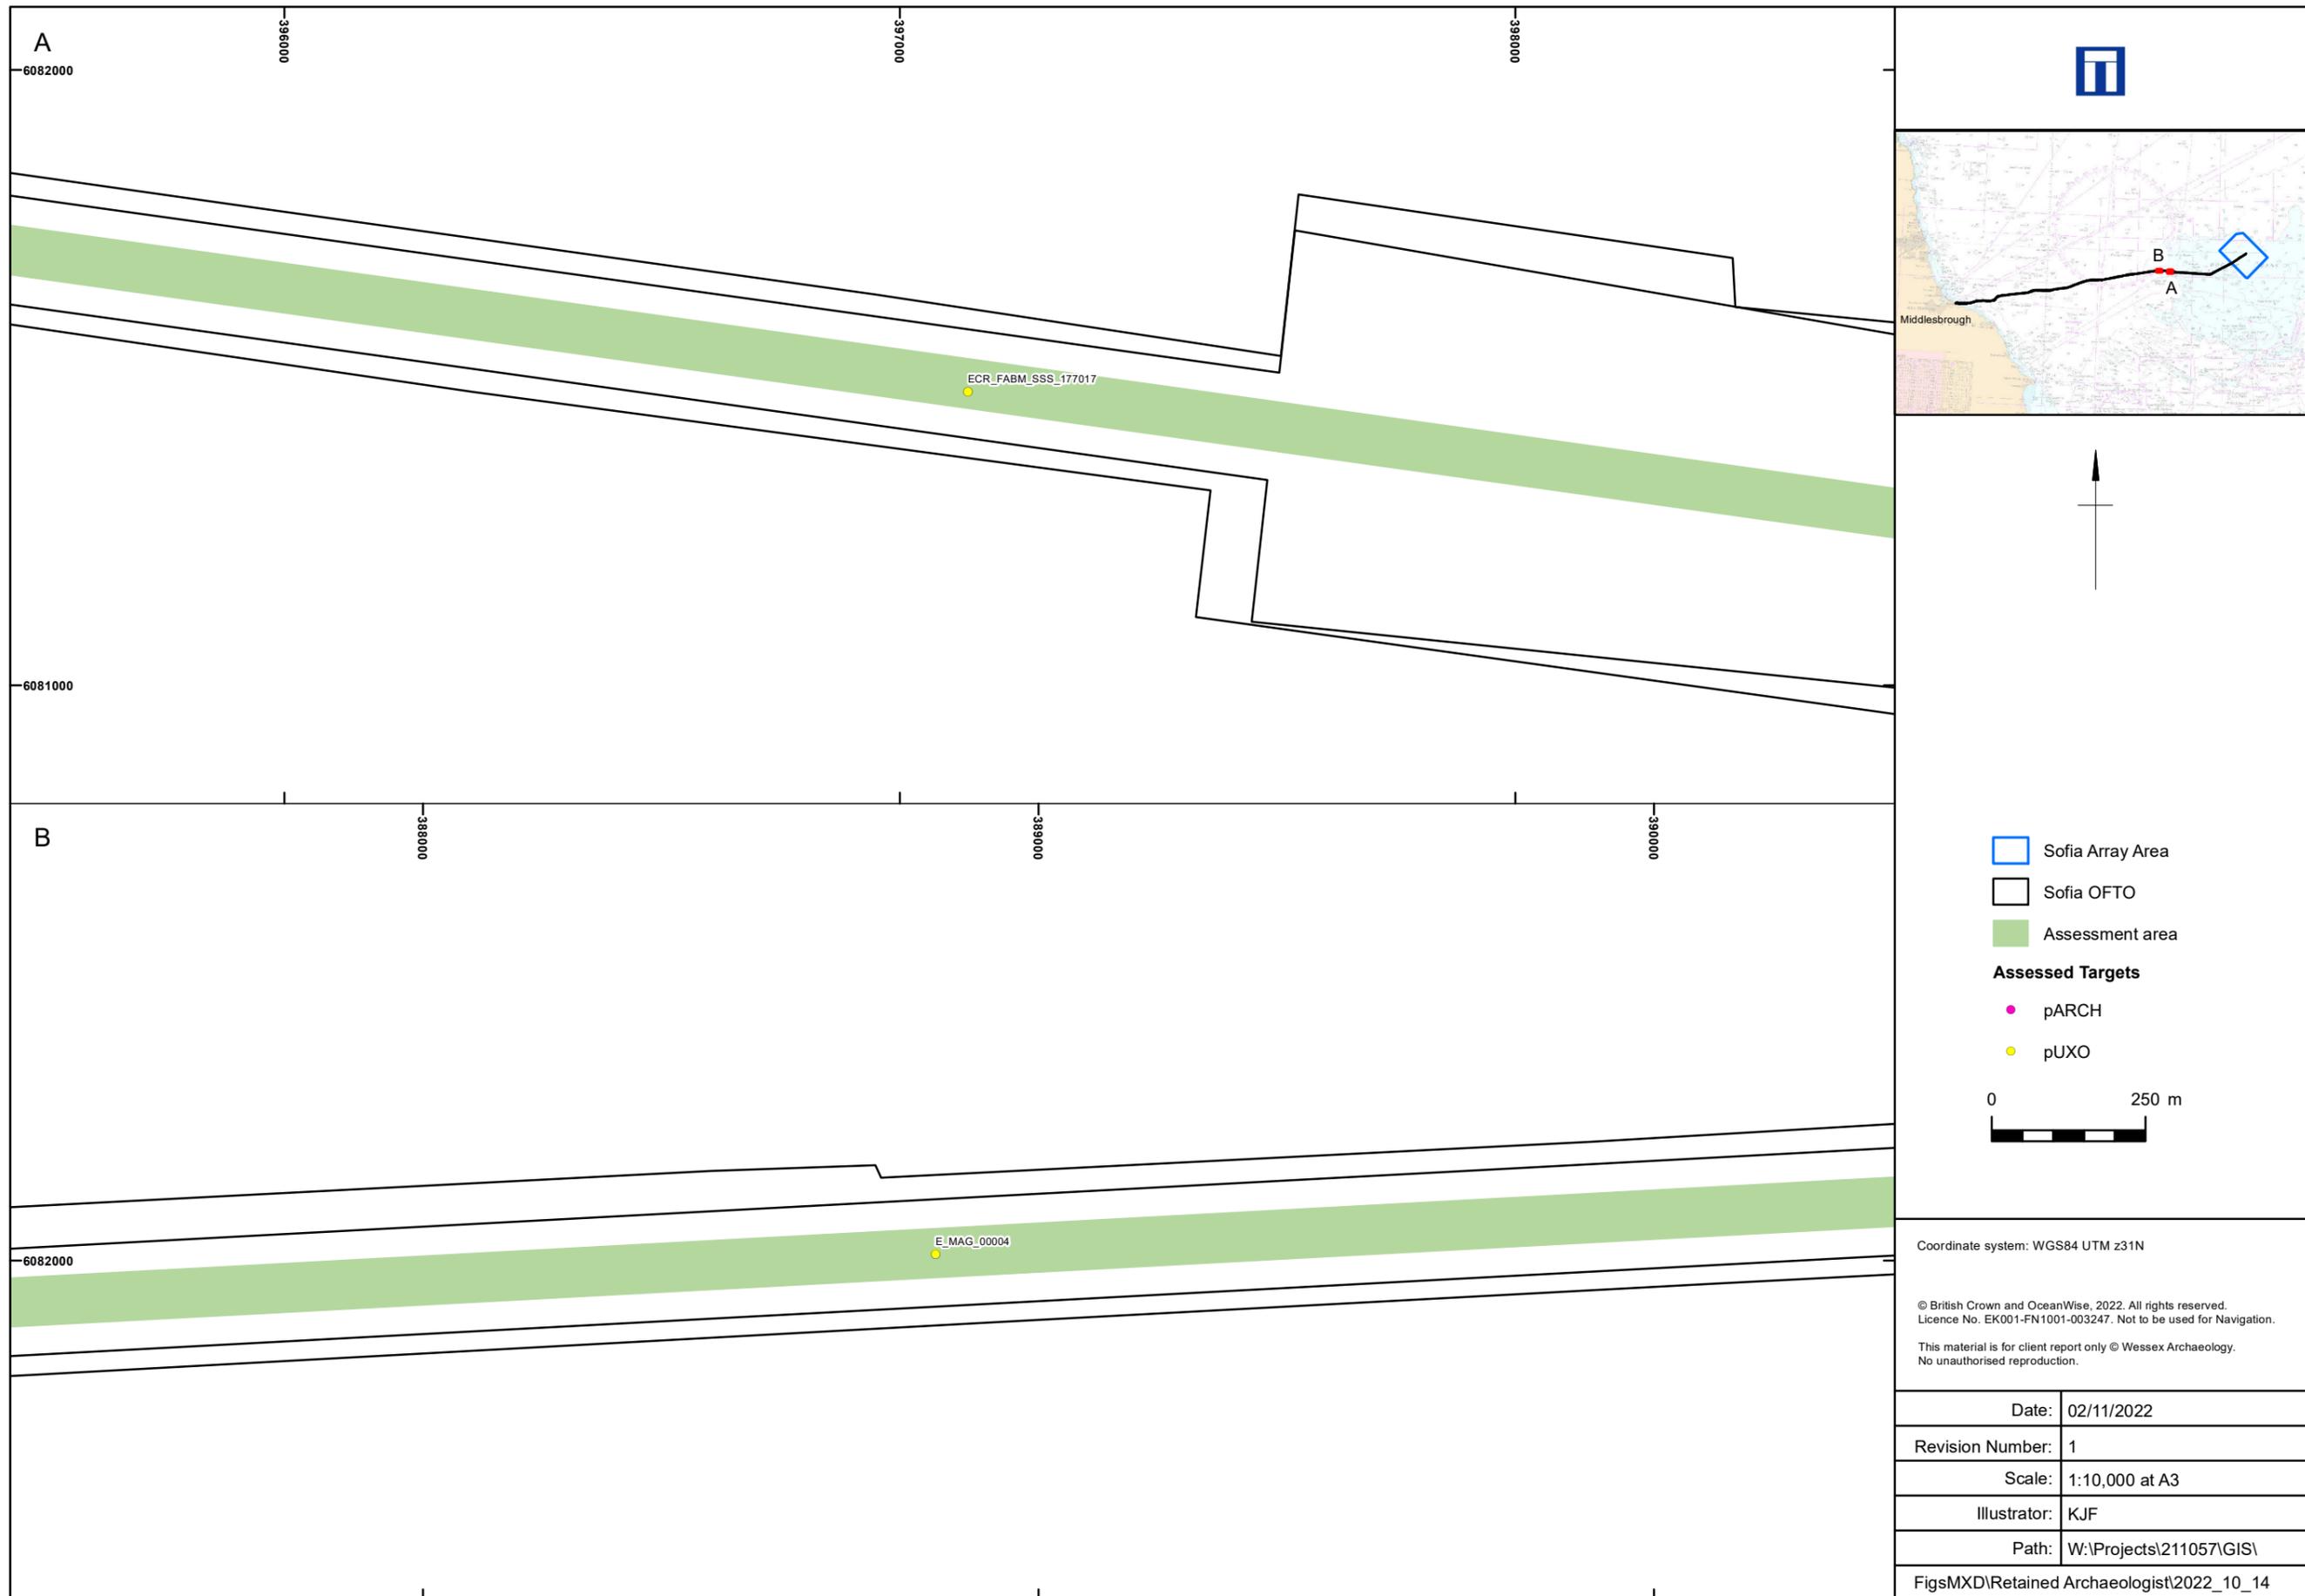
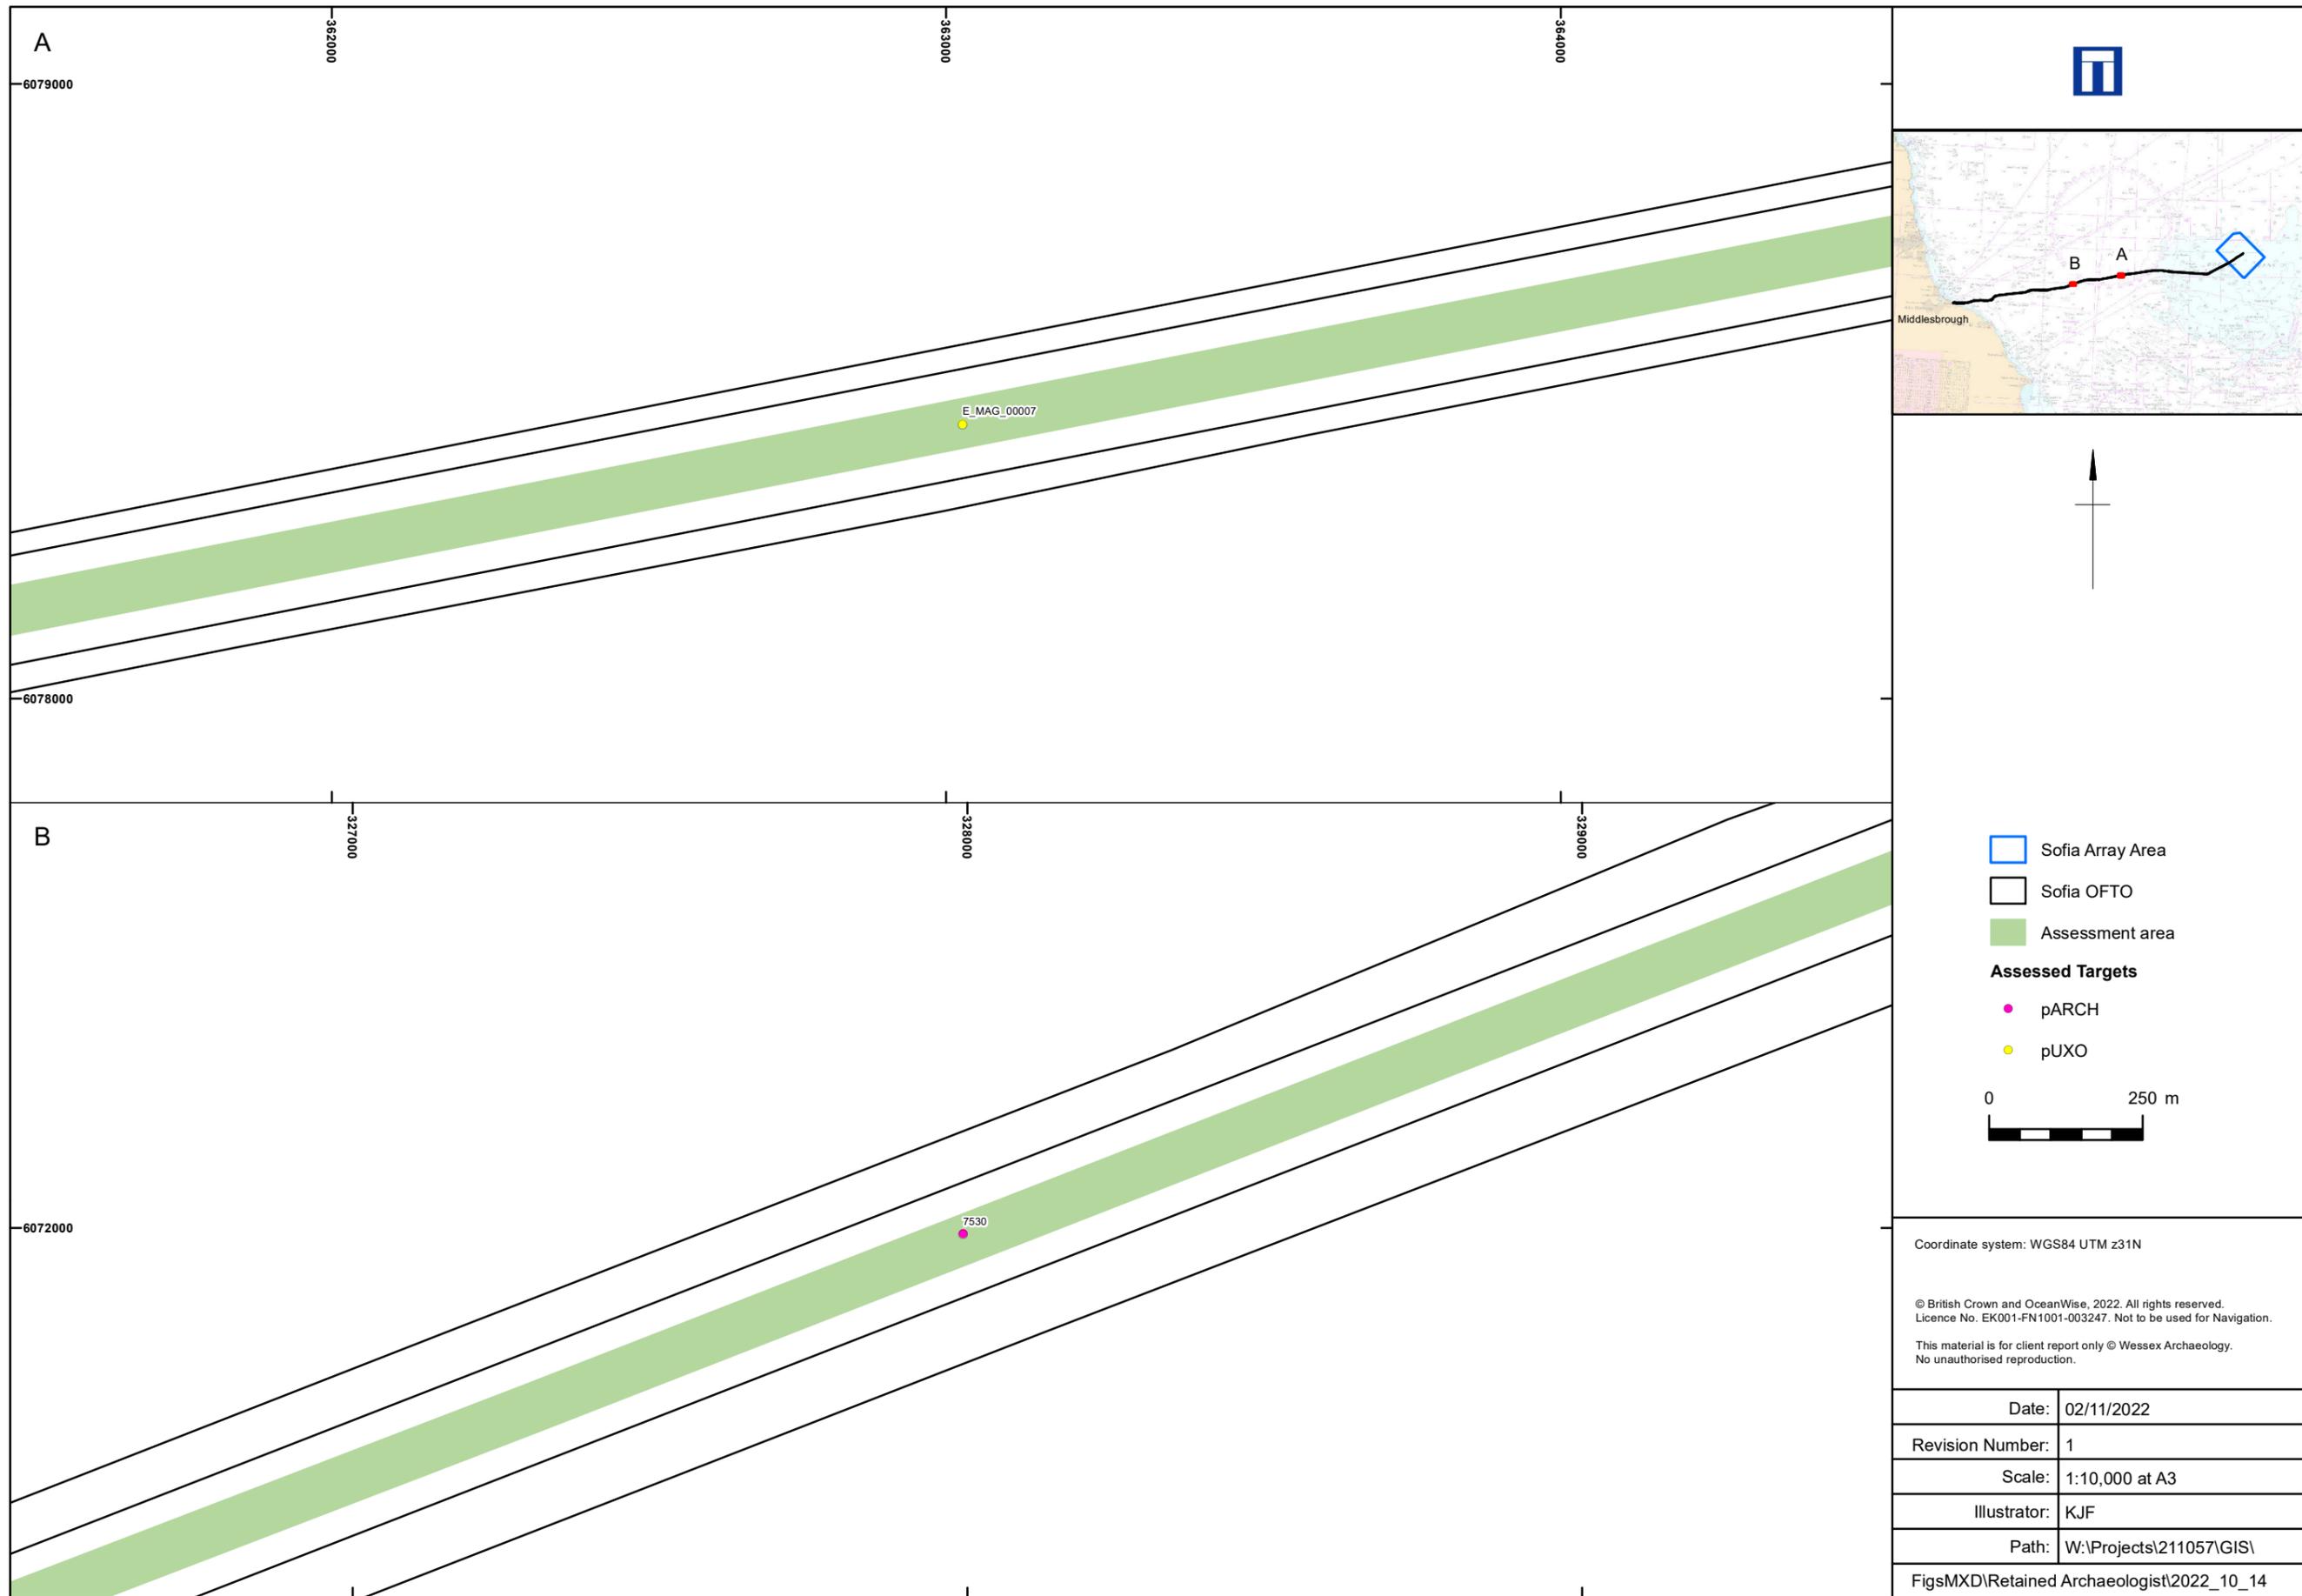
- 3.1.2 **Appendix B** comprises all 221 targets. **Figure 1a–m** illustrates the ‘as found’ location of the targets encountered, however locations where nothing was found are illustrated by their ‘expected location’.
- 3.1.3 Following a review of all TIRs provided by the Client, the archaeological discrimination was updated based on the results from the survey. Definitions of these are presented in **Appendix A**.
