Surface Water Sewer Replacement, High Street, Winchester, Hampshire

Archaeological Watching Brief Report

WINCM Code: AY413

Report reference: 72620.03
Path: X:\PROJECTS\72620\REPORTWinch high st_finalrep_v2_KLDedit

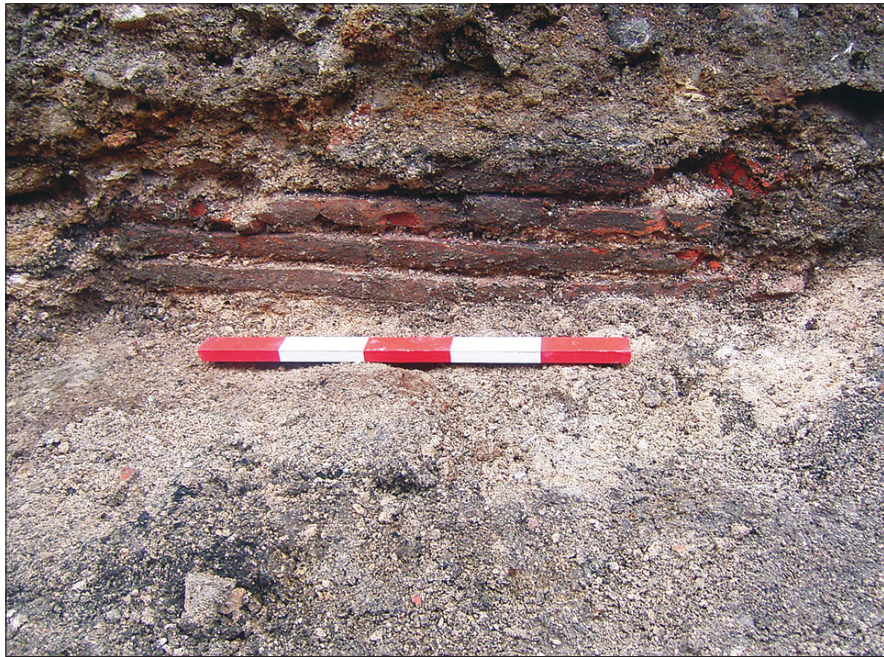
Plate 1: Wall 1 (1022)

4.3.3 **Wall 1 (1022; Figures 2 and 3; Plate 1)**, was located at the eastern end of the Site, outside nos. 18-20 High Street. At a depth of c. 1.0 m, the wall was aligned east-west, within the southern side of the trench. The exposed portion was c. 1.10 m in length and comprised four courses of red/orange tile/brick bonded with mortar. It is not clear if this wall had been truncated.

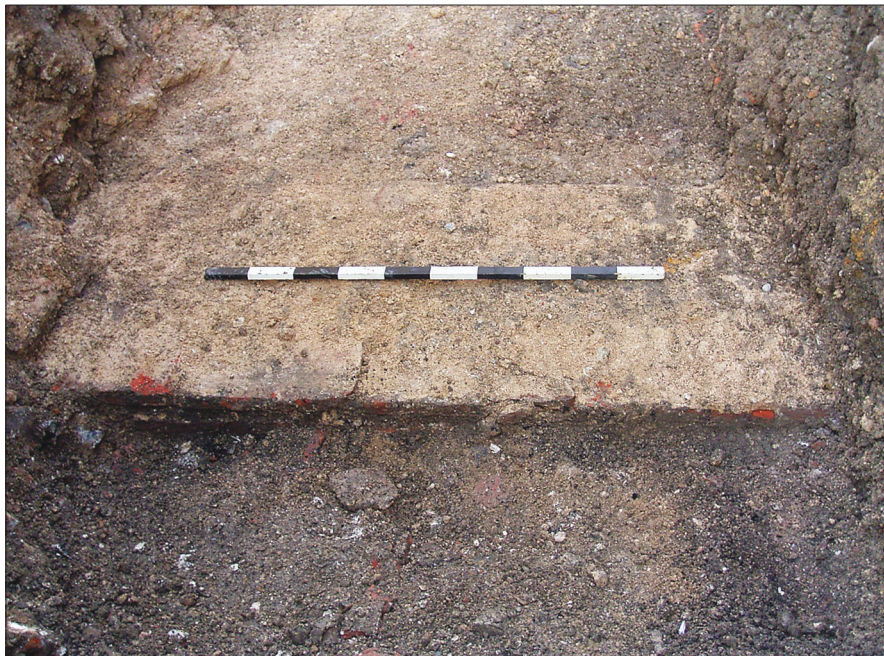
Plate 3: Wall 3 (1045)

- 4.3.9 **Wall 3 (1045; Figures 2 and 3; Plate 3)** was located a few metres to the west of **Wall 2**, almost at the junction with Market Street. It was found 1.10 m below the ground surface, and was aligned north-south (parallel to **Wall 2**). The soundly constructed wall was 0.76 m wide and extended at least 1.50 m, continuing beyond the trench edge to the north, and truncated by a modern manhole to the south. At least three courses of red/orange tile and mortar formed the lower portion of the exposed section, with a subsequent course of large flint nodules and thick mortar seen in section. It appears that this section of the wall had initially collapsed to the east.

- 4.3.10 No floors or surfaces were found in association with this wall; however, given the apparent height of the wall and its collapsed remnants, it may be that such deposits remain undisturbed below the base of the pipe-trench.

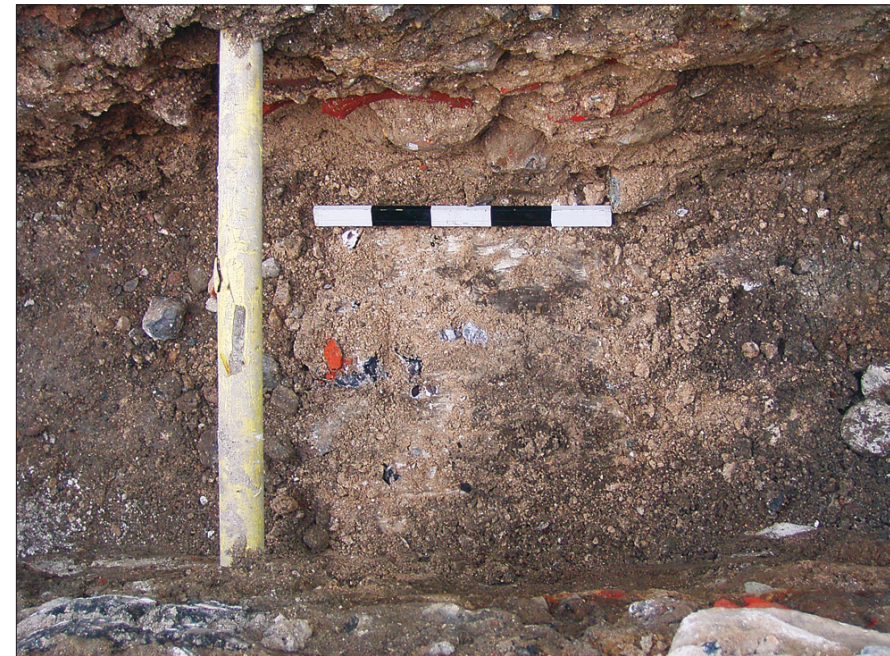
Plate 4: Wall (1058)

- 4.3.11 **Wall 4 (1058; Figures 2 and 3; Plate 4)** was located to the west, outside No. 30 High Street, halfway between the junctions with Upper Brook Street and Parchment Street. Found at a depth of c. 1.05 m, it was aligned north-south, extending beyond the edges of the trench. The lower course(s) or foundation comprised mortared flint nodules, which continued below the base of the trench. Two courses of red/orange tile bonded with thick layers of mortar followed. It appeared that a further course of flint nodules formed the upper extent of the wall. A gas service trench had removed most subsequent deposits.
- 4.3.12 Surrounding deposits appeared to represent dumped material, probably associated with demolition of a Roman building.

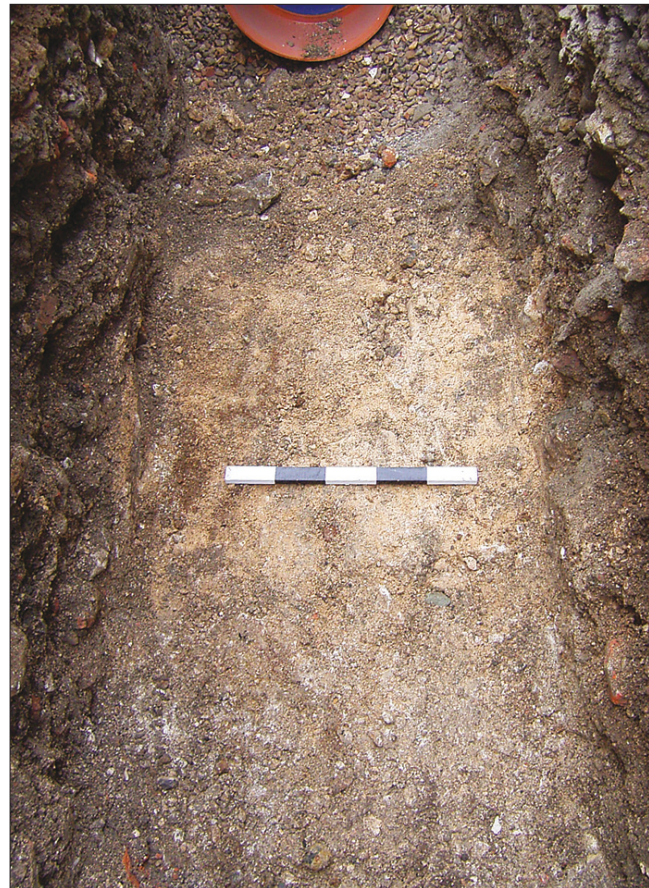
Plate 6: Floor surface (1074)

- 4.3.16 Also outside No. 30 High Street, to the west of **Wall 5**, was a flat, evenly distributed deposit of chalk and lime mortar (**1074; Plate 6**). Located at a depth of c. 1.50 m, it extended for more than 1.95 m wide and beyond the edges of the trench. It lay below a deposit of flint-rich probable demolition debris. Together with overlying 'cess-like' deposits with animal bone and oyster shell inclusions, it is possible that this represented a Roman floor surface. However, the presence of modern services and the depth of the trench precluded a more detailed investigation.

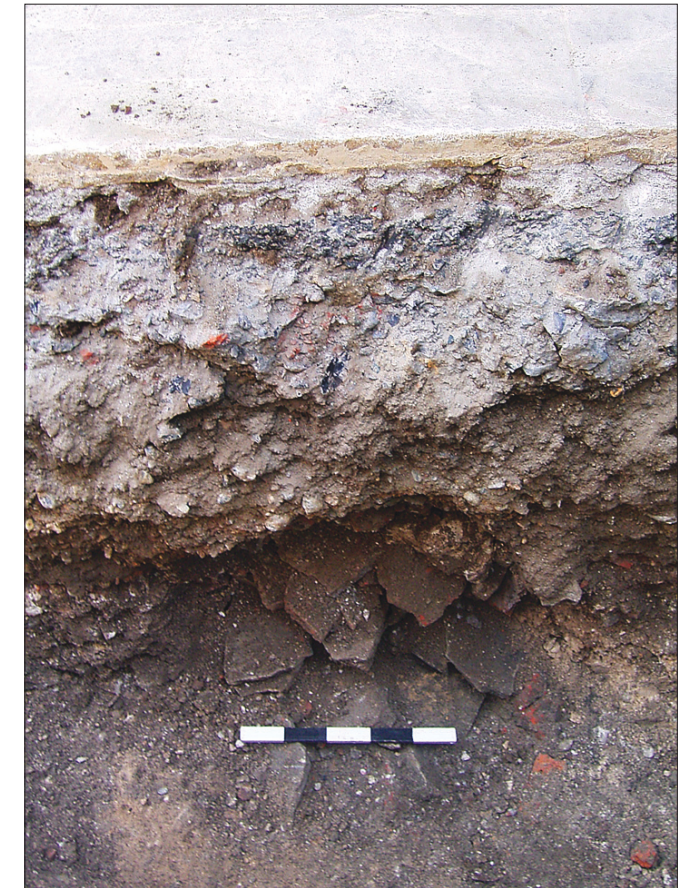
Plate 7: Floor surface (1095), collapsed wall (1081) and wall foundation (1096)

- 4.3.17 Further to the west, outside No. 35-36 High Street, a large, loose deposit of red/orange and stone tiles (**1081**) was revealed in the southern section below a compacted dump layer (**1082**). To the west a flinty mortar deposit was evident (**1096**), whilst a smoother mortar layer was present to the east (**1095**). These may represent the remains of a wall, collapsed to the east (possibly into a cut feature) onto a floor surface, whilst the foundations remain to the west (**Figure 3; Plate 7**).
