Harvington Hall Scheduled Monument No.3008, Winterfold, Worcestershire

Archaeological Watching Brief Report

Report reference: 75920.04

March 2011

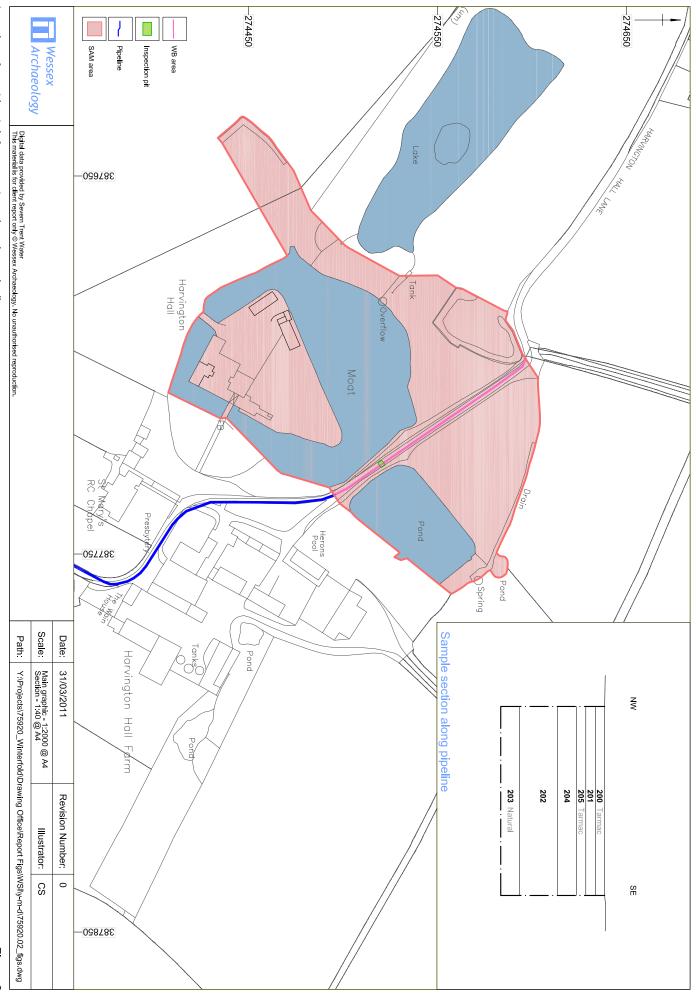
Figure 2: Watching brief area and representative section of pipe trench

- 4.2.1 One 120m pipe trench was excavated along Harvington Hall Lane. The trench was 0.3m wide and 1m deep on average (Figure 2; Plate 1). The tarmac road surface (200) overlay a layer of grey-black gravel (201). Beneath this was an former tarmac surface (205) which overlay another levelling layer consisting of course gravel (204), and beneath this was a red sandy clay deposit (202). This overlay reddish brown clay natural deposits (203) (Figure 2; Plate 1). These deposits were identical to those identified within the inspection pit, through which the pipe trench was excavated.

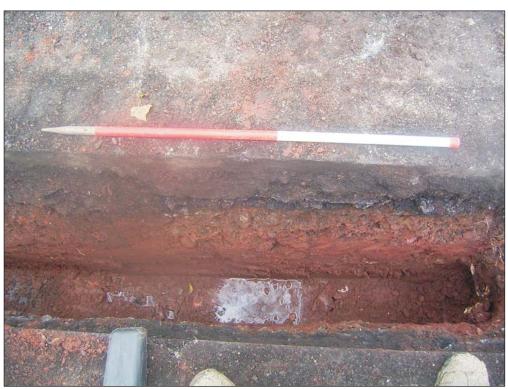
Plate 1: South west facing section of pipe trench

- 4.2.2 Contexts (**204**) and (**205**) were not present at the very northern end of the pipe trench demonstrating the most recent resurfacing work had also included the removal of earlier surfaces in places.

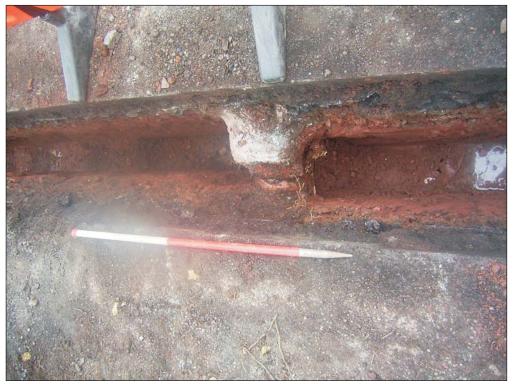
Plate 2: Concrete capped culvert

- 4.2.3 A concrete capped culvert was located 40m along the pipe trench (**Plate 2**). The concrete cap overlay a ceramic pipe, both of which underlay the former tarmac surface.
