**Bramber Castle
Bramber, West Sussex**

Archaeological Watching Brief Report

Report reference: 77150.03

April 2011

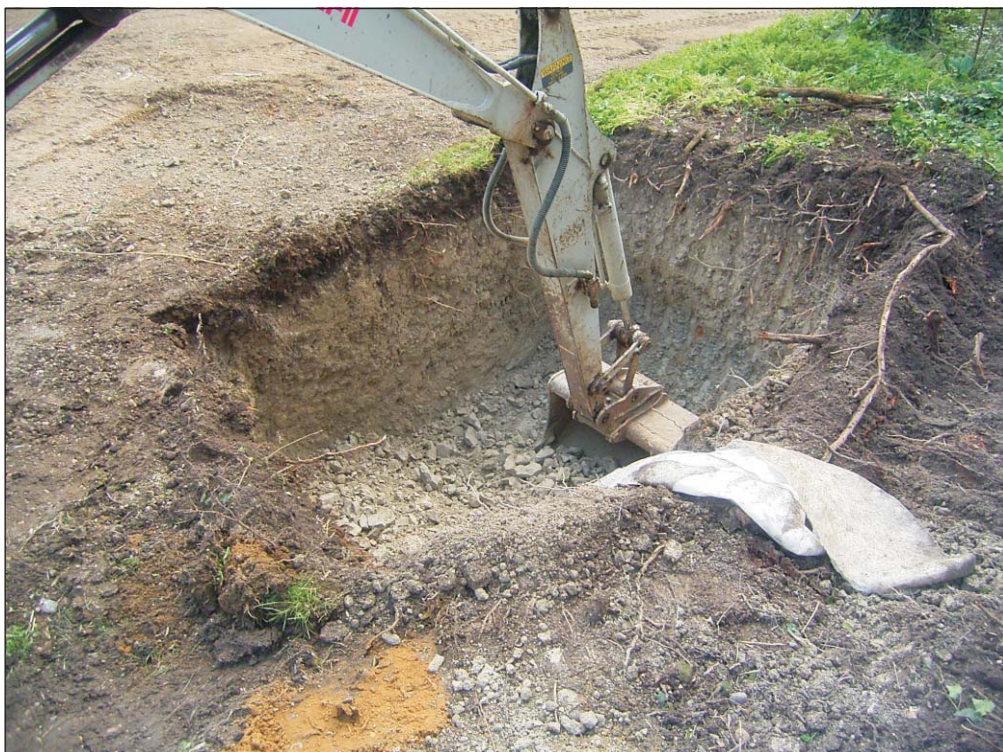
Plate 1: Machine excavation of the soakaway trench, view from north-east

- 5.2.1 Topsoil, of approximately 0.3m depth, comprised a dark greyish brown silty loam and was observed overlying the natural geology in the soakaway trench (**Figure 2, Plate 1**).
- 5.2.2 In the drainage trench across the access track, a modern gravel made ground layer overlay the natural deposits (**Figure 2, Plate 2**).
- 5.2.3 The natural geology recorded across the Site comprised weathered chalk.

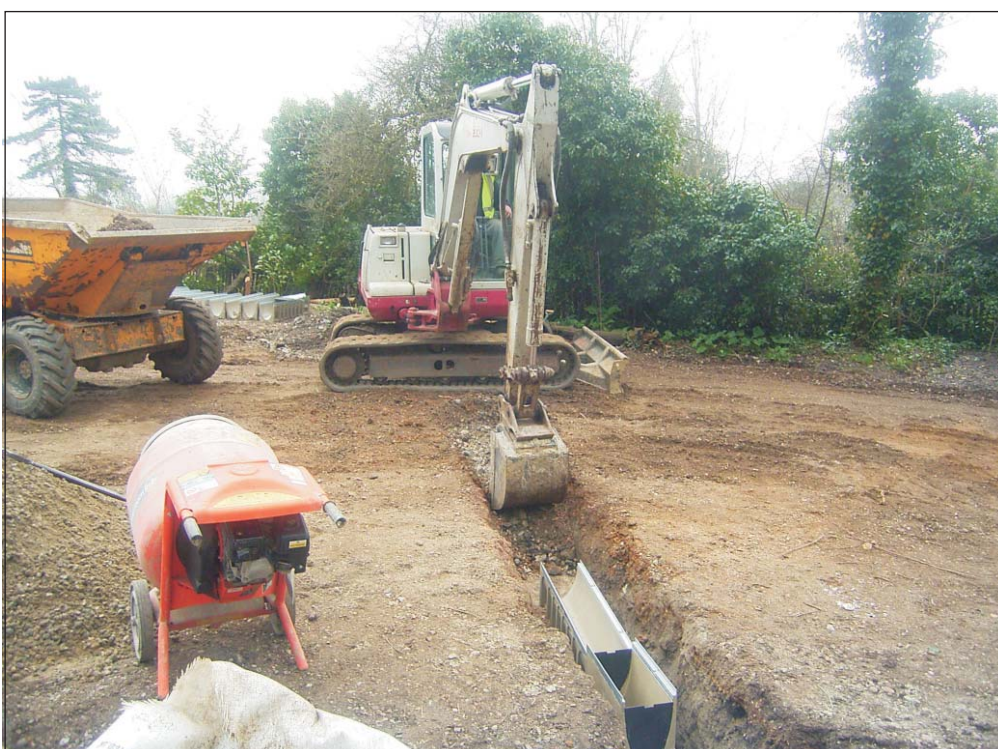
Plate 2: Machine excavation of the drainage trench, view from north-east
