Land Off Hind Street Ottery St Mary, Devon

Addendum to Archaeological Evaluation Report

Ref: 76050.03

May 2011

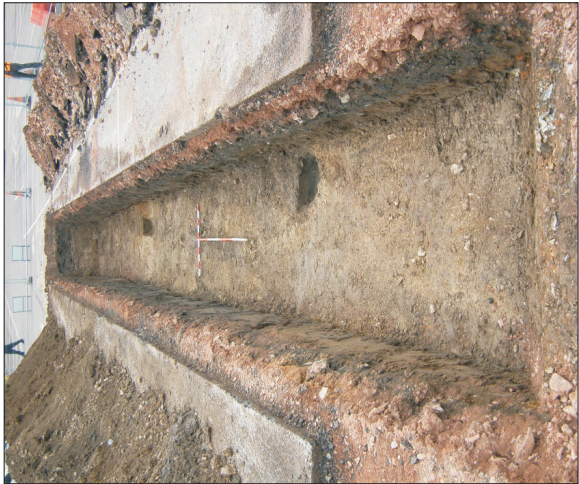
Plate 1: General view of Trench 17, view from south (scales 1 x 1 and 2m)

Trench 17	Ground Level AOD 48.72m	Dimensions(m): 18.80m x 1.8m Max. depth(m): 1.45m
Context	Description	Depth (m)
1700	Tarmac. Car Park Surface	0 - 0.1m
1701	Made Ground. Modern levelling for tarmac.	0.1 - 0.29m
1702	Made Ground. Dark grey, sandy clay with large sand stone and river gravels. CBM, slate and building rubble throughout layer.	0.29 – 0.61m
1703	Made Ground. Mid brown, sandy clay with moderate large sandstone and river gravels. CBM, slate, charcoal and building rubble throughout.	0.57 – 0.61m
1704	Made Ground. Mid greyish-brown silty sand, moderately compact with common large sandstone and river gravels. Charcoal flecks and slate.	0.62 – 1.45
1705	Cut of Pit. Oval pit of post-medieval date.	0.3m
1706	Deliberate Backfill of Pit. Dark Grey-brown sandy clay.	0.3m
1707	Cut of Ditch. NE-SW aligned ditch, shallow 'U' shaped profile. Undated.	0.21m
1708	Secondary Fill of Ditch. Mid grey-brown silty sand.	0.21m

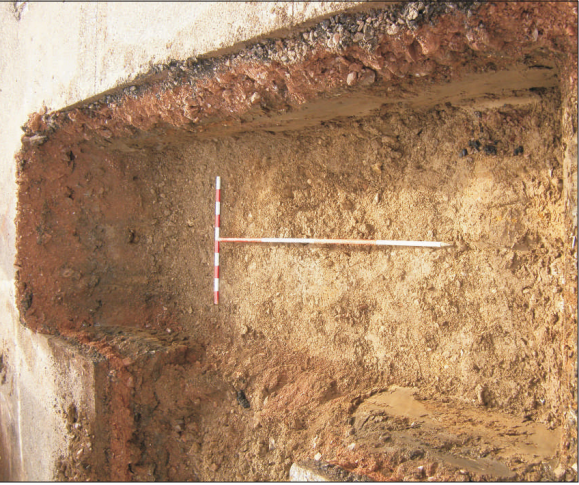
Plate 2: General view of Trench 18, view from west (scales 1 x 1 and 2m)

Trench 18	Ground Level AOD 48.74m	Dimensions(m): 5.1m x 1.87m Max. depth(m): 1.04m
Context	Description	Depth (m)
1801	Tarmac. Modern car park surface.	0 - 0.1m
1802	Made Ground. Modern levelling for car park.	0.1 – 0.17m
1803	Made Ground. Large stones levelling/made ground for car park.	0.17 – 0.3m
1804	Made Ground. Dark grey-brown, sandy clay with common sandstone and flint. CBM, charcoal, slate and mortar throughout.	0.3 – 0.49m
1805	Made Ground/Subsoil. Mid grey-brown sandy clay fairly loose and friable. Flecks of charcoal and CBM throughout. Sparse large flint cobbles.	0.49 – 0.77m
1806	Natural. Light grey-brown sandy clay with abundant flint gravels, possibly river terrace gravels.	0.77m +
1807	Cut of Ditch, recorded in corner of trench not enough of feature visible in plan. Unexcavated same as 1707.	0.77m +
1808	Fill of Ditch, unexcavated same as 1708.	NA

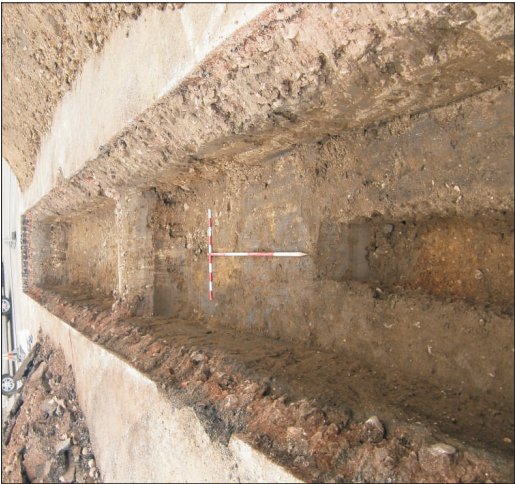
Plate 3: General view of Trench 19, view from south-east (scales 1 x 1 and 2m)

Trench 19	Ground Level AOD 49.51m	Dimensions(m): 15.21m x 1.95m Max. depth(m): 1.60m
Context	Description	Depth (m)
1900	Tarmac. Modern car park surface.	0 - 0.1m
1901	Made Ground. Modern levelling for car park.	0.1 – 0.35m
1902	Made Ground. Dark grey-brown sandy clay with sparse sandstone and flint gravels. Slate, CBM and mortar were present throughout deposit.	0.35 – 0.5m
1903	Made Ground. Mid to dark brown silty sandy clay with sparse sandstone inclusions. Slate, CBM, mortar and charcoal was present throughout layer.	0.5 – 0.64m
1904	Made Ground. Pale brown silty sand with common rubble consisting of mortar, CBM slate and building materials	0.64 – 0.8m
1905	Made Ground. Mid to dark brown sandy clay with sparse sandstones. Common slate, CBM, and concentrations of post-medieval pottery.	0.8 – 1.60m
1906	Natural. Pale yellow sand to the western end of trench and mid yellow-brown sand and gravels to eastern end of trench.	1.4m +

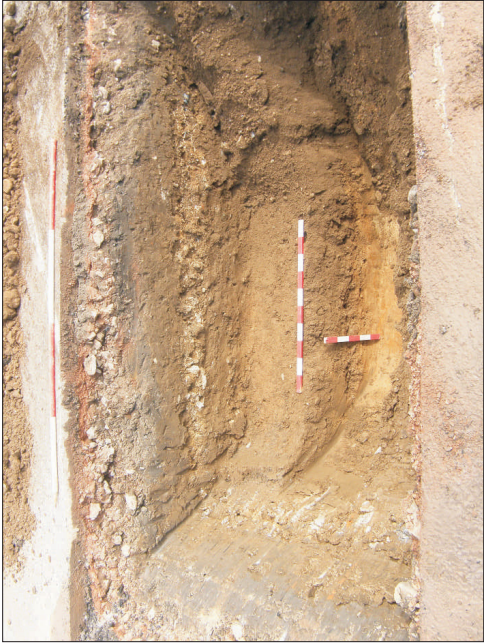
Plate 4: South-west facing section of Trench 19 (scales 1 x 2, 1 and 0.5m)

- 4.2.2 To the south of the car park in Trench 18 natural sand and gravel geology was recorded at a depth of 0.77m below ground level. The sand sloped down to the north and was recorded at a depth of 1.4m in Trench 17. In Trench 19 modern made ground was present up to a depth of 1.6m, due to Health and Safety constraints natural geology was only recorded within test pits at either end of Trench 19, these were immediately backfilled.
