Project Allenby/Connaught Buildings at Aldershot Army Camp Aldershot, Hampshire

Historic Building Recording

Report reference: 74403.01

June 2011

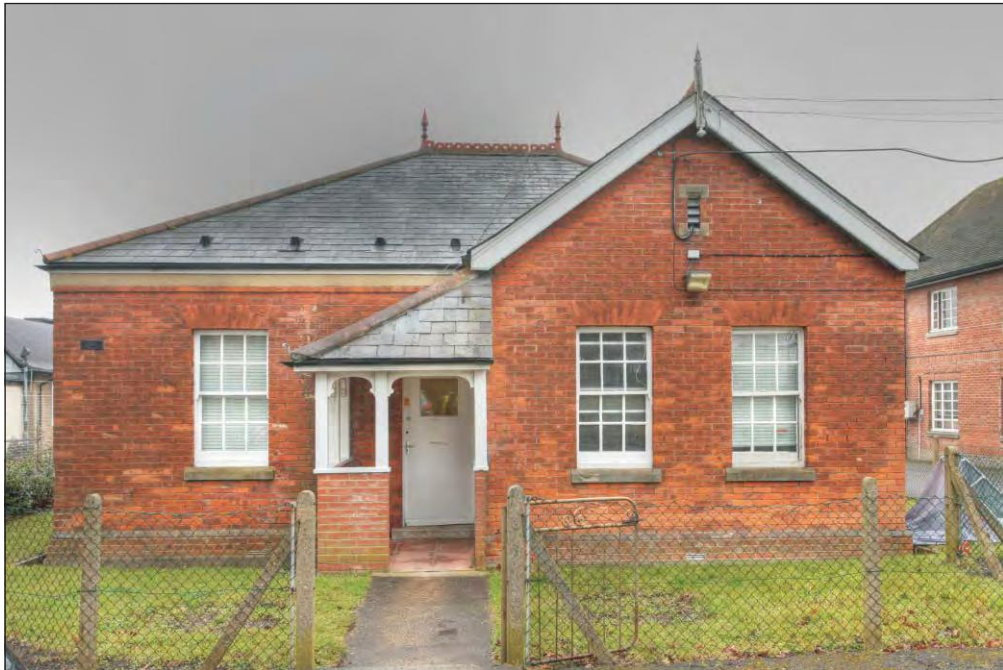
Plate 1: Building PVA 071 viewed from the south-west

4.1.2 Principal access into the property is via a central doorway on the south-west elevation with modern replacement door. The entrance is sheltered by a brick and timber porch with hipped, slate-clad lean-to roof. The brickwork of the plinth wall suggests that either the entire porch is a later addition or that the plinth has been renewed within the last fifty years.

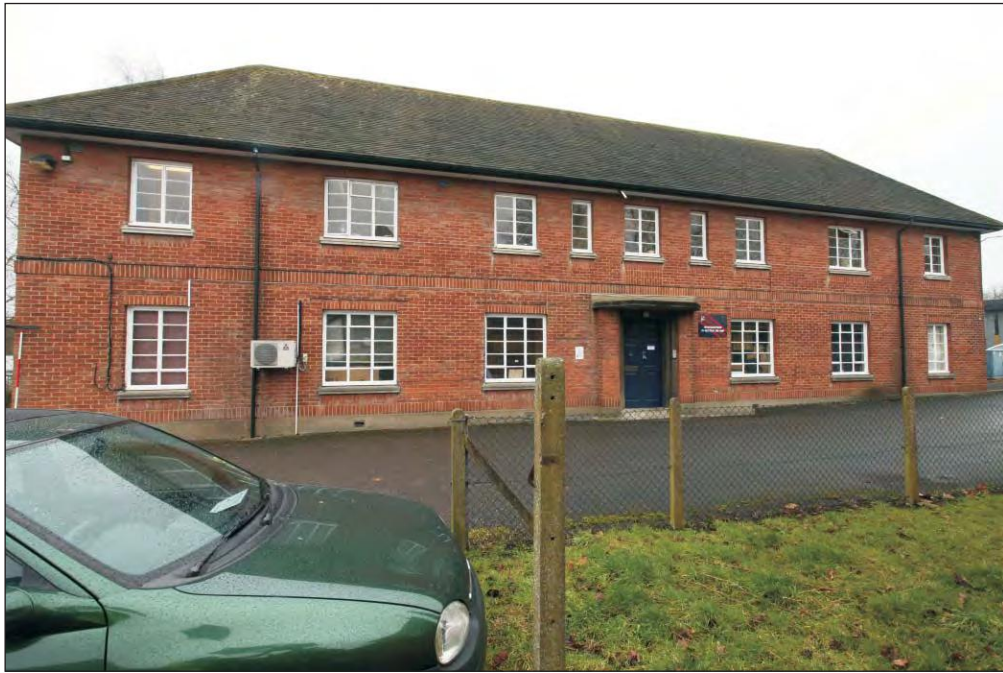
Plate 7: Building PVA 073 viewed from the north-west

- 4.2.3 Although utilitarian in style, the building contains some decorative elements including a decorative Soldier course plat band situated above plinth height and at first floor level, with similar detailing observed below sill height on the main elevation windows. Windows consist of mild steel casements set in rectangular openings which feature simple flat arches of brick and moulded concrete sills.

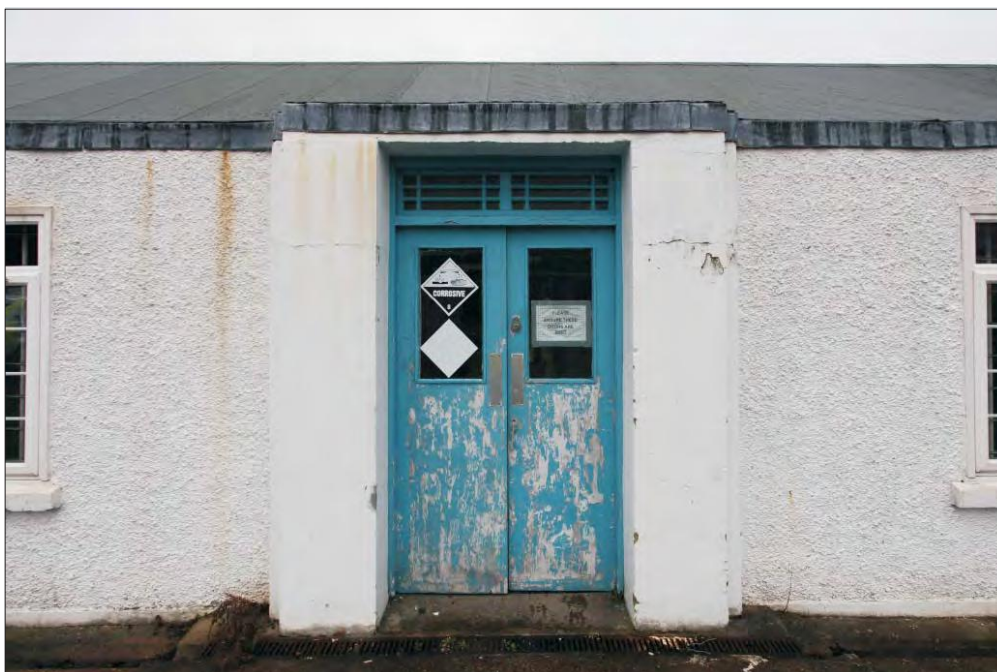
Plate 14: Building PVA 078 entrance viewed from the south-west

- 4.3.3 Access into the building is via a central entrance on the south-west elevation comprising a recessed double-doored arrangement below a fanlight with plain pilasters on either side (**Plate 14**). Windows consist of uPVC replacements throughout set in large rectangular openings with moulded concrete sills.

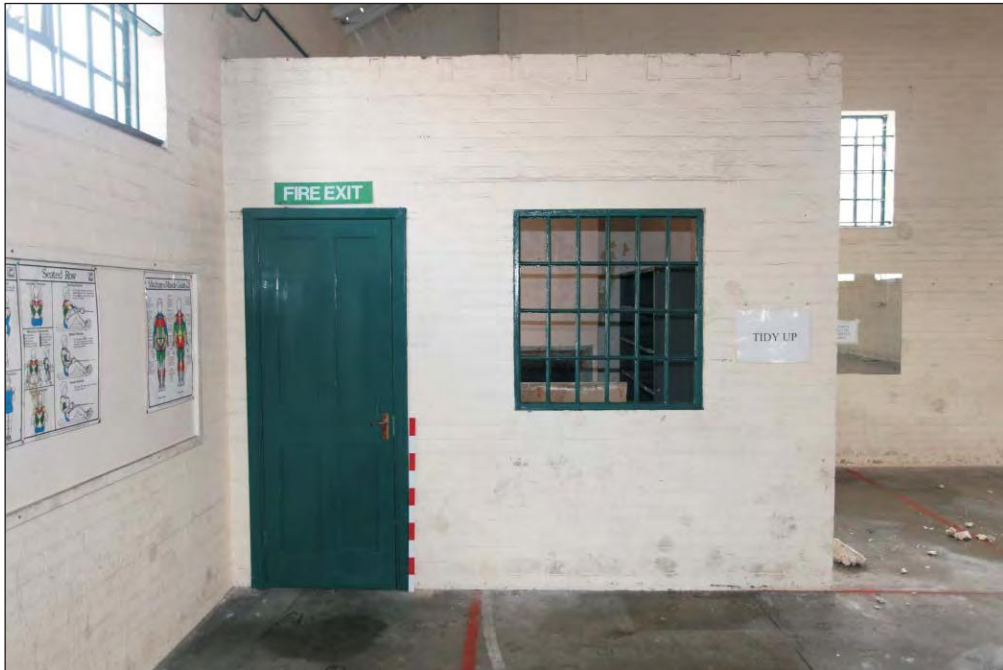
Plate 31: Building WA 0 217 interior – office viewed from the south-west

- 4.7.4 The northern corner of the gymnasium is occupied by a small rectangular brick-built office with flat timber roof (**Plate 31**). A four-panel door and multi-light viewing window are situated within the south-west wall. The office is illuminated by a multi-light mild steel window featuring two casements which is situated within the north-west wall. A single door in the north-east wall is adjacent to a fireplace which is missing its fire surround (**Plate 32**).
