BROMPTON HALL, CHIRBURY,
SHROPSHIRE

Scheduled Monument Nos. 308 and 19210

Archaeological Watching Brief

Report reference: 78690.02

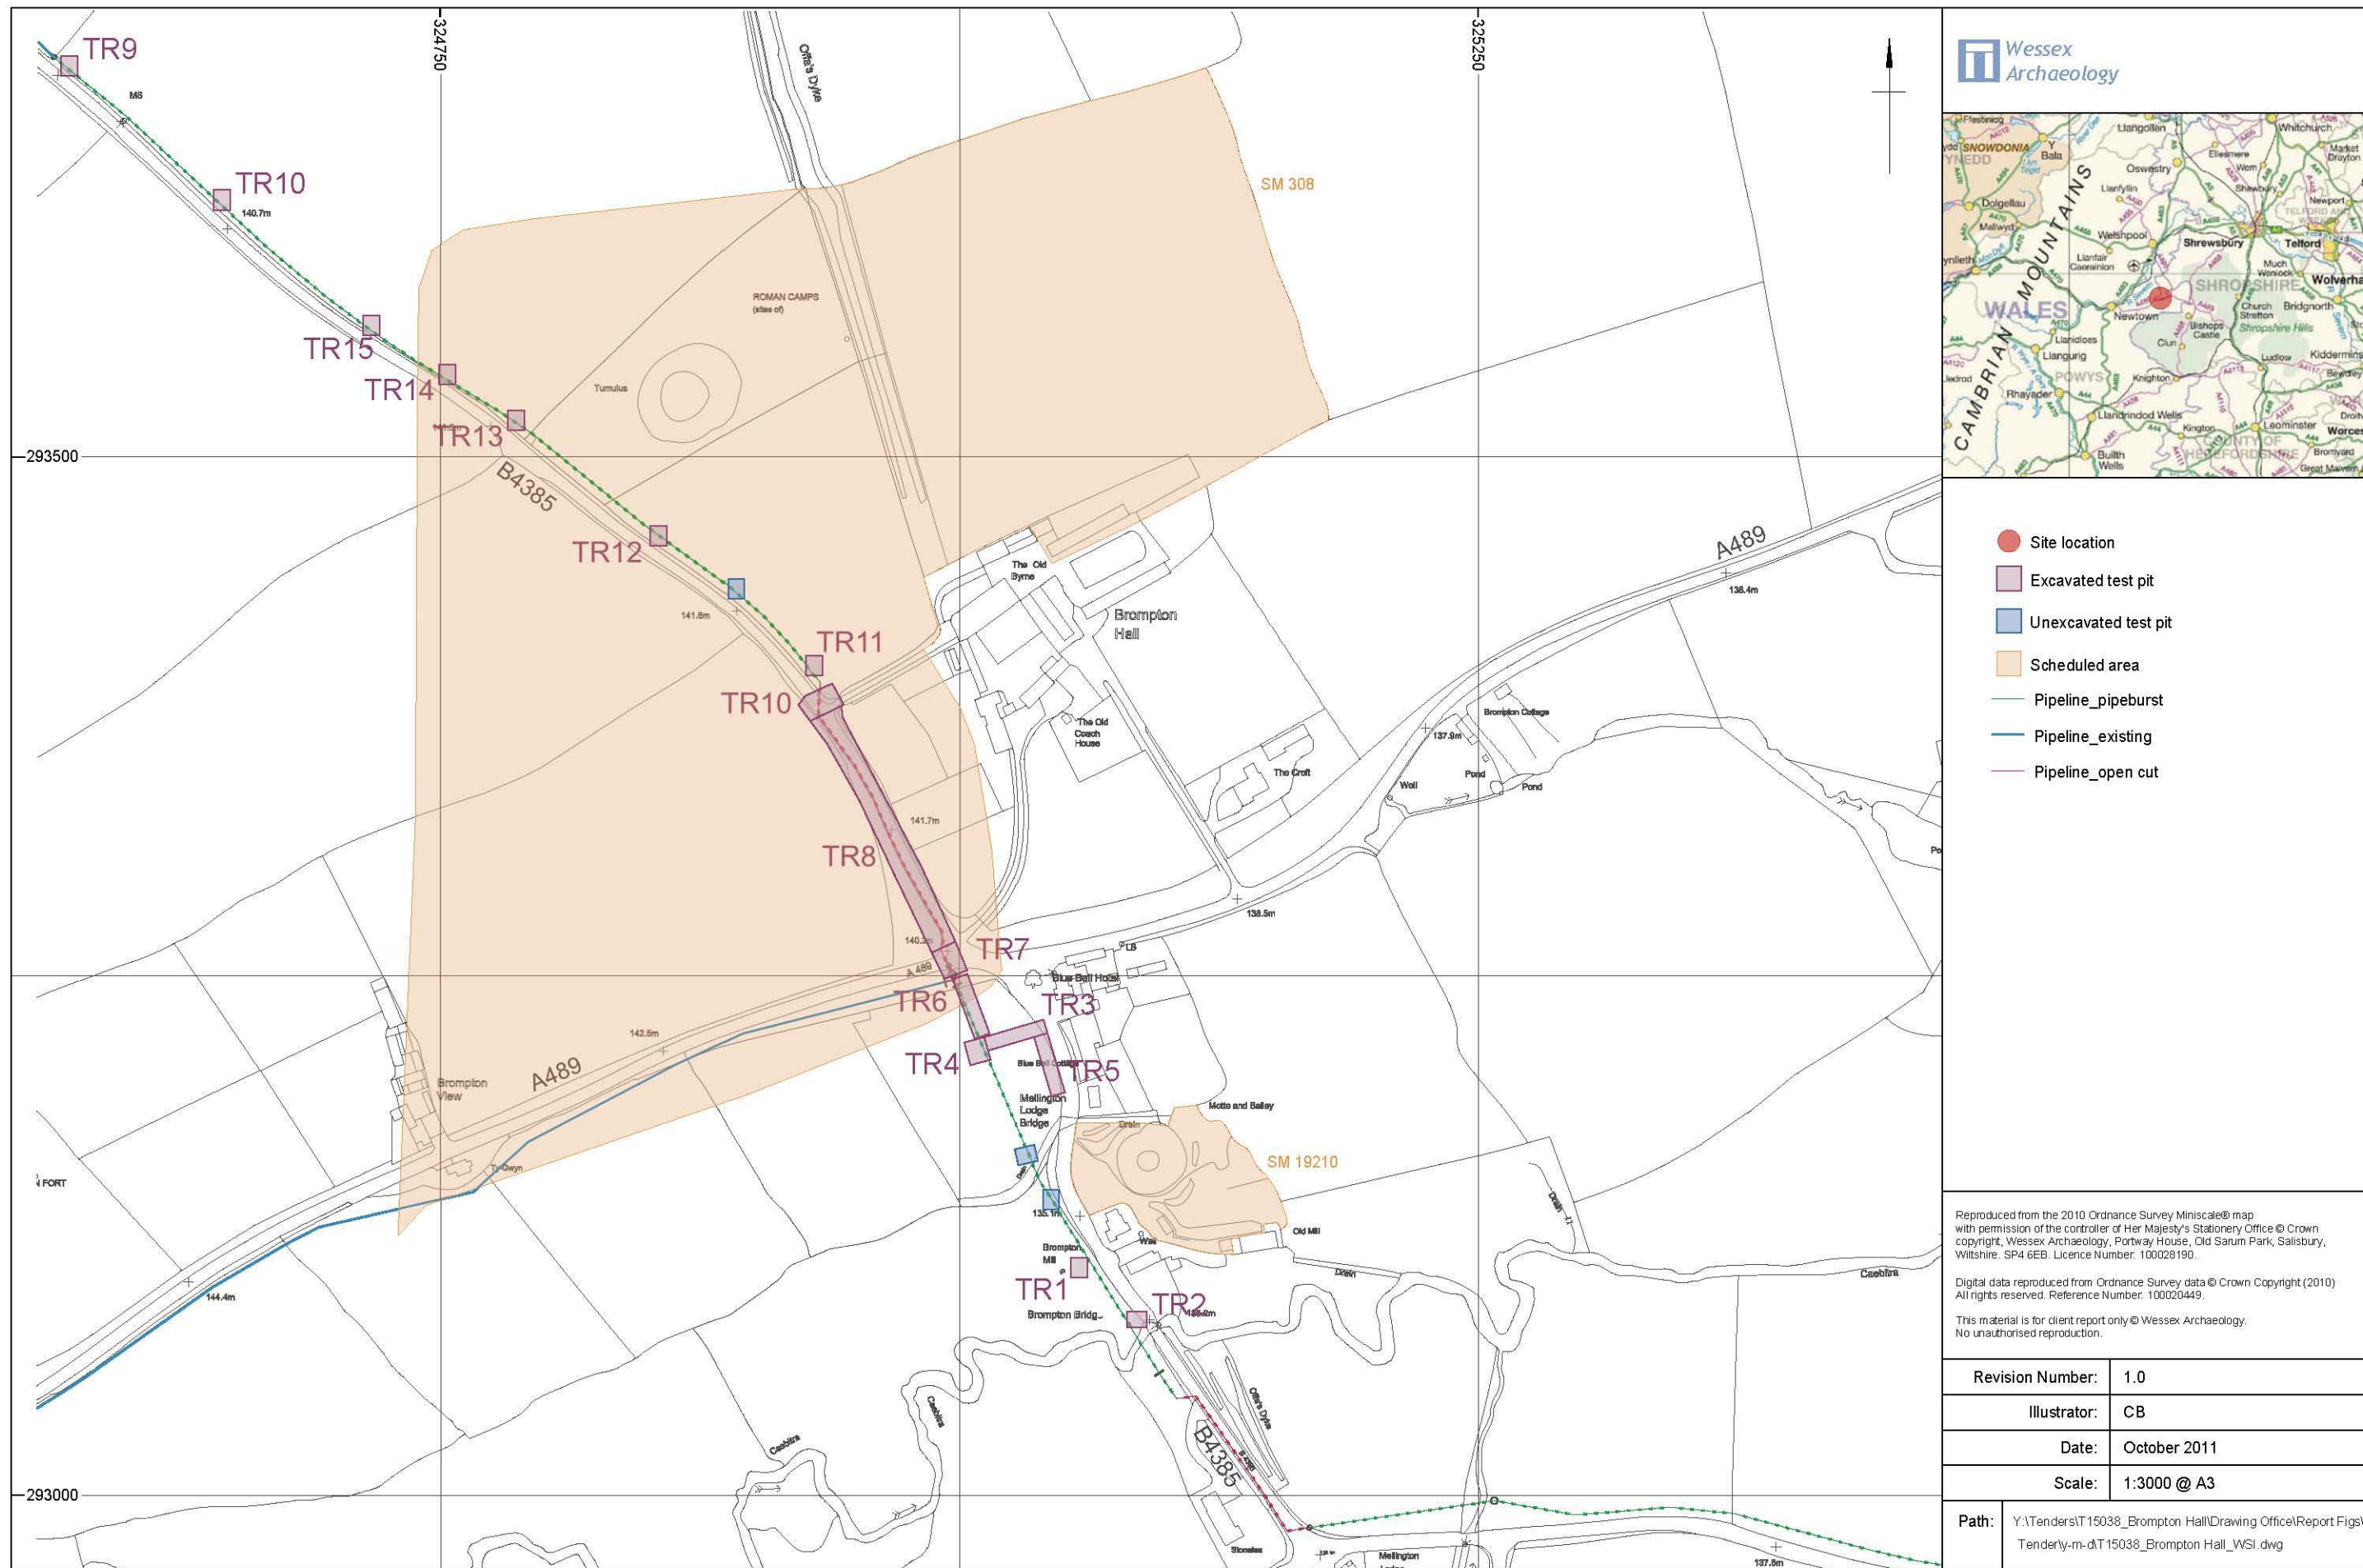
Figure 1

Site location and plan

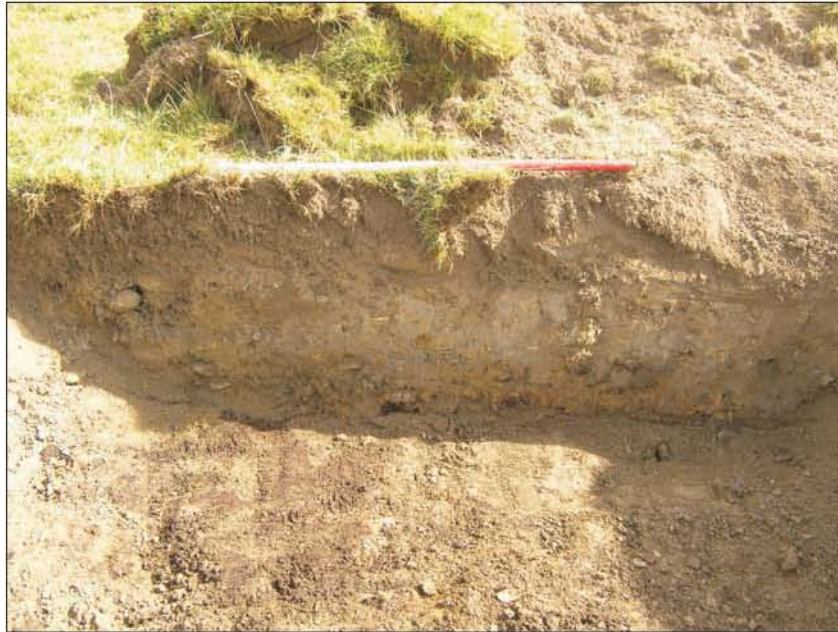
Plate 1: **Trench 1** south-west facing section

4.2.2 Trench 1 was excavated to a depth of 0.72m. Deposits consisted of topsoil 1001, subsoil 1002, and clayey silt deposits 1003, 1004, 1006, and 1007 which may possibly be alluvial in origin. A dark humic layer 1005 (**Plate 1**) was also identified across half of the trench, 0.63m below ground level (bgl) and 0.03m deep. No artefactual evidence was recovered from deposit 1005 and the limited amount exposed within the trench precluded a definitive interpretation.

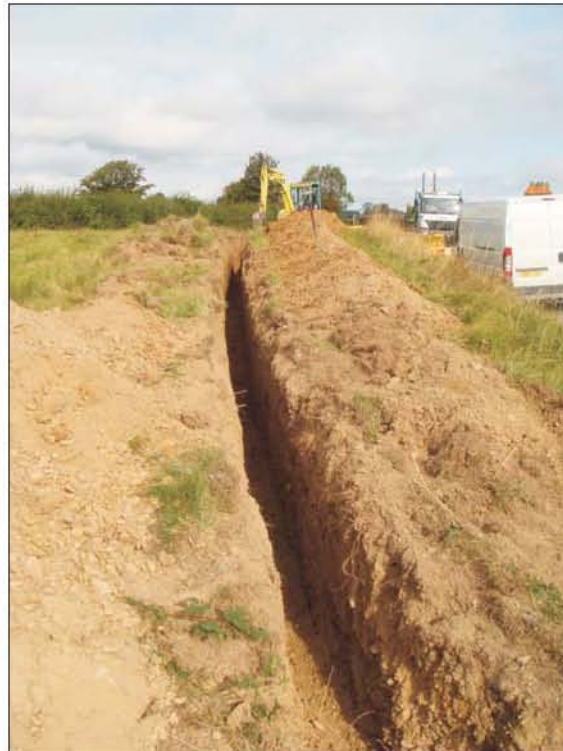
Plate 2: **Trench 8**, view from south

4.3.3 Trenching (Trench 8) continued north from the A489 through the western verge of the B4385, still within SM 308. In this long (c. 140m) trench topsoil

8001 containing litter from the road lay above a silt and gravel deposit 8002 (**Plate 2**). The trench was excavated to a maximum depth of 2m bgl.
