Burhunt Farm, Selborne, Hampshire

Archaeological Watching Brief Report

(LISTED BUILDING 1096923)

Report reference: 79730.03
Path: x:\projects\79730\report\79730_burhunt farm_report v1.doc

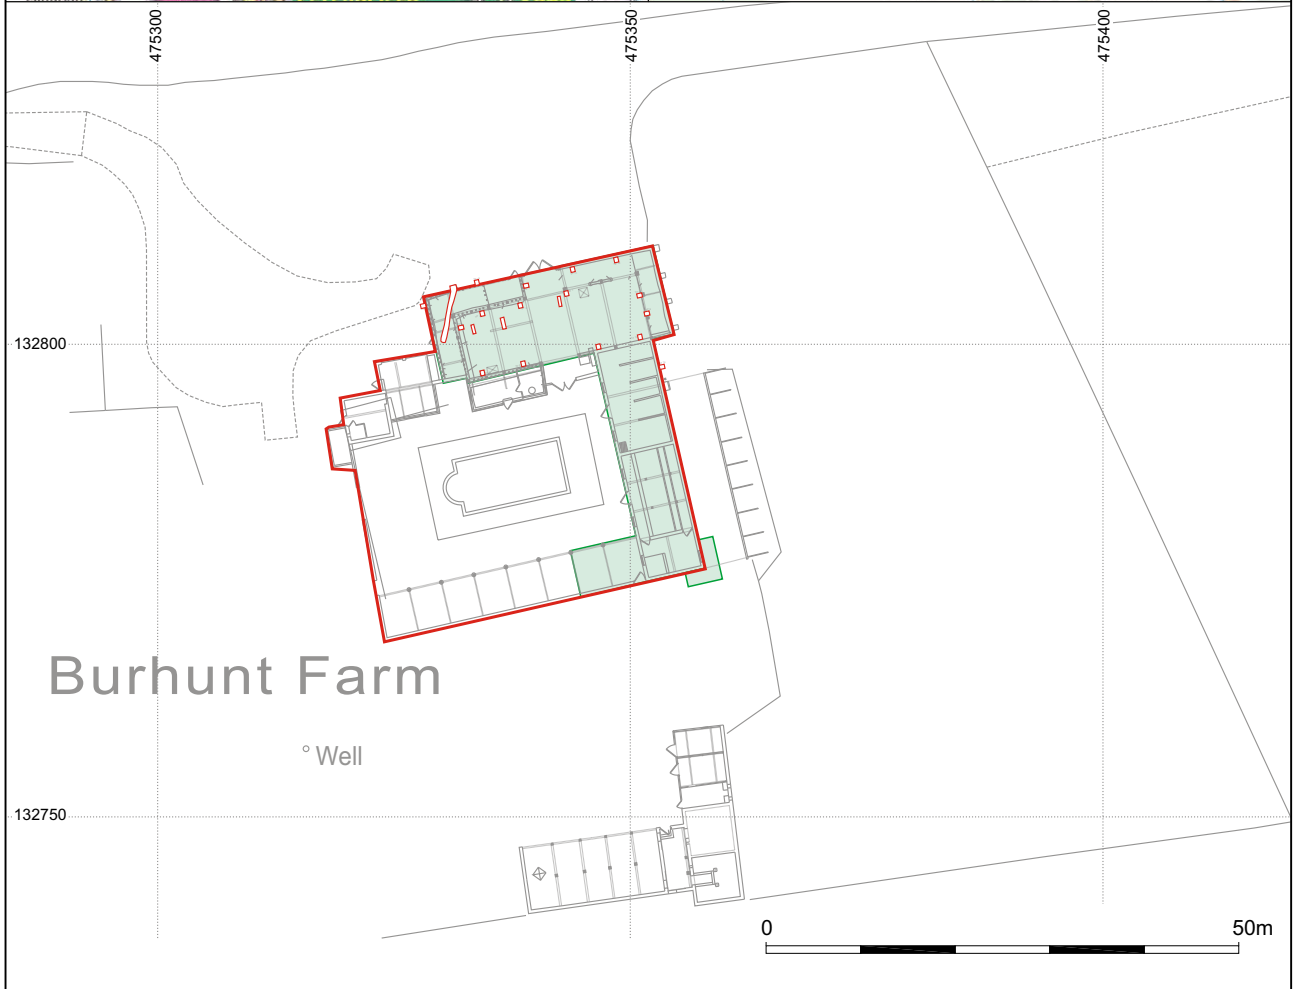
Figure 2 Results from watching brief

<ul style="list-style-type: none"> The Site Watching brief area Test pit/sondage 	<p>Contains Ordnance Survey data © Crown Copyright and database right 2011 Digital data reproduced from Ordnance Survey data © Crown Copyright 2011. All rights reserved. Reference Number: 100020449. This material is for client report only © Wessex Archaeology. No unauthorised reproduction.</p>

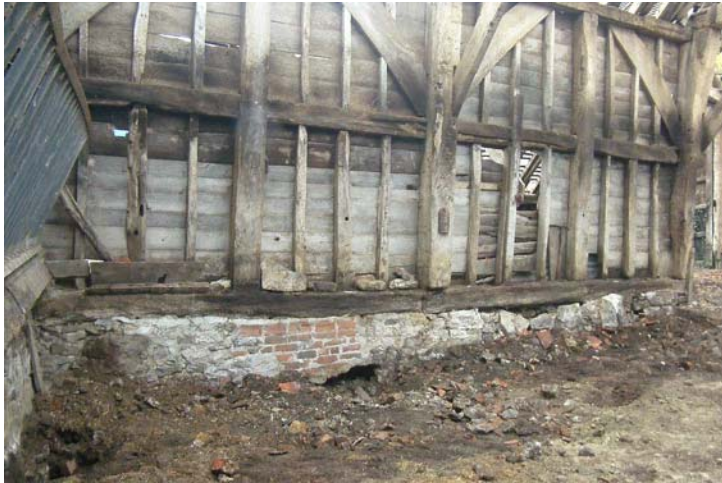
Plate 1: North wall of Main Barn, deposit 1702

3.2.6 Removal of the overlaying earthen floor of the barn (**1701**) exposed a distinct area of demolition debris (**1702**) along the northern wall of the western part of the barn, extending up to 2m from the wall line (**Figure 3, Plate 1**). This deposit was also seen in **Test Pit 2, (201)**. Re-examination in the area of **Test Pit 4** showed that on the southern edge the earthen floor

(400) did overlie the natural (401) but that on the northern edge a significant depth of rubble could be seen. Indeed the natural appeared to shelve up sharply on the southern edge suggesting a possible cut feature. Excavation of two further slots was then undertaken to confirm the presence of the southern edge of this linear feature (1703). Underpinning excavations **B**, **C**, **F** and **G** situated along the adjacent length of the north wall located the northern edge of this feature and demonstrated that it ran beneath the northern wall, thus it predates the construction of the barn (**Figure 3, Plate 2 and section**). The demolition rubble (1702), consisting as it does of abundant tile which almost certainly derives from the degradation of the roof, appears to be a later deposit which has settled into the hollow in this area of the barn caused by the earlier feature below.

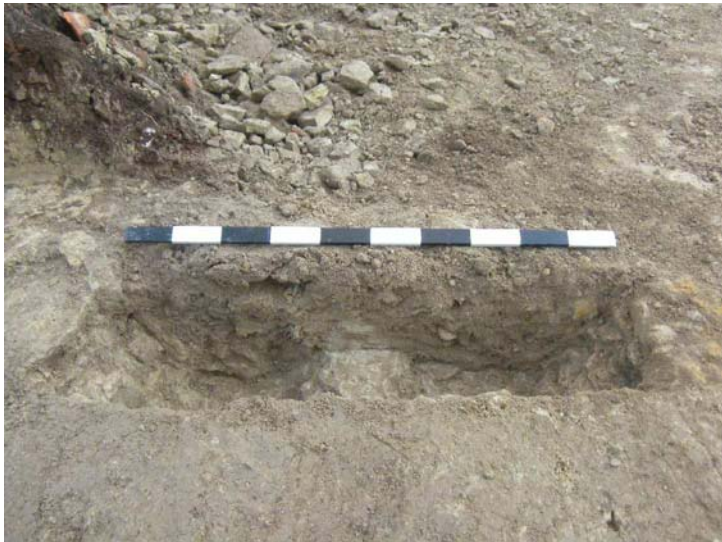
Plate 3: South-west facing section of ditches 1715 & 1717

- 3.2.7 Reduction in the eastern part of the barn revealed that linear 1703, was in fact two parallel overlapping features 1715 and 1717. A section was excavated across both features but a relationship between the two features could not be ascertained (**Figure 3, Plate 3**). Both, although slightly truncated, were relatively shallow, moderately sized north-east – south-west aligned gullies. 1717 terminated some 2m further east from the excavated slot while 1715 continued for nearly a further 4m before terminating. Investigation of termini showed that both features were very shallow by this point.

- 5.1.1 Two features were identified which pre-date the construction of the Main Barn. These were ditches **1715** and **1717**, also identified as **1703**. These north-east – south-west aligned features are likely the remnants of earlier field boundaries. Two sherds recovered from **1715** are thought to be medieval in date though a post-medieval fragment of roof tile was recovered from **1703**. This does suggest that the features and certainly their infilling may have not significantly pre-dated the construction of the barn.

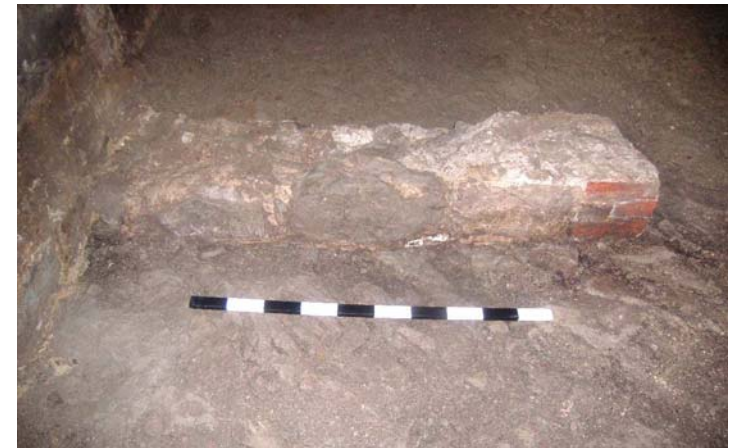
Plate 4: Wall 1804 viewed from south-east

- 3.2.14 In the northern part of the Stable Block the remnants of a north-east – south-west brick and stone built wall 1804 was located during the floor reduction (**Figure 3, Plate 4**). This lay beneath the western wall of the Stable Block and obviously pre-dates this structure. Its location suggests it was the original wall of the south aisle of the Main Barn removed when the Stable Block was inserted.

<i>Context number</i>	<i>Context type</i>	<i>Interpretation</i>	<i>Description</i>	<i>Depth (m)</i>
1804	<i>Wall</i>	<i>Wall</i>	Stone and brick built wall remnant. North-east – south-west aligned. 0.4m wide.	0.24m high
