1 and 2 Court Farm Cottages, Bere Regis, Dorset

Archaeological Watching Brief Report

Purbeck District Council Listed Building Consent 6/2011/0245
Scheduled Monument Consent (SM 28388) English Heritage Ref. S00017808

May 2012

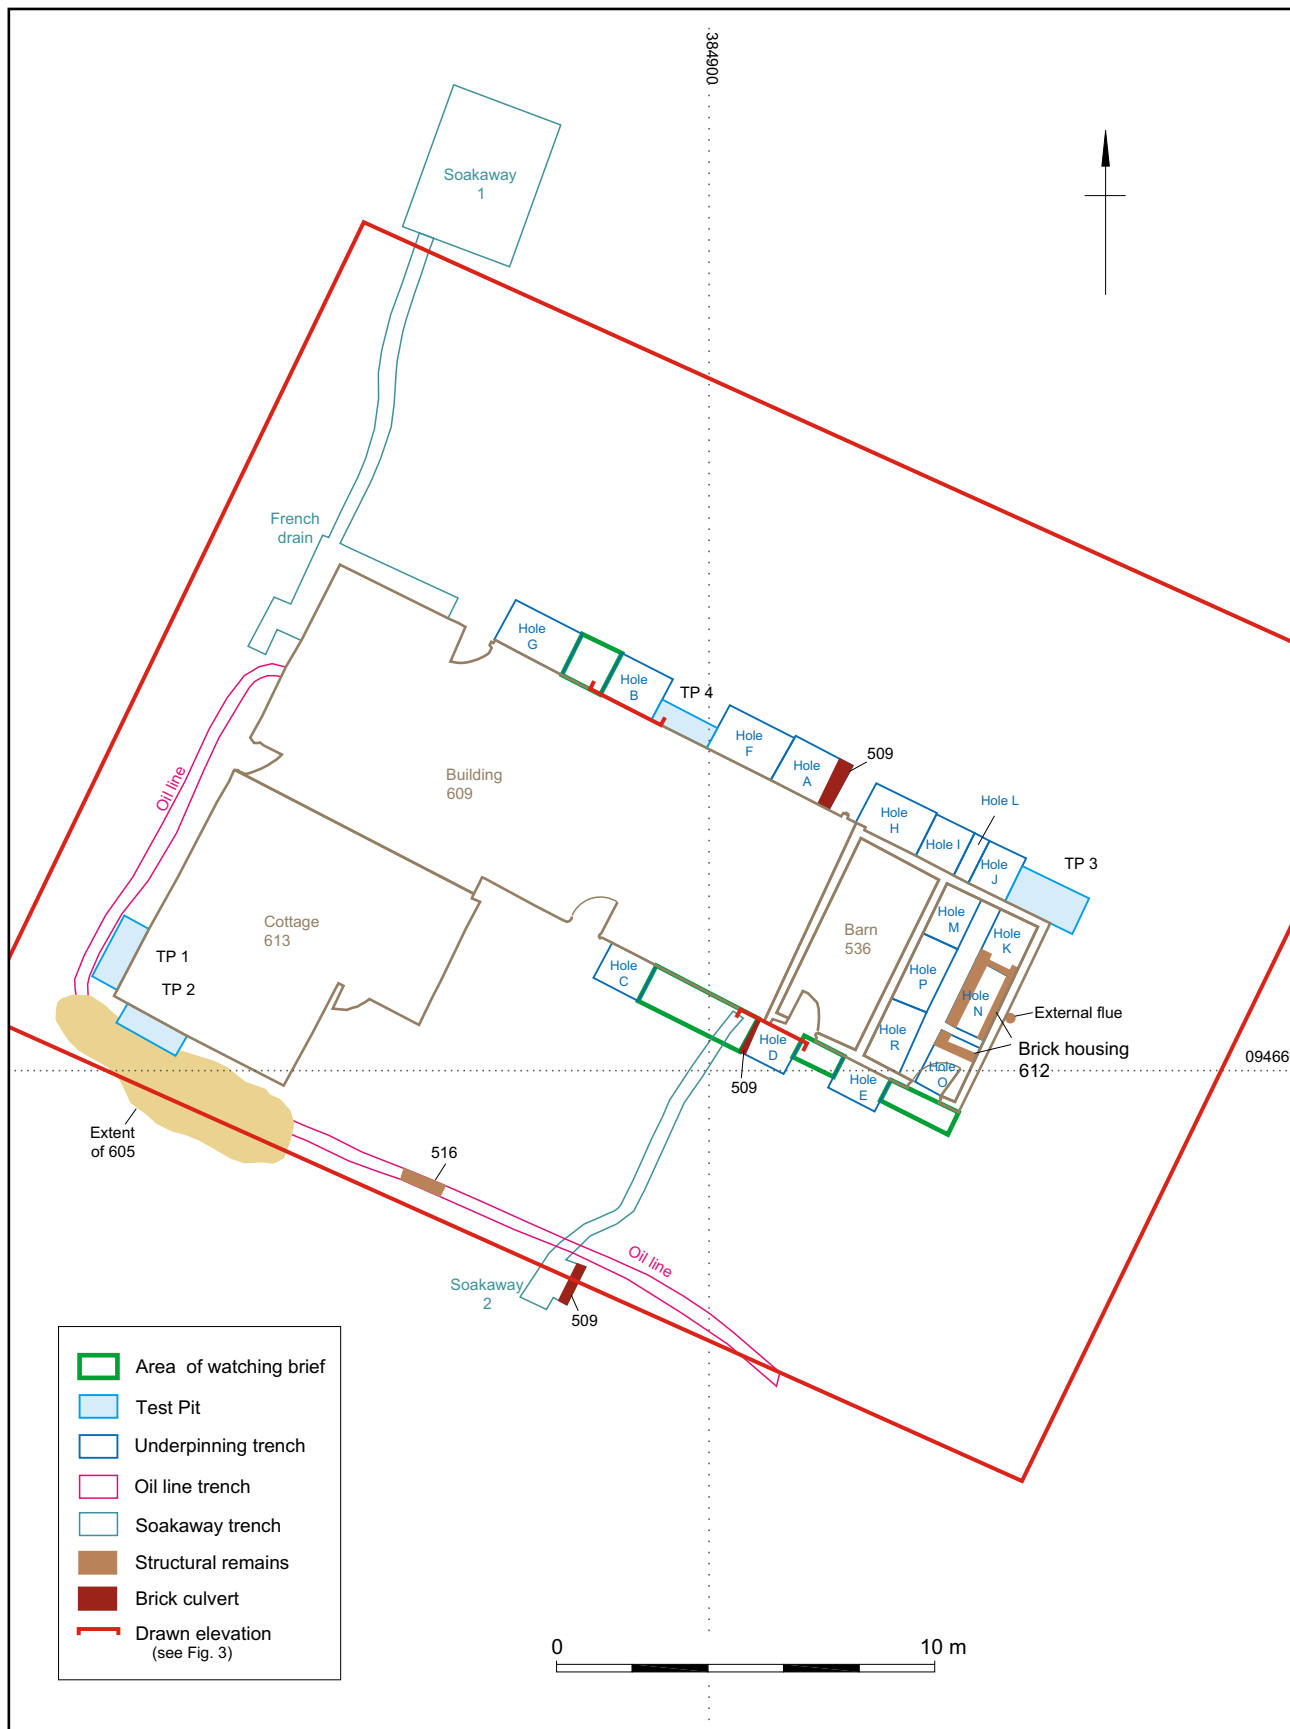
Figure 2

Detailed plan of watching brief areas

5.2.1 Natural geological deposits (**602**) were encountered in Test pit 3, underpinning Holes H, I, J, O, P and R, situated towards the eastern side of the Site (**Figure 2**), at a depth of approximately 1m below ground level and comprised orange clay and head gravels. In underpinning Holes D and E sited on the south-east side of the Site and Soakaway 1 in the north-western corner of the Site (**Figure 2**), natural deposits were reached between 1 and 1.3m below ground level and comprised chalk with clay outcropping.

- 5.2.3 At the south-western corner of the Gable end of Cottage **613**, Test pit 2 and the south-facing side of the Oil line Trench (**Figure 2**), a yellow grey sandy silt with lenses of charcoal debris and degraded roots (**604**) is thought to represent a levelling episode/prior to the building of a possible construction platform (**605**) (**Figure 2**).

- 5.2.6 A deliberate layer of re-deposited clay and gravel (**512**) (underpinning Holes B, F and G, **Figure 2**) included rare ceramic building material (CBM) and overlay the accumulated occupation debris deposit **606**. This formed a consolidation/formation surface for the construction of the later northern and eastern extension (Cottage **609**, **Figure 2**) to the original extant cottage (Cottage **613**). Foundation trench **608** cut through layer **512** and stones derived from demolished earlier, possibly medieval buildings, were used as the foundation courses for this later construction (**609**) (**Figure 3** and **Plates 2-4**).

- 5.2.12 An episode of alteration to the foundation courses of Cottage **609** was recorded in underpinning Hole B and comprised four courses of red brick **513** (**Figures 2 and 3**). The basal course was formed of a row of headers overlain by a mixture of headers and stretchers. No bonding style was used.

- 5.2.14 Underpinning Holes K, N and O (**Figure 2**) revealed the original brick housing **612** which is likely to have contained a stove connecting to the extant flue noted on the outer wall of the outbuilding. A 0.34m deep construction trench, **548** cut through made ground deposit **610**. Brick housing **612** was 0.83m wide and 2.8m long and was formed by walls **541**, **544**, **545**, **546**, each comprising a double brick width laid on clay hard-standing and bonded with a sandy mortar. The floor (**547**) of the structure (**612**) comprised unbonded brick. The housing was demolished prior to the laying of the present concrete floor (**537**, underpinning Hole K) which also overlay made ground deposit **538**.

- 5.2.15 The latest recorded features on the Site were a recently backfilled pond (**514**) and a north to south aligned drainage pipe **516** associated with the previous soakaway system noted in the oil line trench (**Figure 2**).

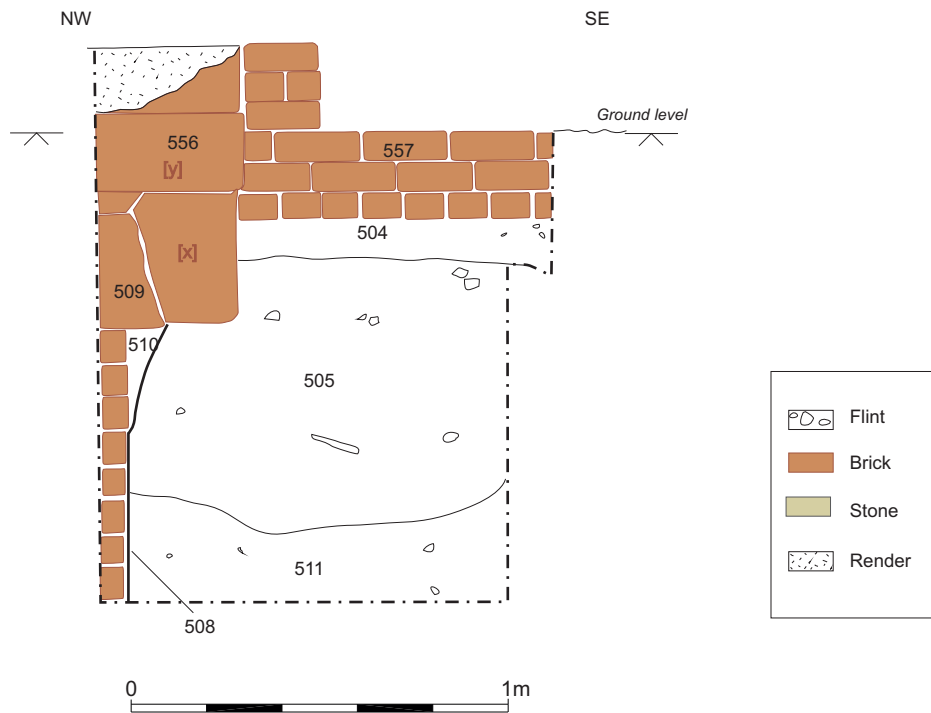
Underpinning Hole D

and Soakaway 2 (**Figures 2 and 3**). Some stone was seen used towards the base of the culvert walls and in underpinning Hole D the top of the culvert was partially exposed revealing large stone capping slabs. The construction trench for the culvert was recorded in Soakaway 2 as cutting through deposit **610**. A mixed backfill of occupation detritus **510** comprising a very dark grey sandy loam with CBM, glass and animal bone was found adhering to the external brick and stone culvert wall. Given the post-depositional waterlogging evident in the earlier deposit **606**, it is likely the culvert served as a substantial storm drain.

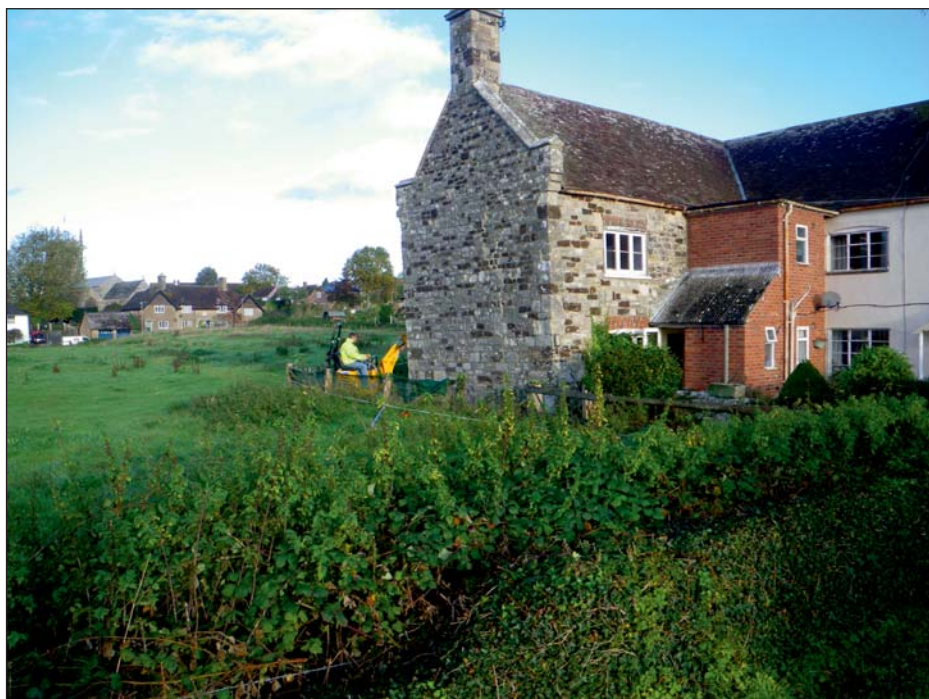
Plate 1: View of south-western gable end of Cottage **613** taken from the south-east

- 8.1.2 The bedding/formation platform formed by a compact sandy mortar deposit with flint inclusions (**605**) below the stone foundations of the south-western gable end of the western wing of the original house (Cottage **613**) was very different from other deposits seen elsewhere during the underpinning process. The absence of any obvious subsequent alteration to the foundations in the south-western end of this range may suggest that this portion of the building foundations are early and may be of medieval origin. However no artefactual or suitable ecofactual remains were present to conclusively confirm a medieval date.

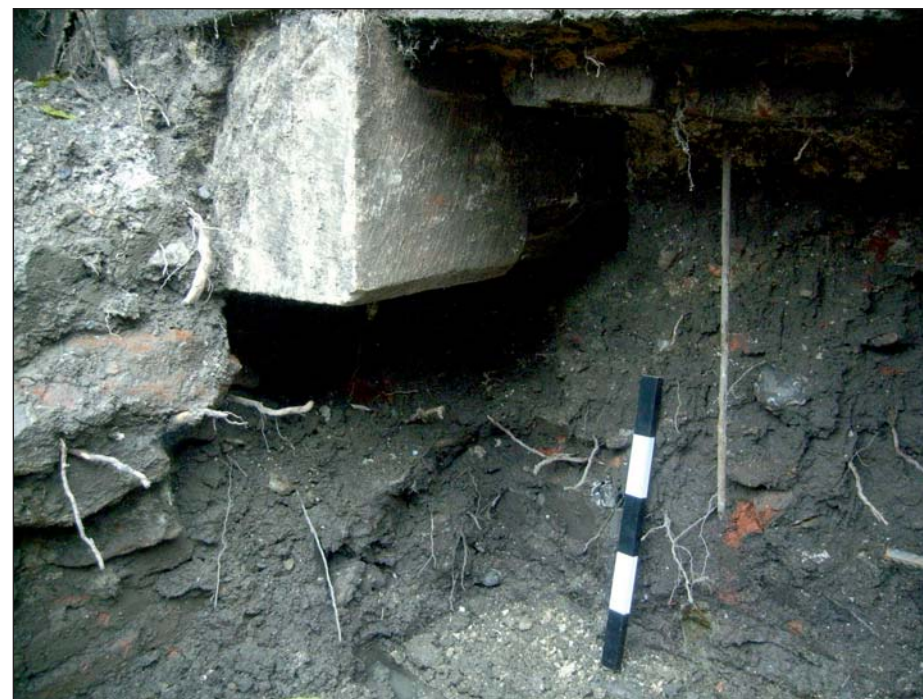
Plate 2: South-east facing view of reused masonry as cornerstone of Cottage **609** in underpinning Hole D

- 8.1.3 The remainder of the archaeological structural remains and deposits recorded during the watching brief were of undoubted post-medieval or modern origin. The south-eastern cornerstone of the rear extension to the original farmhouse (Cottage **609**), with its chamfered edge and *fleur-de-lys* motif derived from the lower section of a fire surround dating to the 15th/16th century, is the most striking example of the re-use of worked stone blocks from demolished structures as foundation material during the building of this extension. One of the sources for these building stones is almost certainly the demolition of the adjacent manorial estate buildings.

511/606	Made ground	Mid-grey green silty clay with CBM fragments	1.1-1.3m
556/609	Structure	Stone foundations for NW-SE later cottage extension. Stone x and y forming corner of structure look to be re-used from demolished medieval buildings	
557/536	Structure	Brick built outbuilding butting SE end of cottage 556	
Foundation shows large corner stone footing of cottage and the header brick foundation course of later adjoining outbuilding (butting). The outbuilding appears to have no below ground foundations but is constructed directly on thin chalk formation layer. The underside of the corner stone of the cottage appears to be a reused piece from the lower section of a fire surround broadly dating to the 15 th -16 th centuries.

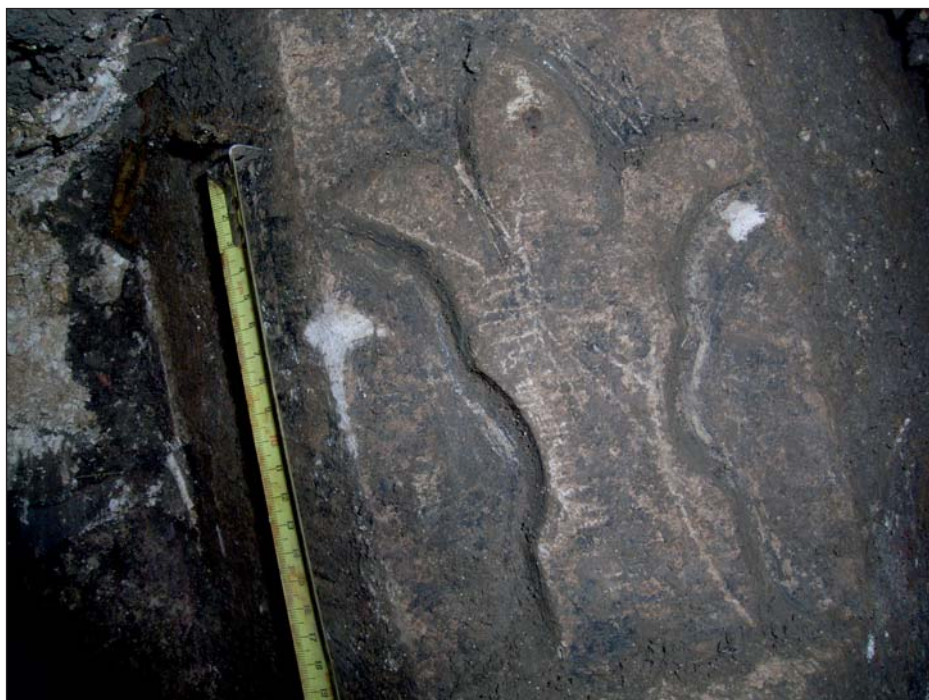
Plate 3: Close up view of *fleur-de-lys* motif on underside of reused masonry in underpinning Hole D

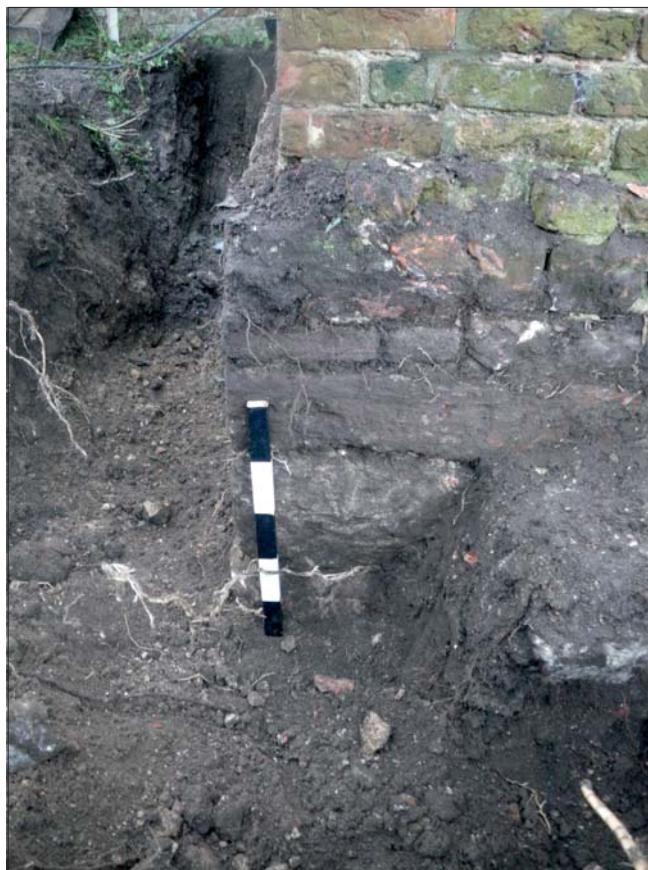
Plate 4: North-west facing elevation of stone foundations at north-western corner of Cottage **609** in the French Drain

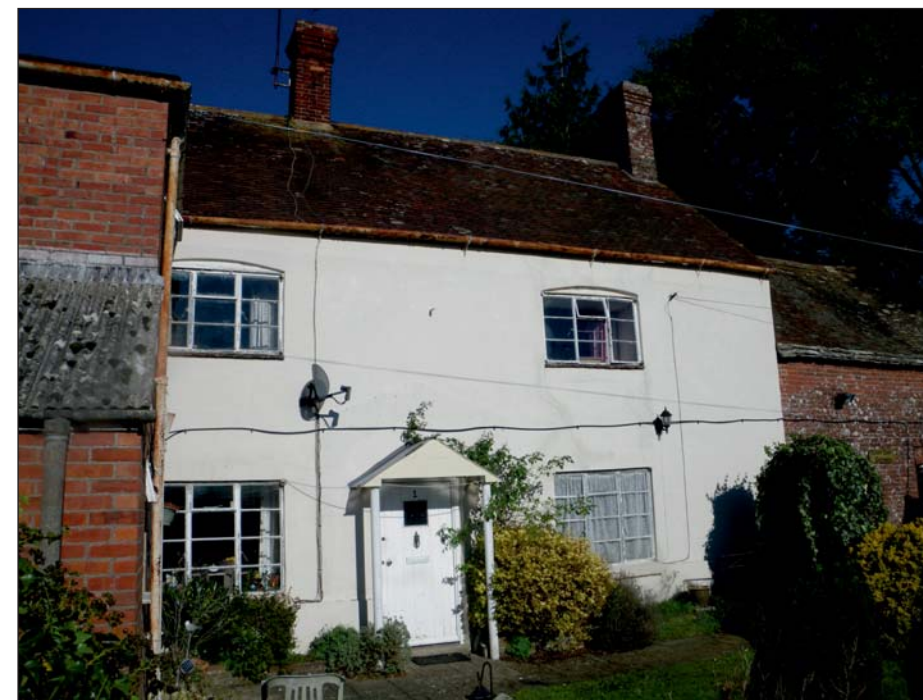
Plate 5: South-west facing view of Cottage **609** and adjacent outbuilding **536**

- 5.2.11 An episode of repair or consolidation to Cottage **613** may also be contemporary with the construction of the Outbuilding **536**. Landscaping of the grounds during this time is suggested by the laying of an associated brick path over a chalk formation layer **607** (noted in underpinning Holes D, E the oil line trench and the French drain) (**Figure 2**). This formation deposit (**607**) overlay made-ground (**610**). The brick built outbuilding (**536**) (**Figure 2** and **Plate 5**) appears to have no below ground foundations but was partially built directly on the chalk formation layer which is also the base for the path which appears to have led from the outbuilding to the side door on the north-western edge of Cottage **609**.
