## Chippenham Golf Course Chippenham, Wiltshire

Archaeological Watching Brief Report

Report reference: 65591.03  
Path: x:\projects\65591\report\65591\_chippenham golf course\_report v1.doc

**May 2012**

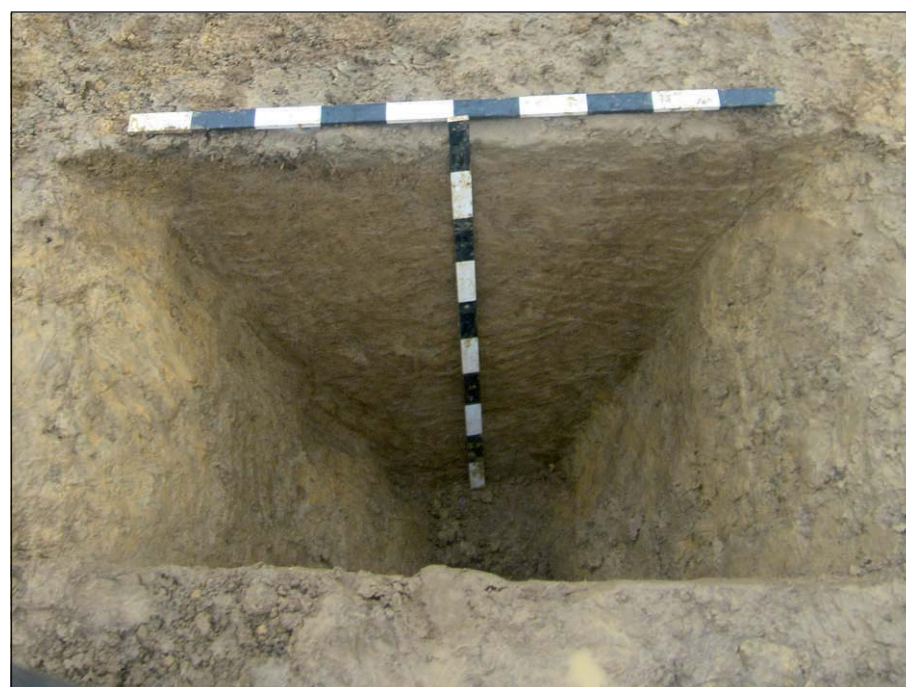
Plate 1: North-west facing section through ditch 2119

3.3.1 A substantial north-west – south-east aligned ditch **2119** was located in the north-western part of the Site (**Figure 3, section and Plate 1**). It was 1.2m wide and had a very steep sided profile. Due to H&S considerations and the difficulty of excavating at depth within a confined space excavation ceased at 1.1m. Given the steep angles of the ditch it is unlikely that the base would have been at any deeper than 1.2m. There were two main deposits within the ditch, separated by a thin lens of re-deposited natural **2121**. The lowest fill was a very hard, compact manganese rich deposit suggestive of slow moving water. The uppermost deposit **2122** was a silty, homogeneous fill suggestive of gradual silting.

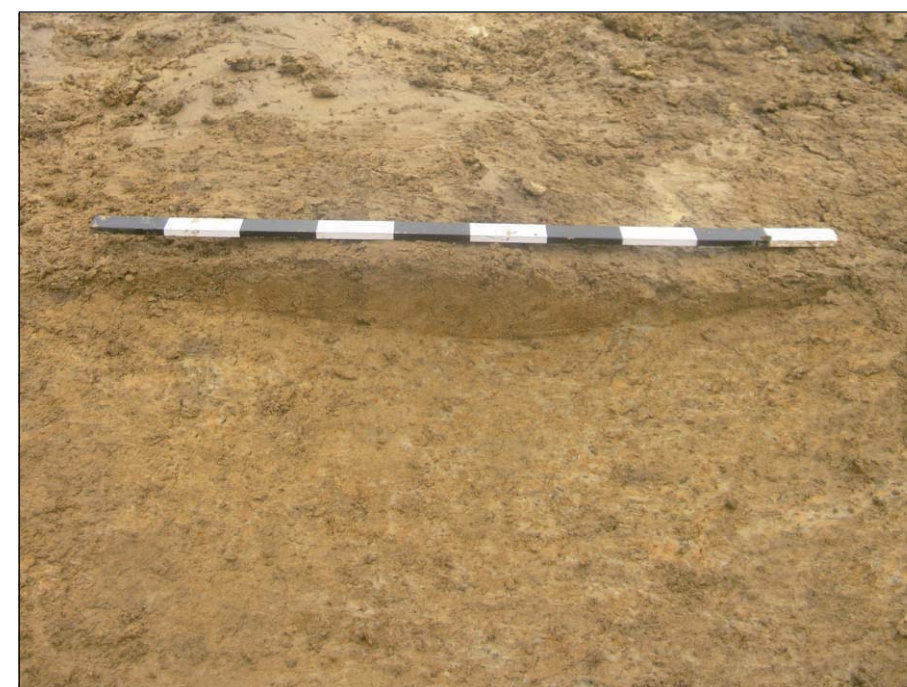
Plate 2: North facing section through ditch 2109

3.3.2 At the south-eastern extent of ditch **2119** it intersected with a roughly north - south aligned linear **2109** (**Figure 3, Plate 2**). The ditch was a shallow, fairly ephemeral feature with a single, secondary fill, **2110**. It was unclear whether this was of manmade origin or a natural runoff channel. Due to the nature of this feature it was not possible to establish a relationship between this and ditch **2119**. Both features contained sterile, homogenous deposits containing no dating material.

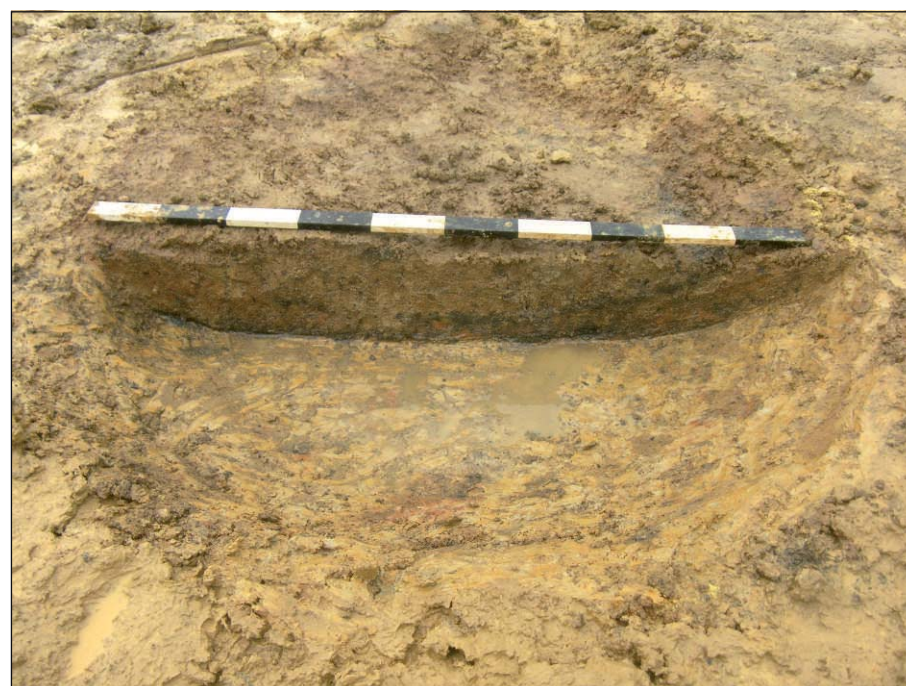
Plate 3: South-west facing section through pit 2114

- 3.3.5 The final pit **2114**, situated in the north-western part of the Site was circular in plan but was otherwise similar to **2104**. It also contained some deliberate deposits of heat affected material and degraded charcoal (**2116**, **2117** and **2130**) along with some more mixed more silty deposits which are also likely to have been deliberately deposited (**2115** and **2118**) (**Figure 3, section and Plate 3**). No dateable material was recovered from this feature.

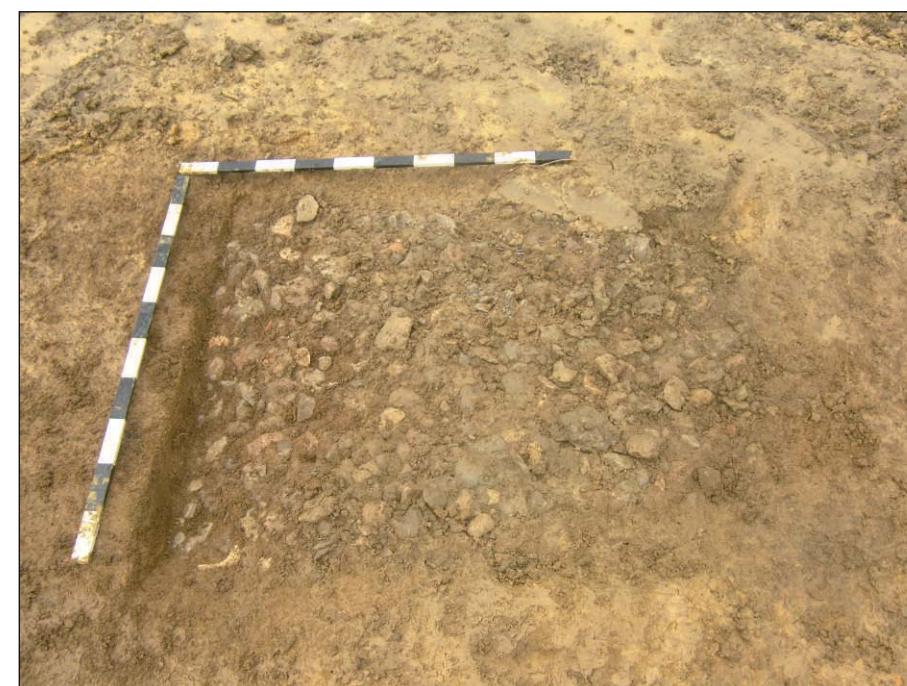
Plate 4: Cobbling 2128, view from north-west

- 3.3.6 The final feature identified was a possible surface **2128** constructed of stones, this was situated within the top of a tree throw hole **2126** (**Figure 3, Plate 4**). Only half the possible surface was excavated but it appeared to be oval in plan, slightly concave in profile and composed of tightly packed fairly small stones. Some of these had slight traces of burning. It is thought that the stones may have been laid to consolidate a soft area of ground and potentially to form a base for a fire, though not all the stones showed signs of being heated. A layer of silt **2129**, overlay the possible surface **2128**.
