450–458 REIGATE ROAD, EPSOM DOWNS, SURREY

Archaeological Evaluation Report

Report reference: 85570

June 2012

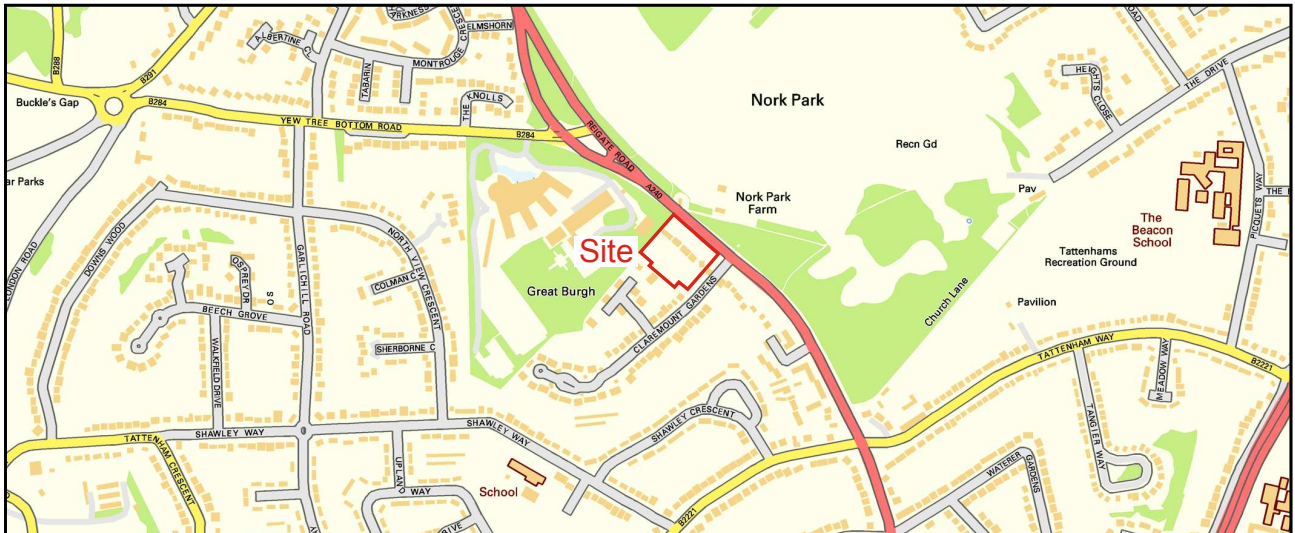
Figure 1

Site and trench location plan

- 3.3.3 Nine trenches were originally stated in the WSI (WA 2012a), however due to constraints of the Site all the trenches had to be relocated (**Figure 1**). A number of trenches had to be shortened, others were extended and a tenth trench was added. All trenches were opened, investigated, recorded and backfilled during the 3 day programme of works.

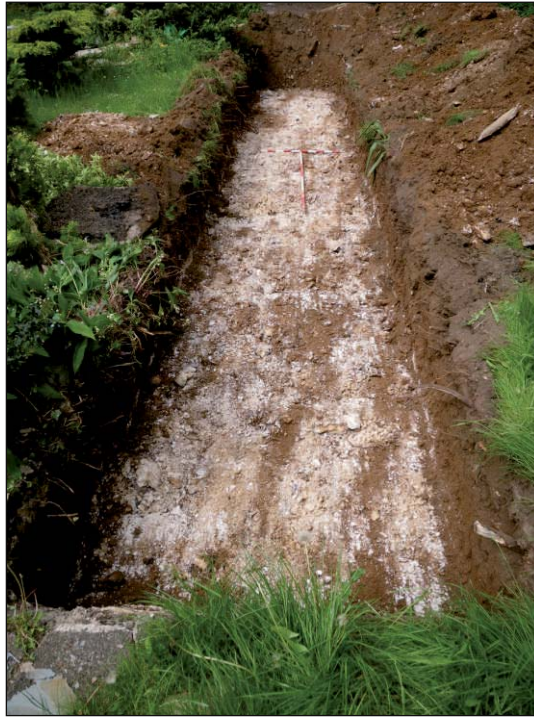
- 4.4.2 Located in the front garden of property no. 450, Trench 1 (11.6m in length) had a maximum depth of 0.85m below current ground level with natural chalk recorded at 0.65m. Topsoil (**101**) and tarmac (**104**) of the driveway overlay 0.4m of colluvium (**102**); this represented the greatest depth of colluvium recorded and corresponded with the lowest part of the Site. Plough scaring cut into the natural chalk (**103**) was evident at the southern end of the trench with a NNE-SSW orientation (**Plate 1**).

Plate 1: Trench 1 (view from the south)

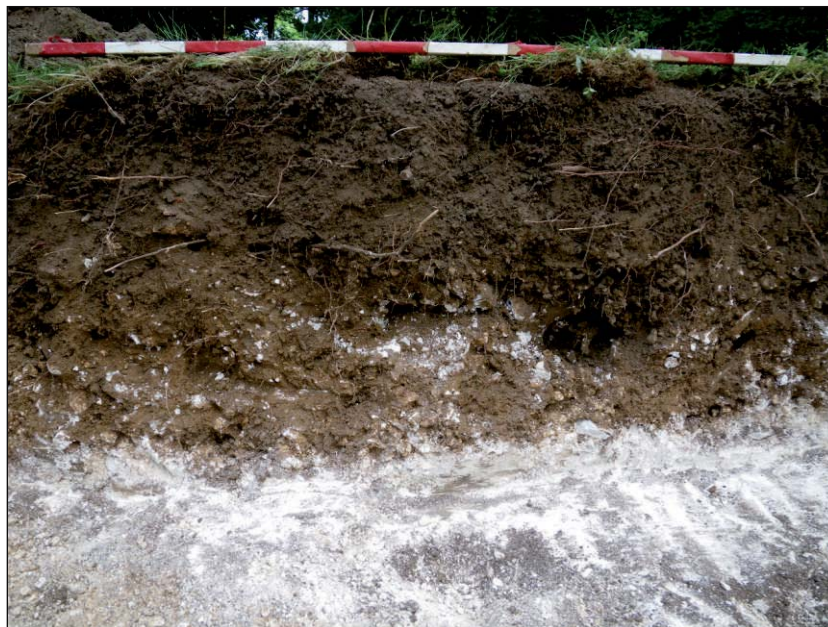
- 4.4.3 Trenches 2, 3, 5, 7 and 9 each had a similar stratigraphy comprising 0.22m of topsoil (**201**, **301**, **501**, **701**, **901**) above approximately 0.2m of colluvium (**202**, **302**, **502**, **702**, **902**), overlying the natural chalk (**205**, **303**, **503**, **703**, **903**) (**Plate 2**).

Plate 2: North-west facing section of Trench 9

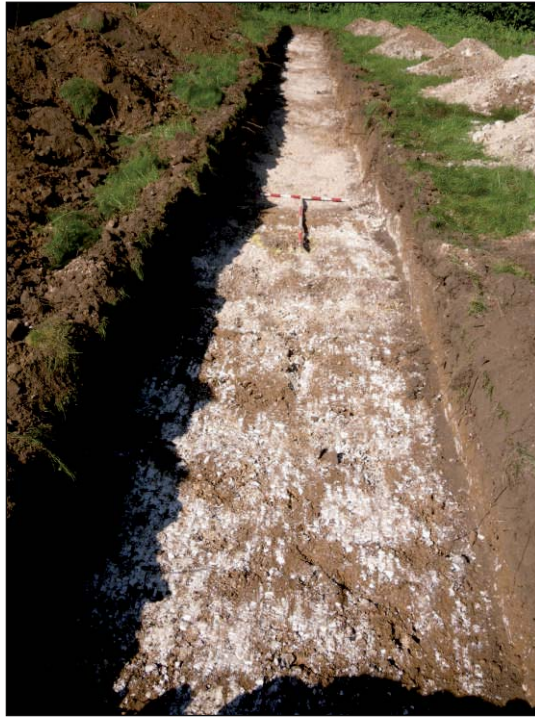
- 4.4.4 Trenches 2 and 3 in the rear garden of property no.450 measured 27.6m and 28.7m respectively (**Plates 3** and **4**). Trench 5 to the rear of property no.452 measured 11.8m (**Plate 5**); Trench 7 to the rear of property no.456 measured 28.75m (**Plate 6**) and Trench 9 in the rear garden of property no.458 measured 22m (**Plate 7**).

- 4.4.5 In Trench 2 a single sub-circular modern feature **204** was recorded towards the north-east end of the trench and was filled by **203** consisting of sandy silt deposit with large flint fragments and Ceramic Building Material (CBM) rubble. This was not excavated as it was clearly cut from within the topsoil, suggesting it was a recent feature associated with the use of the rear garden.

Plate 3: Trench 2 (view from the north-east)

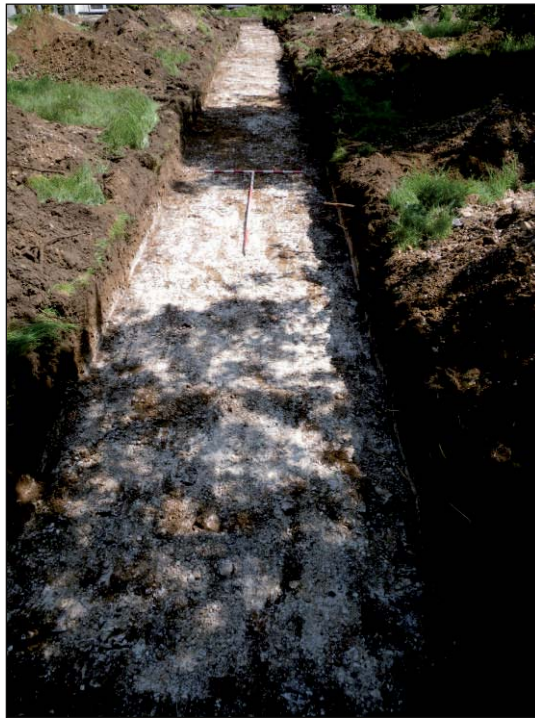
Plate 4: Trench 3 (view from the south-west)

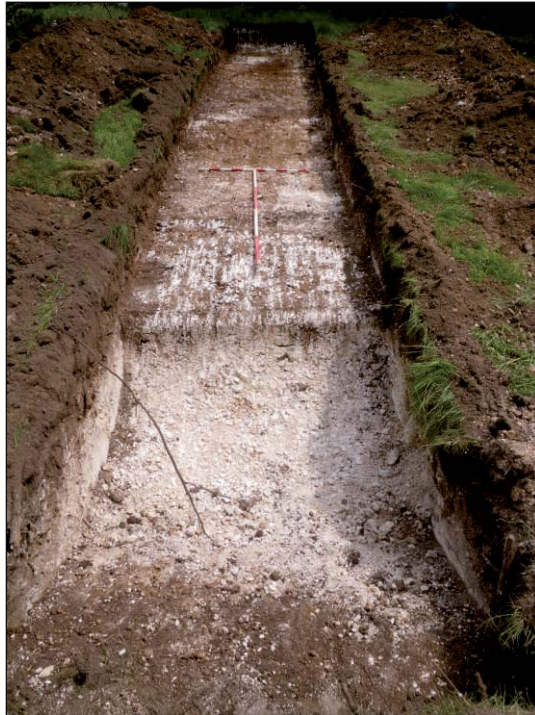
Plate 5: Trench 5 (view from the west)

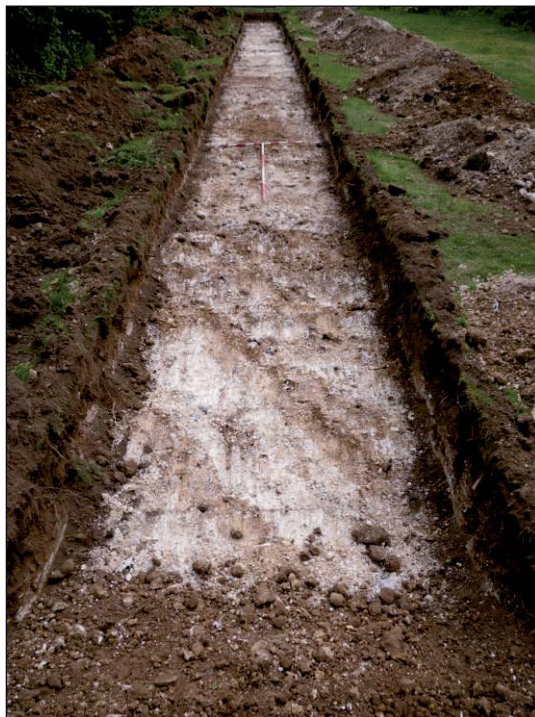
Plate 6: Trench 7 (view from the north-east)

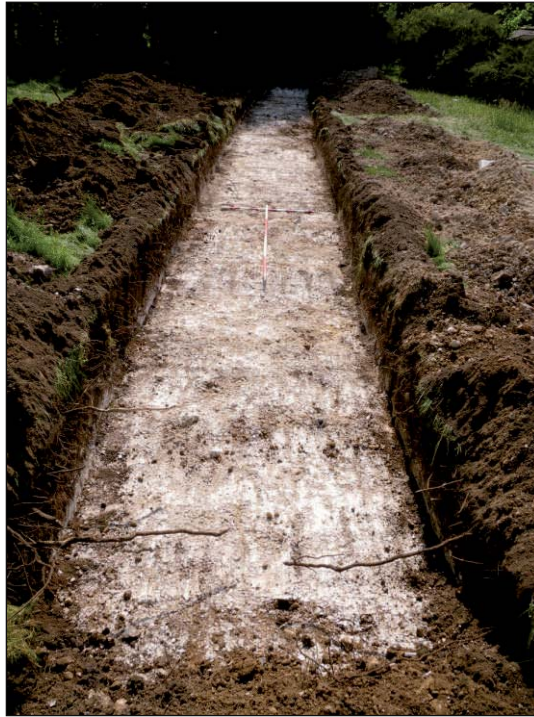
Plate 7: Trench 9 (view from the north-east)

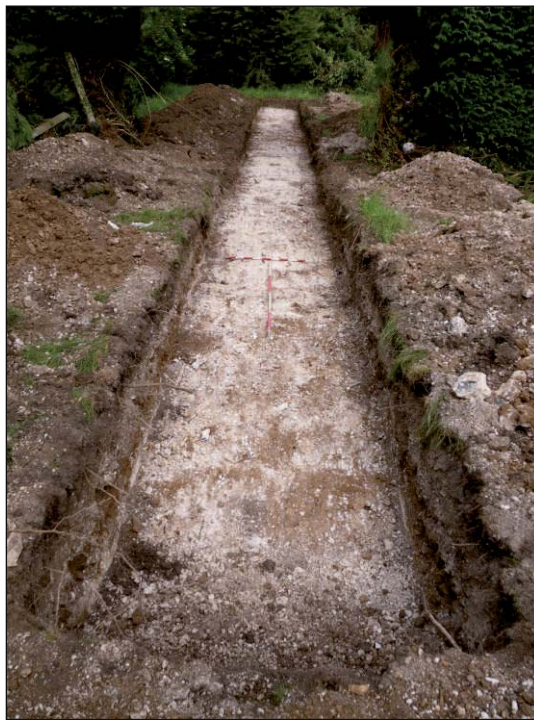
- 4.4.6 Trench 4 (measuring 24.5m) straddled the boundary between properties no.452 and 454 (**Plate 8**). Within the garden of property no.452 at the north-west end of Trench 4 the topsoil (**401**) overlay directly onto the chalk (**404**) with no evidence of colluvial material suggesting some truncation of the top of the natural associated with terracing of the garden (**Plate 9**). However at the south-east end of Trench 4 within the garden of property no.454 a layer of made ground consisting (**402**) of re-deposited chalk with grey brown silt was above the colluvium (**403**) (**Plate 10**). No buried topsoil was visible indicating the original topsoil had been removed and replaced above the made ground. The change in depth of Trench 4 from the north-west to the south-east was 0.45m–0.74m below ground level. In the centre of the trench tree rooting was prominent from the conifers and fruit trees which formed the boundary between the two properties.

Plate 8: Trench 4 (view from the south-east)

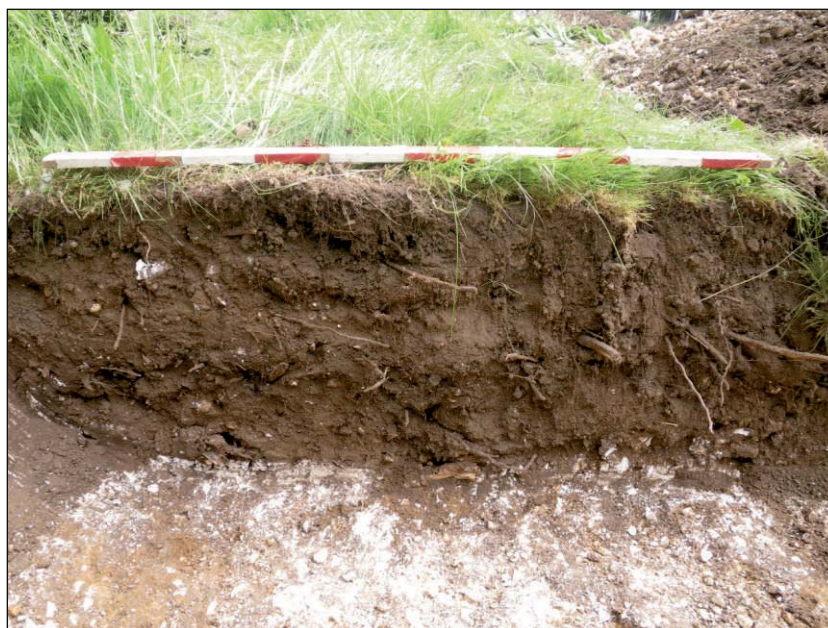
Plate 9: South-west facing section from the north-west end of Trench 4

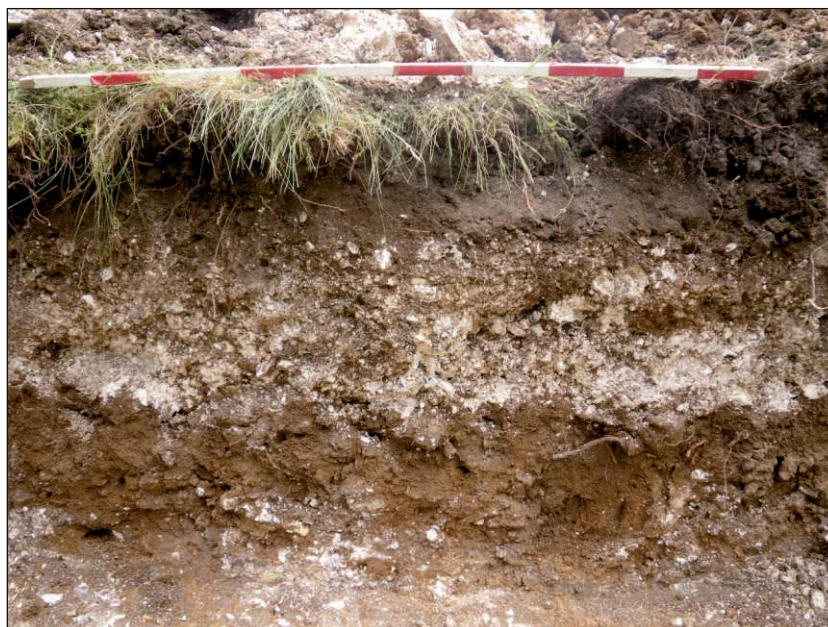
Plate 10: South-west facing section from the south-east end of Trench 4

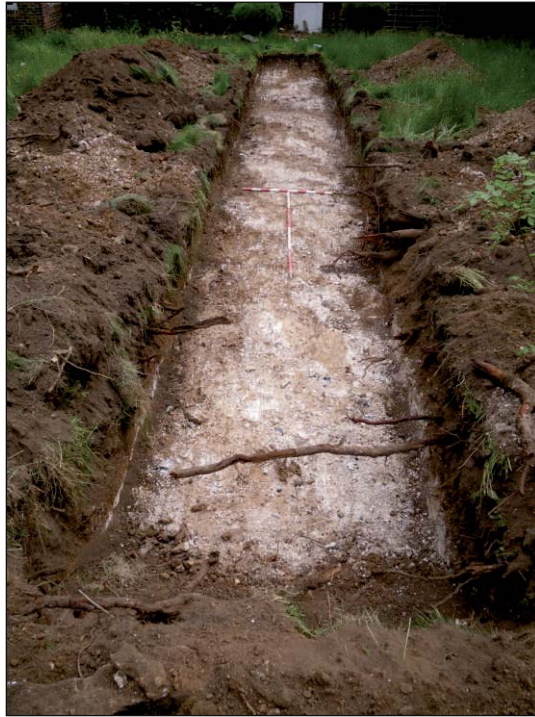
- 4.4.7 Also within the garden of no.454 Trenches 6 and 10 showed evidence of the ground level having been made up in order to create a level terrace area. Trench 6, located on the lower terrace nearest the house measured 14.5m (**Plate 11**). At the north-east end of the trench a similar depth of stratigraphy was seen as in Trenches 2, 3, 5, 7 and 9. Towards the south-west, a gradual

Plate 11: Trench 6 (view from the north-east)

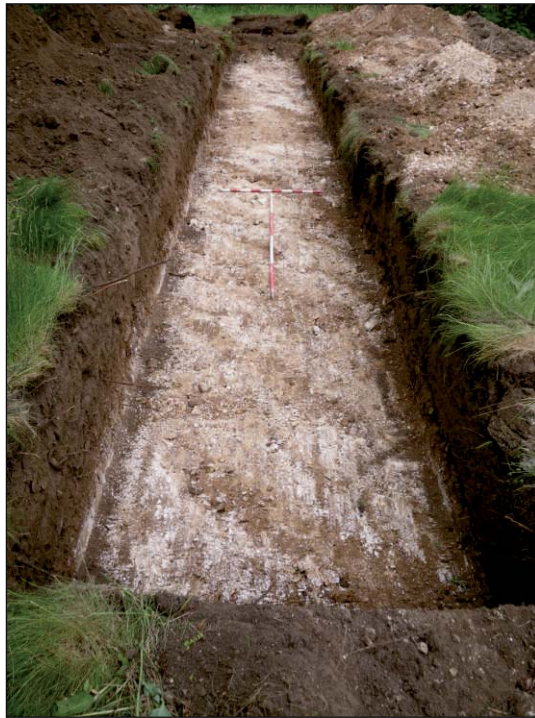
Plate 12: Trench 10 (view from the north-east)

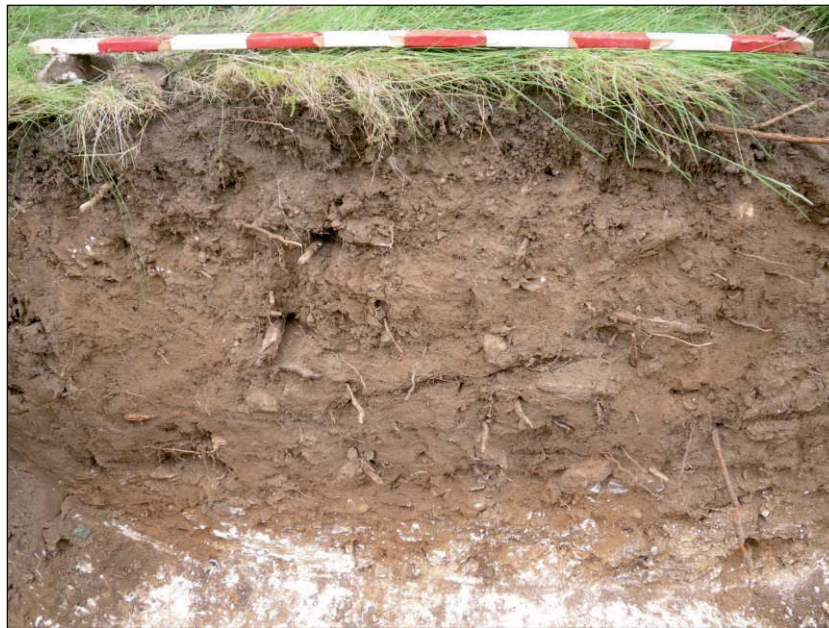
increase in the depth of topsoil was seen as the ground level sloped up. However this was greatly obscured by the extensive rooting of an old tree stump to the south-east of the trench. Plough scarring and natural geological depressions in the chalk filled with orange brown clay silt could be seen. Trench 10 measuring 13.8m was located on the upper terrace of the garden to the south-east of Trench 4 (**Plate 12**). Here the made ground consisted of imported topsoil (**1002**) above the colluvium (**1003**), to a depth of 0.65m below ground level (**Plate 13**). Cut into the chalk (**1004**) more plough scarring was evident on a NNE-SSW alignment.

Plate 13: North-west facing section of Trench 10

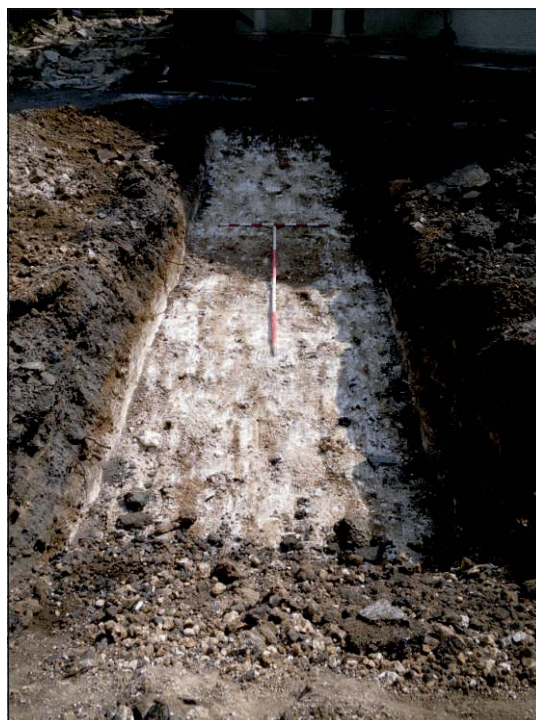
- 4.4.8 Trench 8, located within the front driveway of property no.456, measured 7.6m (**Plate 14**). Here a different stratigraphy was recorded. Two layers of tarmac (**801** and **803**) and hard standing made of brick rubble and concrete lumps (**802** and **804**) indicated a driveway surface which was later built up and resurfaced. These overlaid the same colluvial material (**805**) overlying the chalk (**806**) as seen in the other trenches (**Plate 15**). This would suggest that little impact was caused during the construction of the house and driveway.
- 4.4.9 No archaeological features or finds were encountered during the course of the evaluation.

Plate 14: Trench 8 (view from the north)

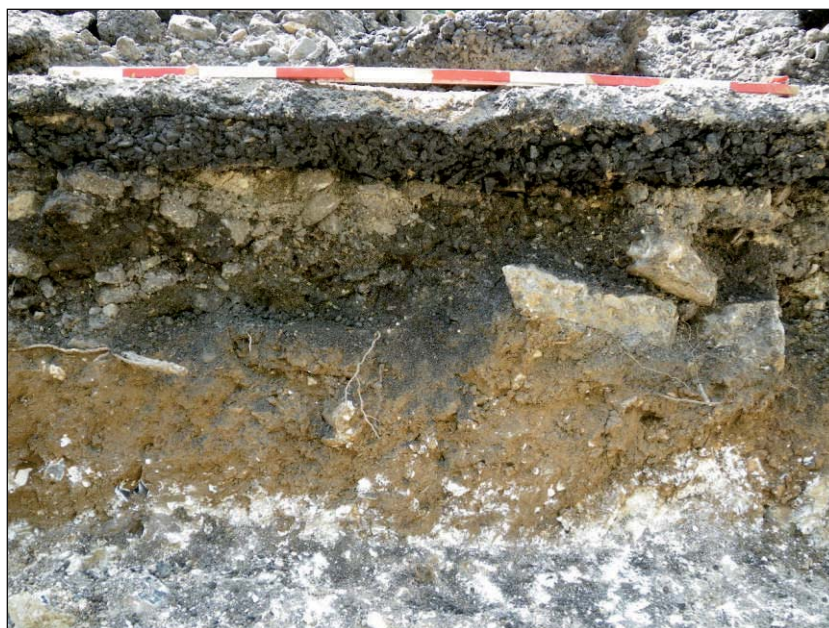
Plate 15: East facing section of Trench 8
